# ***Arborist Report***

**Client: Aveo Pty Ltd**

**Address: Vale Street, Shortland N.S.W  
2308**

Date: 1 November 2017

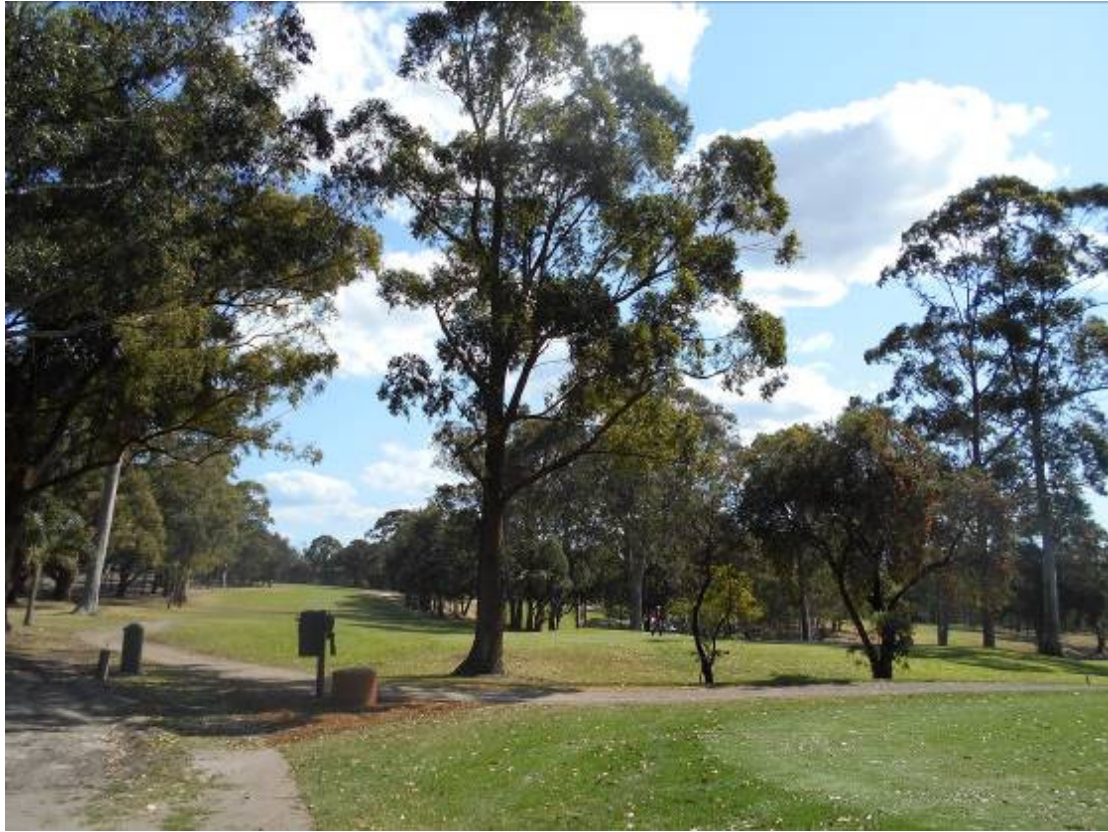
Figure 3 – showing the location of the fairway that will require removal of all trees either side to accommodate the proposed buildings and associated hardstand areas.

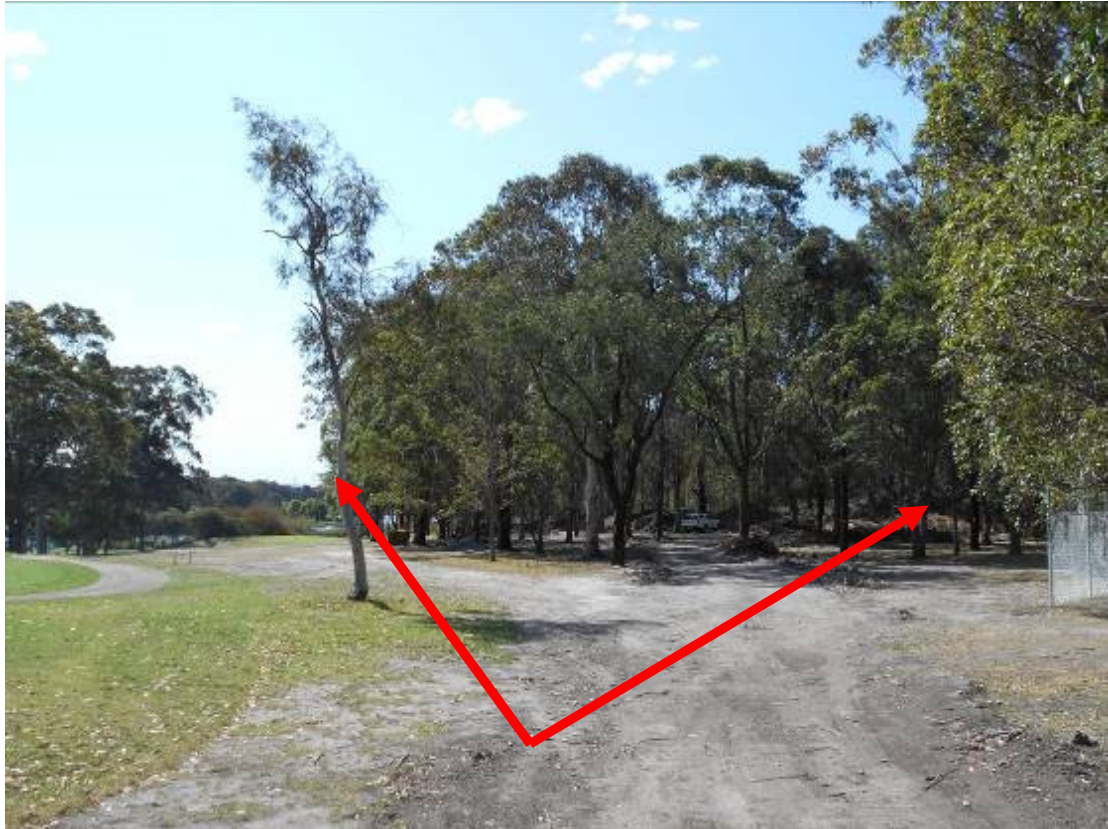
Figure 4 – showing the location of the proposed development as it extends to the western quadrant.

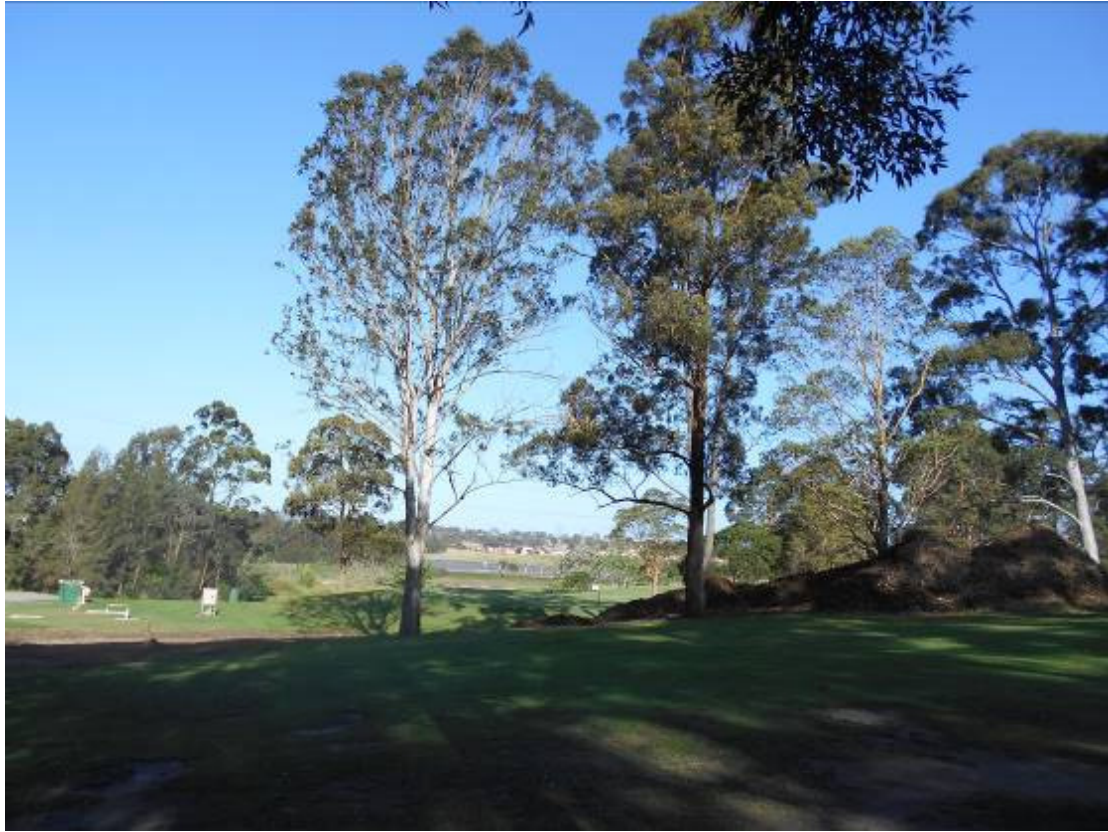
Figure 5 – showing the bottom of the fairway and the start of the row of trees that will require removal in order to construct the proposed development.

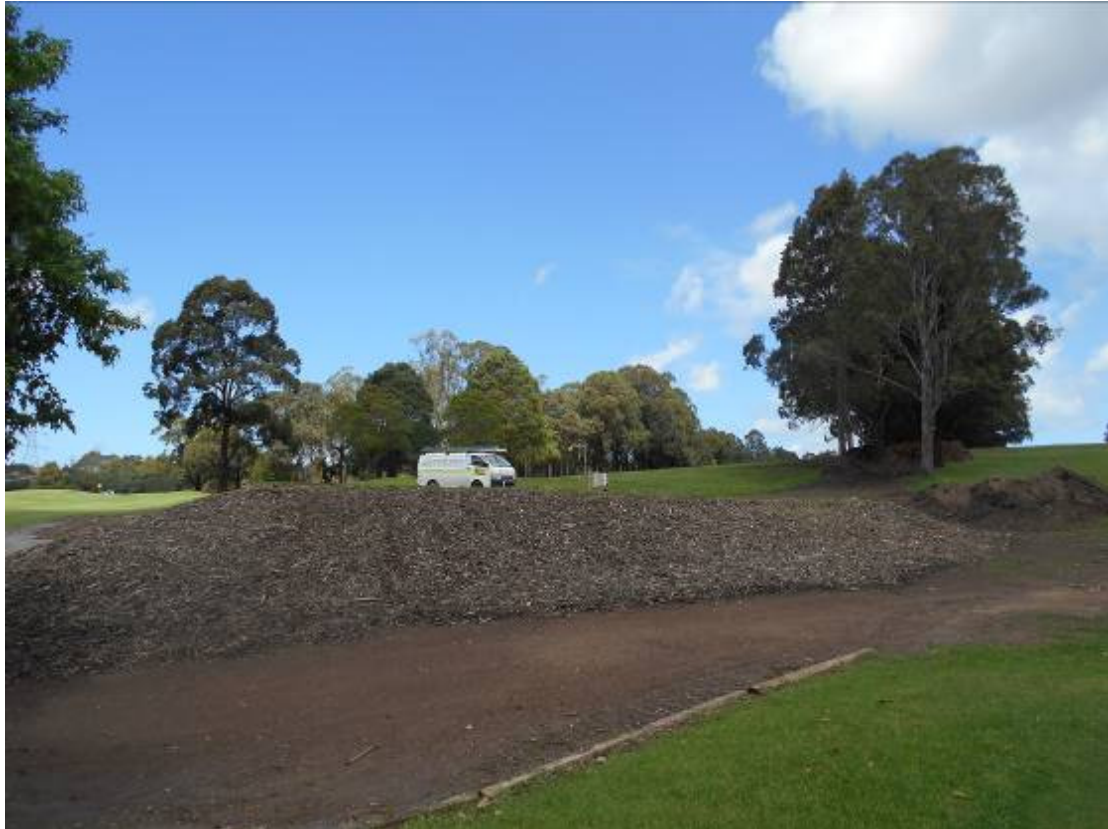
Figure 6 – looking south east towards the two fairways. These two fairways will require removal of majority of the species to accommodate the proposed development and hardstand areas.

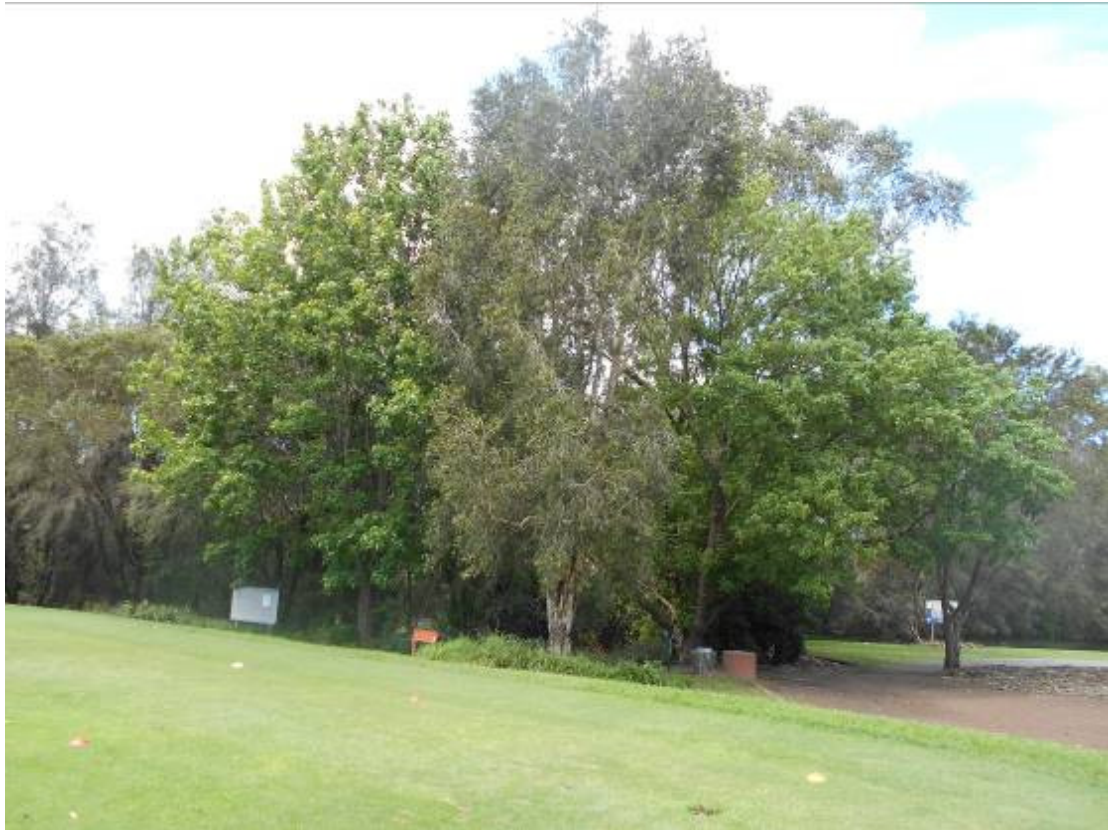
Figure 7 – showing the location of Trees 8039 – 8040. Majority of these trees can be retained except for Trees 8044 & 8043 that will be located on the edge of the proposed internal road.

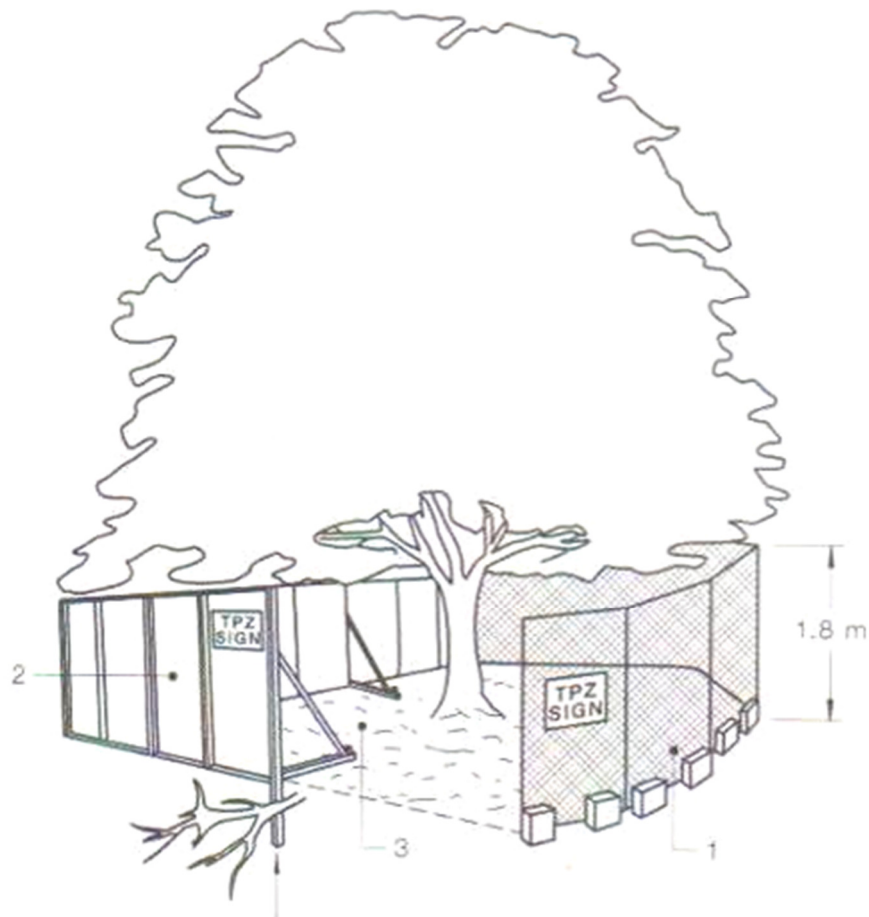
- Figure 8 – showing the proposed fencing that is to be put in place before the commencement of building works on site (Trees 7224, 7223, 7222, 7221, 7219, 7218, 7217, 7216, 7215, 7214, 7212, 7213, 7226, 7104, 7107, 7108, 7118, 7119, 7123, 7126, 7129, 7130, 7134, 7135, 7139, 7140, 7142, 7144, 8207, 8206, 8205, 8179, 8176, 8174, 8102, 8101, 8100, 8171, 8171a, 8170, 8167, 8166, 8162, 8161, 8163, 8168, 8169, 8157, 8156, 8155, 8154, 8153, 8152, 8149, 8020, 8042, 8041, 8040, 7055, 7056, 7045, 7048 (62 in total) only).

- Protection fencing for retained trees will require governance to Australian Standards 4970 – 2009. Retained trees will require 1.8 metre interlocking chain wire fencing installed prior to commencement of all building/civil works on site including all tree removal associated with the development. This will minimise damage to the trees and avoid machinery damage.
