# SCHEDULE OF CONSERVATION WORKS

**Proposed works at  
29A Greenacre Road  
South Hurstville**

Job No. 2978  
December 2017

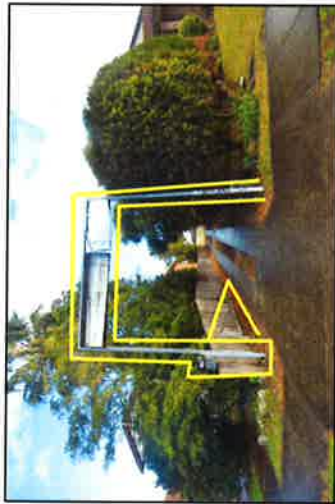
| Description / Image(s) | | Condition | | Significance | Conservation Action/Treatment | | |
|---|---|---|--|---|---|---|---|
| <p>Main entry of former South Hurstville Bowling Club.</p> | Very Good | <p>The main entry of the former South Hurstville Bowling Club has been neglected and is in very poor condition. The same can be said in relation to the associated mailbox and entry gate. However, it is currently in a deteriorated condition and potentially hazardous from a health and safety standard.</p> | | | Exceptional | <p>The fabric is visible from street view and contains moderate significance serving as the main entry to the premises.</p> | <p>The use of the main entry should be retained as a pedestrian entry should the main entry to the site be relocated. The existing entry, gate and mailbox is to be disposed and replaced with something more suitable to the future use of the site. Design and materials are to be approved by a suitably qualified heritage consultant.</p> |

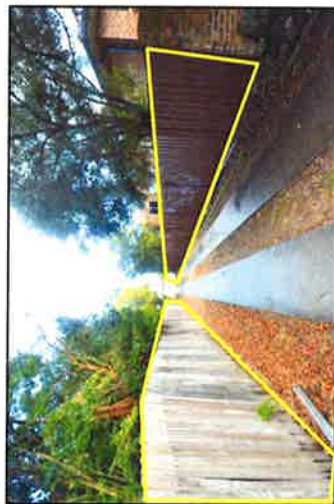
| Description / Image(s) | | Condition | | Significance | Conservation Action/Treatment | | |
|---|---|---|--|---|---|---|---|
| <p>Driveway off Greenacre Road.</p> | Very Good | <p>The Greenacre Road entry that once functioned as the driveway of the main entry of the former South Hurstville Bowling Club remains legible. However, it is noted that vandalism has occurred to the boundary fences along the adjacent properties.</p> | | | Exceptional | <p>This driveway contains moderate significance as it would have been the main entry to the site. The eastern and southern (primary) façade of the former club house also faces towards this entry.</p> | <p>The use of this passage should be retained for vehicle or pedestrian access. Makegood works to the boundary fencing is to be carried out in order to remove the vandalism to the boundary fences.</p> |

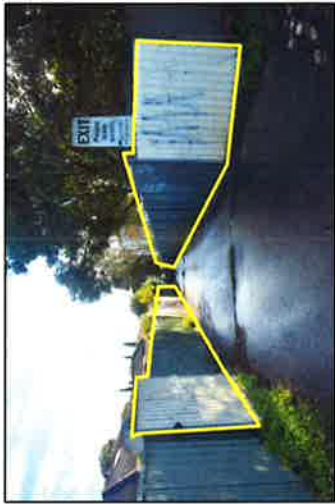
| Description / Image(s) | Condition | | Significance | Conservation Action/Treatment |
|---|---|---|---|---|
| Rickard Road Exit<br> | Very Good | Good | Exceptional | This driveway contains little significance as it would have been the exit from the site. The northern façade (rear of the building) of the former club house also faces towards this entry.<br><br>The use of this passage should be retained for vehicles or pedestrian access. Makegood works to the boundary fencing is to be carried out in order to remove the vandalism to the boundary fences. |

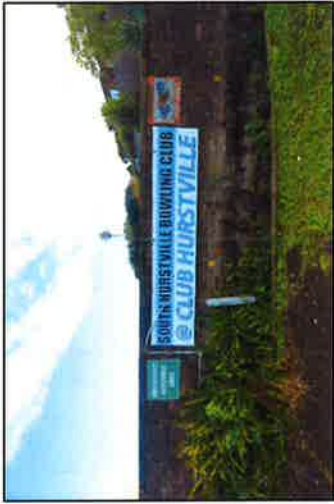
| Description / Image(s) | Condition | | Significance | Conservation Action/Treatment |
|---|---|---|---|---|
| Existing signage.<br> | Very Good | Good | Exceptional | The associated signage is of little significance. It served the purpose of identifying the place but does not offer an insight to the operations of the former bowling club. It is not considered to be rare.<br><br>Existing signage to be photographed for future research material. Following this, the signage is to be permanently removed and appropriately disposed of. Make good to brick masonry as required. |

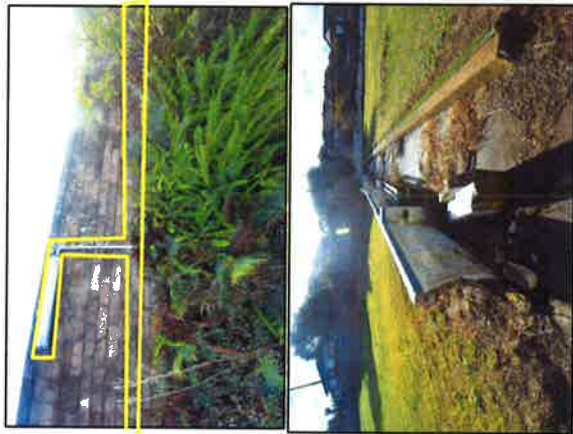
| Description / Image(s) | | Condition | | Significance | | Conservation Action/Treatment | |
|---|--|---|---|---|---|---|--|
| <p>Bowling lawn brick boundary wall with conduits and lighting fixtures affixed.</p> | | Very Good | <p>The low brick boundary wall surrounding and separating the bowling lawns from public access is in very poor condition. The associated conduits and lighting fixtures for external lighting have not been maintained. It is unknown if the external lighting is in working condition.</p> | Exceptional | <p>As these elements once contributed to the operations of the previous South Hurstville Bowling Club, it is considered to be of little significance rather than intrusive. The low boundary walls demarcated the site and marked the bowling lawns.</p> | <p><b>Remove and Dispose</b></p> <p>Safely remove and dispose of conduits. The citing of the low boundary brick walls is to be documented for future research material. Following the documentation, the boundary walls is to be disposed of.</p> | |

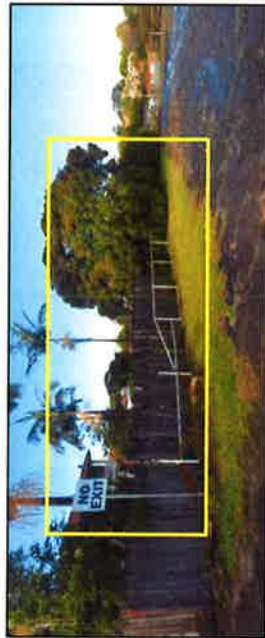
| Description / Image(s) | | Condition | | Significance | | Conservation Action/Treatment | |
|---|--|---|---|---|---|---|--|
| <p>Free standing Signage and balustrading.</p> | | Very Good | <p>Associated signage and balustrading can be found along the boundaries of the car park area. These items are in fair condition and have been left in their current state following the relocation of the South Hurstville Bowling Club.</p> | Exceptional | <p>The associated signage and balustrading do not possess attributes of heritage significance and is considered to be intrusive.</p> | <p><b>Remove and Dispose</b></p> <p>Signage and balustrading to be removed and disposed. Should future use of the site require such structures, these may be relocated elsewhere in the site.</p> | |

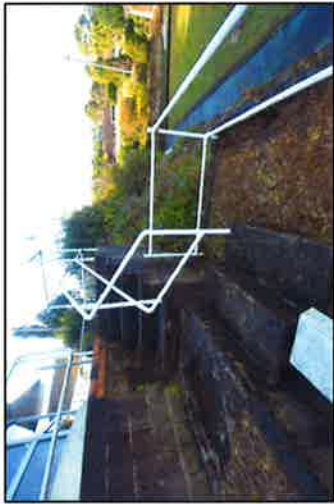
| 3.1.5 External Staircases | | | | |
|---|---|---|---|---|
| External staircase leading to the former club house.<br> | Very Good | As the site is sloping and bowling lawns required a flat surface, external staircases and balustrading were constructed to allow easy navigation across sections of the club. These items have been designed to be subservient to the former club house and are currently in good condition. | Exceptional | Remove and Replace<br><br>External staircases to be removed and replaced. The external staircases are to be relocated where suitable in the layout of the site, provided that it is subservient to the former club house. Make good to any remaining fabric which is found to be damaged as a result of the installation and / or removal of the staircase. |

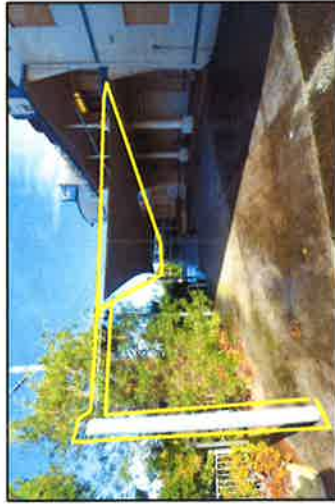
| 3.1.5 External Staircases | | | | |
|---|---|---|---|---|
| Outdoor shade with associated metal pole structures.<br> | Very Good | The outdoor shade structure installed during use of the site as the South Hurstville Bowling Club is in fair condition. | Exceptional | Remove and Dispose<br><br>Outdoor shade with associated metal pole structure is to be permanently removed and disposed. In future, no structures should be installed or constructed within such close proximity to the primary façade of the building that may impact views to the former club house. Following removal of this structure, a photograph is to be taken which captures the primary façade unobstructed in its current state. Make good to cement where found to be damaged from the installation / removal of the metal pole. |

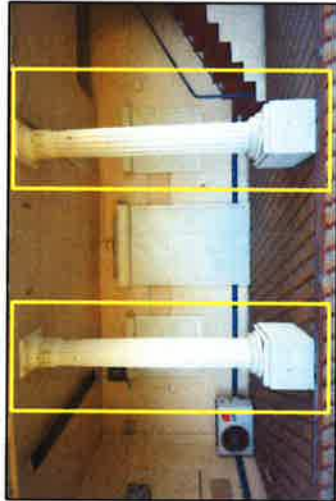
| Description / Image(s) | | Condition | | Significance | | Conservation Action/Treatment | |
|---|--|---|---|---|---|---|---|
| <p>Two existing columns flanking the main entry of the former club house.</p> | | Very Good | <p>The two existing Corinthian columns flanking the main entry to the former club house is in fair condition. Signs of wear and tear are obvious upon inspection of these elements.</p> | Exceptional | <p>The existing Corinthian columns do not conform to the overall character of the building nor are sympathetic to the period. As such, the columns are considered to be intrusive.</p> | <p><b>Replace and Conserve</b></p> <p>The existing columns are to be replaced with columns designed in a style that is sympathetic to the period. Following the replacement, the new columns are to be conserved and routinely maintained in the future. A suitably qualified heritage consultant is to approve details of the proposed design prior to their replacement.</p> | |

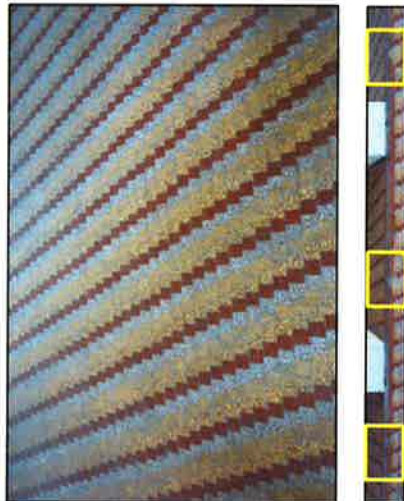
| Description / Image(s) | | Condition | | Significance | | Conservation Action/Treatment | |
|---|--|---|---|---|---|---|---|
| <p>Tiling across the main entry at ground level.</p> | | Very Good | <p>The tiling situated across the main entry of the primary façade is in good condition. It is noted, however, that the nosing tiles to the step are damaged in some parts (see bottom image). No other areas within the former club house have similar tiling to the main entry.</p> | Exceptional | <p>This element is of high significance as it appears to be the original tiling of the former club house. No other areas within the building displays similar features.</p> | <p><b>Retain and Conserve</b></p> <p>The tiling is to be retained and conserved. Patch repair damaged nosing tiles using tile of identical colour and profile. Routine maintenance is to be carried out.</p> | |

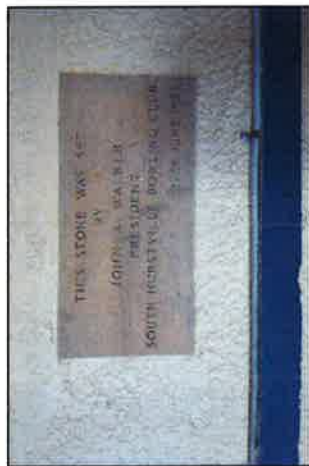
| Description / Image(s) | Condition | Significance | Conservation Action/Treatment |
|---|---|---|---|
| Commemorative plaque affixed to the western wall.<br> | Very Good | Exceptional | <b>Retain and Conserve</b><br><br>This item is to be retained and conserved. Routine maintenance is to be carried out to ensure that this item is conserved over time. |

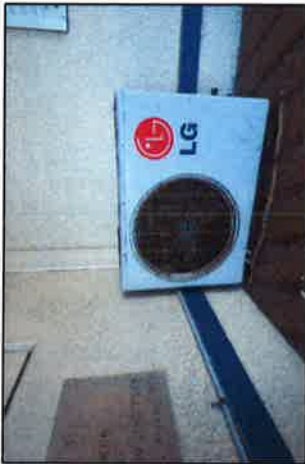
| Description / Image(s) | Condition | | | | | Significance | Conservation Action/Treatment | |
|---|---|---|--|--|--|---|---|--|
| <p>Exhaust fan against the main entry of the building.</p> | Very Good | The exhaust fan against the main entry of the building is in fair condition. This item has been left in its current state following the relocation of the South Hurstville Bowling Club. | | | | Exceptional | <p><b>Remove and Dispose</b></p> <p>This item is to be permanently removed and disposed of. Make good to tiling where found to be damaged as a result of the installation and / or removal of the unit. In future, there are to be no services installed at the main entry that would detract from the significance of the building. The discreet installation of such services may be permissible provided that advice from a suitably qualified heritage consultant is sought.</p> | |

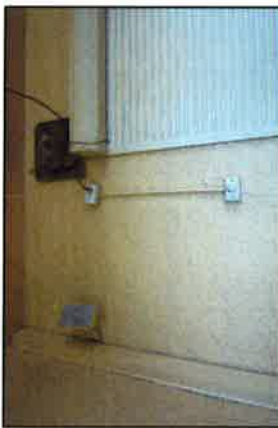
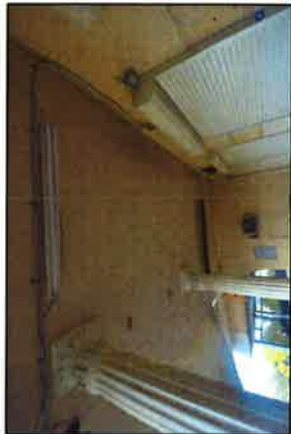
| Description / Image(s) | Condition | | | | | Significance | Conservation Action/Treatment | |
|---|---|---|--|--|--|---|---|--|
| <p>Conduits and lighting fixtures.</p> | Very Good | Associated conduits, services and external lighting fixtures affixed along the main entry of the building is in fair condition. These items have been left in their current state following the relocation of the premises. | | | | Exceptional | <p><b>Remove and Dispose</b></p> <p>These items are to be permanently removed and disposed of. Make good to wall where found to be damaged as a result of the installation / removal of the elements. In future, there are to be no services installed at the main entry that would detract from the significance of the building. The discreet installation of such services may be permissible provided that advice from a suitably qualified heritage consultant is sought.</p> | |

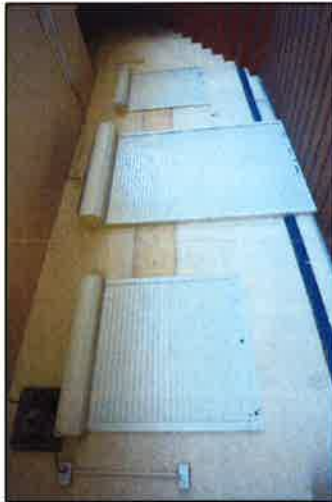
| Description / Image(s) | Condition | Significance | Conservation Action/Treatment | |
|---|---|---|---|---|
| Roller doors to the fenestration.<br> | Very Good | Exceptional | These items are to be permanently removed and disposed of. Make good to walls where found to be damaged as a result of the installation / removal of the doors. In future, all fenestration to the building is to be left exposed. Roller doors are not to be installed to any areas of the building. | |

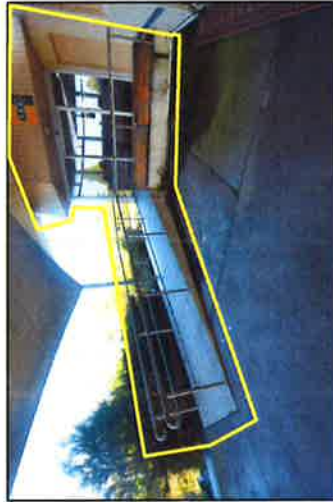
| Description / Image(s) | Condition | Significance | Conservation Action/Treatment | |
|---|---|---|---|---|
| Addition to the primary façade and disability access ramp.<br> | Very Good | Exceptional | These items are to be permanently removed and disposed of. Make good to cement where found to be damaged as a result of the installation and / or removal of the addition and ramp. In future, no additions or structures are to be constructed within such close proximity of the primary façade of the heritage building. | |

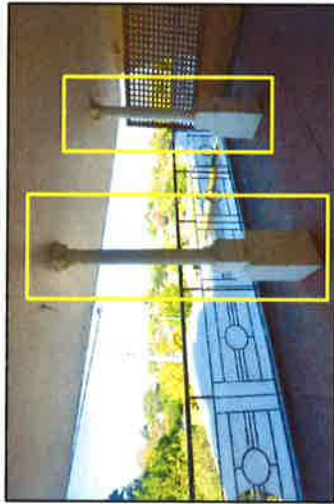
| 3.2.2 Veranda at First Level | | | | | | |
|---|--|---|---|---|---|---|
| <p>Two existing columns at first level</p> | | Very Good | <p>The two existing Corinthian columns of the veranda at first level of the primary façade are in good condition. There are signs of wear and tear upon inspection of these elements. These are in the same sitting as the columns at ground level but are at a smaller scale in comparison.</p> | Exceptional | <p>The existing Corinthian columns do not conform to the overall character of the building nor are sympathetic to the period. As such, the columns are considered to be intrusive.</p> | <p>Replace and Conserve</p> <p>The existing columns are to be replaced with a style that is sympathetic to the period. Following the replacement, the new columns are to be conserved and routinely maintained in future. A suitably qualified heritage consultant is to approve details of the proposed design prior to the replacement.</p> |

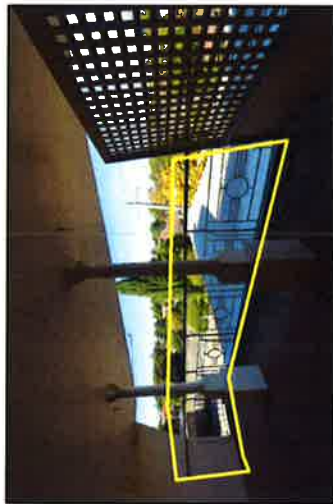
| 3.2.2 Veranda at First Level | | | | | | |
|---|--|---|---|---|---|---|
| <p>Curvilinear metal balustrading</p> | | Very Good | <p>The curvilinear metal balustrading of the veranda at first level of the primary façade is in fair condition. There are signs of wear and tear upon inspection of these elements.</p> | Exceptional | <p>The balustrading is reflective of the curvilinear form of the heritage building and is considered to be of high significance.</p> | <p>Retain and Conserve</p> <p>This item is to be retained and conserved. Advice must be sought from a suitably qualified heritage consultant or trades person should any works be undertaken concerning this element.</p> |

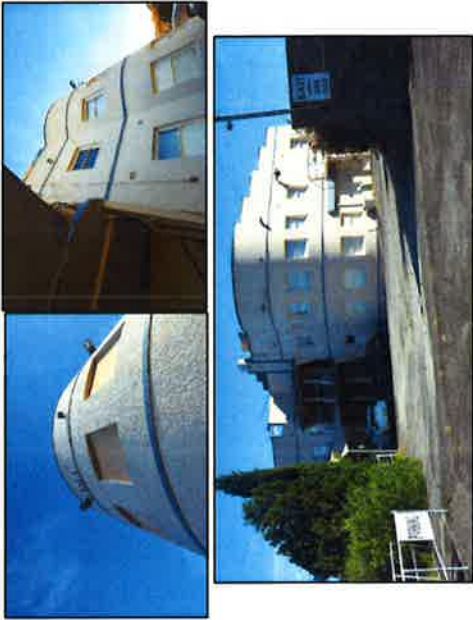
| Description / Image(s) | Condition | | Significance | Conservation Action/Treatment | |
|---|---|---|---|---|---|
| Photos of First floor pod, views of the east, west and south facades.<br> | | | | | |

| Description / Image(s) | Condition | | Significance | Conservation Action/Treatment | |
|---|---|---|---|---|---|
| All timber framed windows are to be retained and conserved. Make good works should be carried out to all windows during works for the adaptive reuse of the site by a suitably qualified heritage carpenter. Advice from a heritage architect or consultant must be sought in relation to the specifications. All works and repairs must comply with the National Timber Framing Code (AS 1684). | | | | | |

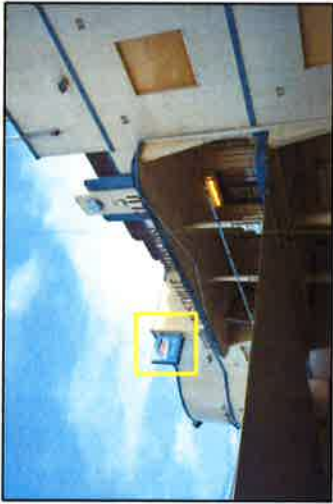
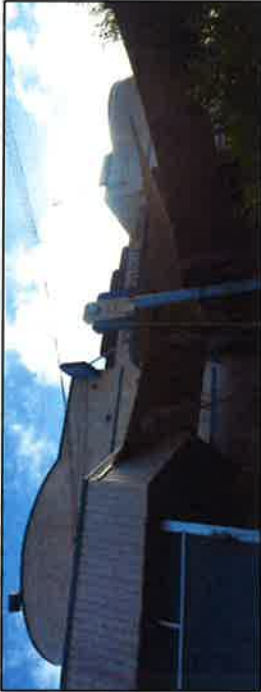
| 3.2.3 Parapet | | | | |
|---|--|---|---|---|
| Parapet inclusive of the clock, flagpole, and signage. | | Very Good | The parapet is in fair condition. Elements of the parapet include the bulk of the parapet and the clock. Associated elements include the sign affixed to the nearby section and the previous signage of the South Hurstville Bowling Club. The clock is currently inoperable. The original flagpole is missing. | Exceptional |

| 3.2.3 Parapet | | | | |
|---|--|---|---|---|
| | | | Retain and Conserve | Intrusive elements to be permanently removed. Clock is to be repaired and conserved. Flagpole is to be reinstated. Make good works to the overall form of the parapet as required upon inspection by a suitably qualified heritage trades person. The signage of the former South Hurstville Bowling Club is to be documented for future research material. It is not required to retain and conserve the signage. |

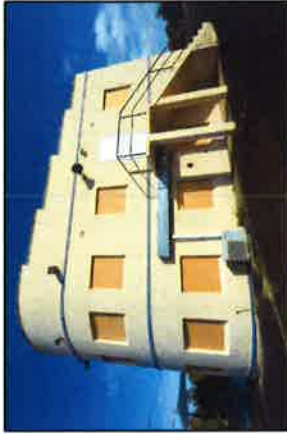
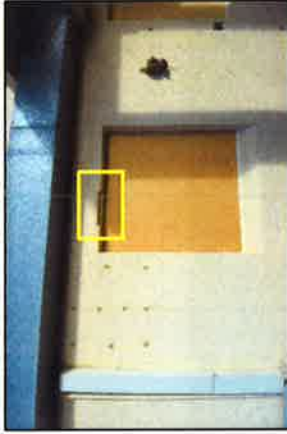
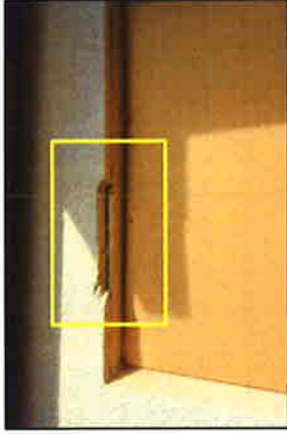
| Description / Image(s) | Condition | | Significance | Conservation Action/Treatment | |
|---|---|---|---|---|---|
| Eastern façade.<br><br><br> | Very Good | The eastern façade of the heritage building is in poor condition. Upon inspection, previous modifications during occupation of the building by the South Hurstville Bowling Club have seen intrusive elements installed such as conduits and external fixtures (exhaust). | Exceptional | Repair and Conserve | Intrusive elements to be permanently removed and disposed of. In future, if any fixings are to be made, existing penetrations and fixings are to be utilised. These are to be minimal. Advice from heritage consultant to be sought prior to such works. Make good works to the façade are to be undertaken. |

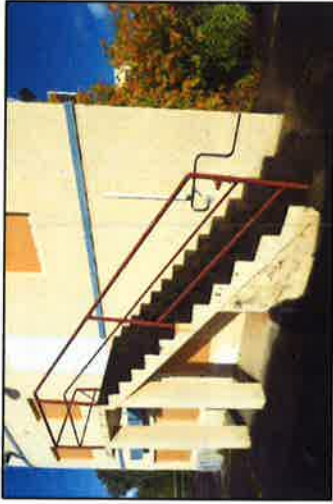
| Description / Image(s) | Condition | | Significance | Conservation Action/Treatment | |
|---|---|---|---|---|---|
| External staircase on the eastern façade of the building.<br> | | | High | | |

| Description / Image(s) | Condition | | Significance | Conservation Action/Treatment | |
|---|---|---|---|---|---|
| | Very Good | Good | Exceptional | Remove and Dispose | The external staircase and associated support structure is to be permanently removed and disposed of. Make good to extent fabric where damage is found as a result of the installation and / or removal of the stairs. The existing doorway is to be sealed off. There are to be no structures constructed or affixed to the eastern façade. |

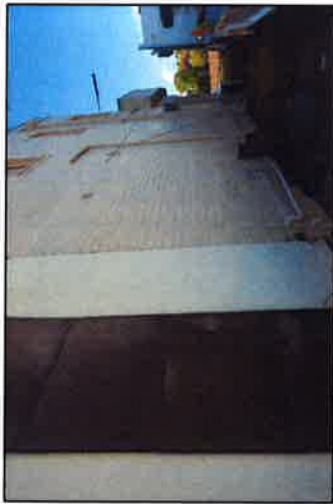
| Description / Image(s) | Condition | | Significance | Conservation Action/Treatment | |
|---|---|---|---|---|---|
| Western façade of the building<br> | | | Exceptional | | |

| Description / Image(s) | Condition | | Significance | Conservation Action/Treatment | |
|---|---|---|---|---|---|
| | Very Good | Good | Exceptional | Repair and Conserve | Intrusive elements to be permanently removed and disposed of. In future, if any fixings are to be made, existing penetrations and fixings are to be utilised. These are to be minimal. Advice from heritage consultant to be sought prior to such works. Make good works to the façade are to be undertaken. |

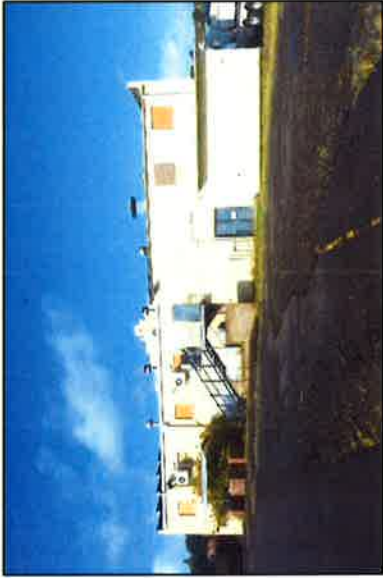
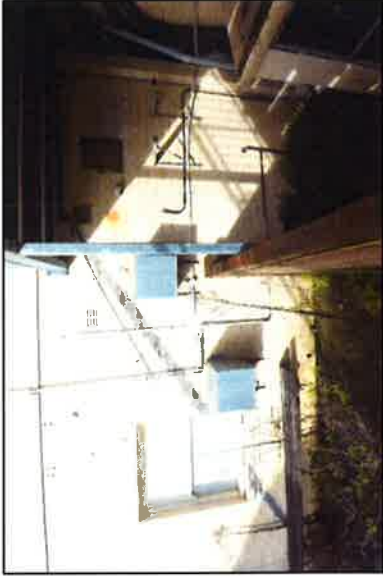
| Description / Image(s) | Condition | | Significance | Conservation Action/Treatment |
|---|---|---|---|---|
| <p>Northern façade of the heritage building.</p> | The northern façade of the heritage building is the rear façade of the building. There are also multiple access points to both levels of the building from this façade. The northern façade is in poor condition. Numerous modifications throughout the years has seen conduits and external fixtures affixed to the façade. | | Being one of the primary access points to the heritage building, the northern façade is of exceptional significance. A large portion of the site faces the rear façade of the heritage building. | Intrusive elements to be permanently removed and disposed of. In future, if any fixings are to be made, existing penetrations and fixings are to be utilised. These are to be minimal. Advice from heritage consultant to be sought prior to such works. Make good works to the façade are to be undertaken. |

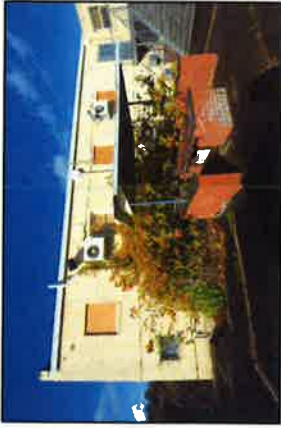
| Description / Image(s) | Condition | | Significance | Conservation Action/Treatment |
|---|---|---|---|---|
| BBQ Area<br> | | | | The BBQ area is to be permanently removed and disposed of. Make good to extant fabric where damage is found as a result of the installation and / or removal of intrusive fabric. In future, additions to the rear may be permissible provided that it is sympathetic to the bulk, scale and form of the existing building. Design advice must be sought from a suitably qualified heritage consultant. No free-standing structure is to be constructed in such close proximity to the rear façade of the building. |

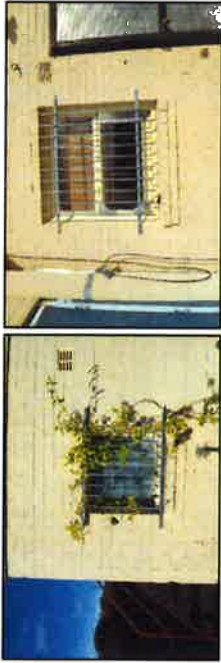
| Description / Image(s) | Condition | | Significance | Conservation Action/Treatment |
|---|---|---|---|---|
| Bar grilles affixed to the timber framed windows.<br> | | | | All bar grilles are to be permanently removed and disposed of. Make good to extant fabric where damage is found as a result of the installation and / or removal of the grilles. In future, installation of such items are not permitted. |

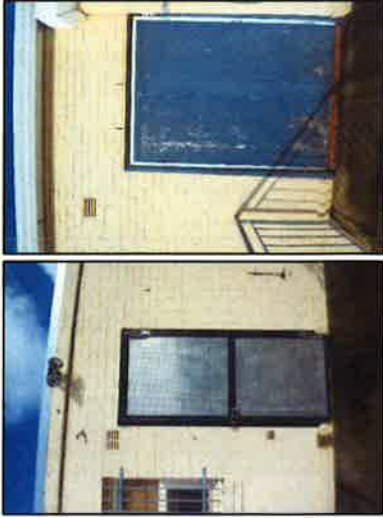
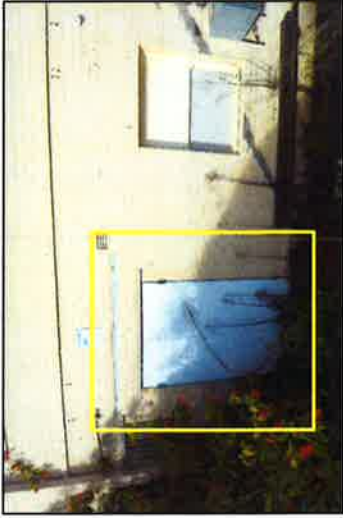
| Description / Image(s) | Condition | | The existing doors of the former club house to the rear of the building are in poor condition. | Significance | Over the years, modifications to the former club house saw the replacement of doors that are not sympathetic to the heritage character of the building. Following the relocation of the bowling club, some access points have also been sealed and boarded to prevent unauthorised access of the building. These elements are considered to be intrusive. | Conservation Action/Treatment | |
| <p>Existing doors access from rear of the building.</p> | | | | Exceptional | | Remove and Replace | |

| Description / Image(s) | Condition | | The existing doors of the former club house to the rear of the building are in poor condition. | Significance | Over the years, modifications to the former club house saw the replacement of doors that are not sympathetic to the heritage character of the building. Following the relocation of the bowling club, some access points have also been sealed and boarded to prevent unauthorised access of the building. These elements are considered to be intrusive. | Conservation Action/Treatment | |
|---|---|---|---|---|---|---|---|
| | Very Good | Good | Fair | Poor | Very Poor | Remove and Replace | The existing doors are to be permanently removed and replaced with doors that are more suitable to the character of the heritage building. Make good to extant fabric where damage is found as a result of the installation and / or removal of the doors. |

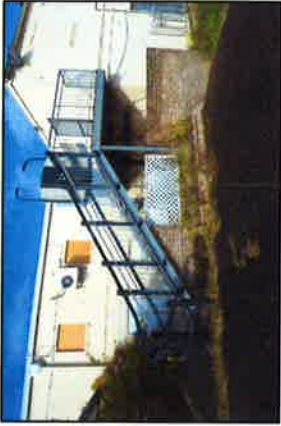
| Description / Image(s) | Condition | | Significance | Conservation Action/Treatment |
|---|---|---|---|---|
| External staircase to the rear of the building.<br> | | | Exceptional | The external staircase detracts from the heritage significance of the building and is considered to be intrusive.<br><br>Remove and Dispose<br><br>The external staircase is to be permanently removed and disposed of. Make good to extant fabric where found to be damaged as a result of the installation and / or removal of the stairs. In future, refrain from installation of external staircases to the rear façade. It is preferable that the legibility of the façade is kept intact. Advice from a suitably qualified heritage consultant must be sought. |

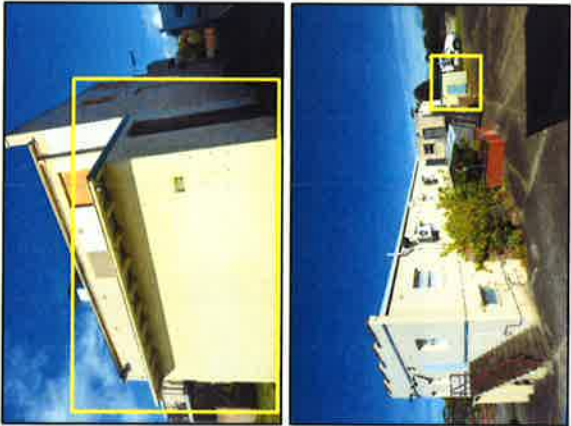
| Description / Image(s) | Condition | | Significance | Conservation Action/Treatment |
|---|---|---|---|---|
| Rear addition.<br> | | | Exceptional | External addition is to be permanently removed and disposed of. Make good to extant fabric where found to be damaged as a result of the construction and / or removal of the rear addition.<br><br>Remove and Dispose<br><br>Any additions to the building in future must be designed to be sympathetic with the bulk, scale and form of the heritage building. Advice from a suitably qualified heritage consultant must be sought. |

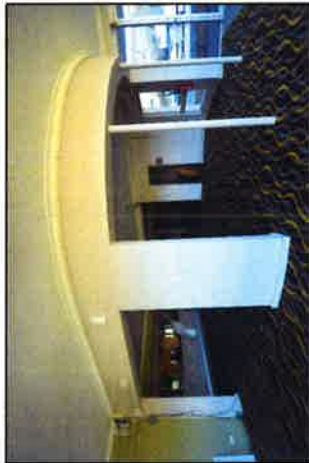
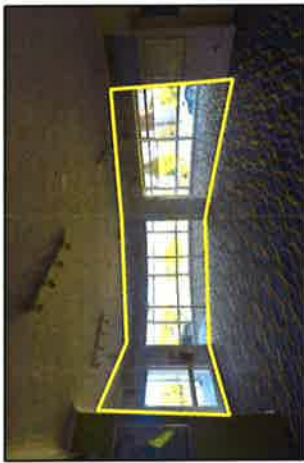
| Description / Image(s) | Condition | | The extension to the primary façade (southern façade) of the building is in good condition. The original boundary of the primary façade maintains to be identifiable and has retained original columns. | Significance | The extension is a later modification to the site and does not contribute to the heritage significance of the building. It has negatively impacted the legibility of the primary façade externally and is considered to be an intrusive element. | Conservation Action/Treatment |
| <p>Extension to the southern façade of the building.</p> | Very Good | Exceptional | | | | |

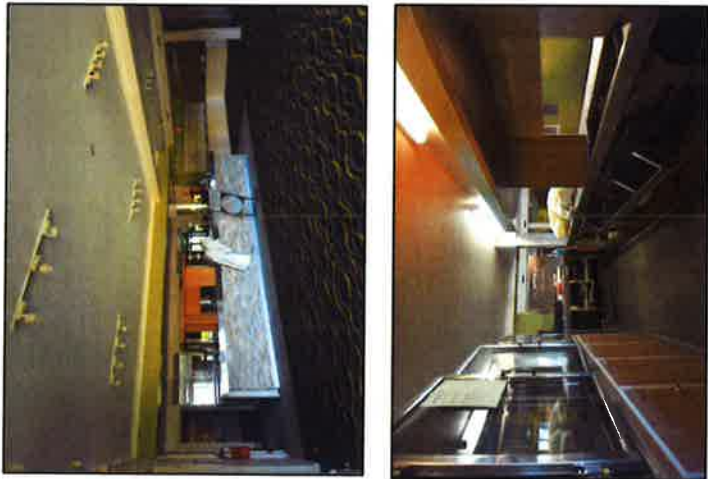
| Description / Image(s) | Condition | | Significance | Conservation Action/Treatment | |
|---|---|---|---|---|---|
| <p>Internal fitout (bar and joinery).</p> | The internal fit out of the former club house has been refurbished several times throughout the years. It no longer retains any heritage significant features. As it has been renovated sometime prior to the relocation of the bowling club, the internal fitout appears to be in good condition. | | The internal fit out is not of heritage significance. It has not been designed to be sympathetic to the modernist style attributed to the former club house. As such, it is considered to be intrusive. | | |

| Description / Image(s) | Condition | | Significance | Conservation Action/Treatment | |
|---|---|---|---|---|---|
| | Very Good | Good | Exceptional | Remove and Dispose | The internal fit out is to be removed permanently and disposed of. Make good to extant fabric where found to be damaged as a result of the installation and / or removal of the bar and associated elements. Future works to the fit out should take into consideration the heritage context of the building. Reversibility should be the key intention of future works and no damage to heritage fabric identified. |

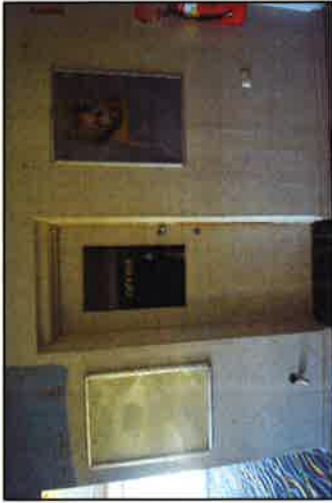
| 3.6.3 Internal Doors | | | | | |
|---|---|---|---|---|---|
| Description / Image(s) | Condition | | The office door remains to be operable with the text legible. It appears to be in fair condition. | Significance | |
| Office door.<br> | | | | | |

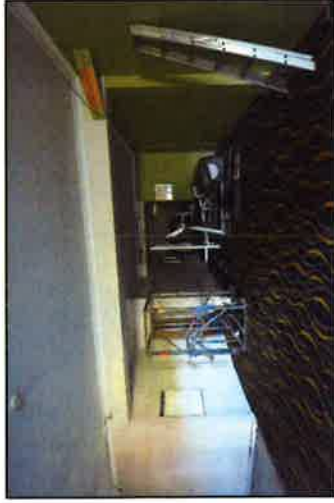
| 3.6.3 Internal Doors | | | | | |
|---|---|---|---|---|---|
| Description / Image(s) | Condition | | The internal walls and flooring of the former club house is in good condition. | Significance | |
| Internal fitout at ground level.<br> | | | | | |

| 3.6.3 Internal Doors | | | | | |
|---|---|---|---|---|---|
| Heritage significant doors are to be repaired and conserved. Should the internal configuration of the ground level be modified, it is not necessary to retain the doors in their exact location. However, the doors are to be reused at ground level for similar purposes. | | | The existing flooring is to be permanently removed and replaced. Make good to substrate where found to be damaged. The walls and ceiling are to be repainted in a colour sympathetic to the modernist aesthetic of the building. Design advice from a suitably qualified heritage consultant must be sought. | | |

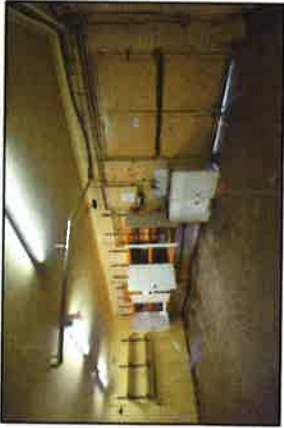
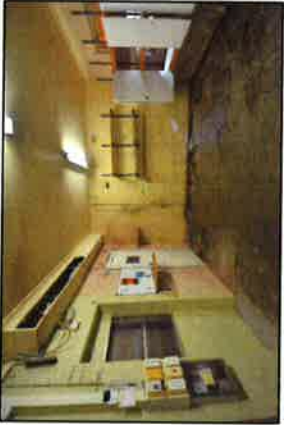
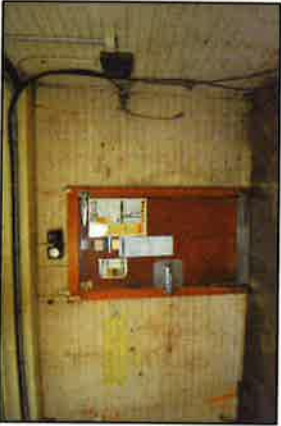
| 3.6.5 Storeroom | | Conservation Action/Treatment | |
|---|--|---|---|
| <p>Storeroom at ground level.</p> | | Very Good | Exceptional |

| 3.6.5 Storeroom | | Conservation Action/Treatment | |
|---|--|---|---|
| | | Remove and Repair | The store room is to be modified and repurposed for the adaptive reuse of the building. Design advice from a suitably qualified heritage consultant must be sought. |

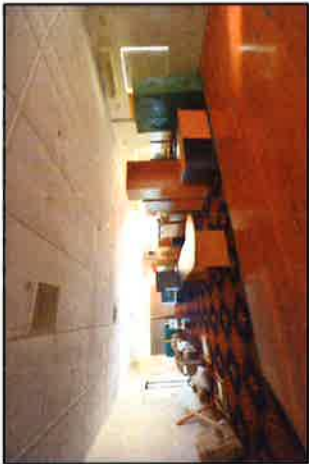
| Description / Image(s) | Condition | | Significance | Conservation Action/Treatment | |
|---|---|---|---|---|---|
| Internal fitout at first level.<br><br> | | | Exceptional | Several modifications of the former club house attempted to modernise the premises. As a result, the internal fitout no longer retains heritage significance and is now considered to be intrusive. | |

| Description / Image(s) | Condition | | Significance | Conservation Action/Treatment | |
|---|---|---|---|---|---|
| | Very Good | Good | | Remove and Replace | The existing flooring is to be permanently removed and replaced. Make good to substrate where found to be damaged. The walls and ceiling are to be repainted in a colour sympathetic to the modernist aesthetic of the building. Design advice from a suitably qualified heritage consultant must be sought. |
