**Phase 1 Contamination Assessment and  
Geotechnical Investigation  
Proposed Residential Apartment Building  
Lots 1-4 DP 581963 and Lot 11 & 13 DP 1000689  
Nos 25, 25a, 27, 27a and 29 Rookwood Road  
Yagoona NSW 2170**

**Ref: JC17306A**  
**September 2017**

Our Ref: JC17306A-r1

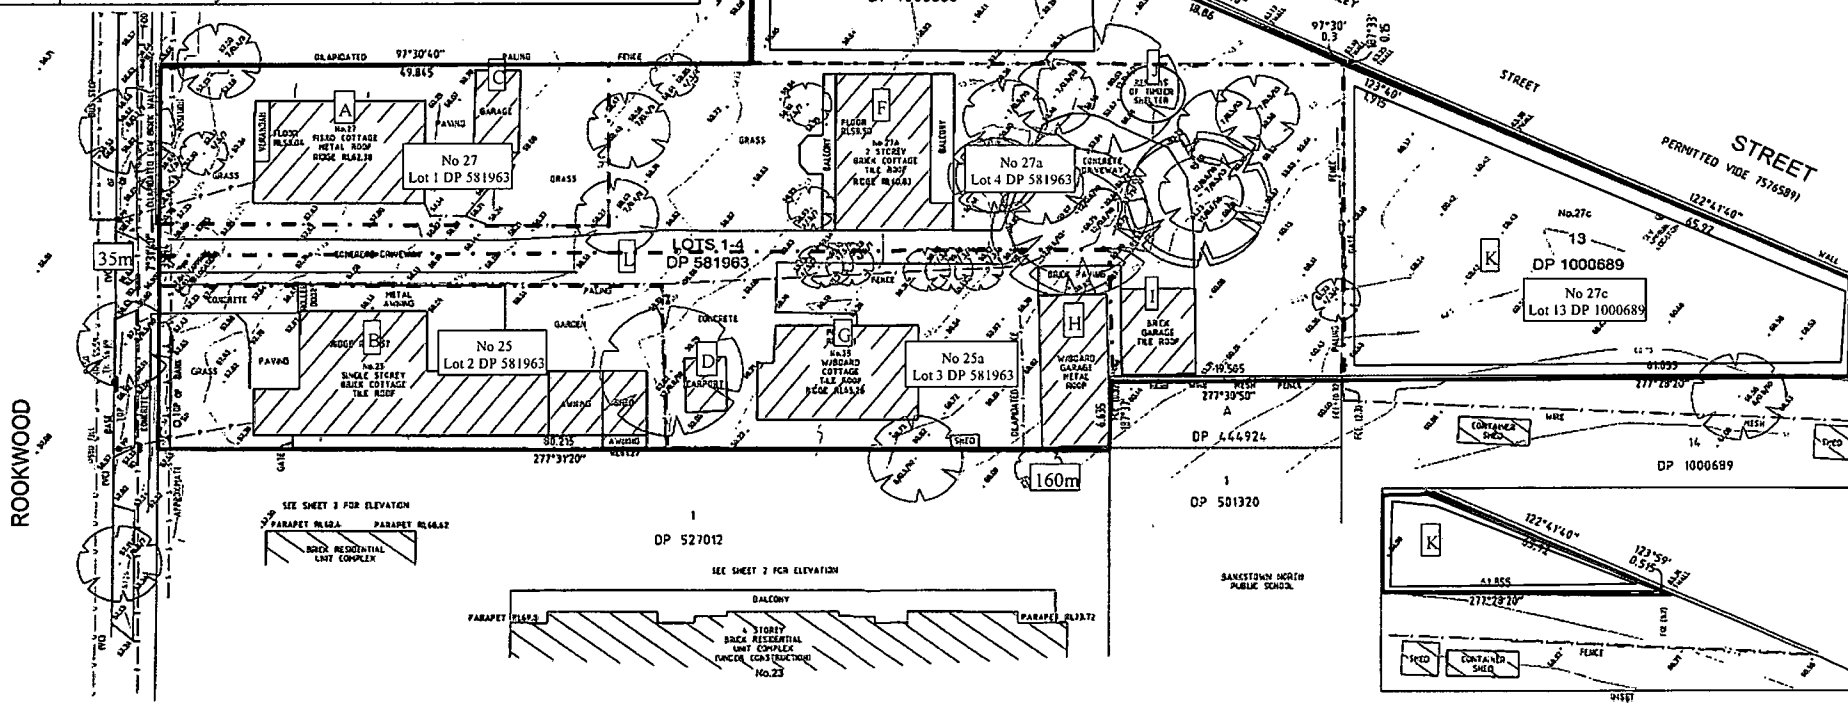
Drawing No: 1

At the time of our site investigation, property Nos 25, 25a, 27 and 27a were mainly being used for residential purposes with dwellings occupying the properties. The rear of property No 25a and 27a were being used by an appliance repairer with several white goods stored around the garages. The northern corner (ie No 29b) of the site was used as a storage area for old cars, trucks, container, caravan and scrap metal. The rear of the site (ie No 27c) was vacant with some stockpiles of bricks and tiles, a caravan and some building debris including bricks, tiles and fibro pieces sparsely scattered on the ground surface. Reference should be made to Drawing No 1 for site features and locality.

The inspection did not reveal any obvious signs of gross ground contamination indicated by odour, discolouration of the ground or signs of vegetation distress.
