Hazardous Building Materials Report – 101 Nuwarra Road, Moorebank NSW

Appendix A:
Hazardous Building Materials Register

Site: 101 Nuwarra Rd, Moorebank NSW			Hazmat Register Summary					Survey Conducted by: M.Tofler	
Inspection Date: 13 February 2019		Building Reference: Residential/commercial			Client: OAR2		Asbestos Analysis:		
Location	Building Component or land	Asbestos Detected CHR, AMO, CRC, SMF, NAD	ID	Photo		Risk Assessment			Comments & Recommendations
					Analysed	Friable or Non-friable	Priority Risk Rating	Material Condition	
Structures – Subfloor	Packing	-			N	ND	2	-	Subfloor inaccessible during site inspection. Recommendation during demolition works (if present) emu pick ACM packers from subfloor; engage Class B Asbestos Removal Contractor to remove ACM and dispose at lawful facility. All works as per the Code of Practice How to Safely Remove Asbestos September 2016 (SafeWork NSW). At completion of asbestos removal works a Competent Person is to conduct a clearance inspection and issue a clearance certificate for the works as per the WH&S Regulation 2017.

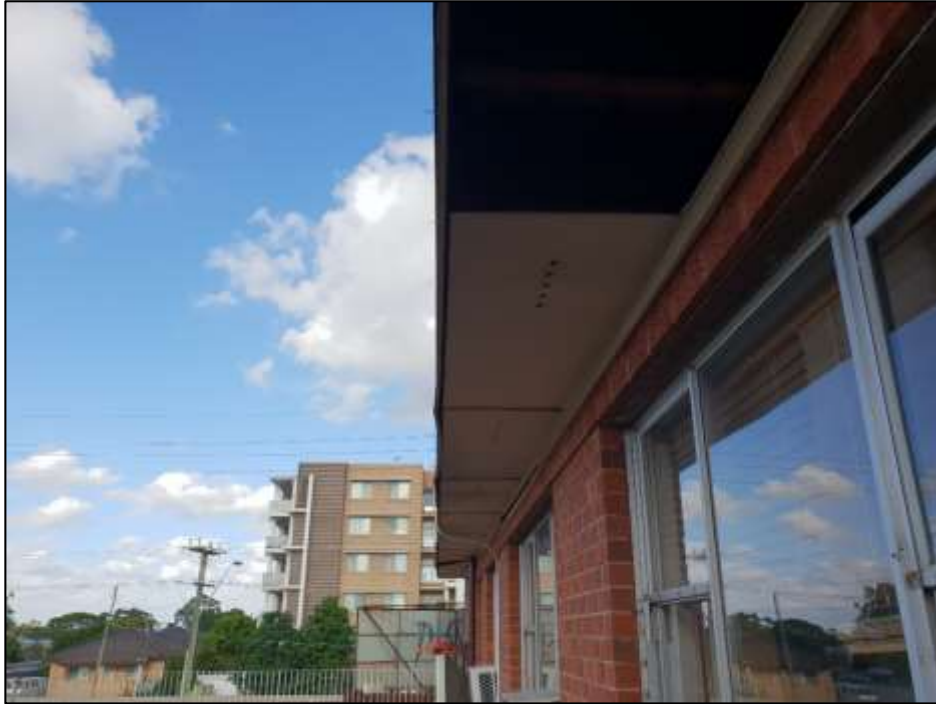
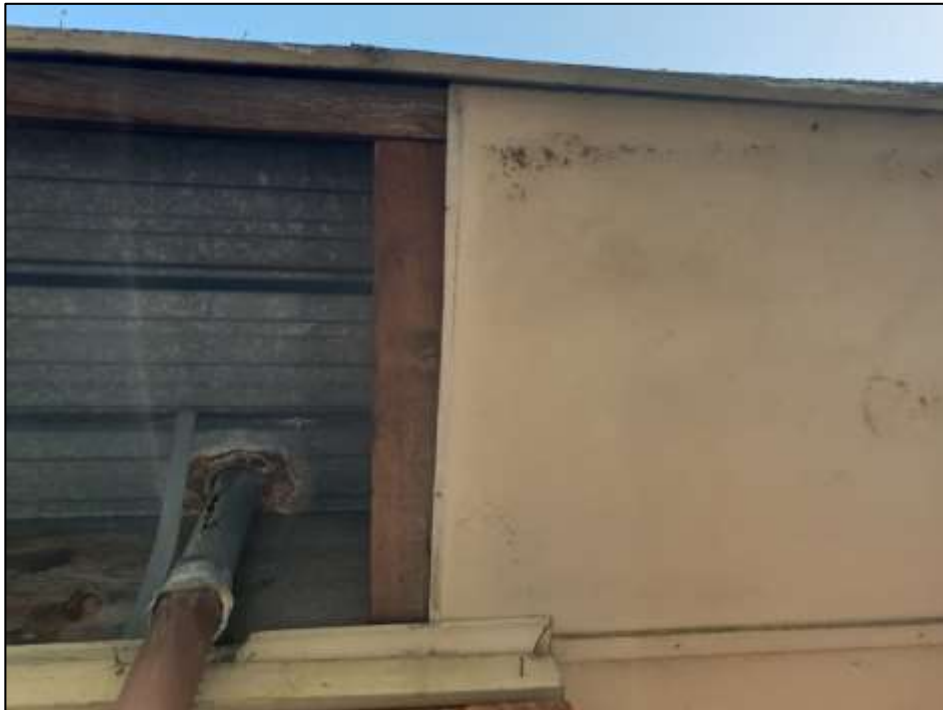
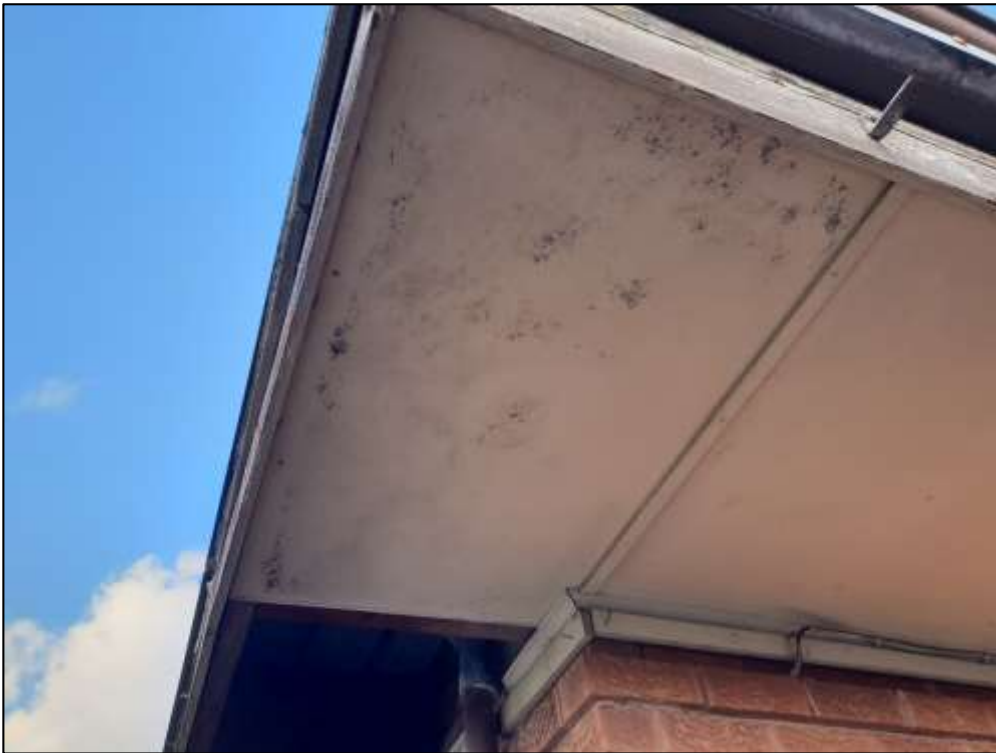
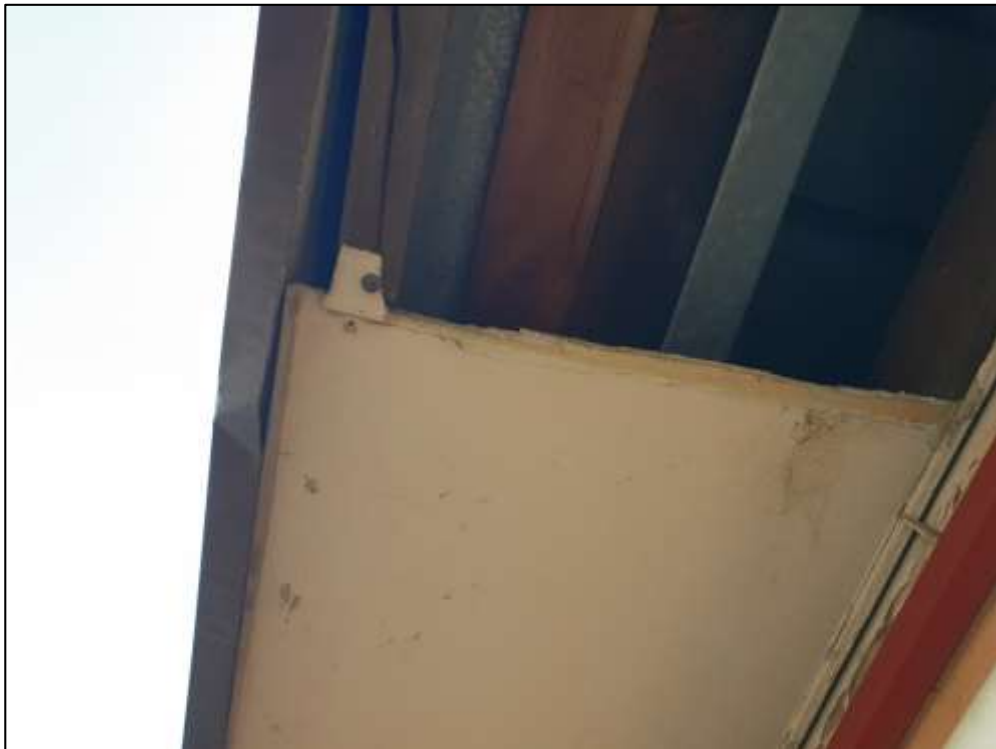
Structures – External	Eaves	ACM	-

N	NF	3	Good	The external eaves are suspected ACM. Recommendation engage Class B Asbestos Removal Contractor to remove and dispose at lawful facility. All works as per the Code of Practice How to Safely Remove Asbestos September 2016 (SafeWork NSW). Engage Licensed Asbestos Assessor to undertake a clearance inspection and issue a clearance certificate as per the WH&S Regulation 2017 prior to proposed demolition.

ACM in Eaves

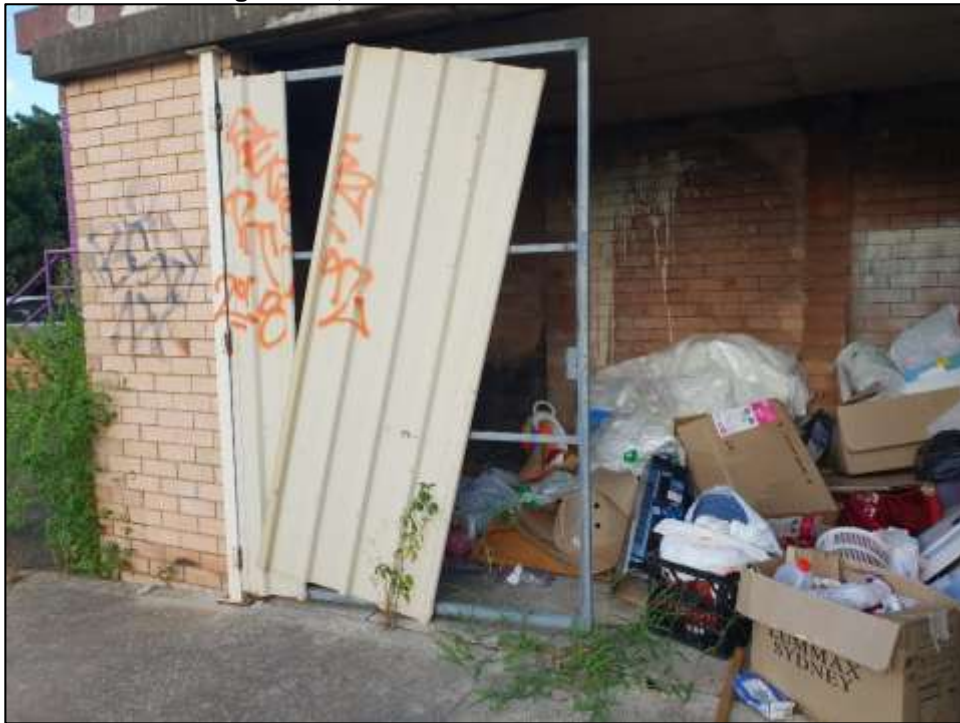
Storage Shed, Contains General Household Waste
