## Memorandum

| <b>Subject</b> | Inspection of BH9- Proposed Residential Aged Care Facility, Marsh Parade, Casula | <b>Project No.</b> | 85600.00.R.003 |

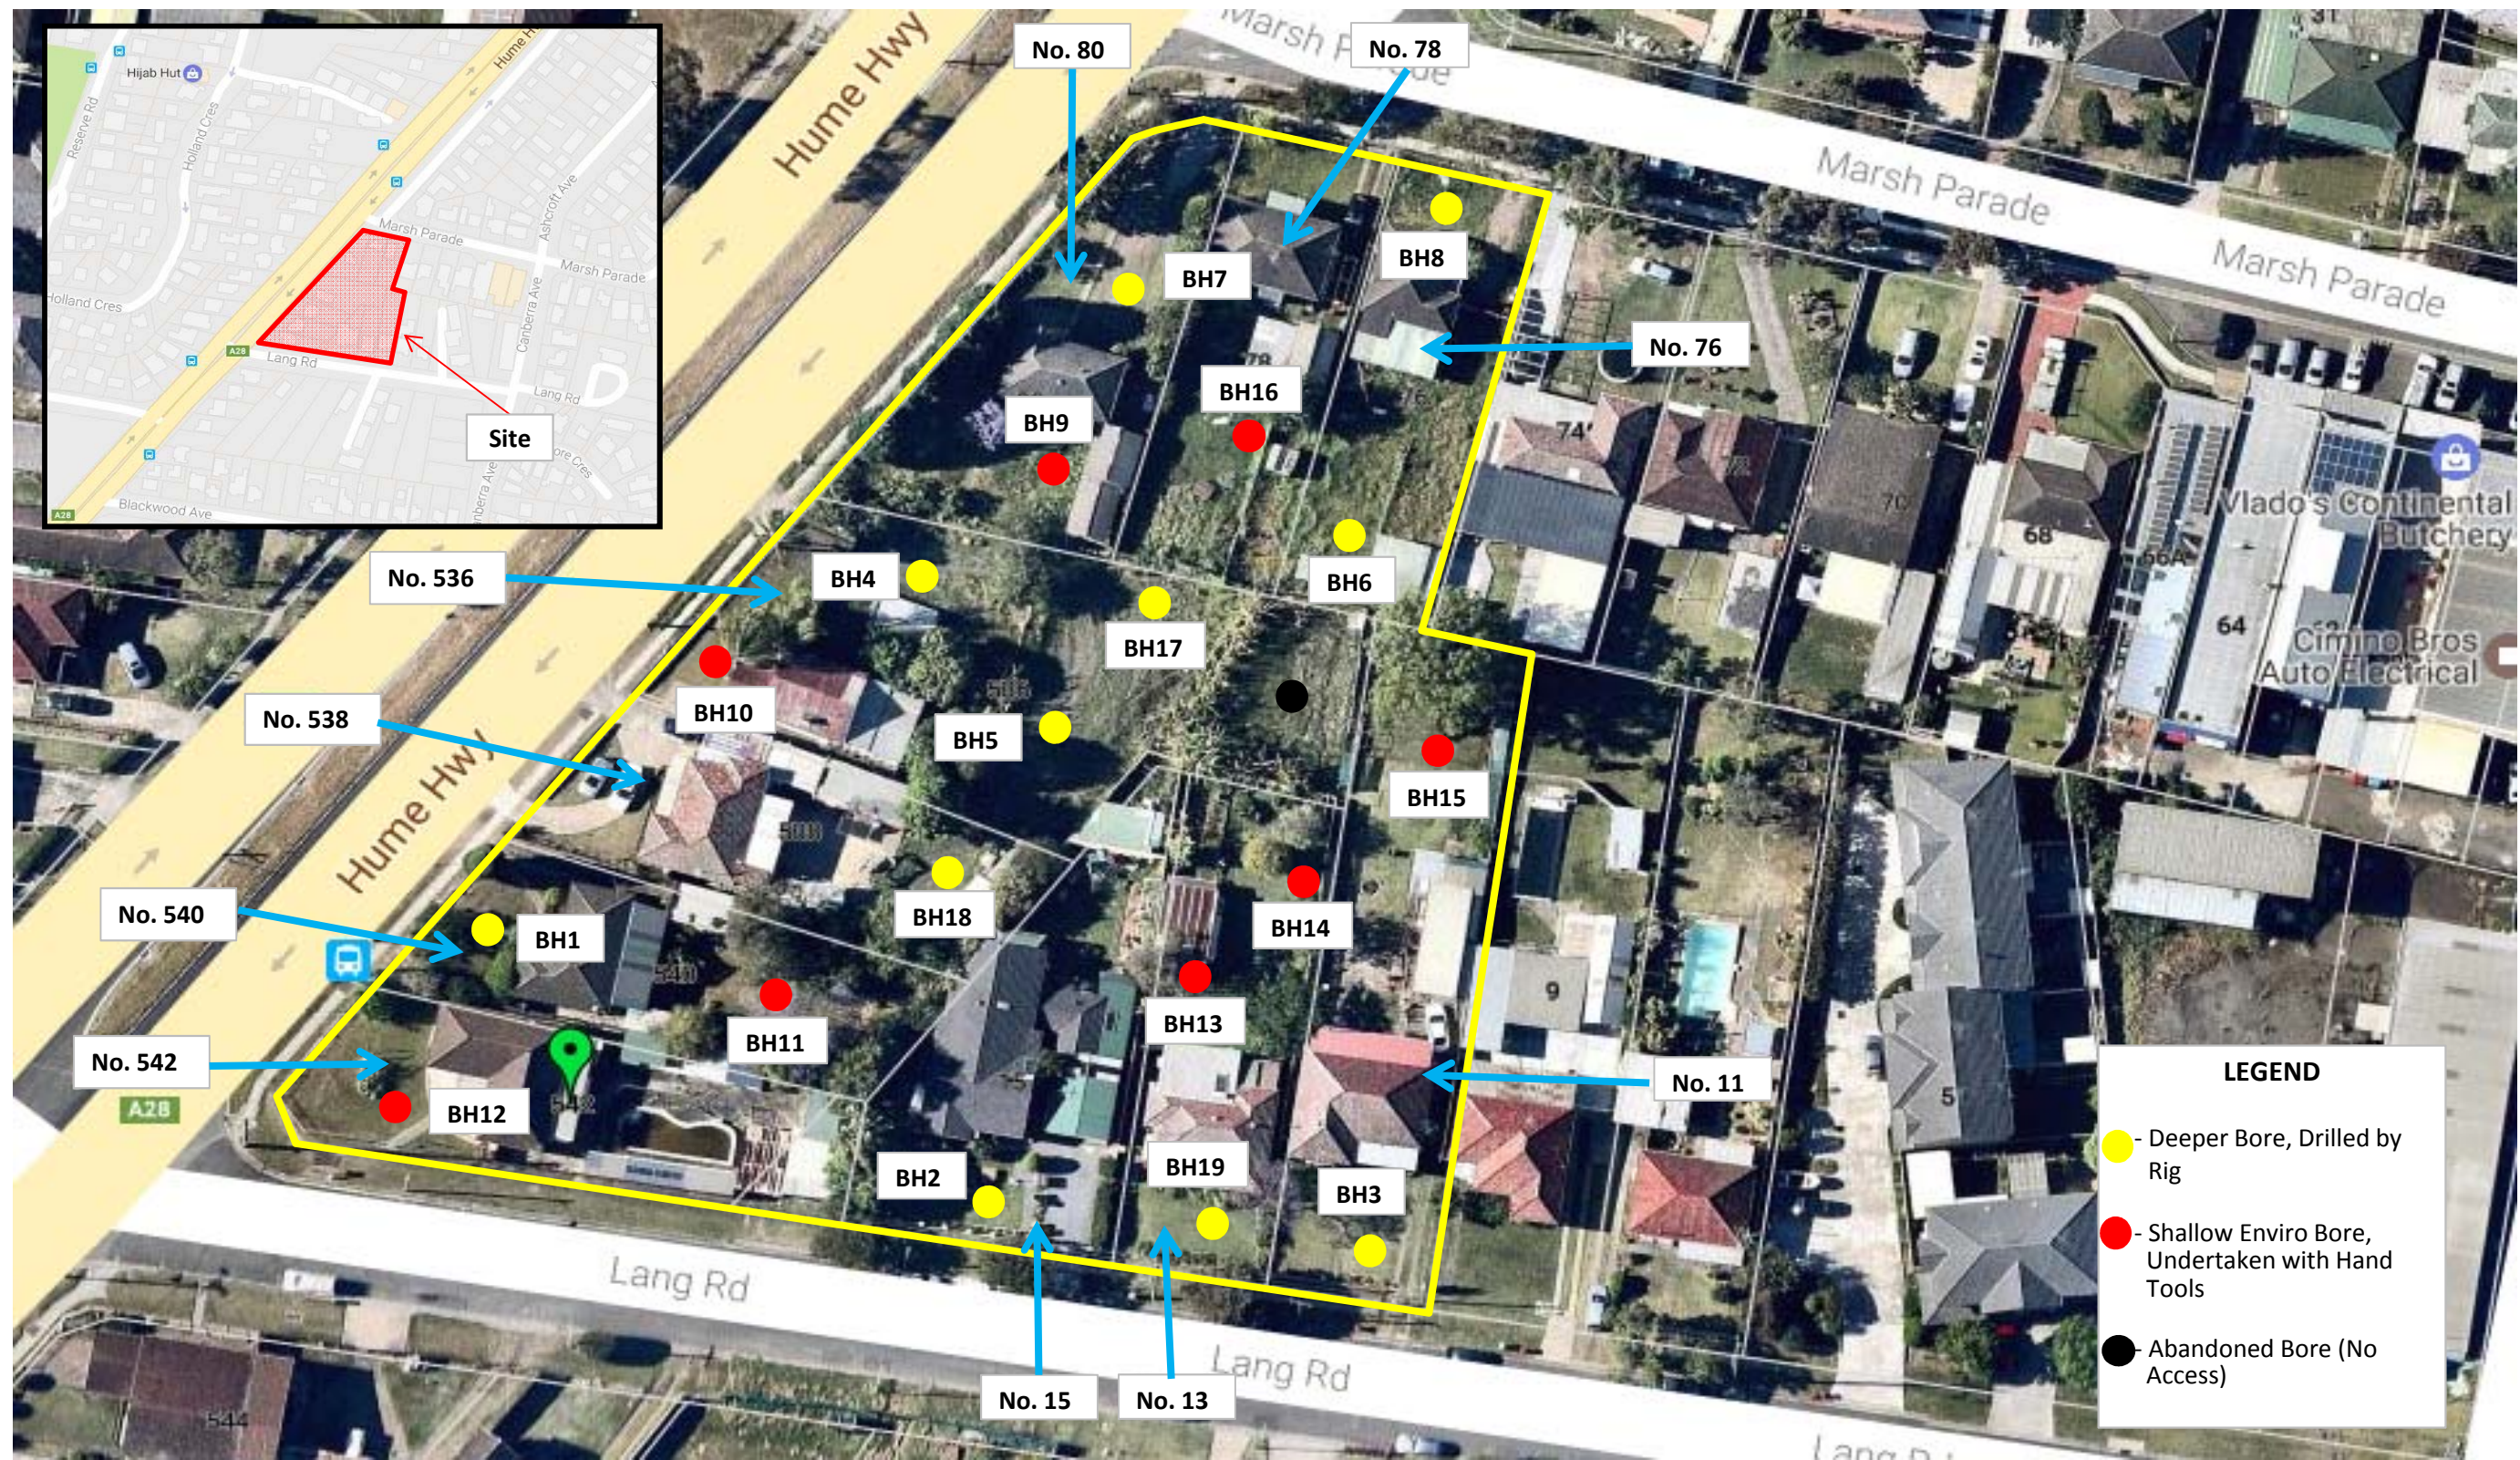
DP's report titled '*Report on Detailed Site investigation, Residential Aged Care Facility, Lang road, Marsh Parade and Hume Highway, Casula*', dated March 2017, DP ref: 85600.00.R.002.rev2 (DP 2017) observed the presence of a bonded fragment of material in the near surface soils at BH9 (see attached Drawing 1) which was subsequently confirmed to contain chrysotile and amosite asbestos. DP (2017) also reported that the recorded asbestos concentration in the soil sample at BH9 taken between 0.02 m and 0.1 m below ground level (bgl) was below the laboratory reporting limit (LRL) of 0.1 g/kg. Given the field observations and the laboratory results, DP considered that the fragment of asbestos containing material was likely due to either current or past structures on the site which are known to contain asbestos.

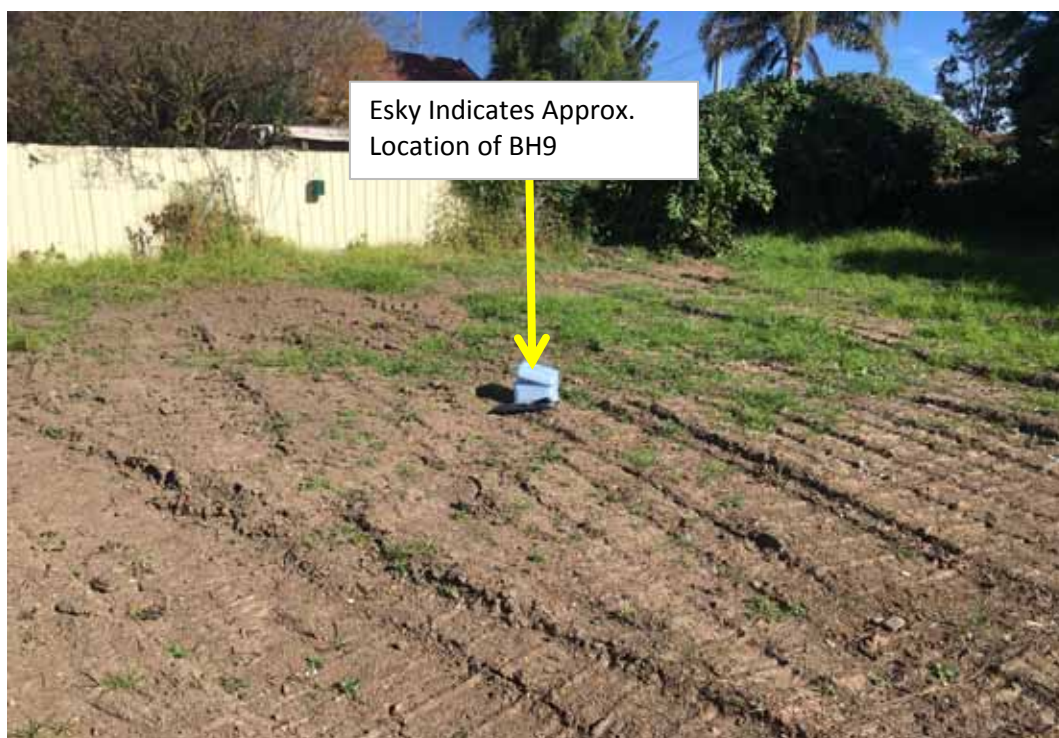
Inspection of the surface observed that the grass vegetation was no longer present exposing the underlying brown silty clay topsoil/filling (see photos attached). No asbestos fragments around BH9 were observed. There were a few tile and plastic fragments in the near surface soils (top 20 mm) which may be associated with the demolition works currently being undertaken. Notwithstanding these observations, as a conservative approach two samples (BH9- A and BH9-B) were collected from the near surface soils (0-0.1 m) and analysed for the presence of asbestos fines/friable asbestos.

Photograph 1 - Looking West in the Area of BH9

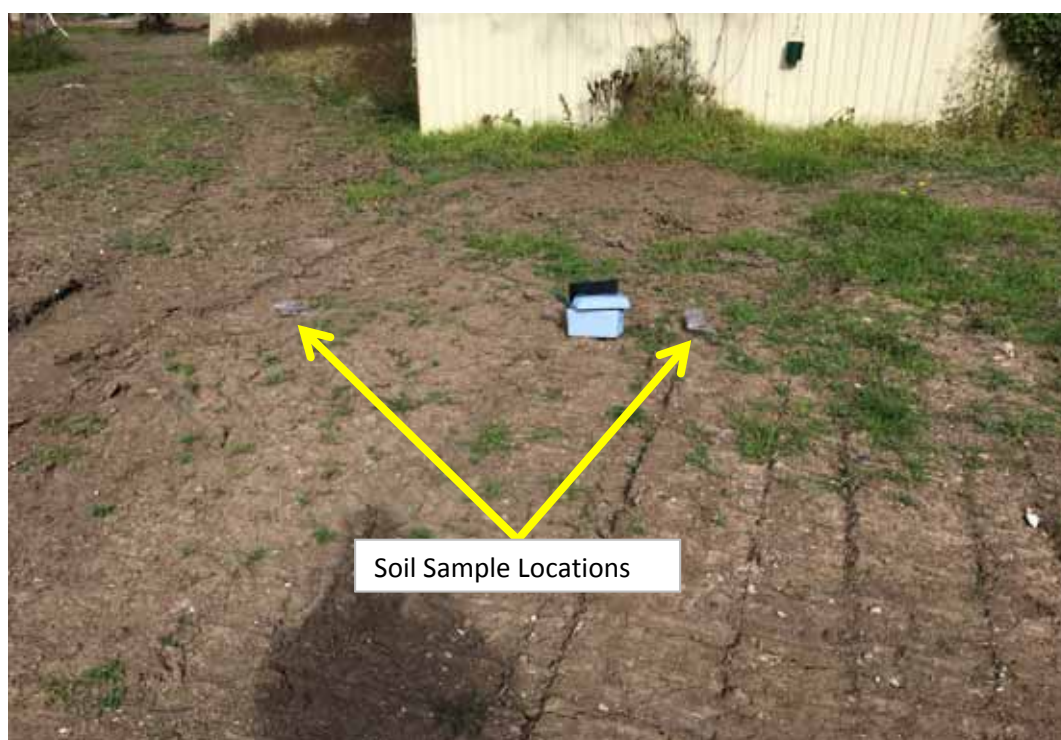
Photograph 2- Looking South in the Area of BH9
