CONSERVATION SCHEDULE OF WORKS

Former C.B.C. Bank 263 Queen Street Campbelltown **MARCH 2017**

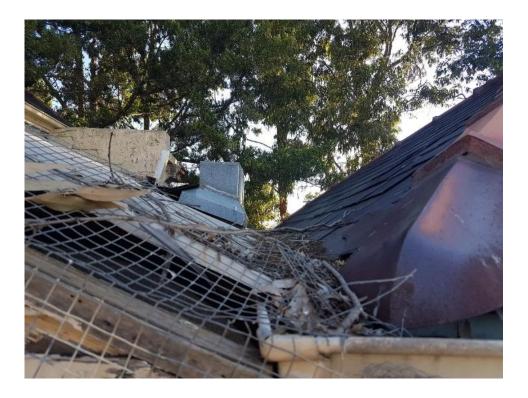
Figure 5 – View of the roof between the Services Building and the Main Building

To be replaced as part of the replacement of the veranda to this level. This includes all associated flashings and rainwater disposal.

Carefully remove the existing roofing taking care to minimise disturbance to the original masonry as much as possible. Repair all cavities so formed.

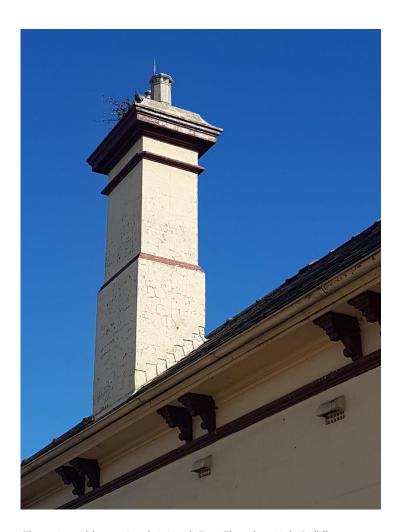
Figure 6 - Chimney Stack 1, North East Elevation, Main Building

- Provide scaffold access to all faces of each stack.
- Determine condition of each chimney pot and associated flaunching.
- Allow to replace two pots to match existing.
- Re flaunching all stacks and undertake necessary repairs to all associated masonry.
- Hammer test the render to all surfaces.
- Redecorate render defective areas
- Remove all flaking and impervious paint and re decorate in colour to be determined by the conservation architect.

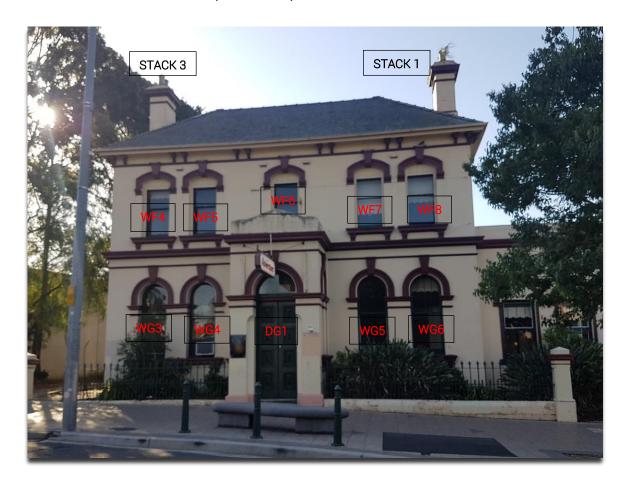
Figure 7 - Queen Street Elevation

- Chemically paint strip to remove all paint.
- Cut out and repoint all joints.

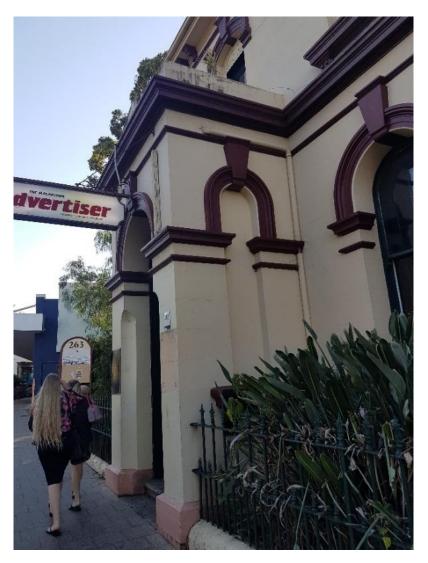
Figure 8 - Porch

- Hammer test all render to determine drummy areas. Replace in matching render. Undertake other minor render repairs.
- Re secure any loose stonework.
- Re render upstand above top cornice, front, top and rear down to flashings.
- Remove timber battens and make good holes.
- Remove sign to keystone and all supports and conduits. Make good holes.
- Remove fixings to previous signage and make good holes.
- Paint strip stone plinth and repoint.
- Replace threshold in Mintaro slate.

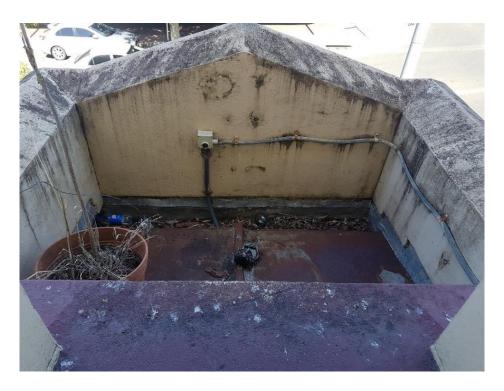
Figure 9 – Roof of the Queen Street porch

- Replace galvanized sheet roofing in lead sheet Code 6, to LSA details.
- Replace gutter all associated lead flashings. Make good previous reglets and reform new ones as required.
- Redesign North end of the gutter to improve junction with external down pipe and to improve cleaning access. In stall brass mesh leaf cage over North end.
- Replace galvanized + pvc round downpipe to external wall, to match existing galvanized.

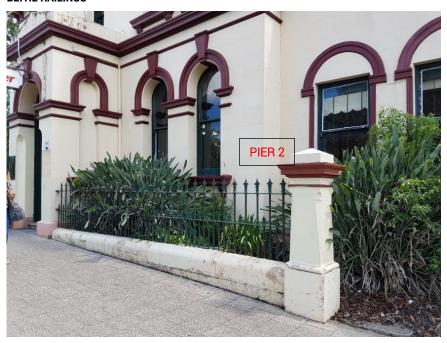
Figure 10 – Queen Street railings

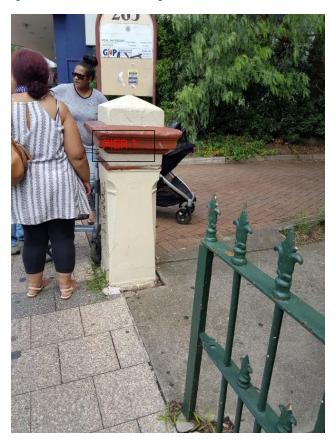
Figure 11 - Position of gate to the Queen Street railings

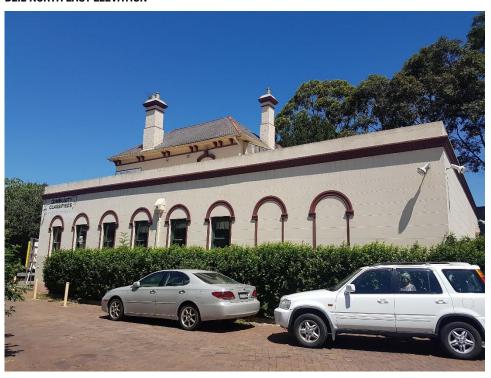
Figure 12 – Single storey building to be demolished

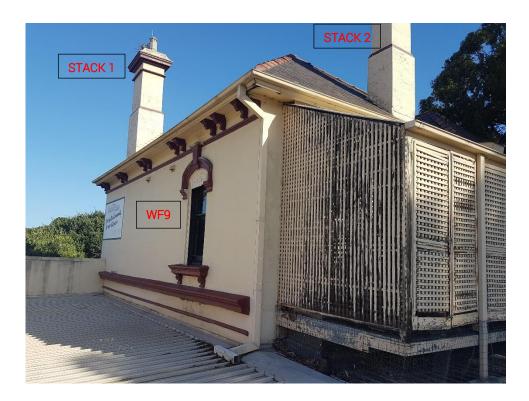
Figure 13 - First floor façade to be retained

- Infill all holes with brick and then render to match existing up to match original surface.
- Make good all fixing holes and reglets.
- When repaired, this zone is to match the existing render above and the new render to the ground floor below.

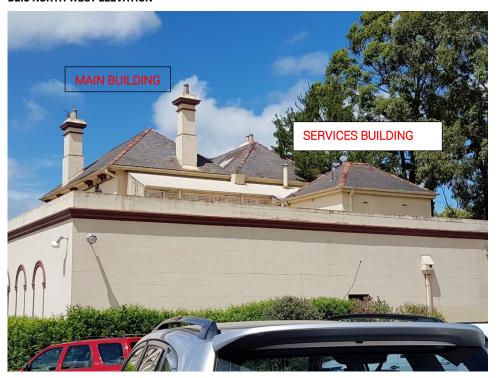
Figure 14 - Ground floor building to be demolished

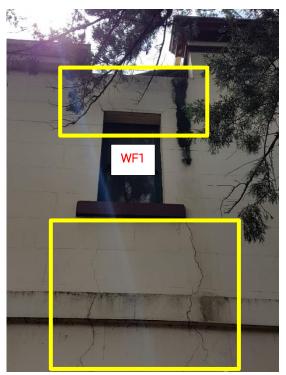
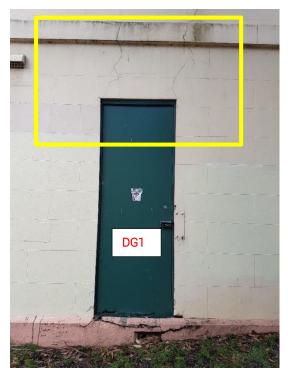
Figure 20 & Figure 21 - South West elevation - lintels to be replaced and surfaces rerendered
