CONSERVATION WORKS SCHEDULE

RAITH
74 -92 Fern Avenue, Bradbury

November 2018

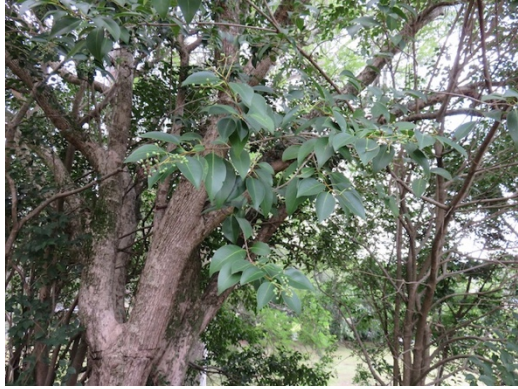
Broad Leaf Privet

Item	Heritage Significance	Works required	Timeframe	Specialist	Probable cost
Weed species trees and plants – noxious	Varies	Remove all noxious weeds carefully using hand tool methods and limited localised poisoning. Take care to treat weed species only and minimise ground disturbance.	Cyclical – Annual check	Specialist Noxious Weed removal horticulturists	\$2000/annum
Weed species - invasive	High	Review by specialist horticulturist. If a stable means of retention and management is possible retain significant federation plantings that may now be deemed weeds as advised by the specialist team	Cyclical Annual Check	Specialist Horticulturist	Included above
Ongoing maintenance		Weed management, Tree management Garden maintenance and pruning	Regular cyclical maintenance by specialist gardeners Weekly / fortnightly	Horticulturist Gardeners	\$8000/annum

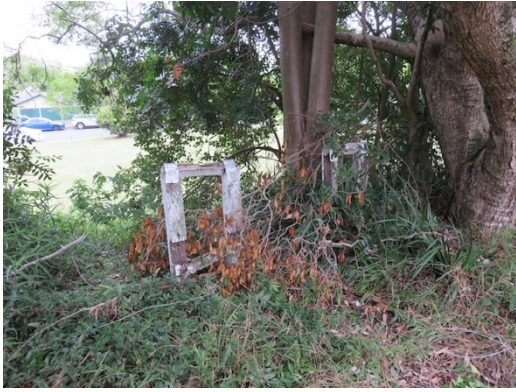
Remains of garden fence at the top of the northern Embankment (Federation Era)

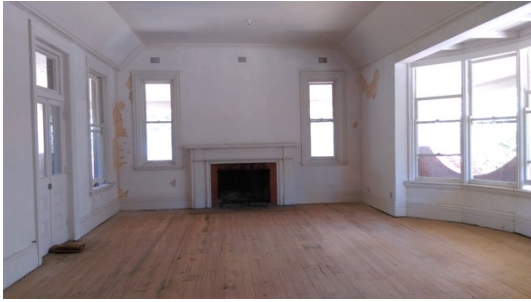
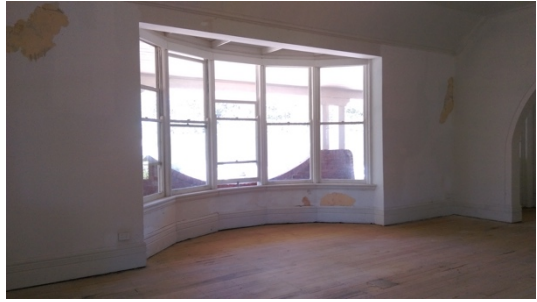
Room 1 conservation issues

Room 1 Reception	High	Refix loose skirting boards	Immediate	Carpenter	\$500.00
Repainting	High	Note previous colour schemes for walls include : - Eu de Nil - Rich Cream - Eggshell blue	After repairs	Painter	See Cyclical maintenance cost below.
Room 2 Study	High	Ceiling paint peeling – test for chemical /oil deposits.	Immediate	Specialist Renderer damp / render / toxin removals	Included above
Room 3 / 4 Vestibule to sitting room	High	Remove drainage pipe from redundant bathroom over. Repair and repaint	Immediate	Carpenter / plasterer	\$2500.00
Hall 2 – western end	High	Substantial sub floor damage area, substantial damp area.	Immediate	Carpenter / renderer toxin specialist	See above
Room 6 Bedroom	High	Floor damage – remaining fire damage, termites, floor bounce.	Immediate	Carpenter	\$3000.00
Bath 1	High	After wall treatment noted above, refit bathroom with new fitout to functioning bathroom – retain existing	Prior to occupation	Builder	\$10000.00

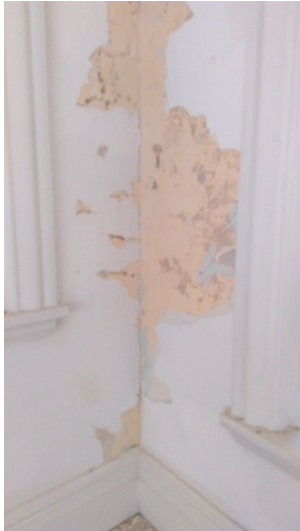
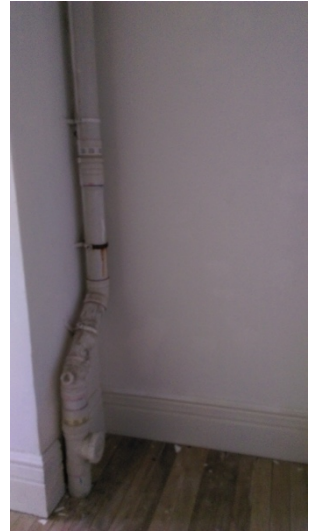
Room 1 conservation issues

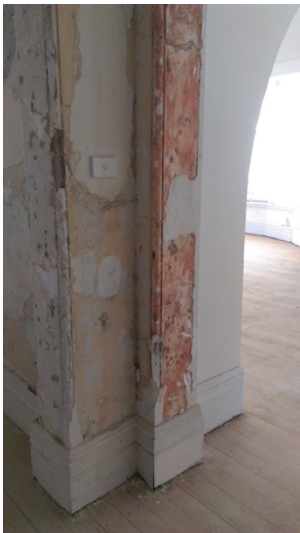
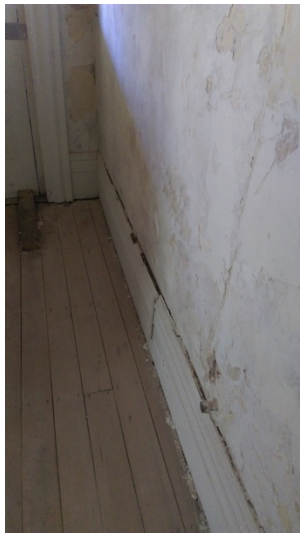
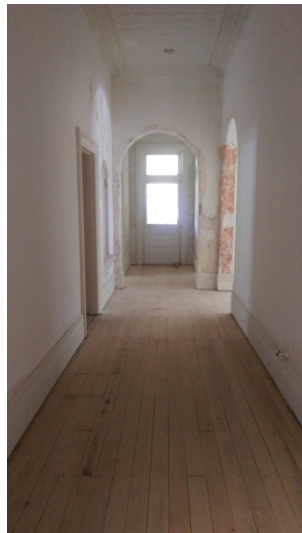
Hall 2 west Conservation Issues

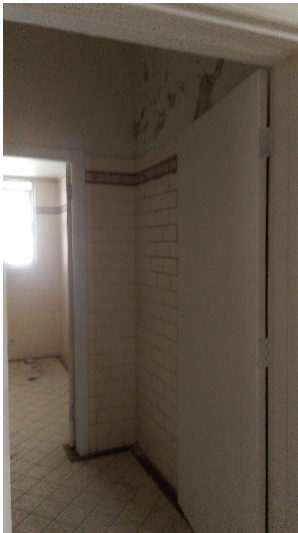
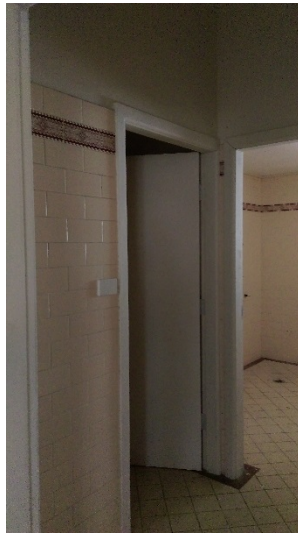
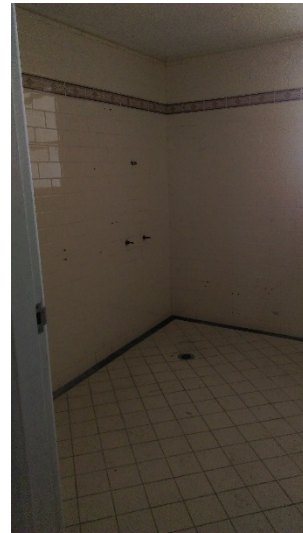
Bath 1 Condition

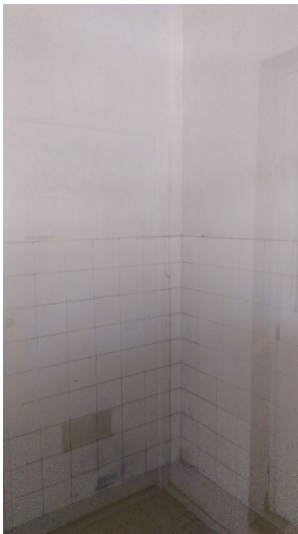
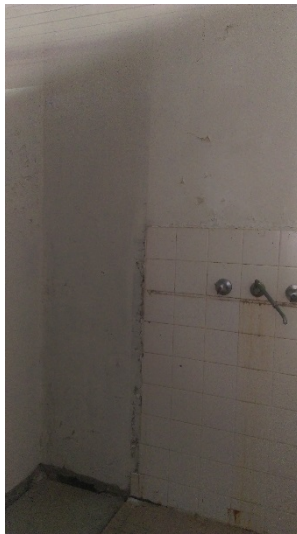
Room 9 Former Laundry Condition

wall and floor tiles. Use existing plumbing.			
Room 9	Moderate	Refit room for laundry use using existing plumbing.	Prior to occupation	Builder	\$10000.00
Kitchen	Moderate	Refit room for kitchen use using existing plumbing.	Prior to occupation	Builder	\$20000.00
Room 10a (former Cool room)	Moderate	Severe damp from external roof drainage failure. Repair external failure and leave to dry out until moisture is cleared. Provide additional ventilation to room	Prior to occupation / use of room	Builder	\$3000.00 For additional ventilation
Hall 3a (former part of kitchen)	High – remnants of kitchen hearth	Remove timber flooring and inspect subfloor – remove rotted and damaged timbers, replace sub structure for flooring and rework to enable stable and termite secure connections with the former fire place hearth. Repair / reinstate damp proof course along the western wall.	Prior to occupation	Carpenter/ builder	\$10000.00

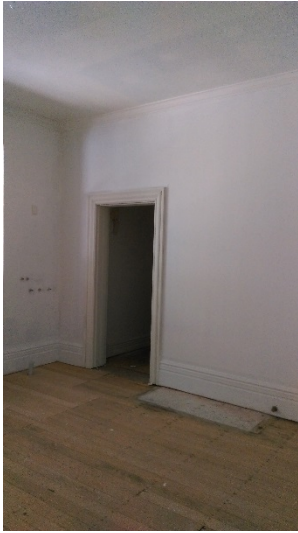
Kitchen Condition

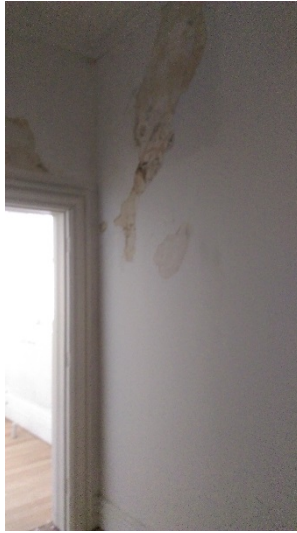
Room 10a (Cool Room Davies) Poor condition

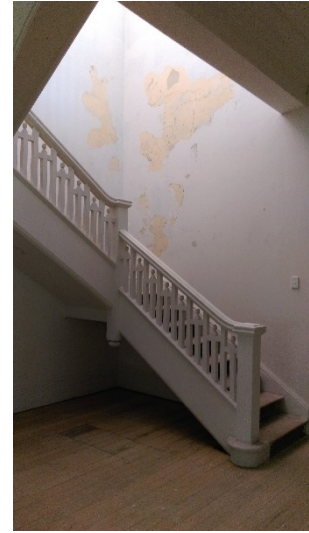
Typical Wall paint damage

Item	Heritage Significance	Works required	Timeframe	Specialist	Probable cost
All rendered masonry walls throughout.	High	Check moisture chemical and oil levels and for rising and falling damp in masonry walls. Desalinate remove toxins as required after repair of DPC (Ref external works) Remove flaking paint	Immediate	Specialist Renderer damp / render / toxin removals	\$8000.00
All sub floor areas skirtings and architraves	Moderate	Termite and rot inspection	Immediate	Specialist timber scientist	\$2500.00
Internal painting	Existing colours low significance	Walls low sheen breathable paint. Timbers full gloss enamel Paint only existing surfaces. Colours may be based on original colour schemes identified (see below)	Prior to occupation, after walls have been checked and cleared of chemical and moisture damage	Painter	\$50000.00
		Remove termite damaged timbers and replace with matching sections in termite resistant timbers. Where possible provide physical termite barriers to underfloor areas.	Immediate	Carpenter	\$5000.00

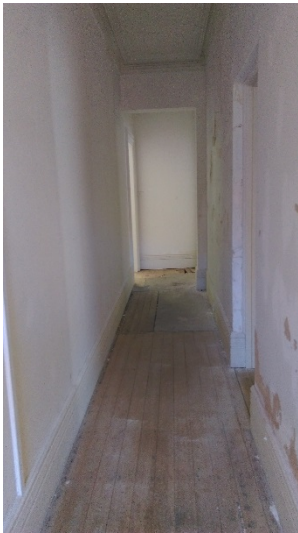
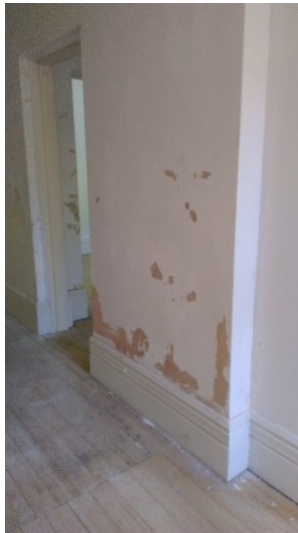
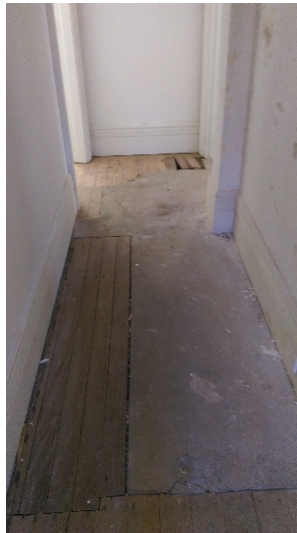
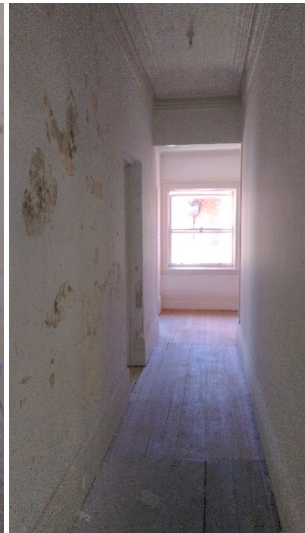
Hall 3a condition

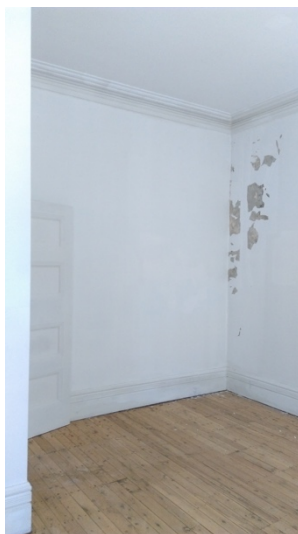
Room 11 falling damp from external roof failure

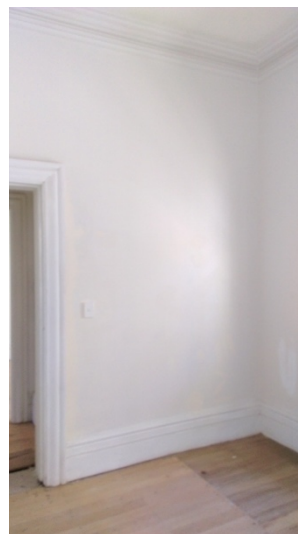
Room 14	Moderate	Evidence of floor damage around external perimeter. Check sub floor and clear if required after external works. Replace sub structure as required.	Prior to occupation	Carpenter / Builder	\$500.00
Bathrooms 3 and 4	Low	Inspect damp proof coursing and repair if needed. Check and clear sub floor as required after external works completed. Provide mechanical exhaust with light switching. Treat mould on walls prior to repainting.	Prior to occupation	Builder	\$10000.00

Room 14 timber flooring replaced at perimeter.

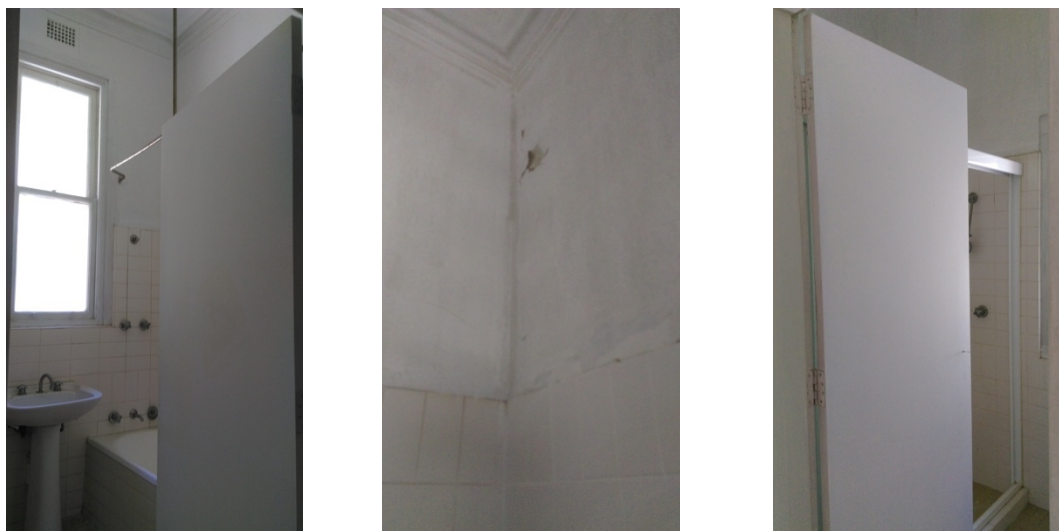
Bathrooms 3 and 4 mould damage in walls

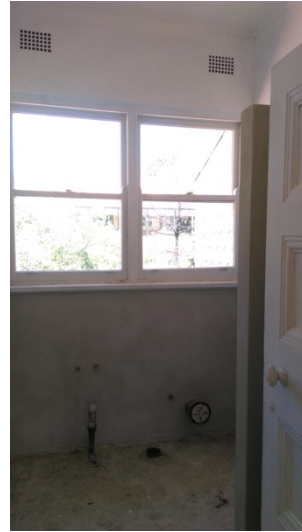
Bathroom 5

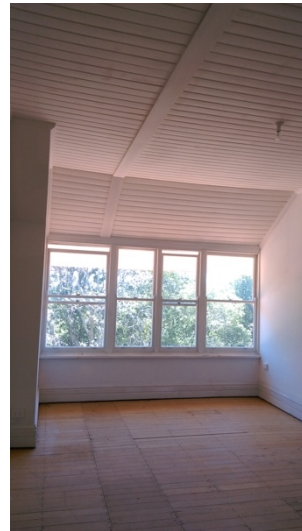
Room 18 sagging ceiling

Item	Heritage Significance	Works required	Timeframe	Specialist	Probable cost
Throughout	Moderate	Check and refix loose floor boards and ceiling boards throughout	Prior to occupation	Carpenter	\$2000.00
Throughout	Moderate	Painting	Prior to occupation	Painter	\$10000.00
Roof space	High	Provide bulk insulation to ceiling space R3	Prior to occupation	Builder	\$5000.00
Ceilings Room 18 and Hall 5	Moderate	Structural inspection of span and ceiling support Provide additional structural support as required	Prior to Occupation	Structural engineer Builder	\$4000.00 TBC
Bathroom 5	Low	Refit Bathroom for use using existing plumbing points.	Prior to occupation	Builder	\$20000.00
Bathroom 6	Moderate	Reline and finish room for storage room – do not reinstate bathroom. Remove plumbing fixtures. Retain remnant wall boarding within wall.	Prior to occupation	Builder	\$6000.00
