24 August 2018

Project No. 1786325-005-L-Rev3

**BIALA WIND FARM, CROOKWELL, NSW – ASSESSMENT OF TRENCHING ACTIVITIES**

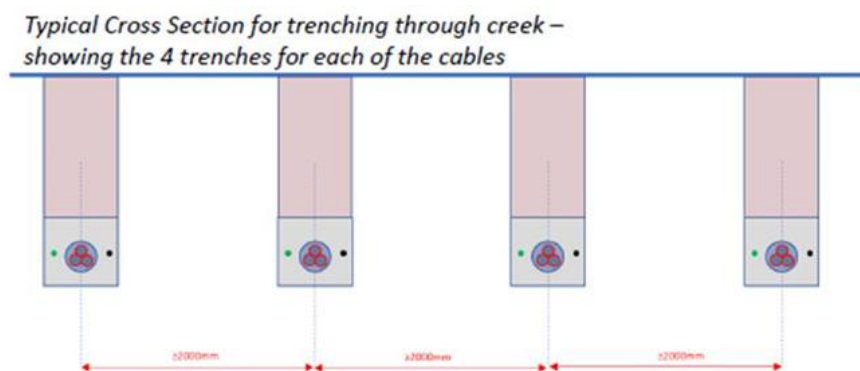
Figure 3: Trench Cross Section Specs (provided by Developments Biala)

The trench comprises of four power cables which influences the size and depth of the overall proposed trenching works. Developments Biala indicated to Golder that it is appropriate for the cables to be under the water table if necessary. Four cables are to be fitted into the single trench, each requiring a two meter offset as shown in Figure 3.

It is understood that based on these specifications, the entire trench to install the transmission line will need to be approximately 8 m in width and between about 0.95 and 1.4 m deep. Golder understands from Developments Biala that the trenching will be undertaken by a company that specialises in equipment that trenches, lays, and backfills the trench in a single pass. Therefore, it is understood that the time when the excavation is open is minimised.

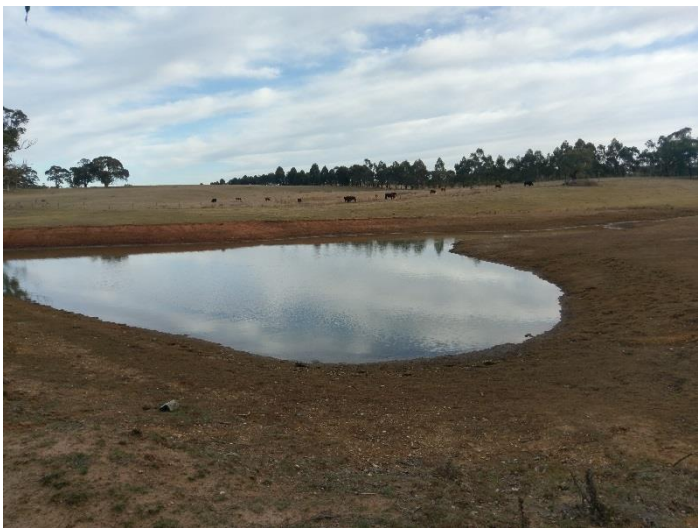
Photo Number	Brief Description and direction	Photographs
1	South of the reservoir – looking north west

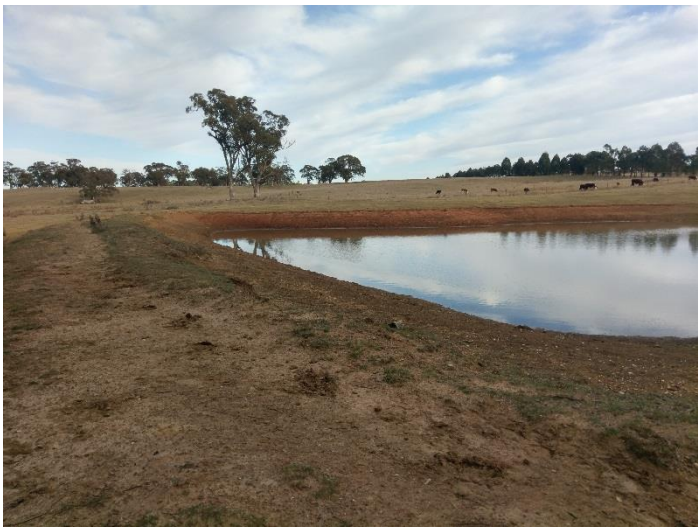
2	South of the reservoir – looking north west. Artificial dam impeding flow of Gurrundah Creek roughly 100m south of proposed trench

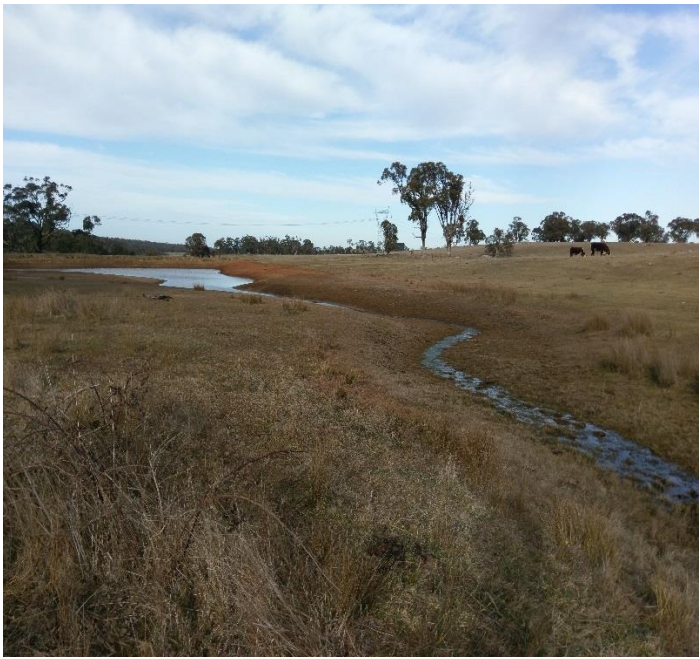
Photo Number	Brief Description and direction	Photographs
11	<p>Gurrundah Creek – looking south.</p> <p>Photo taken adjacent to where trenching would cross the Gurrundah Creek would occur.</p> <p>Almost dry, with intermittent flow</p>

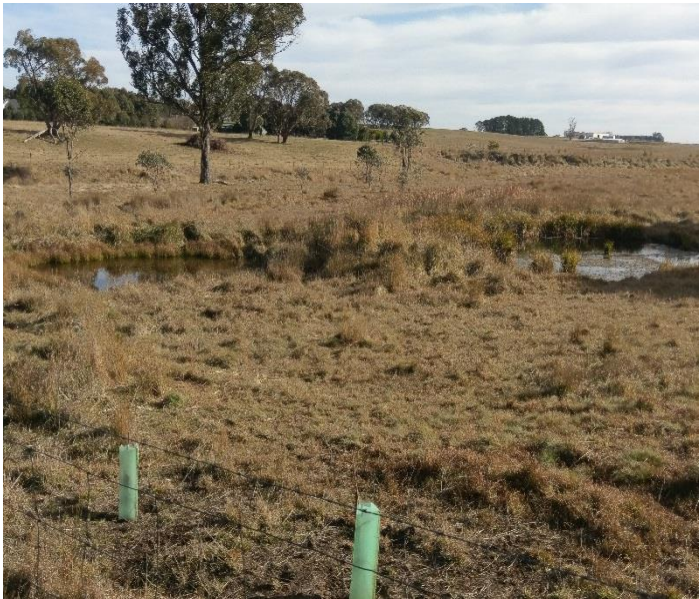
- Pond 1 and Pond 2 occur as surface depressions within a generally flat area. The ponds are of similar size, are round and roughly 2.0 m in diameter. An embankment separates the two ponds which may be artificial.
- Based on site visit and field photos it is estimated the top of water levels in Pond 1 and Pond 2 are roughly 1.0 m and 1.2 m below ground level (m bgl) respectively.

14	<p>Two Ponds (inferred spring locations) – looking northwest.</p> <p>Within 20 m disturbance zone</p> <p>Pond 1 on the left, pond 2 on the right.</p> <p>Estimated top of water in pond 1 is 1.0 m below surface level at this location</p>

- During trenching
  - Trenching to be undertaken by simultaneous trenching and filling.
  - Level of water in ponds to be monitored.
  - If open trenches are required, trenches to be monitored for volume of water flowing

- Trenches to be left open for the minimum possible time period
- Post trenching
  - Level of water in ponds and installed monitoring points to be monitored.

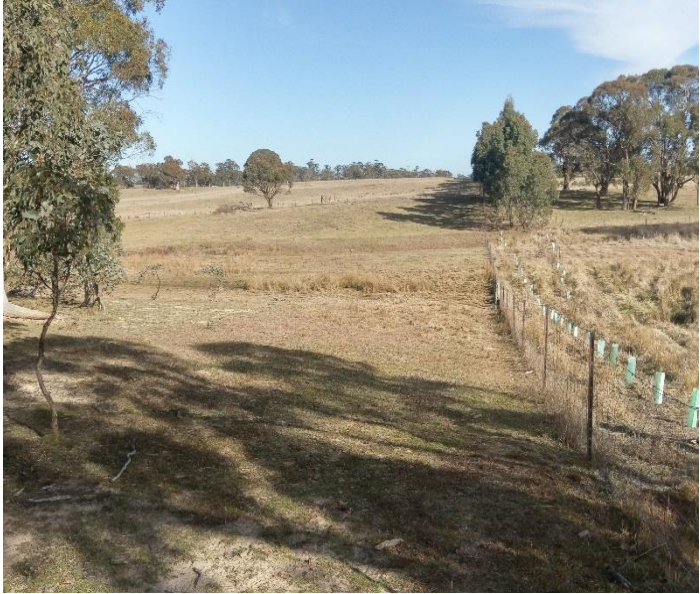
Photo Number	Brief Description and direction	Photographs
20	<p>Approximately 40 m to the east of the ponds – looking west</p> <p>Within the 20 m disturbance zone.</p>

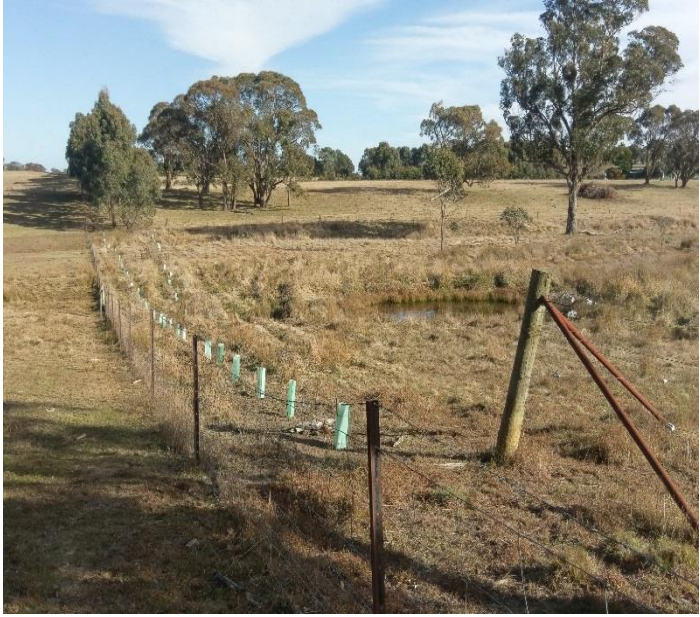
21	<p>Approximately 30 m to the east of the pond 1 – looking north west</p> <p>Within 20 m disturbance zone.</p> <p>Surface level between pond 1 where trenching would occur are relatively the same.</p>

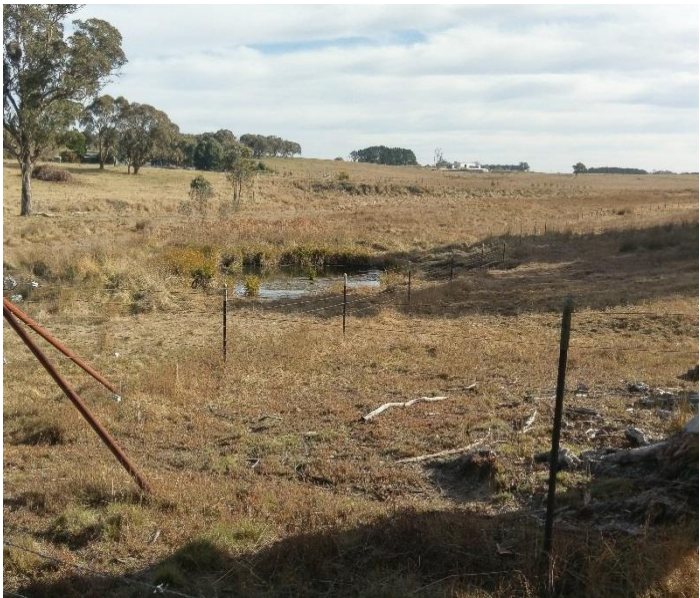
Photo Number	Brief Description and direction	Photographs
22	<p>Approximately 20 m to the east of the pond 1 – looking north</p> <p>Observing Pond 2.</p> <p>Barrier between Pond 1 and Pond 2</p> <p>Surface topography gently slopes to the south west.</p>

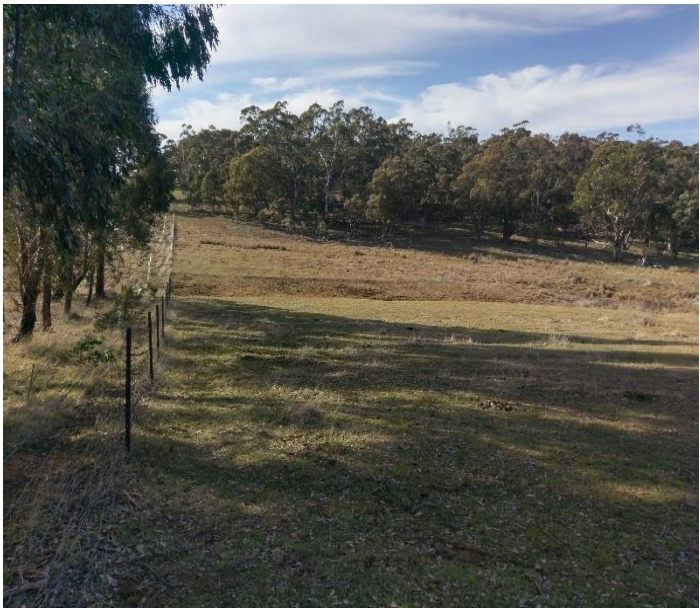
23	<p>Approximately 40 m to the west of the creek – looking east</p> <p>Within the 20 m disturbance zone.</p> <p>Topography gently sloping to the east in this location</p>

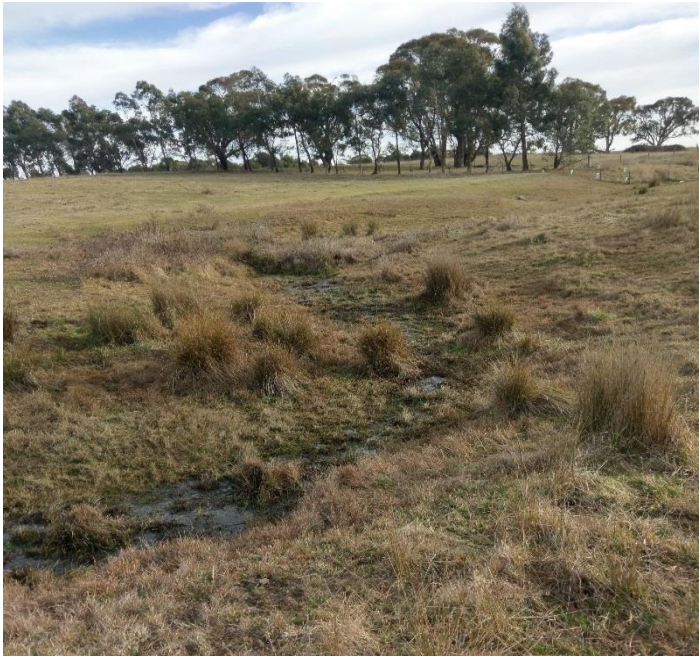
Photo Number	Brief Description and direction	Photographs
33	<p>Western side of the Gurrundah Creek, roughly 25 m south of the disturbance zone – looking north west.</p> <p>Low Creek levels with discontinuous flow and slight ponding.</p>
