## **Sub-division Tree Survey**

Bathurst Regional Council  
197 Limekilns Road Kelso  
Version #1  
20/07/17

**RE: Sub-division Tree Survey at property 197 Limekilns Road Kelso, 2795**

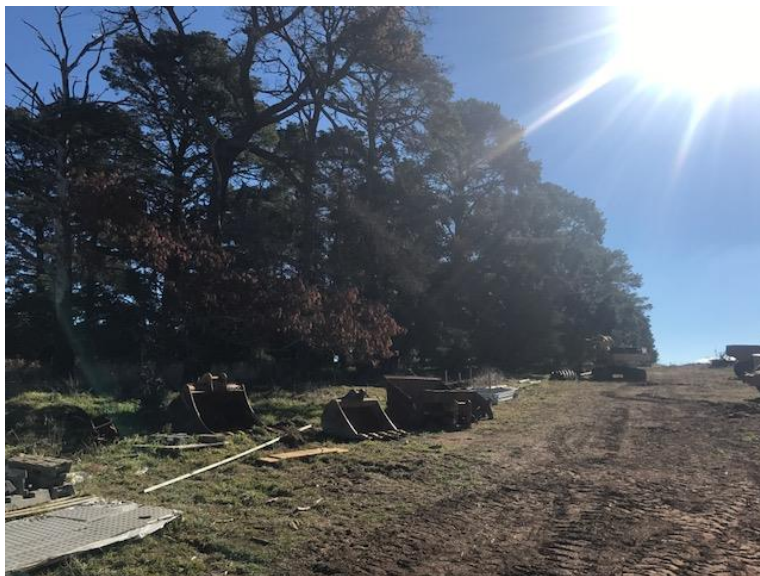
Figure 1

Part of the windbreak, consist of mature *Pinus radiata* trees

20% decline from drought stress. The trees are an estimate of 60 years old with a canopy of approximately average height of 25mtrs. The amenity value is currently medium to high as they are visible from the southern town boundary.

The Red zone A, B and C have been excavated within their structural root zone (SRZ). There are no cavities or hollows visible.

I highly recommend that all trees within Group 1, Group 2, Group 3 and Group 4 are removed in order to provide a newly planted street scape that can evolve from the newly cultural conditions.

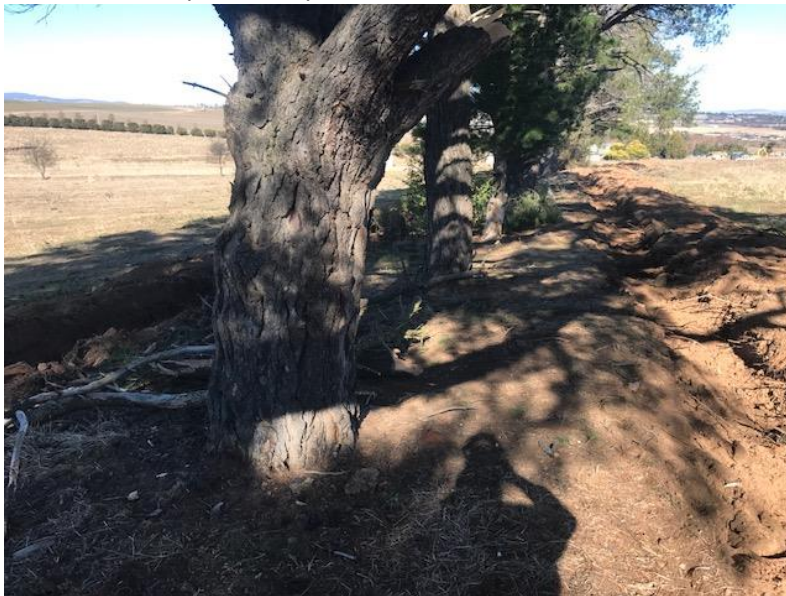
Figure 6:

**Red zone A**

Structural root plate compromised

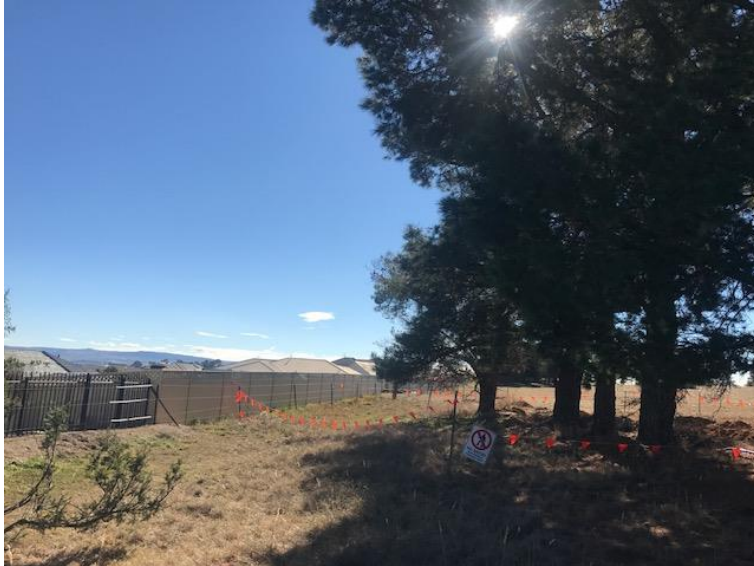
Figure 7

**Red zone B**

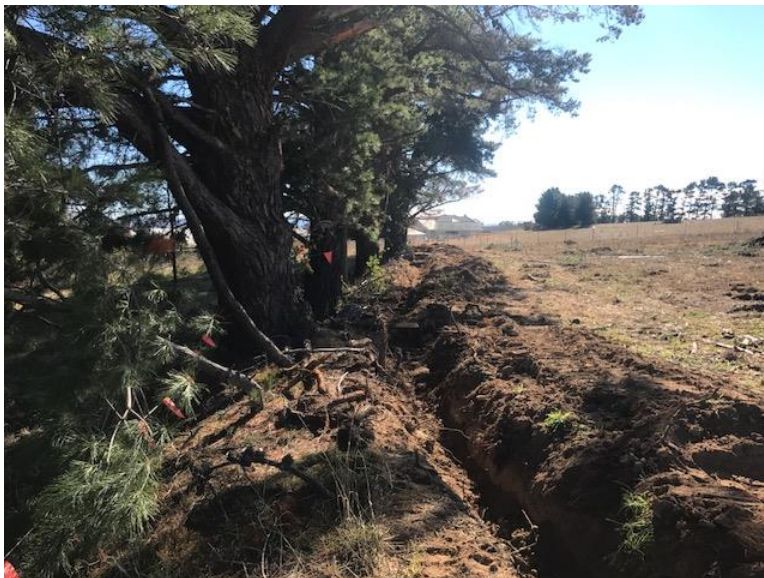
Figure 8:

**Red zone C**

The three trees identified in *Figure 8: Red zone C*, Group 1 with the potential to fall on neighbouring property to be removed as soon as possible

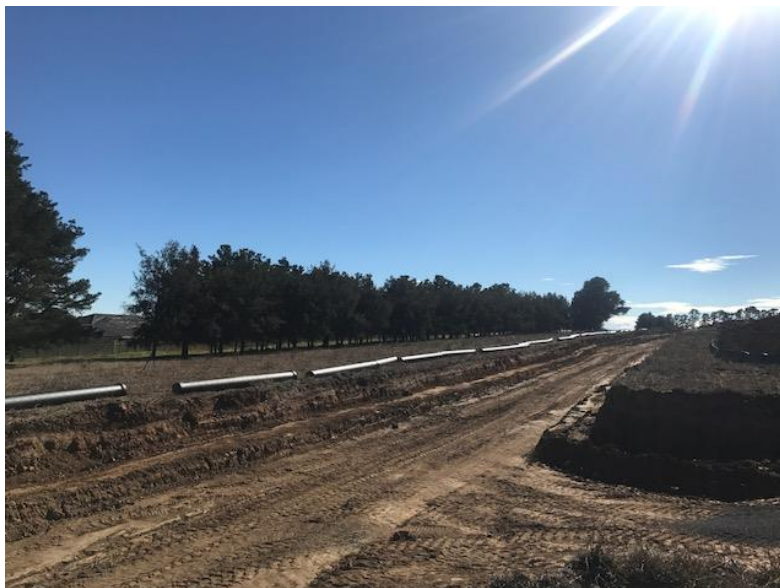
Figure 12:

Consisting of immature *Pinus radiata* and *Casuarina cunninghamiana* trees.

These three young grove plantings are closely planted as a temporary screening for the reservoir.  
The trees are too closely planted.

The *Casuarina cunninghamiana* trees are approximately 8mtrs tall and are overshadowed by the single row of *Pinus radiata* trees that stand approximately 12mtrs tall.

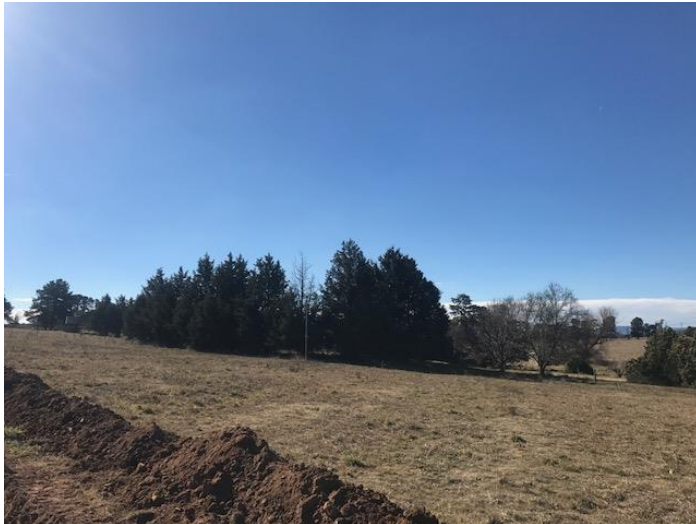
Figure 15:

Consist of *Cupressus macrocarpa*, *Cedrus deodara*, *Cupressus macrocarpa* 'aurea' and *Fraxinus raywoodi*

All of the *conifers* have suffered from drought stress. Average canopy height is approximately 10mtrs and represent a low amenity value. The only tree in good condition is the *Cedrus deodara*

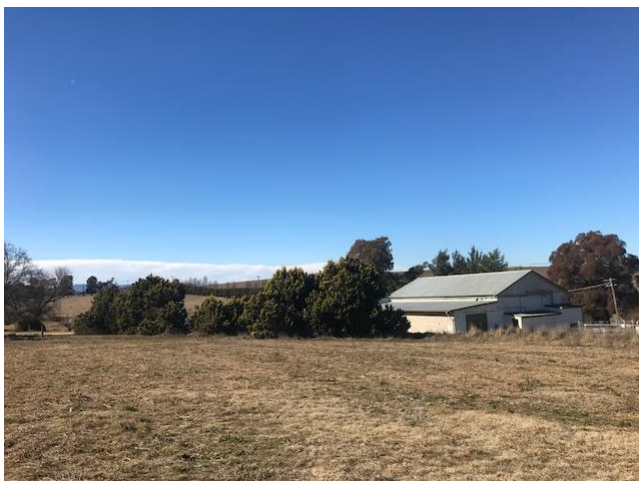
Figure 16:

Consist of *Eucalyptus Nicholii* and *Casuarina cunninghamiana*

The mature *nicholii* trees have evidence of recent storm damage and are in poor condition. The canopy height is approximately 18mtrs and represent a medium to low Amenity value

The *Casuarina cunninghamiana* are in fair condition and have a canopy height of approximately 18mtrs and represent a medium Amenity value

The trees located on the roadside (GROUP 4) are predominantly mature *Eucalyptus nicholii* trees and have a history of branch failures and have included bark regions in trunks.

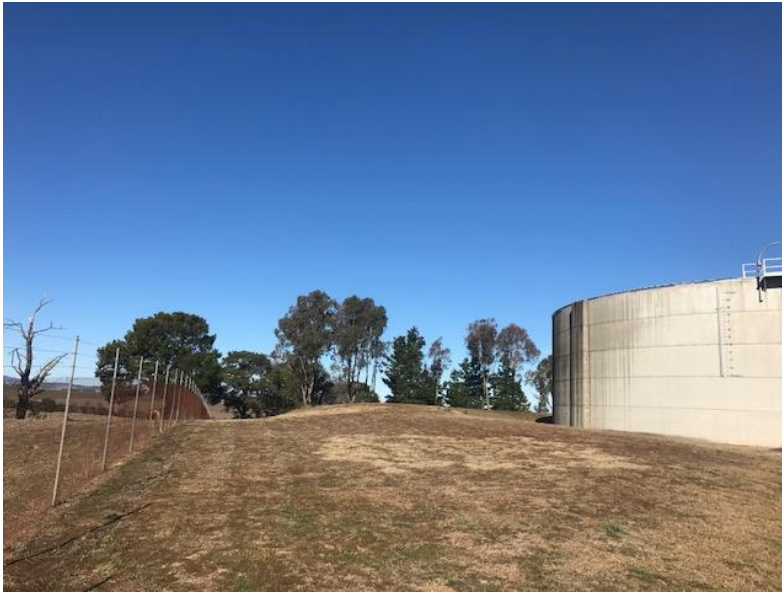
Figure 17:

Consist of seedlings of *Pinus radiata* trees. The canopy height is approximately 12mtrs and represent a medium to high Amenity value

The endemic trees, *Eucalyptus goniocalyx* within Group 5 are to be retained and *Pinus radiata* seedlings to be removed and additional native vegetation to be planted in order to screen the water tank.

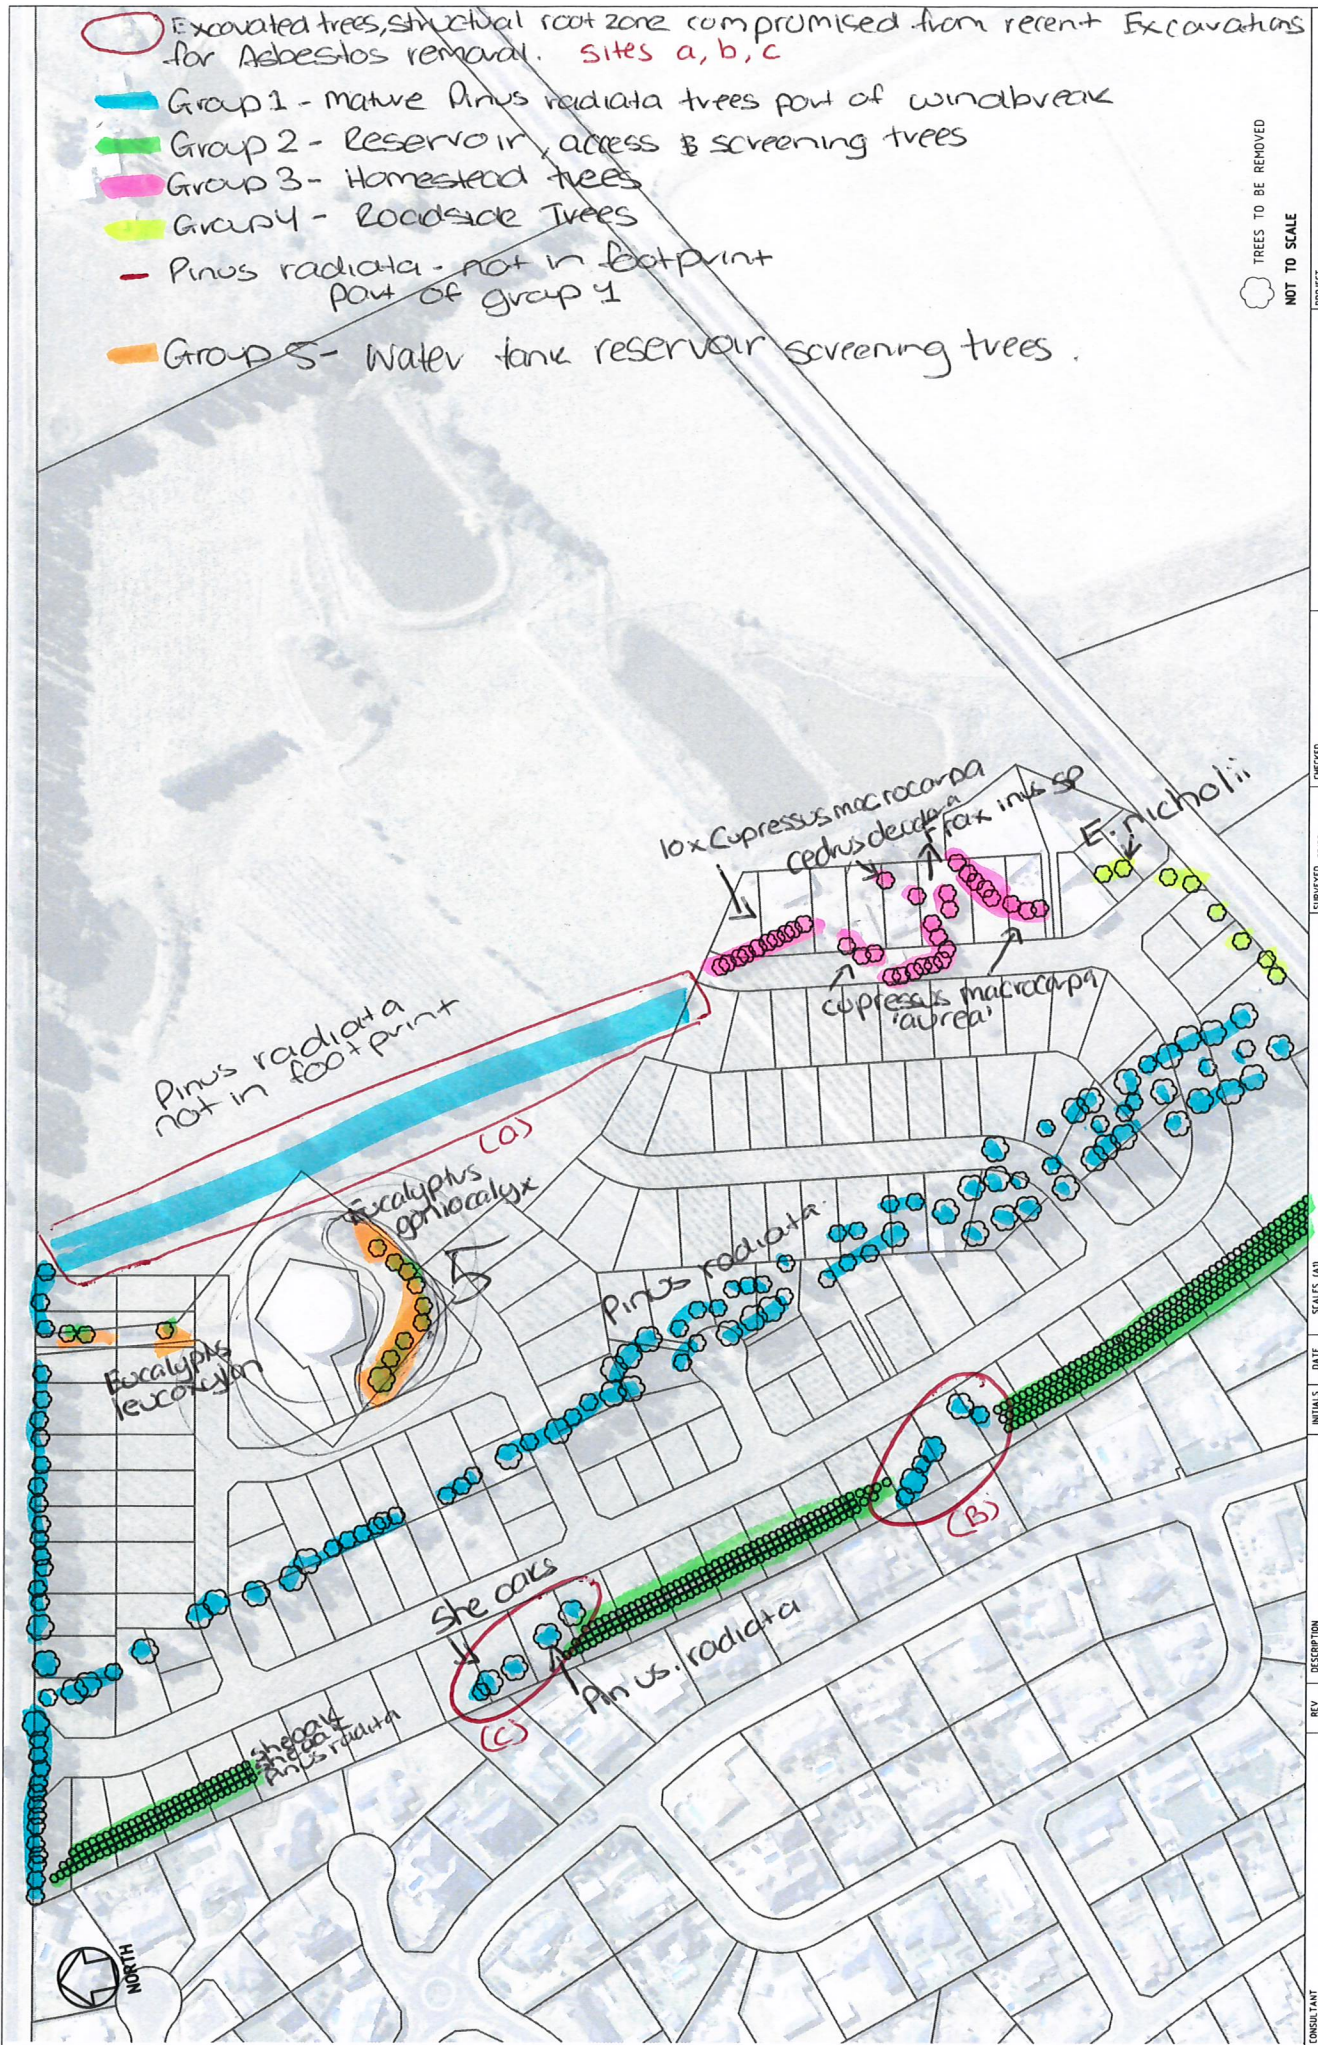
DESCRIPTION  
TREES LAYOUT

Excavated trees, structural root zone compromised from recent Excavations for Asbestos removal. Sites a, b, c

TREES TO BE REMOVED
