Our Ref: 217032_STR_002a.docx

12 August 2016

WELLINGTON SWIMMING POOL – STRUCTURAL CONDITION ASSESSMENT. FULL REPORT.

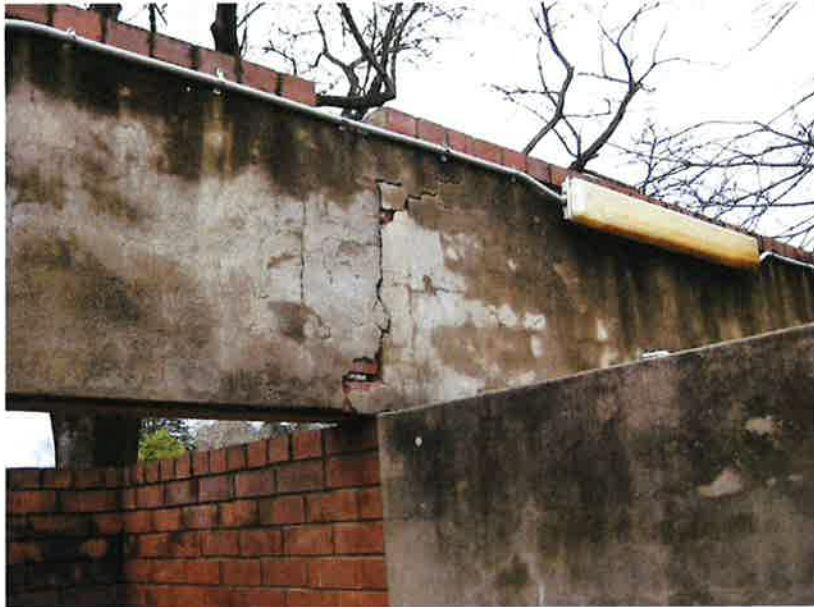
1. The wall around and over the poolside entrance to the men's change room is cracked, loose and dangerous. The wall above the entry is badly broken up and in danger of collapse. We recommend the following:
 - At a minimum, the wall above the lintel level (approx. 2.3 m) needs to be removed. This should include the wall over the entrance, above the urinal and above the sinks. As an alternative, the wall could be removed just above the entrance, however both sides will need supporting through the addition of steel posts on both sides of the opening where the door frames would be (if there were a door in the space). This action will provide a short term fix to the problem and make the change room temporarily safe.

- A better, and long term, solution is to replace the entire wall of the men's changing room, together with the urinal and wash hand basins. The wall and floor in this area is badly affected by the tree roots and has multiple cracks. The movement of the urinal is to the extent that hygiene is affected and it is likely that the drainage pipes have broken or cracked.

Figure 1: The pool side entrance on the men's changing room.

The underlying cause of the movement in the men's changing room wall is the large tree nearby, visible in the background of the photograph. We recommend that consideration be given to installation of a root barrier beside the building to limit on-going damage. This will require consultation with a tree specialist to avoid damage to the tree. Removal of the tree would also be an option.

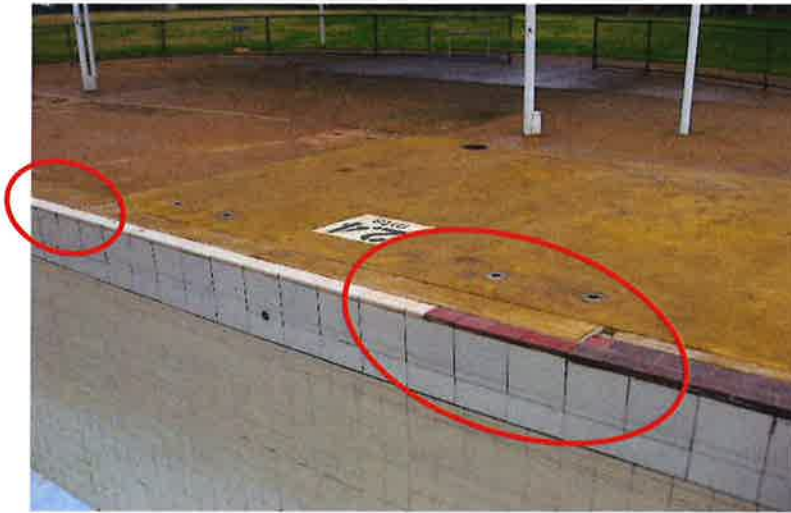
2. The deep end wall of the Olympic pool is unstable. The top metre or so of the pool wall is loose and can be moved by hand in 2 locations along the deep end wall. In its current condition, it is possible that a swimmer in the pool could unintentionally pull the side of the wall into the pool, injuring themselves or others. This is a serious safety risk.

Figure 2: The circled areas of the Olympic pool deep end are both loose.

Note: The assessment of the end wall of the pool is based on the engineer's ability to visibly move the end wall by hand during the inspection. This probably indicates the wall is weak and could break, but it is possible that the wall is still much stronger than anticipated. If a high amount of force is applied and the wall does not break or significantly move, this repair may be unnecessary. However we would recommend monitoring the edge for future deterioration.

We have detailed a temporary repair to the side of the pool. This is included in appendix B to this report. This temporary repair is cheaper and easier to complete and will be suitable for a period of 2-3 years until the more substantial works required on the pool can be determined.

A more permanent repair is as follows:

- Break off the loose parts of the wall. This can be done with a crow bar or similar. We expect that two 2-4 metre sections 300 mm to 1 m deep will be able to be broken off. A jack hammer may be required to remove the concrete from around the reinforcement.
- Clean off the break lines with a jack hammer. Cut off and remove rusted or bent reinforcing steel. If steel is rusty at connection, additional concrete may need to be removed.
- Drill and chemset in place new reinforcing steel for the swimming pool wall patch.
- Form and pour a new concrete wall.

- Tile over patch and finish.

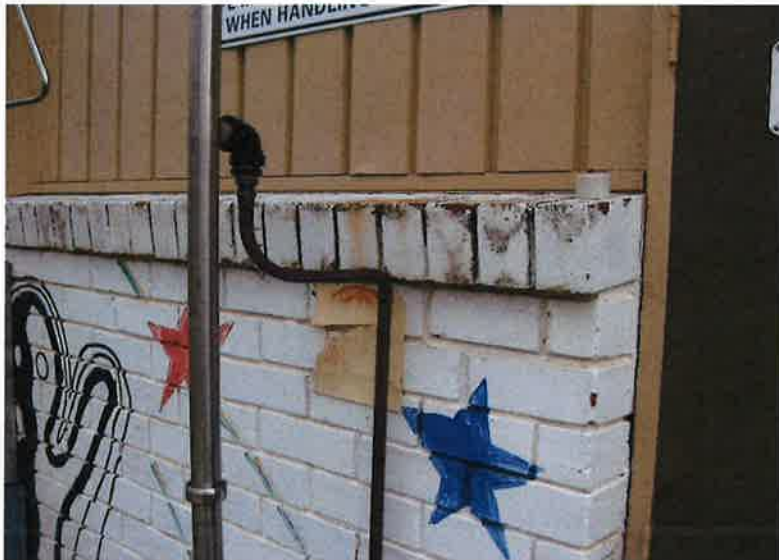
3. The brick wall of the pump house beside the door is loose and could easily collapse if someone pushed hard on it. This part of the wall needs to be demolished and rebuilt with proper support.

Figure 3: This brick wall is loose and unstable. (entry to pump house)

The wall appears to be a stud frame construction with brick veneer. We believe the stud frame is adequate, thus just the brick section needs to be fixed. If required, the bricks could be replaced with external cladding.

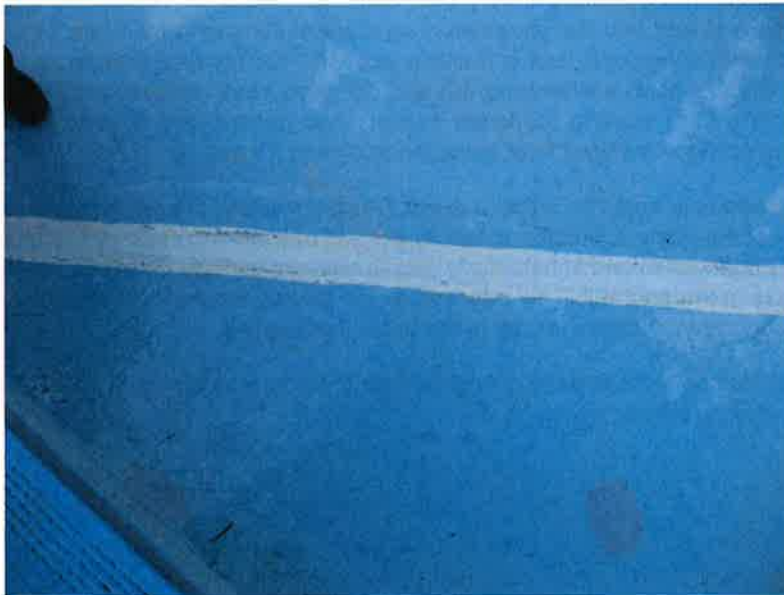
- 1 new crack in fibre glass near old, 0.4 mm wide.

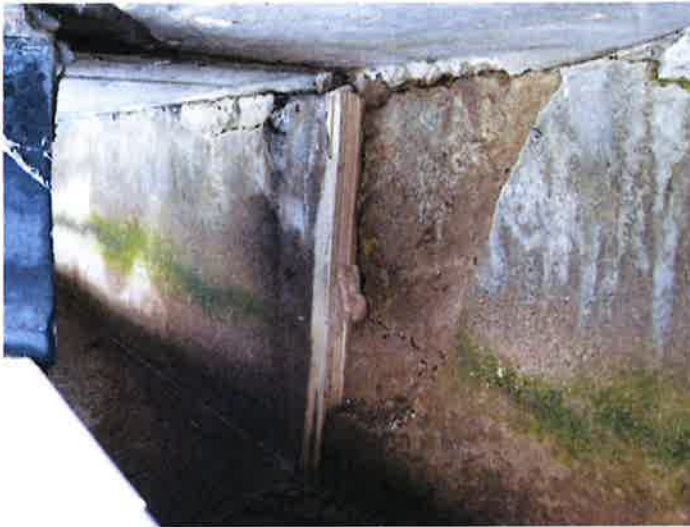
- A number of tiles on the walls are cracked. – especially East wall (deep end)

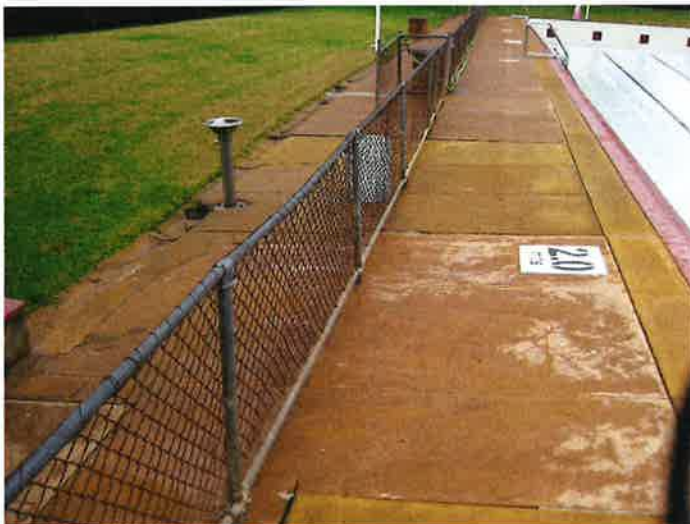
- At 2.0 m marker (joint) on south side – ground subsidence suggests leak. Leak could be from balance tank or pool. Subsidence has damaged corner of pump house (out of picture to the left). From the other side of the pool, the dip in the fence line shows the degree of subsidence.
- crack at mid deep end wall (vertical)
- Pool attendant reports bubbles emerge from filling holes in side of back wall during back wash operations, suggesting a void behind the deep end pool wall.

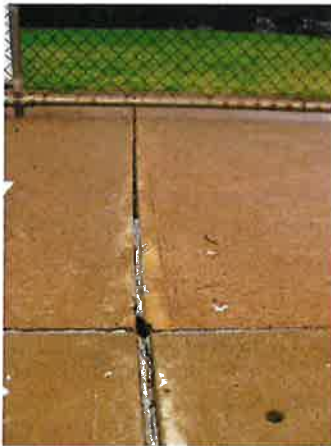
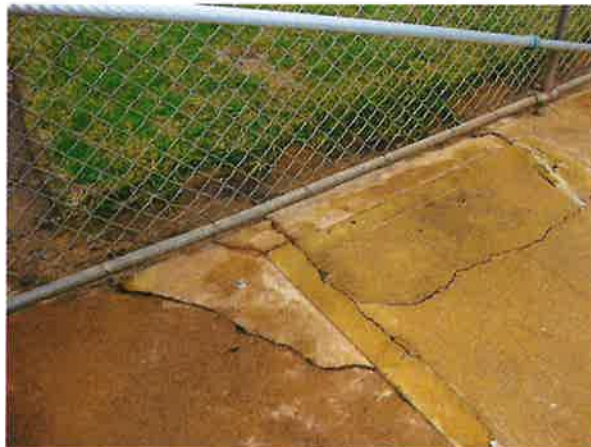
Multiple paths and concrete slabs have moved. Trip hazards need to be ground off, gaps filled and broken corners patched and replaced.

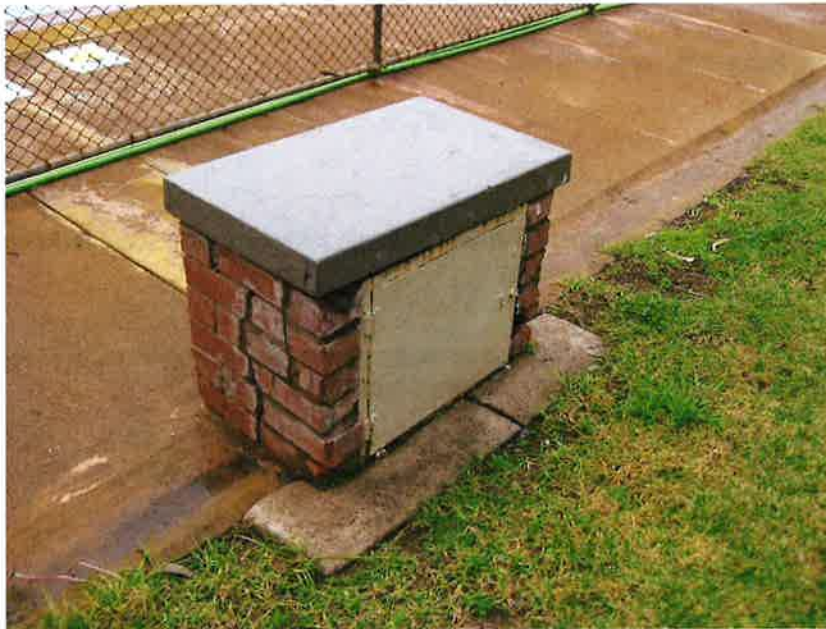
This electrical box was built over an expansion joint and thus has cracked. It needs to be move or demolished.

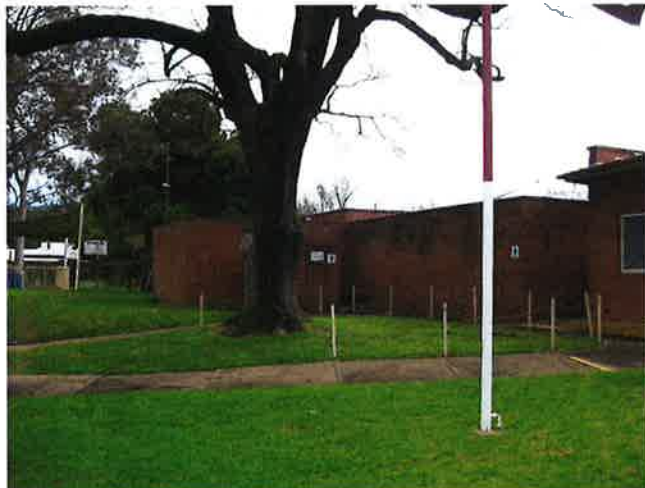
- This tree near the entrance has affected the concrete paths around and the mens change room. For long term repairs, or for a new change room, consider a root barrier between the tree and the building. Please consult a tree specialist to avoid damage to the tree.

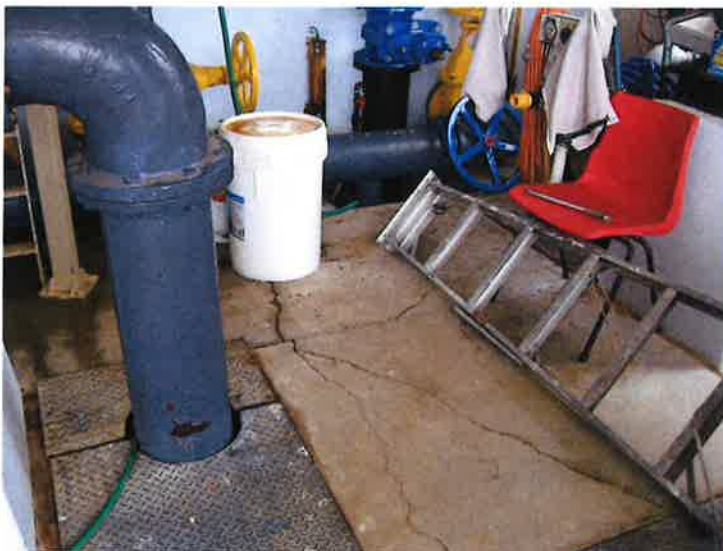
- Pipes rusty and near end of life. Trip hazards, etc.
- Tank is cracked, probably leaks – putty, etc. to fill
- Brick wall by door very loose and unsafe (see in front section of report for repair).

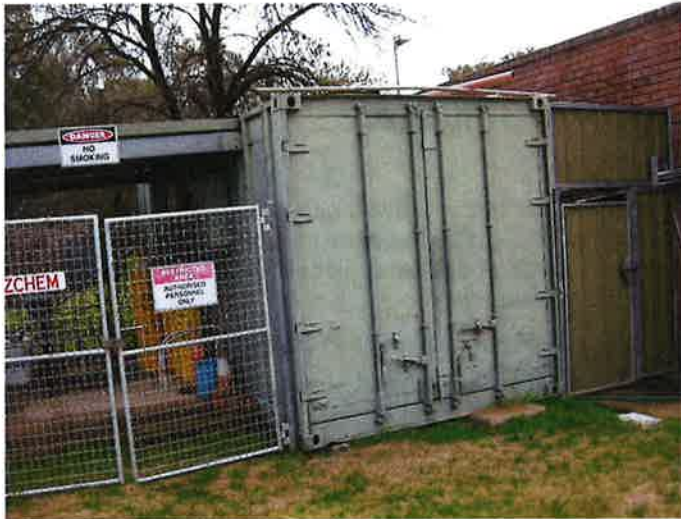
- Chlorine store room is old shipping container – leaks, sits on the dirt, will rust quickly. Fence around chlorine may not be adequate for safety.
- Valve pit often full of water.

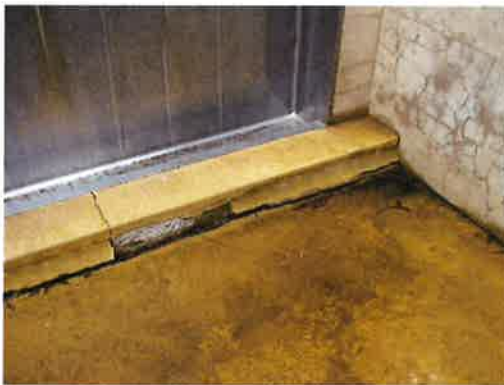
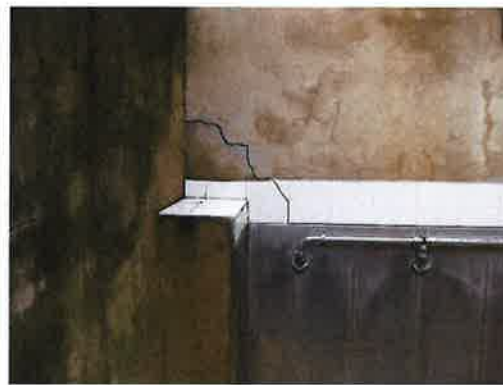
- The cracks around the urinal affect the drainage and sanitary conditions. This is integral with the wall which needs replacing.

- Need to re-build whole wall (long term). Make safe in short term – consider remove wall above plaster line at 2.2 – 2.4 m

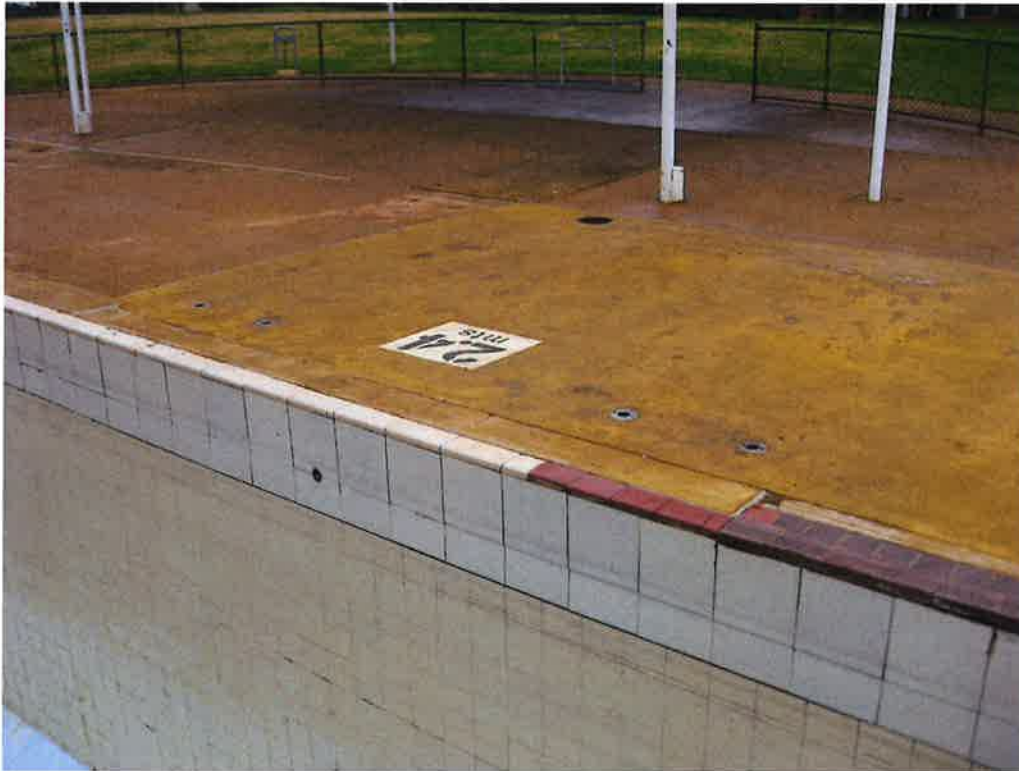
Appendix B Urgent temporary repair to swimming pool edge

The purpose of this repair is to secure the edge of the pool back to the ground behind so that a swimmer cannot accidentally pull the wall down onto themselves. This repair is temporary repair and is safe for 3 years. After 3 years it will need reassessment to determine on going effectiveness or alternative repairs.

1. Drill hole through yellow slab beside pool to determine thickness.
 - a. If slab is 150mm or thicker, use method 1 (or method 2)
 - b. If slab is less than 150mm thick, use method 2.
