## Hazardous Construction Materials Survey

65 – 71 Kerrs Road, Lidcombe NSW

5 October 2018

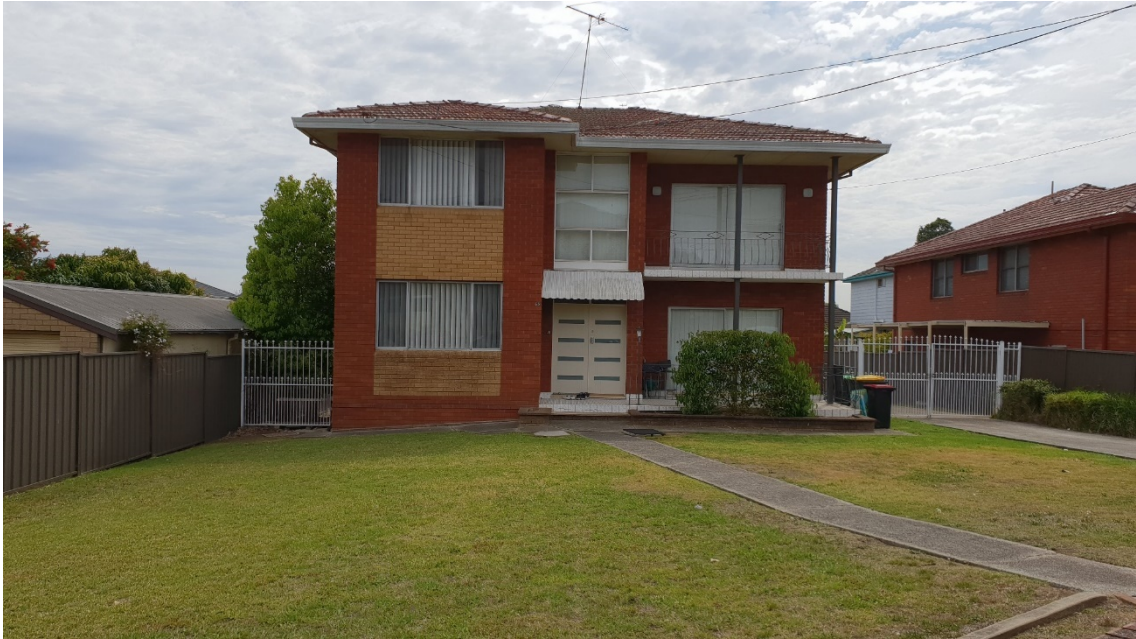
**House at 65 Kerrs Road, Lidcombe NSW**

The house located at 65 Kerrs Road is a two-storey building that has terracotta roof tiles, face brick veneer cladding to the external walls, aluminium and timber framed windows and entry doors, asbestos cement sheet eaves and upper level front verandah soffit linings, metal eaves fascia guttering and metal downpipes.

- The eave linings to the perimeter of the upper level and soffit lining over the upper level verandah are flat asbestos cement sheet. See upper photograph and photograph Nos. 1 and 2.
- The backing board in the electrical meter cabinet on the western wall near the front of the house is a 'Zelemite' board that contains chrysotile asbestos. See photograph No. 3.

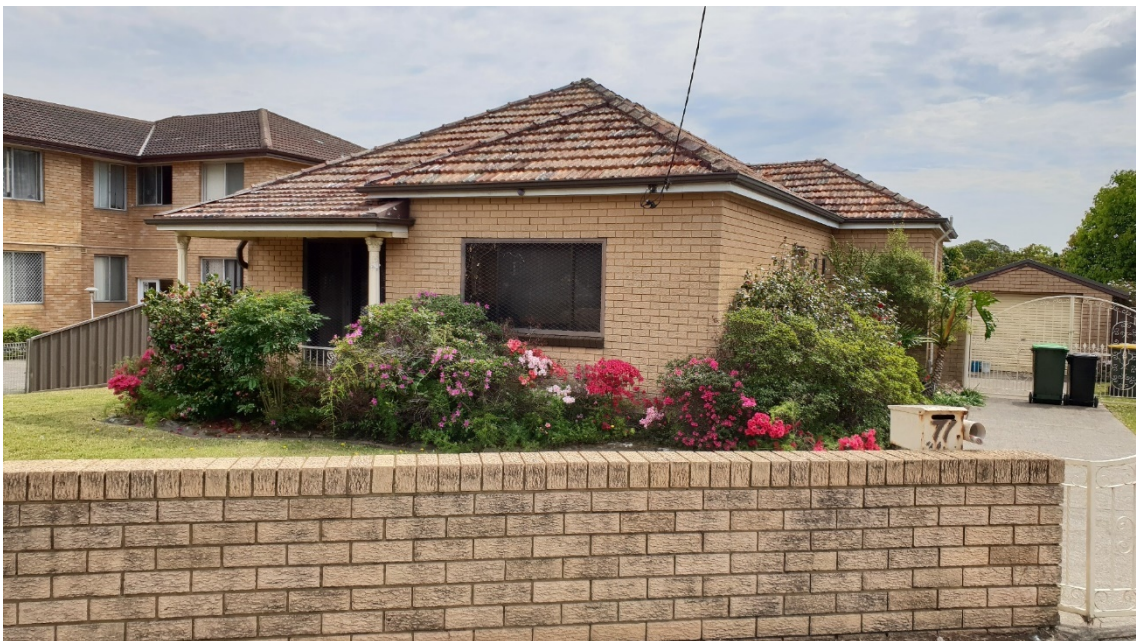
### **House at 71 Kerrs Road, Bexley NSW**

The house on the property at 71 Kerrs Road has terracotta roof tiles, flat asbestos cement sheet wall cladding that has been over-clad with face brick veneer, flat asbestos cement sheet eaves linings, aluminium and timber framed windows and entry doors. The interior of the house was unable to be accessed and is likely that the ceiling and wall linings will be fibrous plaster and flat asbestos cement sheet and the floors will be timber boards or concrete slabs.

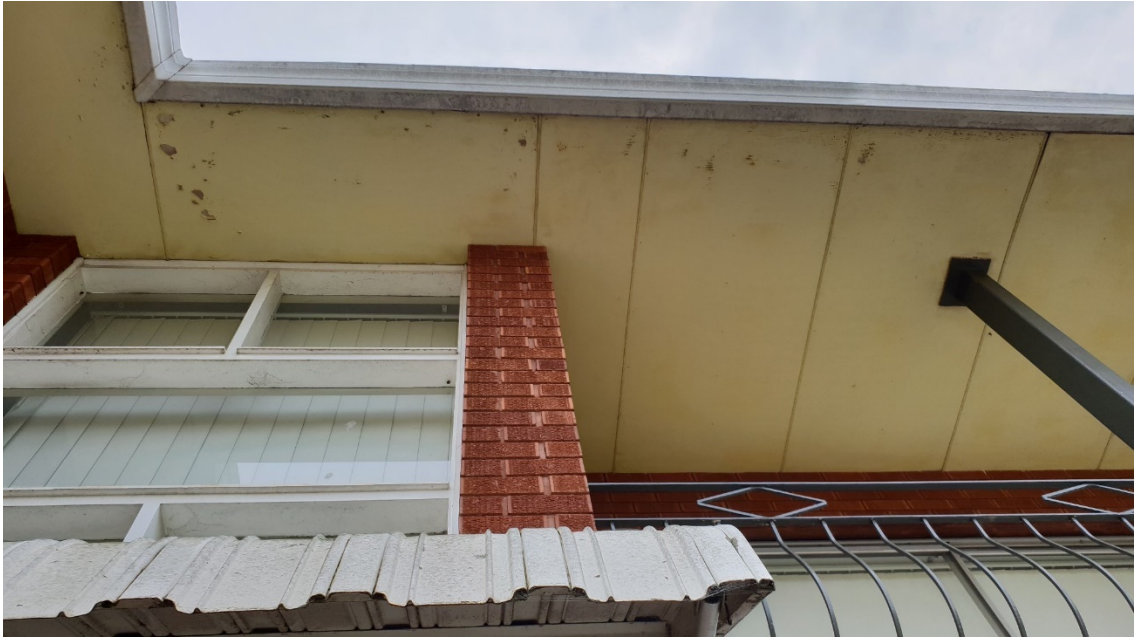
**Photograph No. 1: Asbestos cement sheet eave and upper level verandah soffit lining on the front of the house at 65 Kerrs Road, Lidcombe NSW**

All hazardous construction materials located within the buildings and on the ground areas within the site are to be removed prior to or in conjunction with the proposed demolition work. All identified asbestos containing construction materials in the buildings at the site are classified as non-friable asbestos containing materials. These asbestos containing materials may only be removed by a contractor holding a Class A licence for friable asbestos removal or a Class B licence for non-friable asbestos removal.

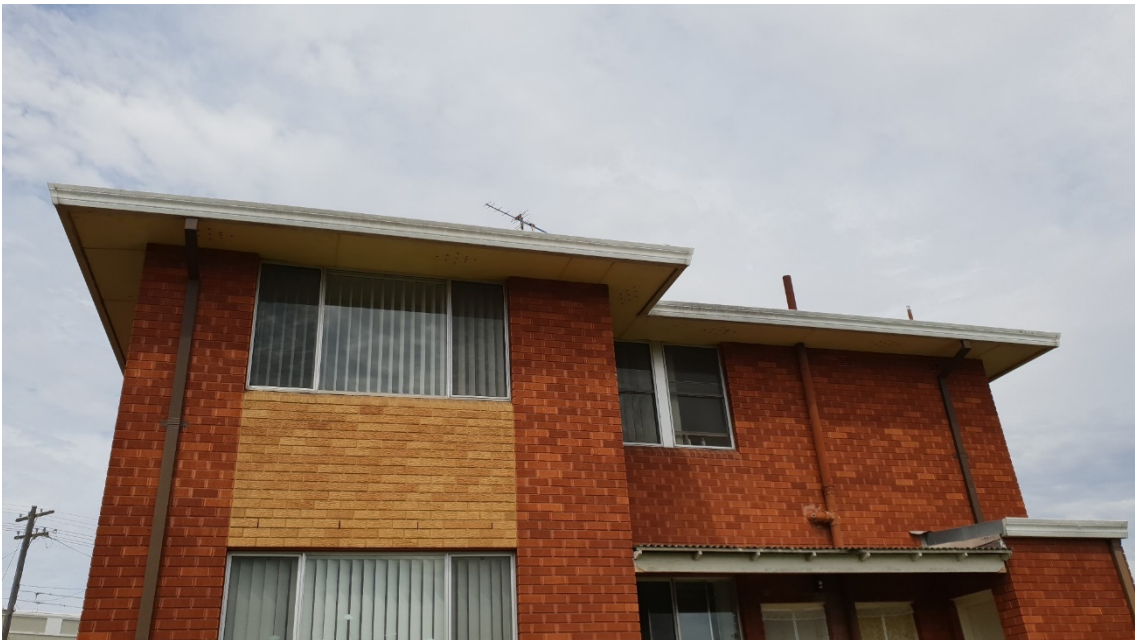
**Photograph No. 2: Asbestos cement sheet eaves soffit lining on the rear of the house at 65 Kerrs Road, Lidcombe NSW**

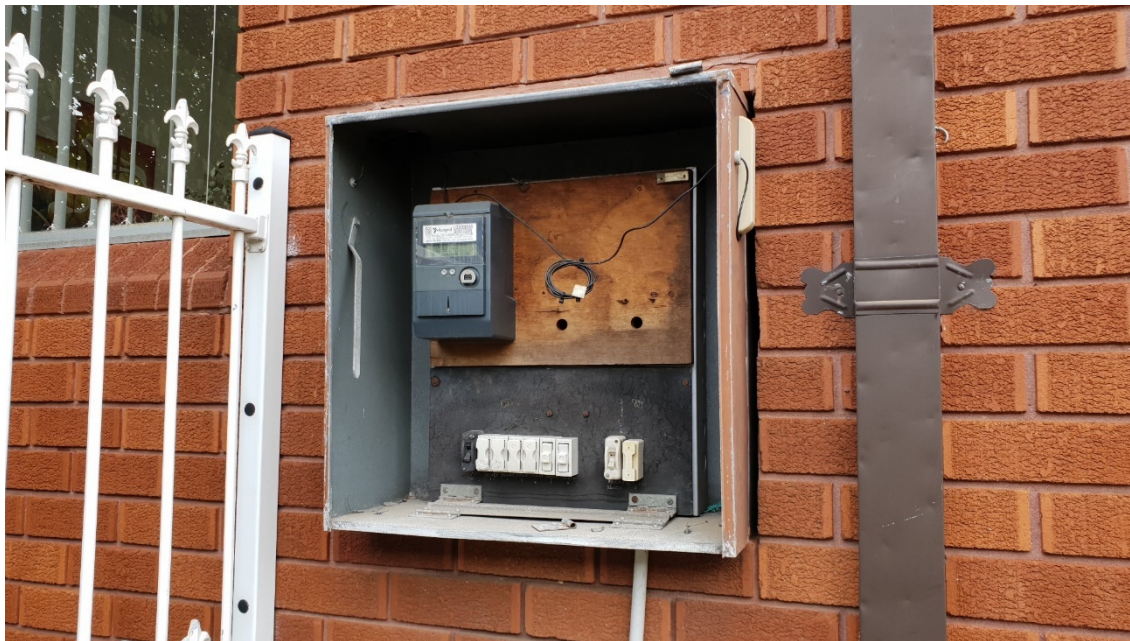
**Photograph No. 3: Asbestos based 'Zelemite' electrical backing board  
in electrical meter cabinet at 65 Kerrs Road, Lidcombe NSW**

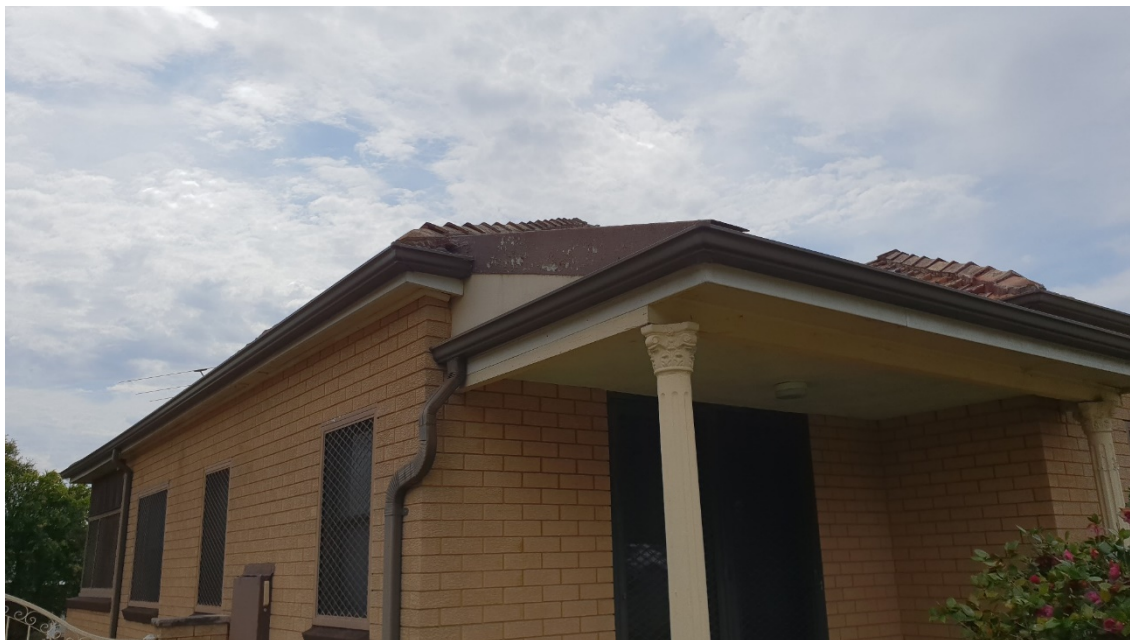
- The capping on the sides of the skillion roof over the front verandah are moulded asbestos cement. See photograph No. 4.
- The cladding on the external walls of the house is flat asbestos cement sheet. This cladding has been over-clad with face brick veneer. See photograph No. 5. The cladding on the small dutch gables on the ends of the front verandah are flat asbestos cement sheet.

**Photograph No. 4: Moulded asbestos cement capping to west side of roof over the front  
verandah. The small dutch gable is clad with flat asbestos cement sheet**

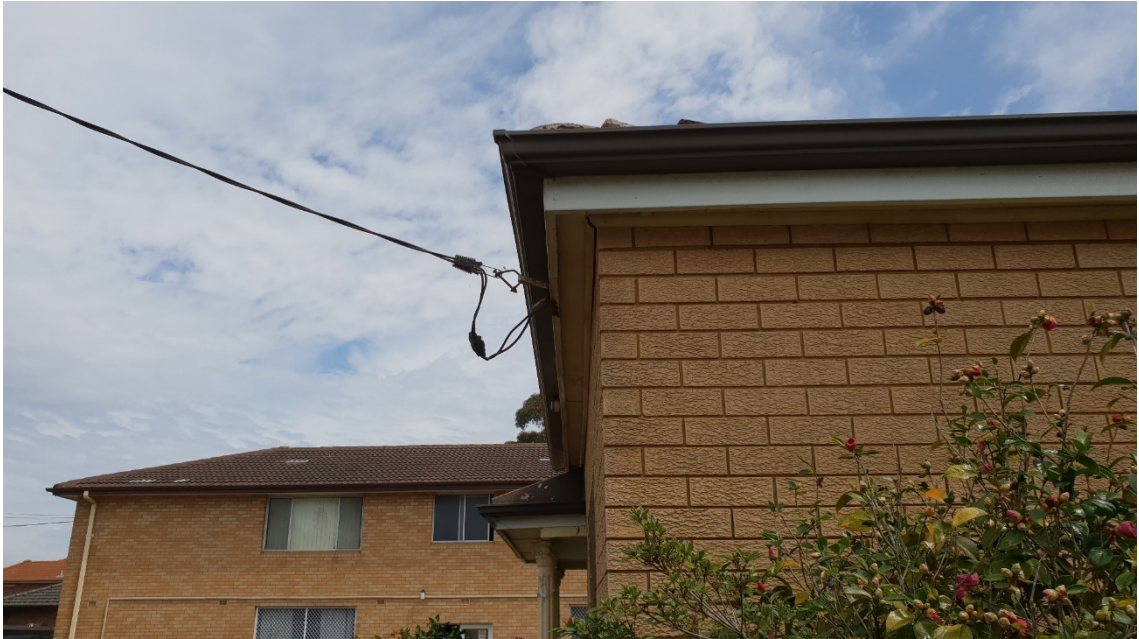
- The eaves linings to the perimeter of the house and soffit linings to the east side entry porch and to the front verandah are flat asbestos cement sheet. See photograph No. 5 and 6.

**Photograph No. 5: Narrow flat asbestos cement sheet eave lining on house at 71 Kerrs Road, Lidcombe. Most of the eave lining and the asbestos cement sheet wall cladding is concealed behind the brick veneer wall cladding**

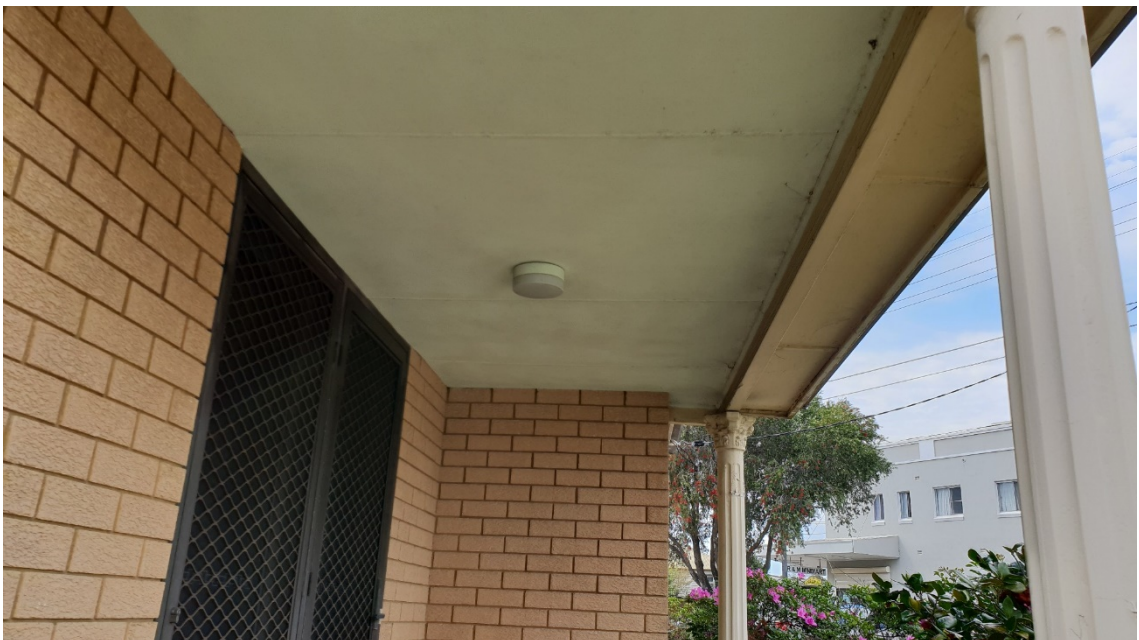
**Photograph No. 6: Asbestos cement sheet soffit lining over the front verandah at 71 Kerrs Road, Lidcombe NSW**

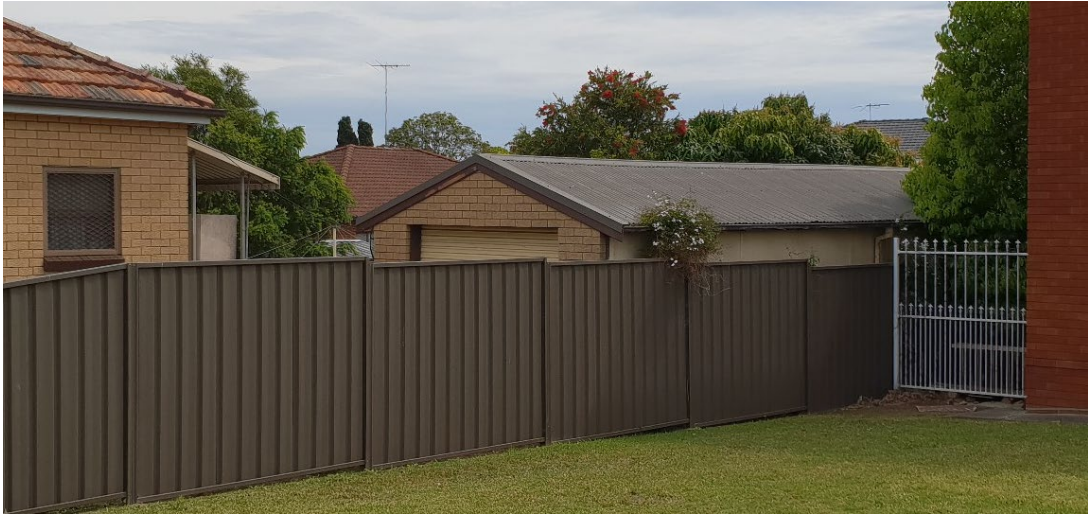
- The wall cladding on the garage in the rear yard area is flat asbestos cement sheet. See photograph No. 7. The front wall of the garage is covered with brick veneer.

**Photograph No. 7: Garage at 71 Kerrs Road, Lidcombe  
that has flat asbestos cement sheet wall cladding**

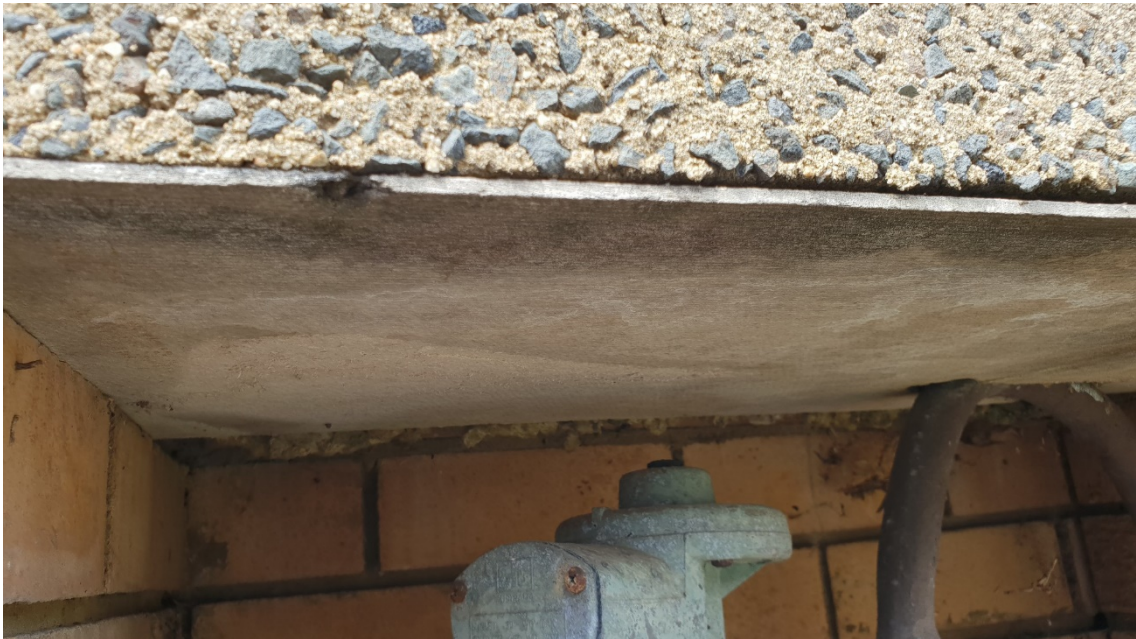
- The wall cladding on the shed in the centre of the rear yard area is assumed to be flat asbestos cement sheet.
- The substrate to the concrete top over the gas meter adjacent to the front fence is flat asbestos cement sheet. See photograph No. 8.

**Photograph No. 8: Flat asbestos cement sheet substrate to  
concrete lid over gas meter at 71 Kerrs Road, Lidcombe**
