NSW Police Force C/- Brookfield Global Integrated Solutions
NSW Police Force Hazardous Materials Surveys
Taree Police Station and Demountables
83 Albert Street, Taree NSW 2430

Date of Inspection: 2 November 2016

Date of Issue: 2 February 2018

Client: NSW Police Force C/- Brookfield Global Integrated Solutions
Title: NSW Police Force Hazardous Materials Surveys
Subtitle: Taree Police Station and Demountables
83 Albert Street, Taree NSW 2430
Document No: 0326_HBMR_02022018
Date of Inspection: 2 November 2016
Date of Issue: 2 February 2018

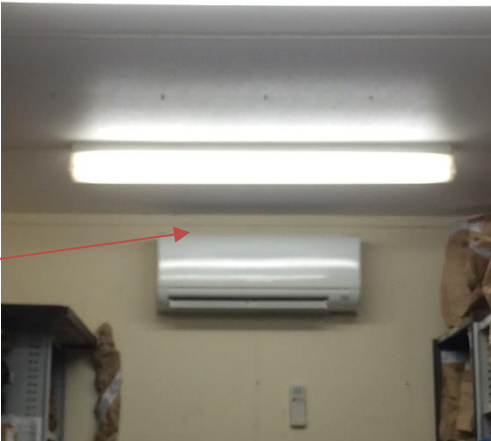
<p>Photo 5: Internal Police Station; Filing Room – Refrigerant gas within Daikin air conditioning unit – ODS (A4)</p>	<p>Photo 6: Internal Police Station; Muster Room – Refrigerant gas within Daikin air conditioning unit and Refrigerant gas within Fujitsu air conditioning unit – ODS (A4)</p>

ODS	Visual observation	HFC	5	Refrigerant gas within Daikin air conditioning unit	Internal Police Station; Filing Room	1 unit	NA			G	Y	L				L	A4	WSP PB 2016: Item in good condition, leave and monitor condition		
ODS	Visual observation	HFC	6	Refrigerant gas within Daikin air conditioning unit	Internal Police Station; Muster Room	1 unit	NA			G	Y	L				L	A4	WSP PB 2016: Item in good condition, leave and monitor condition		
ODS	Visual observation	Suspect HFC	6	Refrigerant gas within Fujitsu air conditioning unit	Internal Police Station; Office off Muster Room	1 unit	NA			G	Y	L				L	A4	WSP PB 2016: Item in good condition, confirm, leave and monitor condition		
ODS	Visual observation	Suspect HFC	7	Refrigerant gas within Lemair air conditioning unit	Internal Police Station; Filing Room	1 unit	NA			G	Y	L				L	A4	WSP PB 2016: Item in good condition, confirm, leave and monitor condition		
PCB

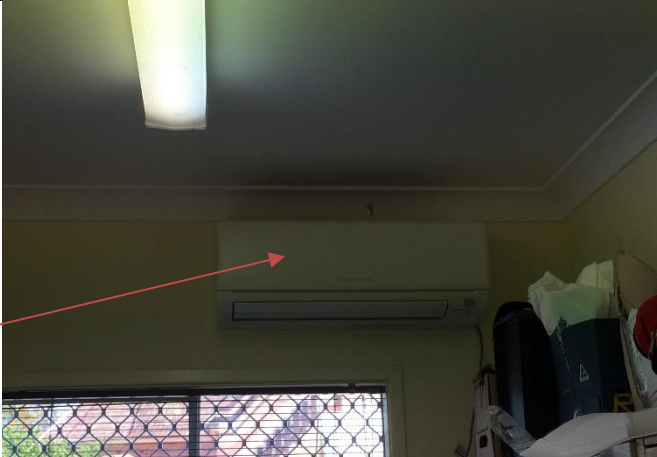
<p>Photo 7: Internal Police Station; Filing Room – Refrigerant gas within Lemair air conditioning unit – ODS (A4)</p>	<p>Photo 8: External and Internal: throughout all buildings – Suspect PCB Capacitors (A4)</p>

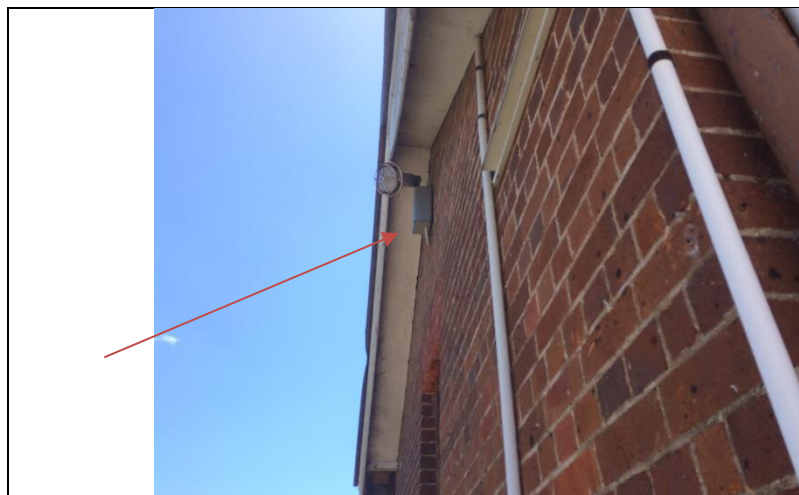
Photo 9: Highway Patrol Office – External; Eaves, north and south – Suspect asbestos cement lining (A4)

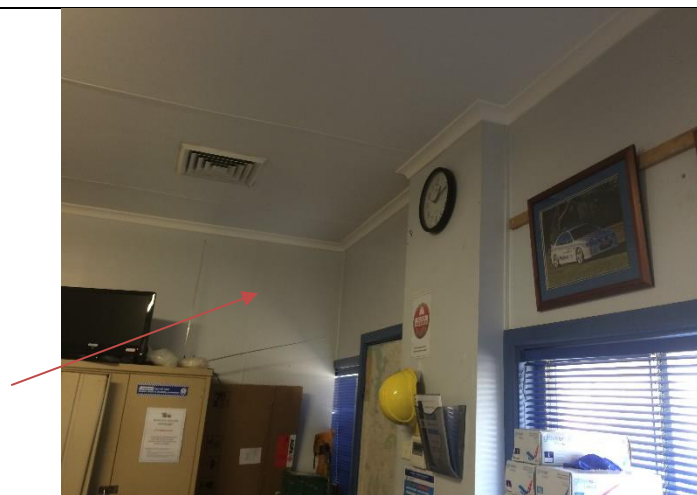
Photo 10: Highway Patrol Office – Internal; Constables Office, walls and ceiling – Asbestos Fibre cement lining (A3)

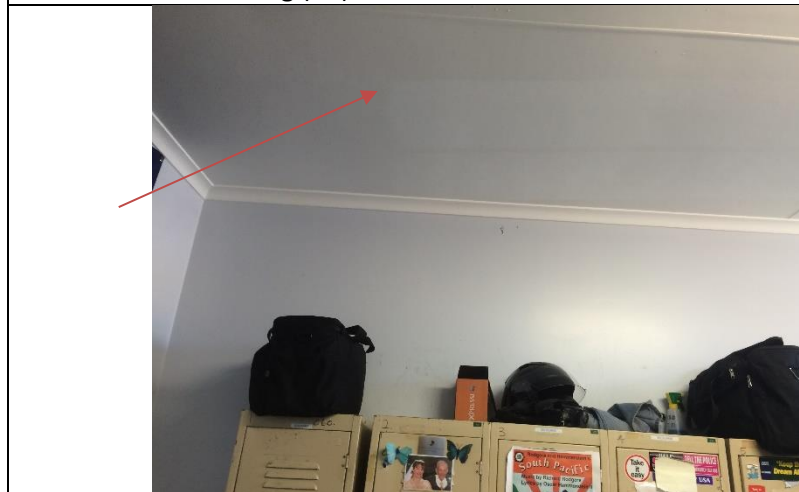
Photo 11: Highway Patrol Office – Internal; Sergeants Office, walls and ceiling – Asbestos Fibre cement lining (A4)

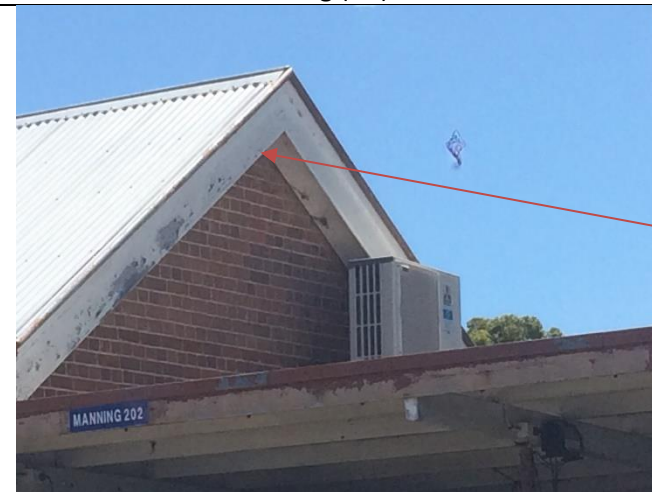
Photo 12: Highway Patrol Office – External; eave, fascia barge boards – Lead Paint (A4)

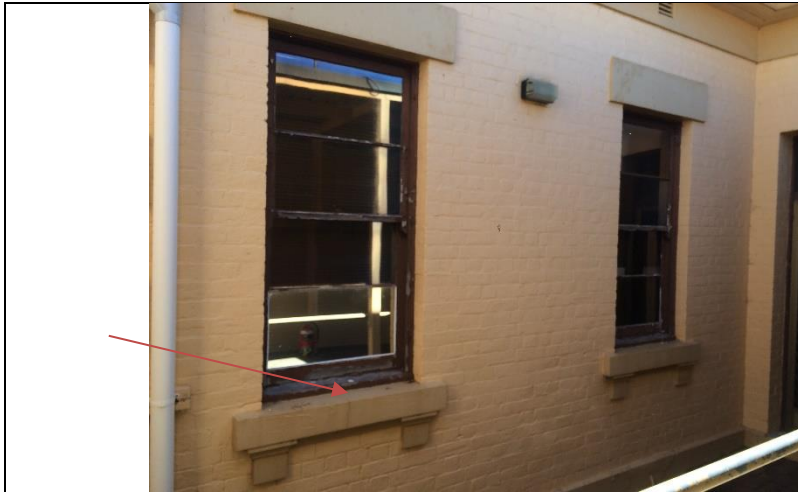
Photo 13: Highway Patrol Office – External; Window frames lower, cream – Lead Paint (A3)

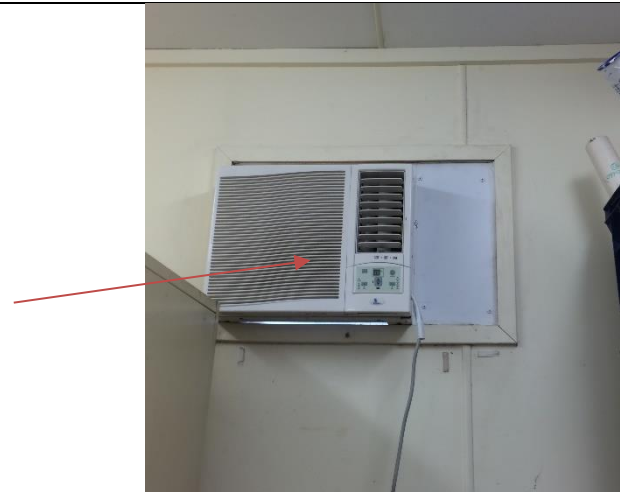
Photo 4: Exhibits – Internal – Refrigerant gas within Kelvinator air conditioning unit – ODS (A4)

Exhibits																				
ODS																				
ODS	Visual observation	HFC	14	Refrigerant gas within Kelvinator air conditioning unit	Internal Demountable buildings	1 unit	NA			G	Y	L				L	A4	WSP PB 2016: Item in good condition, leave and monitor condition
