Arboricultural Impact Assessment Report

461-473 Pacific Highway
Asquith NSW

Prepared for: Calder Flower Architects
c/- Chinese Australian Services Society
Limited

Prepared by: Jack Williams
Urban Arbor Pty Ltd
Ref: 18/08/23/461PHA
Date prepared: 26 June 2019
Revision: A

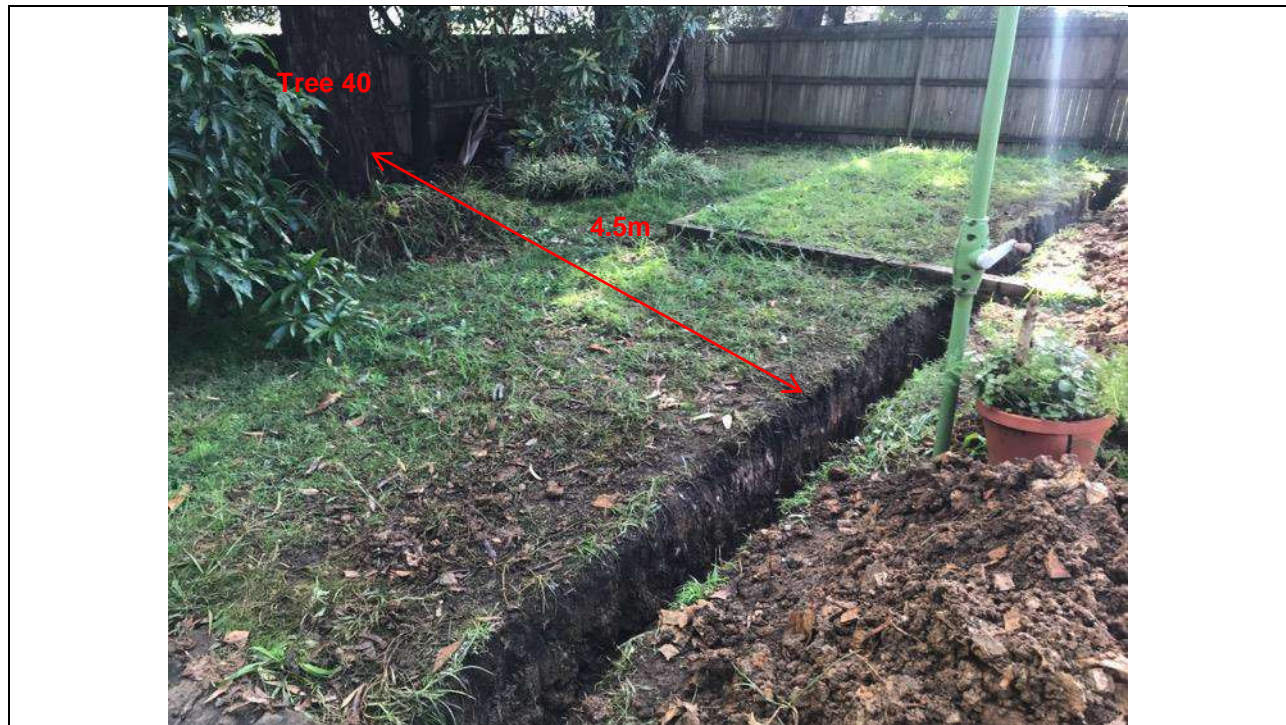
Image 1: Looking North West to root investigation trench 1. Showing tree 40 and 4.5m setback from the centre of the tree.

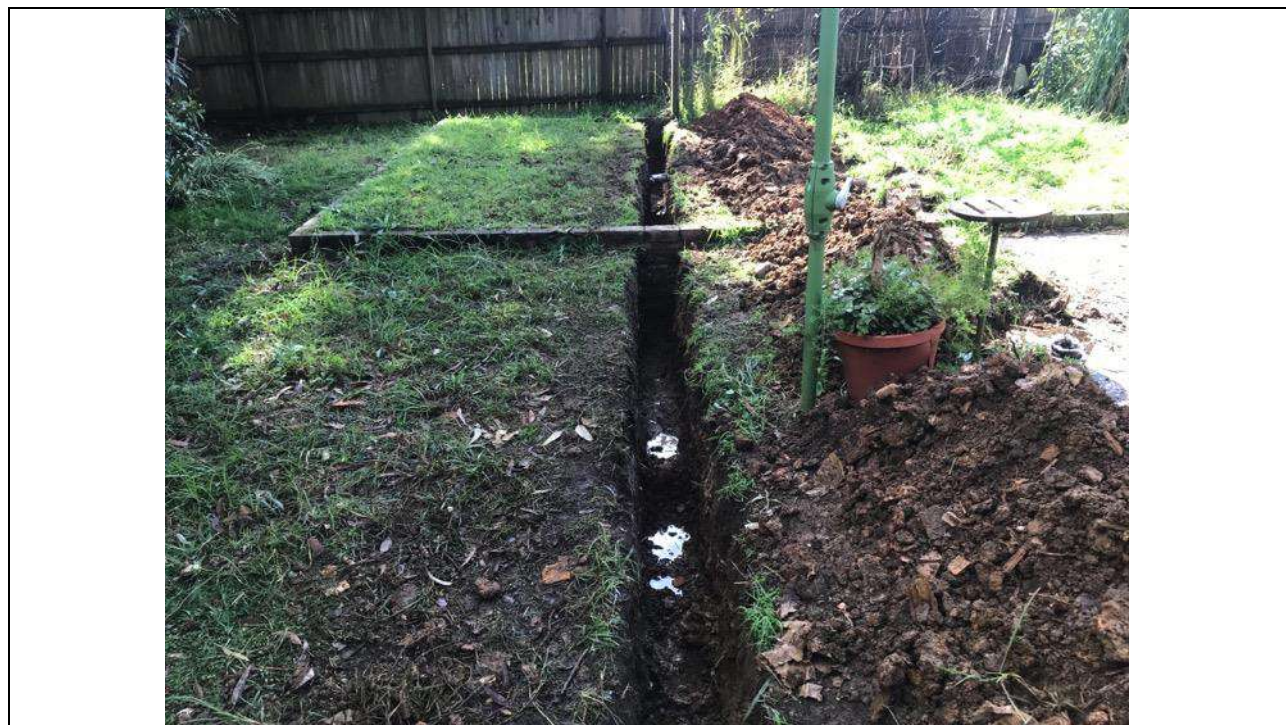
Image 2: Looking North along root investigation trench 1. No roots identified.

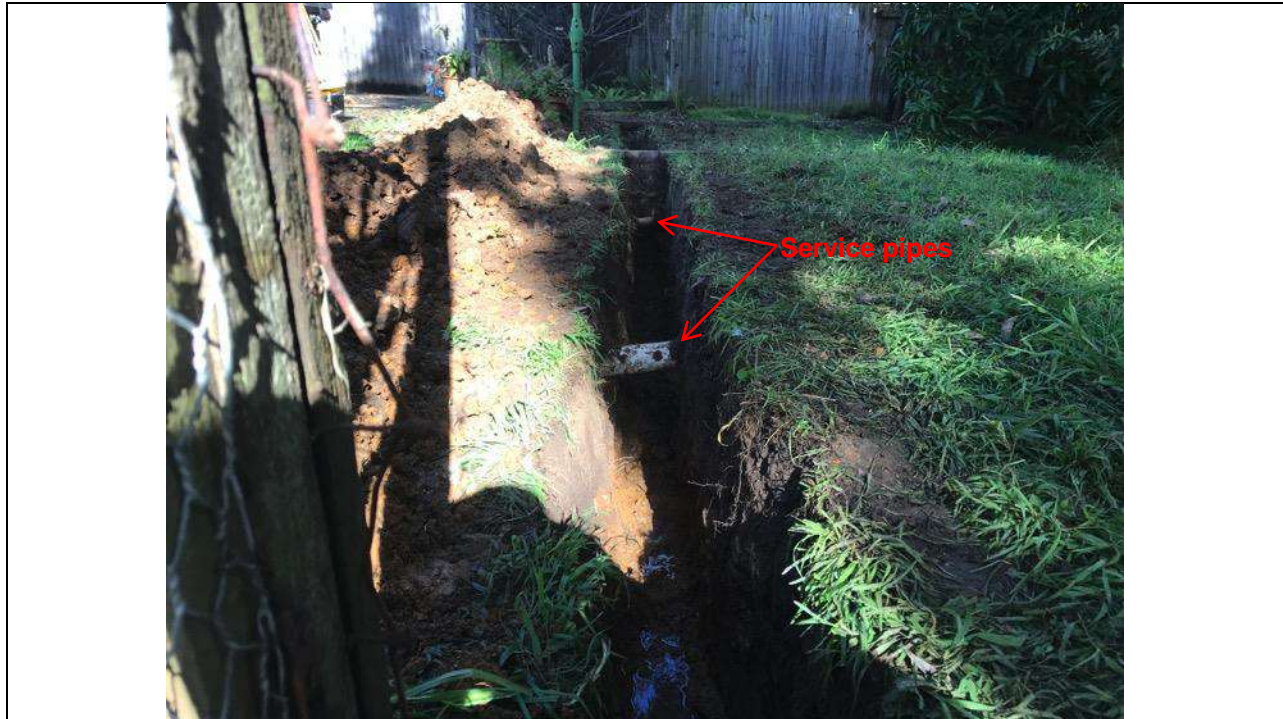
Image 3: Looking South along root investigation trench 1. Showing service pipes. No roots identified.
