ARBORICULTURAL IMPACT REPORT

56-60 BURNS BAY ROAD
LANE COVE NSW

REVISED REPORT
9 MAY 2019

PREPARED FOR A PLUS DESIGN GROUP

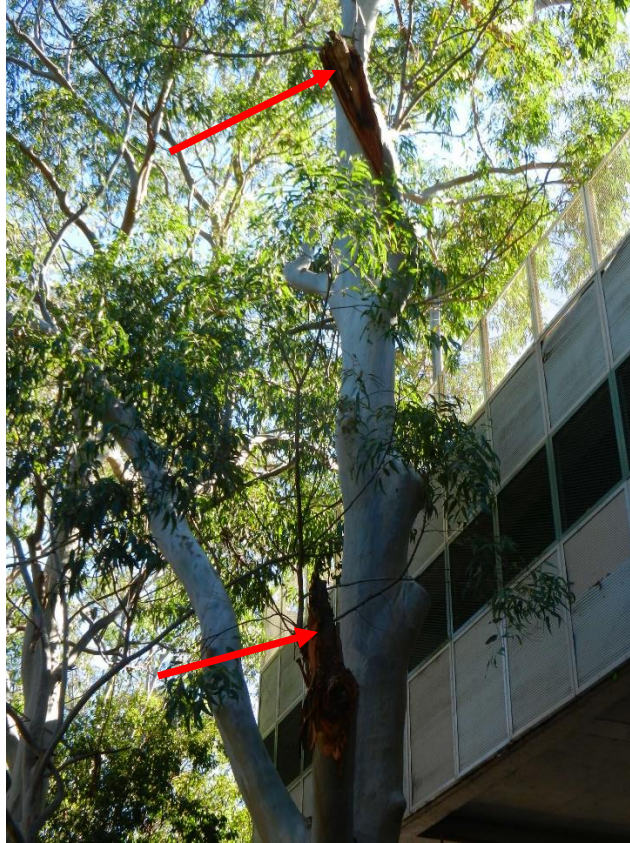
8	<i>Eucalyptus saligna</i> (Sydney Blue Gum)	8.4 metres	3.1 metres	A mature, single trunked specimen approximately 28 metres in height with a canopy spread of 14 x 20 metres and a DBH of 700mm. In good health and of high landscape significance. Slight canopy bias to E x W axis. The tree displays fair to poor branch attachment with 2 recent branch failures at 4 and 8 metres on the NE side (it appears the failure at 8 metres

may have caused the failure at 4 metres). There is evidence of other failures. Bird nest in upper crown. Tagged as T8
10	<i>Eucalyptus saligna</i> (Sydney Blue Gum)	10.4 metres	3.1 metres	A mature, single trunked specimen approximately 30 metres in height with a canopy spread of 18 metres and a DBH of 870mm. In good health and of high landscape significance. Slight canopy bias to the south Tagged as T10.
18	<i>Eucalyptus saligna</i> (Sydney Blue Gum)	7.9 metres	3 metres	A mature, single trunked specimen approximately 28 metres in height with a canopy spread of 16 metres and a DBH of 660mm. In good health and of high landscape significance. At the time of inspection the tree was of fair vigour and exhibited low levels of dieback and epicormic growth. Tagged as T19..
28	<i>Eucalyptus saligna</i> (Sydney Blue Gum)	8.2 metres	3.1 metres	A mature, single trunked specimen approximately 32 metres in height with a canopy spread of 20 metres and a DBH of 680mm. In good health and of high landscape significance. Slight canopy bias to the south. The tree displays fair to poor branch attachment with multiple leaders from 4 metres with evidence of poor attachment at the junction - the junction is a weak point in the tree's structure with increased risk of failure - while not considered at risk of failure in the short term an aerial inspection/further investigation of the junction to check structural integrity is recommended. Small to medium sized deadwood over carpark requires management. Tagged as T27.

Photograph 5: Tree # 8 - Illustrating 2 recent branch failures at 4 and 8 metres on the NE side.

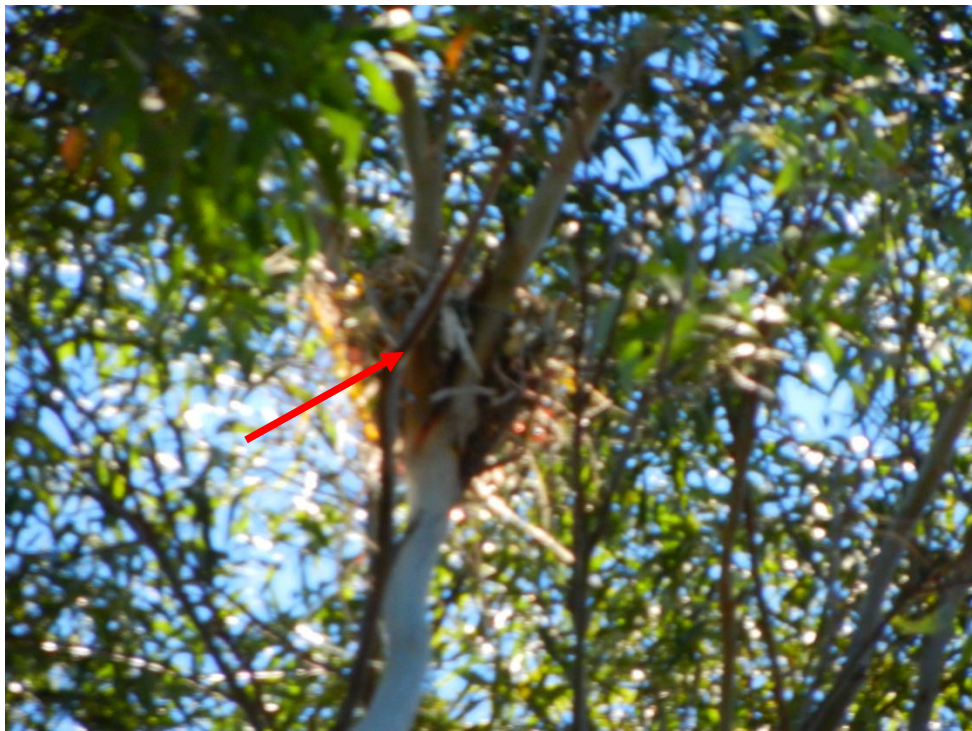
Photograph 6: Tree # 8 - Illustrating the bird nest in the upper crown.

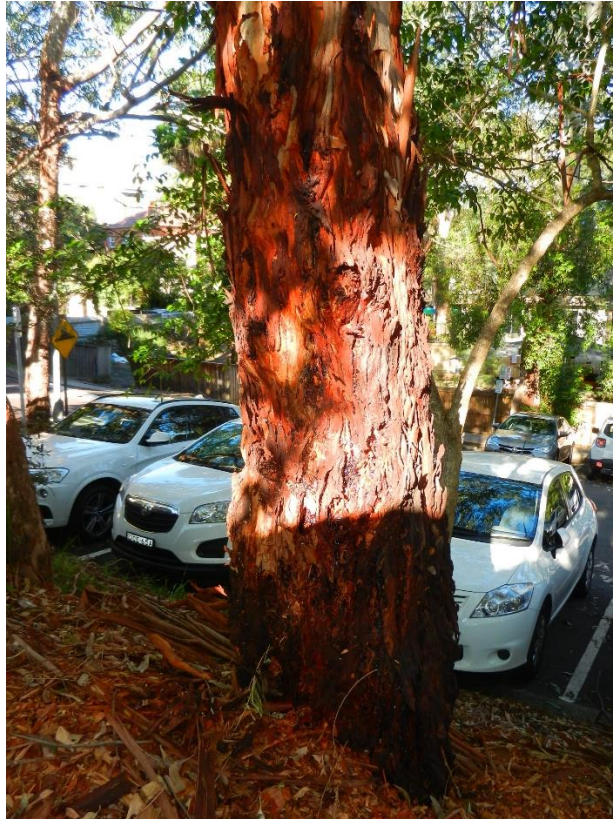
Photograph 7: Tree # 17 – Illustrating the tissue dysfunction in the lower trunk.

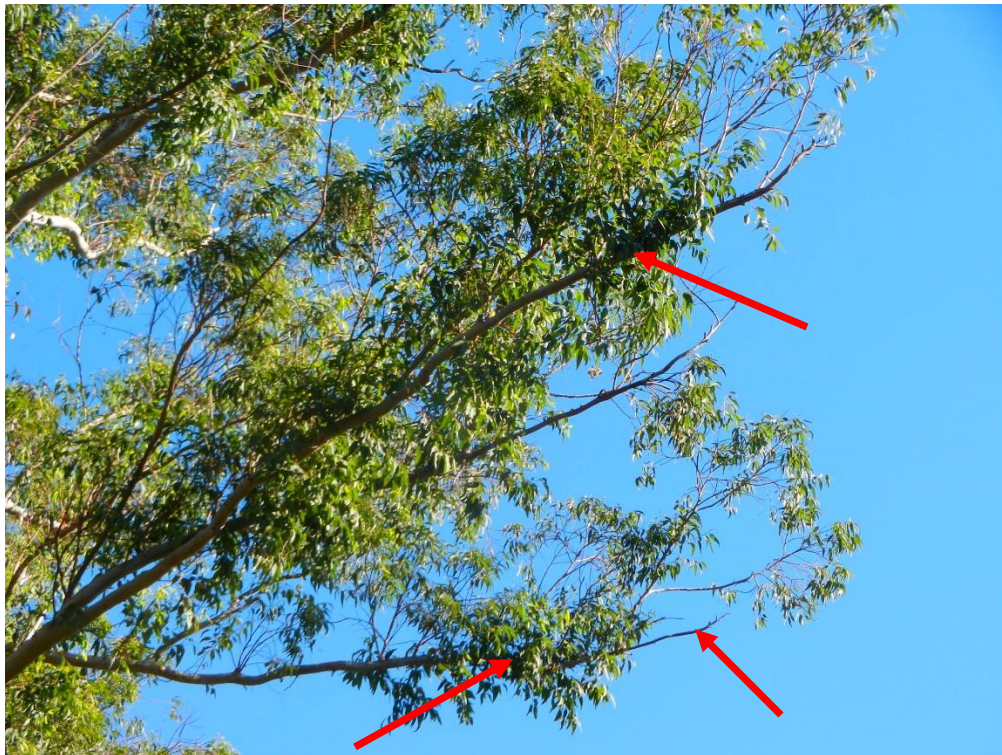
Photograph 8: Tree # 24 - Illustrating the moderate to high levels of outer canopy dieback and epicormic growth.

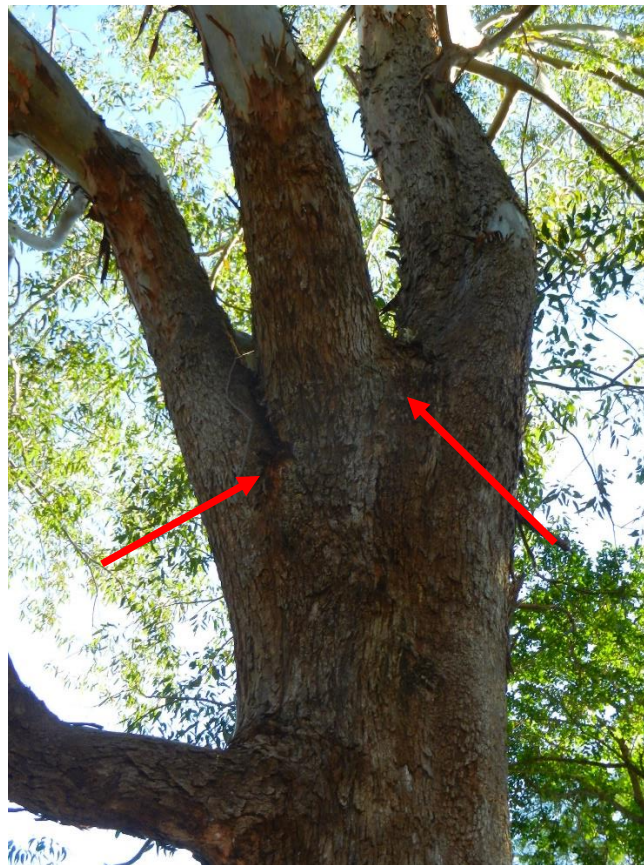
Photograph 10: Tree # 28 - Illustrating the multiple leaders from 4 metres with evidence of poor attachment at the junction (aerial inspection recommended).

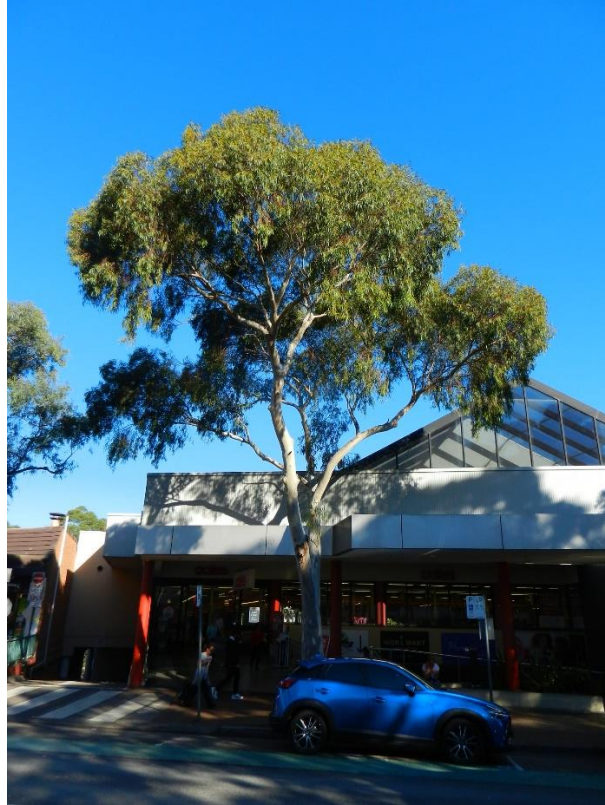
TREE NO.	SCIENTIFIC AND COMMON NAME	TPZ	SRZ	COMMENTS*
31	<i>Eucalyptus scoparia</i> (Wallangarra White Gum, Willow Gum)	6.1 metres	2.7 metres	The proposed works are located 4.2 metres from the tree at the closest point and are calculated to encroach within 17.10m ² or 14.54% of the tree's identified TPZ – this is a low to moderate level of encroachment and within an acceptable threshold. Continued next page... In addition, the impacts will be minimised due to the existing building within the footprint of the proposed works which will have limited the potential for root growth in the impacted area of the minimal TPZ. Specific tree protection measures (e.g. trunk and branch protection) will need to be installed prior to commencement of any works at the site in addition to design measures to minimise the potential for canopy conflict with awnings.
32	<i>Angophora costata</i> (Smooth Barked Apple, Sydney Red Gum)	4.6 metres	2.4 metres	The proposed works are located 3.71 metres from the tree at the closest point and are calculated to encroach within 7.74m ² or 11.85% of the tree's identified TPZ – this is a low to moderate level of encroachment and within an acceptable threshold. Continued next page... In addition, the impacts will be minimised due to the existing building within the footprint of the proposed works which will have limited the potential for root growth in the impacted area of the minimal TPZ. Specific tree protection measures (e.g. trunk and branch protection) will

need to be installed prior to commencement of any works at the site in addition to design measures to minimise the potential for canopy conflict with awnings.
--	--	--	--	--

Photograph 11: Tree # 31 - Illustrating the location and context.

In addition to this it is recommended specific tree protection measures for trees 31 and 32 (e.g. trunk and branch protection) be installed prior to commencement of any works at the site in addition to design measures to minimise the potential for canopy conflict with awnings.

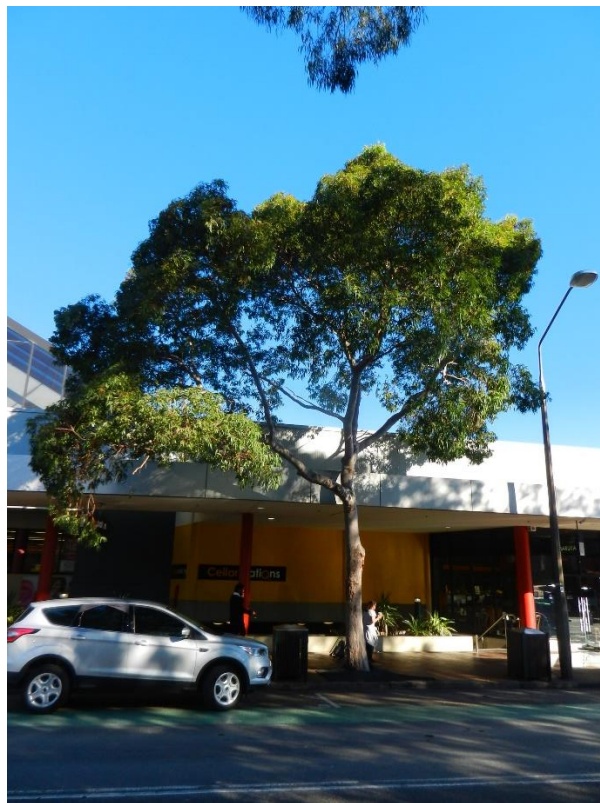
32	<i>Angophora costata</i> (Smooth Barked Apple, Sydney Red Gum)	4.6 metres	2.4 metres	A young mature, single trunked specimen approximately 11 metres in height with a canopy spread of 10 metres and a DBH of 380mm. In good health and of moderate to high landscape significance.

Photograph 12: Tree # 32 - Illustrating the location and context.
