## **ARBORICULTURAL IMPACT REPORT**

LINDFIELD VILLAGE LIVING  
LINDFIELD NSW

30 NOVEMBER 2018

PREPARED FOR KU-RING-GAI COUNCIL

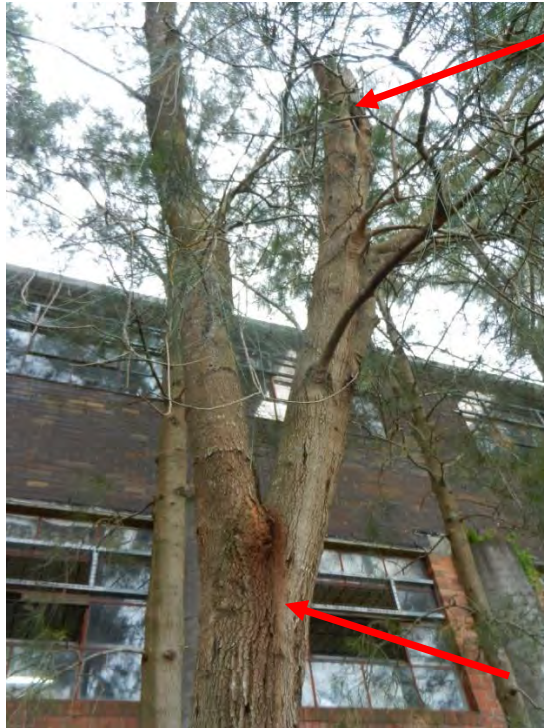
Photograph 1: Tree # 19 - Illustrating the fair to poor branch attachment with codominant leaders from 2.5 metres with poor attachment and the SE leader has failed at 5 metres.

| Tree No. | Genus, Species (Common Name) | Height (m) | Canopy (m) | DBH (mm) | DBH for TPZ | DGL for SRZ | Foliage Condition | Age Class | Trunk | Trunk Lean | Crown balance | Past Pruning | Stability | Branch Attachment | Health | Vigour | Dead Wood | Pest or disease | ULE | Landscape Significance | Retention Value* | Comments |
|---|---|---|---|---|---|---|---|---|---|---|---|---|---|---|---|---|---|---|---|---|---|---|
| 19 | <i>Casuarina glauca</i> (Swamp Oak) | 11 | 4 x 6 | 320 | 320 | 370 | Good foliage condition | Mature | Single trunk | Slight trunk lean south | Majority of canopy to the south | No evidence of significant past pruning | Appears stable | Fair to poor branch attachment | Good health | Good vigour | <5% | No visual evidence of significant pest or disease | 3 Short (5 to 15 years) | Moderate landscape significance | 3 | Minor mechanical damage to basal trunk tissue (mower impact damage) - appears sound. The tree displays fair to poor branch attachment with codominant leaders form 2.5 metres with evidence of poor attachment at the junction and the SE leader has failed in the past at 5 metres. |

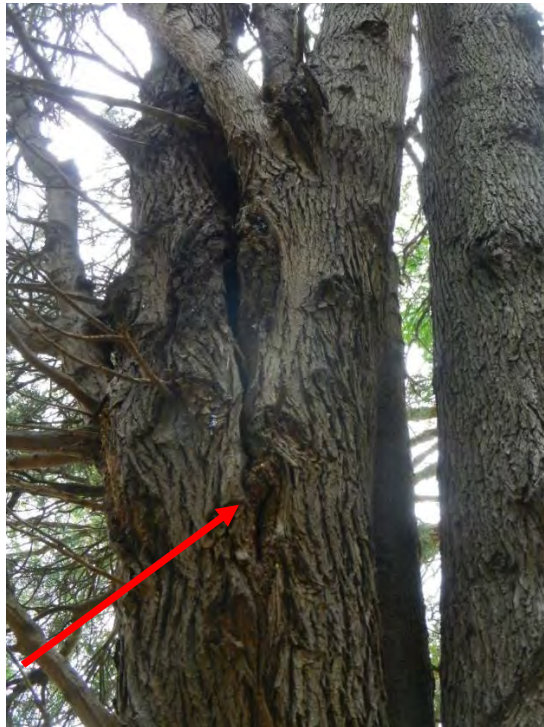
Photograph 2: Tree # 21 - Illustrating the evidence of partial failure at a junction

| Tree No. | Genus, Species (Common Name) | Height (m) | Canopy (m) | DBH (mm) | DBH for TPZ | DGL for SRZ | Foliage Condition | Age Class | Trunk | Trunk Lean | Crown balance | Past Pruning | Stability | Branch Attachment | Health | Vigour | Dead Wood | Pest or disease | ULE | Landscape Significance | Retention Value* | Comments |
|---|---|---|---|---|---|---|---|---|---|---|---|---|---|---|---|---|---|---|---|---|---|---|
| 21 | <i>Callitris columnaris</i> (Coastal Cypress Pine) | 17 | 6 | 580 x 640 | 610 | 720 | Good foliage condition | Mature | Single trunk | Upright trunk | Balanced canopy area | No evidence of significant past pruning | Appears stable | Poor branch attachment | Good health | Fair vigour | 5 to 10% | No visual evidence of significant pest or disease | 3 Short (5 to 15 years) | Moderate to high landscape significance | 3 | The tree displays poor branch attachment with codominant leaders form 2 metres with evidence of poor attachment at the junction and multiple leaders form 3 metres with poor attachment and evidence of partial failure at a junction (deep split at 3 to 4 metres). Large diameter exposed root with evidence of past mechanical damage. At the time of inspection the tree was of fair vigour and exhibited low levels of dieback (mostly internal). |

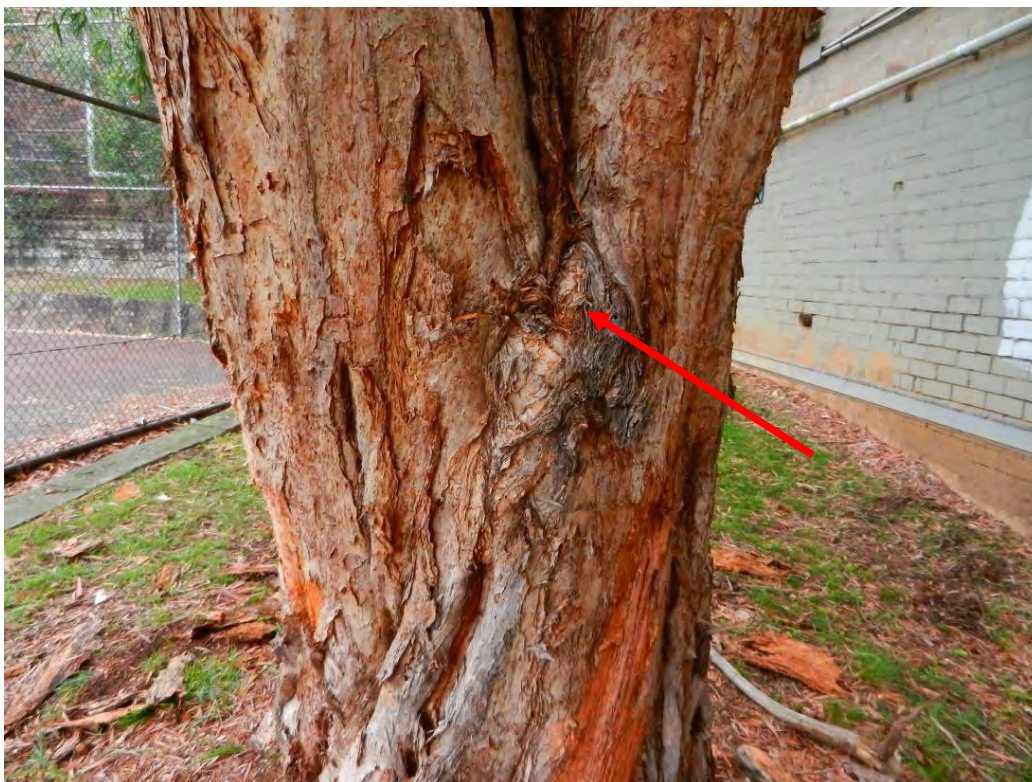
Photograph 3: Tree # 22 - Illustrating the multiple leaders from 1 metre with evidence of poor attachment.

| Tree No. | Genus, Species (Common Name) | Height (m) | Canopy (m) | DBH (mm) | DBH for TPZ | DGL for SRZ | Foliage Condition | Age Class | Trunk | Trunk Lean | Crown balance | Past Pruning | Stability | Branch Attachment | Health | Vigour | Dead Wood | Pest or disease | ULE | Landscape Significance | Retention Value* | Comments |
|---|---|---|---|---|---|---|---|---|---|---|---|---|---|---|---|---|---|---|---|---|---|---|
| 22 | <i>Callistemon salignus</i> (Willow Bottlebrush, White Bottlebrush) | 14 | 12 x 13 | Up to 450 (760 above root flare) | 760 | 760 | Good foliage condition | Mature | Multi trunked | Slight trunk lean south | Majority of canopy to the south | Lower limbs pruned in past to 3 metres, upper branches pruned for building on north | Appears stable | Fair to poor branch attachment | Good health | Good vigour | 5% | No visual evidence of significant pest or disease | 3 Short (5 to 15 years) | Moderate to high landscape significance | 3 | Slight canopy bias to the south. The tree displays fair to poor branch attachment with multiple leaders form 1 metre with evidence of poor attachment at the junction and evidence of past failure at a junction at 3 metres on the SW side. |

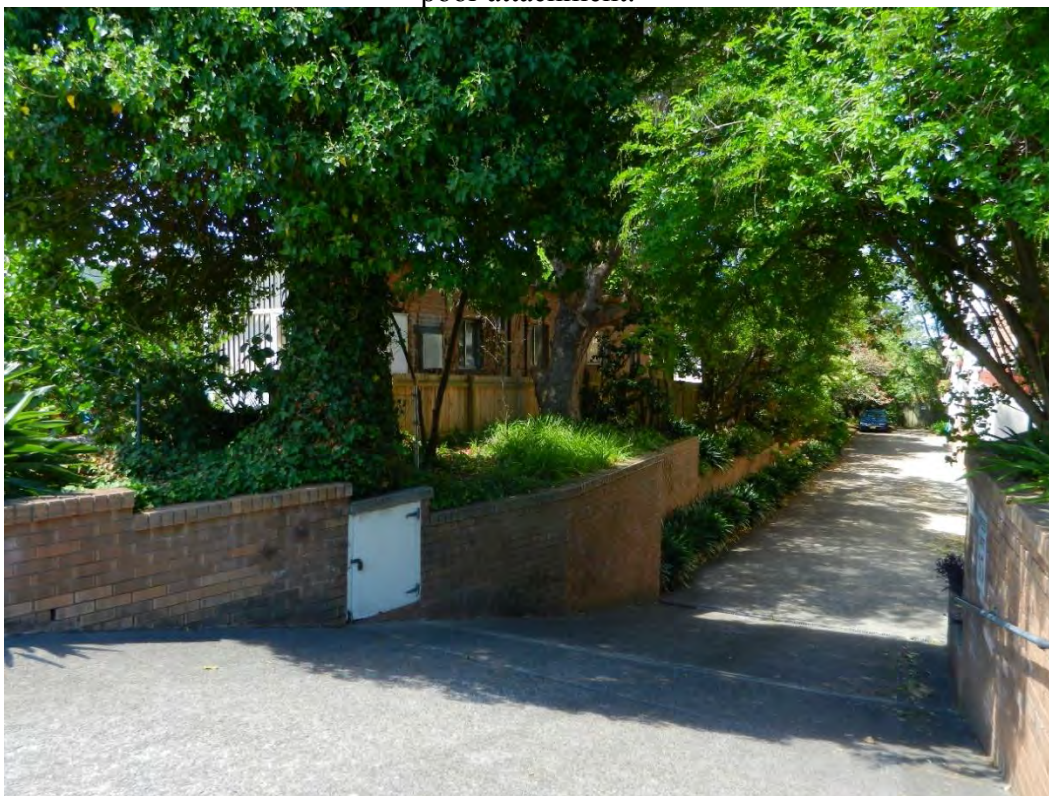
Photograph 4: Illustrating the trees on the adjoining property to the south (trees 49 to 61).

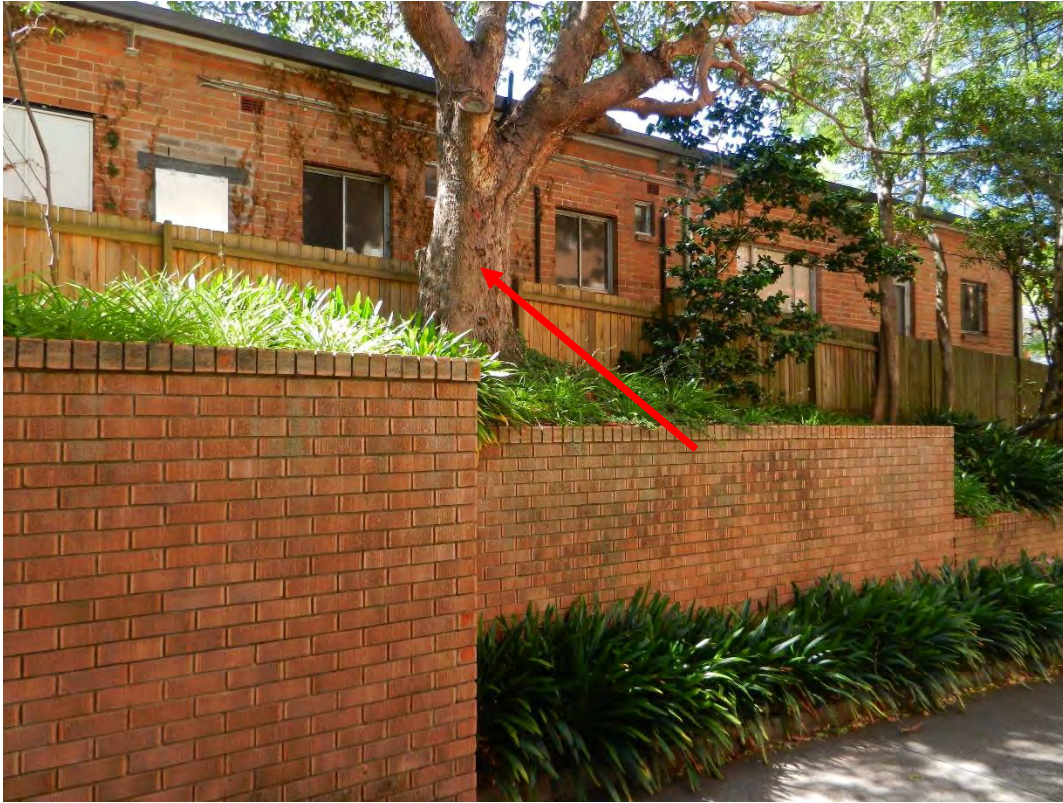
Photograph 5: Tree # 50 - Illustrating the location and context.

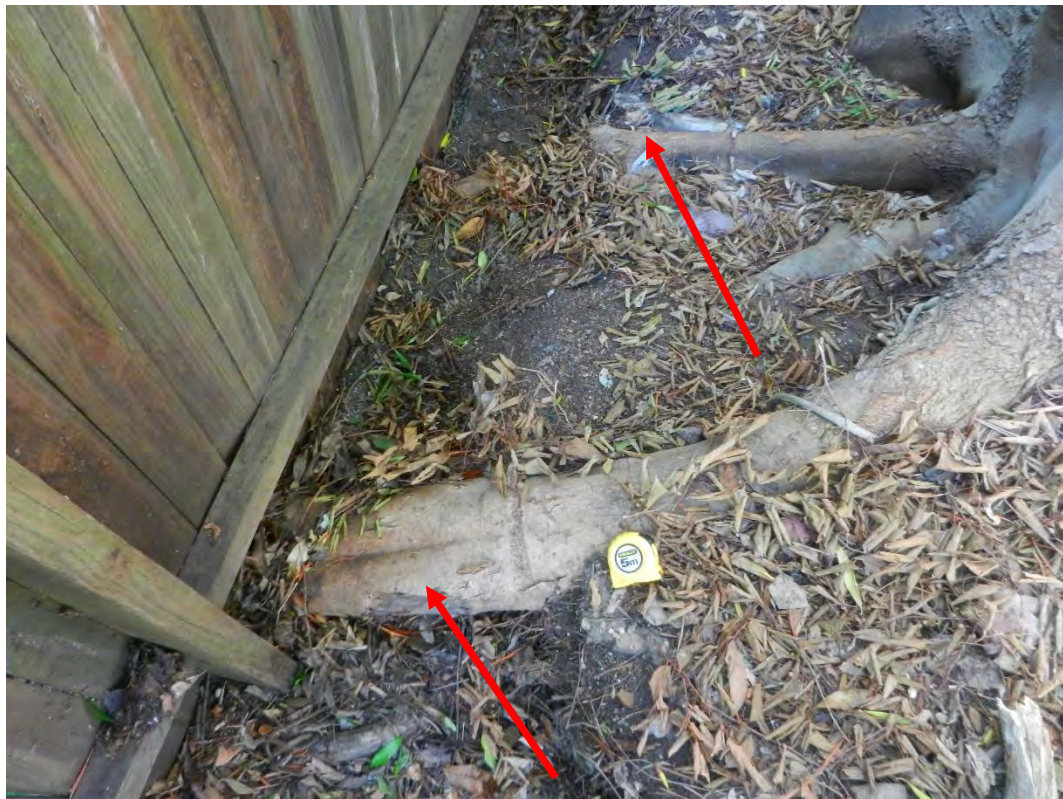
| 61 | <i>Celtis sinensis</i> (Chinese Hackberry) | Located in adjoining property to south and approx. 1.1 metres from boundary. The tree's past canopy development has been suppressed by an immediately adjacent <i>Celtis</i> to the south. The tree displays poor branch attachment with codominant leaders from near ground level with evidence of poor attachment at the junction - the junction is a weak point in the tree's structure with increased risk of failure. Large diameter, partially exposed woody roots from the tree are growing into the site. |

Photograph 6: Tree # 61 - Illustrating the roots from the tree growing into the site.

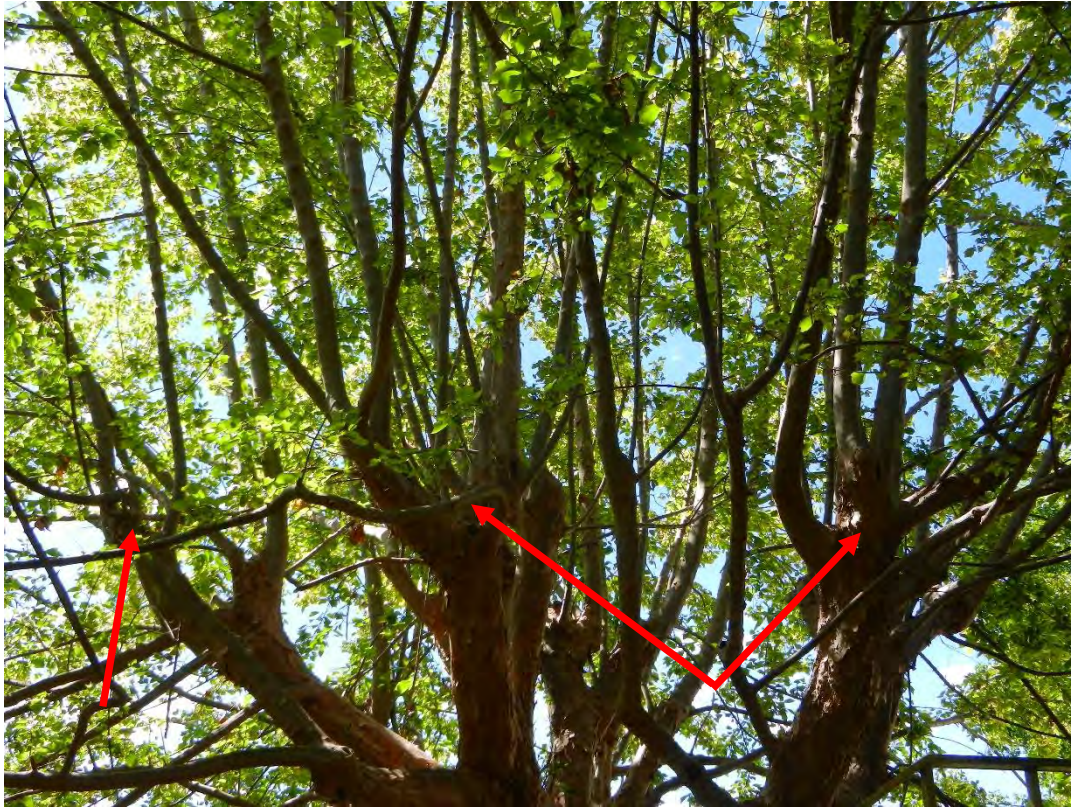
Photograph 7: Tree # 62 - Illustrating multiple regrowth following severe past pruning.

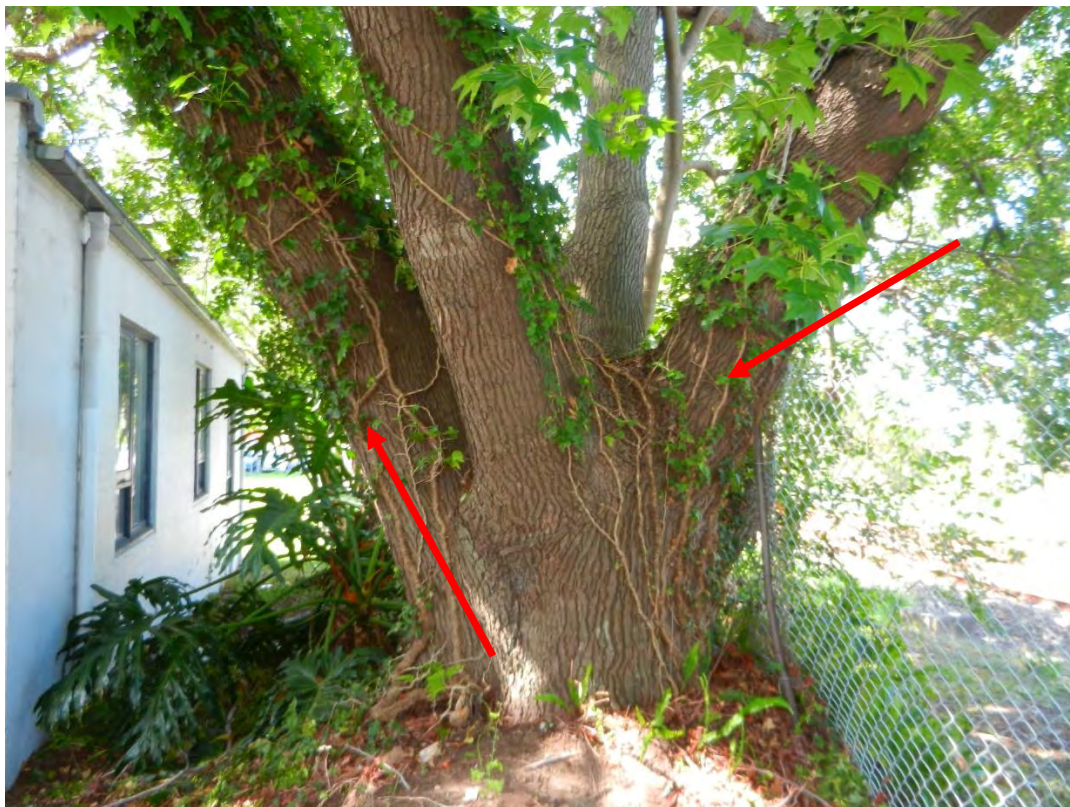
Photograph 8: Tree # 63 - Illustrating the multiple leaders from 1 metre.

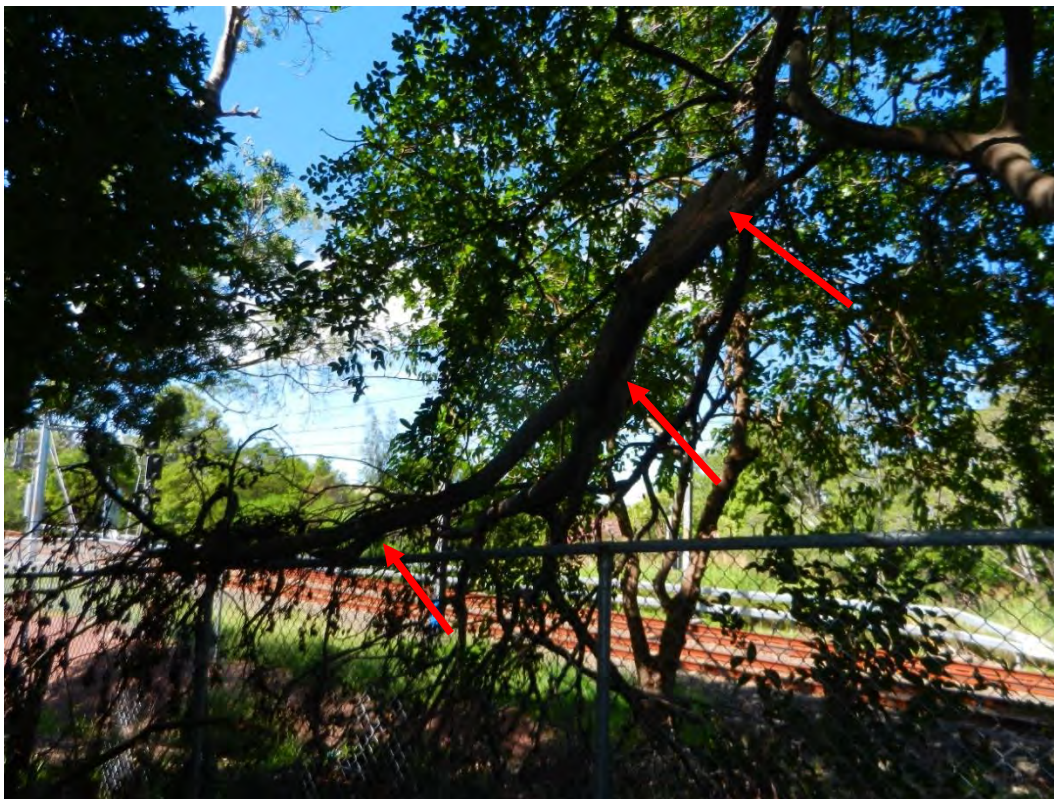
Photograph 9: Tree # 63 - Illustrating a recent branch failure.

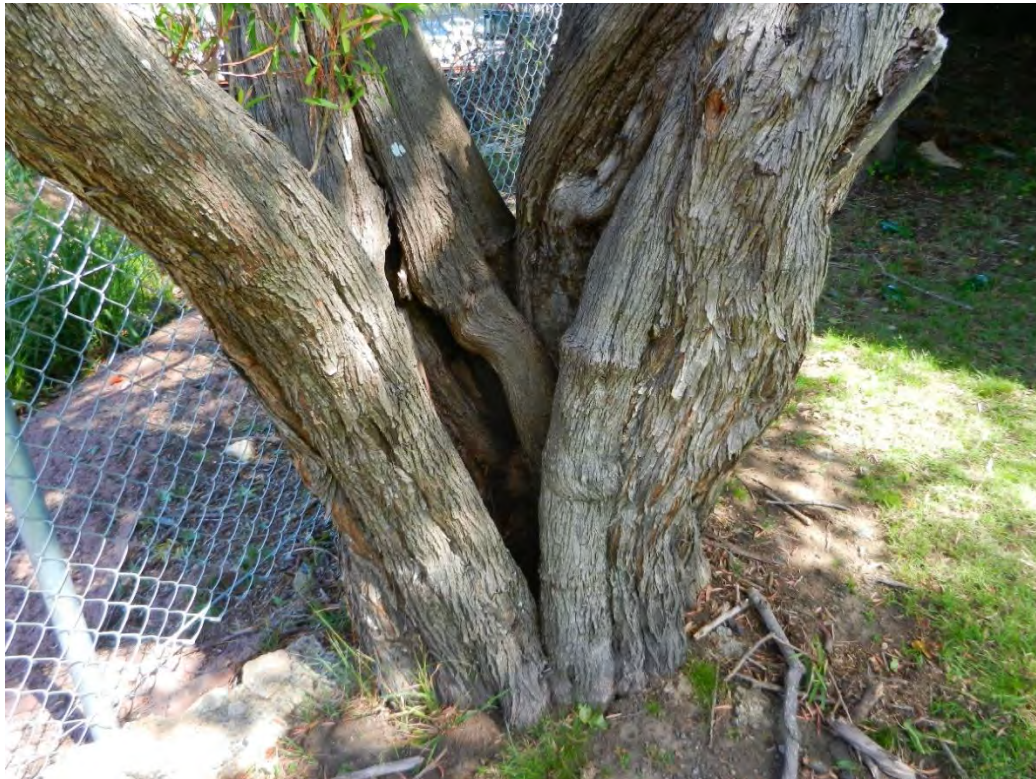
Photograph 10: Tree # 64 - Illustrating multiple leaders, poor attachment and extensive decay in the basal trunk.

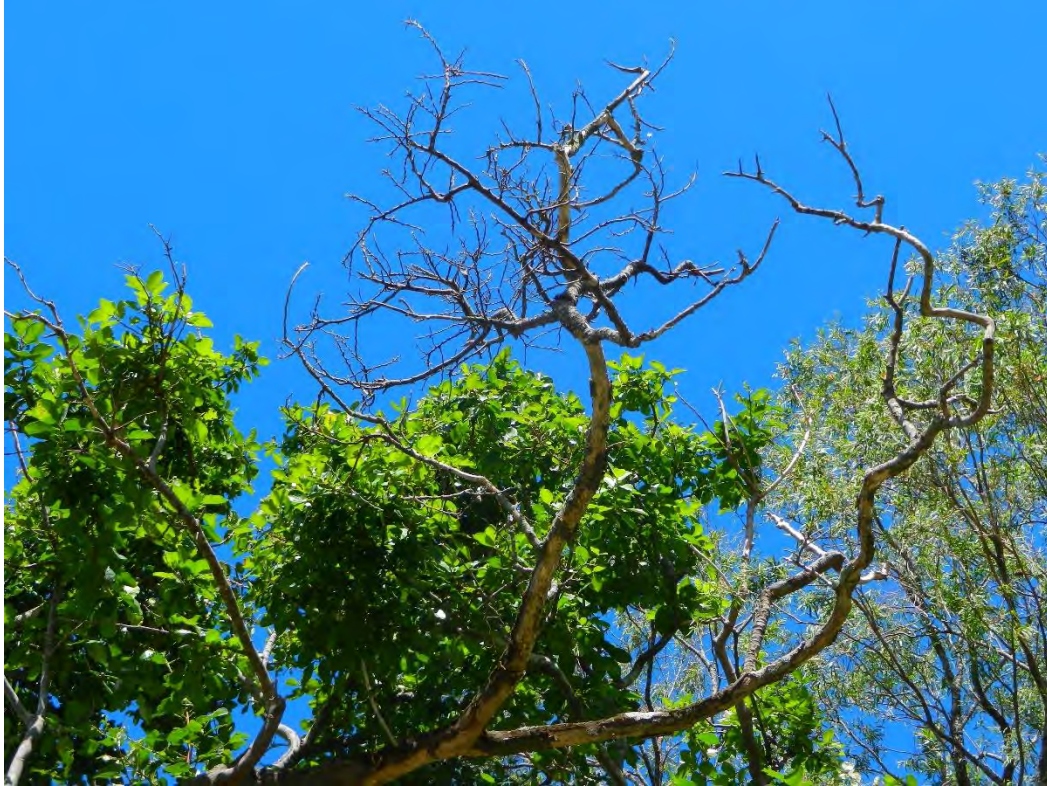
Photograph 11: Tree # 66 - Illustrating moderate to high dieback.

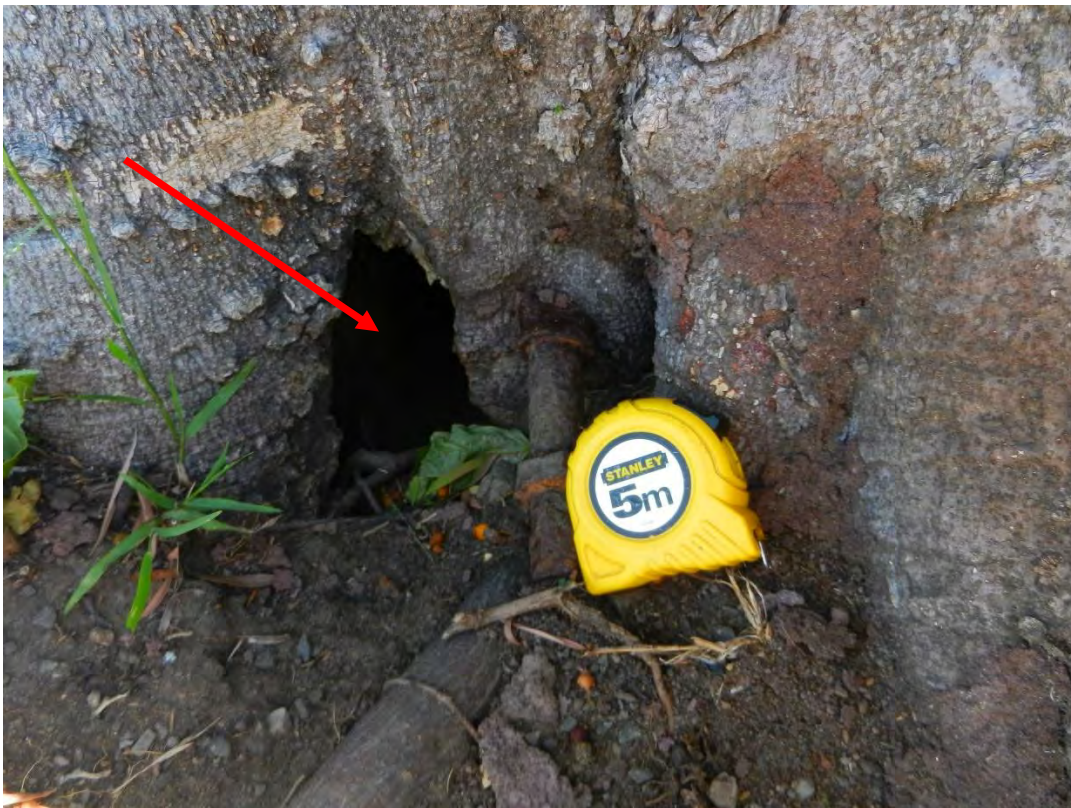
Photograph 12: Tree # 66 - Illustrating the opening to extensive decay in the basal trunk.

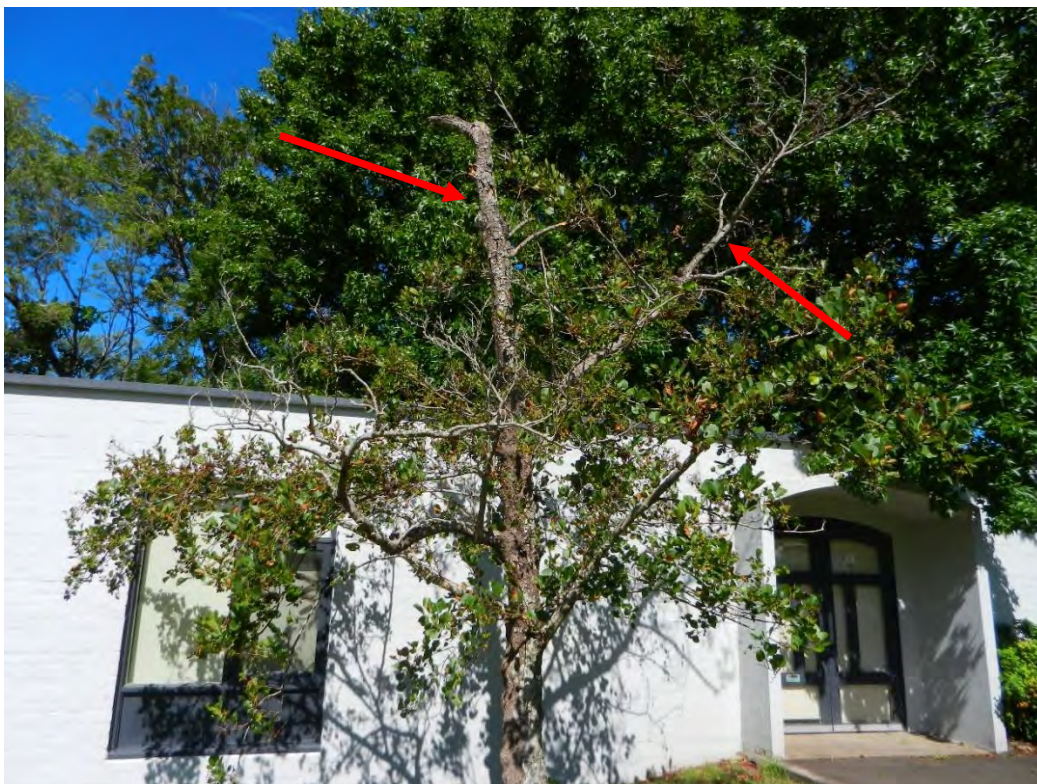
Photograph 13: Tree # 67 - Illustrating the high dieback.

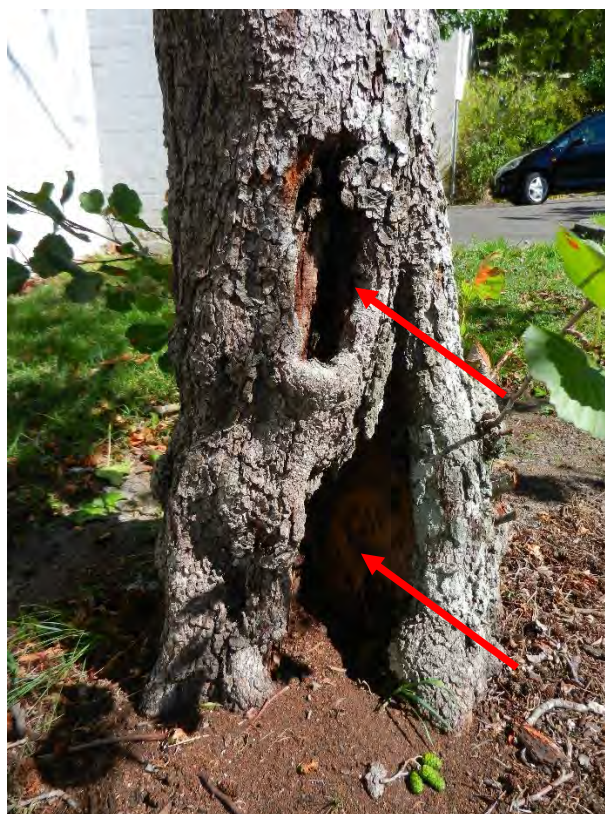
Photograph 14: Tree # 67 - Illustrating the extensive basal decay.

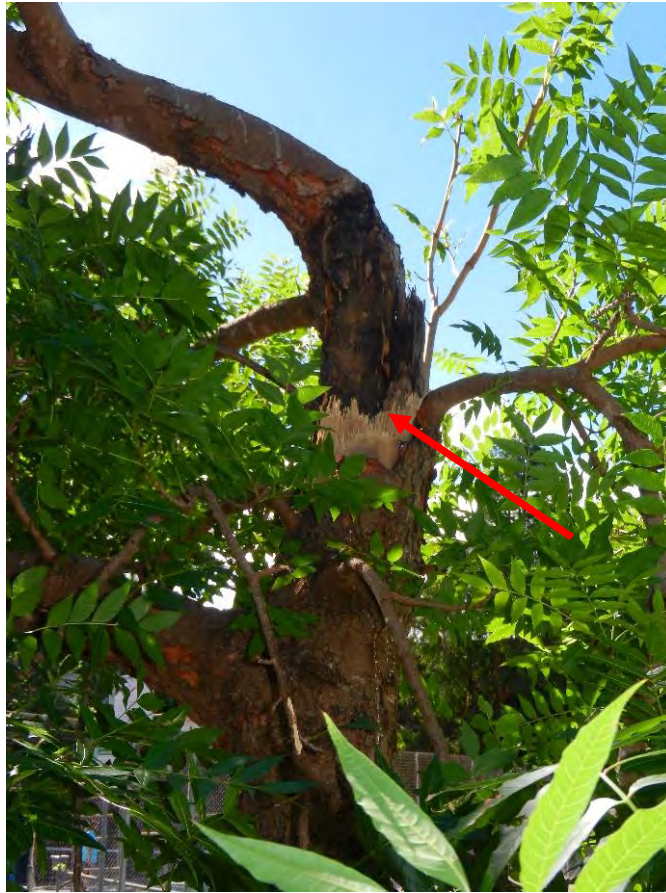
| 68 | <i>Pistacia chinensis</i> (Chinese Pistacia, Pistacia) | Majority of canopy to the west due to recent failure of main leader. The tree displays poor branch attachment with a recent failure of the main leader at 2 metres - there is evidence the junction had partially failed in the past with complete failure subsequently occurring in the very recent past. The tree is considered to be structurally compromised following this failure with a poorly attached branch growing to the west considered to be at risk of failure in the short term. Removal recommended. |

Photograph 15: Tree # 68 - Illustrating recent failure of the main leader.
