# ARBORICULTURAL IMPACT ASSESSMENT AND TREE MANAGEMENT PLAN

## NEW BUILDING HALL AND LEARNING FACILITIES

### MAGDALENE CATHOLIC HIGH SCHOOL

12th January 2018

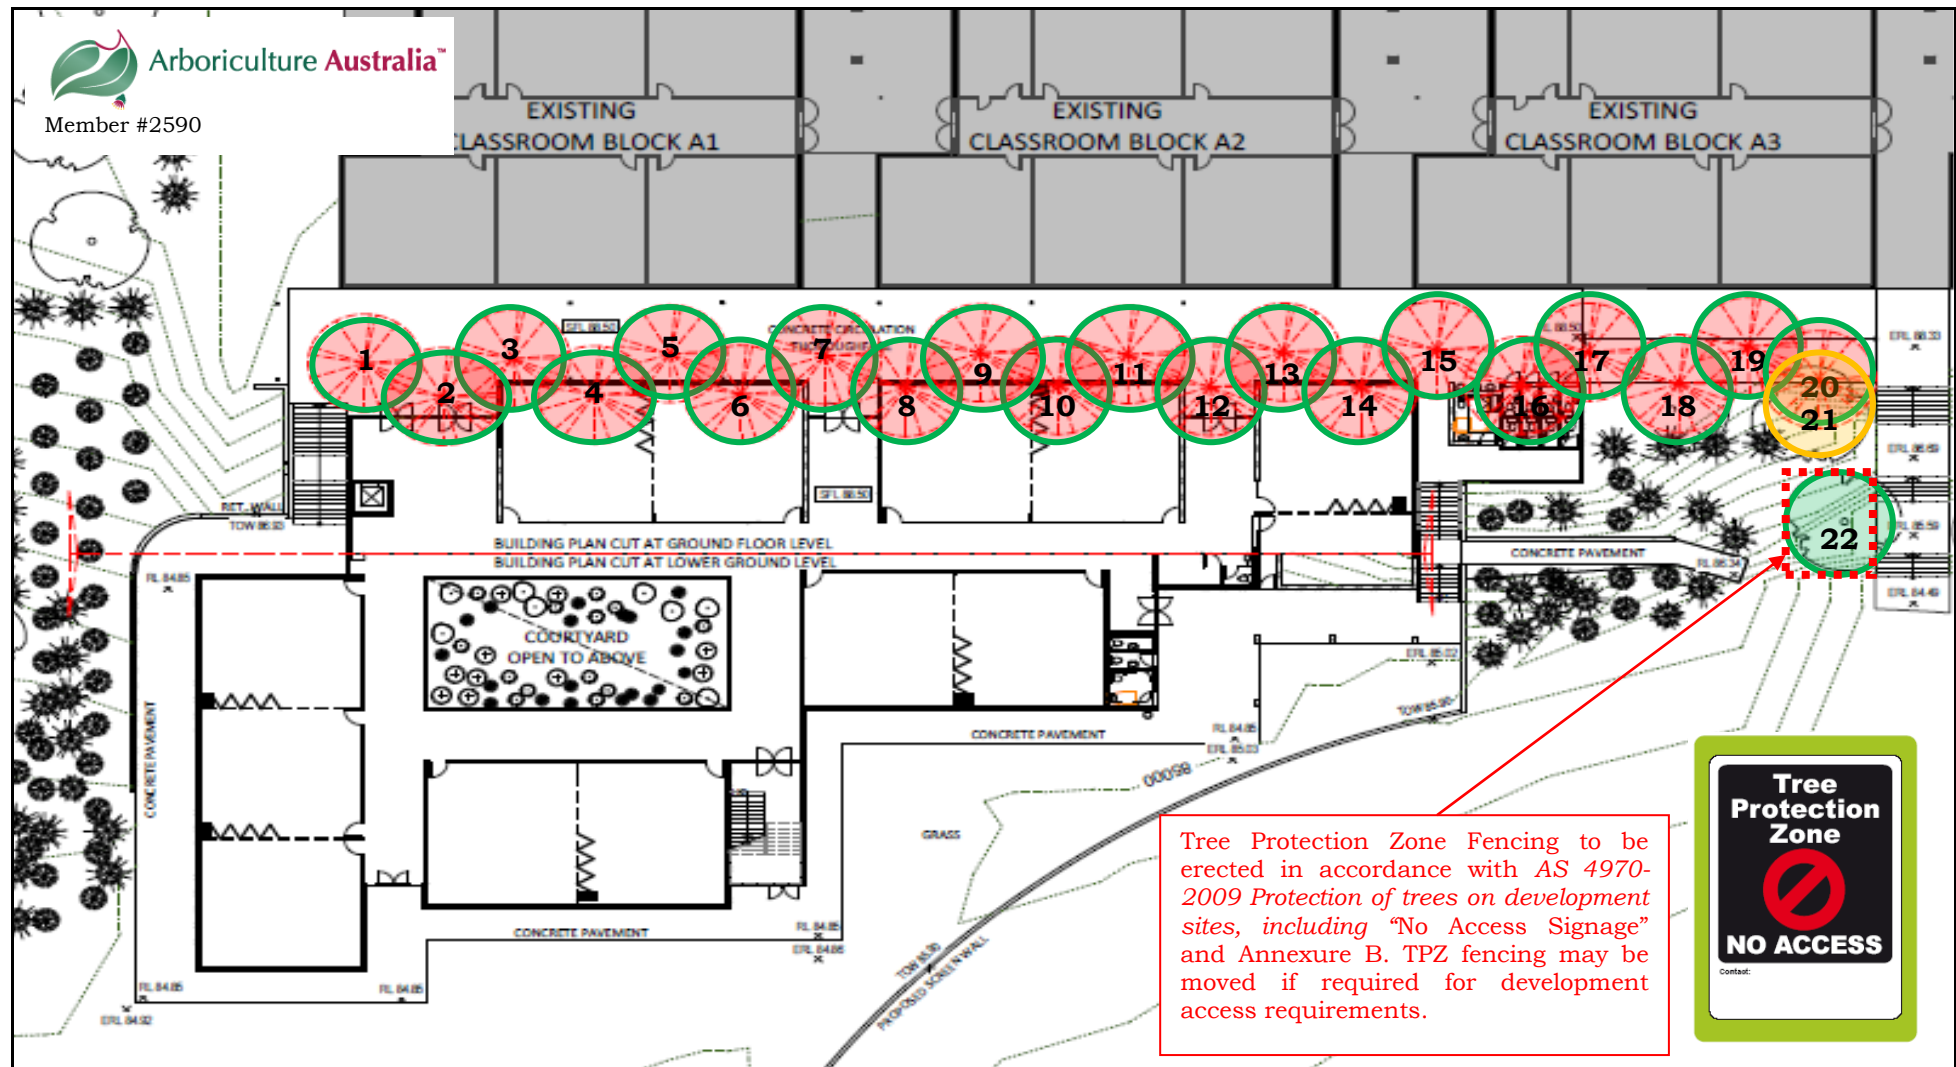
Figure 7 Shows trees 22 to be retained and on-site tree management.

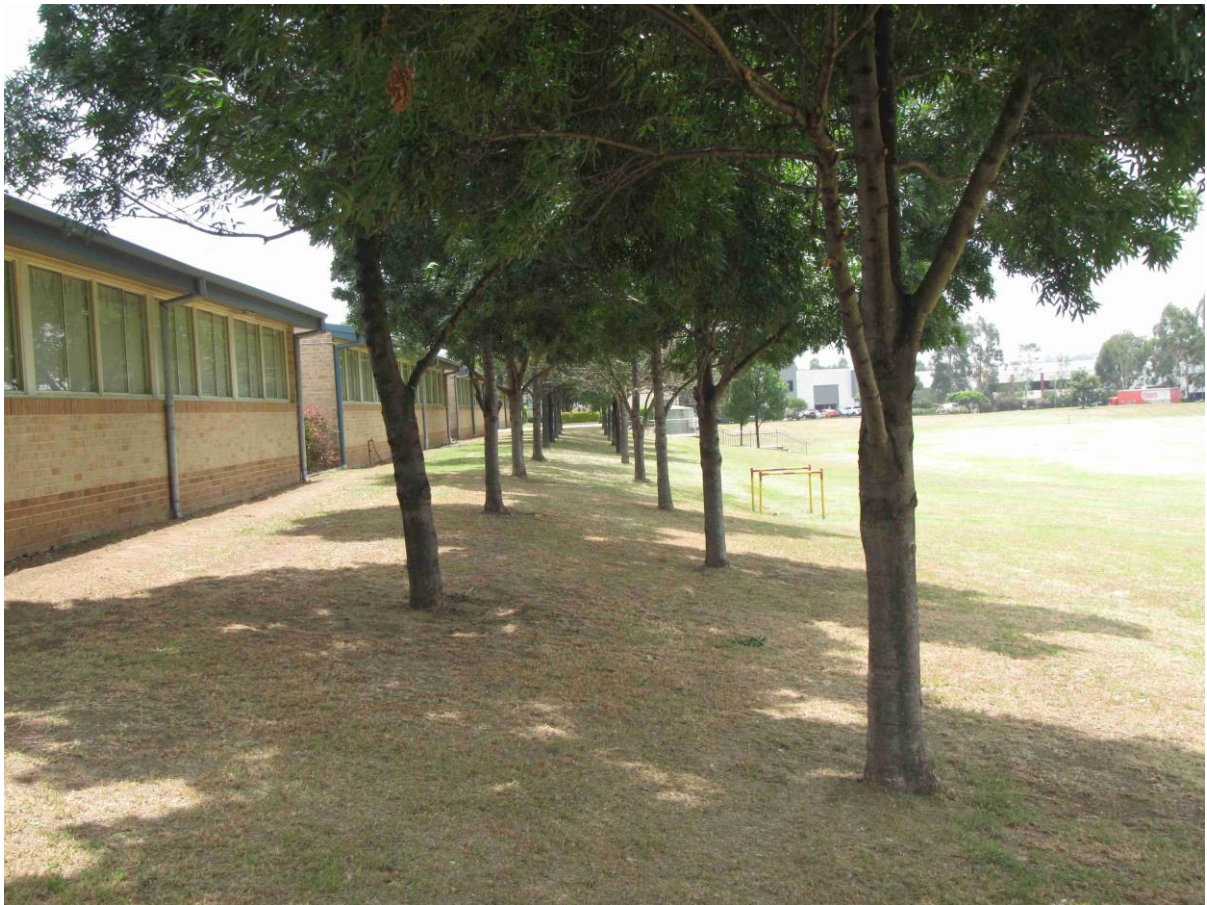
**Figure 8 Shows looking at the trees that are located in the new building area.**

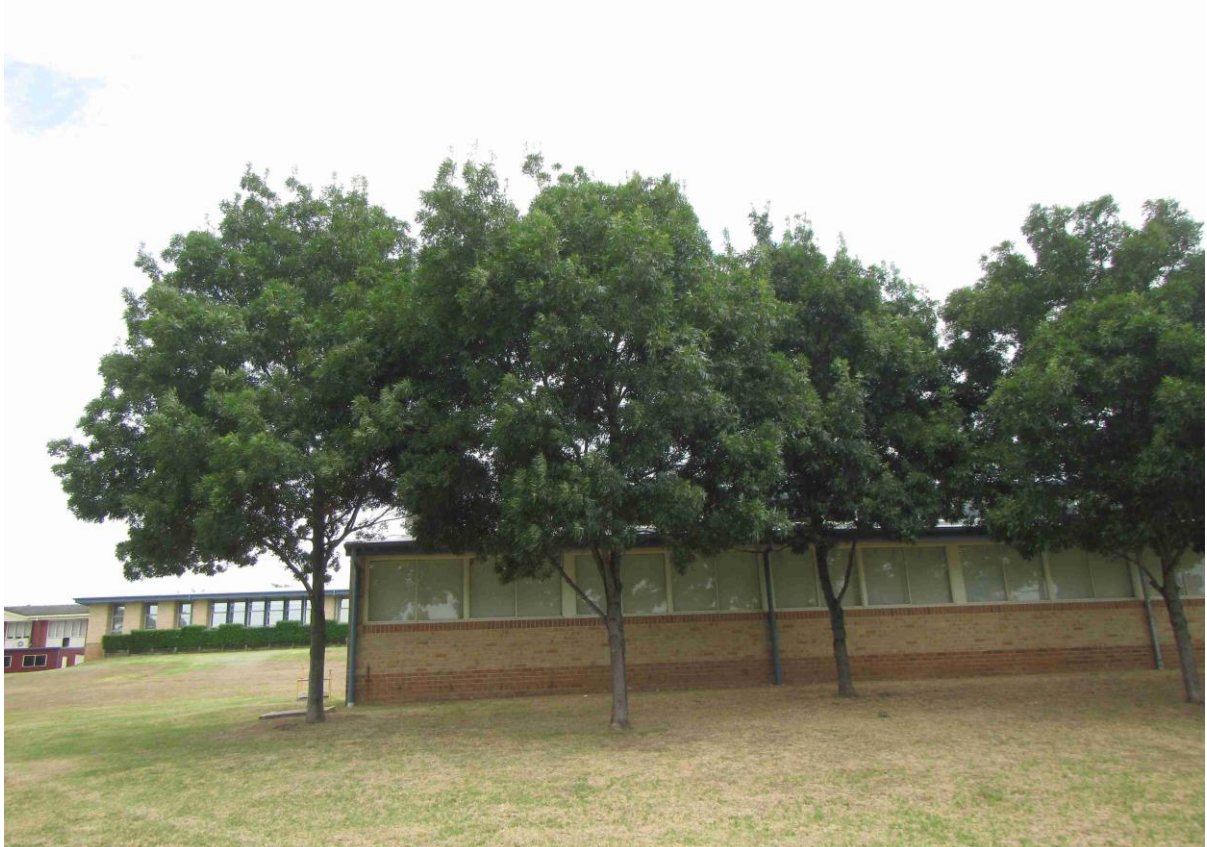
**Figure 9 Shows Trees the trees in good health from a distance.**

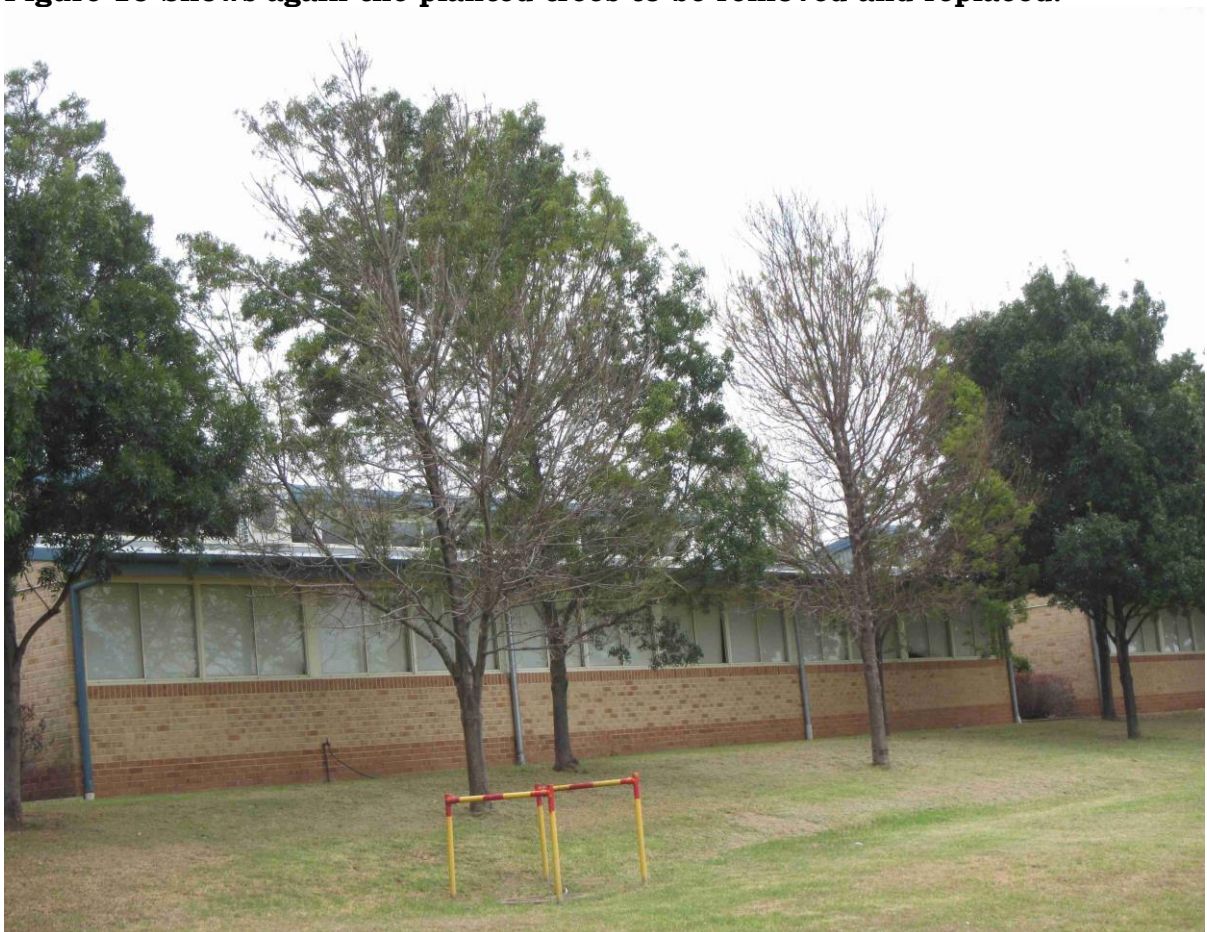
**Figure 11 Shows trees 12 and 14 from a distance in fair condition.**

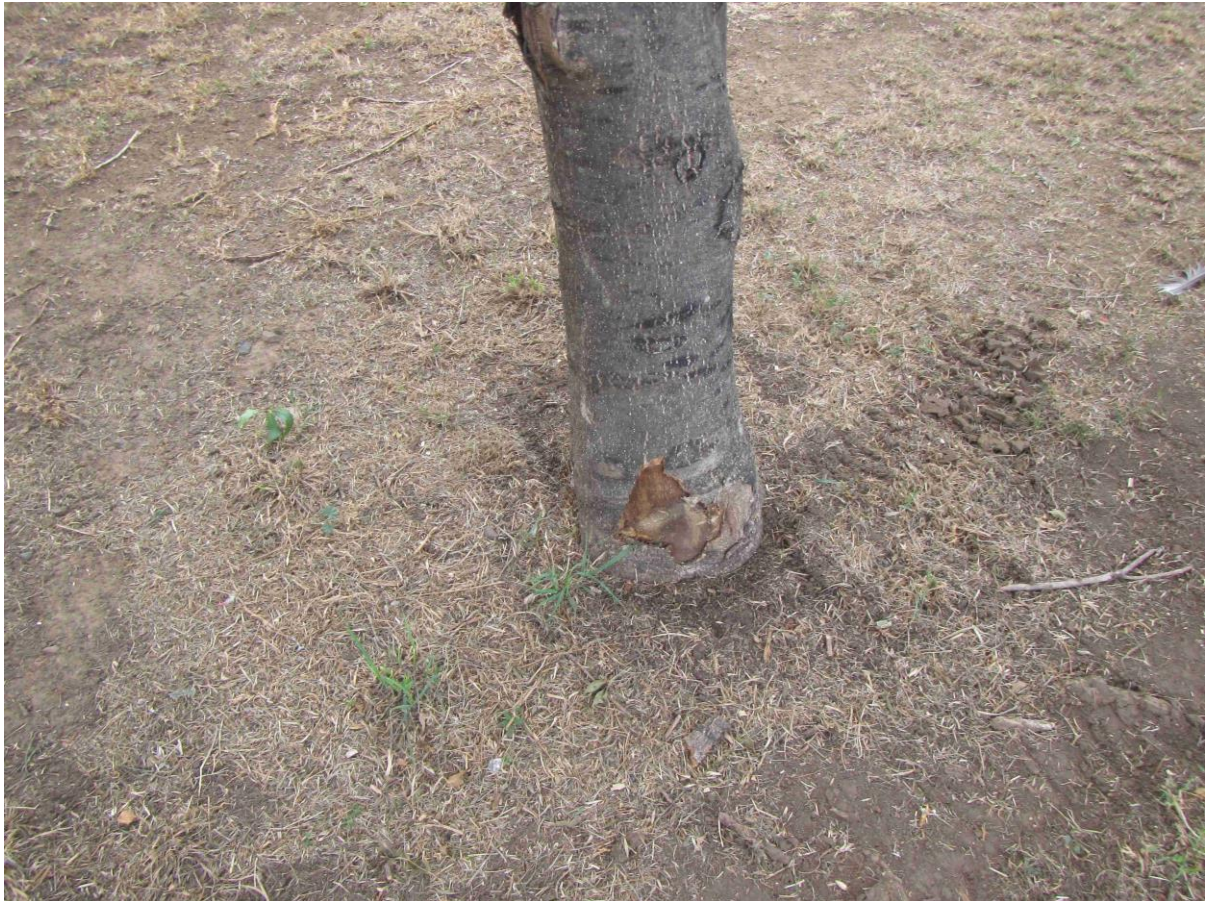
**Figure 12 Shows minor mechanical damage to a trees lower trunk.**

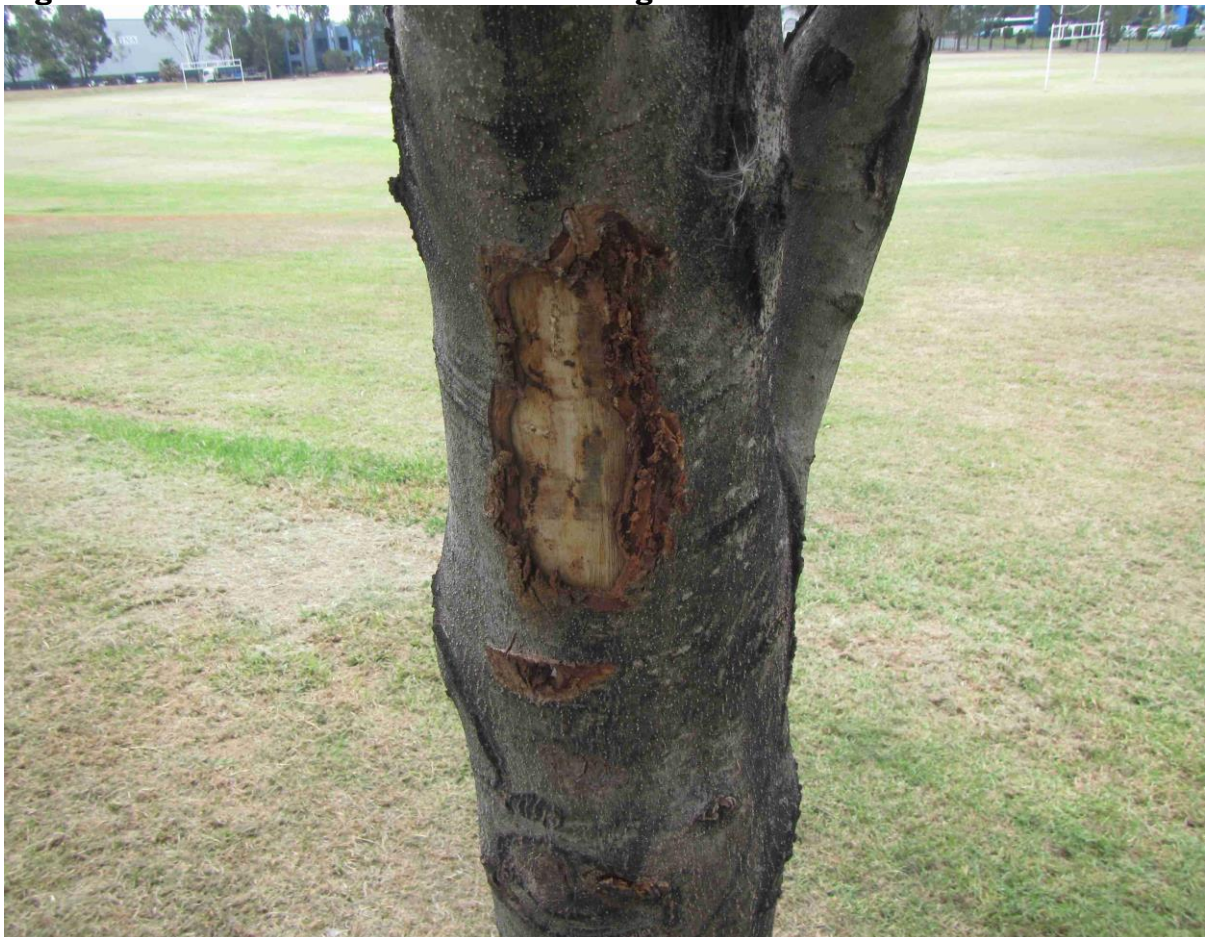
**Figure 13 Shows an open wound in the mid trunk from mechanical damage.**

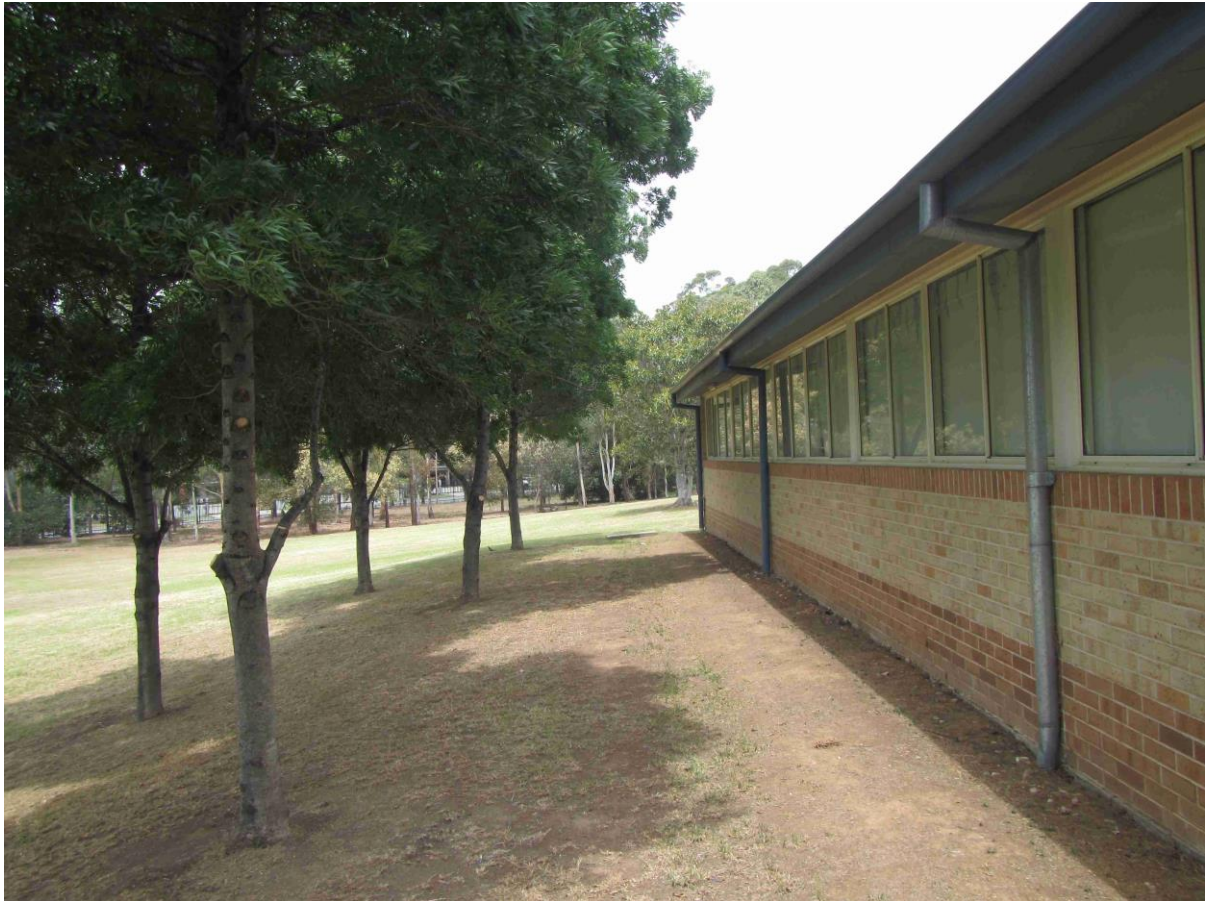
**Figure 14 Shows the trees location to the existing building being 3.5m away.**

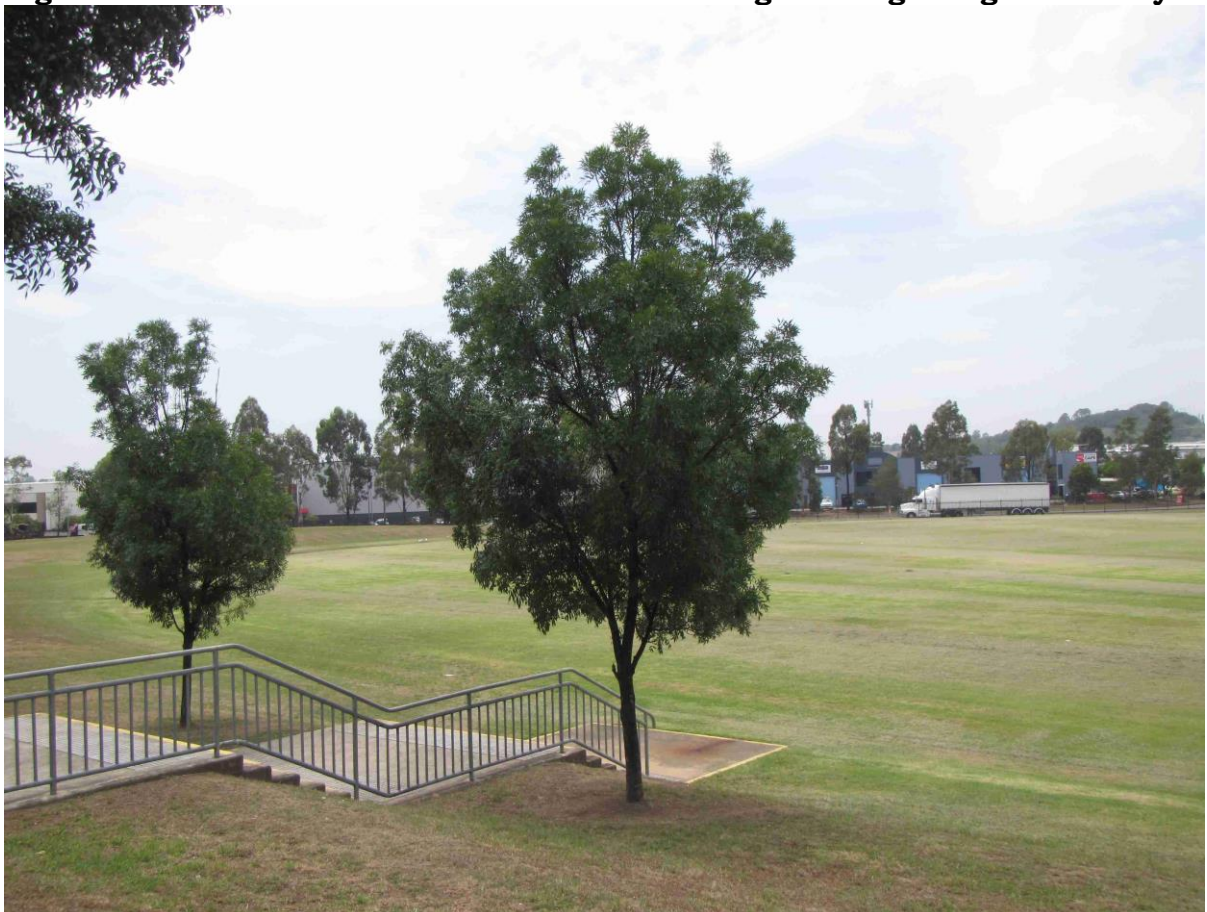
**Figure 15 Shows Tree 22 from a distance, which is sufficiently distanced to be retained.**
