SCHEDULE of CONSERVATION WORKS

3 William Street

FAIRFIELD

Job No. 8842

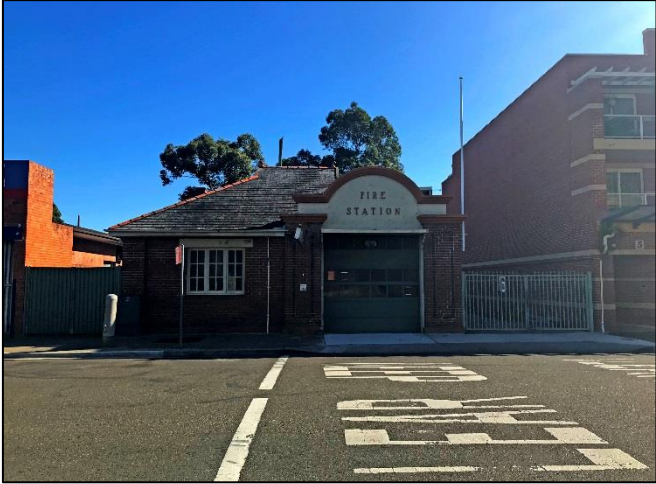
FAIR - GOOD	HIGH	<p>Slate shingle hipped roof with gablet and terracotta capping, timber fascia and ram horn finials to be retained and conserved in situ.</p> <p>Retain and conserve face brick masonry interspersed with columns and a rendered semi-circular pediment, timber window with rendered lintel and large metal roll up garage door for fire engine.</p> <p>Original chimney stack still intact. This is to be retained.</p> <p>Primary driveway along northern edge and secondary entrance along southern extent.</p> <p>Allow general cleaning of façade before beginning conservation works.</p> <p>All drainage, water supply and electrical fitting should be rationalized and decluttered.</p> <p>Remove metal roll-up door and reinstate original timber door as shown in original elevation drawing.</p>

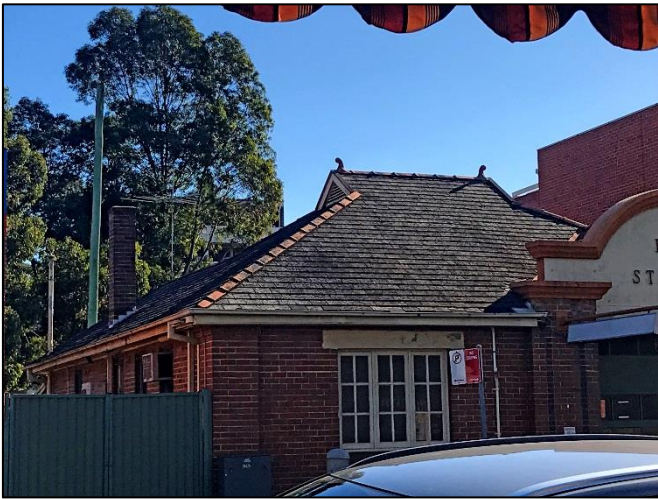
GOOD - FAIR	HIGH	<p>Slate shingle hipped roof with gablet and terracotta capping, timber fascia and ram horn finials.</p> <p>Slate shingles appear to be in POOR condition due to water ingress indication in various internal rooms. A further detailed inspection is recommended.</p> <p>Any deterioration of nails/pegs; damage to laths, battens or rafters; delamination or cracking of slates should be repaired.</p> <p>As much as possible original roof covering and supporting structure should be retained and conserved. Reuse all original slates in original orientation. Any new slates</p>

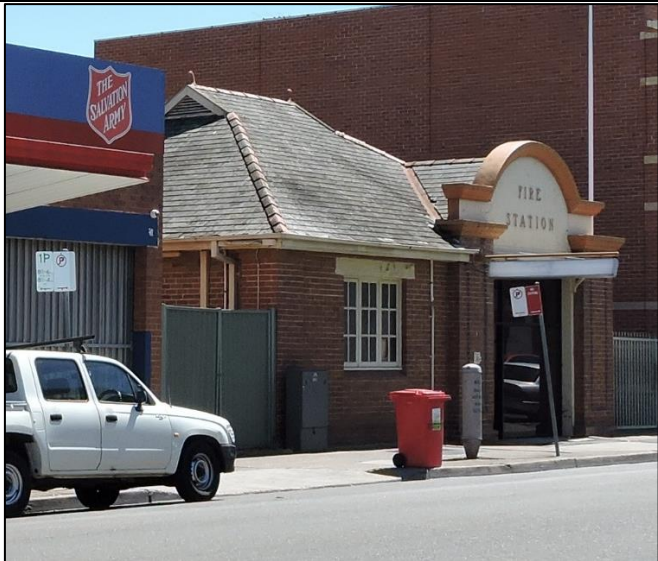
<p>required should match like for like. Retain all historic detailing of fixings, laths and battens.</p> <p>Terracotta capping and ram horn finials appear in fair condition.</p> <p>Timber fascia requires repairs.</p>
Rendered Pediment		GOOD - FAIR	HIGH	<p>Rendered semi-circular pediment with coloured cornice and historic signage of Fire Station.</p> <p>Plaster appears in good condition.</p> <p>Surface staining due to black soiling from carbon deposits and surface streaking due to irregular water channeling on wall face. General cleaning is prescribed prior to any conservation works.</p>

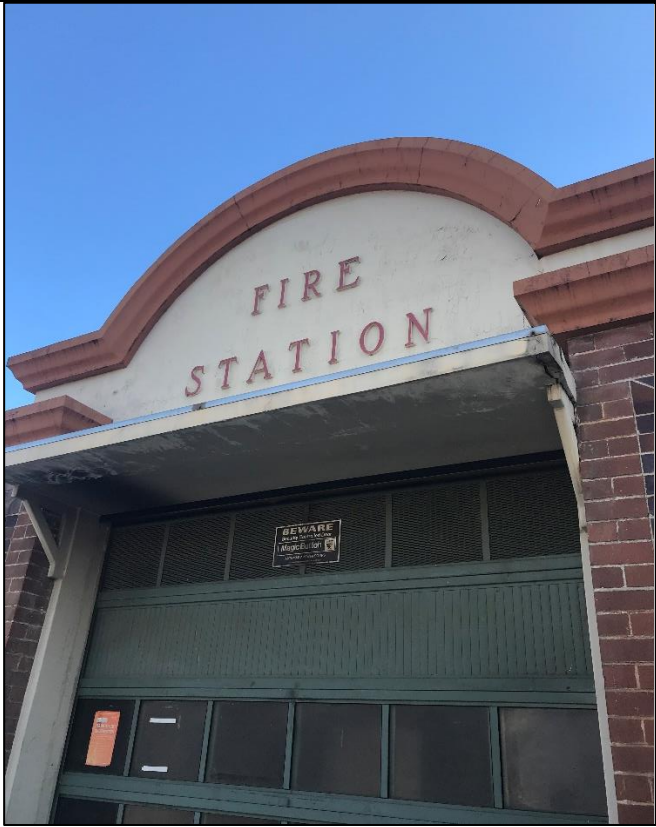
<p>Testing of paint should be undertaken to determine presence of lead and calcimine. Paint displays typical signs of calcimine due to surface cracking.</p> <p>If traces of lead or calcimine appear in testing, all paint should be removed to the substrate. Where lead paint is present, it should be removed in accordance with the appropriate Australian Standards and EPA guidelines. The surface is then to be and repainted using Murobond mineral based paint. Paint should be removed using a Peel-Away system or other non-abrasive removal techniques after consultation with the appointed Heritage Architect. Colour Scheme to be like for like or other age appropriate to match building style and period, selected after consultation with the appointed Heritage Architect.</p> <p>Retain and conserve original signage within pediment.</p>

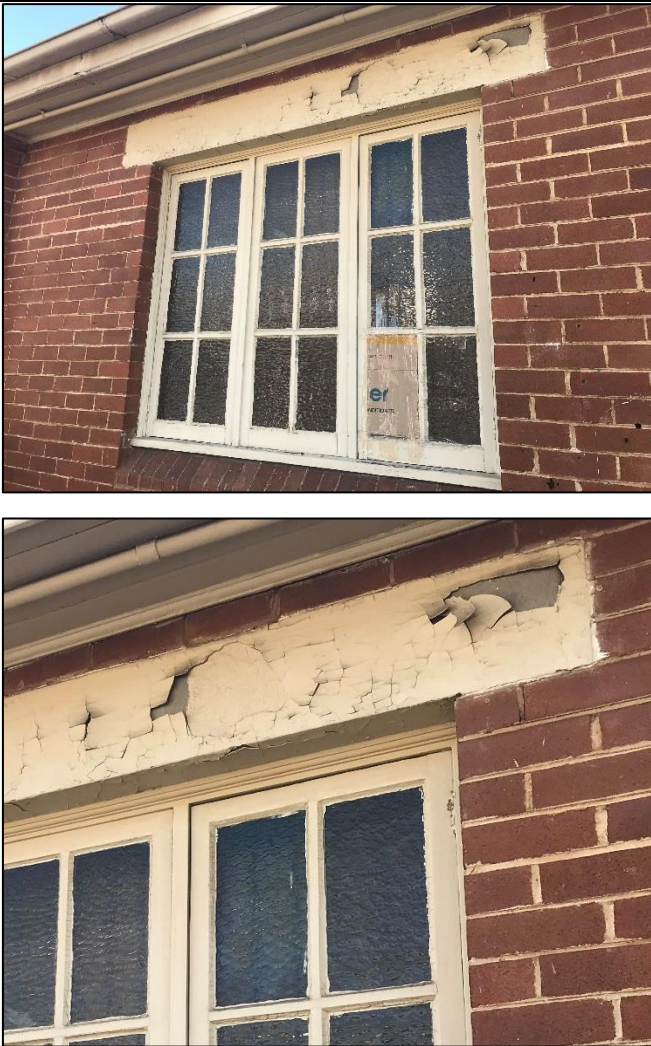
Window		FAIR - POOR	HIGH	<p>Timber window with rendered lintel, brick sill and textured glass panes.</p> <p>Timber window leaves and frame appear in fair condition. Window should undergo further inspection to ensure all</p>

<p>leaves are in working condition and all hardware is sound. Replace like for like if any damages found.</p> <p>Face putty along muntins requires cleaning and repair as years of over painting have resulted in putty being unequal and covering glass panes. This can be done at a later time.</p> <p>Paint cracked and blistering on rendered lintel. This cracking is characteristic of calcimine. Paint should be tested for lead and calcimine content. If traces of lead or calcimine appear in testing, all paint should be removed to the substrate. Where lead paint is present, it should be removed in accordance with the appropriate Australian Standards and EPA guidelines. The surface is then to be and repainted using Murobond mineral based paint. Paint should be removed using a Peel-Away system or other non-abrasive removal techniques after consultation with the appointed Heritage Architect. Colour Scheme to be like for like or other age appropriate to match building style and period, selected after consultation with the appointed Heritage Architect.</p> <p>Glass panes are in fair condition. Remove paint from panes. Missing panes should be replaced with like for like.</p>

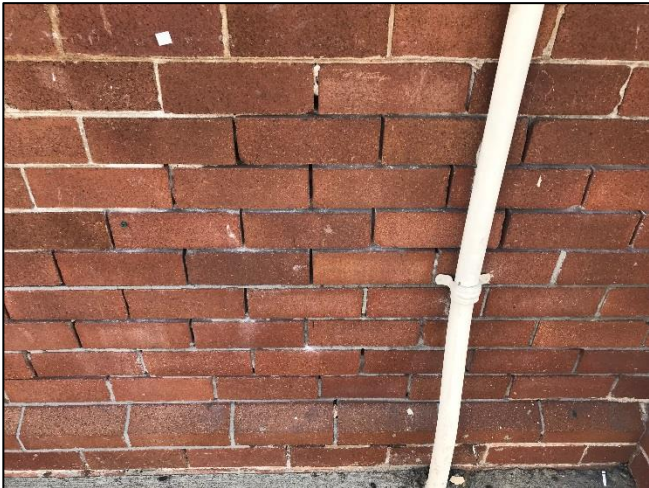
GOOD - FAIR	HIGH	<p>Face brick masonry in running bond with coloured accents in columns.</p> <p>Loss of pointing in isolated areas of the northern elevation. Repointing to be undertaken with Westox pointing mortar in flushed finish. Mortar to be pre-mixed by weight and not volumetrically. Take care to point all corners.</p> <p>Isolated incidents of discolouration at the base of the wall. General cleaning recommended prior to the commencement of any conservation works.</p> <p>Missing and spalled bricks to be replaced like for like onto the original brick courses.</p> <p>Remove concrete infill at the base of the southern column of roll up door (red outline) and replace with specifically cut brick onto original brick.</p> <p>Inclusions and drill holes may be retained.</p> <p>All drainage, water supply and electrical fitting should be rationalized and decluttered. Remove all PVC pipes and replace with age appropriate materials.</p>

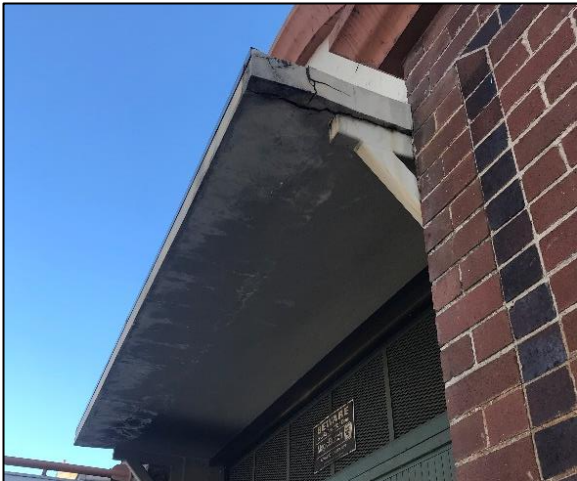
FAIR – POOR	LITTLE	Original Sun projector has been replaced with a concrete section. To be removed and reinstated with age appropriate timber projection and timber brackets. Metal Roll-up shutter door to be replaced with original timber doors illustrated in original elevation drawings.
Concrete side panels

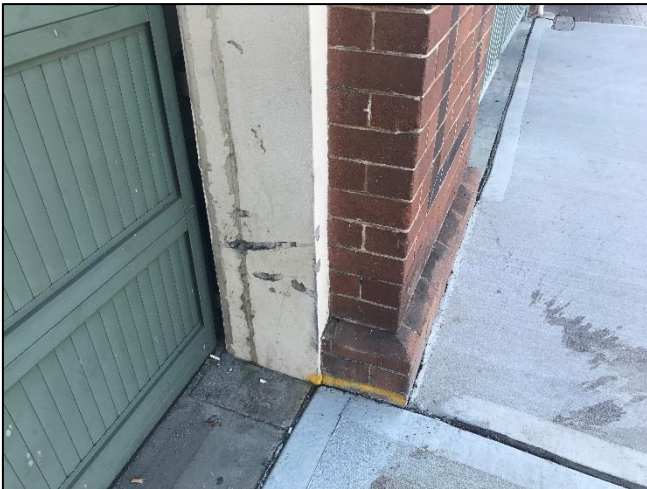
POOR – VERY POOR	MODERATE	Side panels along engine room entrance show signs of damage possibly caused by approaching or reversing vehicles. Repair render like for like to match existing. Repaint entire panel in matching colour scheme after consultation with the appointed Heritage Architect.

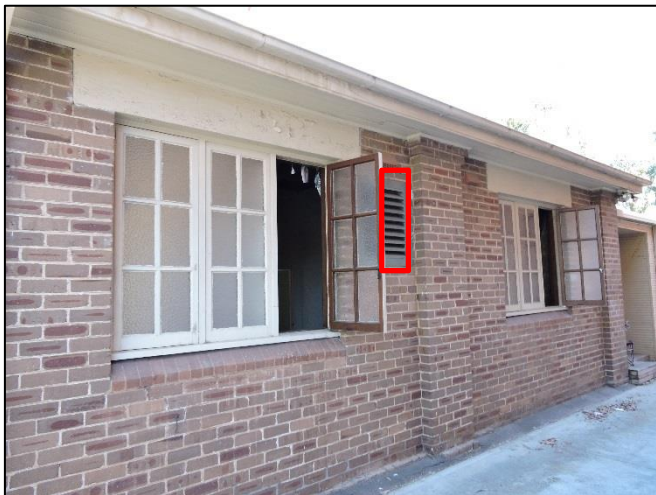
FAIR	BRICK – HIGH WEATHER BOARD – INTRUSIVE	<p>Northern Elevation is divided into two sections – The original brick and a weatherboard extension constructed in the 1980s.</p> <p>Demolition of weatherboard extension is recommended.</p> <p>Where the weatherboard extension is to be demolished, the works to be carried out should, in general, involve the least possible level of physical intervention to significant fabric.</p> <p>Any demolition to, or in the vicinity of, original external brickwork is to be carried out using hand-held tools only.</p> <p>Allow general cleaning of façade before beginning conservation works.</p> <p>All drainage, water supply and electrical fitting should be rationalized and decluttered.</p> <p>Retain original exhaust vent from Engine room (outlined red).</p> <p>The concrete courtyard to the north is to be demolished and replaced with soft landscaping. Demolition works is to be carried out using hand-held tools only.</p>

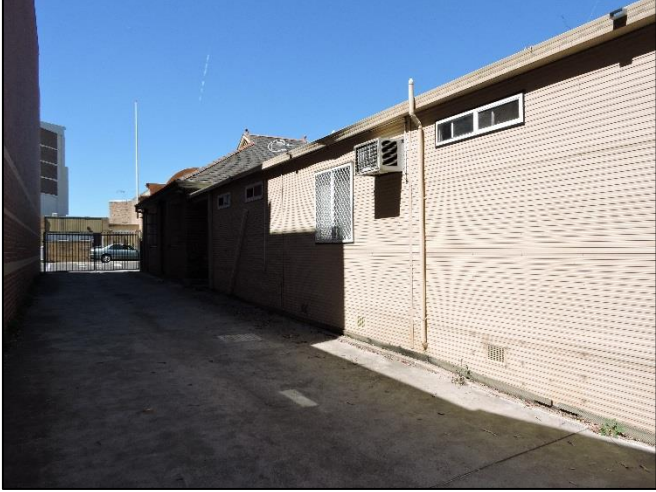
Brick masonry walls adjacent to the concrete courtyard is to be protected during demolition of the concrete courtyard.
Timber steps		POOR	LITTLE	<p>Timber step podium added to rationalize change of level into later weather board extension.</p> <p>Retain original water supply pipe connected to engine room.</p> <p>Timber steps along with weatherboard extension to be demolished.</p>

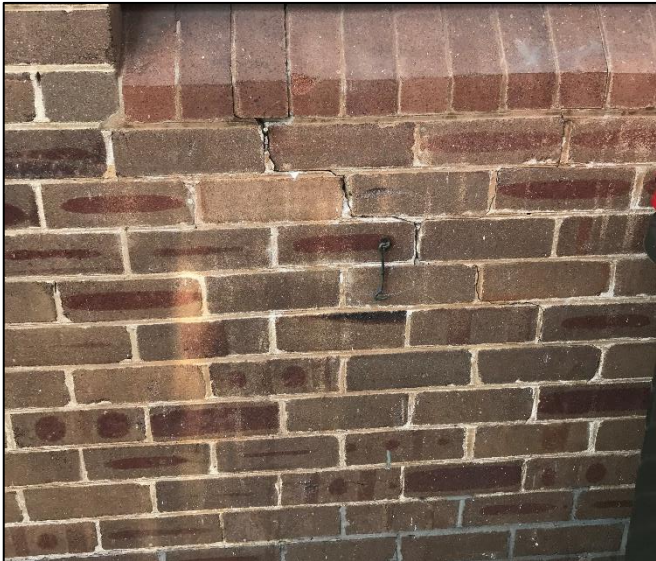
POOR	HIGH	<p>Face brick masonry appears in poor condition due to later repointing that is feathered. Rack joint and repoint using Westox pre-mixed mortar in flushed finish. Mortar to be supplied pre-mixed by weight and not volumetrically.</p> <p>Isolated incidents of diagonal spilt of mortar to be repaired in matching mortar from Westox.</p> <p>Should any masonry be damaged while works are being carried out, repair/replacement should be undertaken after consultation with the appointed Heritage Architect.</p>
Windows

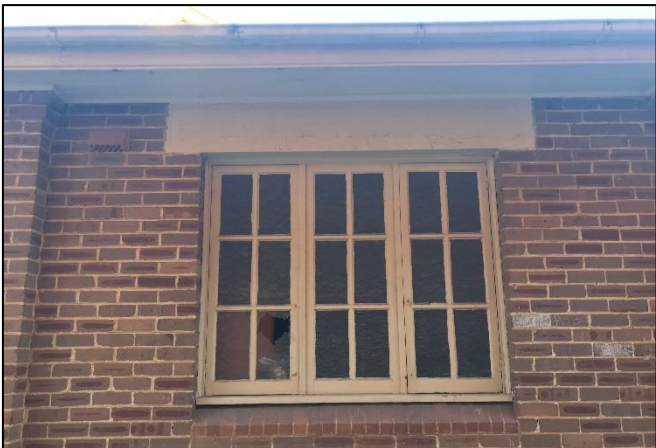
FAIR -POOR	HIGH	<p>Timber window with rendered lintel, brick sill and textured glass panes.</p> <p>Minor damages to window frames to be repaired.</p> <p>Window should undergo further inspection to ensure all leaves are in working condition and all hardware is sound. Replace like for like if any damages found.</p> <p>Face putty along muntins requires cleaning and repair as years of over painting have resulted in putty being</p>

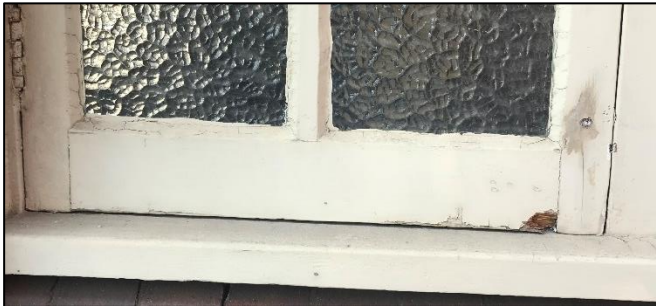
<p>unequal and covering glass panes. This can be done at a later time.</p> <p>Paint cracked and blistering on rendered lintel. This cracking is characteristic of calcimine. Paint should be tested for lead and calcimine content. If traces of lead or calcimine appear in testing, all paint should be removed to the substrate and repainted using Murobond mineral based paint. Paint should be removed using a Peel-Away system or other non-abrasive removal methods after consultation with the appointed Heritage Architect.</p> <p>Colour Scheme to be like for like or other age appropriate to match building style and period.</p> <p>Glass panes are in fair condition. Remove paint from panes. Missing or broken panes should be replaced with like for like.</p> <p>External painted scheme should be retained.</p>

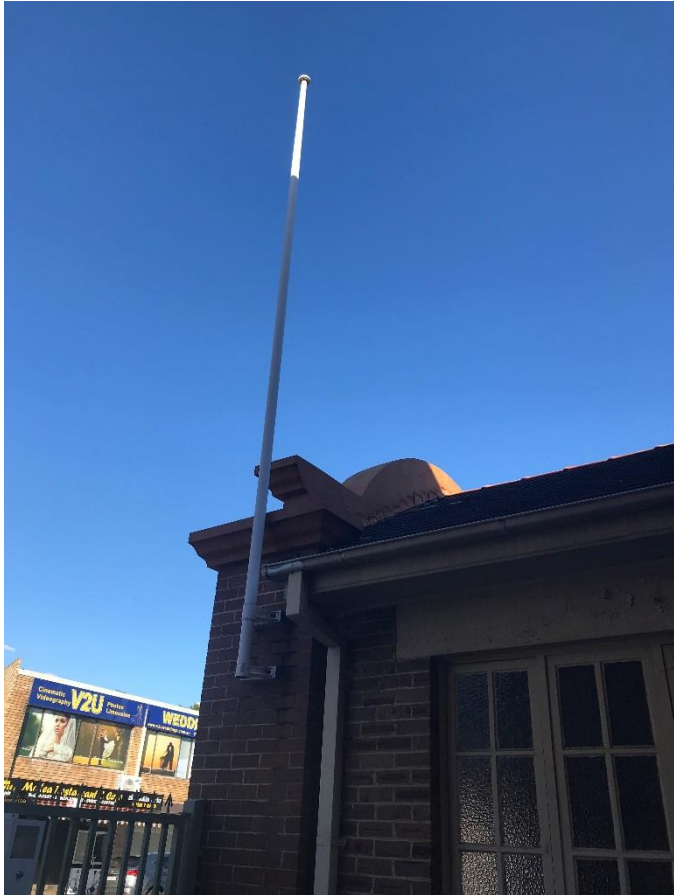
GOOD	HIGH	Retain original flag pole.

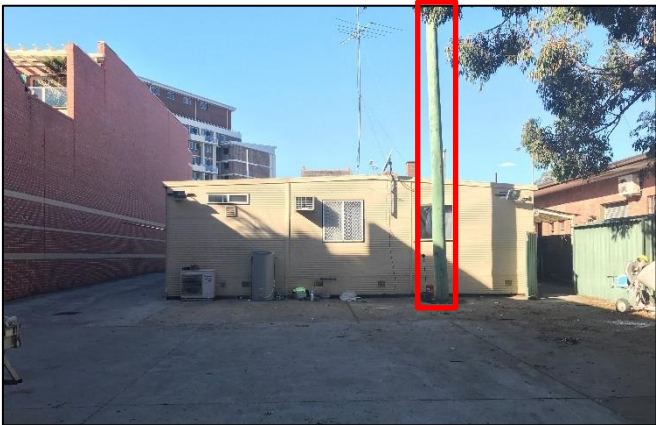
FAIR	INTRSUIVE	<p>Repoint and restore all original face brick details.</p> <p>All drainage, water supply and electrical fitting should be rationalized and decluttered.</p> <p>Timber electricity pole (highlighted red) may be removed but should either be relocated or stored on site.</p> <p>Weatherboard extension added in 1980s would be demolished and original brick elevation exposed. Allow general cleaning of façade before beginning conservation works.</p> <p>Where the later addition extensions are to be demolished, the works to be carried out should, in general, involve the least possible level of physical intervention to significant fabric.</p> <p>Any demolition to, or in the vicinity of, original external brickwork is to be carried out using hand-held tools only.</p> <p>Should any masonry be damaged while works are being carried out, repair/replacement should be undertaken after consultation with the appointed Heritage Architect.</p>

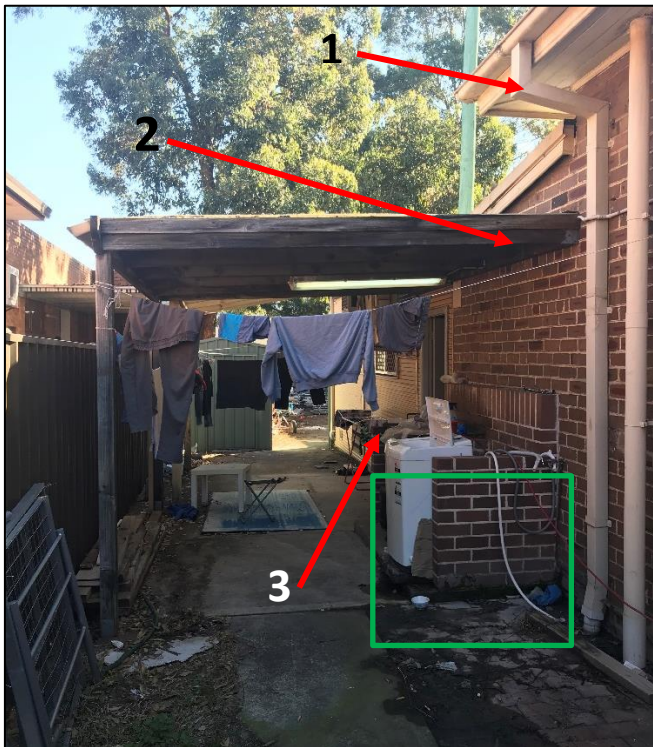
FAIR - POOR	<p>BRICK FACE – HIGH</p> <p>WEATHER BOARD – INTRUSIVE</p>	<p>Southern Elevation is divided into three sections –</p> <ol style="list-style-type: none"> 1. The original face brick structure; 2. a skillion roofed lean-to; and 3. the weatherboard extension added in the 1980s. <p>Remove weatherboard extension.</p> <p>Demolition of temporary timber awning is recommended.</p> <p>Demolition of fibre board awning is recommended.</p> <p>Remove sink and brick extension attached to the brickwork (outlined in green). Make good brickwork after the removal works have been completed.</p> <p>Where the weatherboard extension is to be demolished, the works to be carried out should, in general, involve the least possible level of physical intervention to significant fabric.</p> <p>Any demolition to, or in the vicinity of, original external brickwork is to be carried out using hand-held tools only.</p> <p>Should any masonry be damaged while works are being carried out, repair/replacement should be undertaken after consultation with the appointed Heritage Architect.</p>

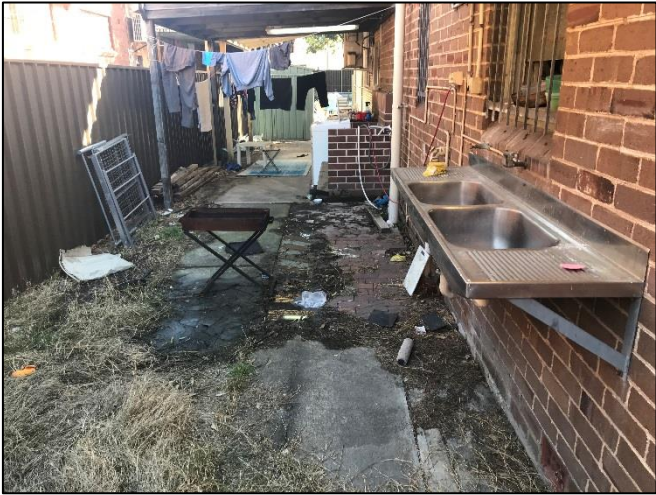
POOR	LITTLE	<p>Alleyway flooring is highly damaged and uneven. Collection of water from washing machine runoff and rainwater collection exasperates damage to base of walls.</p> <p>Repair floor and replace concrete slabs with terracotta pavers. A 300mm pervious apron should be cut at the base of the wall around the perimeter of the building to prevent rising damp and subsequent exfoliation of brick work, plaster and paint. Apron to be filled with loose gravel.</p>

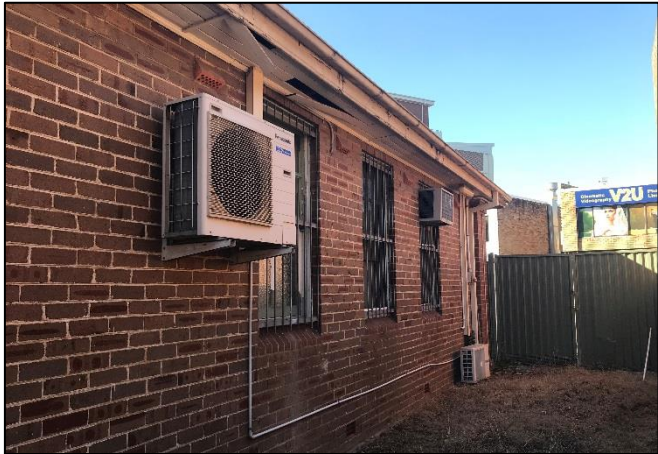
FAIR – POOR	HIGH	<p>Face brick masonry appears in poor condition due to later repointing that is feathered. Rack joint and repoint using Westox pre-mixed mortar in flushed finish. Mortar to be supplied pre-mixed by weight and not volumetrically.</p> <p>Isolated incidents of discolouration due to water ingress. Source of water damage to be investigated and repaired. General cleaning recommended prior to the commencement of any conservation works.</p> <p>Missing and spalled bricks to be replaced like for like onto the original brick courses.</p> <p>Terracotta ventilators and chimney stack are in fair condition and should be retained and conserved.</p>

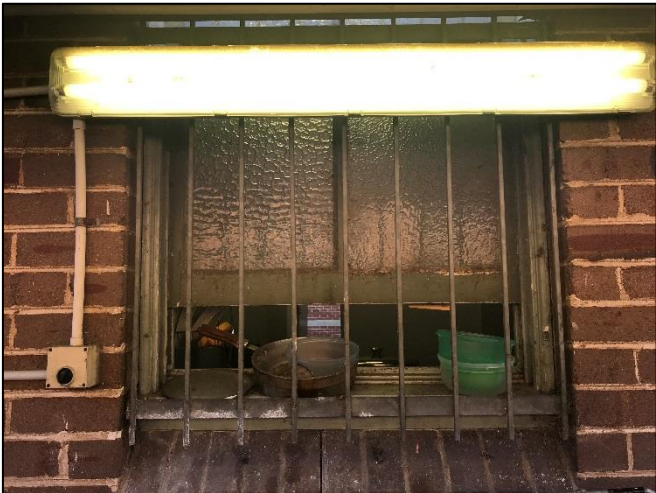
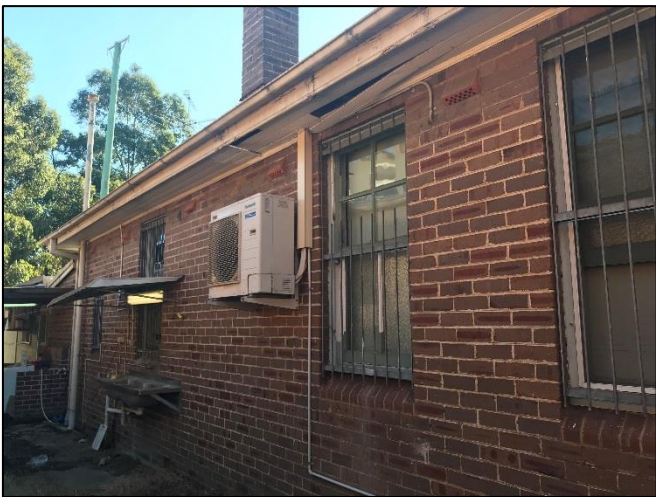
POOR	HIGH	<p>Timber window with rendered lintel, brick sill and textured glass panes.</p> <p>Minor damages to window frames to be repaired.</p> <p>Window should undergo further inspection to ensure all leaves, sash cords are in working condition and all hardware is sound. Replace like for like if any damages found.</p> <p>Face putty along muntins requires cleaning and repair as years of over painting have resulted in putty being unequal and covering glass panes. This can be done at a later time.</p> <p>Glass panes are in fair condition. Remove paint from panes. Missing or broken panes should be replaced with like for like.</p> <p>External painted scheme should be matched to other elevations.</p> <p>Aluminium grills to be removed from the original fabric.</p> <p>Light attached to window details should be removed.</p>

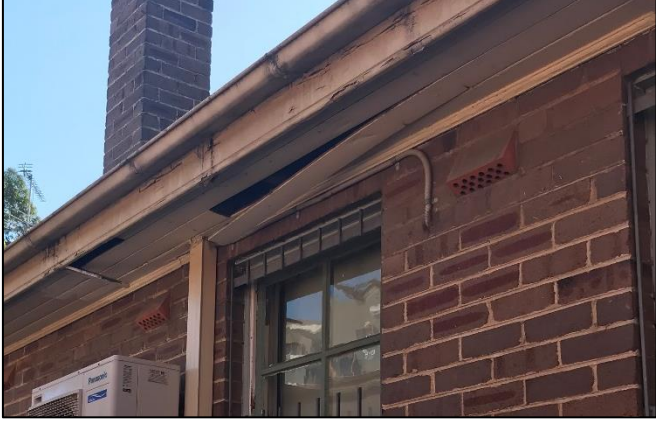
POOR	HIGH	Original timber fascia is painted. Investigate water ingress or other signs of damage. Repair fascia boards.

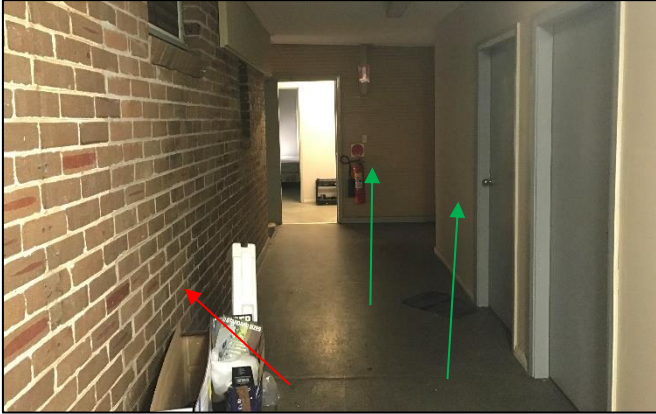
FAIR - POOR	<p>BRICK FACE – HIGH</p> <p>WEATHER BOARD – INTRUSIVE</p>	<p>Internal areas are divided into two sections, original 1925 building (red arrow) and 1980s weatherboard construction (green arrow).</p> <p>Demolish weatherboard extension.</p> <p>Where the later addition extensions are to be demolished, the works to be carried out should, in general, involve the least possible level of physical intervention to significant fabric.</p> <p>Any demolition to, or in the vicinity of, original brickwork is to be carried out using hand-held tools only.</p> <p>Demolition work is to be carried out in accordance with the current and relevant sections of National Construction Code (NCC); and Australian Standard AS2601: The demolition of structures (AS 2601).</p> <p>Prior to any demolition, a dilapidation record is required. Either as a photographic or video and written record of the condition of the portion of the existing building retained, adjacent buildings, and other relevant structures or facilities;</p>

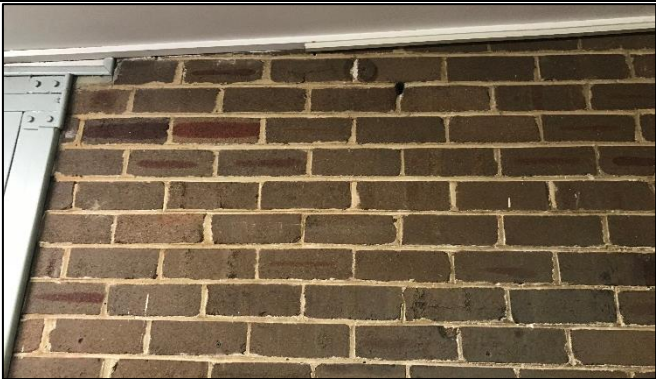
<p>Once weatherboard extension has been removed repair all face brick masonry.</p> <p>Remove later addition timber rails and boards.</p>
Rendered Internal walls

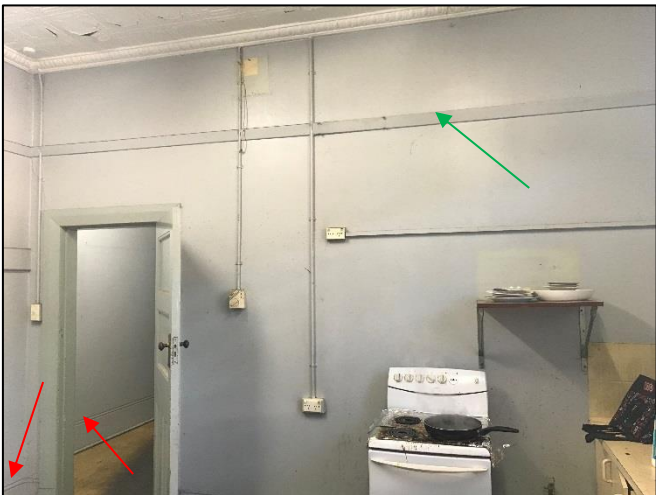
FAIR - POOR	HIGH	<p>Internal masonry walls with plaster with original picture rails and dado skirting.</p> <p>Retain and conserve all original masonry walls as much as possible. Remove original paint using Peel-Away system and repaint in age appropriate colour scheme after consultation with the appointed Heritage Architect.</p> <p>Where the proposal requires the removal of parts of the original internal walls, nibs on either side of the wall and spandrels above are to be retained. Nibs are to be minimum 450mm, while spandrels are to be at 2100mm height.</p> <p>Where new partition walls and any other new fabric is to be introduced within the space, the new fabric is, as far as possible, not to be fixed to the original brickwork. New</p>

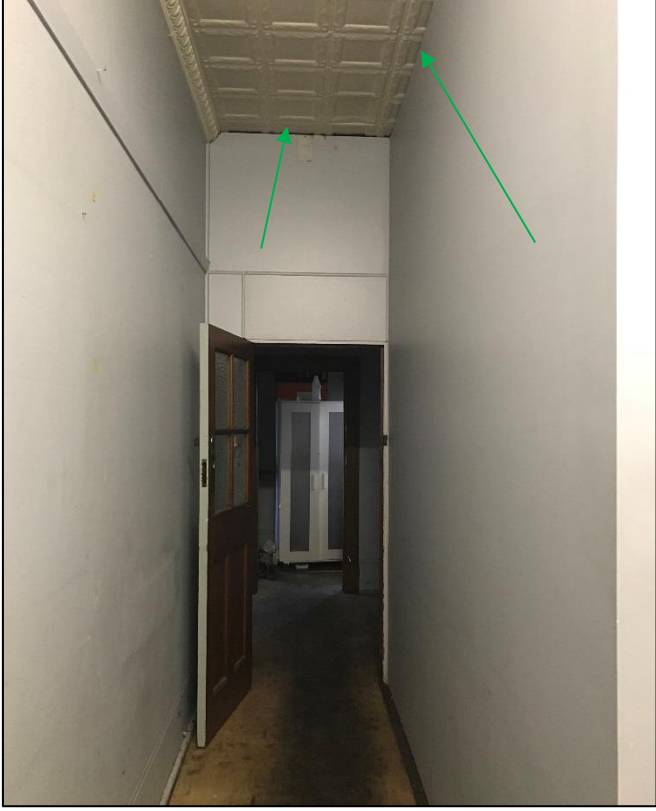
Removal of internal non-original plasterboard walls. Care must be taken to ensure that no original pressed metal ceilings, cornices, bevelled picture rails or masonry are damaged during removal.

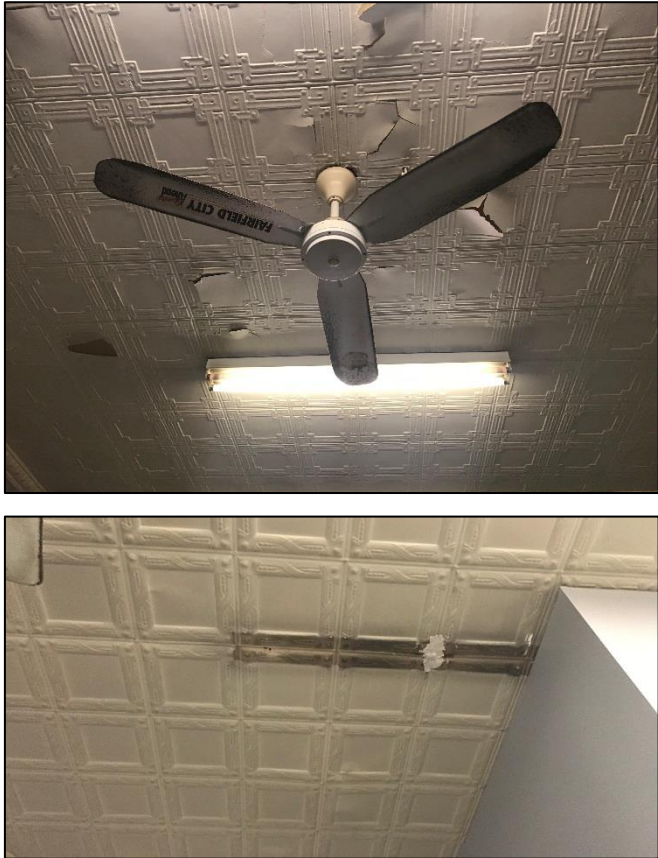
FAIR – POOR	HIGH	<p>Retain and conserve original ceilings, including the pressed metal ceilings.</p> <p>Pressed metal ceilings appear in various stages of disrepair ranging from good to very poor. Where condition is very poor, it is primarily due to water infiltration from exterior sources.</p> <p>It is firstly important to identify the metal that is used and if panels are secured. Lathing can deteriorate from prolonged water damage and/or termites. Plumbing pipes, electrical fixtures and other apertures not only affect the structural soundness of the ceiling but also destroy the visual continuity of the pattern.</p> <p>Decisions regarding the viability of repairs, wholesale replacement or a combination of both need to be made under the guidance of the appointed heritage architect.</p> <p>Where ceilings are damaged, they are to be made good.</p> <p>Where surfaces are patchy/ rusted, remedial action to be taken if required and monitor for further deterioration.</p>

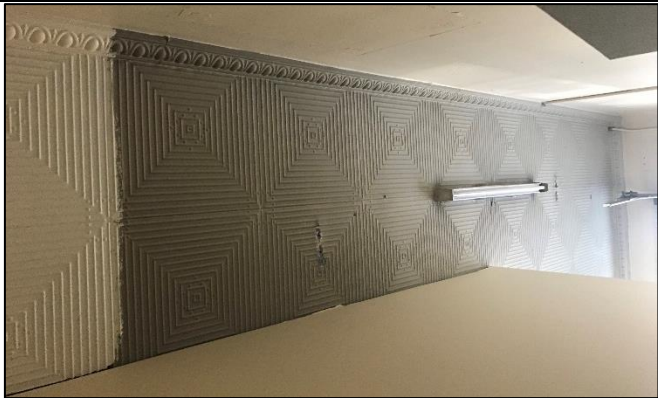
<p>If wholesale replacement is to happen, the pattern of the pressed metal panels are to match existing in all respects.</p> <p>A heritage consultant should be consulted if the pressed ceiling panels are to be replaced with a different pattern.</p> <p>Inspection and testing of paint must be undertaken to assess the likely presence of lead-based paints. Where lead paint is present, it should be removed in accordance with the appropriate Australian Standards and EPA guidelines. The surface is then to be and repainted. Paint should be removed using non-abrasive removal techniques after consultation with the appointed Heritage Architect. Colour Scheme to be like for like or other age appropriate to match building style and period, selected after consultation with the appointed Heritage Architect.</p> <p>Where new internal partition walls are to be inserted, care must be taken that the walls are not fixed to the pressed metal ceiling. The walls are to be at a height of 2400mm and a secondary ceiling is to be introduced at 2400mm.</p>

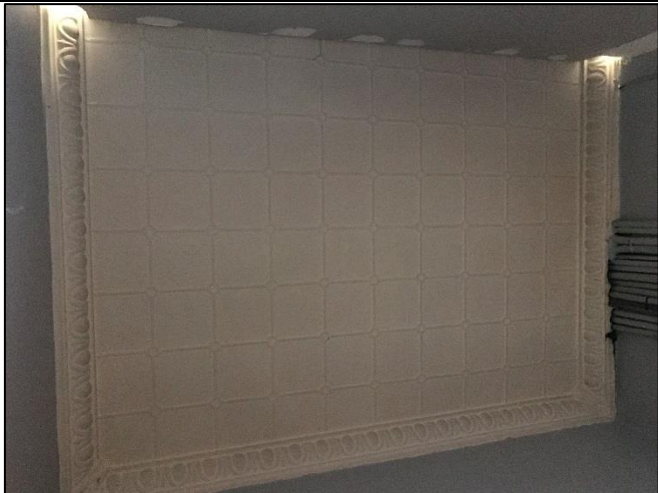
Cornices		FAIR	HIGH	<p>Original cornices appear in fair condition. Repaint to match new colour scheme after consultation with appointed Heritage Consultant. Minor repair should be undertaken as specified in specifications.</p> <p>Where cornices are damaged, they are to be made good.</p> <p>Inspection and testing of paint must be undertaken to assess the likely presence of lead-based paints. Where lead paint is present, it should be removed in accordance with the appropriate Australian Standards and EPA guidelines. The surface is then to be and repainted. Paint should be removed using non-abrasive removal techniques after consultation with the appointed Heritage</p>

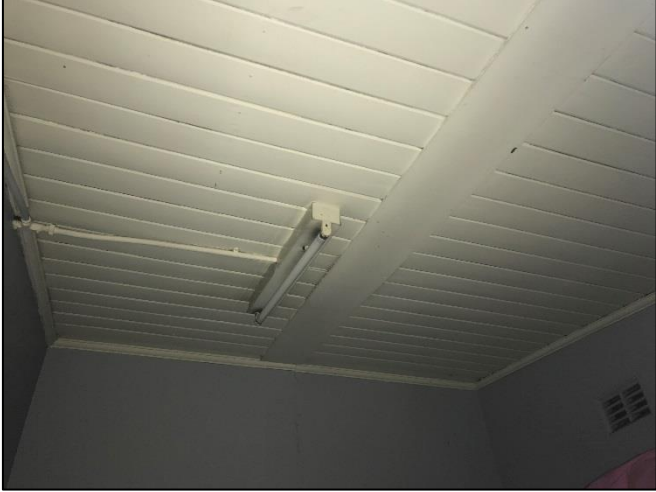
FAIR	HIGH	Timber ceilings appear in fair condition. Regular maintenance is recommended.
Ceiling in Bathroom (Original Structure)

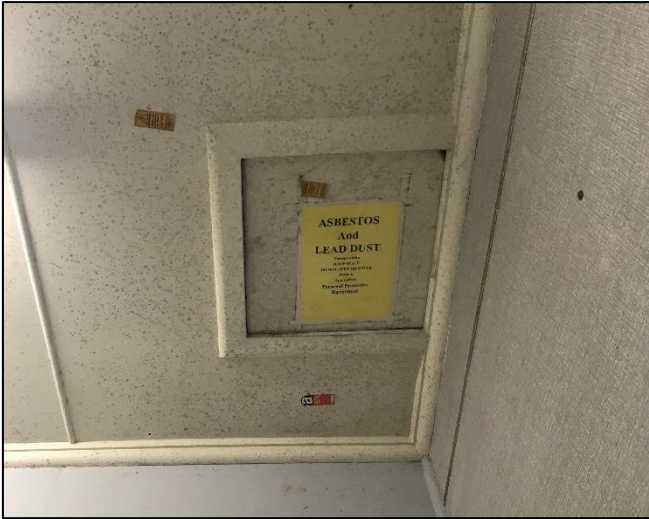
FAIR	LITTLE	<p>Warning in bathroom of lead and asbestos to be considered. Pre-emptive measures to be taken on site and all toxic materials removed according to Australian Standards and EPA guidelines.</p> <p>A heritage expert should be consulted if the ceiling is to be replaced. The new ceiling is to be of age appropriate material.</p>

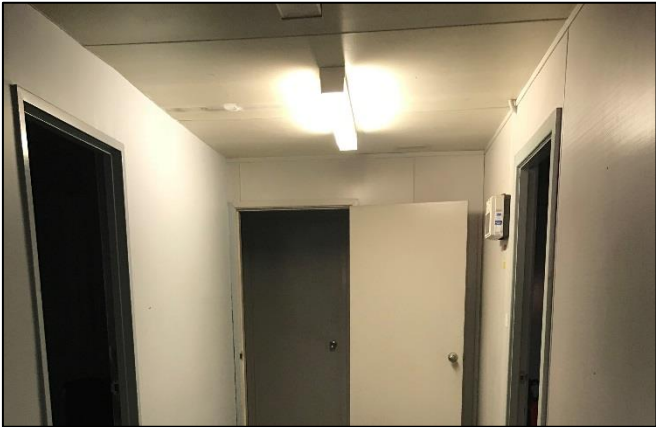
FAIR	INTRUSIVE	Later addition plasterboard ceilings to be demolished with entire weatherboard construction.

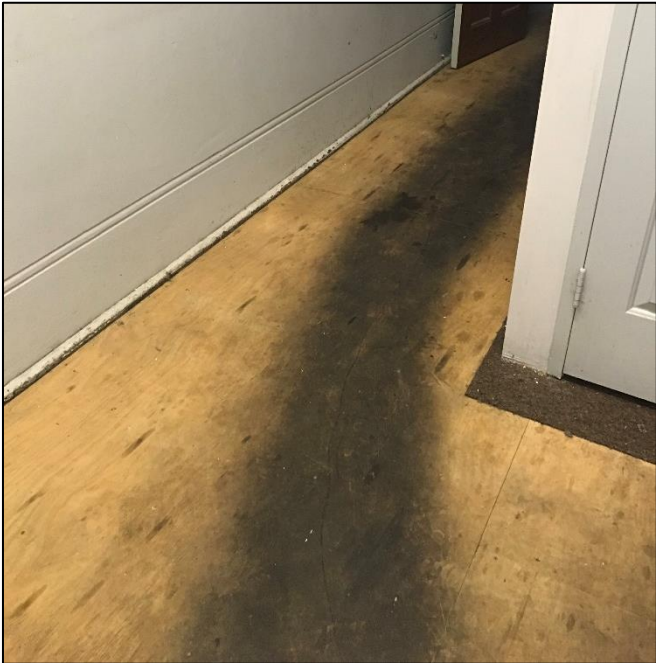
POOR	INTRUSIVE	<p>Ply is a later addition and should be removed to investigate material below.</p> <p>Original or age appropriate flooring should be rationalised and reinstated.</p> <p>Where original and significant flooring is extant below, any new flooring material is to be placed on top of a 6mm CFC sheeting to ensure that the significant flooring is retained and protected.</p>
Flooring – Tiles		FAIR	<p>MOROVIAN – HIGH</p> <p>OTHER – LITTLE</p>	<p>Morovian tiles in bathroom may be considered of high significance. These should be retained, cleaned and repaired.</p> <p>Where tiling has been damaged, it is to be repaired.</p> <p>Where repairing is not possible, a Heritage Architect is to be consulted and a period appropriate Morovian tiles is to replace damaged tile. Replacement tile is to be sourced</p>

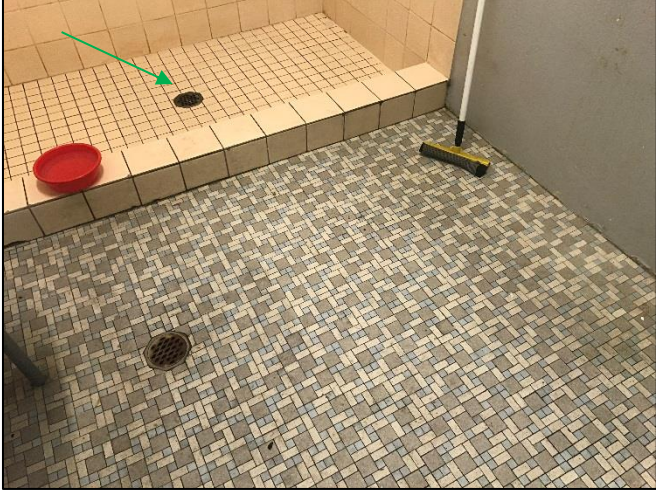
<p>from old tiles sourced from restoration shops and tile specialists or cut from modern tiles of similar finish into the shape required.</p> <p>Non-original tiles (green) are of low significance and may be removed if required.</p> <p>Where new bathroom fittings are to be introduced, they should be located where the existing fixtures and services are located to ensure minimum damage to the original fabric of the building.</p> <p>No new penetrations are to be made while inserting new fixtures, including those for BCA compliance. The existing plumbing and floor wastes should be used.</p>

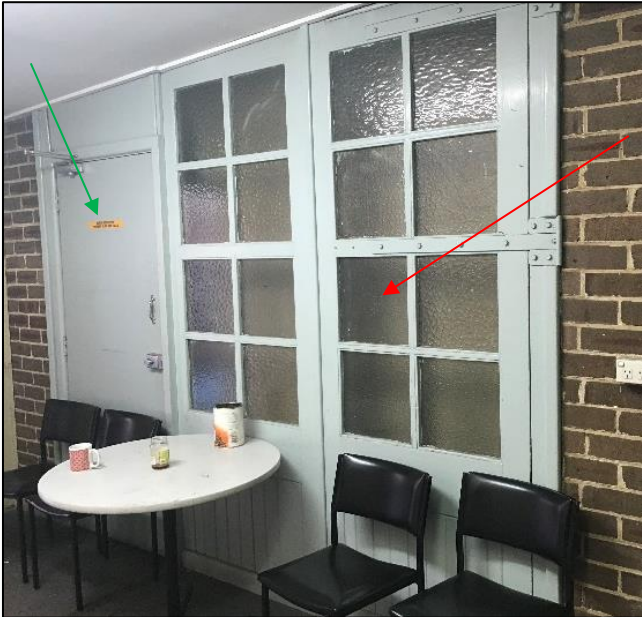
GOOD	HIGH	<p>Original three leaves door has been modified. This door would have been similar to the door on the Eastern Elevation. Recommendation has been made in Section 3.1.1 to replace rollup shutter door with timber door.</p> <p>Main timber doors to the rear of the Engine room is currently blocked. Doors should undergo further inspection to ensure all leaves are in working condition and all hardware is sound. Replace like for like if any damages found.</p> <p>Secondary later addition door (green arrow) to be removed and original three panelled (red) door to be completed and reinstated. Minor damages to timber should be repaired.</p> <p>Once weatherboard extension is removed, this door will be converted into an external door, therefore paint finish to be retained. Colour scheme should match external scheme and be period appropriate.</p>

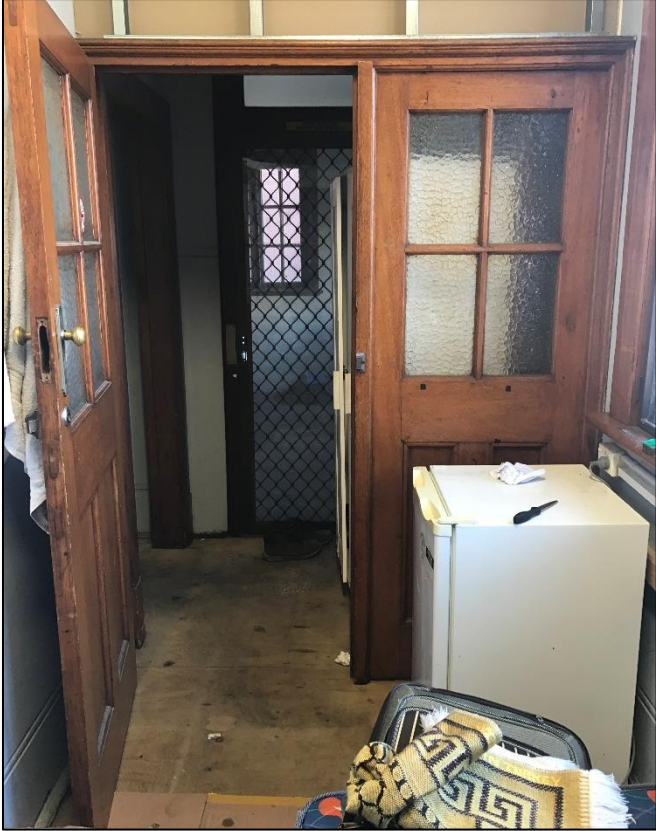
<p>Doors should undergo further inspection to ensure all leaves are in working condition and all hardware is sound. Replace like for like if any damages found.</p> <p>French polish finish to be reinstated along all internal facing. Textured glass panes to be retained. Missing or broken panes to be replaced like for like.</p> <p>Minor dents and scratches may be retained. Advanced damage to frame or leaves (red) may be repaired.</p> <p>The location of some original doors has been changed. It is recommended that original door locations be determined, and doors reinstated.</p> <p>The original internal doors should be retained in-situ. According to the Accessibility Assessment Report, the Clear Opening of Doorways requirement would be addressed through a performance solution.</p>

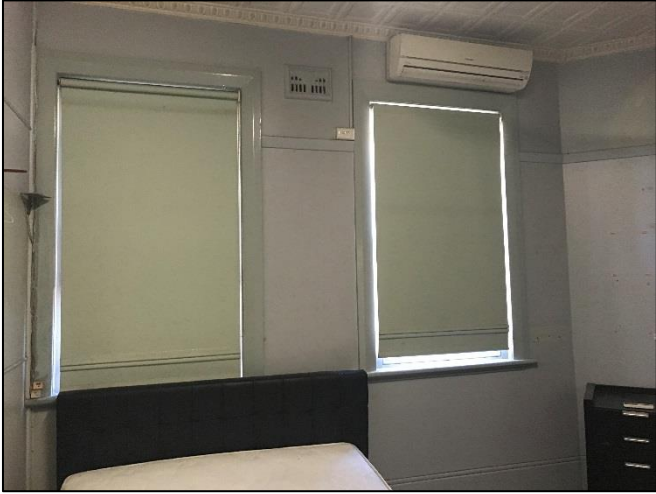
FAIR	HIGH	<p>Original timber windows with architraves have been painted over.</p> <p>Windows should undergo further inspection to ensure all leaves are in working condition and all hardware is sound. Replace like for like if any damages found.</p> <p>French polish finish to be reinstated along all internal facing. Textured glass panes to be retained. Missing or broken panes to be replaced like for like. Remove later addition metal grills.</p> <p>Minor dents and scratches may be retained. Advanced damage to frame or leaves may be repaired.</p>

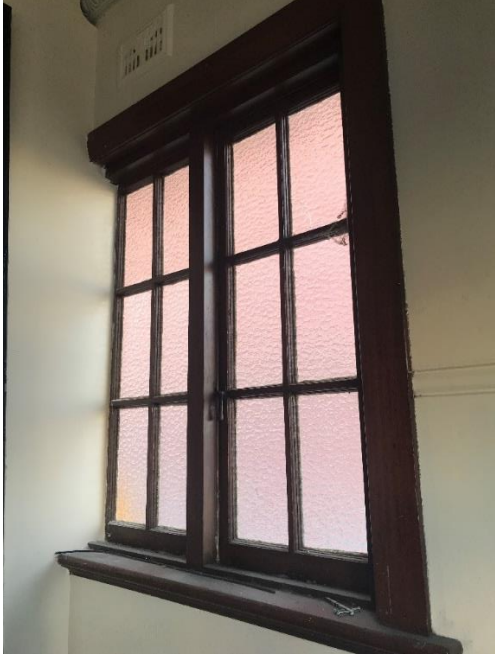
FAIR	HIGH	<p>Later addition partition divides original window into two sections. Remove partition wall to reinstate the original window configuration.</p> <p>Window should undergo further inspection to ensure all leaves are in working condition and all hardware is sound. Replace like for like if any damages found.</p> <p>French polish finish to be reinstated along all internal facing. Textured glass panes to be retained. Missing or broken panes to be replaced like for like. Remove later addition metal grills.</p>

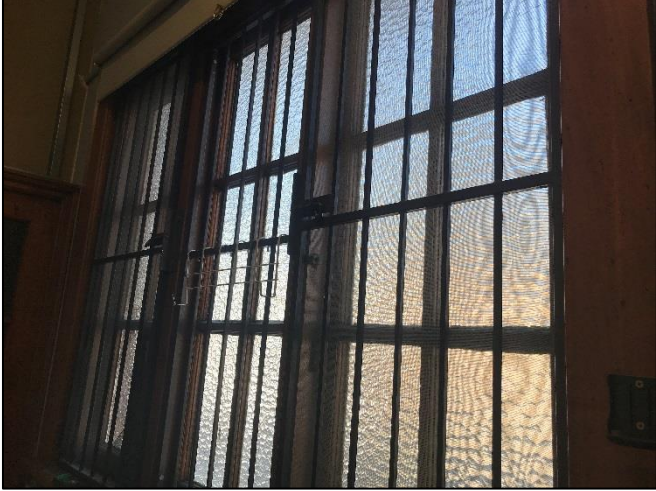
GOOD	HIGH	<p>Original window in good condition. Remove later addition metal grill.</p> <p>Window should undergo further inspection to ensure all leaves are in working condition and all hardware is sound. Replace like for like if any damages found.</p> <p>French polish finish to be reinstated along all internal facing. Textured glass panes to be retained. Missing or broken panes to be replaced like for like.</p>

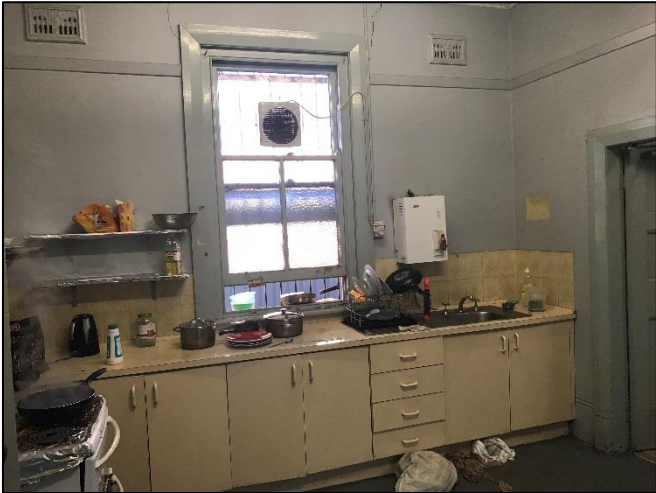
POOR	LITTLE	<p>Kitchen fixtures along internal walls should be removed. All shelves and other fittings attached to original masonry walls to be removed. All resulting drill holes to be filled in pre-mixed Westox Plaster.</p> <p>Allow the heritage architect to carry out intermediate and final inspection of the work as it ensues.</p>
Bathroom Fixtures		POOR	LITTLE	<p>Bathroom fixtures appear to be later addition with exception to the Moravian tiles which should be retained. Rationalise based on future use. Fixtures should be replaced accordingly.</p> <p>If the bathroom fittings are to be replaced, or new fixtures are to be added for BCA compliance, the new fittings are to be period appropriate fittings or sympathetic and compatible simple contemporary fittings.</p>

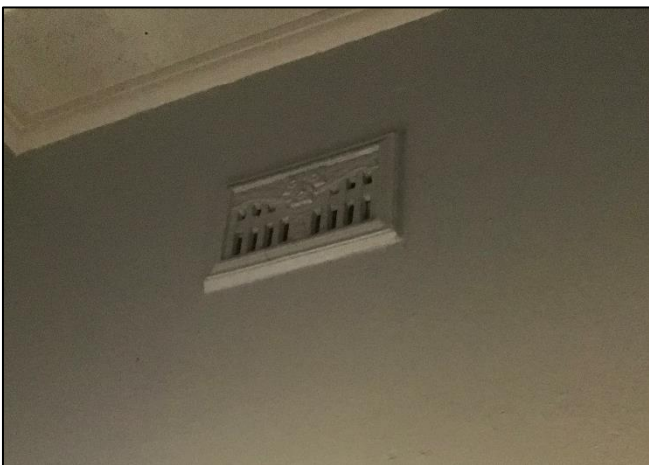
FAIR	HIGH	Original ventilator screens are in fair condition. General cleaning is advised. If internal walls are being repainted, grills should be stripped off paint and repainted.

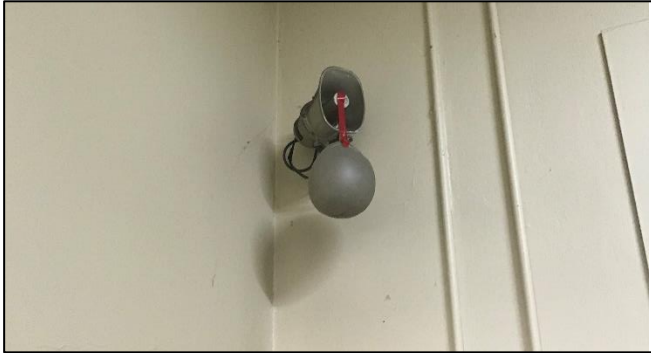
FAIR	HIGH	Retain original fire alarm speaker in engine room. The fire alarms is to be protected insitu during demolition, construction and conservation works to other fabric.
Exhaust – Engine Room		FAIR	HIGH	Retain original Exhaust in Engine room.

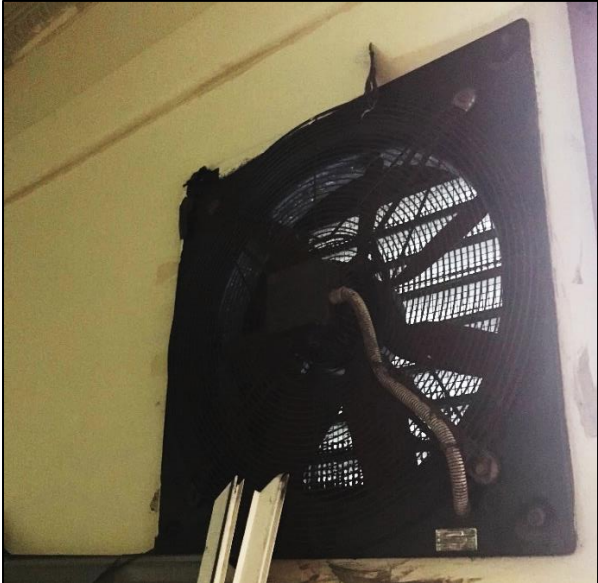
The exhaust is to be protected insitu during demolition, construction and conservation works to other fabric.
Cupboards in Storage		FAIR	LITTLE	<p>Timber built-ins in storage area may be retained.</p> <p>A qualified heritage carpenter is to inspect all existing timber elements and determine condition of each timber built-ins in storage area.</p> <p>Where repairs are required to timber, works are to be taken in situ using the geometric splicing method. This includes removing the entire thickness of the damaged area and geometrically splice in a matching section exactly to the thickness, shape, profile, form and species</p>
