6 April 2018

Ref: 4551

This is an update of Ref: 3888 Rev A with added information from additional tree assessments

Preliminary Arboricultural Report Goulburn Aquatic Centre and Surrounds

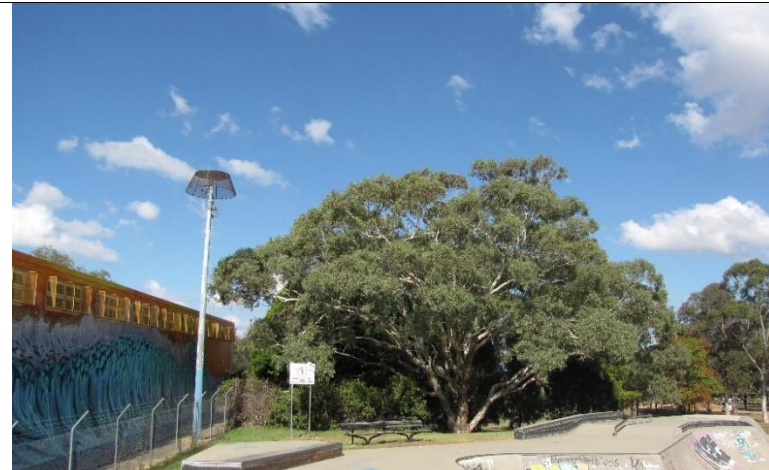
Tree 33

| Tree Number | Species | Height | Canopy Spread | | | | Health | Structure | Tree Protection Status | Tree Quality Classification | Comments | Circumference ⁴⁹⁷⁰ | | | | | Radius TPZ ⁴⁹⁷⁰ | Radius SRZ ⁴⁹⁷⁰ |
|---|--|---|---|---|---|---|---|---|---|---|--|---|---|---|---|---|---|---|
| 33 | Eucalyptus melliodora -Yellow Box | 16 | 16 | 12 | 12 | 12 | Good | Good | Regulated Remnant | High | Deadwood present, small fruiting body present not a problem, some previous branch failures | 2.86 | | | | | 10.9 | 3.4 |

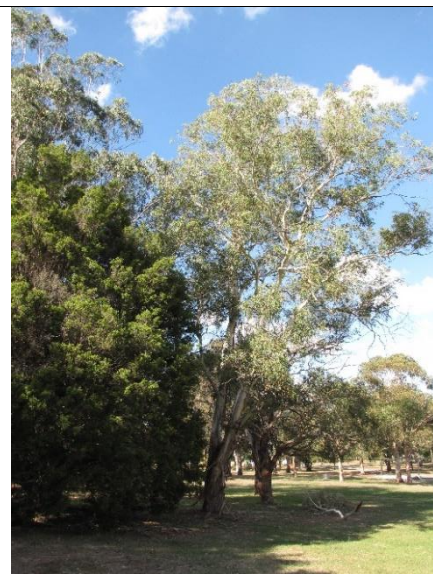
Tree 47

| Tree Number | Species | Height | Canopy Spread | | | | Health | Structure | Tree Protection Status | Tree Quality Classification | Comments | Circumference ⁴⁹⁷⁰ | | | | | Radius TPZ ⁴⁹⁷⁰ | Radius SRZ ⁴⁹⁷⁰ |
|---|--|---|---|---|---|---|---|---|---|---|---|---|---|---|---|---|---|---|
| 47 | Eucalyptus viminalis - Ribbon Gum | 14 | 2 | 5 | 11 | 8 | Fair | Poor | Park Tree | Poor | Decay in trunk, root damage, poor form, fungal fruiting body, large amount deadwood present | 2.38 | | | | | 9.1 | 3.2 |

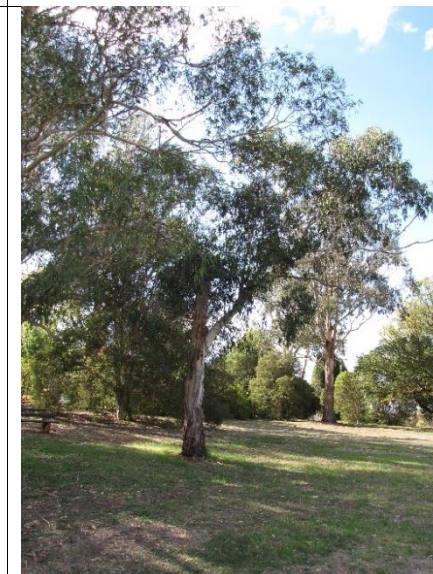
Tree 49

| Tree Number | Species | Height | Canopy Spread | | | | Health | Structure | Tree Protection Status | Tree Quality Classification | Comments | Circumference ⁴⁹⁷⁰ | | | | | Radius TPZ ⁴⁹⁷⁰ | Radius SRZ ⁴⁹⁷⁰ |
|---|--|---|---|---|---|---|---|---|---|---|---|---|---|---|---|---|---|---|
| 49 | Eucalyptus delrympleana | 9 | 3 | 6 | 1 | 1 | Good | Very Poor | Park Tree | Poor | Main leader failed, poor form | 1.52 | | | | | 5.8 | 2.6 |

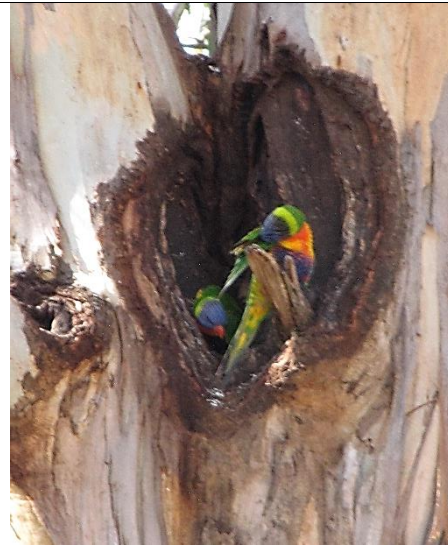
| Tree Number | Species | Height | Canopy Spread | | | | Health | Structure | Tree Protection Status | Tree Quality Classification | Comments | Circumference ⁴⁹⁷⁰ | | | | | Radius TPZ ⁴⁹⁷⁰ | Radius SRZ ⁴⁹⁷⁰ |
|---|--|---|---|---|---|---|---|---|---|---|---|---|---|---|---|---|---|---|
| 57 | Eucalyptus bicostata - Blue Gum | 18 | 8 | 7 | 8 | 7 | Good | Good | Park Tree | Medium | Cockatoo damage in union at 6 m and some root damage, birds nesting Removal of west branch recommended but cut out a bit to save the nesting site | 2.60 | | | | | 9.9 | 3.3 |

Tree 57 Bird damage and nest hollow

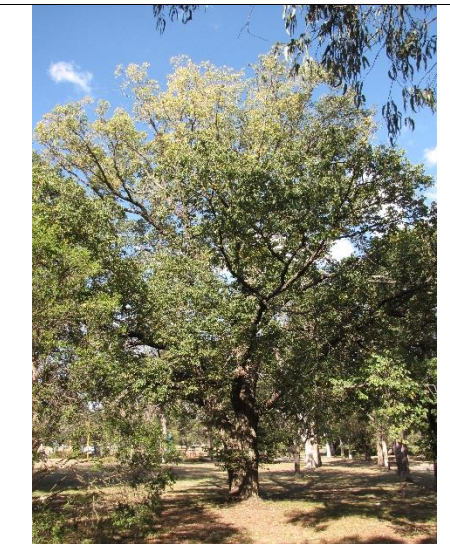
Tree 60

| Tree Number | Species | Height | Canopy Spread | | | | Health | Structure | Tree Protection Status | Tree Quality Classification | Comments | Circumference ⁴⁹⁷⁰ | | | | | Radius TPZ ⁴⁹⁷⁰ | Radius SRZ ⁴⁹⁷⁰ |
|---|---|---|---|---|---|---|---|---|---|---|--|---|---|---|---|---|---|---|
| 60 | Ulmus sp. - Elm | 17 | 6 | 8 | 9 | 10 | Fair | Good | Park Tree | High | Some ELB damage, some slime flux, Canopy thin, trimmed from power lines | 3.23 | | | | | 12.3 | 3.6 |

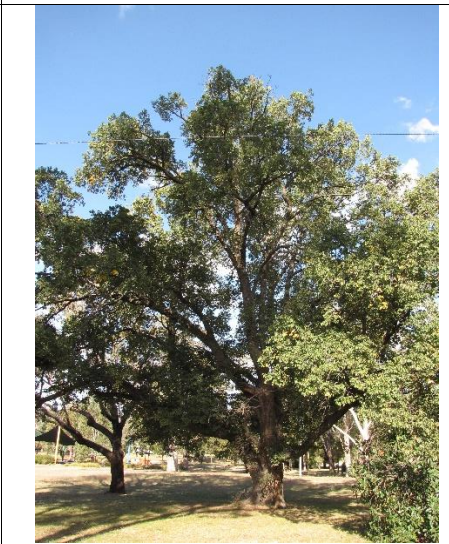
Tree 61

| Tree Number | Species | Height | Canopy Spread | | | | Health | Structure | Tree Protection Status | Tree Quality Classification | Comments | Circumference ⁴⁹⁷⁰ | | | | | Radius TPZ ⁴⁹⁷⁰ | Radius SRZ ⁴⁹⁷⁰ |
|---|---|---|---|---|---|---|---|---|---|---|--|---|---|---|---|---|---|---|
| 61 | Ulmus sp. - Elm | 18 | 13 | 8 | 7 | 11 | Fair | Good | Park Tree | High | Some ELB damage, some slime flux, Canopy thin, trimmed from power lines | 3.64 | | | | | 13.9 | 3.8 |

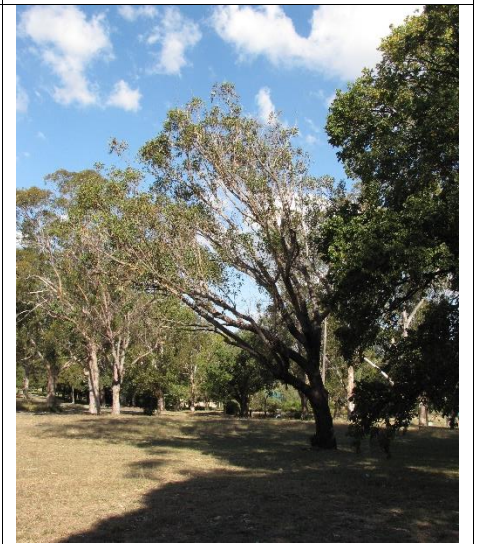
Tree 62

| Tree Number | Species | Height | Canopy Spread | | | | Health | Structure | Tree Protection Status | Tree Quality Classification | Comments | Circumference ⁴⁹⁷⁰ | | | | | Radius TPZ ⁴⁹⁷⁰ | Radius SRZ ⁴⁹⁷⁰ |
|---|---|---|---|---|---|---|---|---|---|---|--|---|---|---|---|---|---|---|
| 62 | Eucalyptus botryoides - Bangalay | 10 | 8 | 8 | 4 | 0 | Very Poor | Fair | Park Tree | Poor | Tree is in decline, deadwood-possibly hazardous, borer damage to trunk, root damage | 1.96 | | | | | 7.5 | 2.9 |

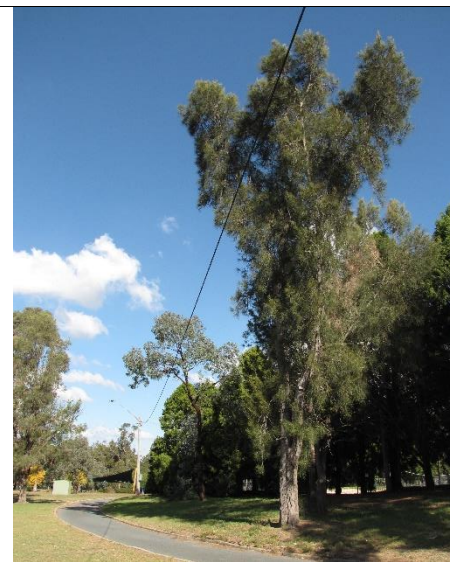
Tree 65

| Tree Number | Species | Height | Canopy Spread | | | | Health | Structure | Tree Protection Status | Tree Quality Classification | Comments | Circumference ⁴⁹⁷⁰ | | | | | Radius TPZ ⁴⁹⁷⁰ | Radius SRZ ⁴⁹⁷⁰ |
|---|---|---|---|---|---|---|---|---|---|---|--|---|---|---|---|---|---|---|
| 65 | Casuarina sp - She-oak | 19 | 4 | 4 | 6 | 6 | Good | Good | Park Tree | Medium | Massive surface root knot near footpath, a number of previous branch failures | 1.86 | | | | | 7.1 | 2.9 |

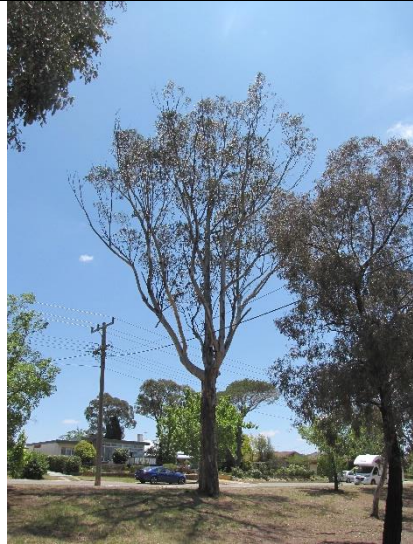
Tree 71b

| Tree Number | Species | Height | Canopy Spread | | | | Health | Structure | Tree Protection Status | Tree Quality Classification | Comments | Circumference ⁴⁹⁷⁰ | | | | | Radius TPZ ⁴⁹⁷⁰ | Radius SRZ ⁴⁹⁷⁰ |
|---|---|---|---|---|---|---|---|---|---|---|--|---|---|---|---|---|---|---|
| 71b | Eucalyptus sp. - Gum Tree | 24 | 9 | 7 | 7 | 3 | Poor | Poor | Park Tree | Poor | Some decline, major deadwood, has been lopped decades ago, trimmed from power lines, cockatoo chewing damage may cause major branch failures | 2.42 | | | | | 9.2 | 3.2 |

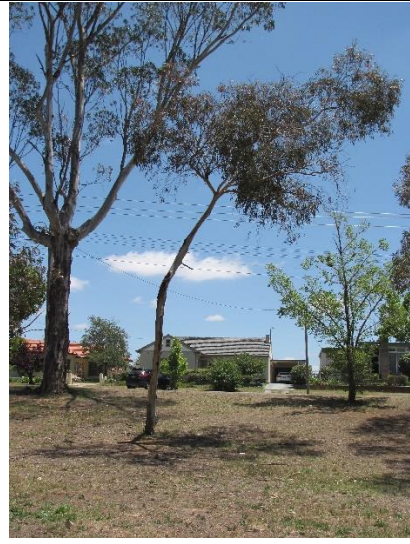
Tree 71e

| Tree Number | Species | Height | Canopy Spread | | | | Health | Structure | Tree Protection Status | Tree Quality Classification | Comments | Circumference ⁴⁹⁷⁰ | | | | | Radius TPZ ⁴⁹⁷⁰ | Radius SRZ ⁴⁹⁷⁰ |
|---|---|---|---|---|---|---|---|---|---|---|--|---|---|---|---|---|---|---|
| 71e | Eucalyptus leucoxylon - SA Blue Gum | 8 | 7 | 2 | 0 | 0 | Fair | Poor | Park Tree | Poor | Tree is struggling, damage to upper trunk | 0.70 | | | | | 2.7 | 1.9 |

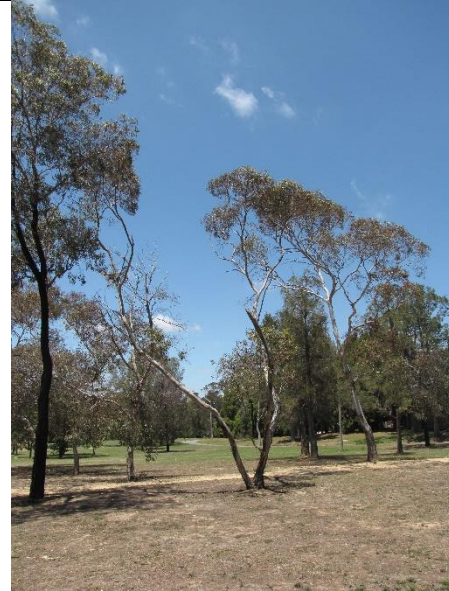
Tree 72c

| Tree Number | Species | Height | Canopy Spread | | | | Health | Structure | Tree Protection Status | Tree Quality Classification | Comments | Circumference ⁴⁹⁷⁰ | | | | | Radius TPZ ⁴⁹⁷⁰ | Radius SRZ ⁴⁹⁷⁰ |
|---|---|---|---|---|---|---|---|---|---|---|--|---|---|---|---|---|---|---|
| 72c | Eucalyptus leucoxylon - SA Blue Gum | 13 | 5 | 2 | 7 | 1 | Poor | | Park Tree | Poor | 3 leaders, 1 broken off, decay infork | 0.49 | 0.5 | 0.62 | | | 3.6 | 2.1 |

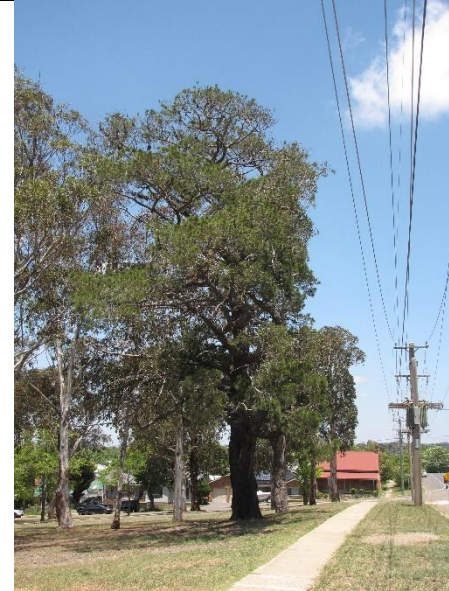
Tree 73a

| Tree Number | Species | Height | Canopy Spread | | | | Health | Structure | Tree Protection Status | Tree Quality Classification | Comments | Circumference ⁴⁹⁷⁰ | | | | | Radius TPZ ⁴⁹⁷⁰ | Radius SRZ ⁴⁹⁷⁰ |
|---|---|---|---|---|---|---|---|---|---|---|--|---|---|---|---|---|---|---|
| 73a | Pinus radiata - Monterey Pine | 22 | 12 | 8 | 10 | 4 | Fair | Good | Park Tree | Medium | Large deadwood, in early stages of decline, has been trimmed from power lines, some root damage | 3.30 | | | | | 12.6 | 3.6 |

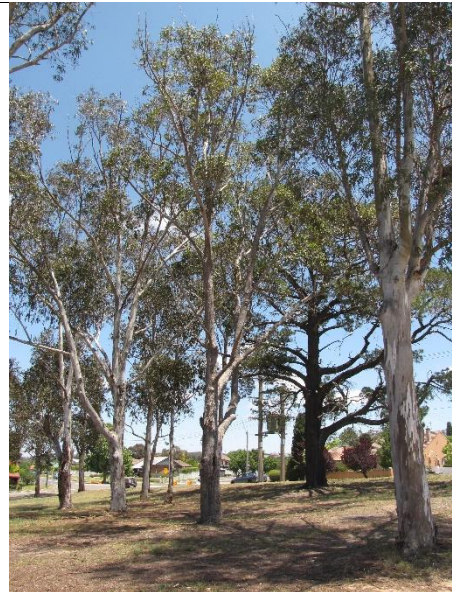
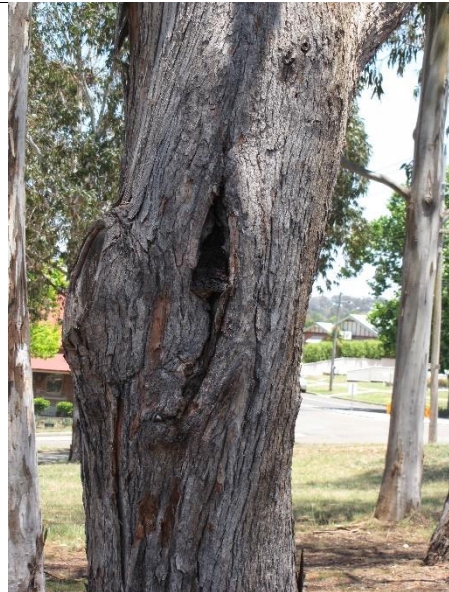
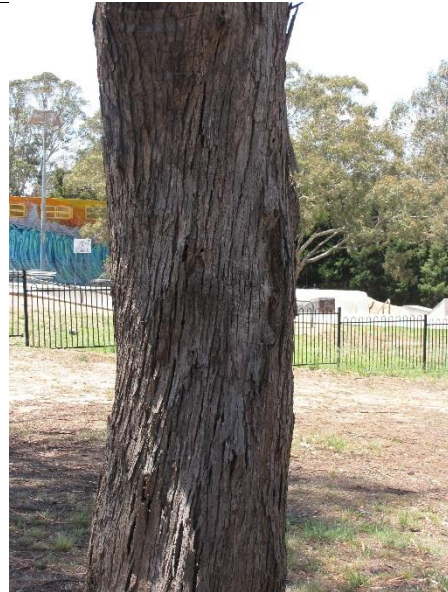
Tree 73c

| Tree Number | Species | Height | Canopy Spread | | | | Health | Structure | Tree Protection Status | Tree Quality Classification | Comments | Circumference ⁴⁹⁷⁰ | | | | | Radius TPZ ⁴⁹⁷⁰ | Radius SRZ ⁴⁹⁷⁰ |
|---|---|---|---|---|---|---|---|---|---|---|--|---|---|---|---|---|---|---|
| 73c | Eucalyptus sp. - Gum Tree | 16 | 5 | 4 | 5 | 7 | Fair | Very Poor | Park Tree | Poor | Decay fungus fruiting body in trunk, dead cambium one side of trunk | 1.80 | | | | | 6.9 | 2.8 |

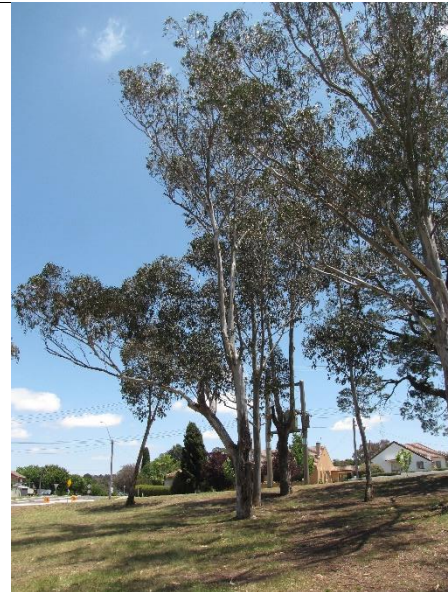
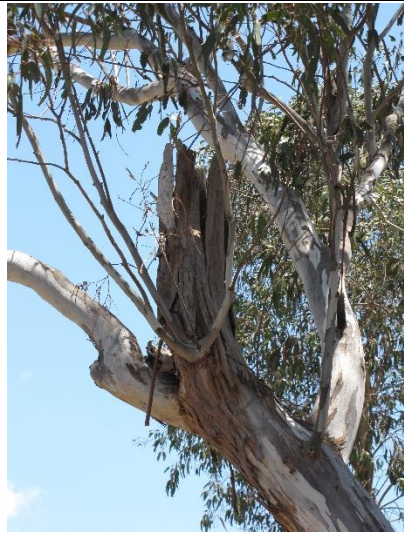
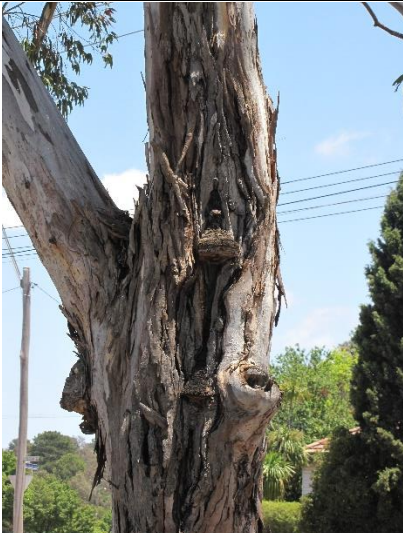
Tree 73f

| Tree Number | Species | Height | Canopy Spread | | | | Health | Structure | Tree Protection Status | Tree Quality Classification | Comments | Circumference ⁴⁹⁷⁰ | | | | | Radius TPZ ⁴⁹⁷⁰ | Radius SRZ ⁴⁹⁷⁰ |
|---|---|---|---|---|---|---|---|---|---|---|--|---|---|---|---|---|---|---|
| 73f | Eucalyptus sp. - Gum Tree | 22 | 6 | 8 | 4 | 5 | Fair | Very Poor | Park Tree | Poor | Was lopped decades ago, Has died back but some recovery, previous branch failures, significant decay in trunk | 2.19 | | | | | 8.4 | 3.1 |

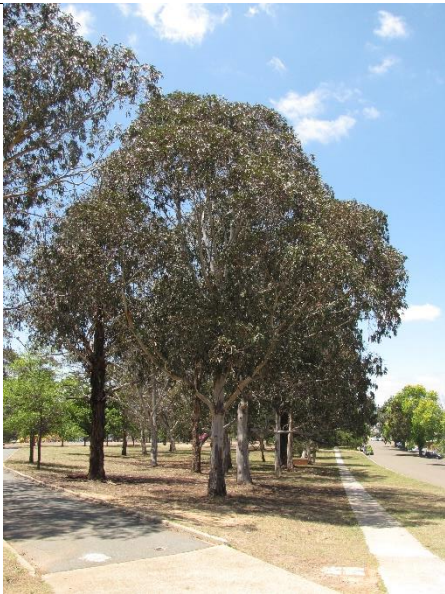
Tree 74c

| Tree Number | Species | Height | Canopy Spread | | | | Health | Structure | Tree Protection Status | Tree Quality Classification | Comments | Circumference ⁴⁹⁷⁰ | | | | | Radius TPZ ⁴⁹⁷⁰ | Radius SRZ ⁴⁹⁷⁰ |
|---|---|---|---|---|---|---|---|---|---|---|---|---|---|---|---|---|---|---|
| 74c | Eucalyptus bicostata - Blue Gum | 17 | 5 | 4 | 6 | 8 | Good | Good | Park Tree | High | Some canopy skew due to adjacent tree, minor deadwood, some mower damage to roots | 1.68 | | | | | 6.4 | 2.7 |

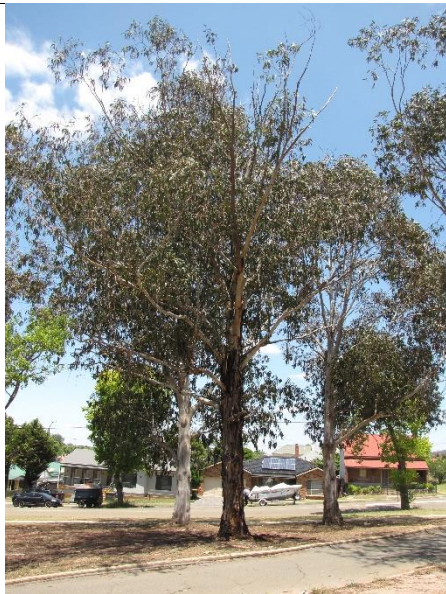
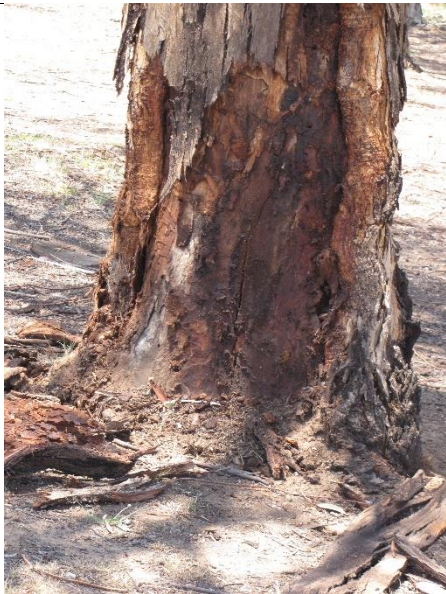
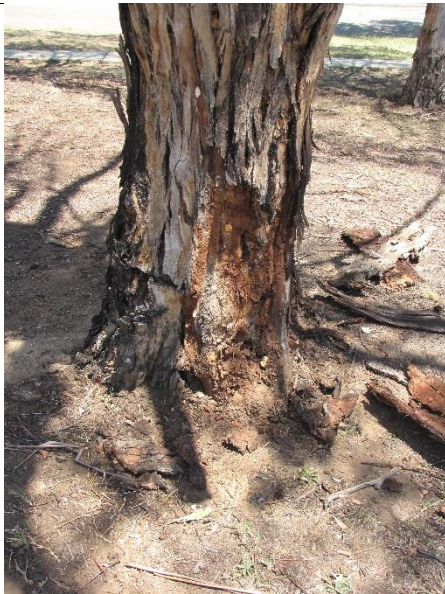
Tree 74d

| Tree Number | Species | Height | Canopy Spread | | | | Health | Structure | Tree Protection Status | Tree Quality Classification | Comments | Circumference ⁴⁹⁷⁰ | | | | | Radius TPZ ⁴⁹⁷⁰ | Radius SRZ ⁴⁹⁷⁰ |
|---|---|---|---|---|---|---|---|---|---|---|---|---|---|---|---|---|---|---|
| 74d | Eucalyptus bicostata - Blue Gum | 17 | 7 | 7 | 5 | 5 | Fair | Very Poor | Park Tree | Poor | Large area of dead cambium resulting in root death and canopy die back | 1.85 | | | | | 7.1 | 2.9 |
