# GEOTECHNICAL ASSESSMENT

# KATOOMBA CHRISTIAN CONVENTION

*119 Cliff Drive, Katoomba, New South Wales*

*Report No: 18/0171*

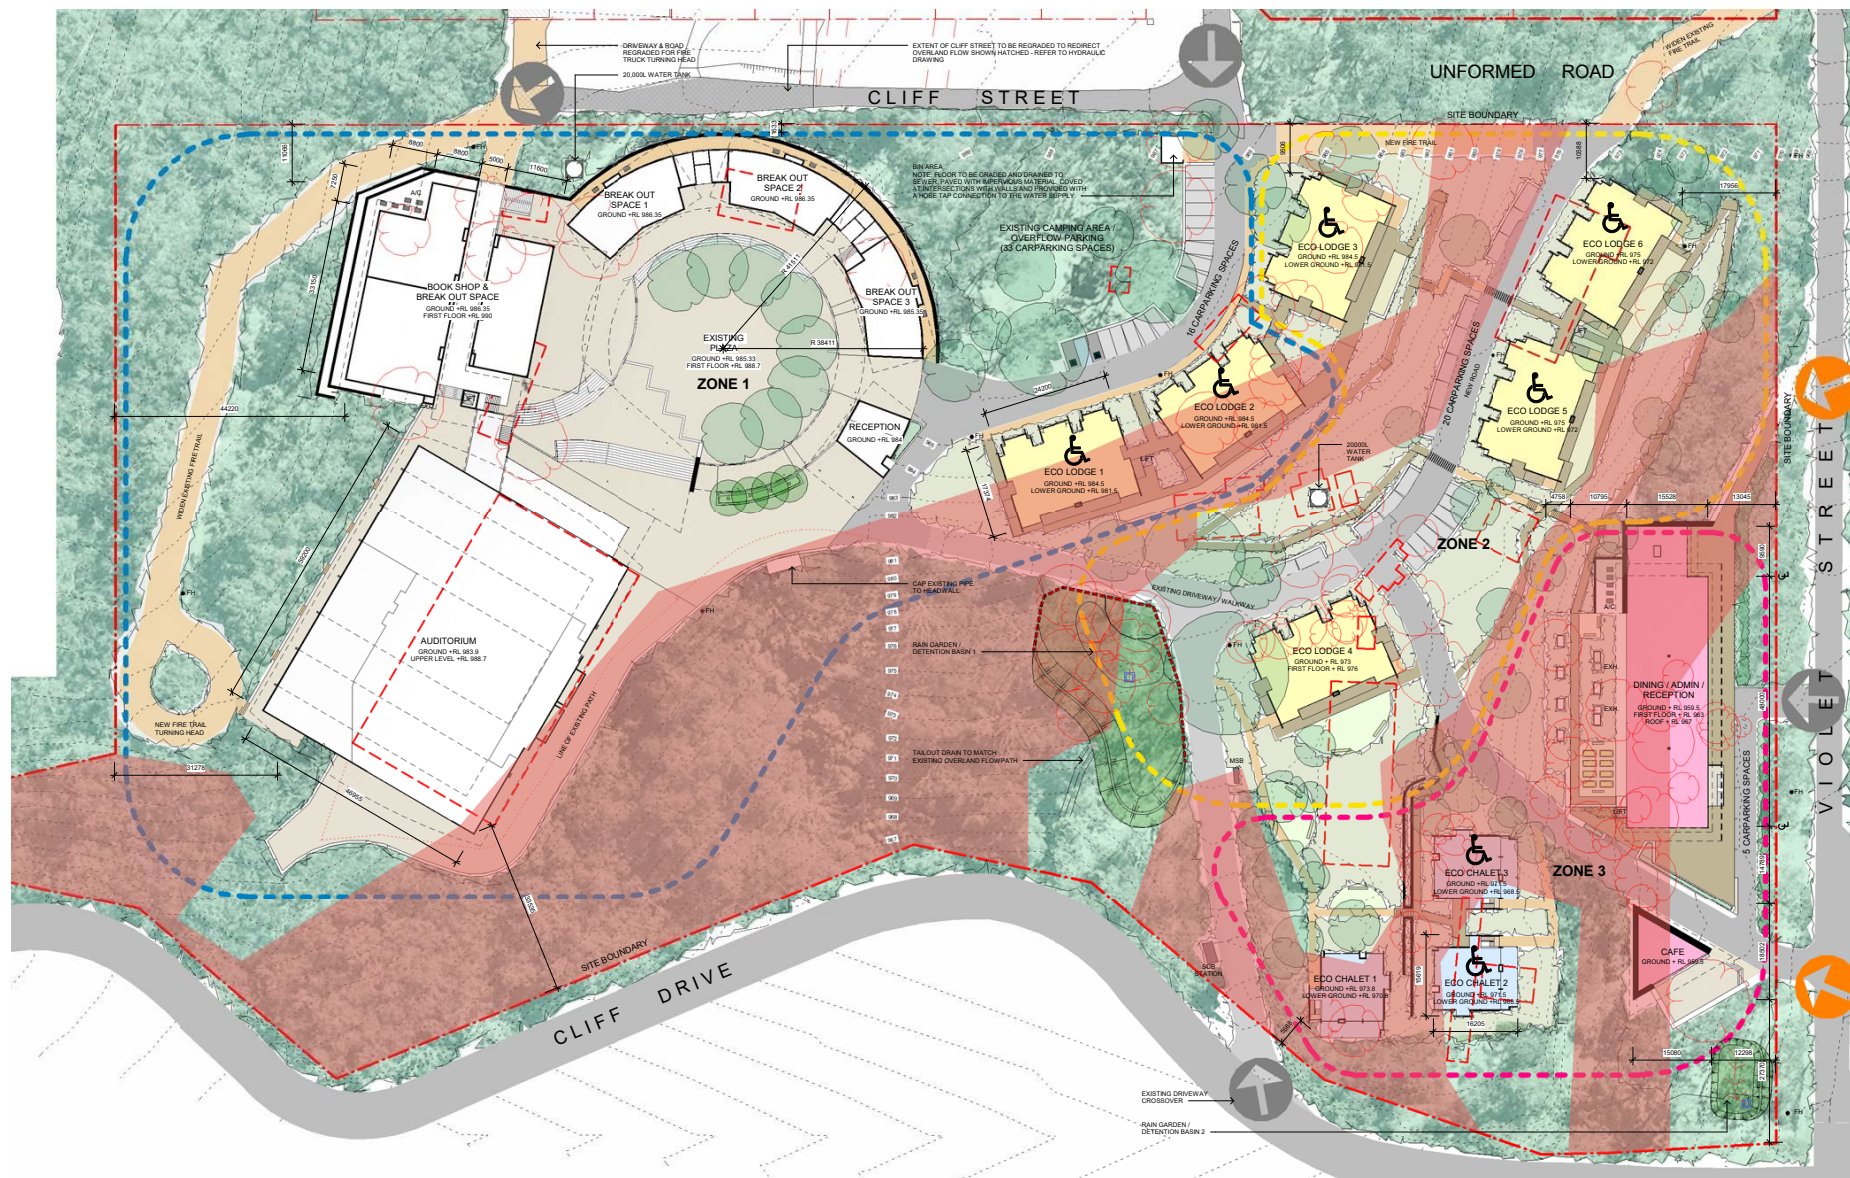
Drawing No: 18/0171

We understand that the parts of the site are identified as having Slope Constraints in accordance with Clause 6.4 of the Blue Mountains City Council LEP. An overlay of the Slope Constraints map in comparison to the proposed works is attached as Appendix A.

The Slope Constraint areas are primarily confined to the dense bushland on the northern and north-eastern parts of the site, where slopes are typically within the 10°-25° range. The Slope Constraint mapping extends into the proposed Ecolodge areas as well as the café and reception area.

Provided the works are undertaken in accordance with the recommendations of this report, in particular regarding safe batter slopes and temporary excavation support, we feel that this site is suitable for the development. Further, any development on the site should follow good hillside construction practices. Some examples are attached in Appendix B.
