**TOGA WICKS PARK  
DEVELOPMENTS PTY  
LTD**

**Hazardous Materials  
Survey**

182-198 Victoria Road & 28-30 Faversham  
Street, Marrickville, NSW

**Report No:** E24098.E10\_Rev0

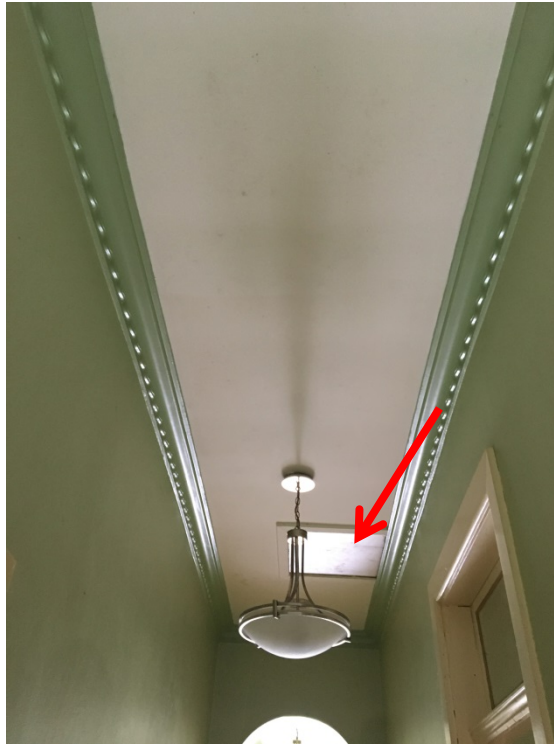
**Photograph 1.**

**Location:** 182-198 Victoria Road & 28-30 Faversham Street, Marrickville, NSW – Brick Cottage adjacent to Smash Repairs

The red arrow points to the entrance to the ceiling cavity that was inaccessible

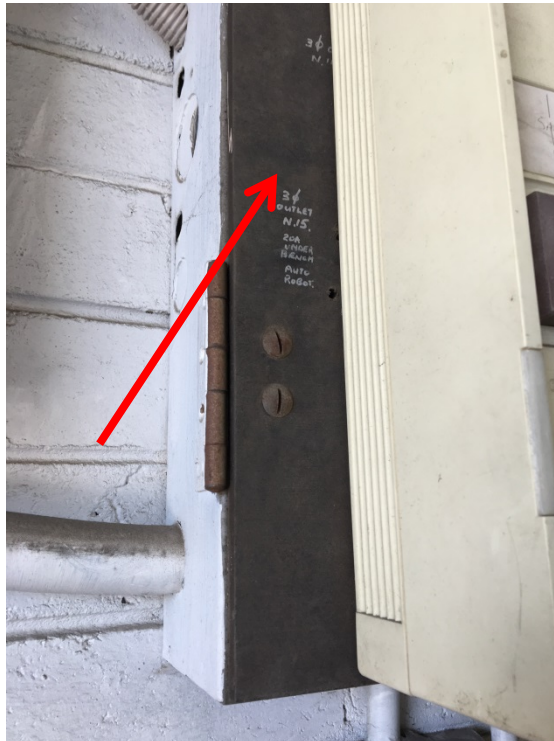
**Photograph 2.**

**Location:** 182-198 Victoria Road & 28-30 Faversham Street, Marrickville, NSW – Smash Repairs

The red arrow points to asbestos containing material forming electrical fuse/switch box on north internal wall of smash repairs

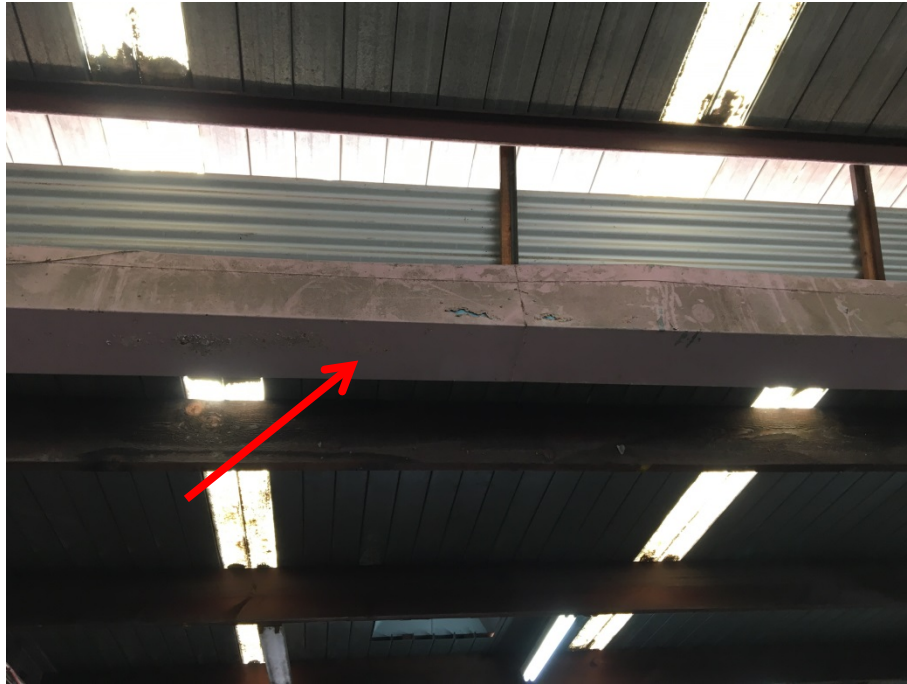
**Photograph 3.**

**Location:** 182-198 Victoria Road & 28-30 Faversham Street, Marrickville, NSW – Smash Repairs

The red arrow points to an inaccessible ceiling support beam with possible lead based paint

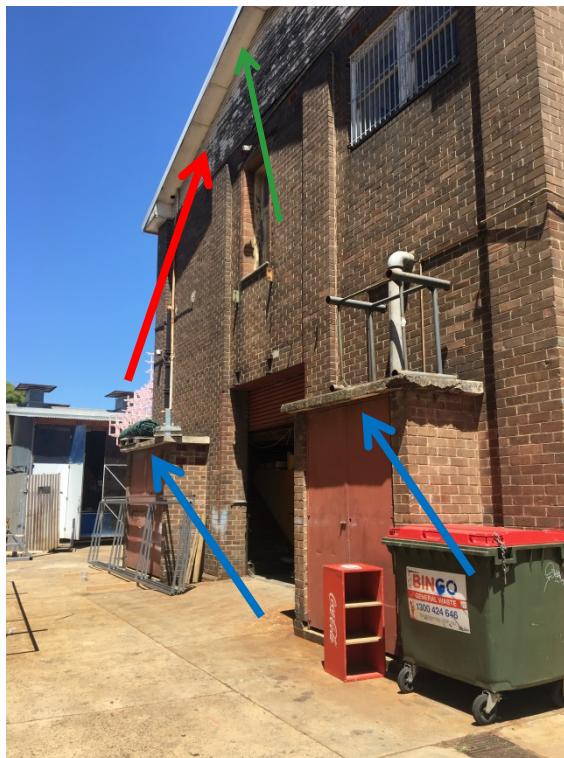
**Photograph 4.**

**Location:** 182-198 Victoria Road & 28-30 Faversham Street, Marrickville, NSW – Spray Painting Workshop

The red arrow points to the assumed location of an internal ceiling cavity.

The green arrow points to the building eaves containing asbestos cement sheeting.

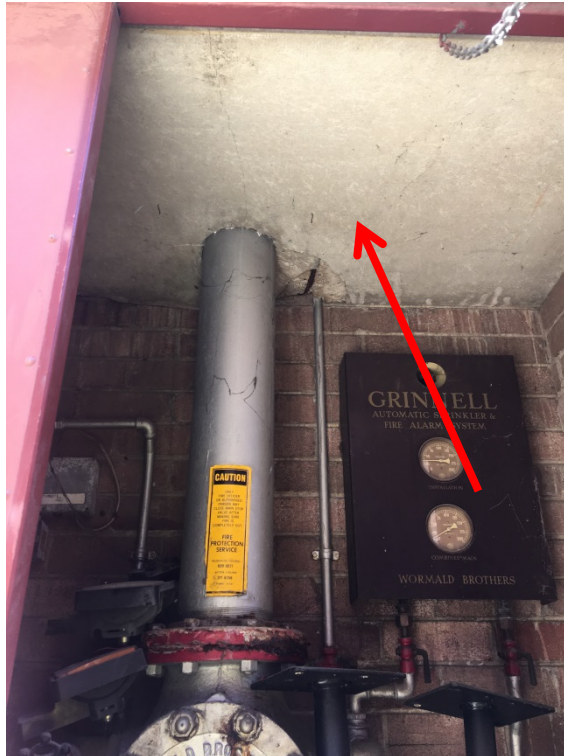
**Photograph 5.**

**Location:** 182-198 Victoria Road & 28-30 Faversham Street, Marrickville, NSW – Spray Painting Workshop

The red arrow points to asbestos cement sheet formwork of the ceiling of the sprinkler room in the Spray Painting Workshop

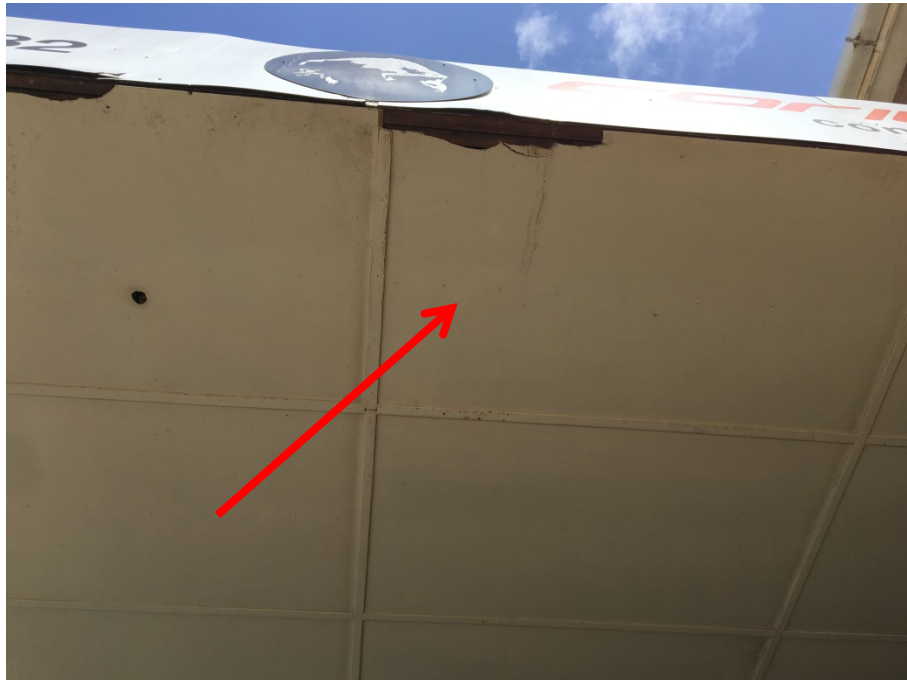
**Photograph 6.**

**Location:** 182-198 Victoria Road & 28-30 Faversham Street, Marrickville, NSW – Spray Painting Workshop

The red arrow points to asbestos cement sheeting forming the ceiling of the awning attached to the Spray Painting Workshop

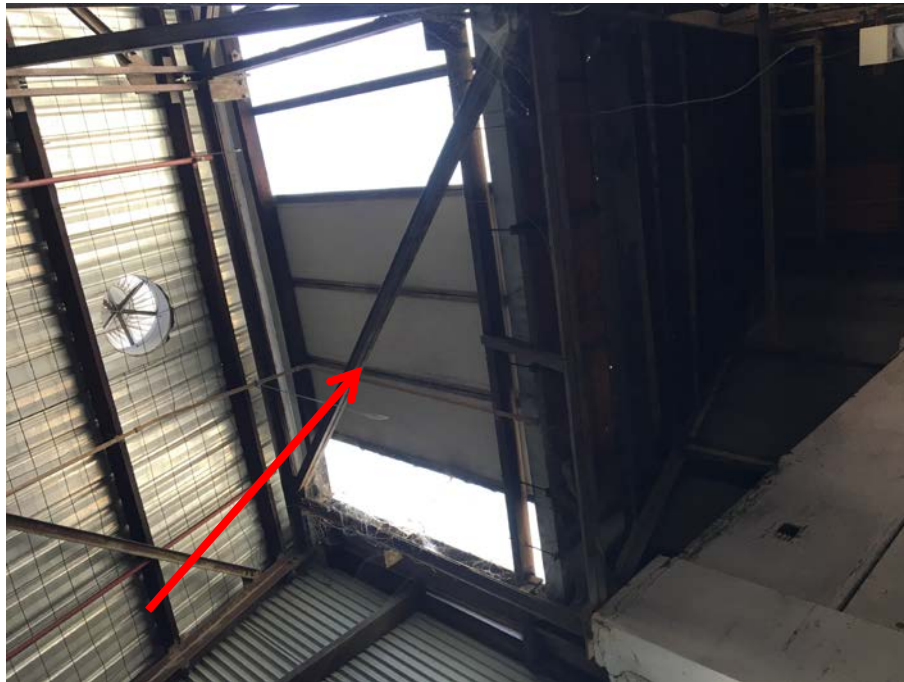
**Photograph 7.**

**Location:** 182-198 Victoria Road & 28-30 Faversham Street, Marrickville, NSW – Stone Cutting Workshop  
The red arrow points to the asbestos cement sheeting window infills on the southern windows of the eastern wall

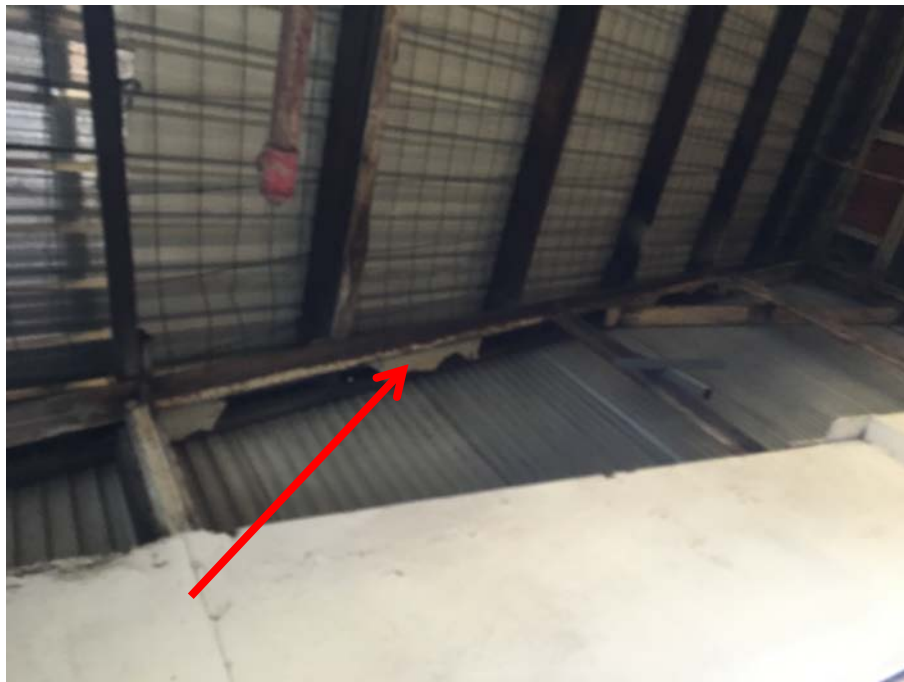
**Photograph 8**

**Location:** 182-198 Victoria Road & 28-30 Faversham Street, Marrickville, NSW – Stone Cutting Workshop  
The red arrow points to the asbestos cement sheeting roof partition on the eastern wall

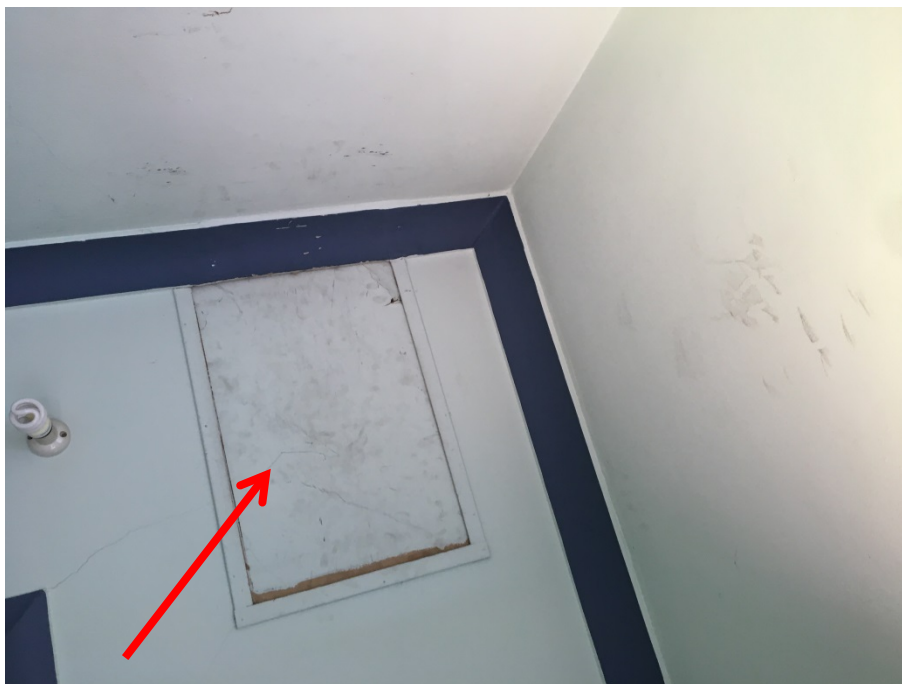
**Photograph 9**

**Location:** 182-198 Victoria Road & 28-30 Faversham Street, Marrickville, NSW – Offices  
The red arrow points to the entrance to the ceiling cavity that was inaccessible

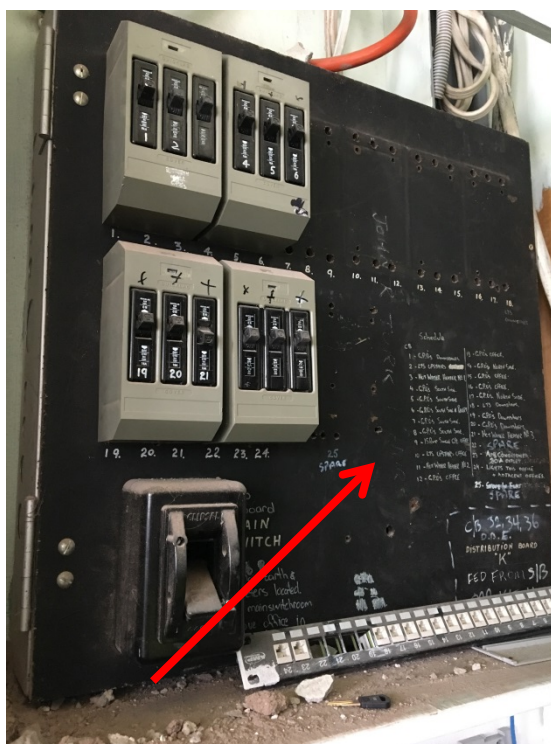
**Photograph 10**

**Location:** 182-198 Victoria Road & 28-30 Faversham Street, Marrickville, NSW - Offices

The red arrow points to asbestos containing material forming electrical fuse/switch box on western internal wall of the rear ground floor room of the office building
