Report on  
Geotechnical Investigation

Alterations and Additions  
20 Illawong Avenue, Tamarama

Prepared for  
Strata Plan 1731

Project 72261.06  
November 2018

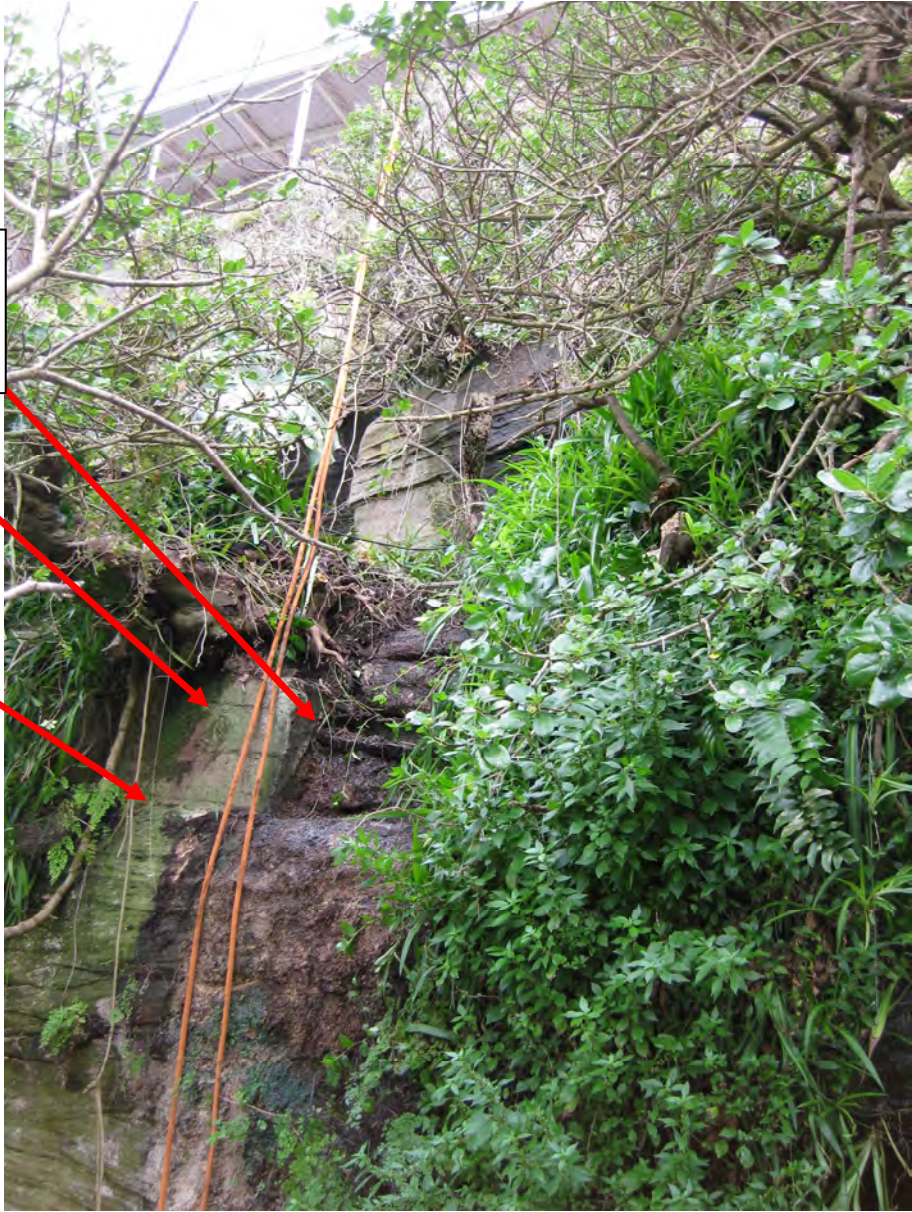
<div data-bbox="177 472 384 640">Rusty pipe behind concrete block</div> <div data-bbox="177 674 384 842">Wedge-shaped concrete block</div> <div data-bbox="177 875 384 1066">Top of cross-bedded sandstone</div>

<p>Mapping Traverse 101, Photo 2 – View of mid-portion of slope along mapping traverse 101. A wedge-shaped concrete block and rusty pipe noted on the mapping section are indicated as shown.</p>

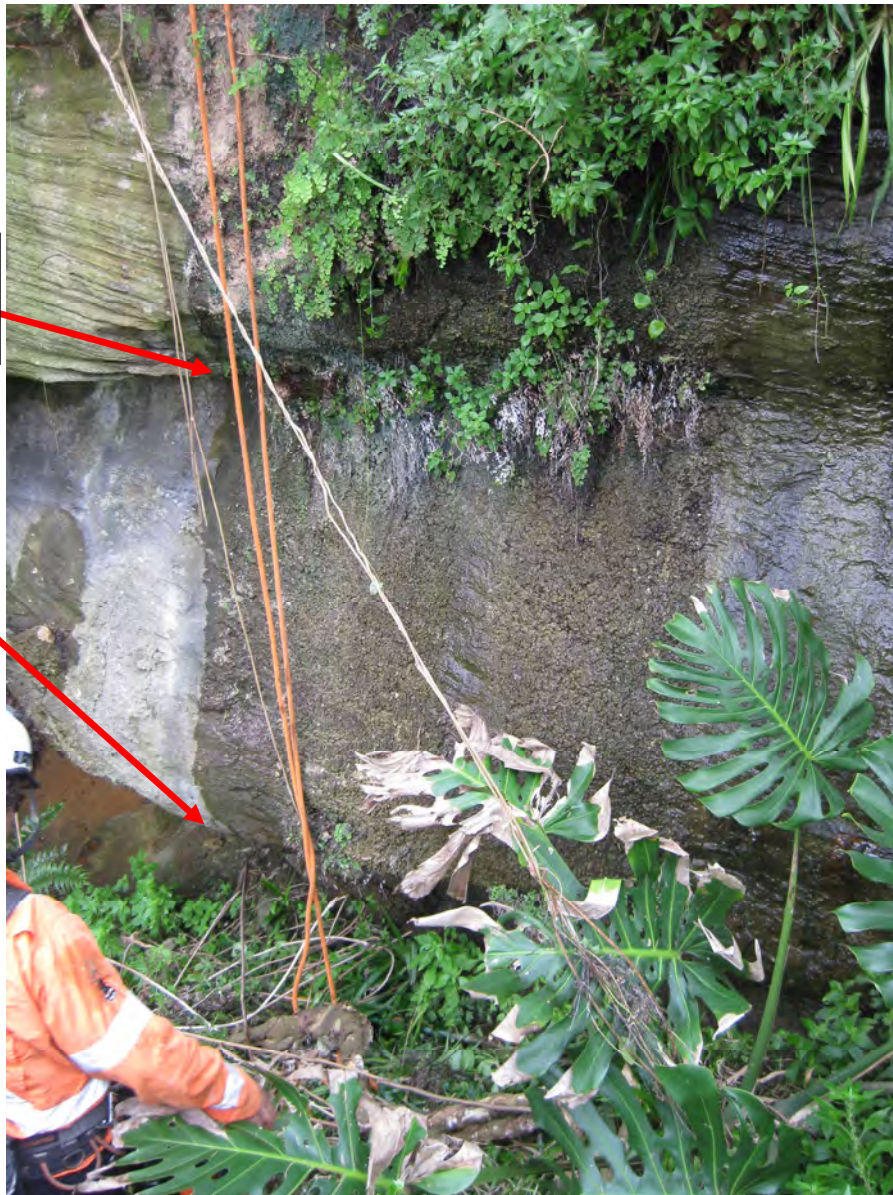
Base of  
'tight' cross  
bed

Overhang,  
formed  
below  
continuous  
bedding  
parting  
defect

Mapping Traverse 101, Photo 3 – View of lower portion of slope along mapping traverse 101. High strength cross-bedded sandstone exposed, and with an overhang formed above a bedding parting defect which extends more than 10 m to either side of the section line.

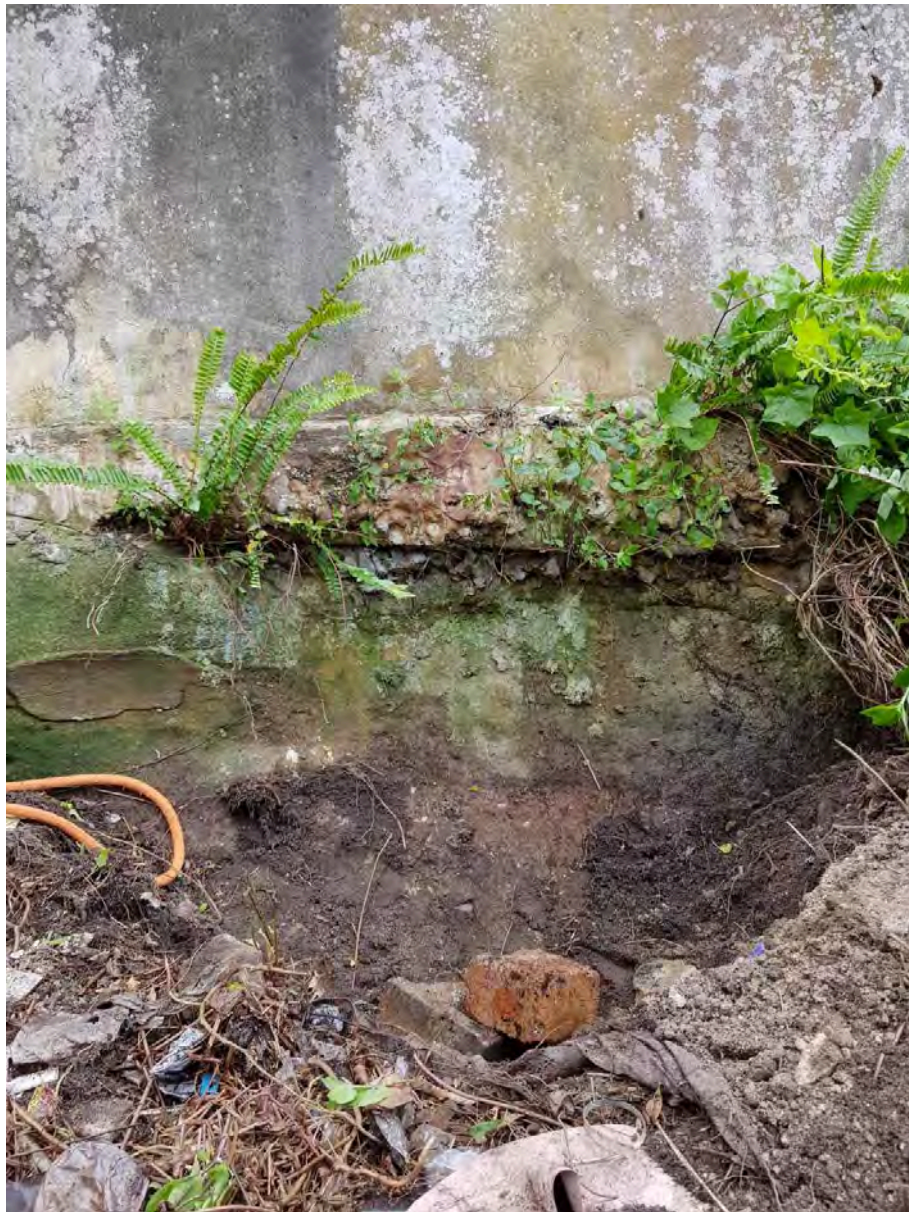
Mapping Traverse 102, Photo 1 – View of interface between rendered brick retaining wall and the underlying sandstone at mapping traverse 102, showing a thin layer of “levelling” concrete on top of the sandstone.

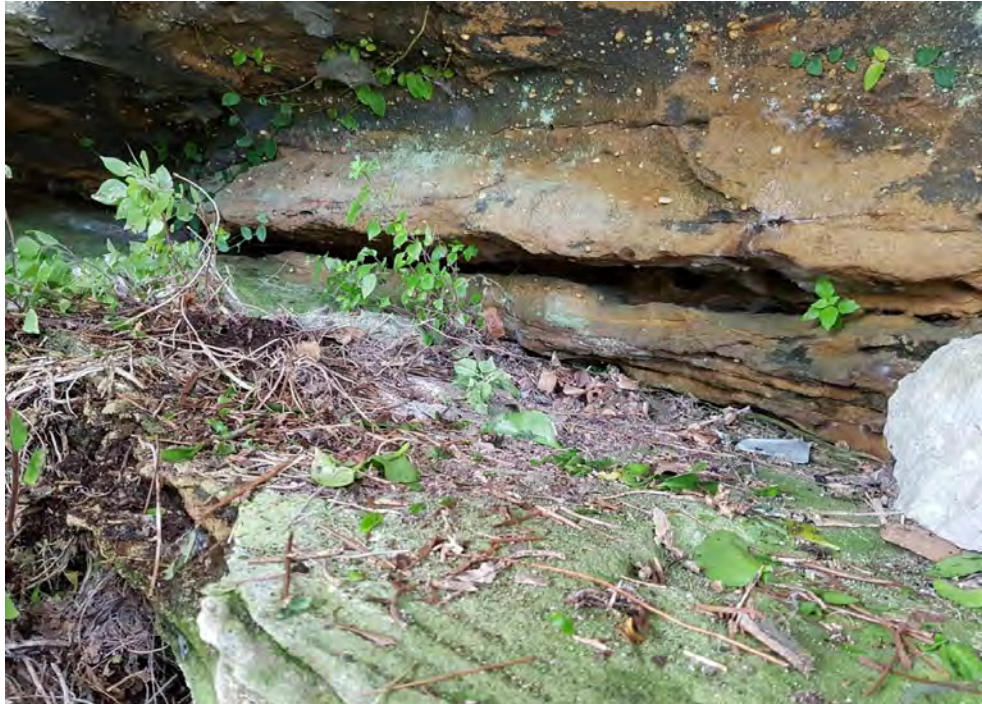
Mapping Traverse 102, Photo 2 – View of a continuous bedding parting defect and overhang (cave) at mapping traverse 102, with a sub-vertical, iron-stained joint plane forming the rear of the 'cave'.

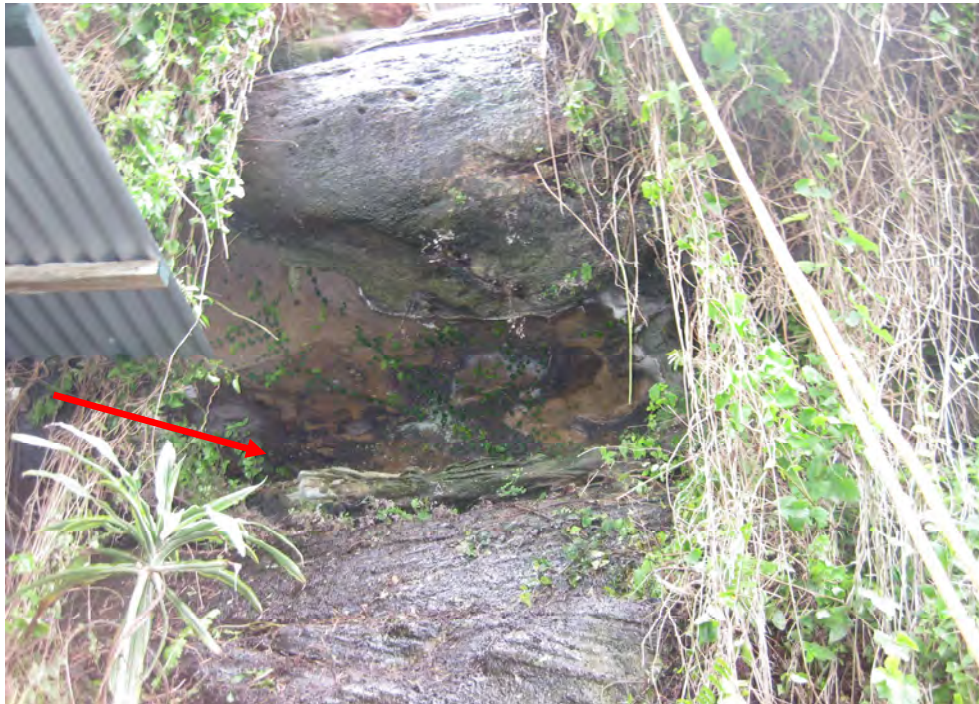
Mapping Traverse 102, Photo 3 – View of overhang at RL51 m on mapping traverse 102, with a bed of massive sandstone above and cross-bedded sandstone below. Cave location is indicated as shown.

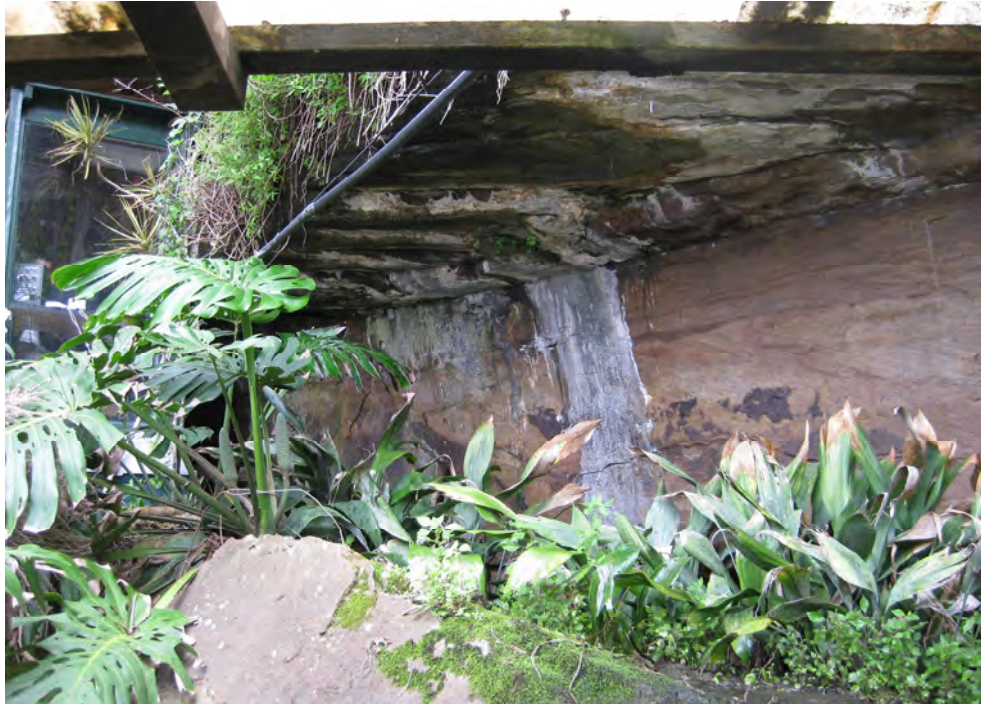
Mapping Traverse 102, Photo 4 – View of overhang in cross-bedded sandstone (RL47.5 m) at mapping traverse 102, with a sub-vertical, iron-stained joint plane forming the rear of the overhang.

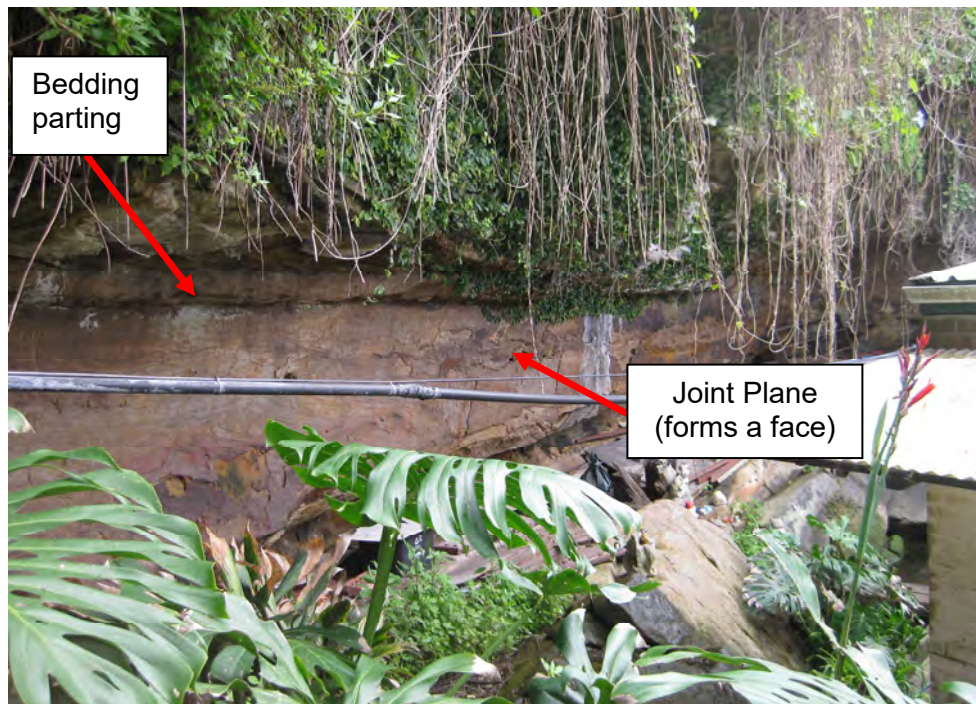
Mapping Traverse 102, Photo 5 – View of overhang in cross-bedded sandstone to the north of traverse 102. Continuous bedding plane and undulating joint plane indicated as shown.

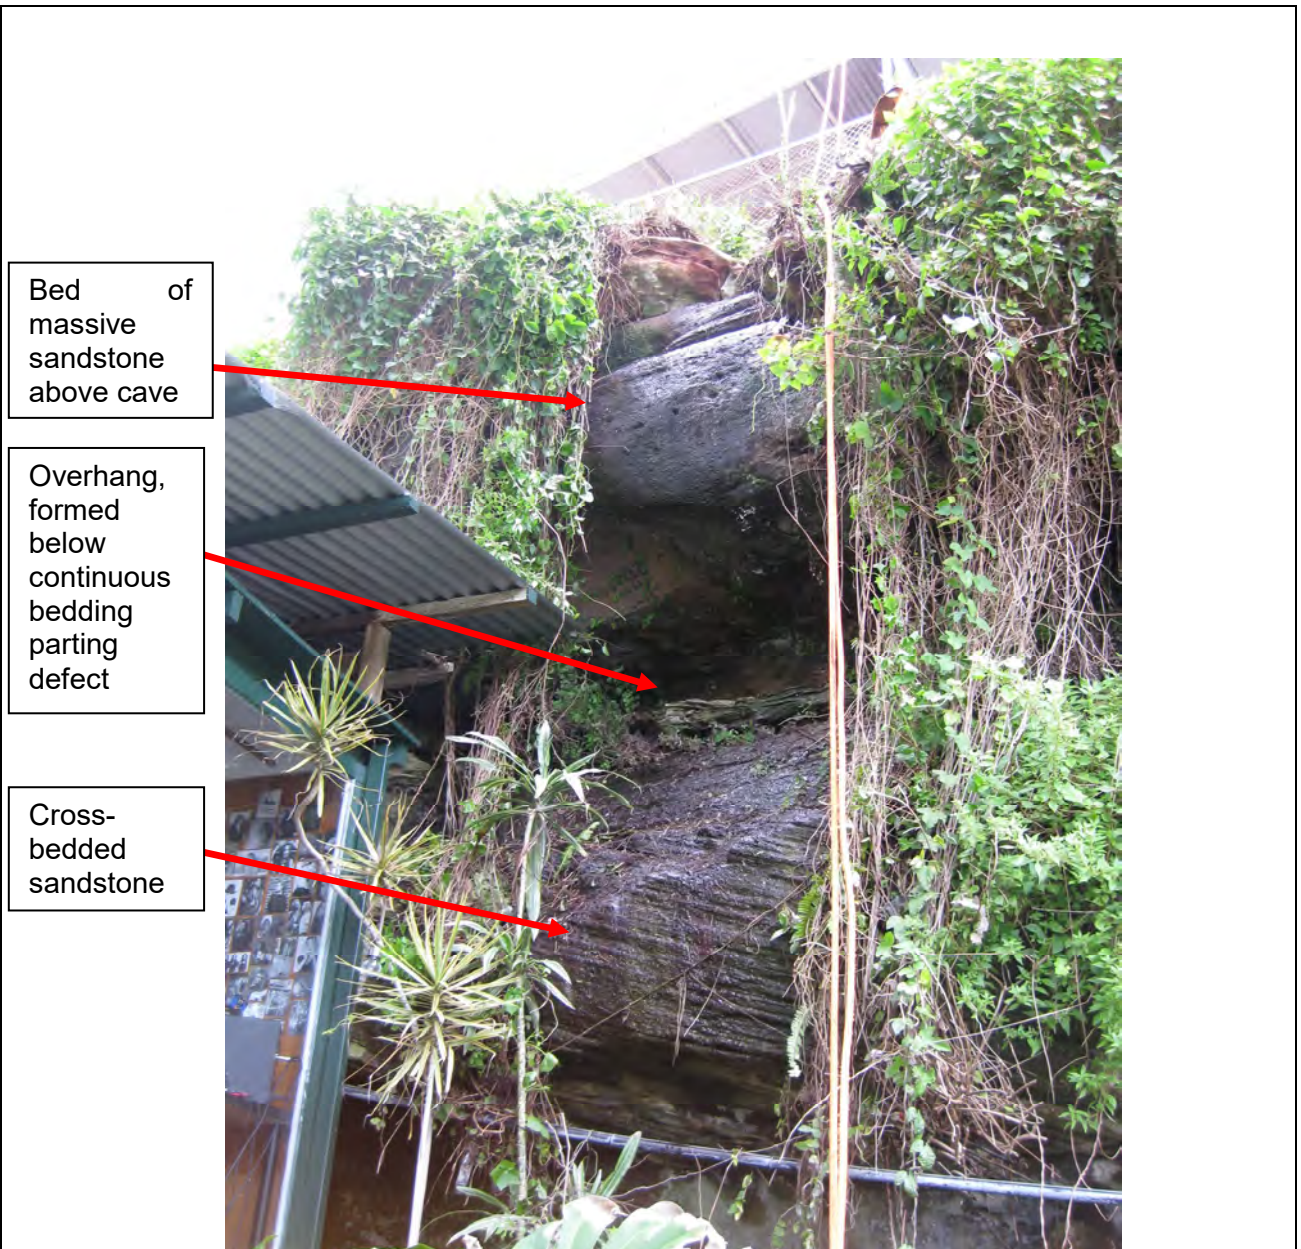
Mapping Traverse 102, Photo 6 – View of lower part of slope along mapping traverse 102. High strength cross-bedded sandstone exposed, and with an overhang formed above a bedding parting defect which extends more than 10 m to either side of the section line.

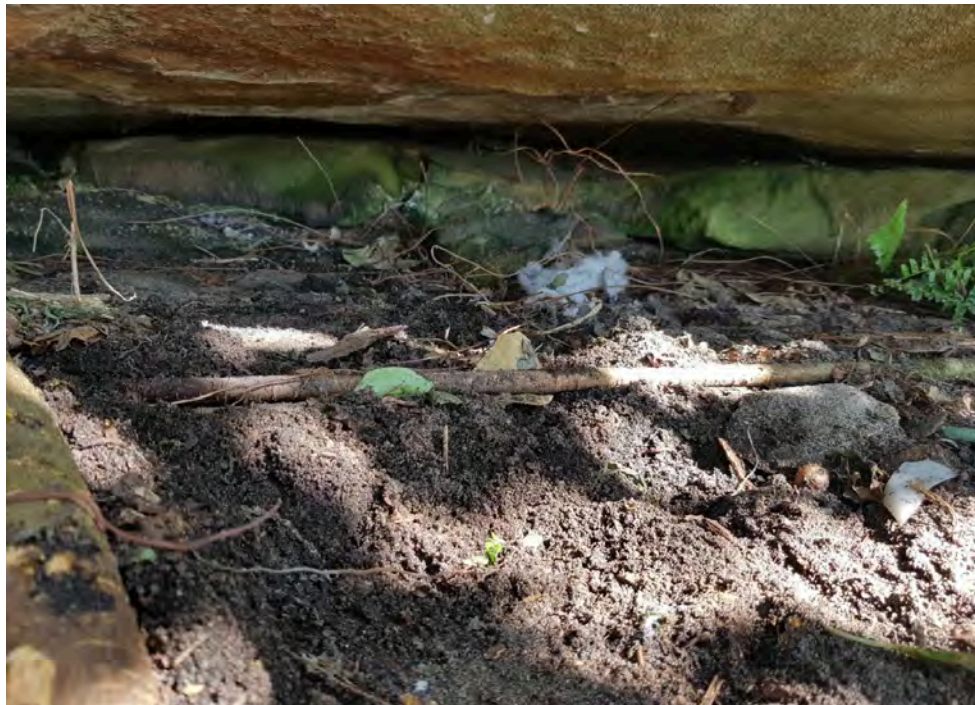
Mapping Traverse 105, Photo 1 – View within a cave formed below a bed of massive sandstone, along a bedding parting defect. Depth of cave from front face is 1.2 m, with sandy colluvium on floor of cave.

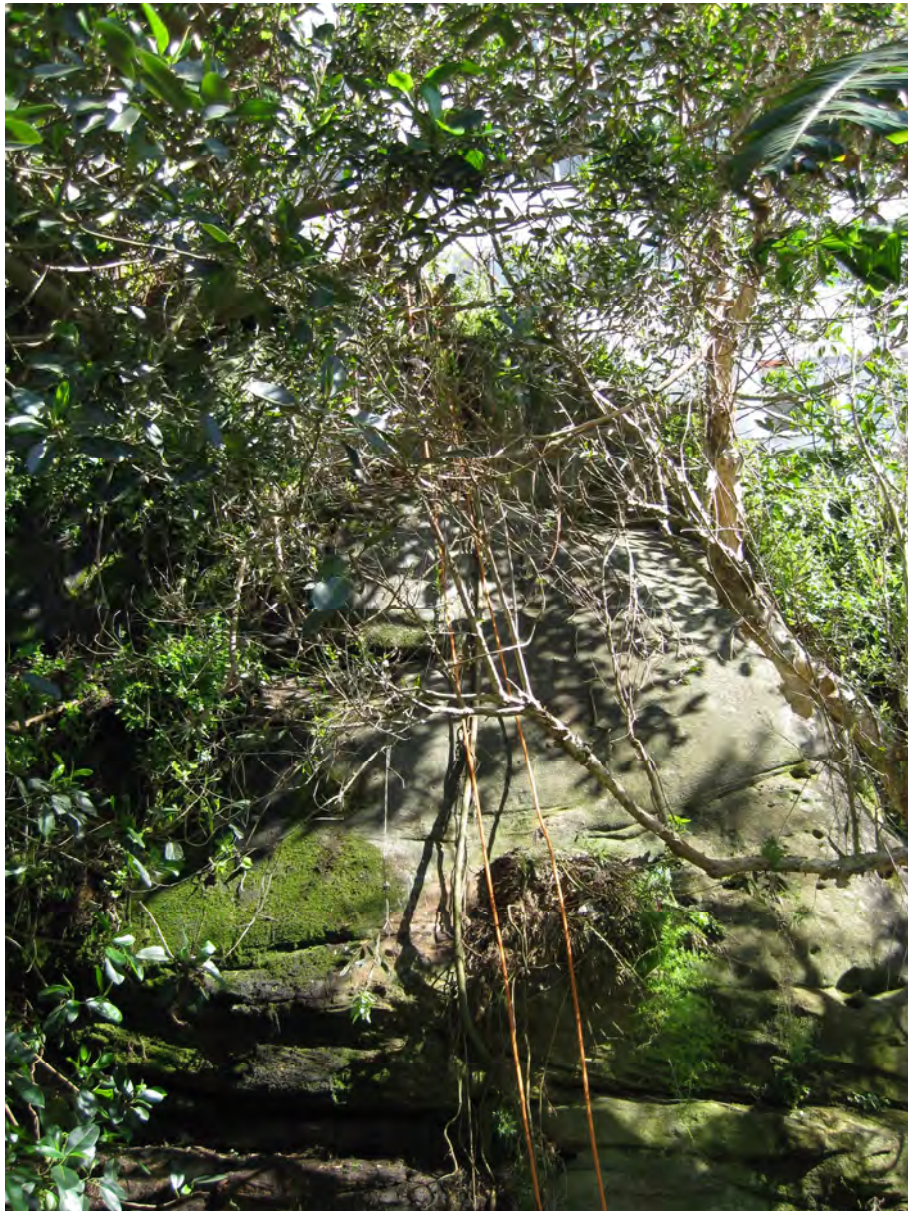
Mapping Traverse 105, Photo 2 – View towards the existing unit building at mapping traverse 105. Interbedded massive and laminated sandstone exposed for most of the lower part of the slope, with some discontinuous siltstone lenses and discontinuous bedding parting defects.

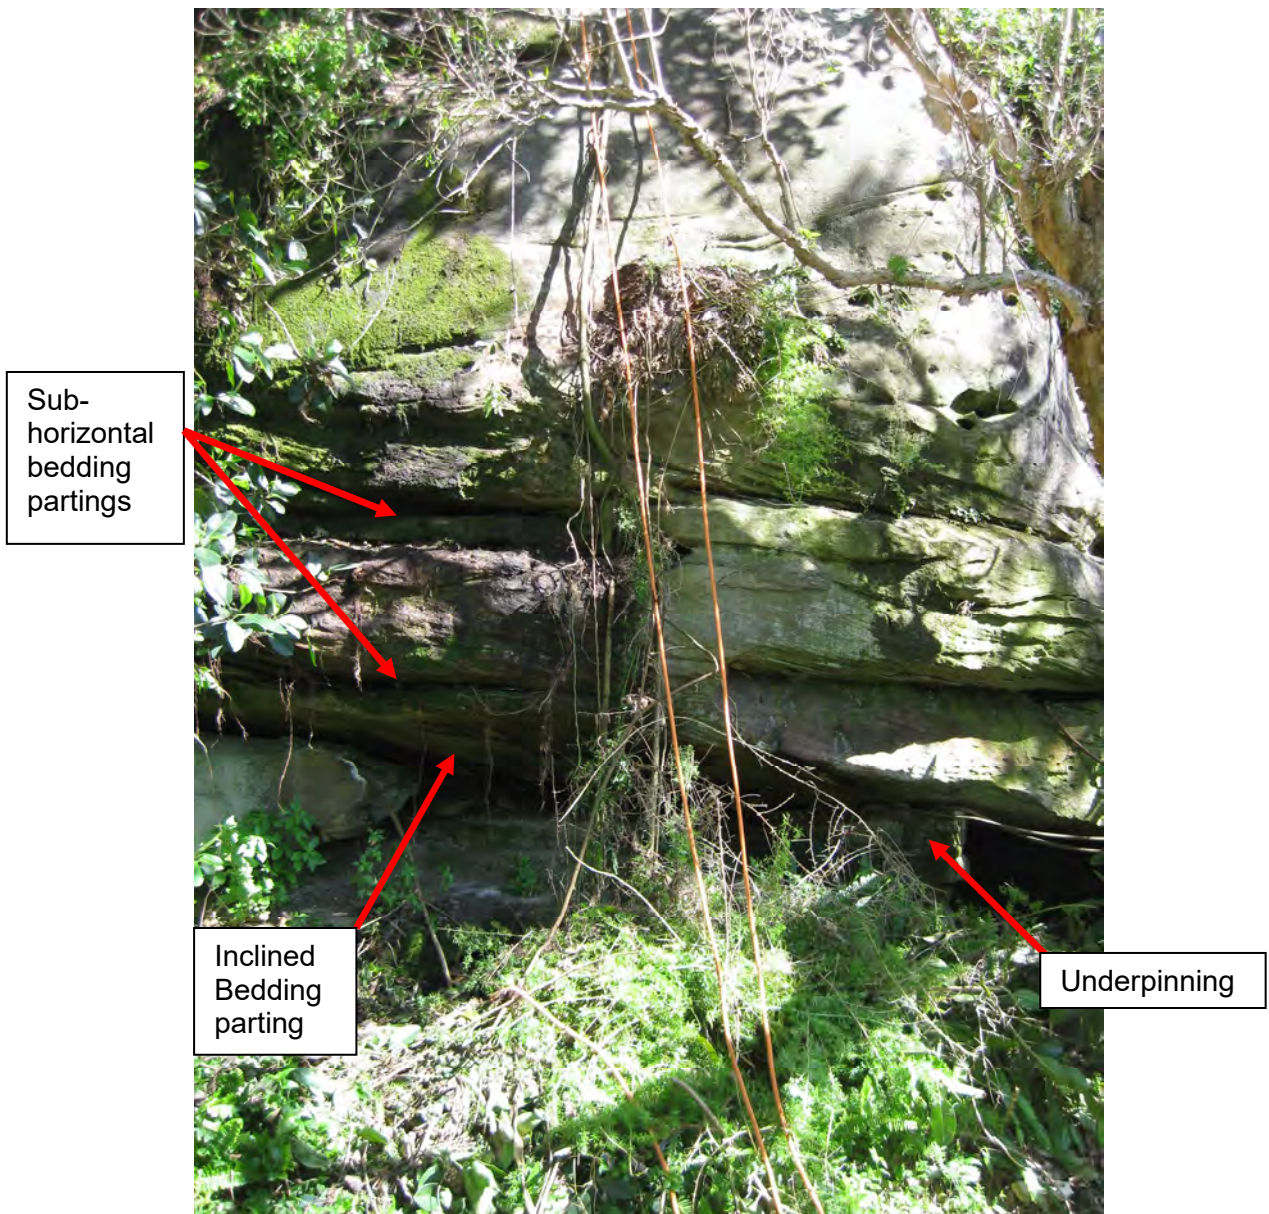
Mapping Traverse 105, Photo 3 – View towards the existing unit building at mapping traverse 105. Overhang and cave formed within cross-bedded sandstone at toe of slope. Sub-horizontal and inclined bedding partings, and a mortared brick underpinning column observed within cave, indicated as shown.

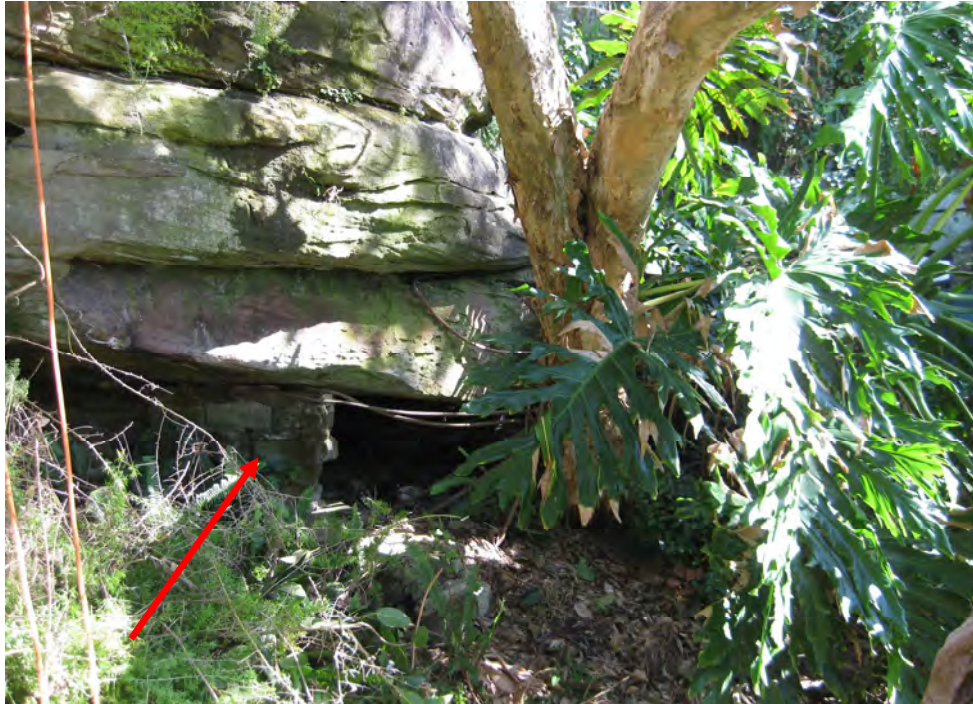
Mapping Traverse 105, Photo 4 – View towards traverse 104 from traverse 105. Overhang and cave formed within cross-bedded sandstone at toe of slope. Mortared brick underpinning observed within cave, indicated as shown.

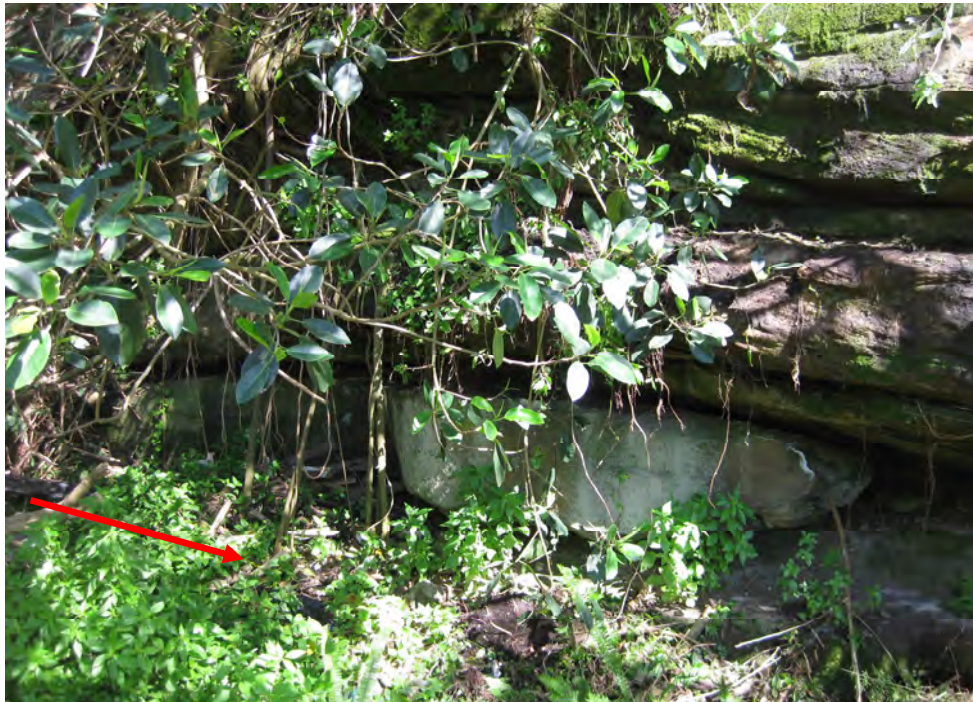
Mapping Traverse 105, Photo 5 – View towards mapping traverse 106 from traverse 105. Tabular boulder on sub-horizontal bedding plane within cave, with debris and colluvium forming a bush path indicated as shown.

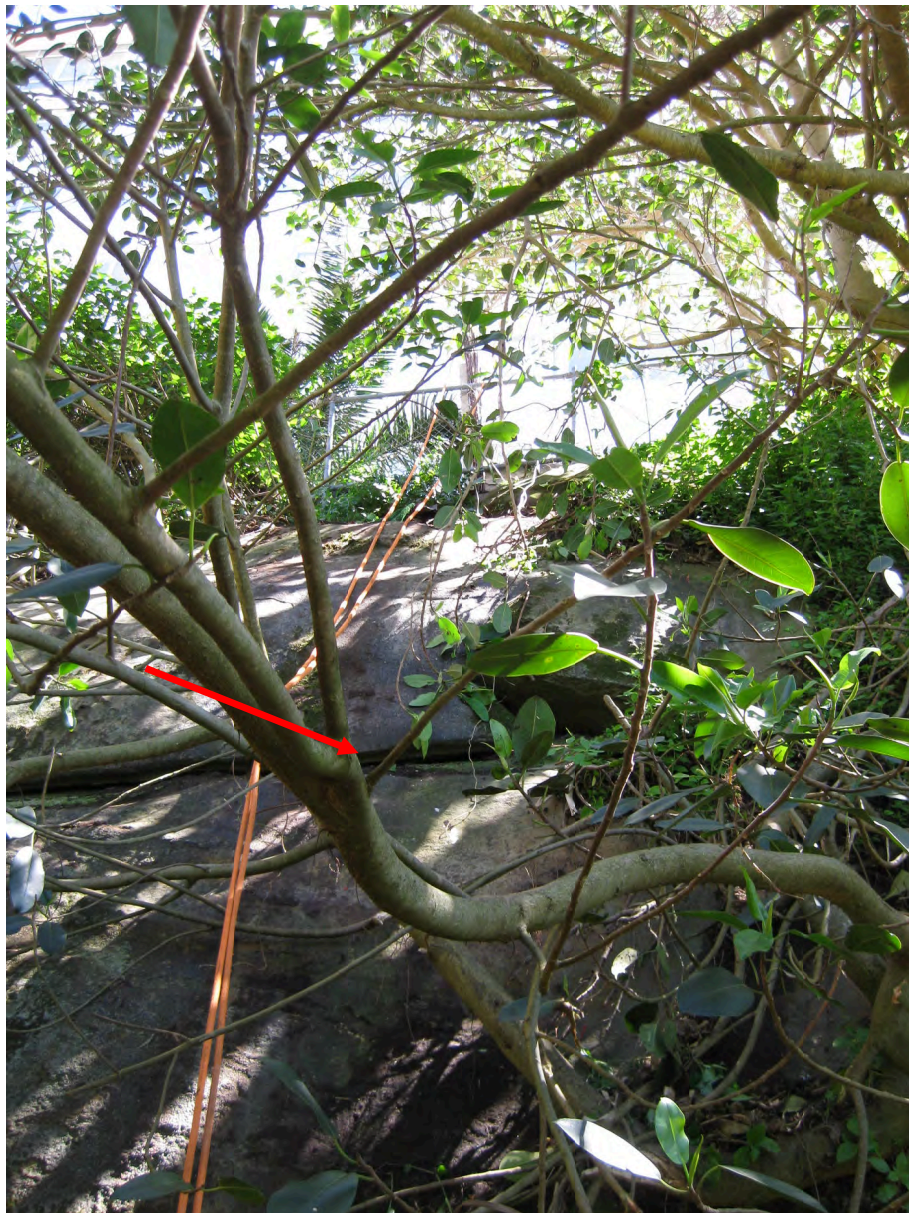
Mapping Traverse 106, Photo 2 – View upslope at mapping traverse 106, with a weathered, inclined and discontinuous bedding parting defect indicated as shown.

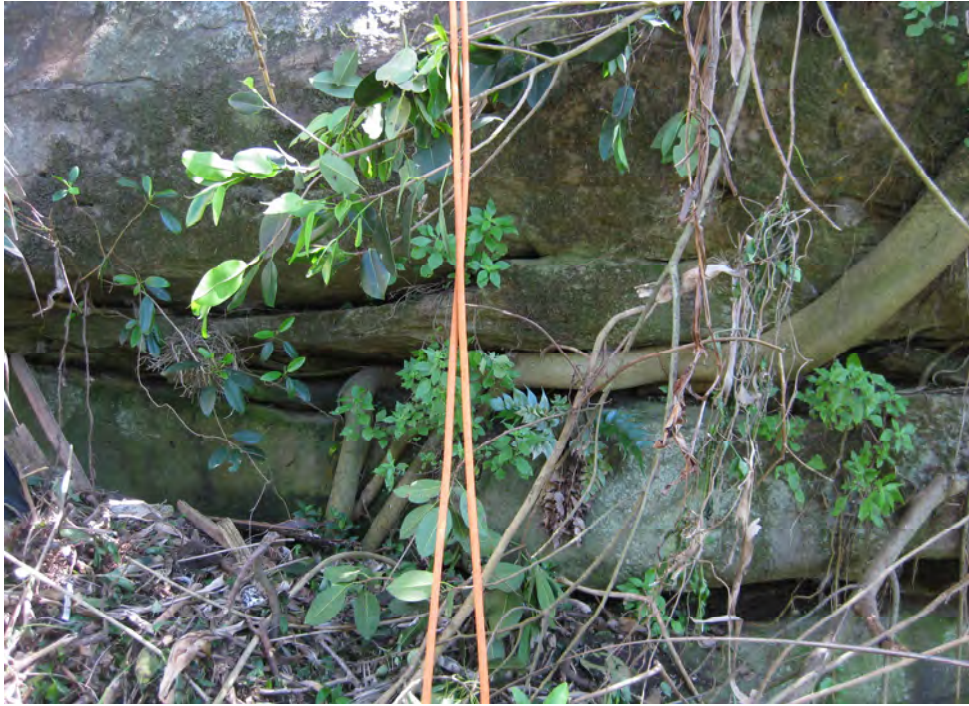
Mapping Traverse 106, Photo 3 – View of base of cliff at mapping traverse 106. Fig tree roots and evidence of past seepage were observed within small caves and overhangs formed in cross-bedded sandstone.

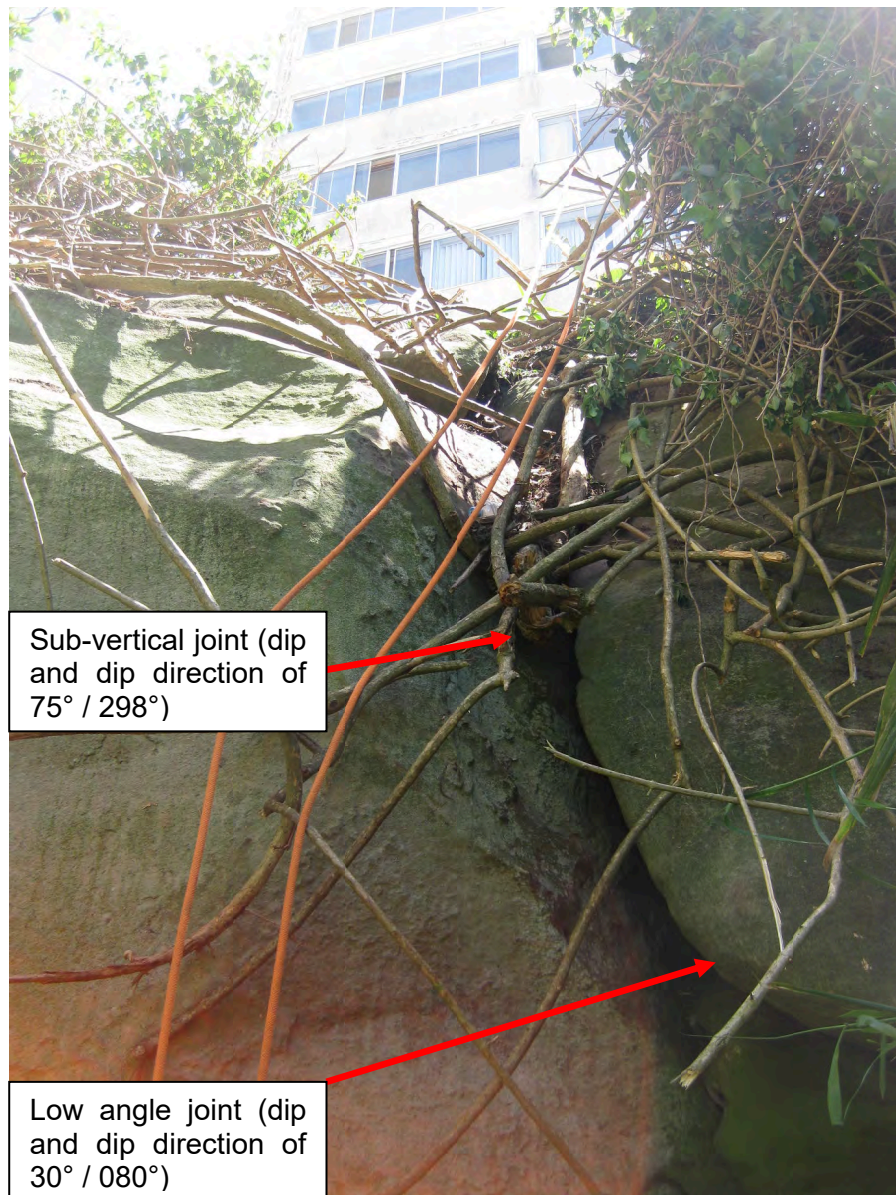
Mapping Traverse 107, Photo 3 – View upslope from base of traverse 107, of sub-vertical and inclined joints within a bed of massive sandstone. The joints and their orientations are indicated as shown.

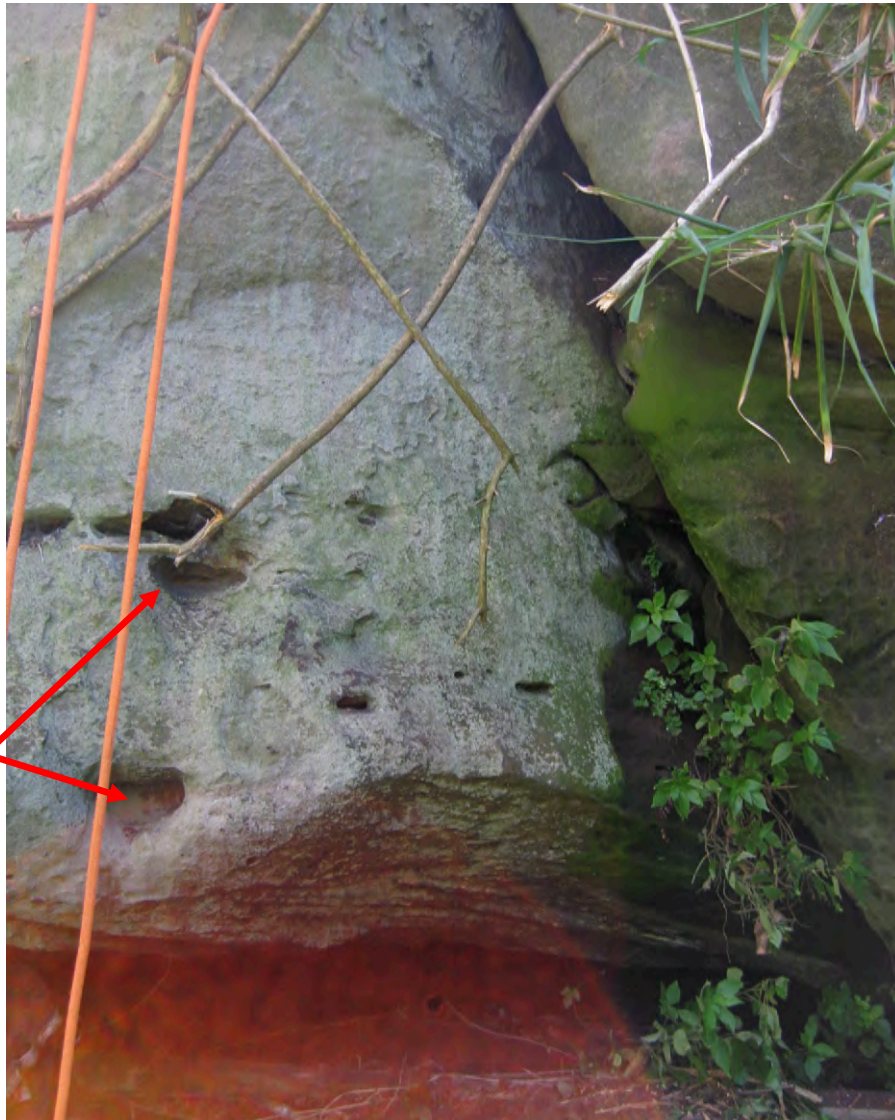
Lenticular  
'pockets' or  
holes within  
sandstone

Mapping Traverse 107, Photo 4 – View of lower part of slope along mapping traverse 107, below Photo 3. Lenticular 'pockets' or holes are present in the sandstone, indicated as shown..

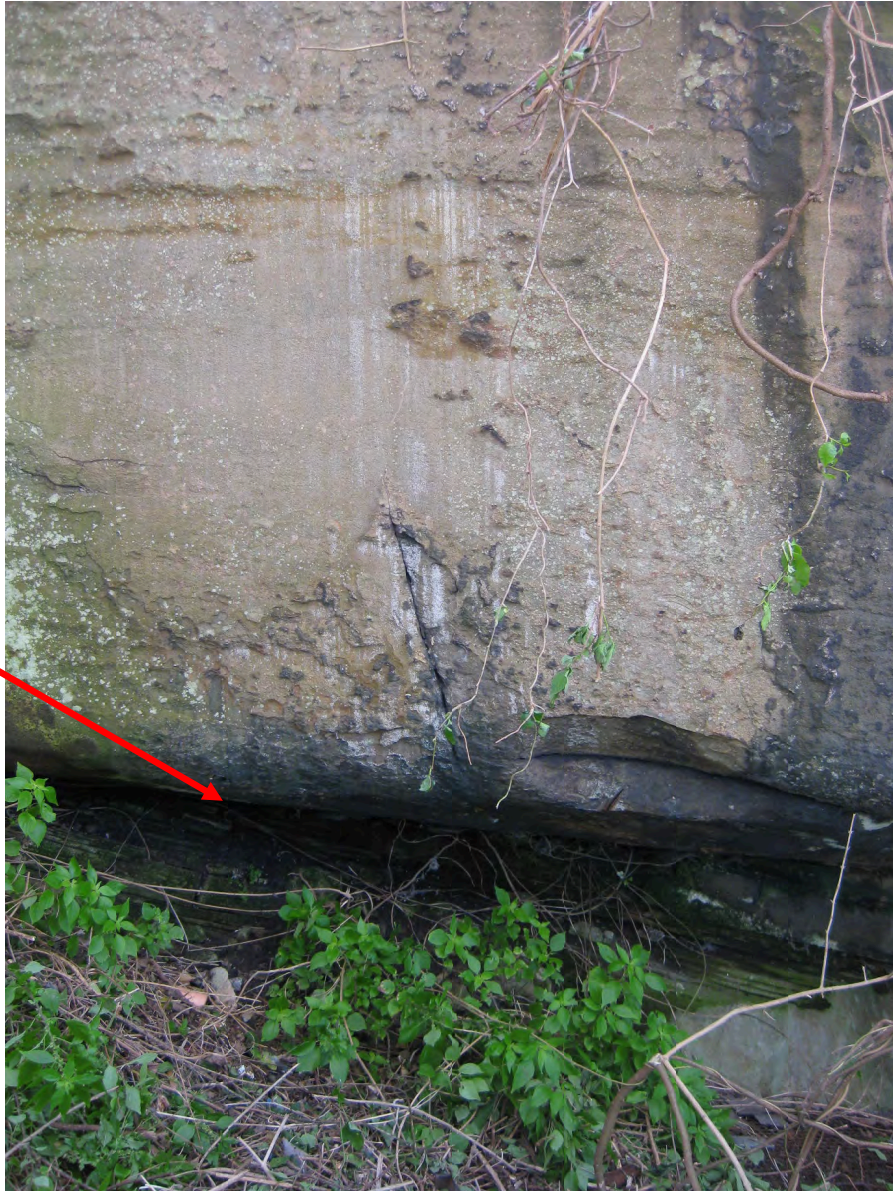
Continuous  
bedding  
parting  
defect, with  
measured  
dip and dip  
direction  
23°/017°

Mapping Traverse 108, Photo 3 – View of lower part of slope along mapping traverse 108, below Photo 2. Overhang formed on continuous bedding parting defect, indicated as shown.

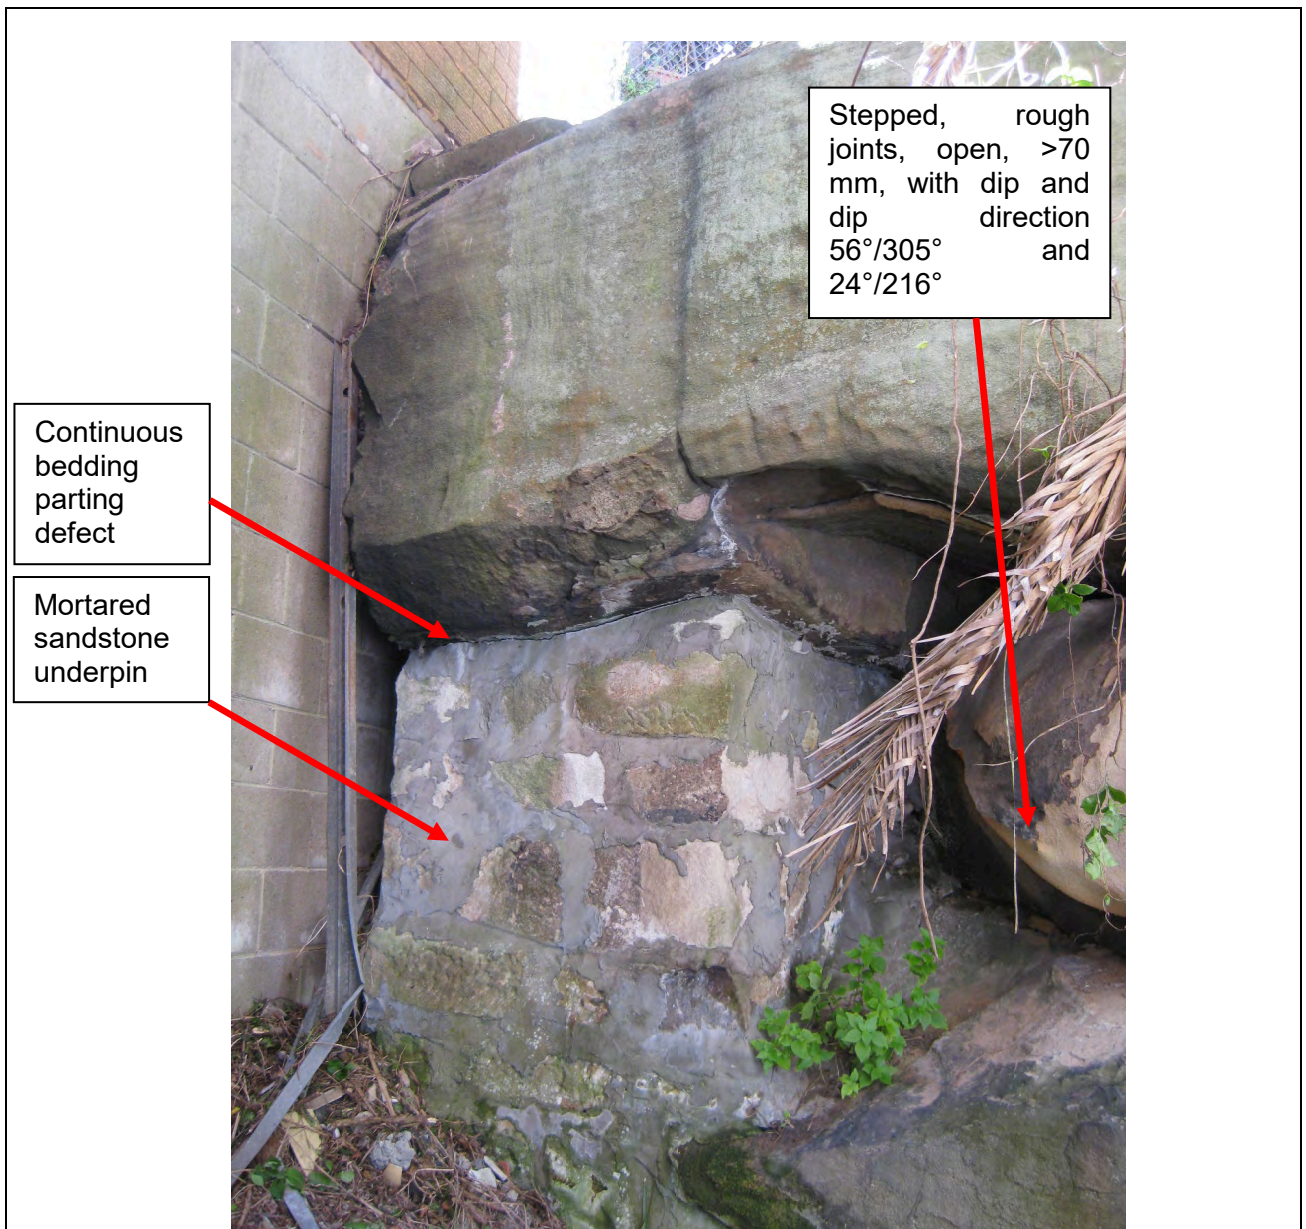
Mapping Traverse 109, Photo 1 – View of southern end of cliff line at mapping traverse 109. Mortared sandstone underpinning is present as indicated. Low angle and moderately dipping joints were present as indicated, adjacent to a 2.3 m deep void.

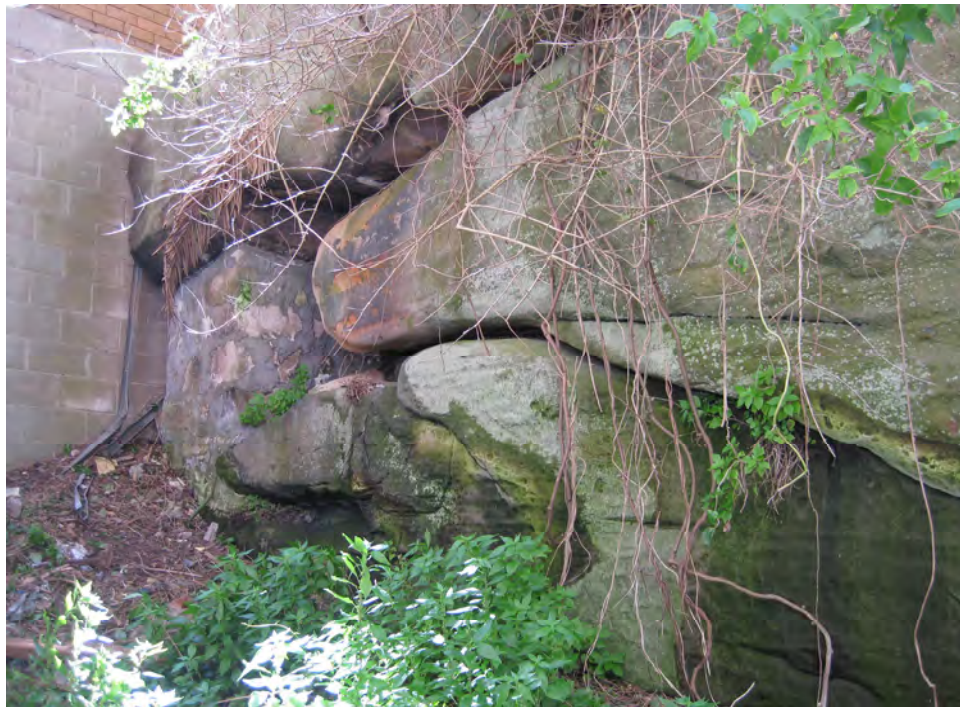
Mapping Traverse 109, Photo 2 – View north towards mapping traverse 109, showing sub-horizontal and dipping bedding plane defects.

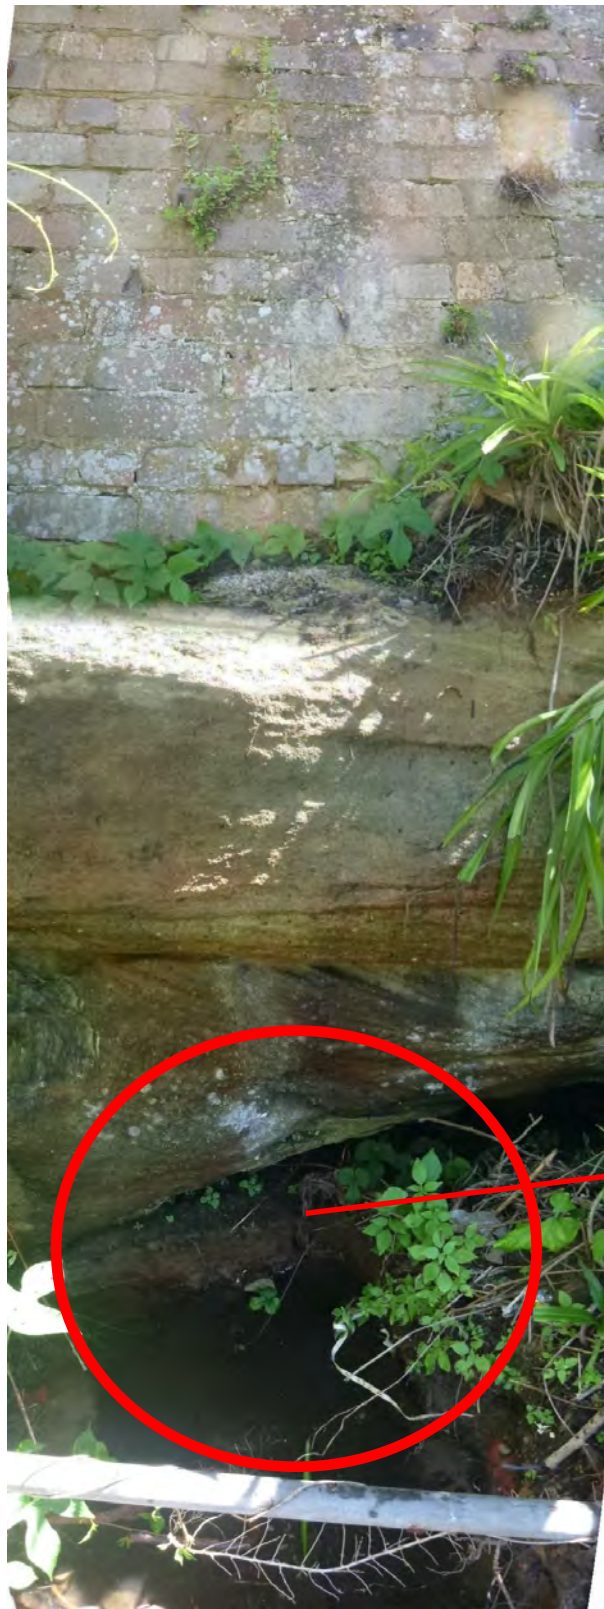
Photo 3. Cross Section 1; contact between brick terrace wall and sandstone bedrock showing lower very low strength rock.
