Report on  
Geotechnical Investigation

Alterations and Additions  
20 Illawong Avenue, Tamarama

Prepared for  
Strata Plan 1731

Project 72261.06  
November 2018

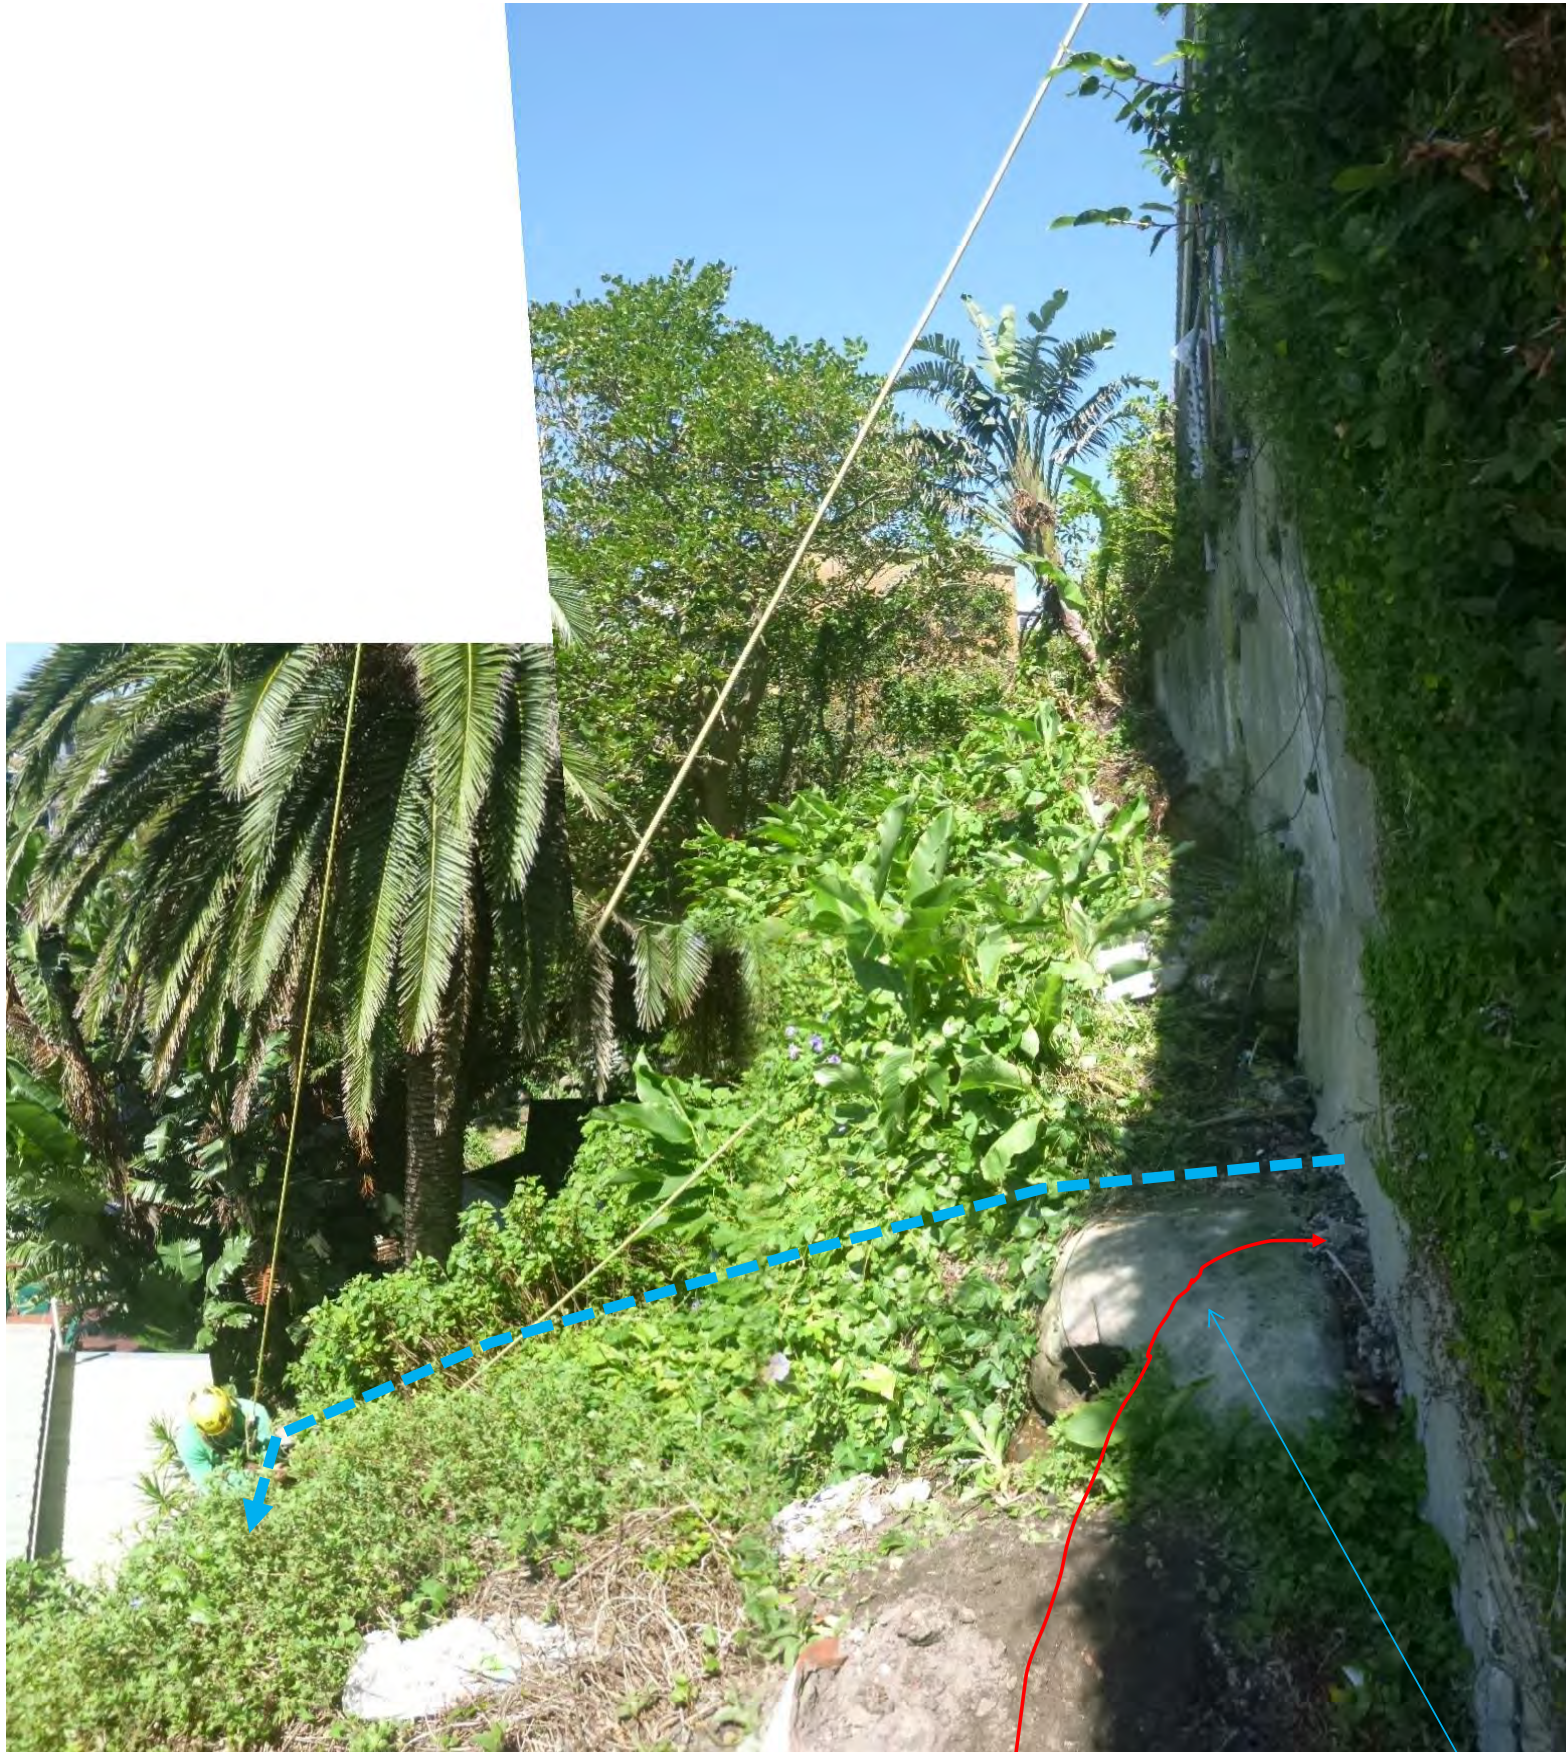
Photo 7. Cross Section 3 viewed towards the south-west. Note adjacent terrace wall has been cut down through detached sandstone block of the outcrop .

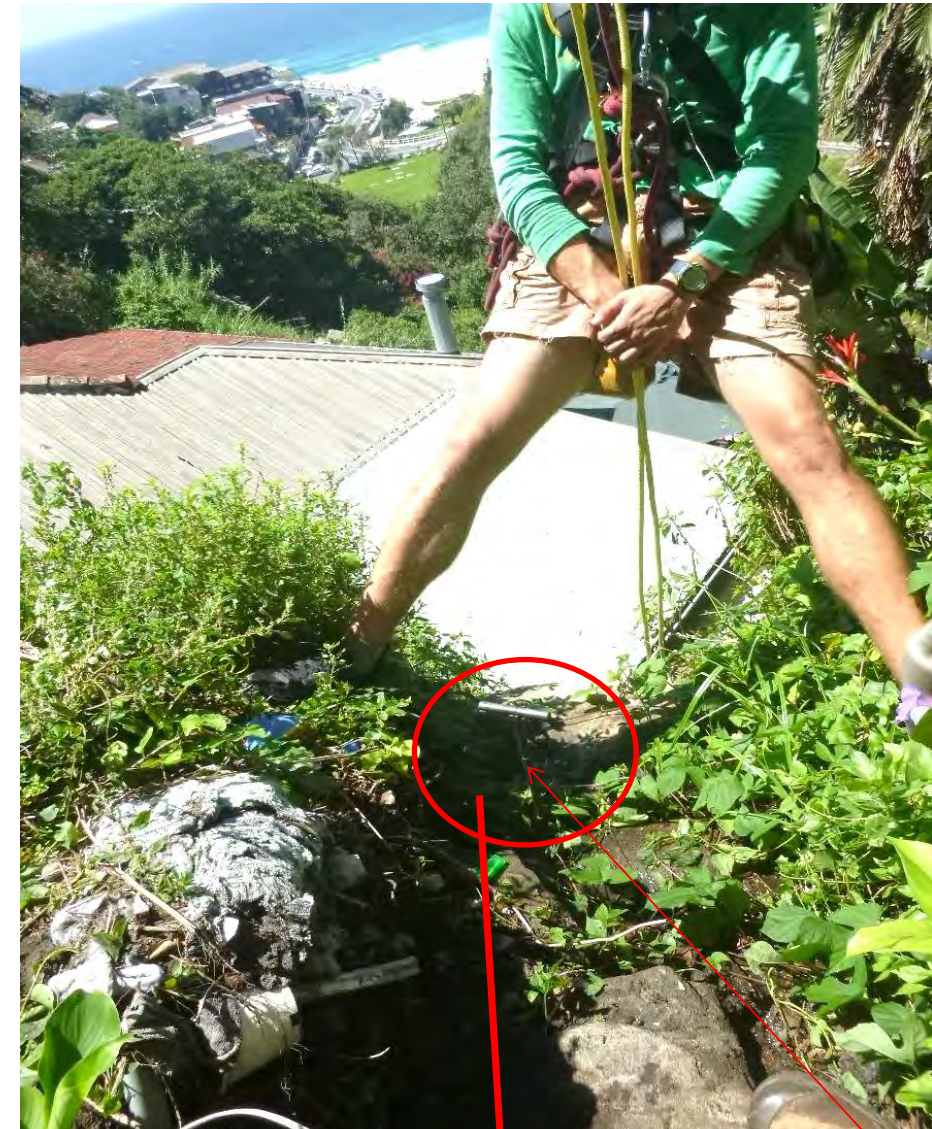
Photo 8. Outer edge of Section 3. Note 1m long steel test probe inserted 700mm into an open, though sand filled, joint, approximately 700mm back from the cliff crest.

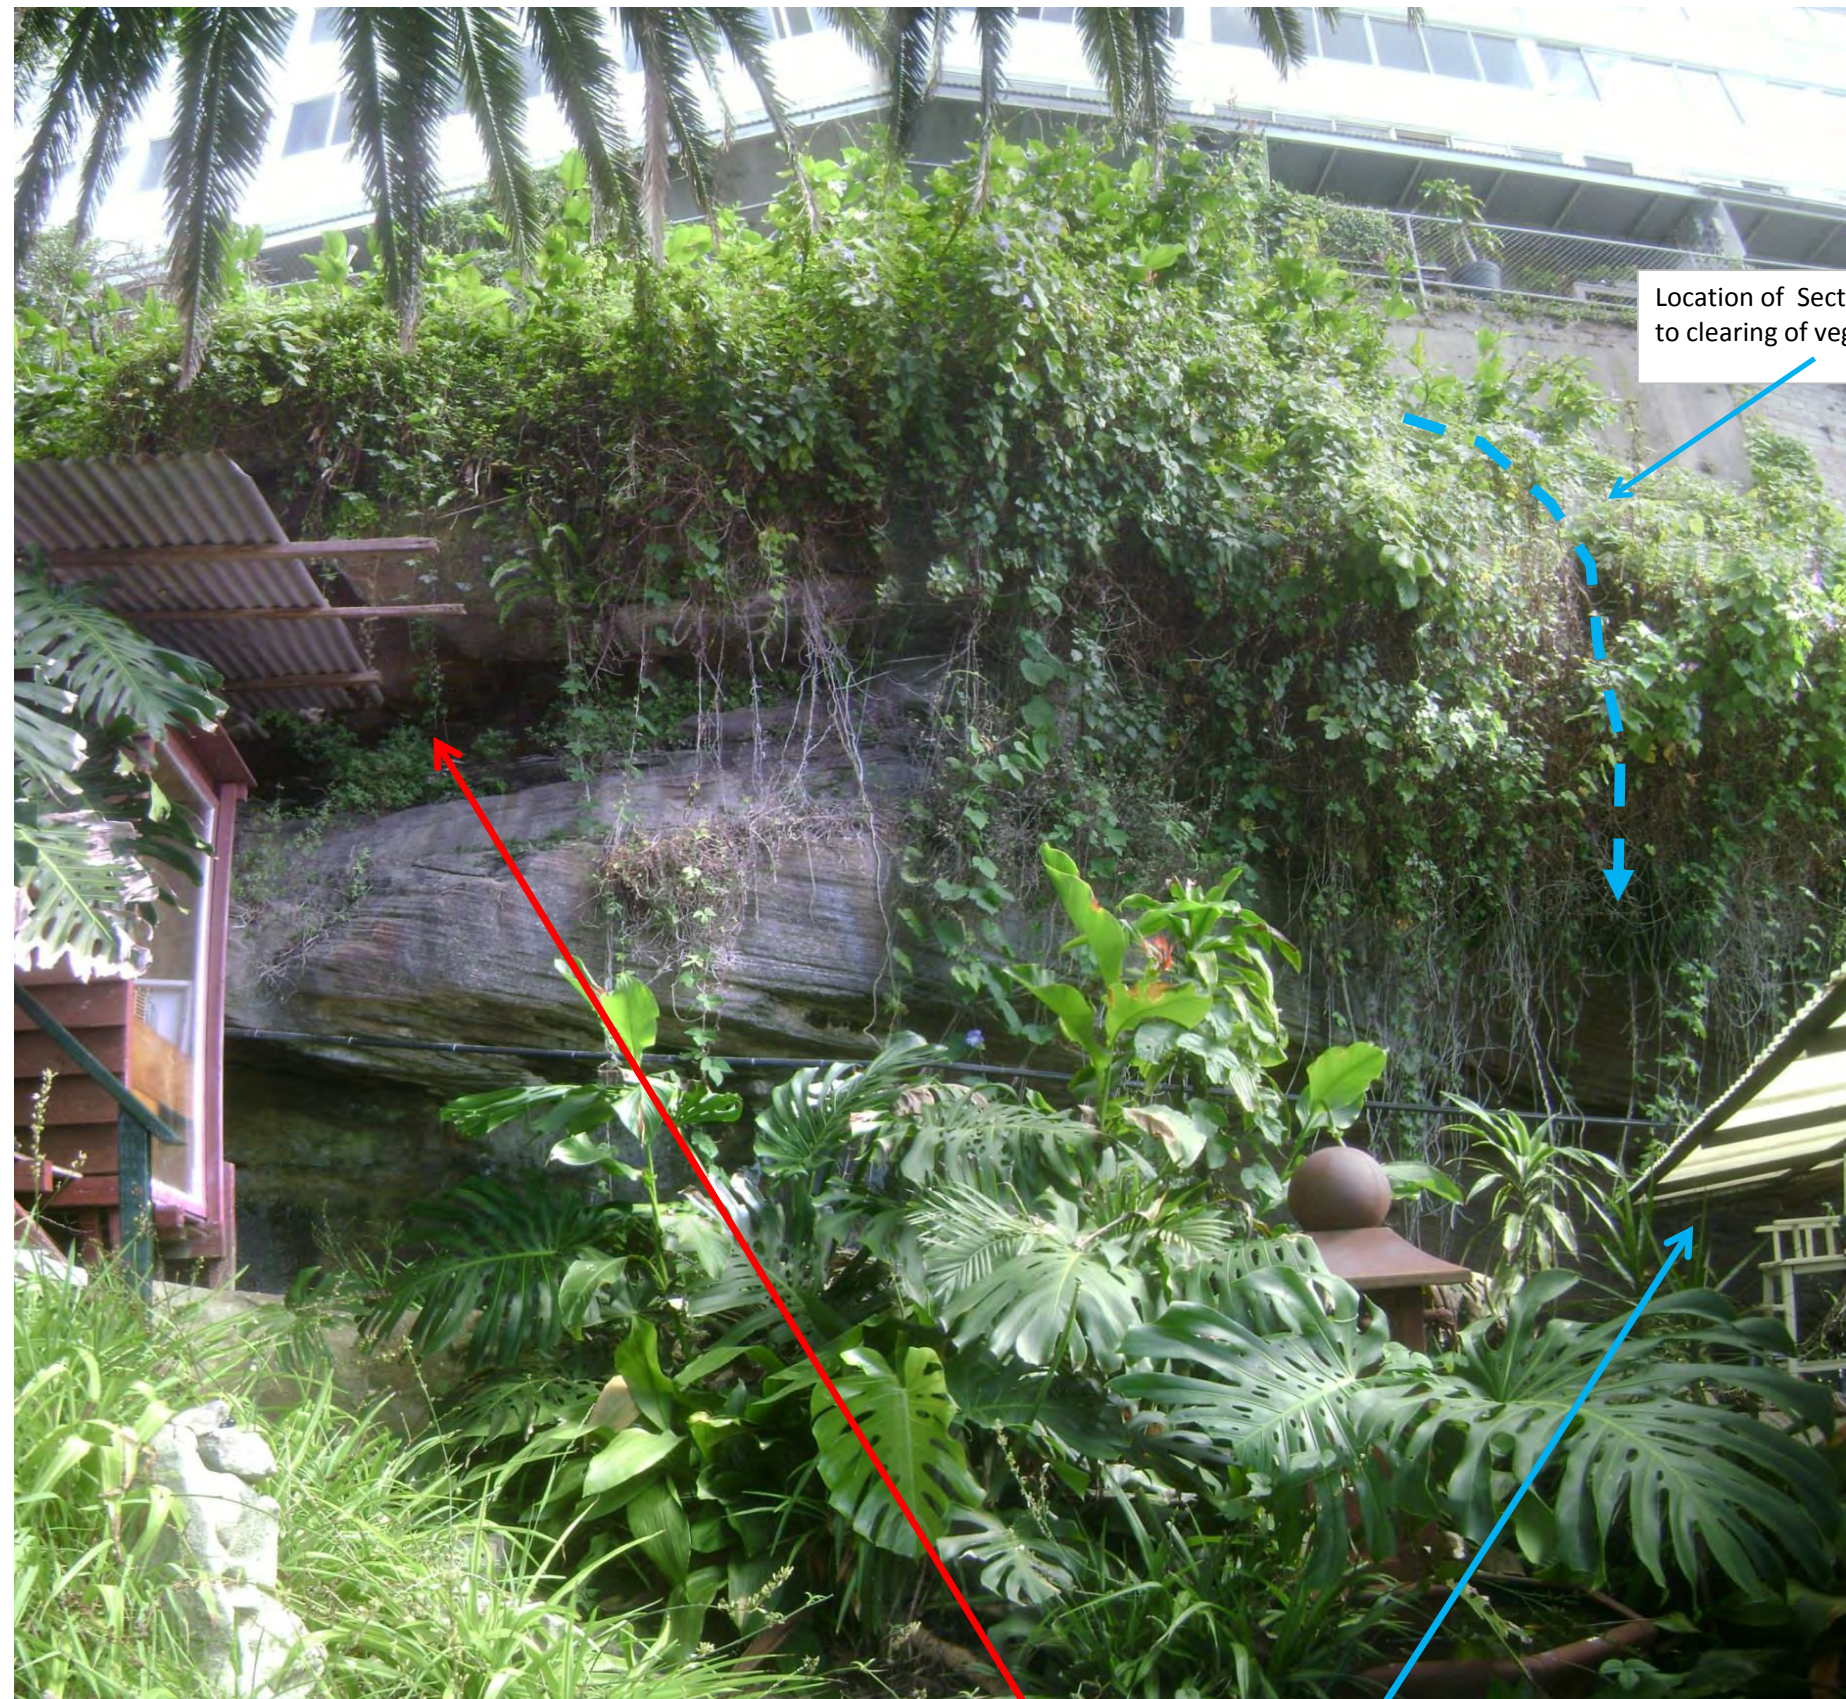
Photo 9. Area to the south-west of Section 3. Note higher level (of less extensive) undercut than the major undercut (refer to Drawing 2 to 4 photos) further to the north at Sections 1 to 3.

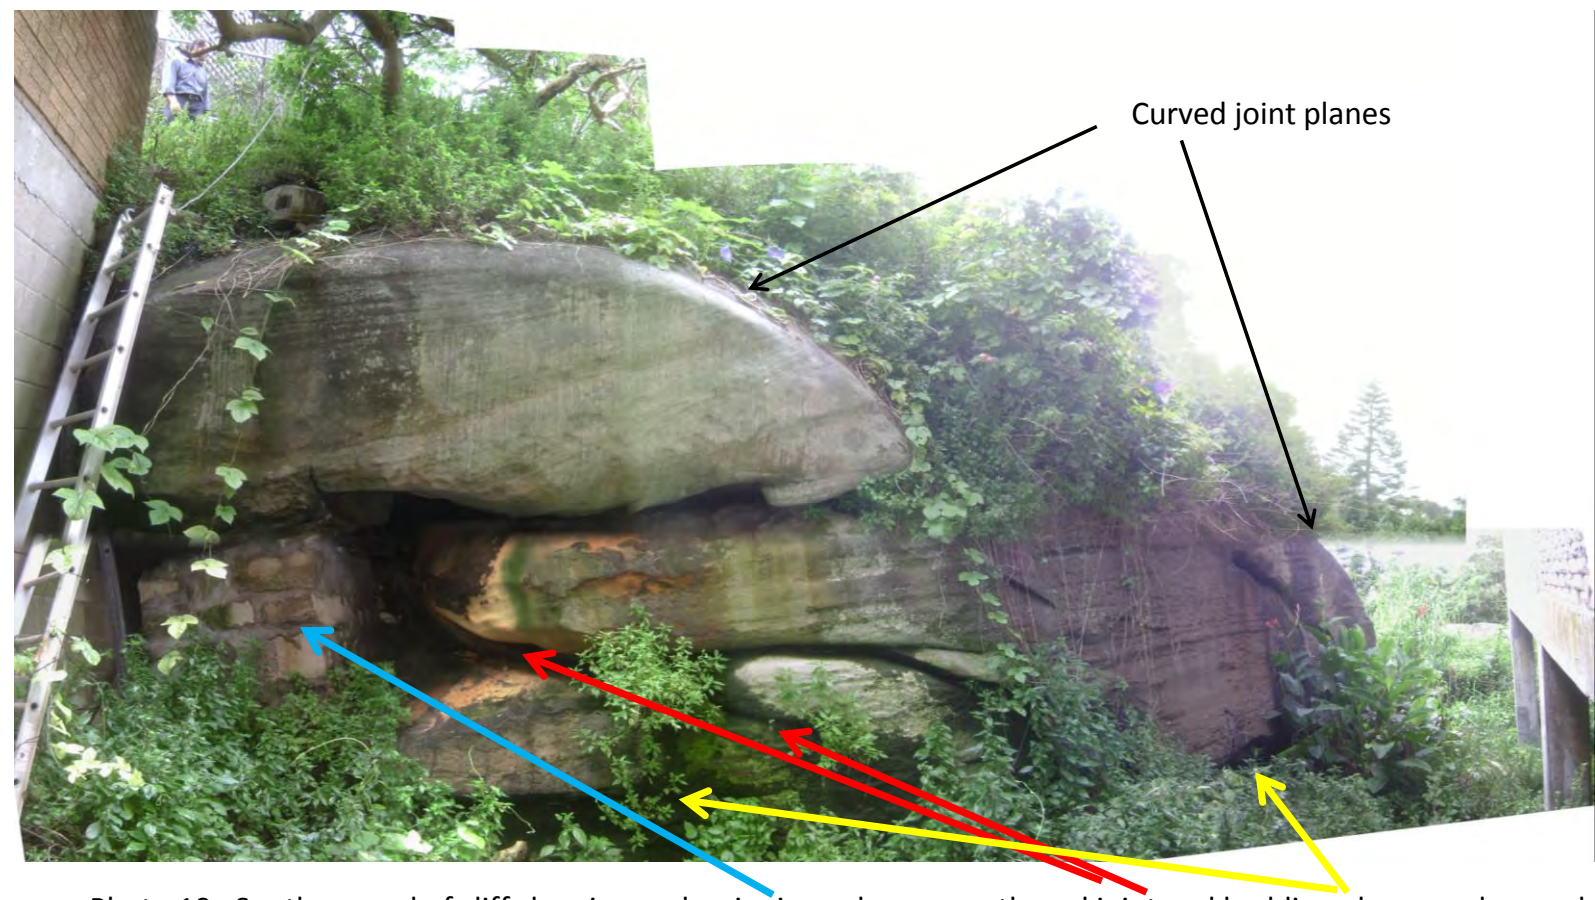
Photo 10. Southern end of cliff showing underpinning column, weathered joint and bedding planes and curved joint planes.

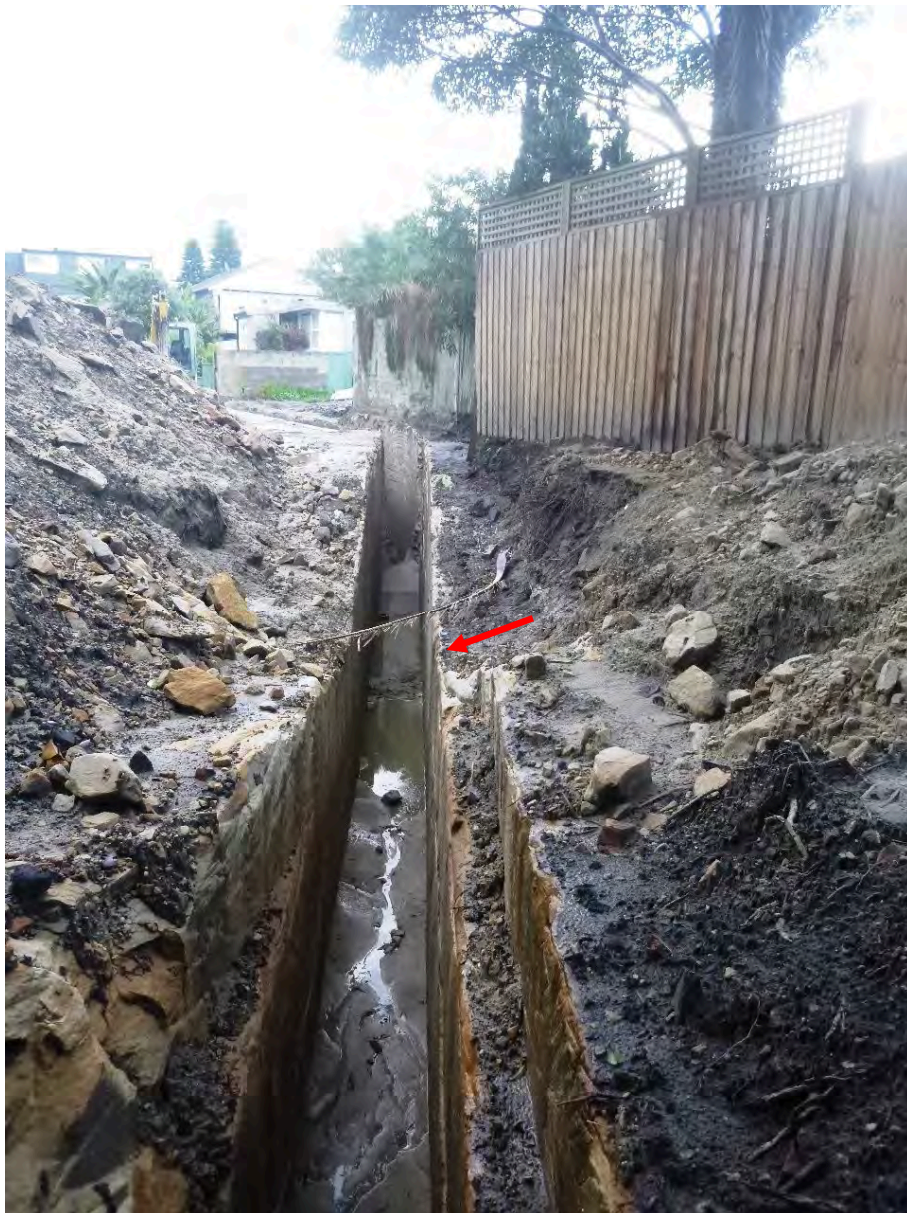
Historical Site Photograph of Sewer Diversion Trench, Photo 3 – View to south-west near Borehole BH5. Solid sandstone exposed at shallow depth along trench excavation. The approximate position of the clayey feature shown in Photo 4 is indicated as shown.

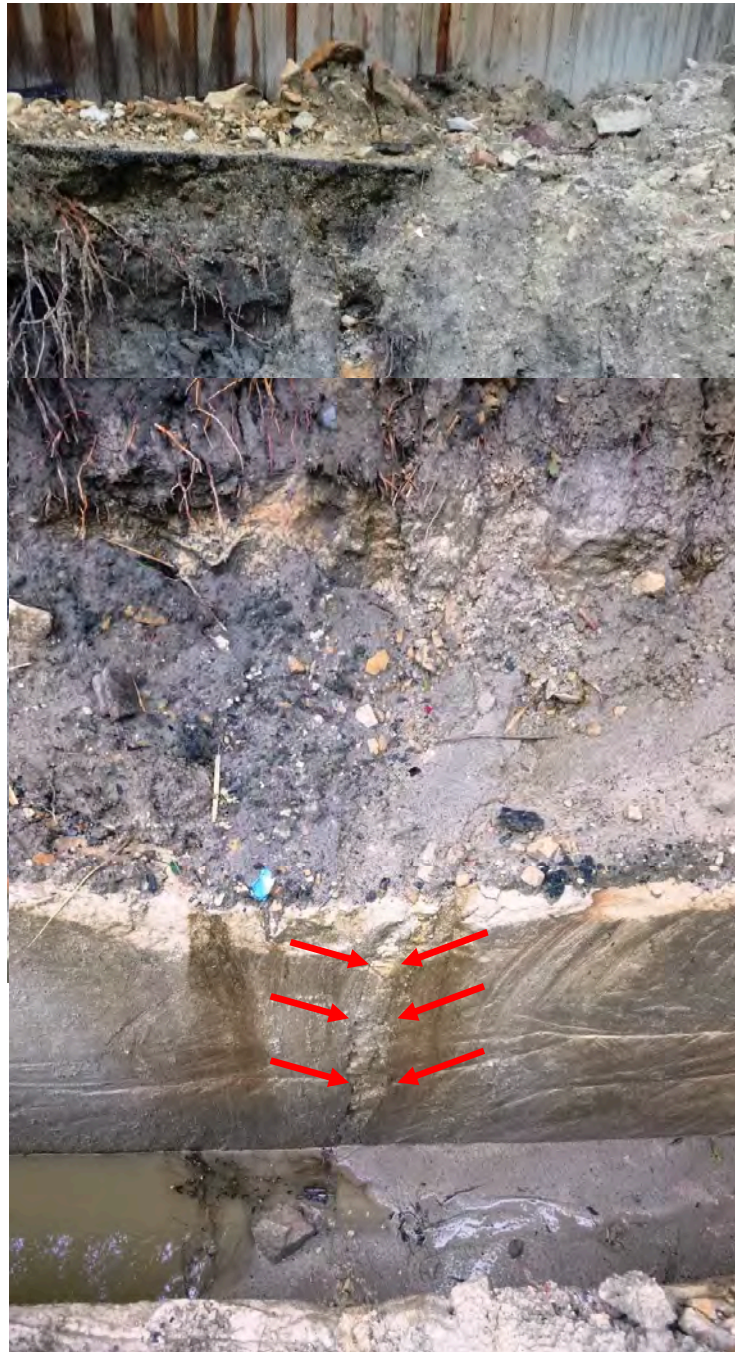
It is noted that the PWD report identified a “clay-infilled ... sub-vertical joint” within the sewer diversion trench, in the vicinity of boreholes BH3, BH5 and BH103. Site observations by DP of this feature interpreted it to be a thin (100-150 mm thick), sub-vertical vein of igneous material which had weathered to clay (refer to Plates F3 and F4 within Appendix F). The orientation of this feature was measured to have a dip and dip direction of 85-90°/200°. This feature was not encountered in any of the boreholes, and was not observed within the cliffline on the south-eastern side of the unit block. In the few cases where sub-vertical joints were encountered in boreholes, thick clay coatings were not observed.

Historical Site Photograph of Sewer Diversion Trench, Photo 4 – View to north-west near Borehole BH5 and BH103. Sub-vertical, clay-infilled undulating defect in rock (indicated between arrows as shown), inferred to be an intrusive dyke weathered to clay, or a clay-infilled joint defect.
