# SCHEDULE OF CONSERVATION WORKS

Burwood Uniting Church  
134A Burwood Road, Burwood NSW

October 2018

Issue B

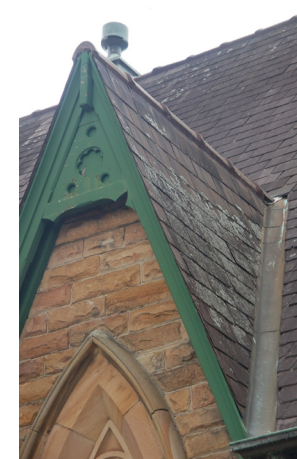
**Figure 2.5**  
Typical gable and timber infill (with missing element on left), slate shingling, ridge vent and valley gutter

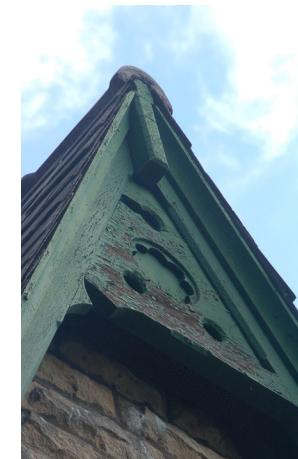
**Figure 2.6**  
Deteriorating gable infill

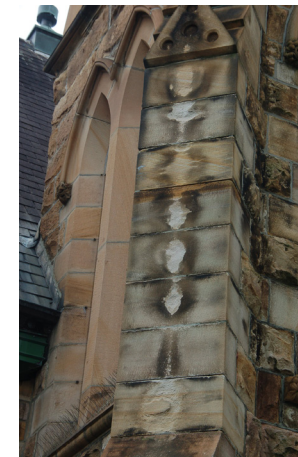
**Figure 2.12**  
Typical buttress with typical deterioration of sandstone

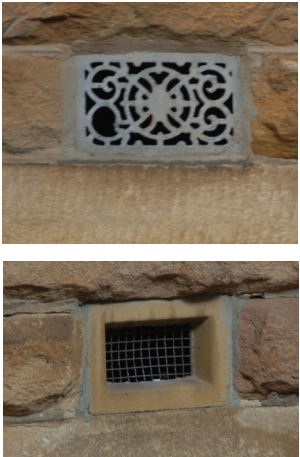
**Figure 2.13**  
Ventilation grilles, likely original (top) and non-original (bottom)

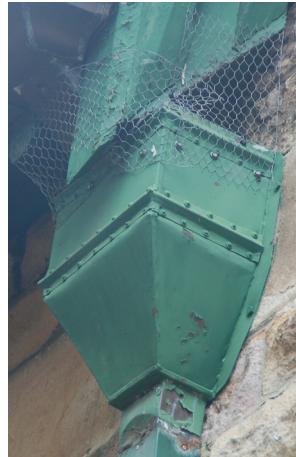
**Figure 2.15**  
Different rainwater heads, southern facade of Church; earlier on left

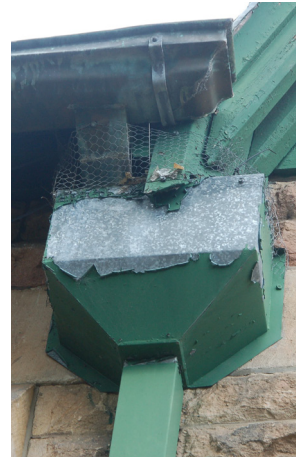
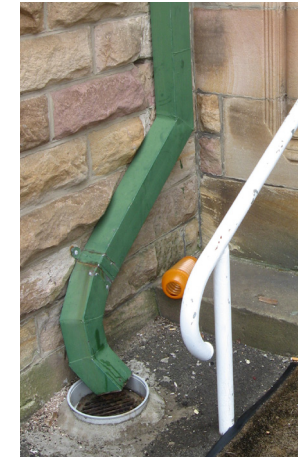
**Figure 2.16**  
Stonework cut to accommodate downpipe, and later handrail

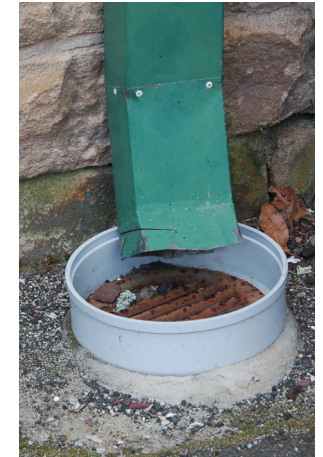
**Figure 2.17**  
PVC collar of downpipe drain

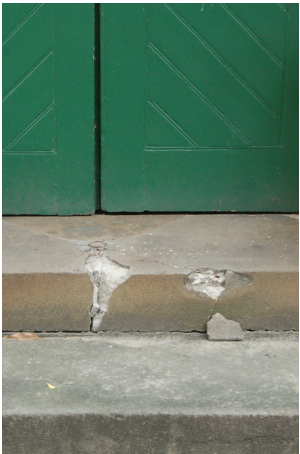
**Figure 2.18**  
Examples of damage to stonework due to wear and tear (left) and past work (right)

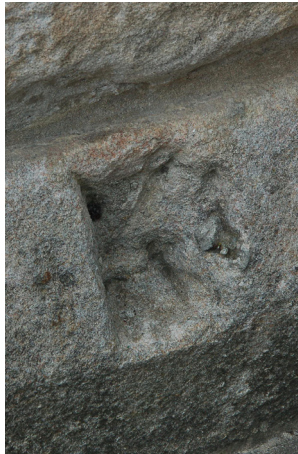
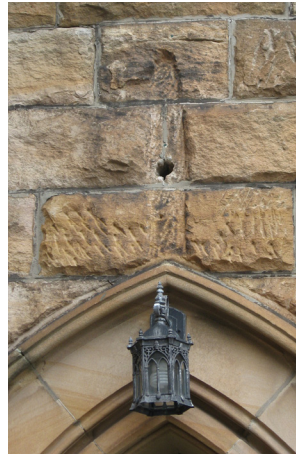
**Figure 2.19**  
Evidence of removed fixture over belfry doorway

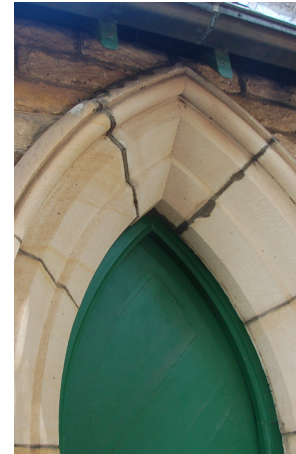
**Figure 2.20**  
Example of inappropriate pointing

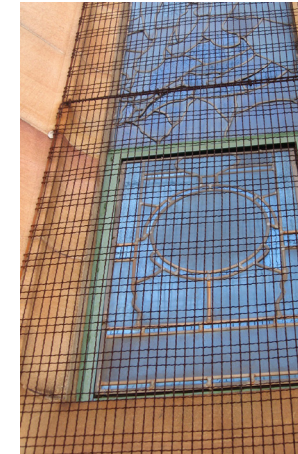
**Figure 2.21**  
Rusted wire screen over deteriorating stained glass window, southern facade

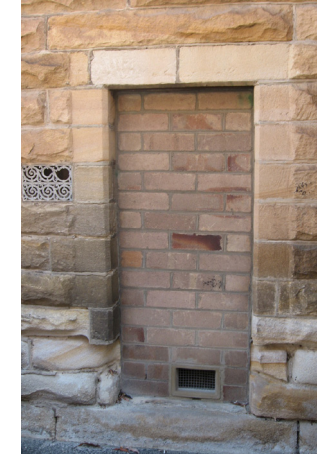
**Figure 2.22**  
Bricked up doorway to old organ location, eastern end of northern facade
