Report on
Pre-Demolition Hazardous Material Survey - Buildings
3, 6, 7, 8 and 9

Proposed Aged Care, Closebourne Retirement Living
Morpeth Road, Morpeth

Prepared for
Lend Lease (Retirement Living)

Project 81251.13
September 2016

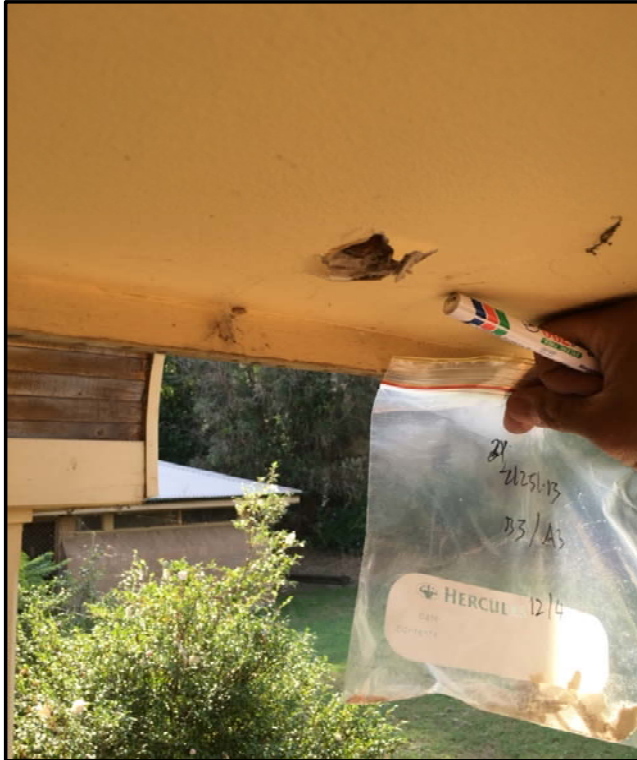
Photo 1: Building 3 - Fibrous Cement Sheet Eaves

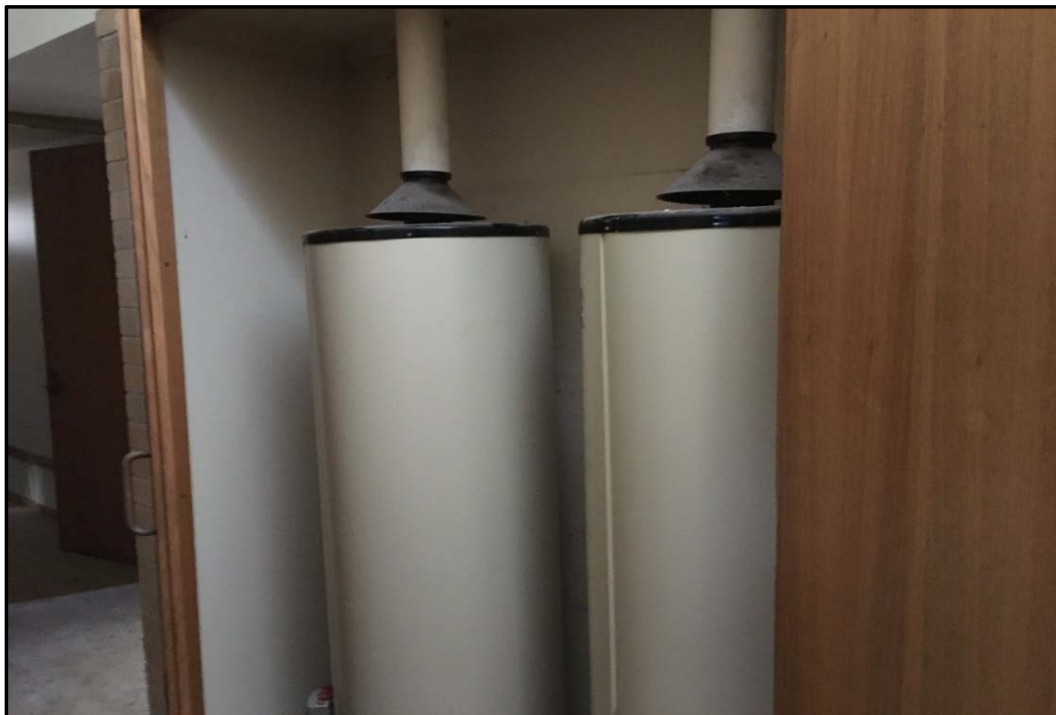
Photo 2: Building 3 - Cement Flue Pipes – Hot Water System

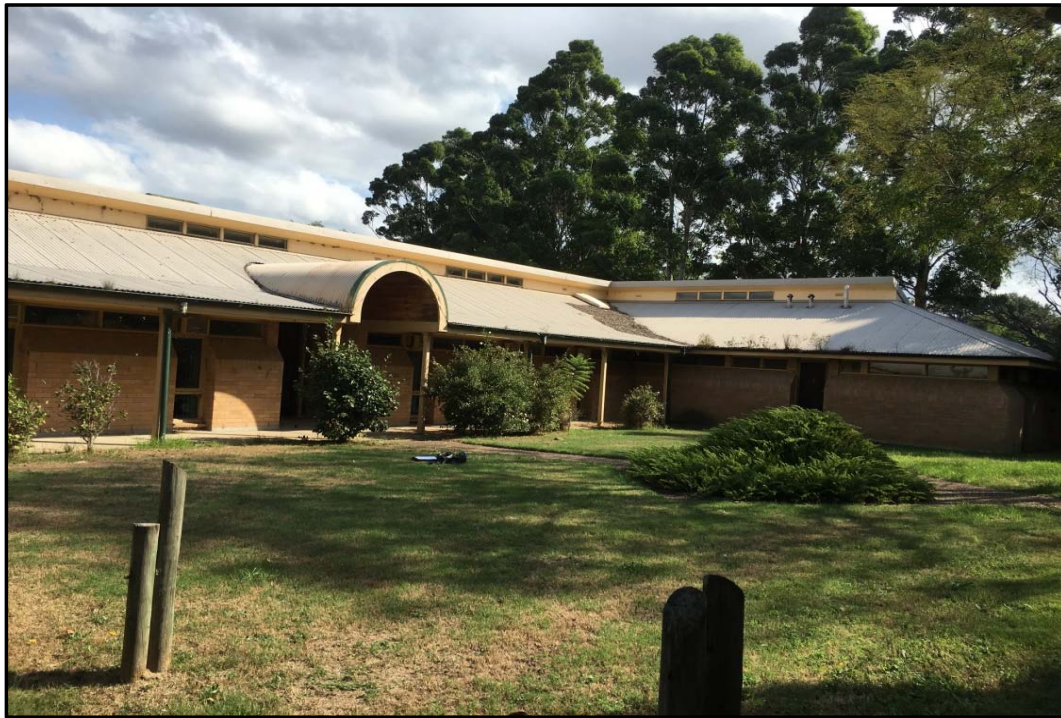
Photo 3: Building 3 - Lead Flashing – Vent Pipe joins

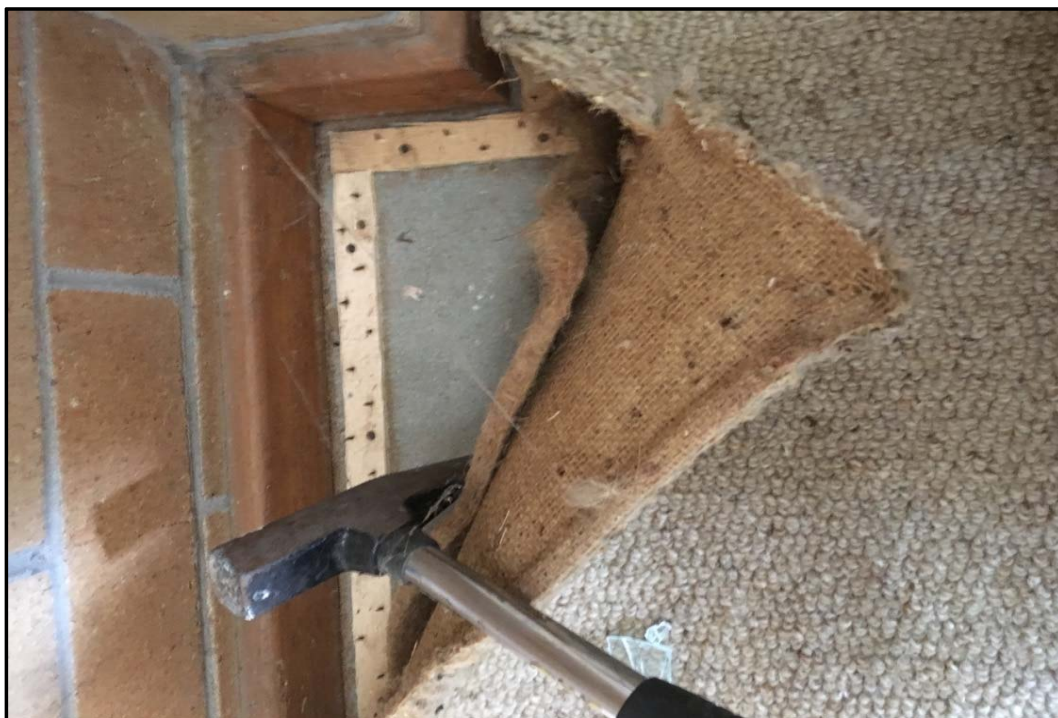
Photo 5: Building 3 - Carpet Underlay under (entire floor area ~700m2).

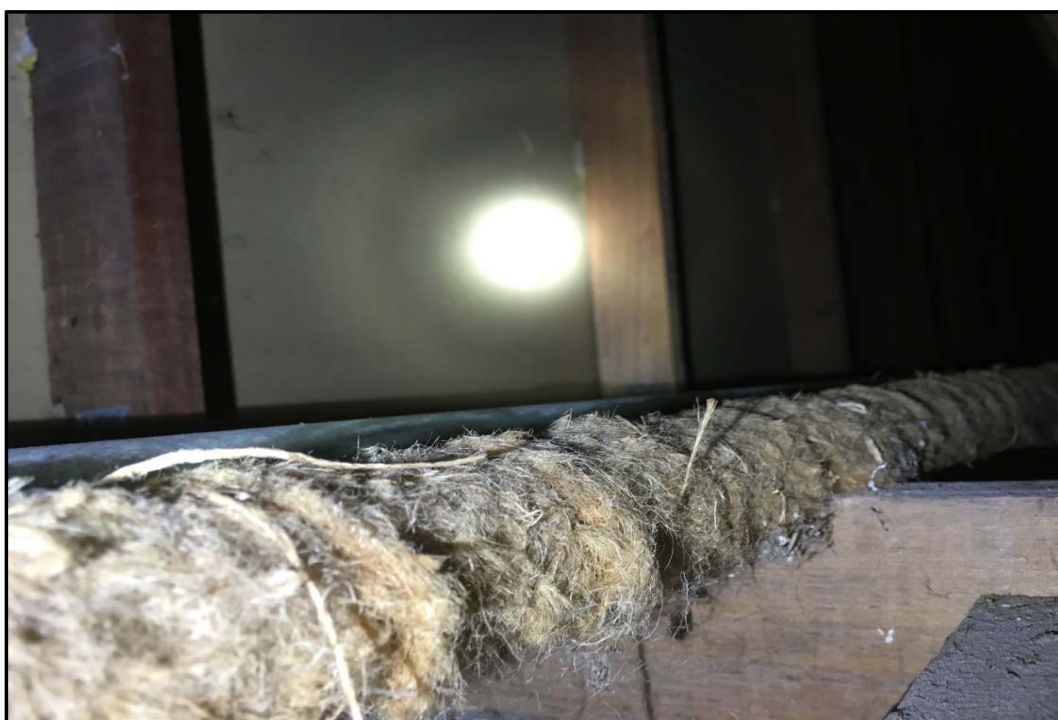
Photo 6: Building 3 - Roof void – Brown fibre lagging around pipe

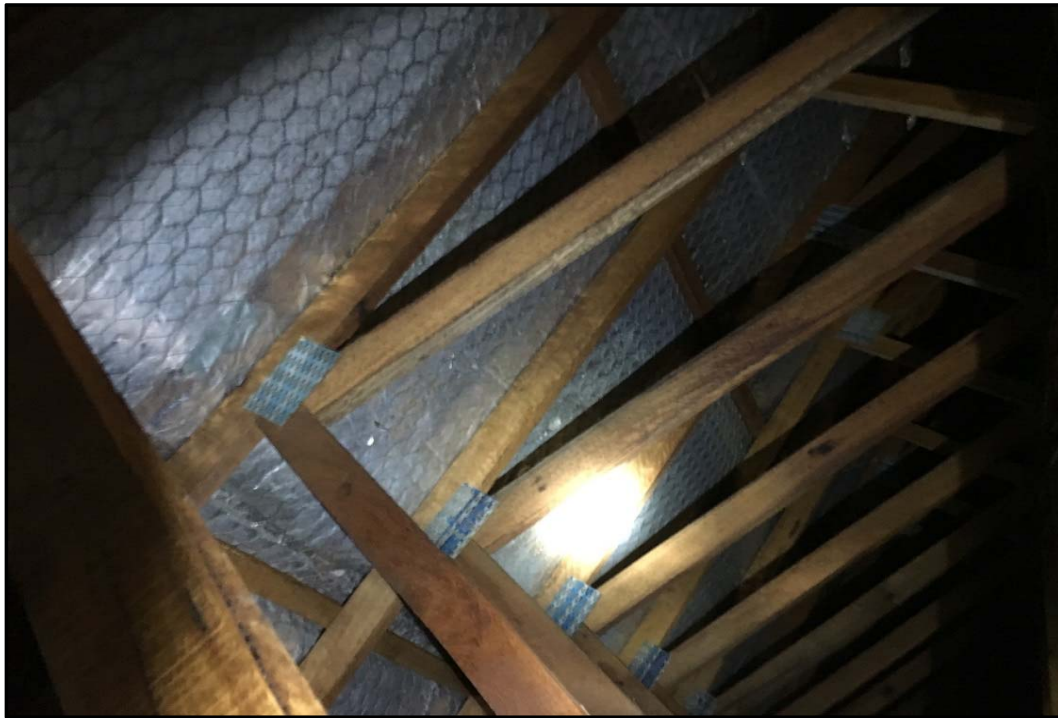
Photo 7: Building 3 - Sarking (entire roof area) insulation lining under roof

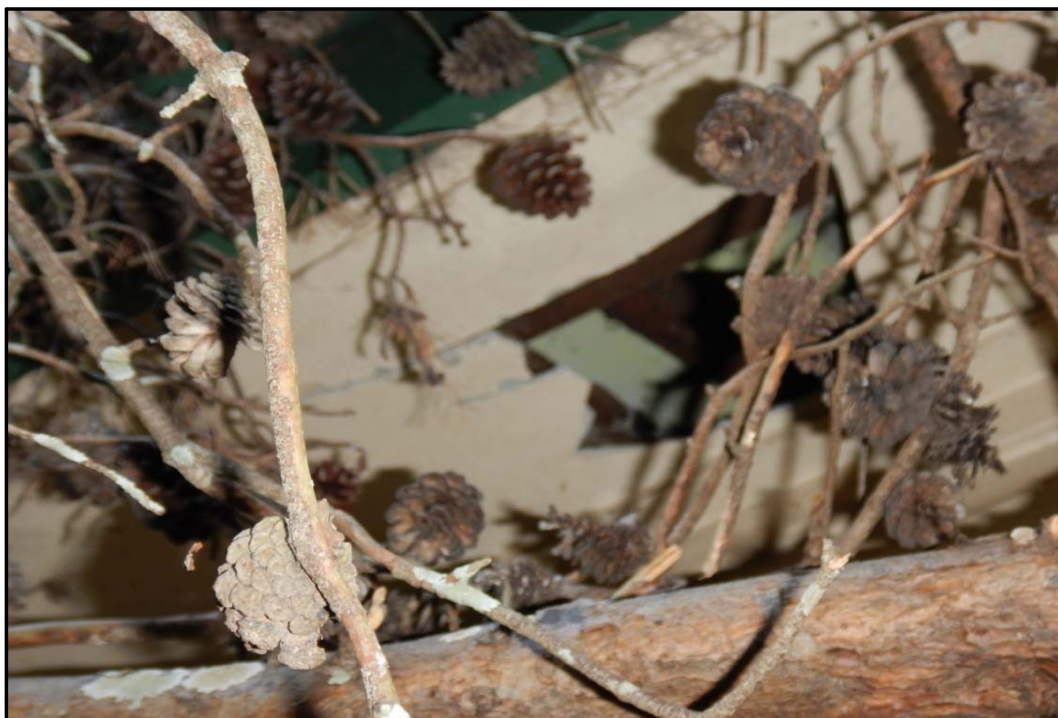
Location Description	Sample No	Photo No	Asbestos Type	Friability Status	Product Type	Extent	Recommendation (A1 - A4)*	Comments / Action
Building 6								
External eaves around building	B6A1	8	Chrysotile Amosite Crocidolite	Bonded	Cement Sheet	~30m ²	A1	Remove prior to any demolition or refurbishment works that may disturb the installation. Should the material not be affected by the works, leave in-situ, affix asbestos warning labels, manage and re-inspect.
Corrugated cement roofing under corrugated iron	Assumed	9	Not known	Bonded	Cement Sheet	~130m ²	A1	Remove prior to any demolition or refurbishment works that may disturb the installation. Should the material not be affected by the works, leave in-situ, affix asbestos warning labels, manage and re-inspect.

Photo 8: Building 6 - External eaves around building

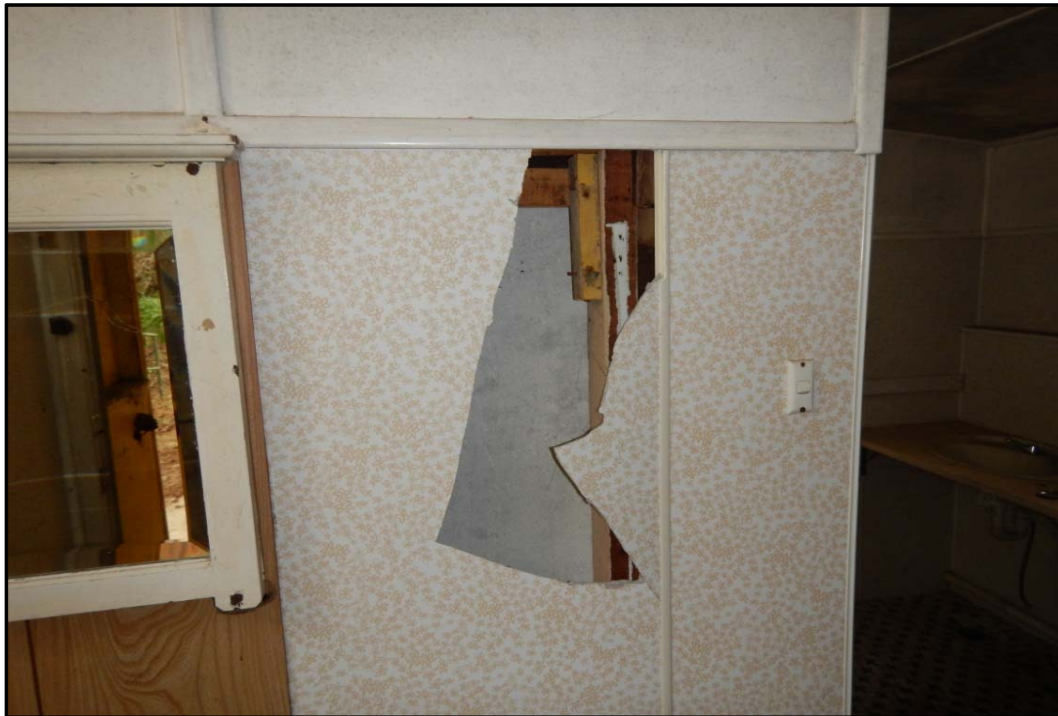
Photo 10: Building 7 - Patterned cement sheeting in bathroom

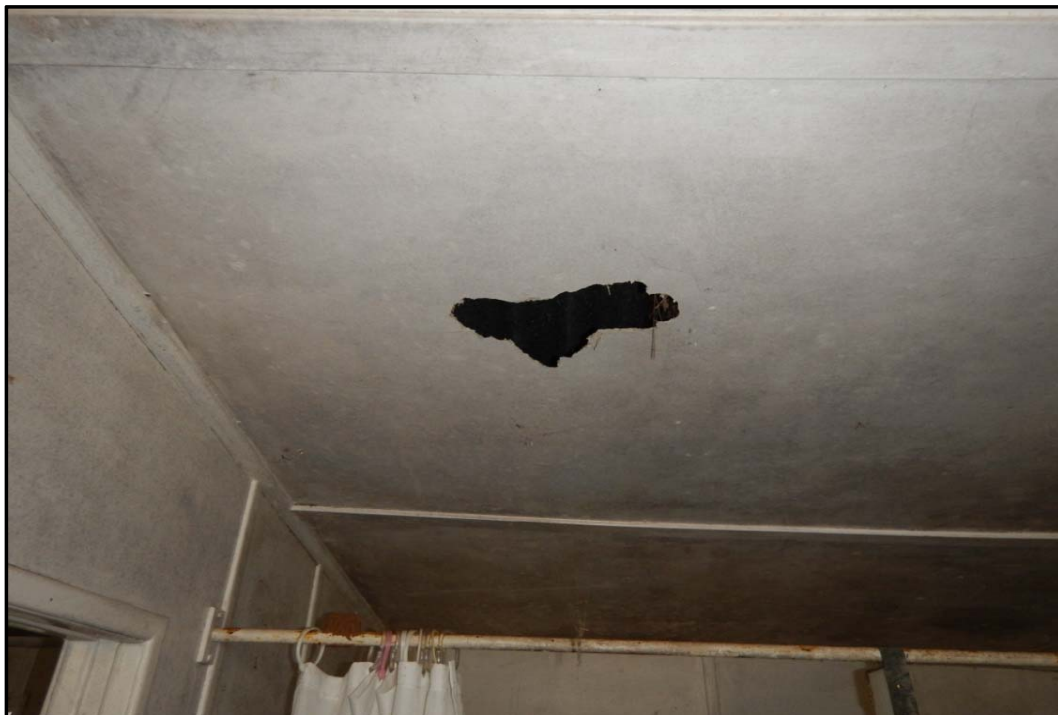
Photo 11: Building 7 - Ceiling sheets in bathroom

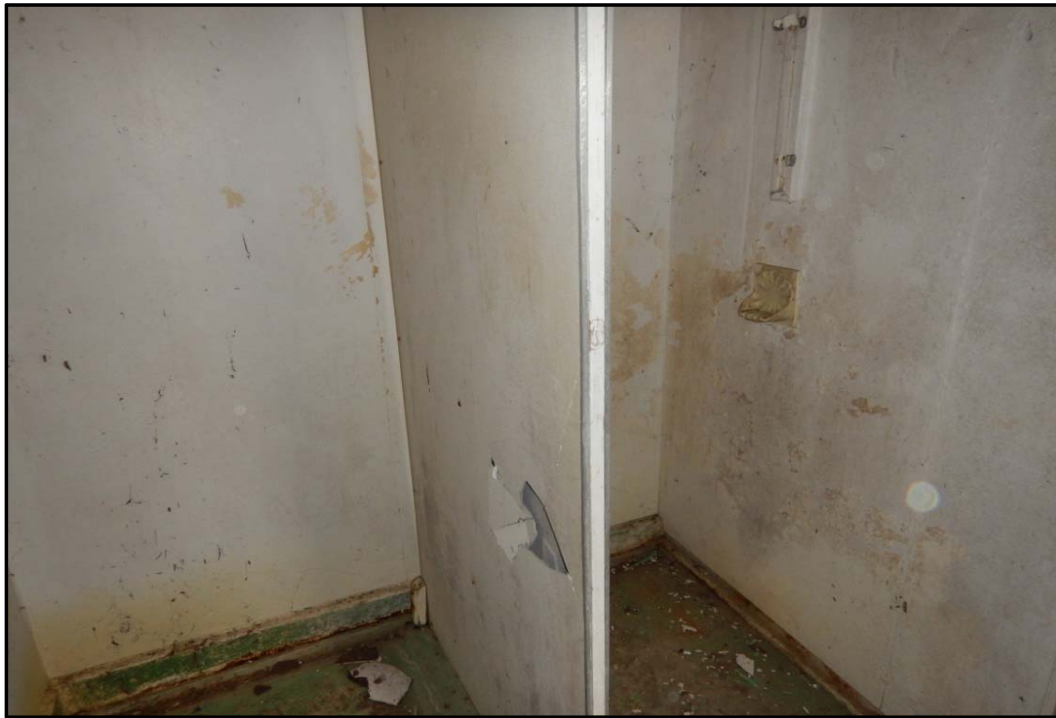
Photo 12: Building 7 - Vertical cement sheeting dividers in shower

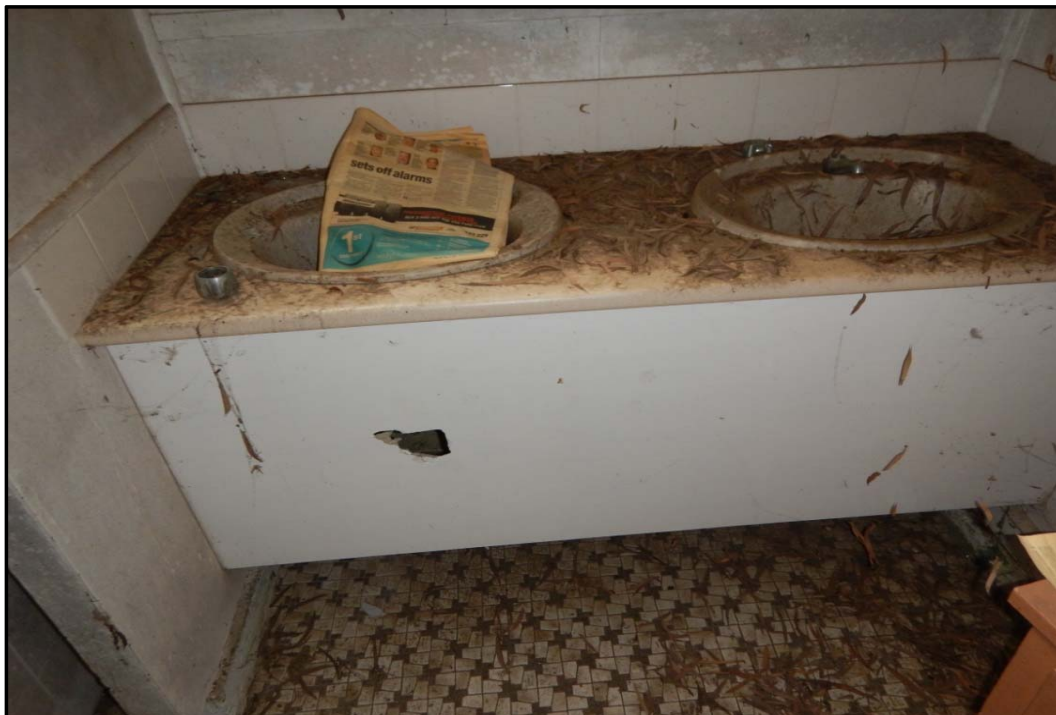
Photo 13: Building 7 - Vertical board in front of sink in bathroom

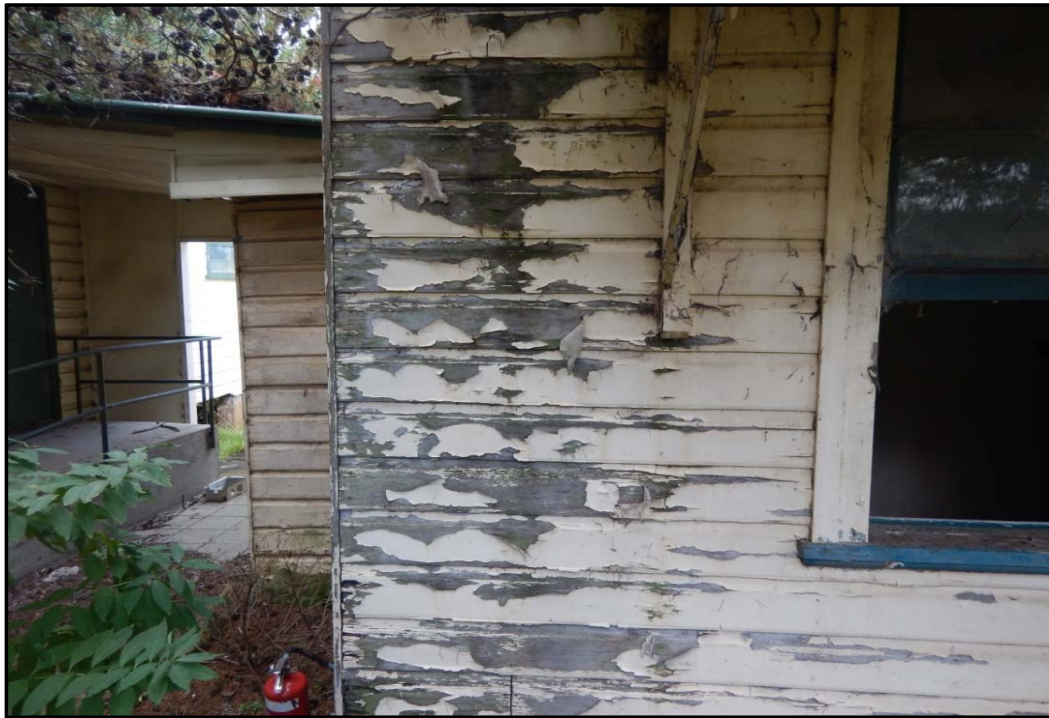
Location and description	Sample ID	% Lead	Photo No.	Recommendation
Building 7				
External cream paint on walls	B7P1	2.2	14	Remove during demolition without discharge to the environment.
External green paint on windows	B7P2	0.3	-	<1.0% Not classified as lead based paint.

Photo 14: Building 7 - Exterior paint

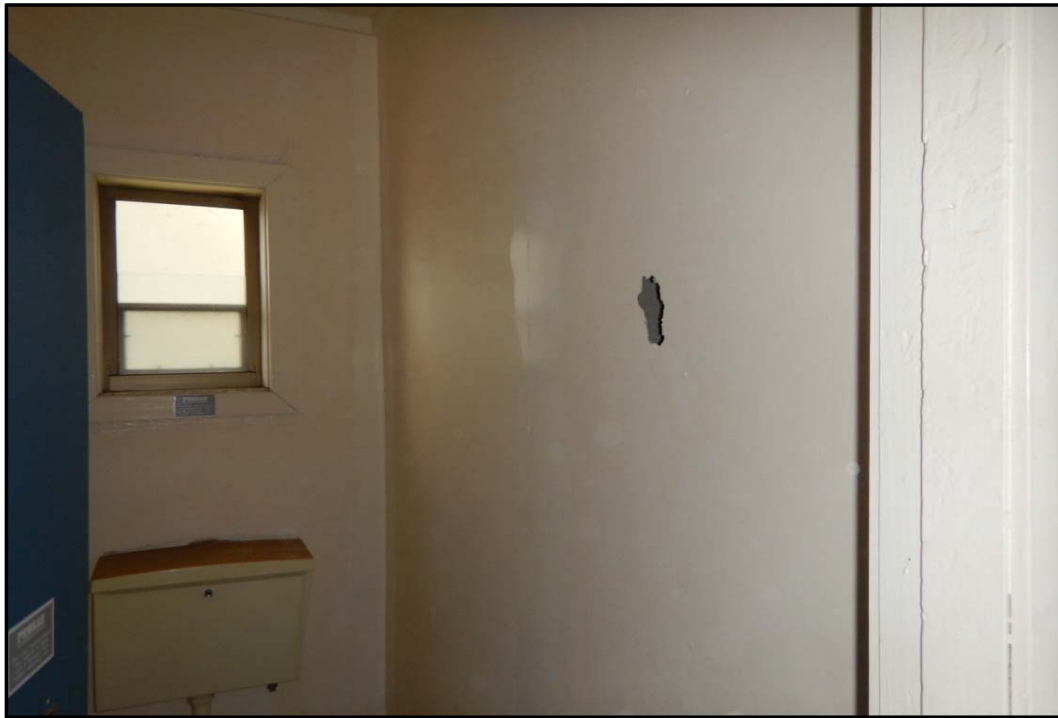
Location Description	Sample No	Photo No	Asbestos Type	Friability Status	Product Type	Extent	Recommendation (A1 - A4)*	Comments / Action
Building 8								
Vertical dividers in toilet and toilet walls	B8A1	15	Chrysotile Amosite	Bonded	Cement Sheeting	~30m ²	A1	Remove prior to any demolition or refurbishment works that may disturb the installation. Should the material not be affected by the works, leave in-situ, affix asbestos warning labels, manage and re-inspect.
Grey vinyl floor tiles in bathroom	B8A2	16	Chrysotile	Bonded	Vinyl Tiles	~6m ²	A1	Remove prior to any demolition or refurbishment works that may disturb the installation. Should the material not be affected by the works, leave in-situ, affix asbestos warning labels, manage and re-inspect.
Light grey vinyl tiles in main bathroom	B8A4	18	Chrysotile	Bonded	Vinyl Tiles	~3m ²	A1	Remove prior to any demolition or refurbishment works that may disturb the installation. Should the material not be affected by the works, leave in-situ, affix asbestos warning labels, manage and re-inspect.

Photo 15: Building 8 - Vertical dividers in toilet and toilet walls

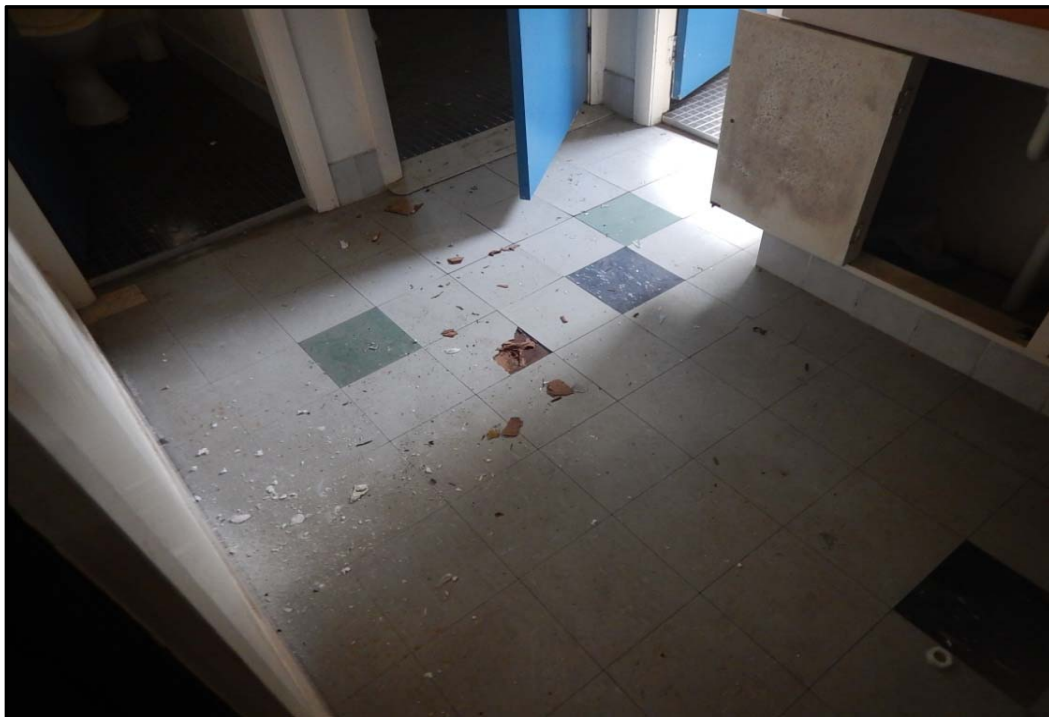
Photo 16: Building 8 - Grey vinyl floor tiles in bathroom

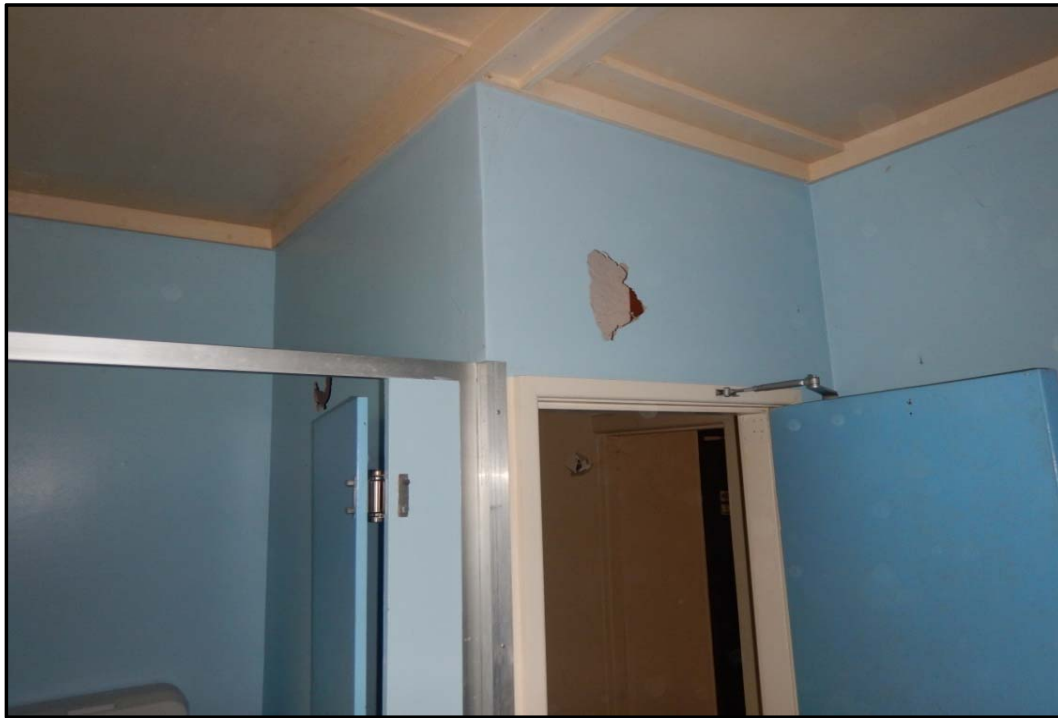
Photo 17: Building 8 - Blue wall sheeting in bathroom

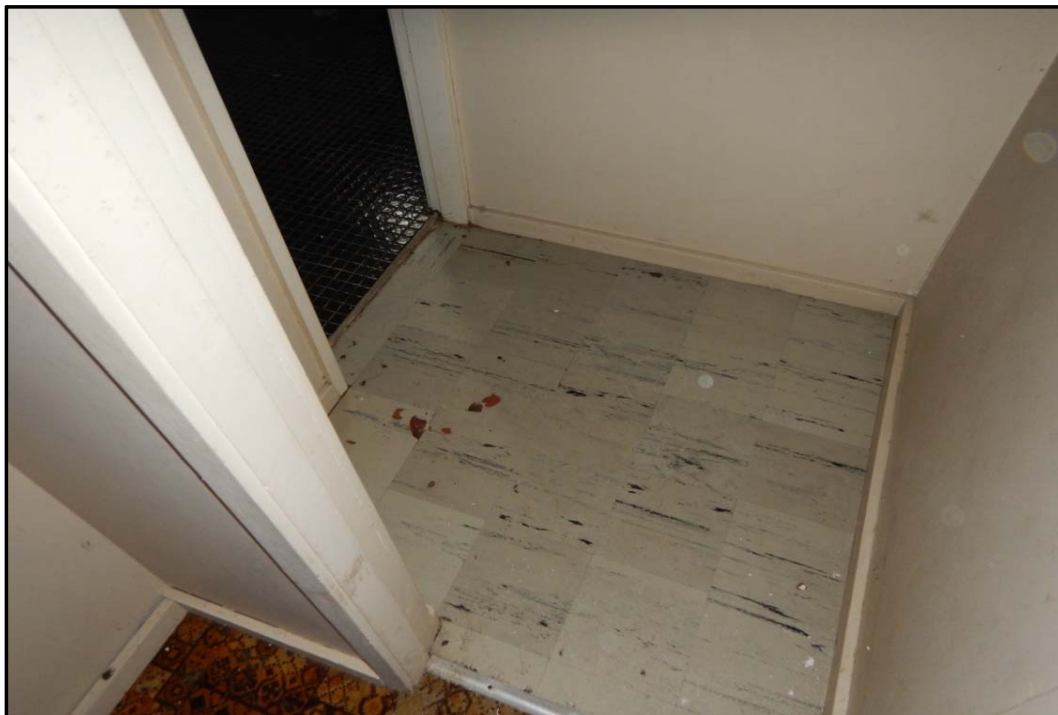
Photo 18: Building 8 - Light grey vinyl tiles in main bathroom

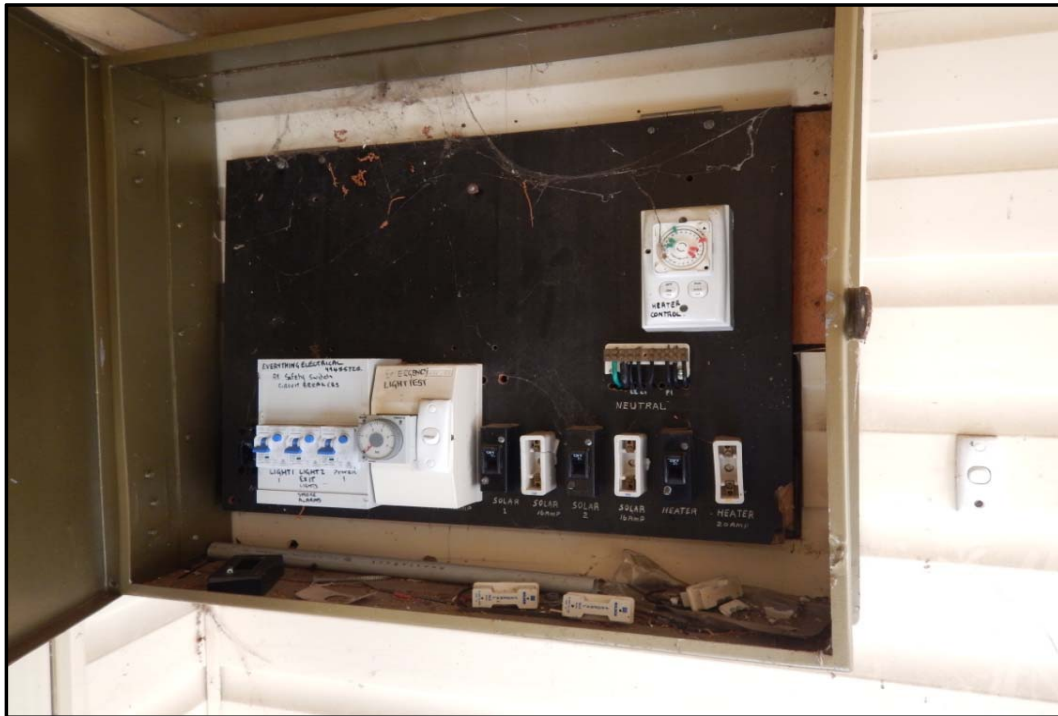
Photo 19: Building 8 - Electrical board

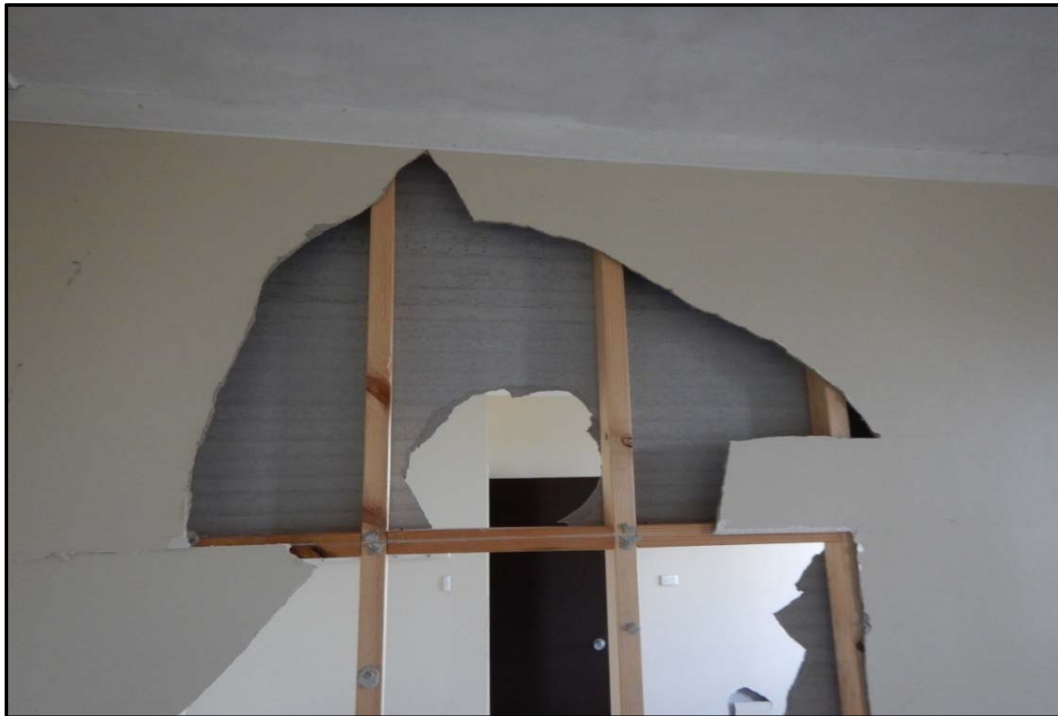
Location Description	Sample No	Photo No	Asbestos Type	Friability Status	Product Type	Extent	Recommendation (A1 - A4)*	Comments / Action
Building 9 – Tillimby House								
Wall sheeting from Room 45 (in all rooms)	B9A1	20	NAD	Bonded	Cement Sheeting	~330m ²	-	-
External eaves around building	B9A2	21	Chrysotile Amosite	Bonded	Cement Sheet	~40m ²	A1	Remove prior to any demolition or refurbishment works that may disturb the installation. Should the material not be affected by the works, leave in-situ, affix asbestos warning labels, manage and re-inspect.
Electrical Board	Visual Assumed	22	Not Known	Bonded	Zelemite	~1m ²	A1	Remove prior to any demolition or refurbishment works that may disturb the installation. Should the material not be affected by the works, leave in-situ, affix asbestos warning labels, manage and re-inspect.
Water Heaters in Roof Space	Visual Assumed	23	Not Known	Bonded	Not known	~5m ²	A1	Remove prior to any demolition or refurbishment works that may disturb the installation. Should the material not be affected by the works, leave in-situ, affix asbestos warning labels, manage and re-inspect.

Photo 20: Building 9 - Wall sheeting in Room 45 (similar in all rooms)

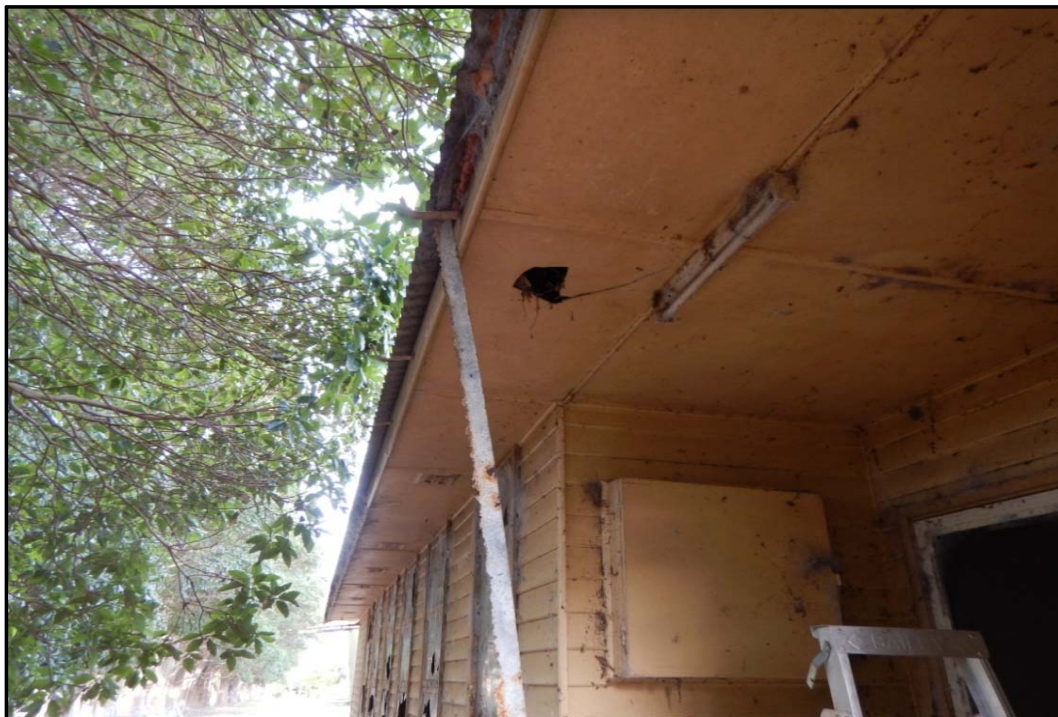
Photo 21: Building 9 - External eaves around building

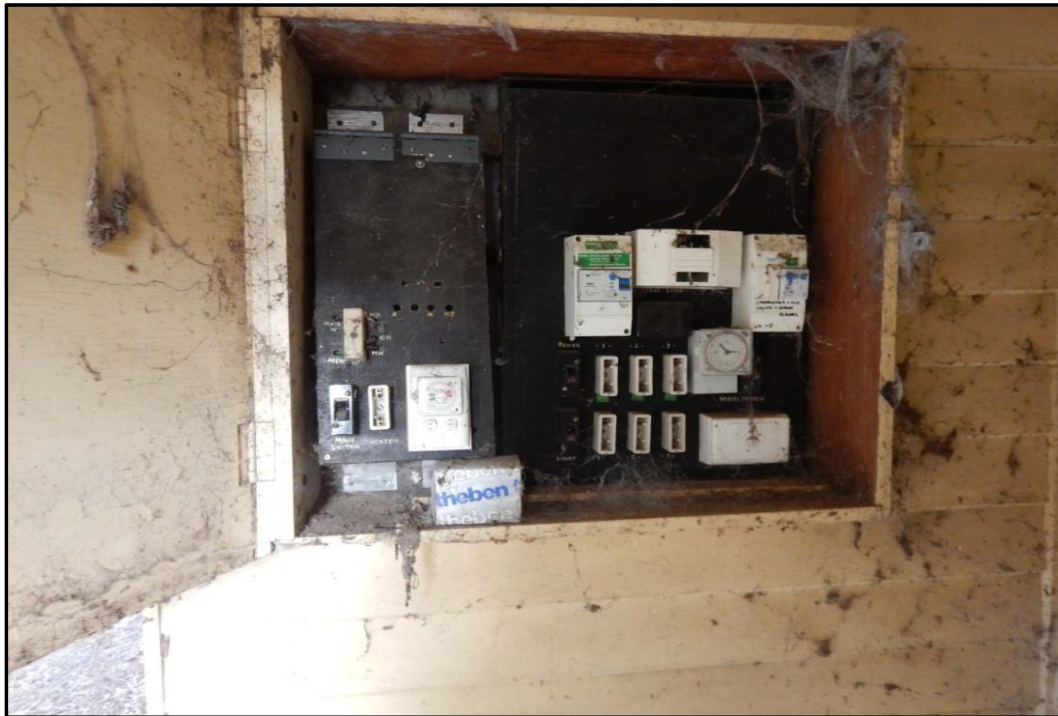
Photo 22: Building 9 - Electrical board

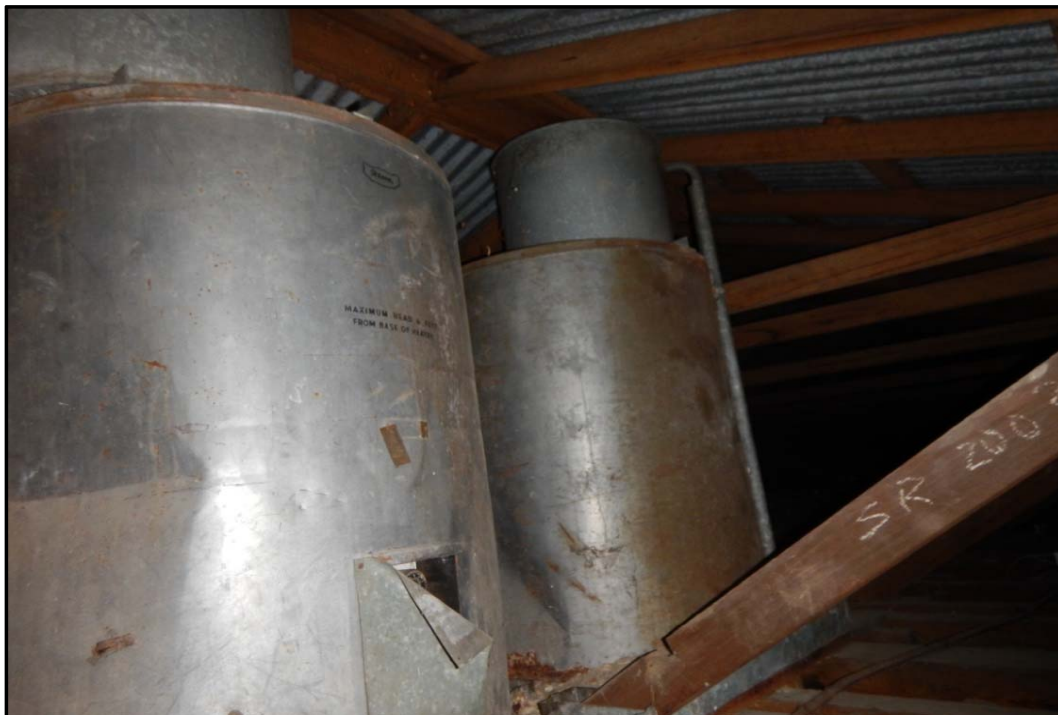
Photo 23: Building 9 - Water Heater in roof space

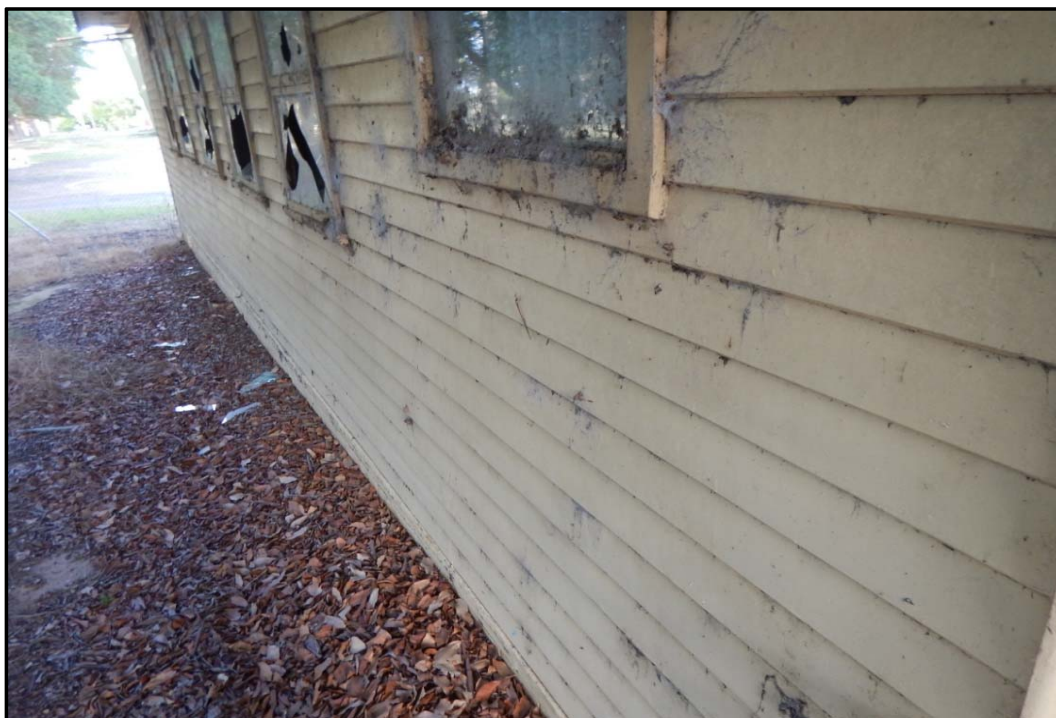
Location and description	Sample ID	% Lead	Photo No.	Recommendation
Building 9 – Tillimby House				
Light yellow / cream external paint on walls	B9P1	3.9	24	Lead based paint.
Dark yellow paint on window frames and sills	B9P2	<0.05	25	<1.0% Not classified as lead based paint.

Photo 24: Building 9 - Light yellow / cream exterior paint

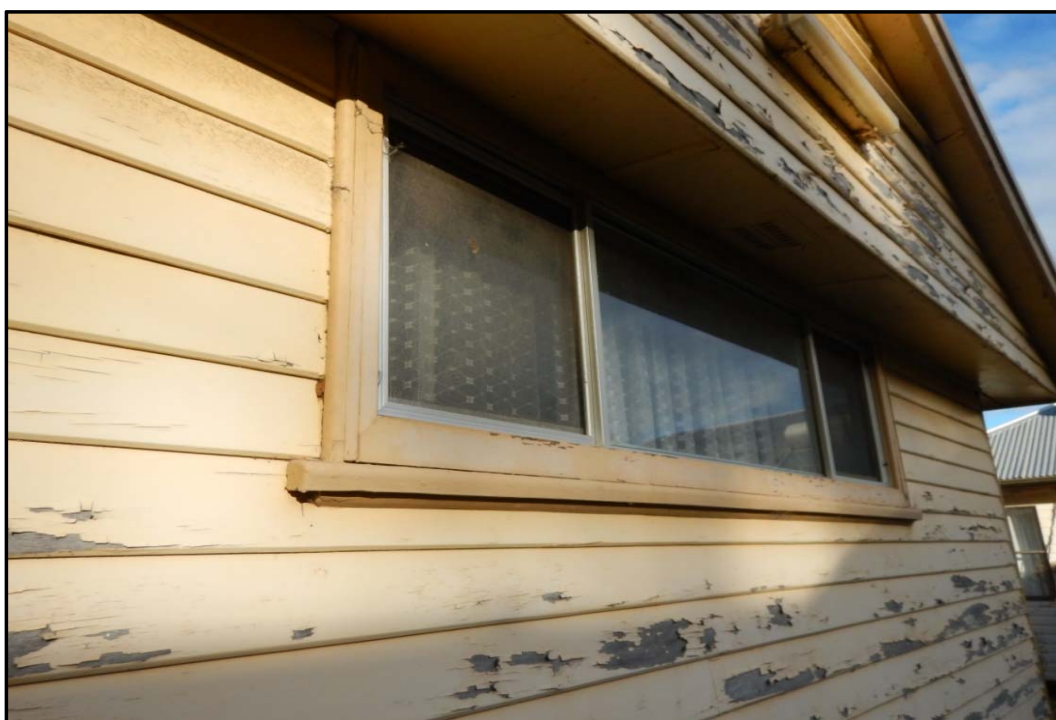
Photo 25: Building 9 - Dark yellow paint on window frames and sills
