Report on  
Geotechnical Assessment, Preliminary Site  
Investigation (Contamination) and  
Salinity Investigation

North Shearwater Residential Subdivision,  
Stages 2 and 3  
Durness Station, Viney Creek Road, Tea Gardens

Prepared for  
Wolin Investments Pty Ltd

Project 81259.01  
June 2018

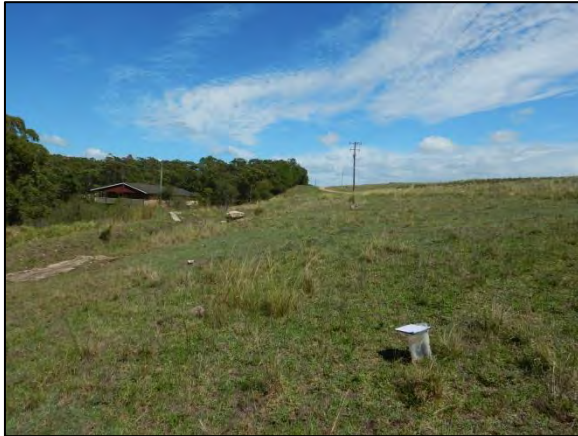
**Figure 2: View looking west from Pit 201**

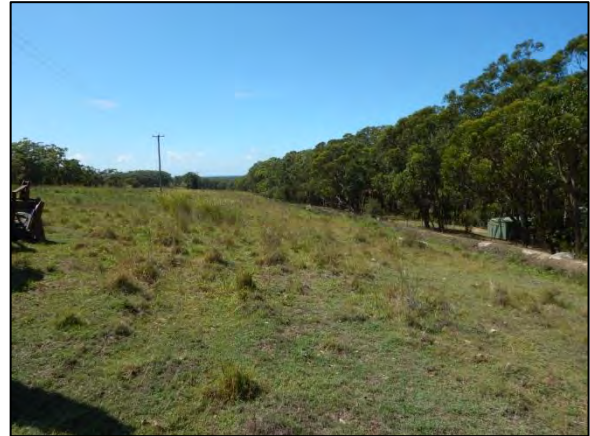
**Figure 3: View looking east from Pit 201**

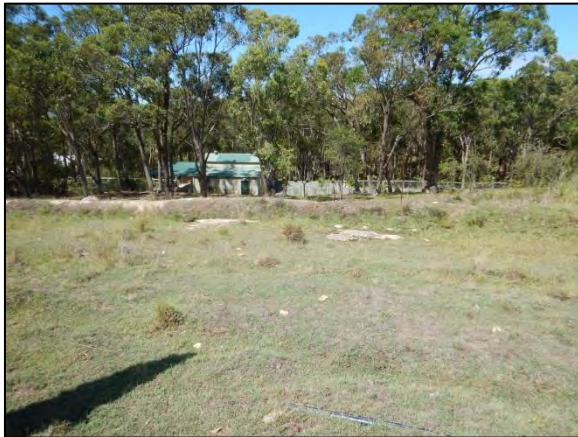
A surface water diversion drain had been cut into the ground surface along the southern boundary with the excavated spoil stockpiled downslope to catch and divert surface water. The base of the diversion drain exposed bedrock along the full length.

**Figure 4: View south towards diversion drain**

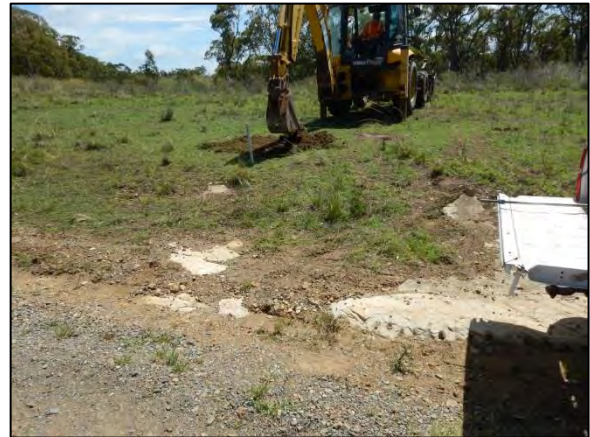
**Figure 5: Rock outcrop near Pit 202**

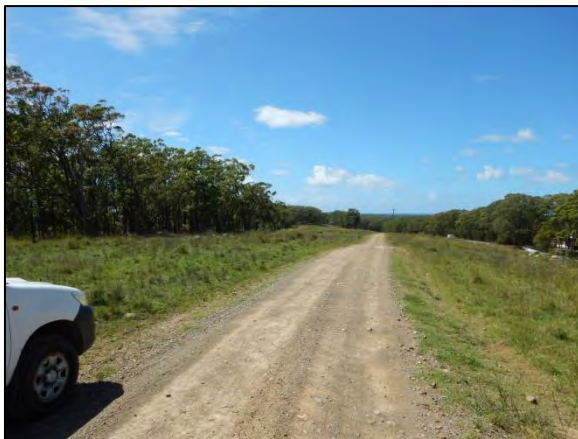
**Figure 6: View east along gravel road**

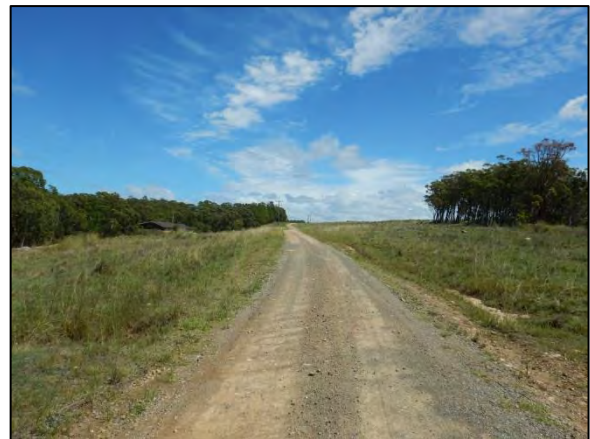
**Figure 7: View west along gravel road**

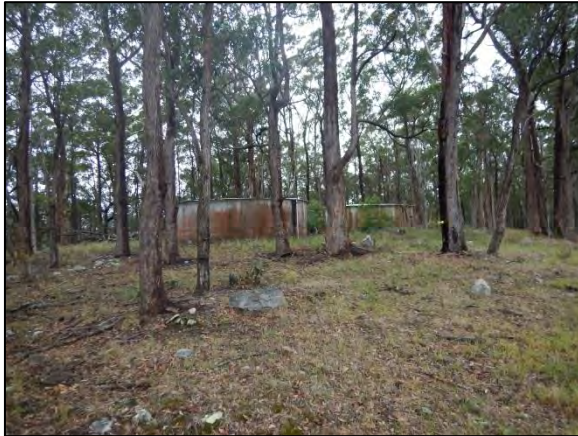
**Figure 8: View of existing water tanks at eastern extent of Stage 2**

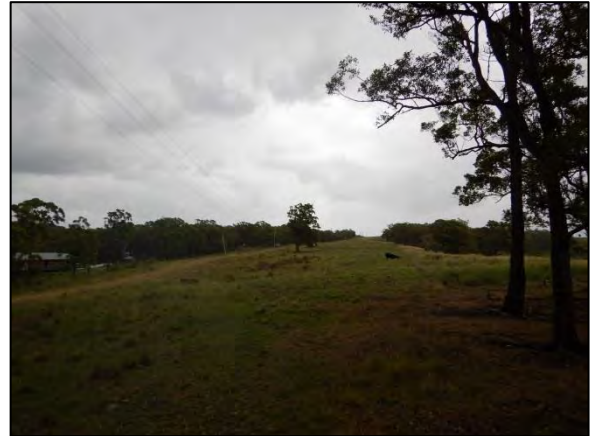
**Figure 9: View west from eastern extent of Stage 2**

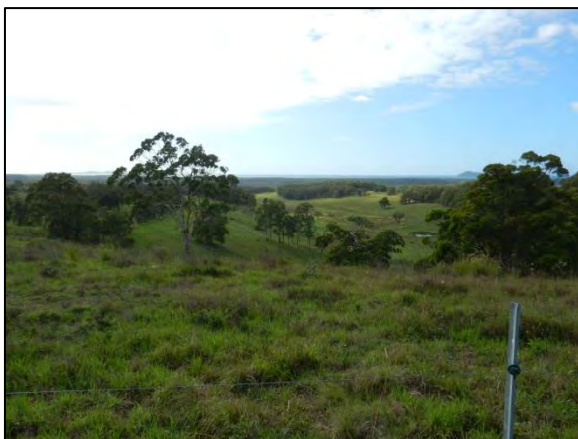
**Figure 10: View east from eastern extent of Stage 1**

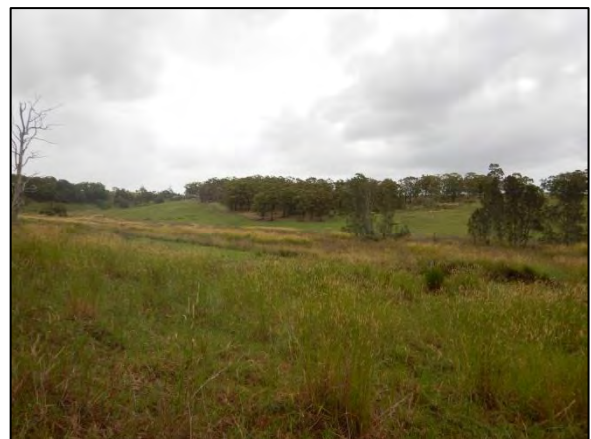
**Figure 11: View west from southern extent of Stage 3**

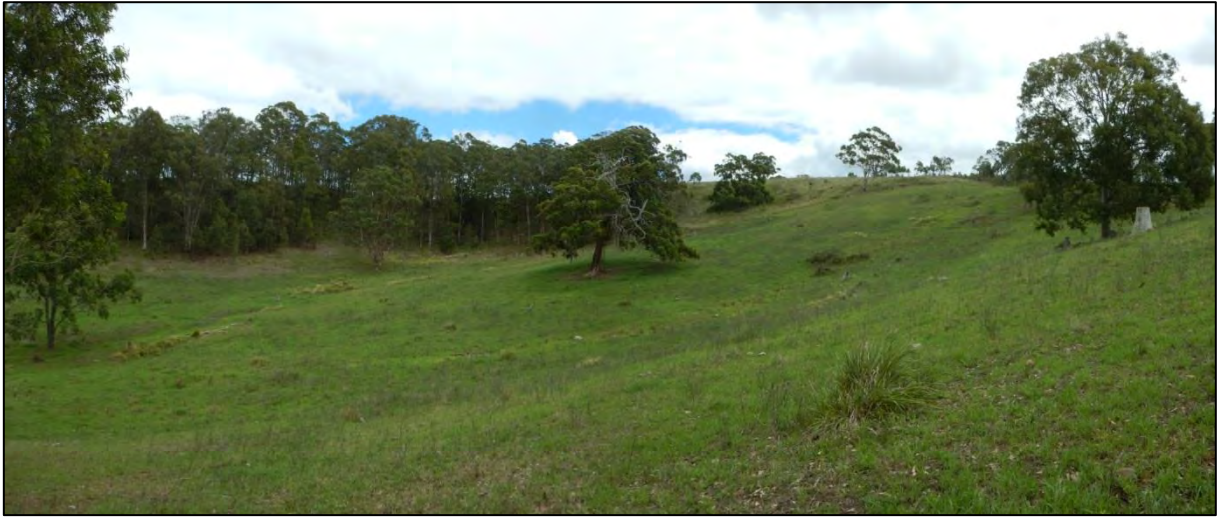
**Figure 12: View west towards steep slope at extent of Stage 1**

Hazard 1 relates to the slow creep of the shallow soil on the steeper slopes within the western and north-western parts of the Stage 3 area. It has been assessed as 'unlikely'. The consequences of creep to the residential development proposed for Stage 3 would be 'minor' provided the footings for the structures are founded on rock. It is noted that bedrock was encountered at depths ranging from 0.25 m to 1.5 m (Lots 301 to 330) in the pits excavated within these lots.

Hazard 2 relates to a slope failure of the soil and rock on the steeper slope within western and north western part of the Stage 3 area. It has been assessed to be 'rare' owing to geological / geomorphology setting of the site, the presence of shallow residual soils of stiff to very stiff consistency and the presence of bedrock at depths of about 0.5 m in Stage 1. The consequences of a deep seated failure, would be 'major' as reconstruction costs would be expected to be about 60% of the value of the development.

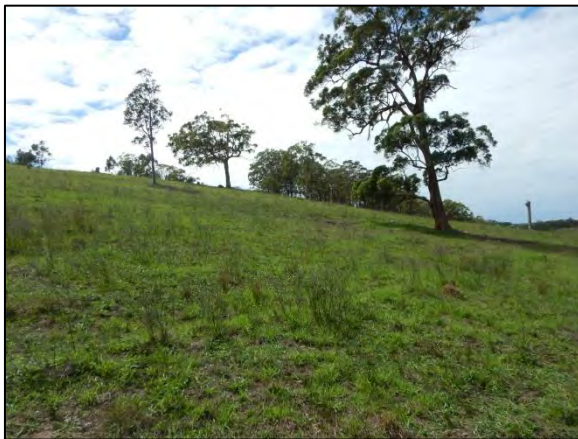
**Figure 13: View east across slope on Stage 3**

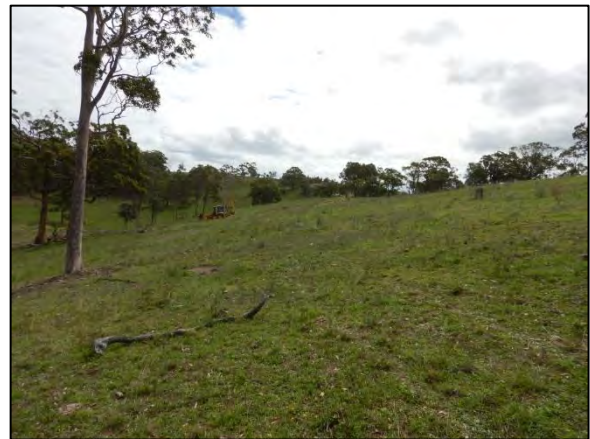
**Figure 14: View west from Pit 319**
