Report on
Geotechnical Investigation

Proposed Aged Care Development
Scaysbrook Drive, Kincumber

Prepared for
Lend Lease Building Pty Ltd

Project 91006.00
November 2016

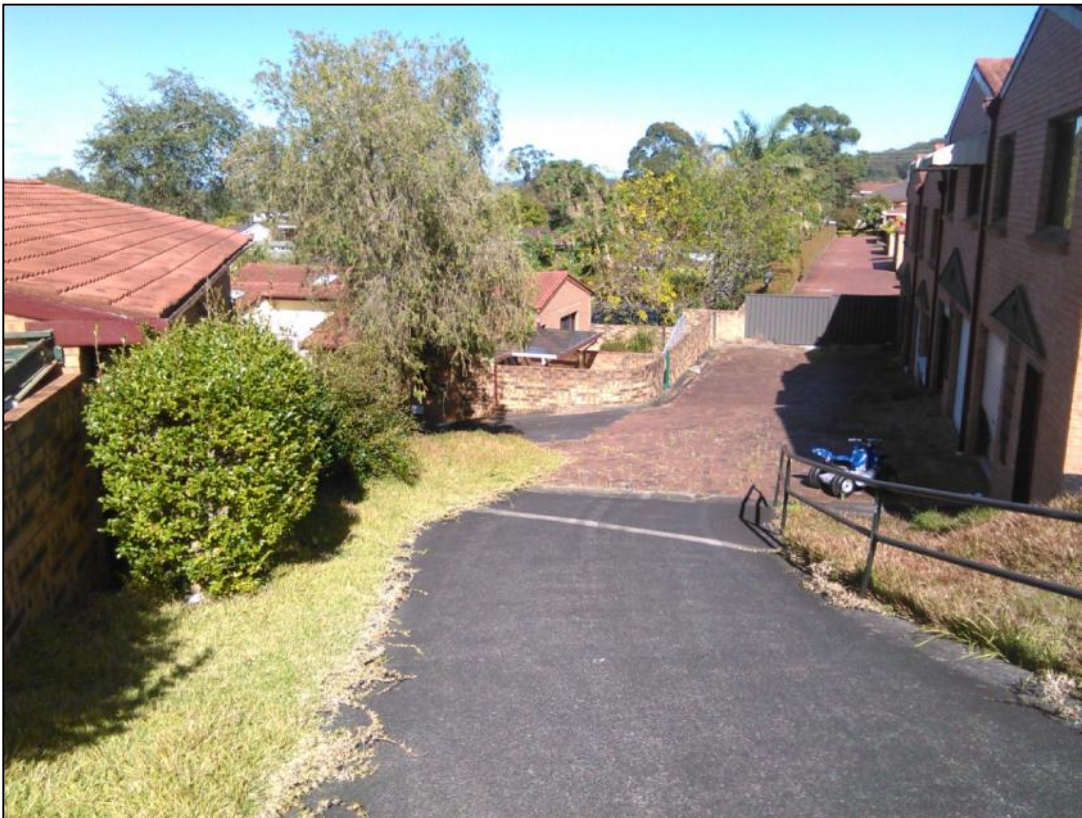
The site slopes down generally towards the south west, with some of the dwellings within the western area of the site located on terraced areas which have been formed by cutting into the hillside. The terraced areas are stepped in multiple levels with retaining walls up to approximately 2 m in height.

Figure 4: Facing west from near Bore 2, showing site slope and retaining walls

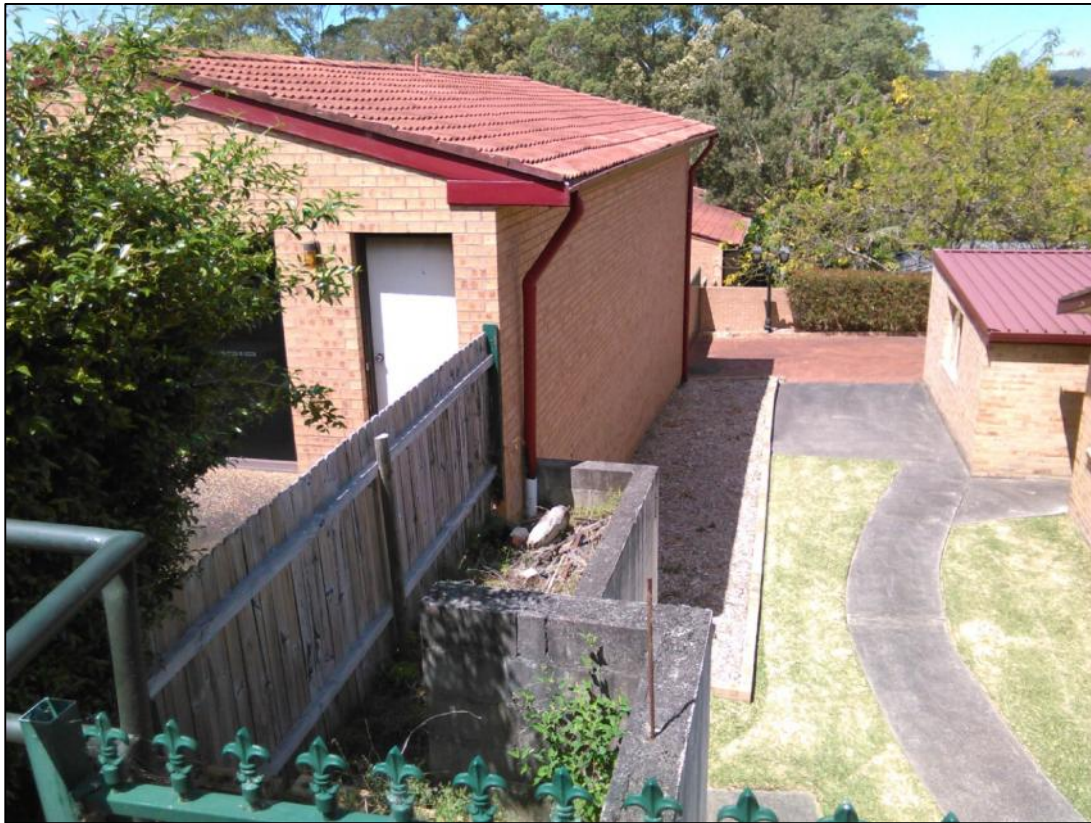
An existing block retaining wall up to approximately 3 m in height is located along the western boundary of site. The retaining wall is stepped in multiple levels down towards the south. Residential buildings are located within several metres of the alignment of this wall.

Figure 5: Facing south from near Bore 1 along western boundary, showing existing retaining walls

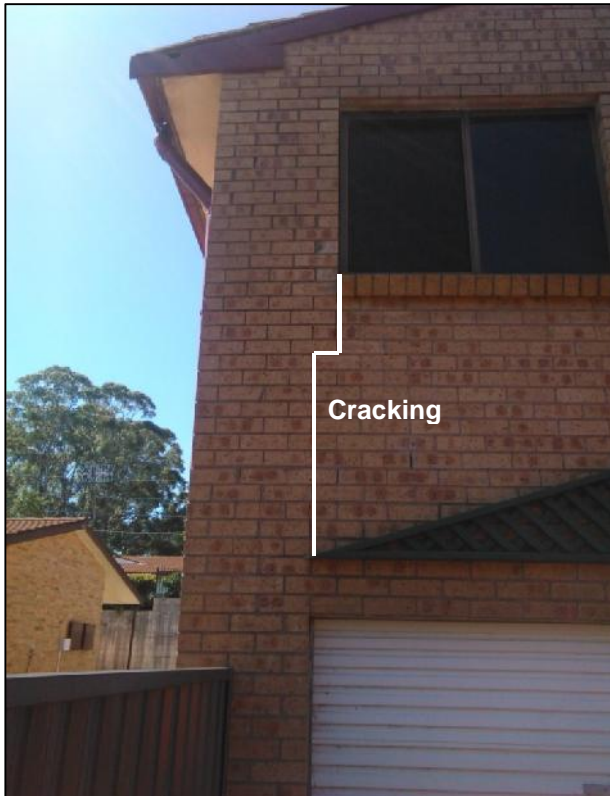
Cracking was observed in the brickwork in some of the existing buildings on the western side of the site, particularly around window edges and within the lower courses of brickwork. Articulation joints were not observed on the damaged buildings at these locations.

Figure 6: Facing north from near Bore 8, showing cracking in existing building beneath window edge

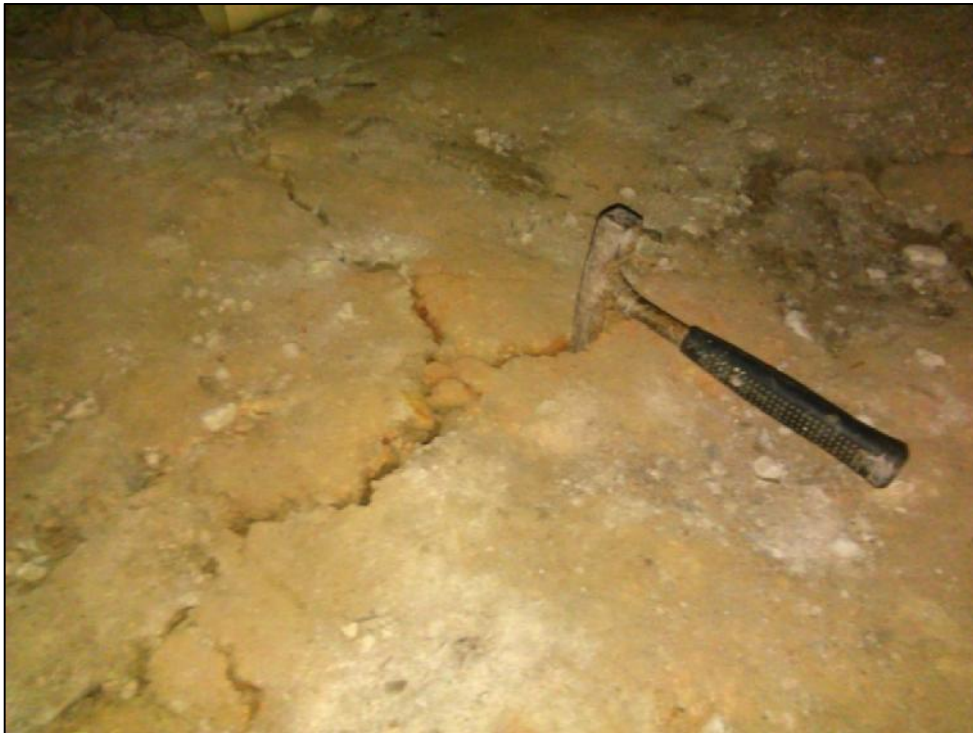
Clay soils were observed within cuttings observed beneath buildings in the western part of the site, at locations shown as Observation 1 and 2 on the Test Location Plan in Appendix D. Tension cracks with an aperture of about 15 mm were observed within the clay soils of the cutting at Observation 1, possibly indicative of reactive soils. A slip failure of the cutting was observed in the clay soils at Observation 2.

Figure 7: Facing north beneath building near Bore 8 (Observation 1) showing soil cracking

It is noted that cracking was observed in existing building brickwork onsite and tension cracking of the clay soils was observed beneath a building in the north west part of the site, as outlined in Section 2. This indicates that reactive soils are likely present.

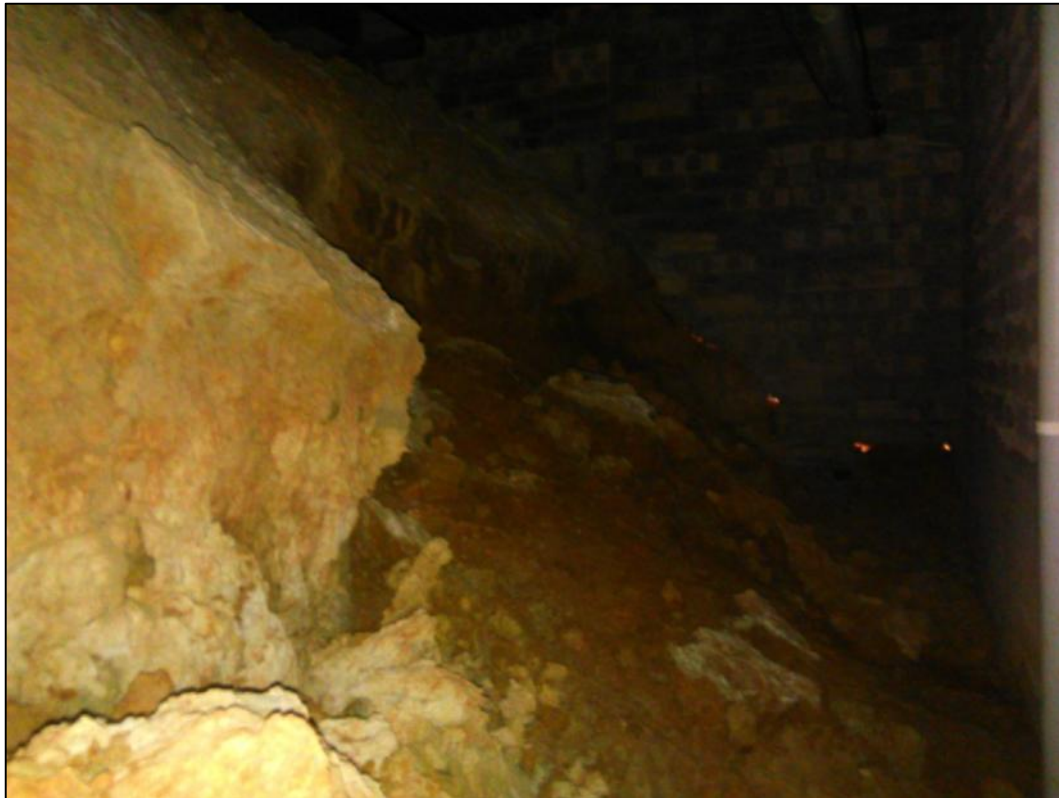
Figure 8: Facing south east at slip failure beneath building in western part of site (Observation 2)
