ARBORICULTURAL IMPACT REPORT

290 AVOCA DRIVE
KINCUMBER

REVISED REPORT 25TH OCTOBER 2019

PREPARED FOR LEND LEASE PTY LTD

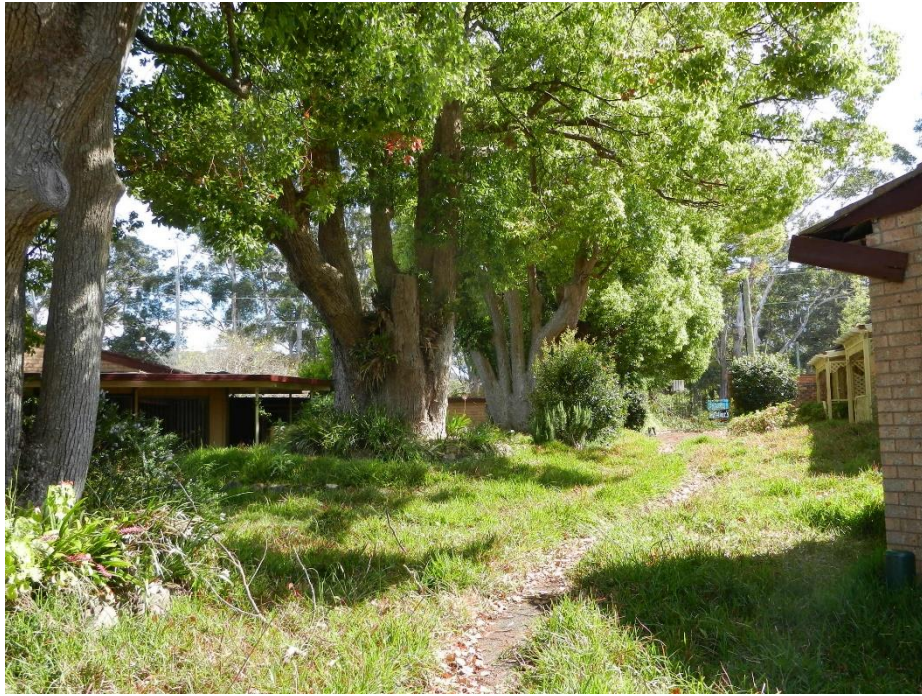
Photograph 1: Tree #s 8 to 10 – Illustrating their location and context.

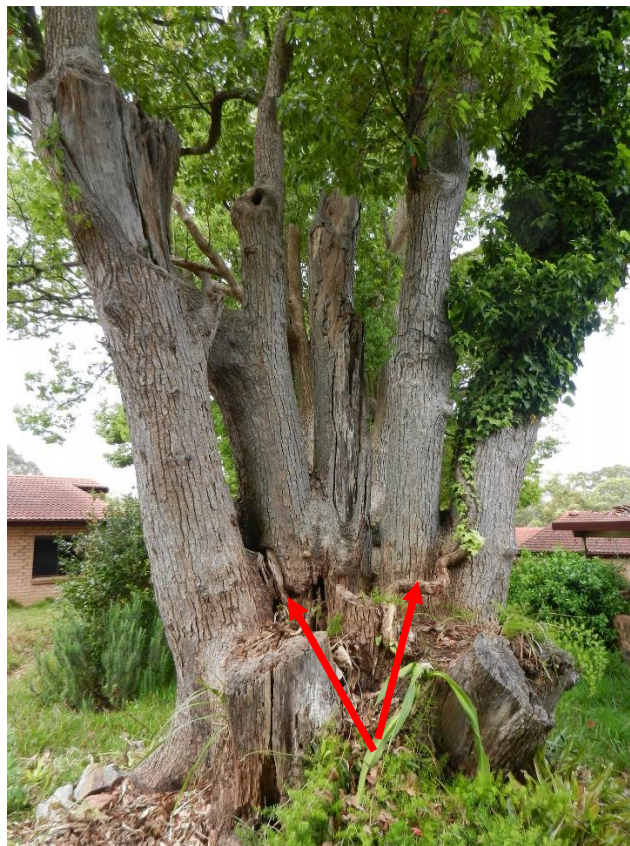
Photograph 2: Tree # 10 – Illustrating the structural issues of trees 7 to 11.

10	<i>Cinnamomum camphora</i> (Camphor Laurel)	18	11 x 16	Up to 1000 (1200 x 2000 above root flare)	1600	1600	Fair foliage condition	Mature	Multi trunked	Upright trunk	Majority of canopy on an east x west axis	Lower limbs pruned in past to 3 meres, upper canopy reduction pruned in past	Appears stable	Fair to poor branch attachment	Moderate health	Poor vigour	10 to 15%	No visual evidence of significant pest or disease	3 Short (5 to 15 years)	Environmental pest species of high visual significance	4	The tree displays fair branch attachment with multiple leaders and poorly attached regrowth following severe past pruning - not considered at risk of failure in the short term. At the time of inspection the tree was of moderate health and poor vigour and exhibited reduced foliage density, moderate to high levels of dieback and epicormic growth. Environmental pest species of high visual significance.

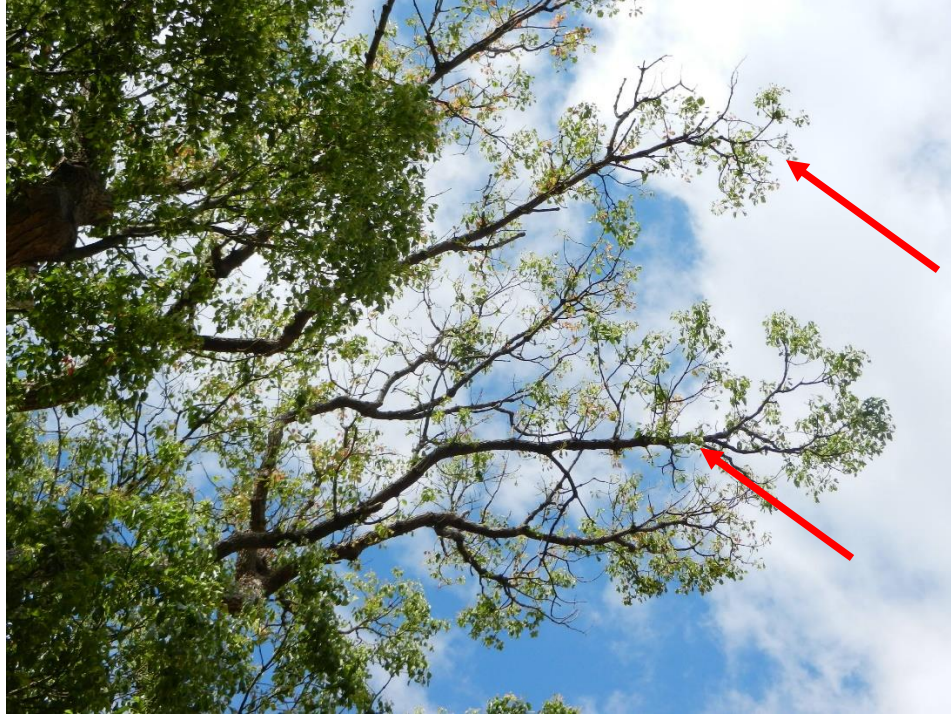
Photograph 3: Tree #s 8 to 10 – Illustrating the declining vigour.

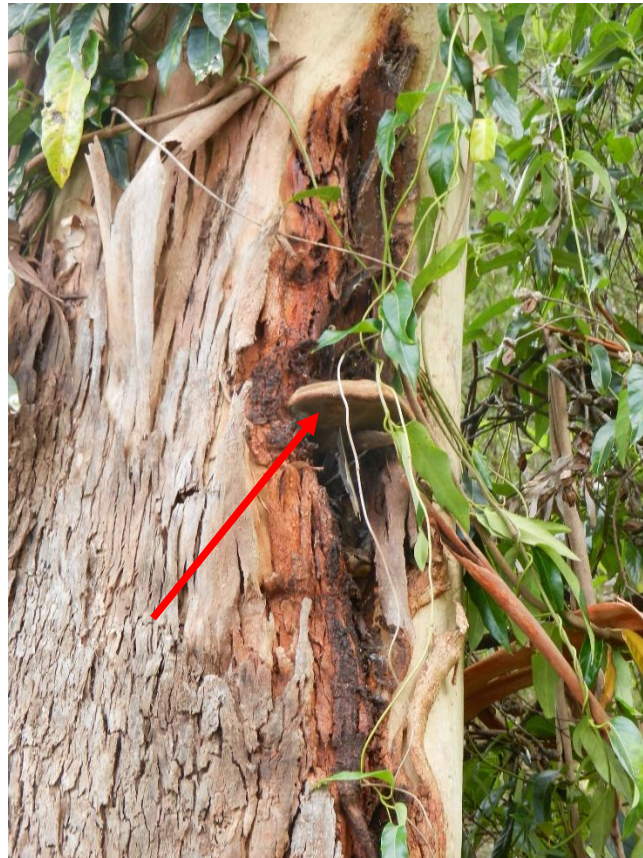
Photograph 4: Tree # 34 – Illustrating past wounding and decay entry with fruiting body (*Phellinus spp.*) at 3 metres on SE.

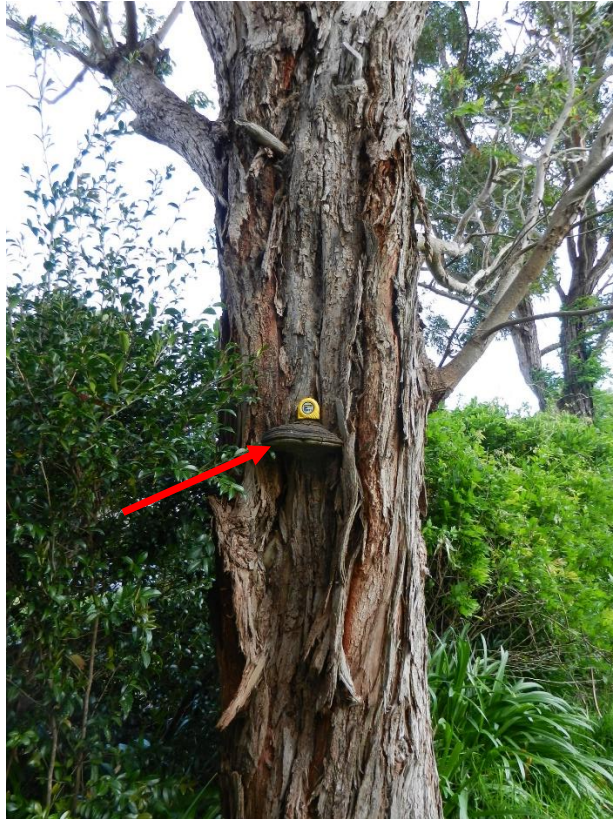
Photograph 5: Tree # 62 – Illustrating past wounding to 3.5 metres with evidence of extensive decay in lower trunk (*Phellinus spp.* fruiting body at 1.6 metres on east side).

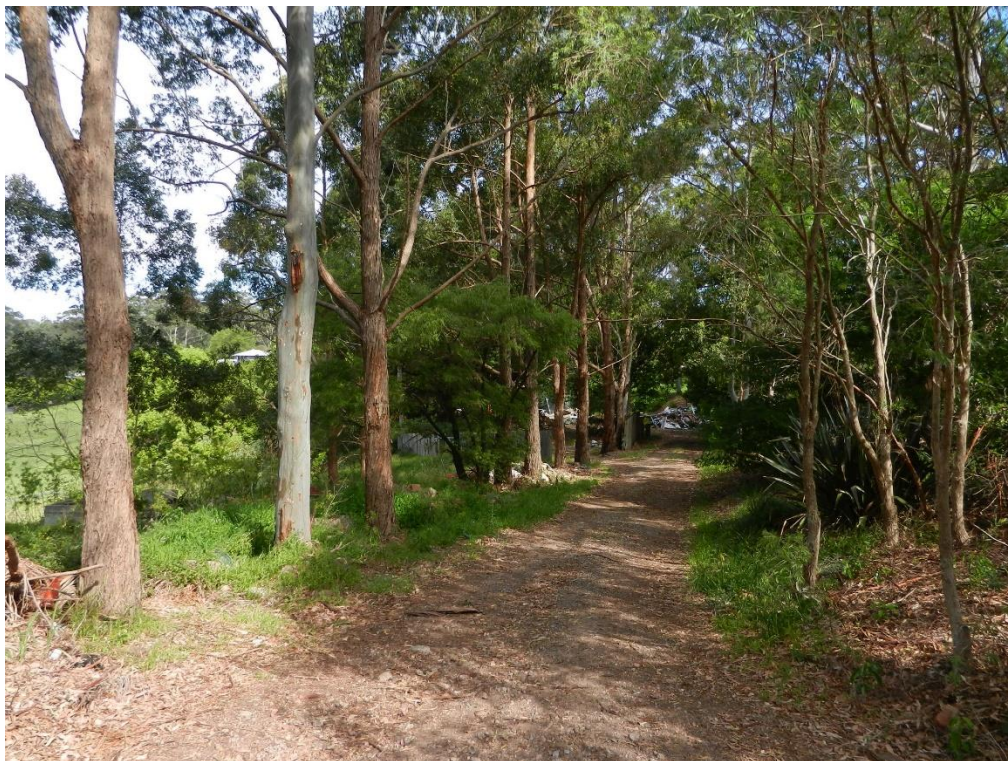
Photograph 6: Illustrating the informal access road within the site and trees 28-33

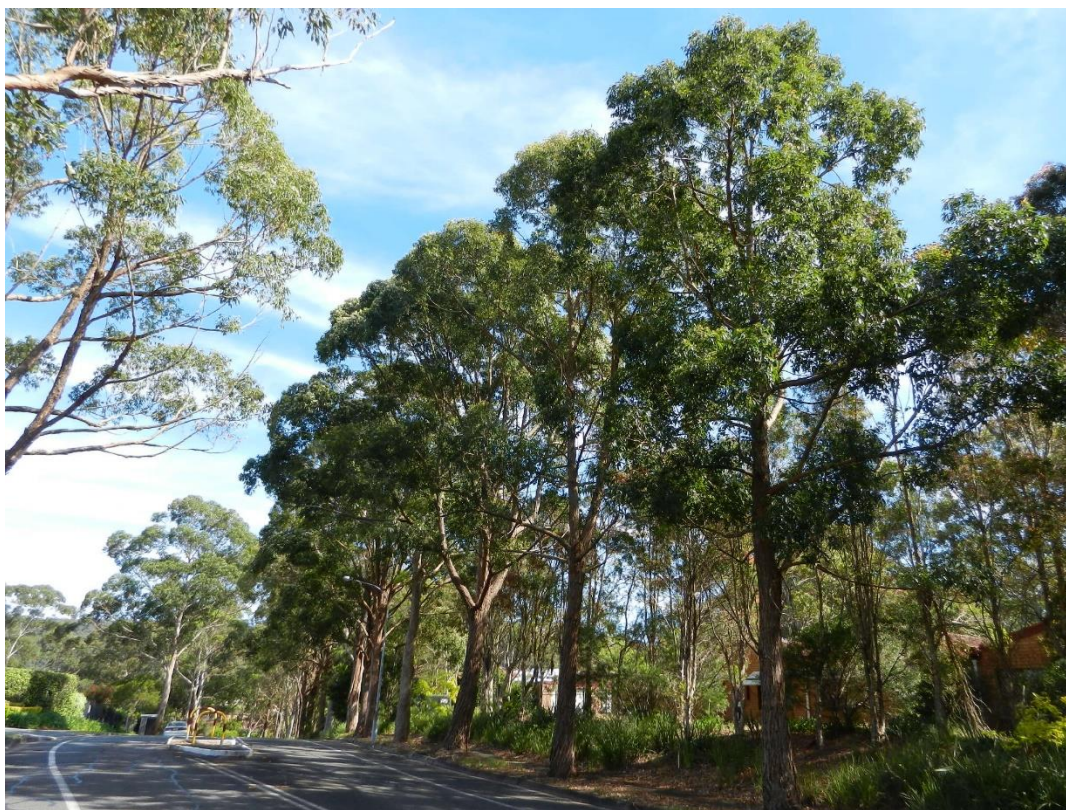
Photograph 9: Illustrating the trees on the street frontage of the site (Trees 83-91).
