Report on
Mine Subsidence Investigation

Proposed Seniors Living Development
Corner of Wilton Drive and Mount Vincent Drive, East
Maitland

Project 81879.00
July 2016

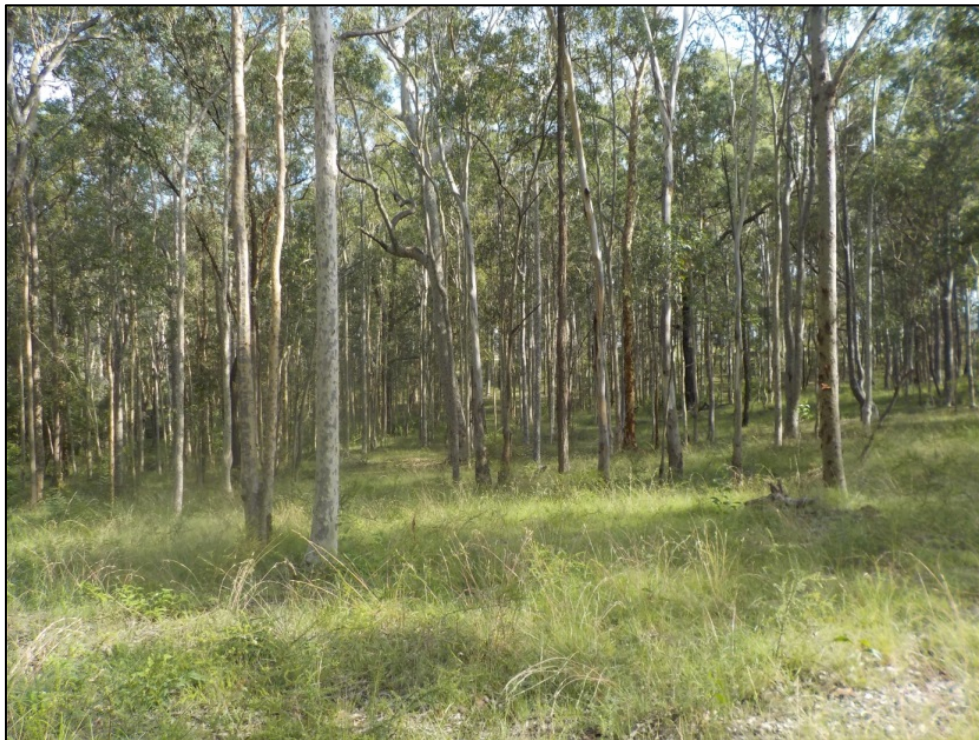
Figure 1: Site facing north-west from south east corner of site

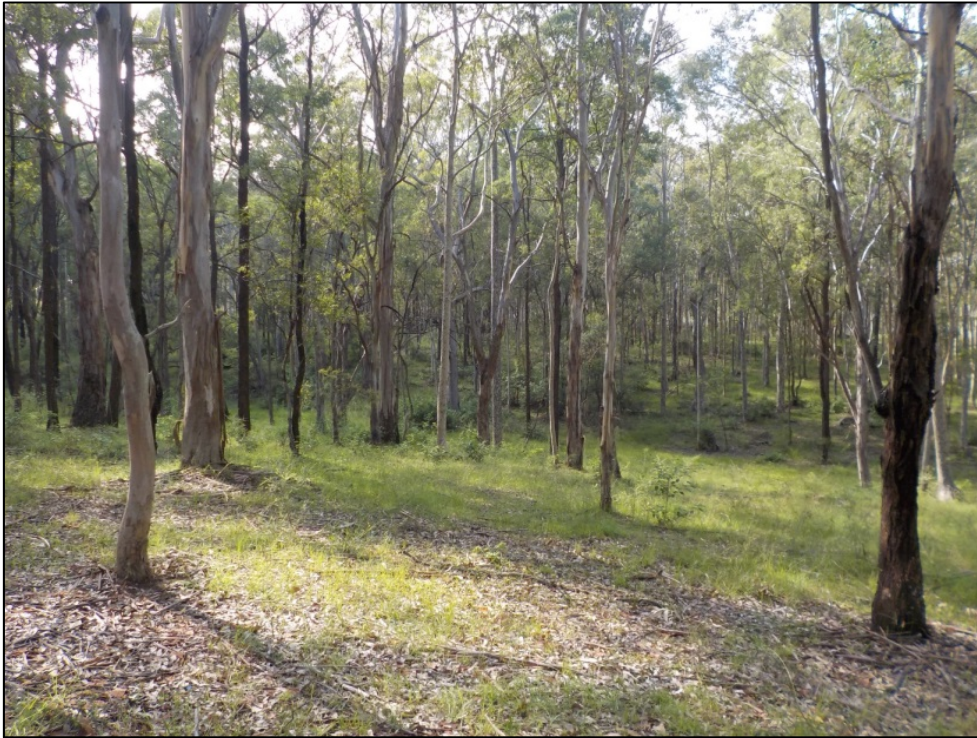
Figure 2: Site facing east from central part of site

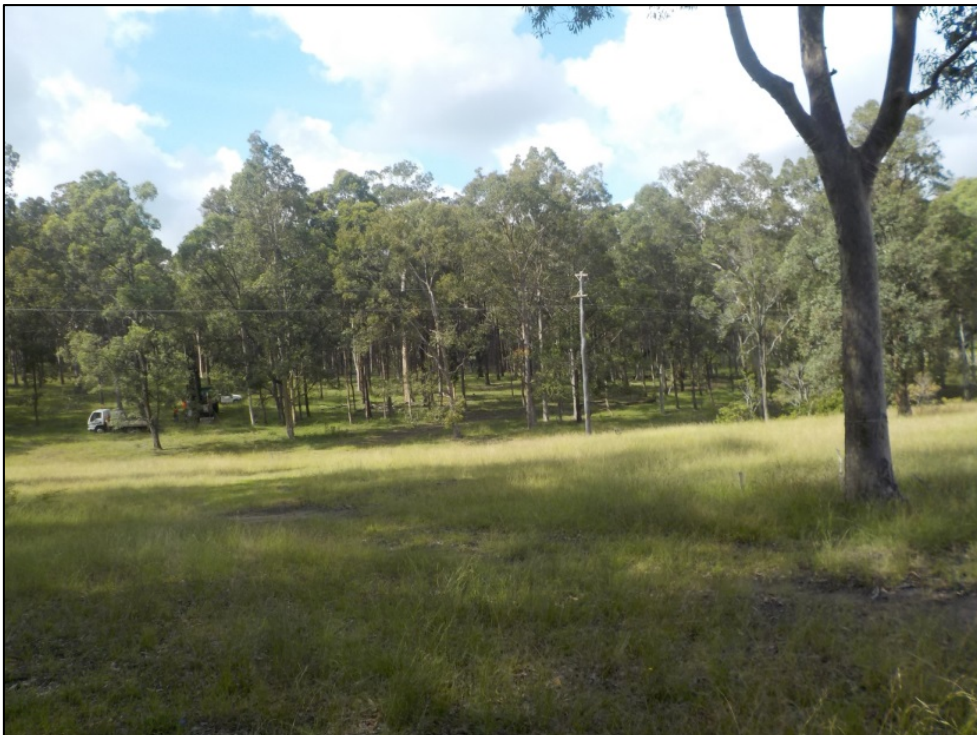
Figure 3: Site facing south east from near adjacent Lot 8

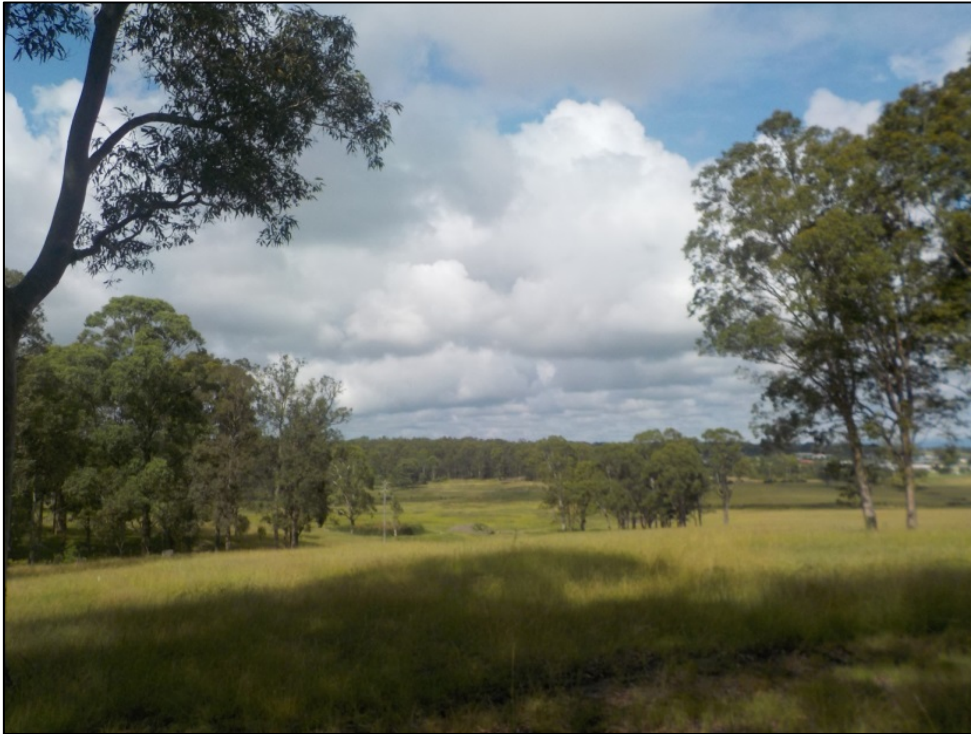
Figure 4: Site facing south west from near the adjacent Lot 8

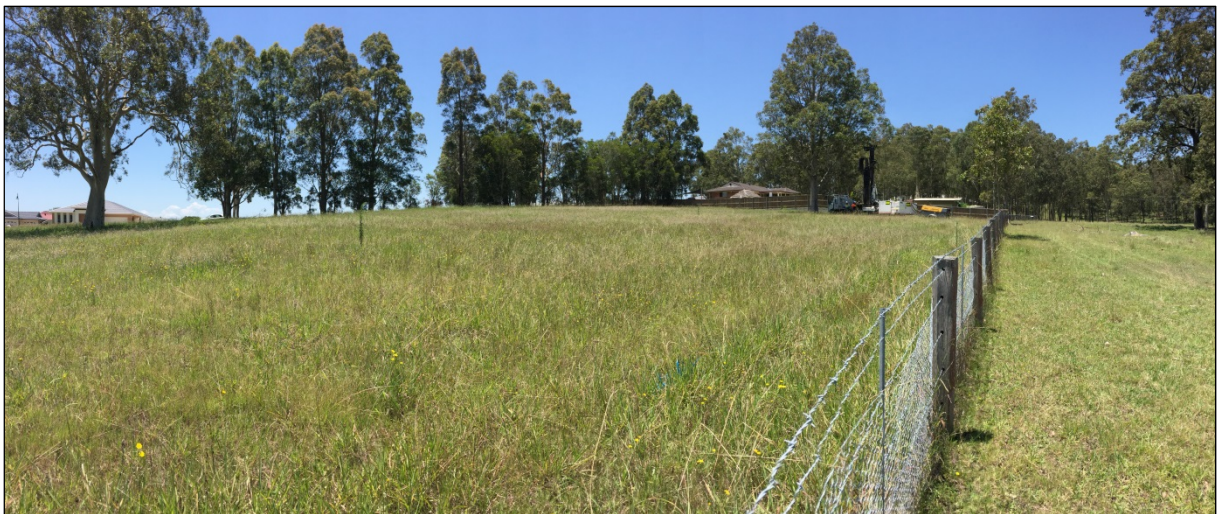
Figure 5: Lot 8 facing north east from south western corner of Lot 8.

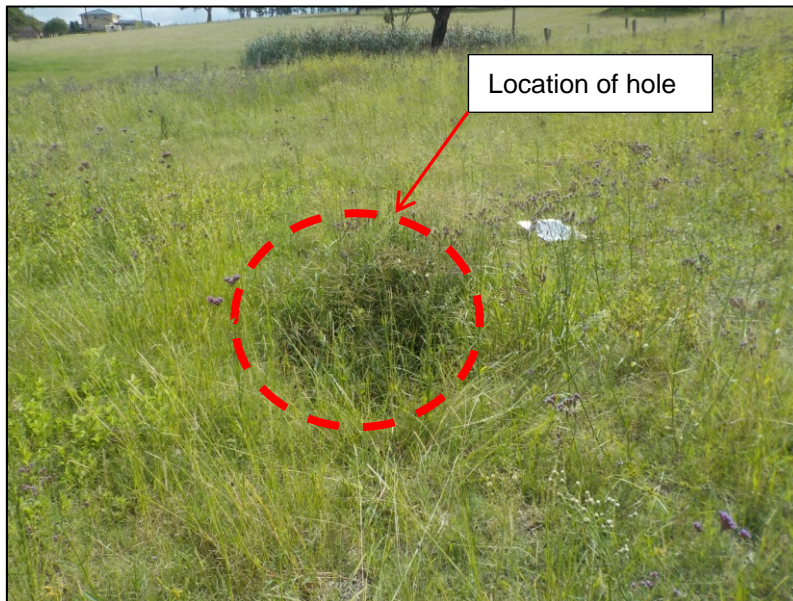
A hole was observed on the neighbouring property to the south of the site. The location of the hole is shown on the attached Test Location Plan and is shown in Figure 7 below.

Figure 7: Hole observed at surface of neighbouring property. The hole diameter was approximately 2 m. The location of the hole coincides with the approximate location of the “Tunnel Mouth” as shown on RT603

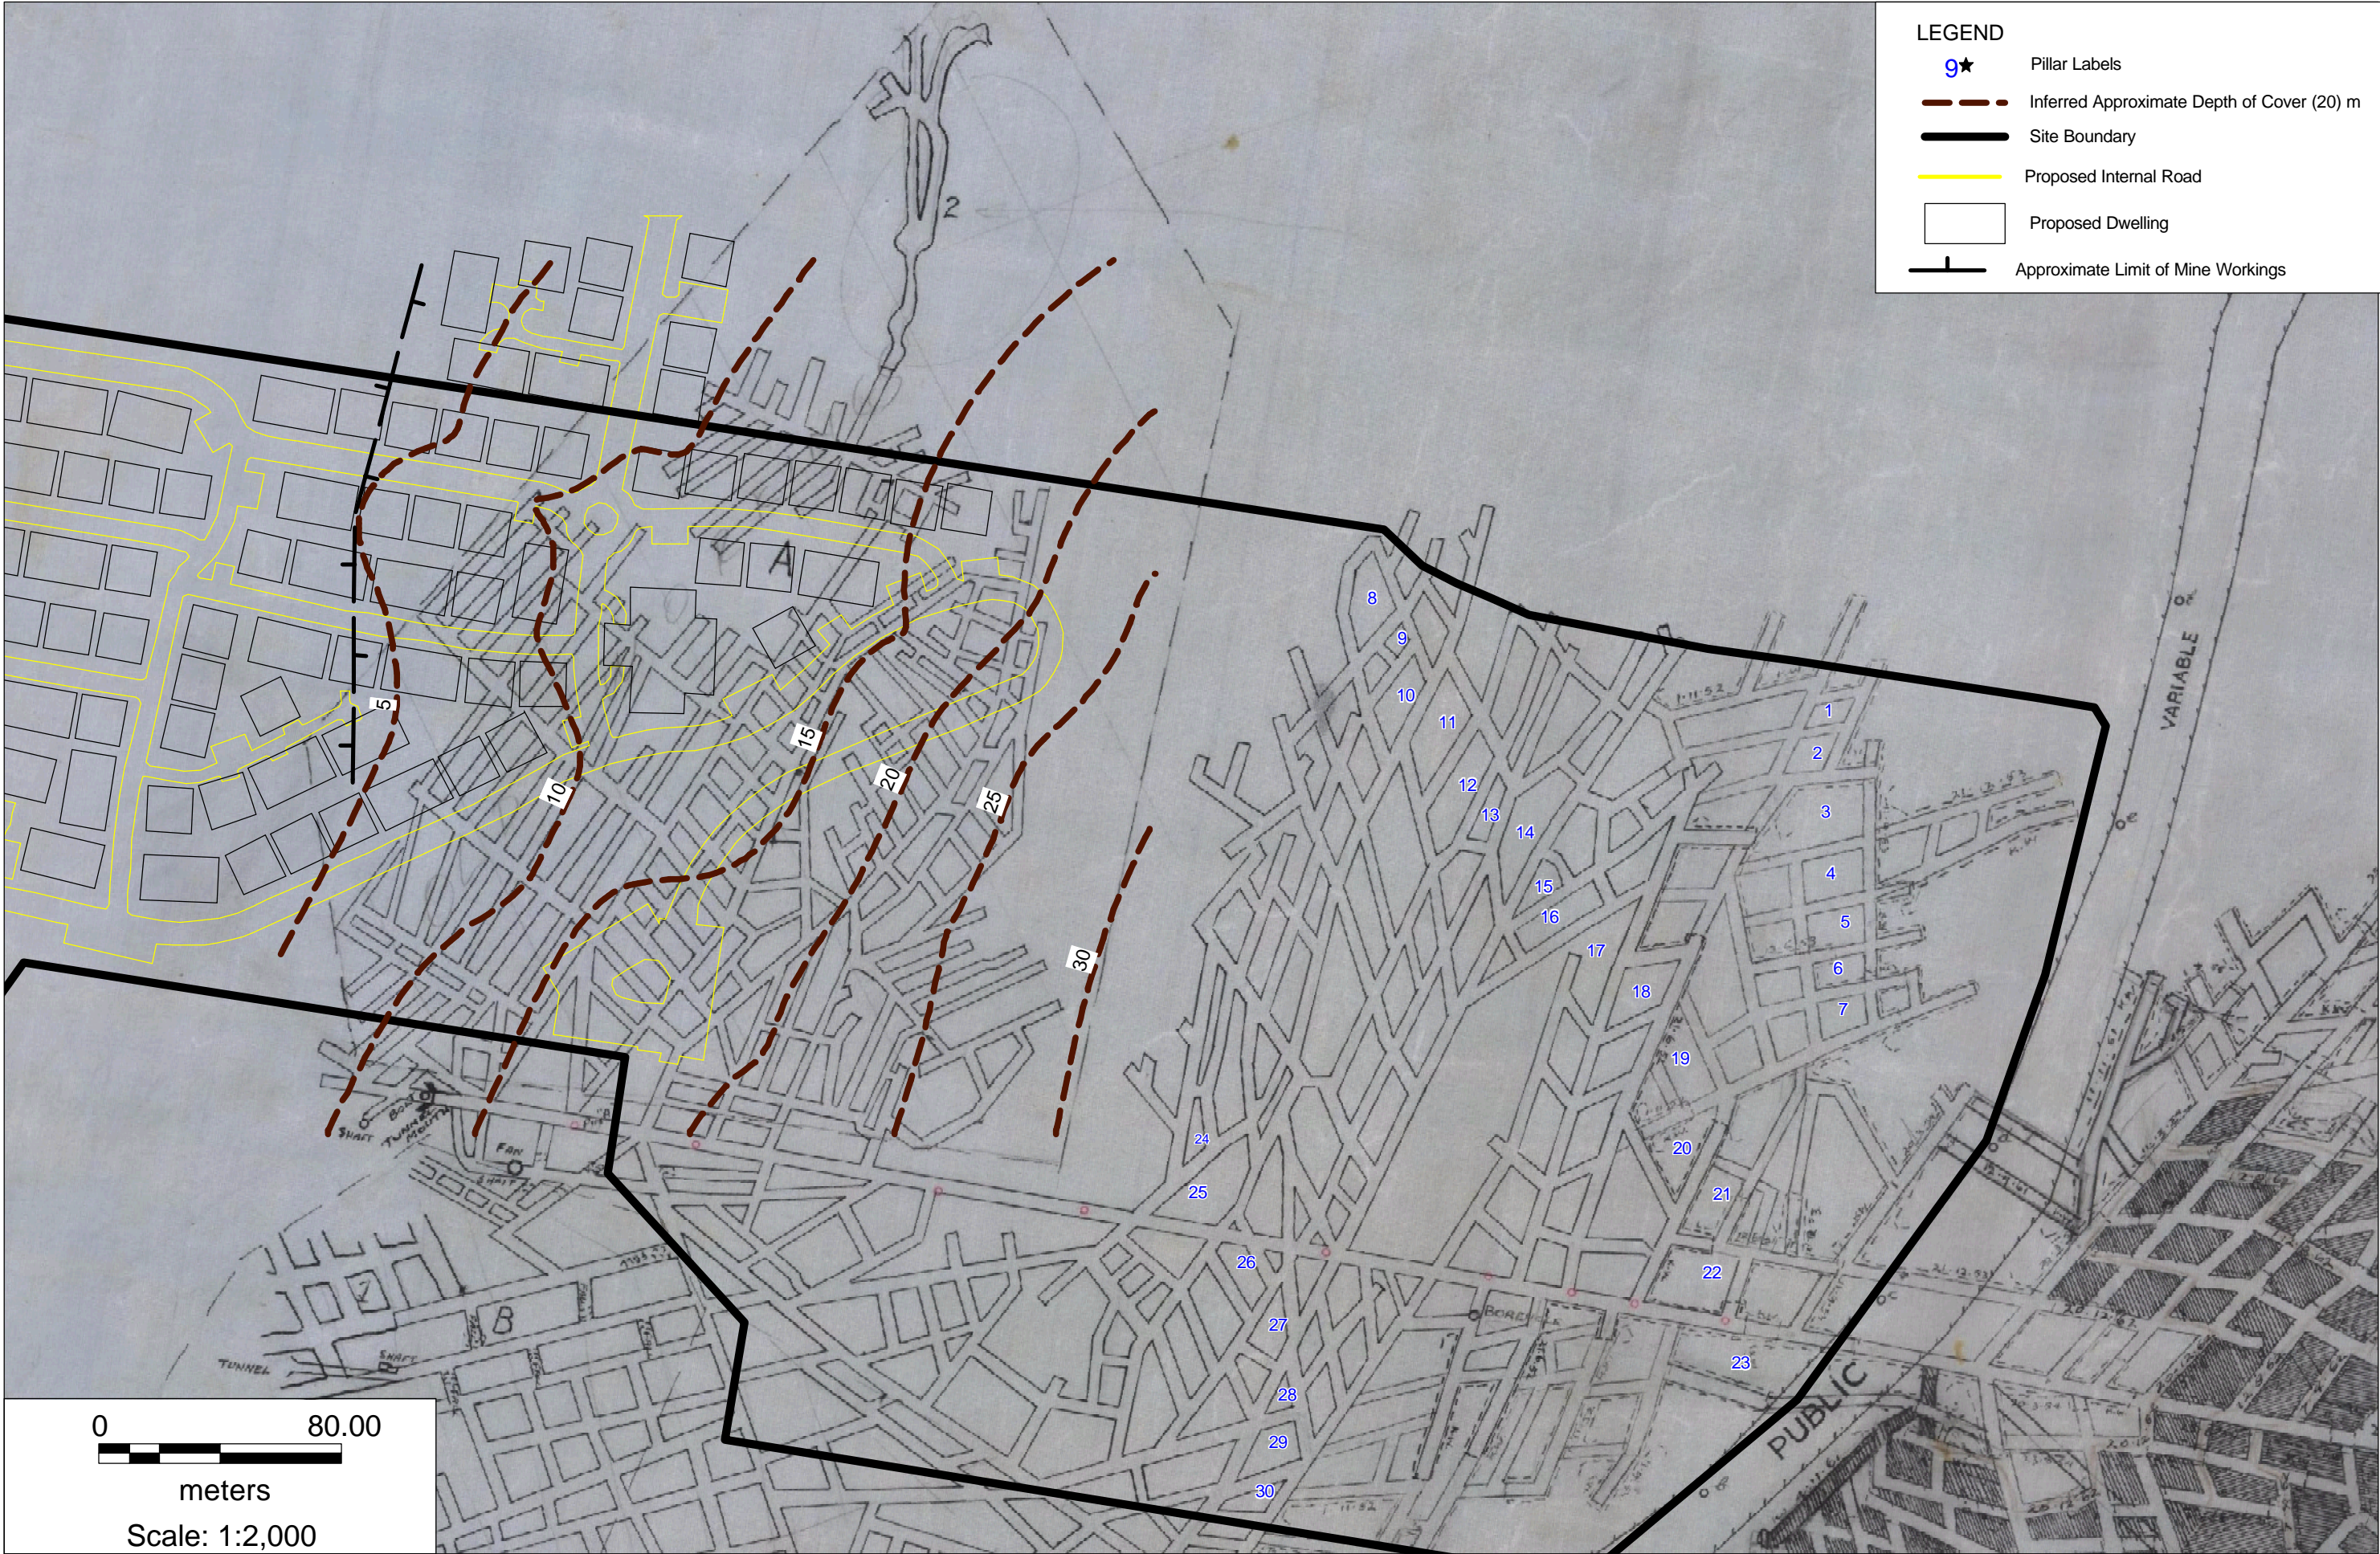
The results of the Case 2 analysis indicate FOS of individual pillars of greater than 2.0 for Pillars 1 to 23, 25, 26, 29 and 30, which indicate a low risk of failure/instability. For Case 2 parameters, for Pillars 24 and 27 the FOSs drop to 1.7 and 1.8 resulting in a theoretical 0.1% chance of failure. For the Case 2 parameters Pillar 28's FOS drops to as low as 1.06, resulting in a theoretical chance of failure of about 50%.

Based on Case 2 most mapped pillars in the eastern part of the site are considered to be at low risk of instability, except for “small, slender or triangular/trapezoidal shaped” pillars such as Pillar 28. It is noted that the RT shows a scattering of such smaller pillars.

It is recommend that further investigation be undertaken to assess actual pillar and mine working dimensions, strength of floor and potential weak zoning to confirm the results of this preliminary pillar stability analysis. This should be undertaken in conjunction with a more detailed pillar stability assessment considering the effects of tributary loading (i.e. load shedding to surrounding larger pillars).
