**Re: Loreto Normanhurst – Early Learning Centre (ELC)
Response to Deferral Decision; Traffic and Transport**

Existing stage road safety audit

Osborn Road, Normanhurst

Mt Pleasant Avenue, Normanhurst

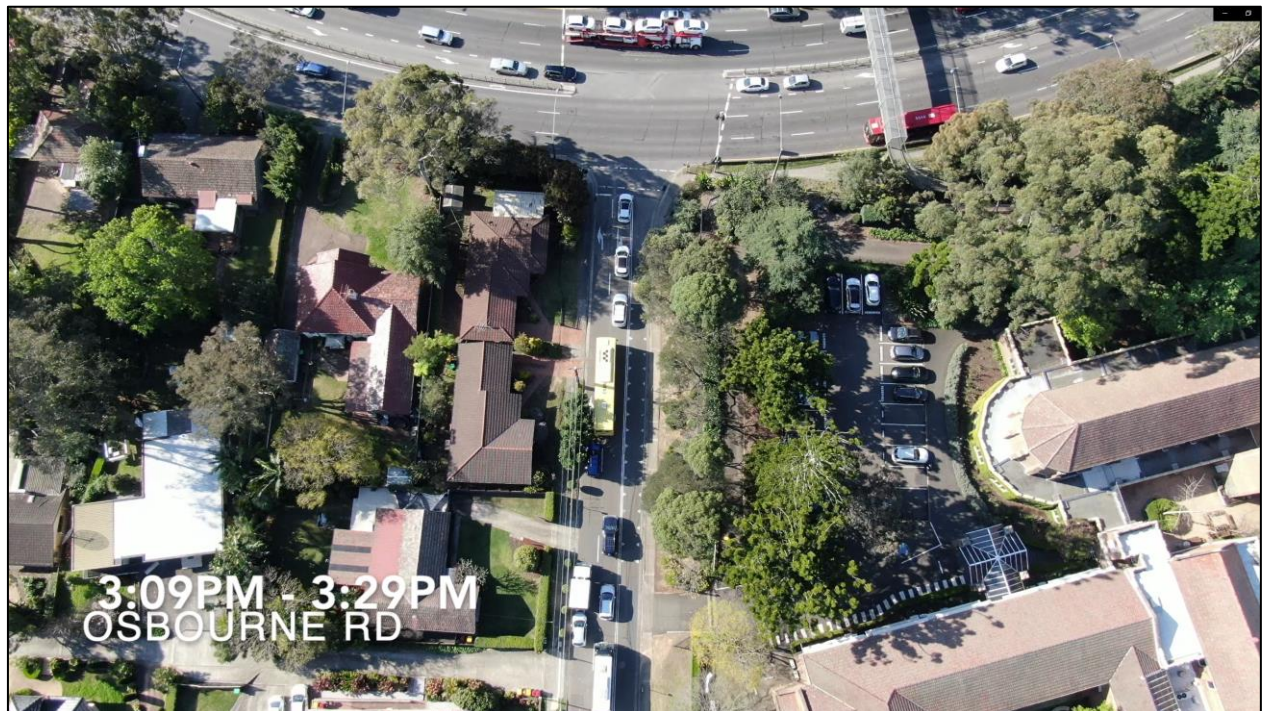
Figure 1: Peak Queuing Observed on Osborn Road

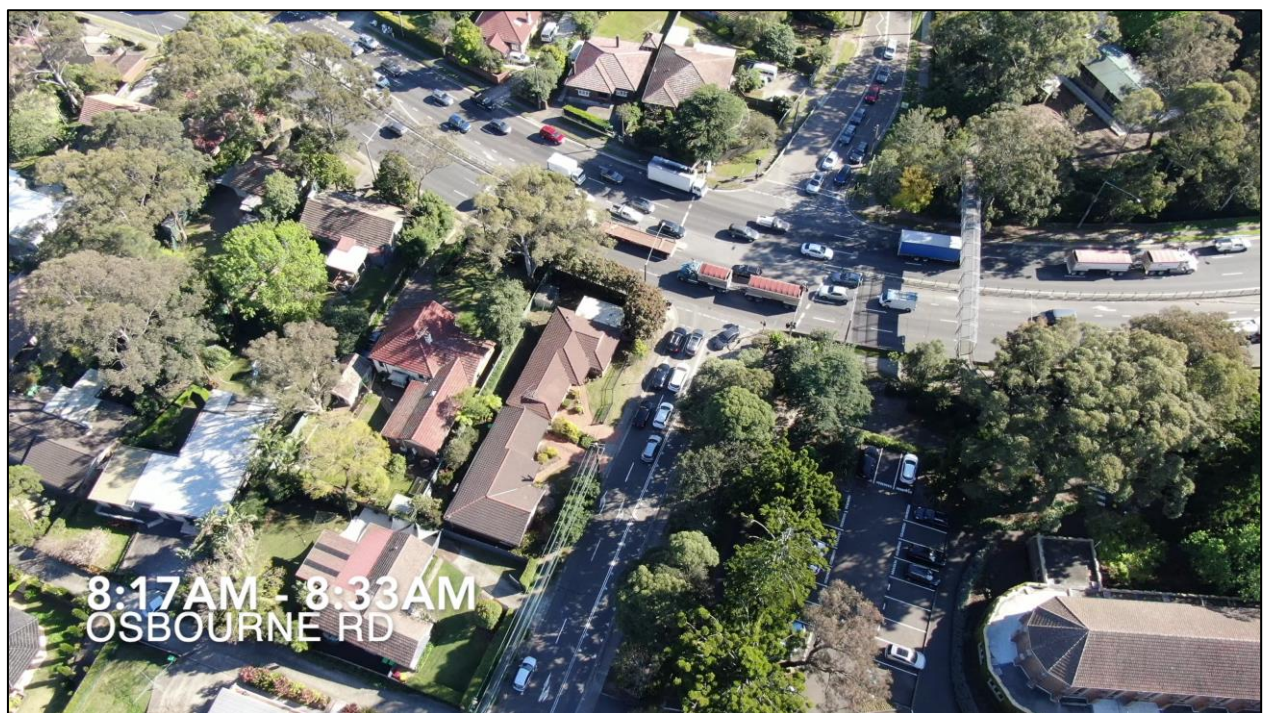
Figure 2: Typical Queuing Observed on Osborn Road

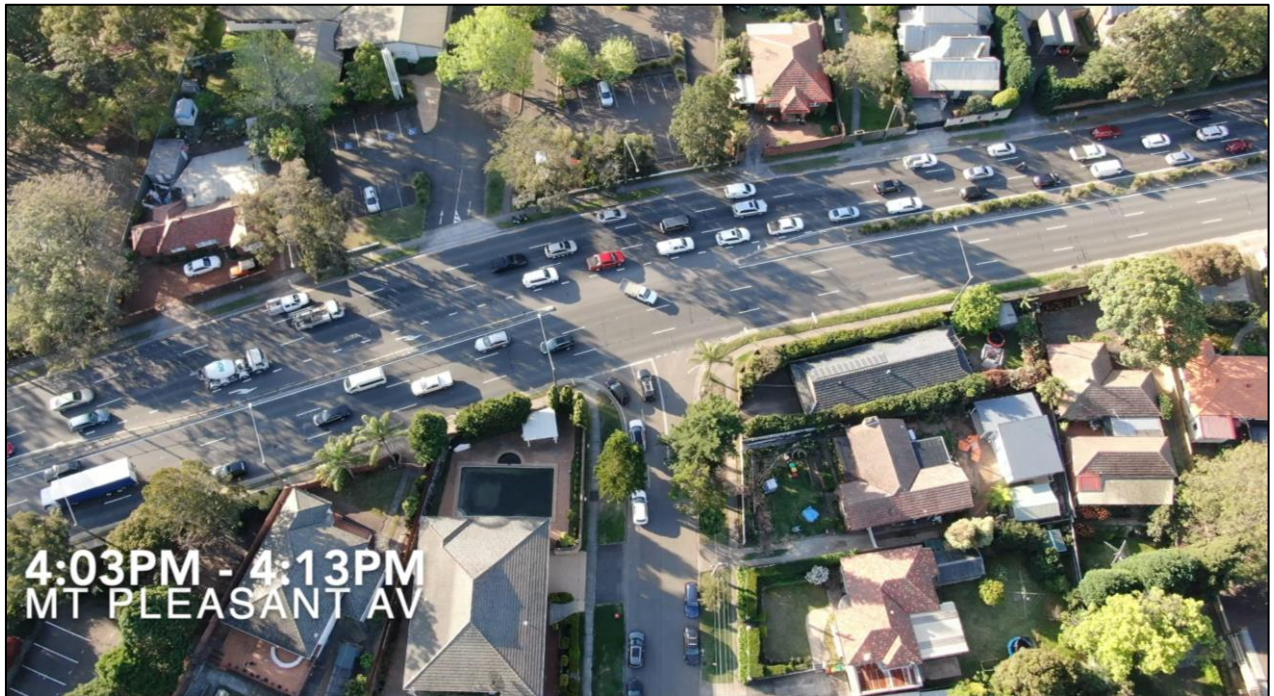
Figure 3: Typical Queuing Observed on Mount Pleasant Avenue

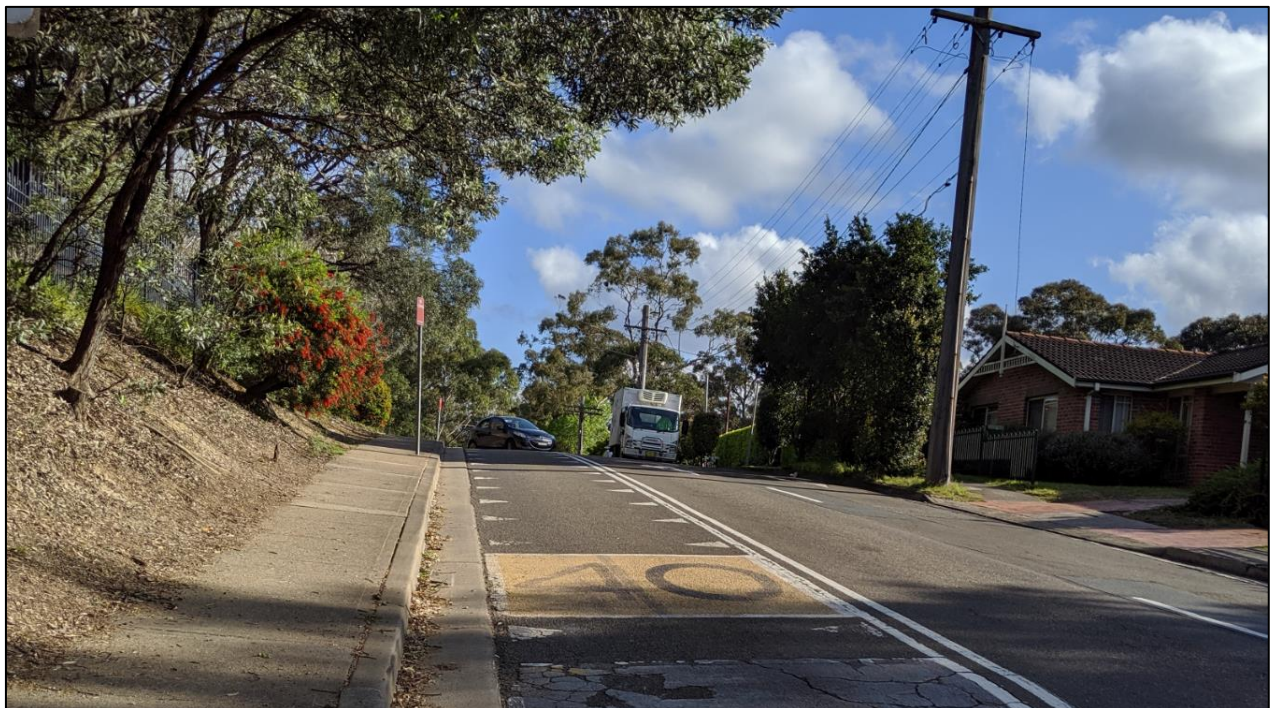
Notwithstanding the above, it was observed during the surveys that parking within Osborn Road on the western side (**Figure 4** and **Figure 5**) does impact the of vehicles (notably buses) to access the dedicated left-turn lane during peak periods. Therefore, it is proposed that these spaces, as illustrated by **Figure 6**, be restricted during School peak to improve the traffic flow in Osborn Road

Figure 4: Osborn Road On-street Parking

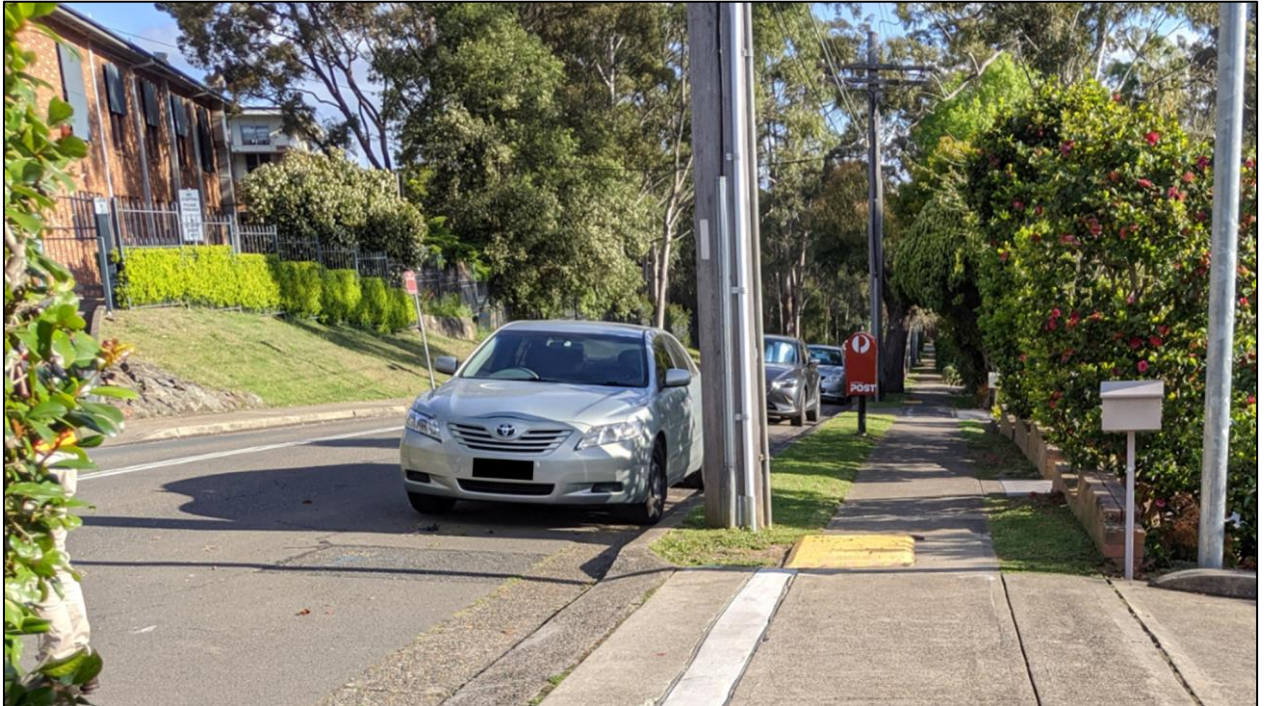
Figure 5: Osborn Road On-street Parking

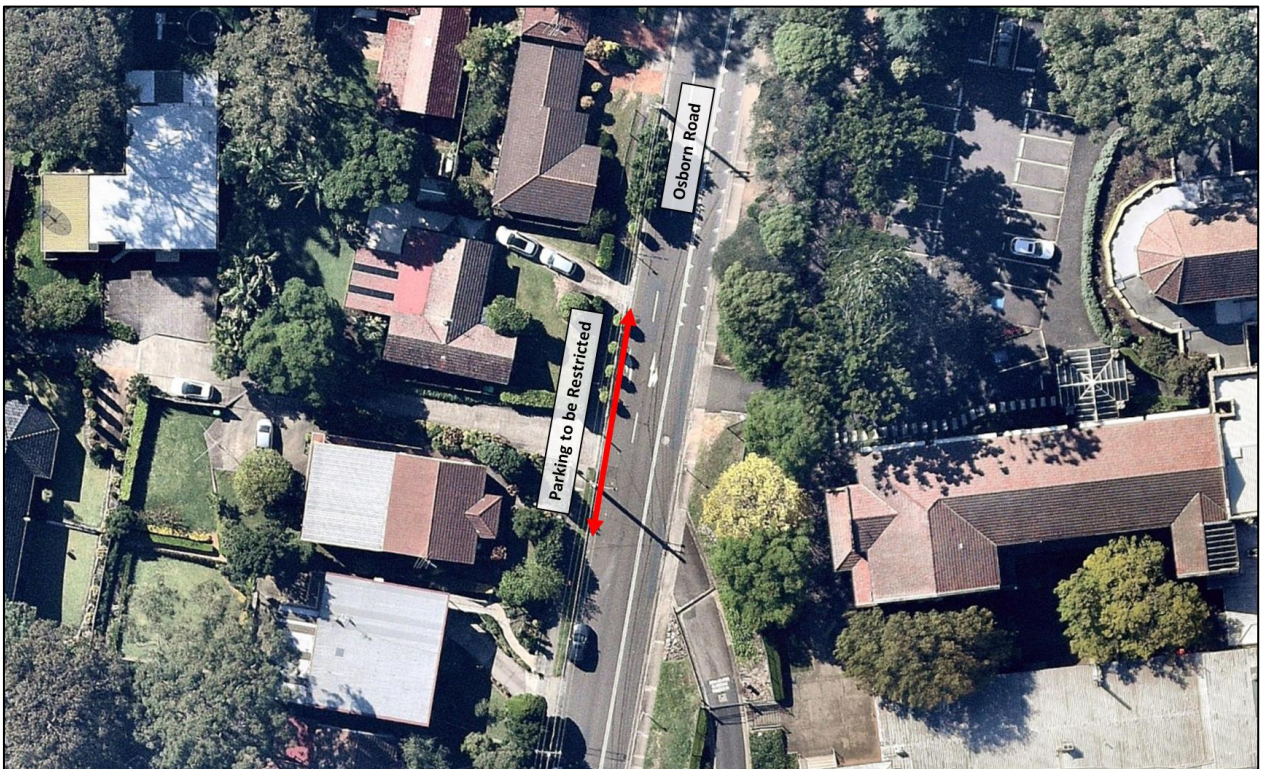
Figure 6: Osborn Road On-street Parking to be Restricted

- It was noted that some of the on-street car parking spaces on the western side of Osborn Road do (from time to time) impact the ability of vehicles (notably buses) to access the dedicated left-turn lane during peak periods. Therefore, it is proposed that these spaces be restricted during School peak to improve the traffic flow in Osborn Road (refer to Attachment 2).

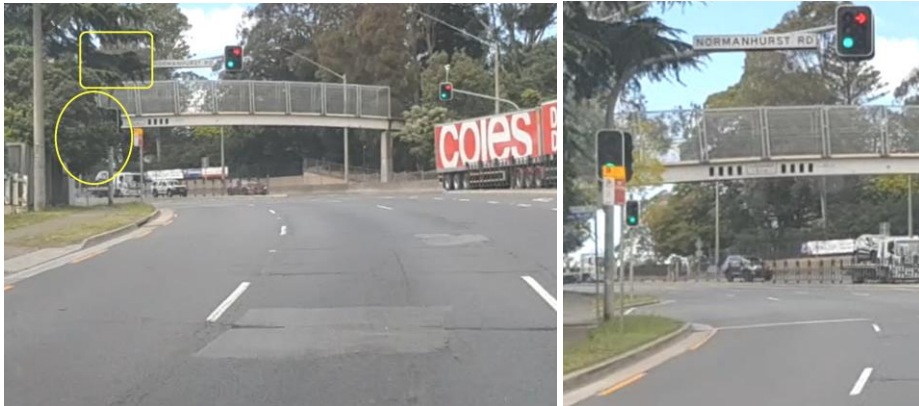
Ref	Theme/ location	Road safety audit finding	Priority
1	Eastbound travel direction of Pennant Hills Road in approach to Osborn Road.	<p>The Pennant Hills Road/ Osborn Road/ Normanhurst Road intersection is traffic signal controlled. However, the combined effect of the curvature of this road, and overhanging tree foliage on the inside (northern) side of the curve have affected the <i>approach sight distance</i> (ASD) available between eastbound drivers and the primary signal lanterns. These are the lanterns on the north-western corner of the intersection. With reduced ASD, drivers may not be aware of the prevailing signal phasing which may lead to red-light breaches and associated crashes with cross traffic streams. Furthermore, as the primary signals are typically placed in line with the hold line of the approach, they also advise drivers <i>where</i> to stop. As such, the restricted view of the signals may lead to drivers over-shooting the hold line and encroaching into the controlled area of the intersection.</p> <p>The left-hand image shows the view from a driver in lane 2 towards the primary signals when approximately 50m upstream of the intersection. The signals on the vertical portion of the mast-arm post are obscured by the tree foliage in the yellow oval. The foliage in the yellow box is starting to visually obscure the street name sign to Normanhurst Road. With further growth, it is likely that this street name sign could become blocked as well. The sight line from lane 1 would be even worse since this is further inside the curve.</p> <p>The right-hand image shows a view from approximately 25m upstream of the intersection where the primary signals are no longer visually blocked by the overhanging tree foliage. However, the signals are partially and momentarily blocked by the parking restriction signs.</p> <p>Driver visibility to the primary signals could be improved by pruning the tree foliage and relocating the parking restriction signs. The restored visibility to the primary signals would also improve pedestrian safety, especially if red signal holds/ delays are in place to safeguard pedestrians on the northern crossing.</p>

<p>Left: Looking eastbound along Pennant Hills Road towards the intersection with Osborn Road-Normanhurst Road from approximately 50m upstream. Right: Looking eastbound towards the signals from approximately 25m upstream.</p>	High

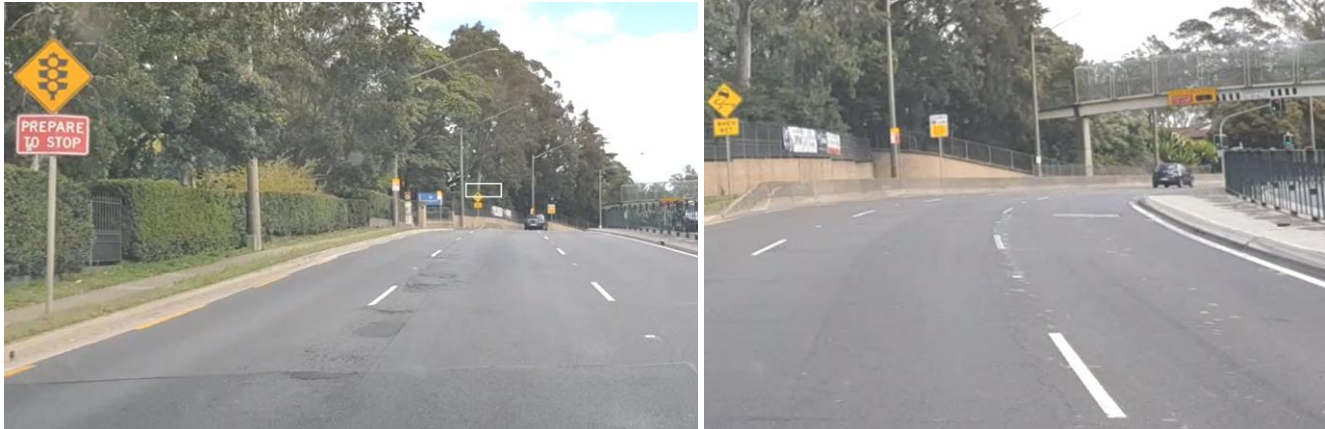
Ref	Theme/ location	Road safety audit finding	Priority
2	Westbound travel direction of Pennant Hills Road in approach to Osborn Road.	<p>Due to the curvature of Pennant Hills Road and the potentially sight-obstructing pedestrian bridge, a dynamic flashing light unit has been provided to alert westbound drivers of the traffic signals in the road ahead. These appear to flash when the downstream signals (at Osborn Road) are on red signal display. This is a compensatory measure for the reduced <i>approach sight distance</i> to the traffic signals. However, the flashing light unit is not optimally positioned.</p> <p>As shown in the images below, the flashing light unit is mounted to the pedestrian bridge above lane 2 (middle lane). When the driver is on the straight line (tangential) portion of the curve (see left-hand image), the flashing light unit is well outside the forward field of view. Some drivers may not have a clear sight line to the flashing lights if they cannot see over the median pedestrian fence. Also, since the road contains a curve-crest combination, any tall vehicles in the road ahead may also block this sight line. If drivers lack clear visibility to the flashing light unit, it renders the device ineffective as an advanced warning system. By the time the driver can see the flashing light unit, they would be able to see the actual signals anyway and would no longer need advanced warning.</p> <p>Using the left-hand image, the flashing light assembly would be more effectively relocated to the projection of the straight line (tangential) portion of the curve. An indicative location is depicted by the white rectangle. This puts the flashing lights in clear view of approaching drivers when they are well upstream of the sight-limiting curve and crest. Also, by being placed further upstream, this would more effectively warn drivers and allow them to control speeds with respects to approaching the back-of-queue. Typically, the back-of-queue would be well upstream of the signals themselves. Also, evident in the left-hand image, if the flashing light unit was relocated, it would also be visible in the same "picture frame" as the TRAFFIC SIGNALS + PREPARE TO STOP signage combination. As such, the flashing light unit would be more meaningful as the driver would receive both advanced warning messages at the same time.</p>

<p>Left: Looking westbound along Pennant Hills Road towards the curve and crest in approach to the traffic signals at Osborn Road. The advanced warning flashing light unit could be better placed on the projection to this straight line (tangential) portion of the curve. Right: Further downstream from the first photo. As shown, by the time the flashing light unit is visible to the driver, they would already be able to see the signals themselves.</p>	High

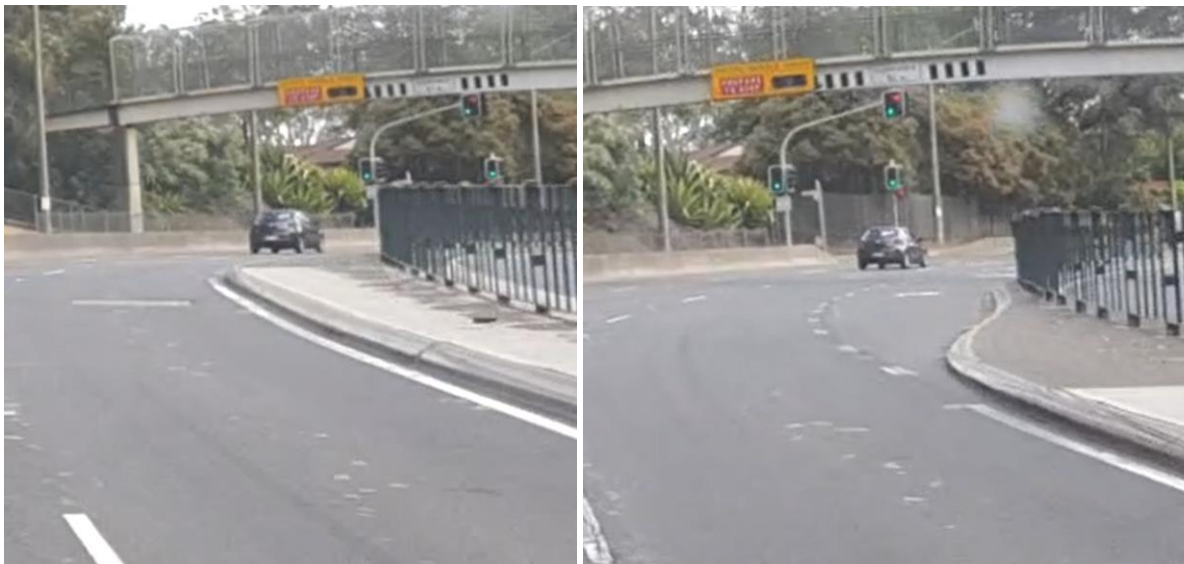
Ref	Theme/ location	Road safety audit finding	Priority
4	Westbound travel direction of Pennant Hills Road in approach to Osborn Road-Normanhurst Road – Visibility to the right-turn lane to Normanhurst Road.	<p>In the westbound direction of Pennant Hills Road, there is a curve-crest combination in approach to the Osborn Road-Normanhurst Road intersection. There is also a pedestrian fence on the median which obstructs the sight bench available across the median. This restricts the <i>stopping sight distance</i> (SDD) from westbound drivers to the right-turn lane to Normanhurst Road. The sight line is most affected in lane 3 (median-side lane) since (i) this is the westbound lane that is furthest on the inside of the curve, and (ii) this the westbound lane that would be most critically affected by conditions in the right-turn lane.</p> <p>The left-hand image shows the view from a westbound driver when approximately 35m upstream of the right-turn lane. At this point, the driver has limited view of the conditions in the right-turn lane including the kerb alignment and pavement conditions. They may also lack full visibility of any vehicles stopped in the right-turn lane, including their brake and indicator lights. The full detail of the right-turn lane only becomes visible a further 20m downstream (see right-hand image) which is only 15m upstream of the start of the right-turn lane. The driver may lack awareness to the conditions in the right-turn lane, and may not have enough time or space to react, such as adjusting their approach speed or even aborting the right-turn altogether.</p> <p>As the pedestrian fence is a major contributor to the loss of sight line to this right-turn lane, and this is also a critical safety amenity itself, the audit team does not recommend any adjustment or removal of this fence. Without increasing the length of the right-turn lane, there is little that could be done to improve driver advanced visibility and awareness of conditions in this lane. As such, consideration should be given to relocating the dynamic flashing light unit as described in item 2. This would at least help to control approach speeds and give drivers real-time advice of the prevailing signal phasing.</p> <div data-bbox="535 670 1715 1236">

</div> <p>Left: Looking westbound along Pennant Hills Road from approximately 35m upstream of the right-turn lane. There is limited visibility to the conditions in the right-turn lane to Normanhurst Road due to the curvature of the road and the median pedestrian fence. Right: Looking westbound from approximately 15m upstream, where the alignment and pavement condition in the right-turn lane are more visible.</p>	Medium

4.	<p>Comment: In the westbound direction of Pennant Hills Road...is also a pedestrian fence on the median which obstructs the sight bench available across the median. This restricts the stopping sight distance (SDD) from westbound drivers to the right-turn lane to Normanhurst Road.</p> <p>Suggestion: As the pedestrian fence is a major contributor to the loss of sight line to this right-turn lane, and this is also a critical safety amenity itself, the audit team does not recommend any adjustment or removal of this fence. Without increasing the length of the right-turn lane, there is little that could be done to improve driver advanced visibility and awareness of conditions in this lane.</p>	N/A – Requires RMS review.

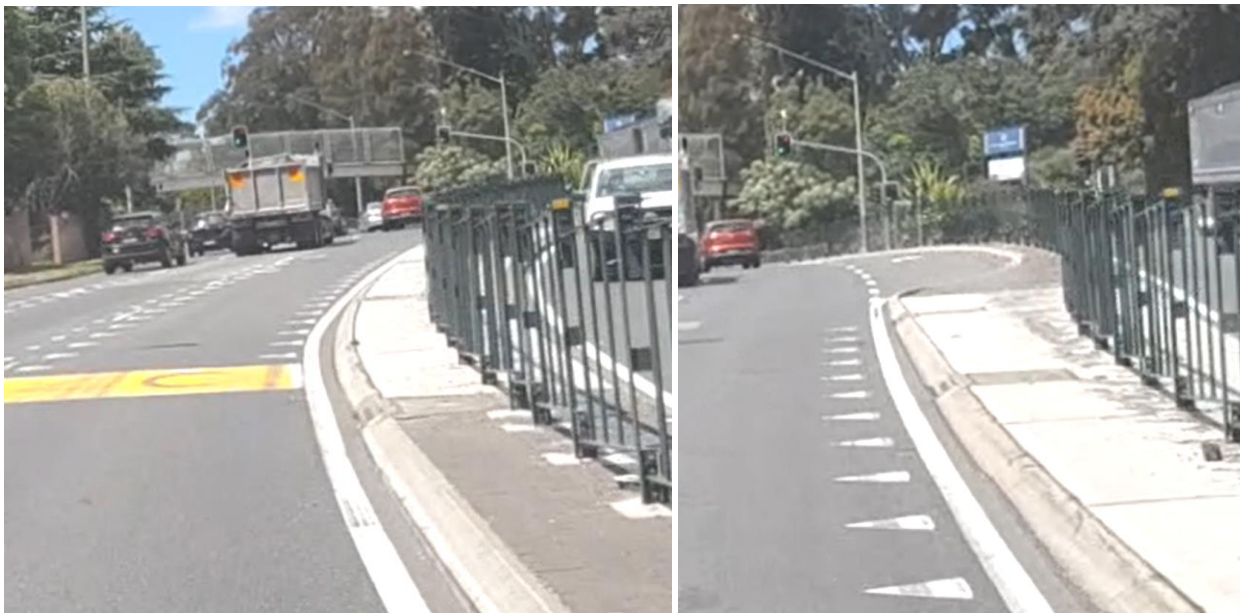
Ref	Theme/ location	Road safety audit finding	Priority
5	Eastbound travel direction of Pennant Hills Road in approach to Osborn Road- Normanhurst Road – Visibility to the right-turn lane to Osborn Road.	<p>In the eastbound direction of Pennant Hills Road, there is a right-hand curve in the immediate approach to the right-turn lane to Osborn Road. There is also a pedestrian fence on the median which obstructs the sight bench available across the median. This restricts the <i>stopping sight distance</i> (SDD) from eastbound drivers to the right-turn lane to Osborn Road. The sight line is most affected in lane 3 (median-side lane) since (i) this is the eastbound lane that is furthest on the inside of the curve, and (ii) this the eastbound lane that would be most critically affected by conditions in the right-turn lane.</p> <p>The left-hand image shows the view from an eastbound driver when approximately 50m upstream of the right-turn lane. At this point, the driver has limited view of the conditions in the right-turn lane including the kerb alignment and pavement condition. They may also lack full visibility of any vehicles stopped in the right-turn lane, including their brake and indicator lights. The full detail of the right-turn lane only becomes visible a further 20m downstream (see right-hand image) which is only 30m upstream of the start of the right-turn lane. The driver may lack awareness to the conditions in the right-turn lane, and may not have enough time or space to react such as adjusting their approach speed or even aborting the right-turn altogether.</p> <p>As the pedestrian fence is a major contributor to the loss of sight line to this right-turn lane, and this is also a critical safety amenity itself, the audit team does not recommend any adjustment or removal of this fence.</p>

<p>Left: Looking eastbound along Pennant Hills Road from approximately 50m upstream of the right-turn lane to Osborn Road. Right: Looking eastbound from approximately 30m upstream of the right-turn lane.</p>	Medium

5.	<p>Comment: In the eastbound direction of Pennant Hills Road...also a pedestrian fence on the median which obstructs the sight bench available across the median. This restricts the stopping sight distance (SDD) from eastbound drivers to the right-turn lane to Osborn Road.</p>	<p>N/A – Requires RMS review.</p> <p>It is critical to note that this is a sightline issue caused by the pedestrian fencing along PHR (i.e. a physical issue) and not an issue that relates to the traffic generation in the area. As</p>

<p>Suggestion: As the pedestrian fence is a major contributor to the loss of sight line to this right-turn lane, and this is also a critical safety amenity itself, the audit team does not recommend any adjustment or removal of this fence.</p>	<p>noted by the RSA, this fence is an important safety amenity in itself and therefore it is not recommended to remove it</p>

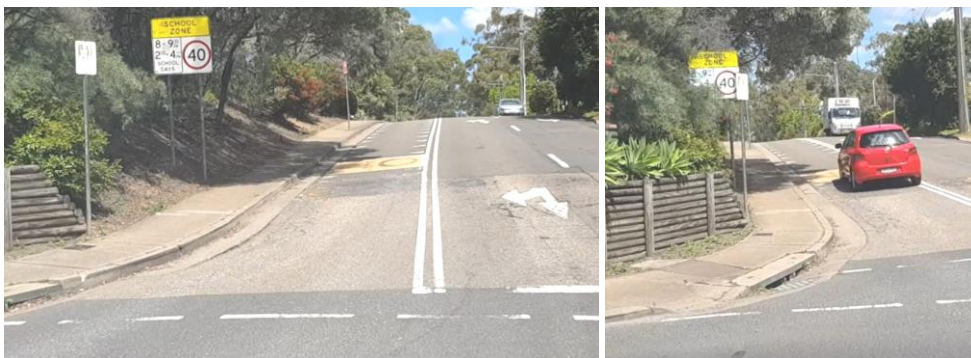
Ref	Theme/ location	Road safety audit finding	Priority
6	Osborn Road in its immediate departure from Pennant Hills Road.	<p>The Osborn Road southbound departure from Pennant Hills Road is narrow (see left-hand image). This is due to the lack of shoulder, limited flaring of the kerblines, and the BB double barrier centreline which appears to have been shifted as far east as possible. The limited departure width would have several road safety implications including:</p> <ul style="list-style-type: none"> There is limited space for vehicles to negotiate this departure. Any vehicles that turn left from Pennant Hills Road East could cross the BB double barrier centreline and increase the risk of <i>head-on</i> crashes with northbound vehicles. Any right-turning vehicle from Pennant Hills Road West could also be at risk of striking the south-eastern kerb return, or tracking across the lane 2 of the northbound direction. Normanhurst Road contains two lanes in the southbound direction approaching Pennant Hills Road. Lane 1 (left-hand lane) is a shared <i>left-through</i> lane. Lane 2 is a dedicated right-turn lane. As such, the southbound straight through movement from Normanhurst Road to Osborn Road would need to commence from lane 1, negotiate a kinked travel path in the control area of the intersection to then enter the narrow departure lane in Osborn Road. The right-hand image shows the view from a driver negotiating this path and illustrates the extreme kinked travel path involved. This kinked travel path could lead to wheel-strikes on the south-eastern kerb return (including pedestrians standing at this location). Alternatively, if the driver avoids impacts with this kerb, they could be at risk of <i>side-swipe</i> crashes with the adjacent right-turn lane. Even if southbound vehicles are able to negotiate this narrow departure channel without striking kerbs or causing a <i>head-on</i> crash, the driver may be required to slow down excessively to successfully negotiate this channel. This could introduce <i>rear-end</i> crash risks in this departure. Alternatively, drivers that hesitate/ baulk could cause “shockwaves” which may also cause <i>rear-end</i> crash risks and queue spillback into the control area of the Pennant Hills Road/ Osborn Road/ Normanhurst Road intersection. <p>Also evident in the images below, the eastern footpath of Osborn Road is narrow and is bounded by a batter slope. This increases the risk of <i>vehicle-pedestrian</i> crashes, especially in light of the wheel-strike risks described above. Pedestrians would be unwilling to walk on the batter slopes due to its slippery surface. The batter slope could also increase risks of debris spillage onto the footpath.</p> <p>There are very few easy solutions to addressing these issues. However, if larger scale improvements are considered along Osborn Road, then consideration could also be given to widening works to improve lane and road widths, as well as safety on footpaths.</p> <div data-bbox="535 970 1503 1329">

</div> <p>Left: Looking southbound into Osborn Road at the narrow departure channel. Right: The view of a southbound driver entering Osborn Road from Normanhurst Road – due to the kinked travel path from the southbound through lane of Normanhurst Road.</p>	Medium

6.	<p>Comment: The Osborn Road southbound departure from Pennant Hills Road is narrow.</p> <p>Suggestion: There are very few easy solutions to addressing these issues. However, if larger scale improvements are considered along Osborn Road, then consideration could also be given to widening works to improve lane and road widths, as well as safety on footpaths.</p>	<p>As noted, the only way to overcome this issue is to widen Osborn Road, which would require significant works.</p> <p>With regard to the ELC DA, these works are not justified at this stage (as already discussed).</p>

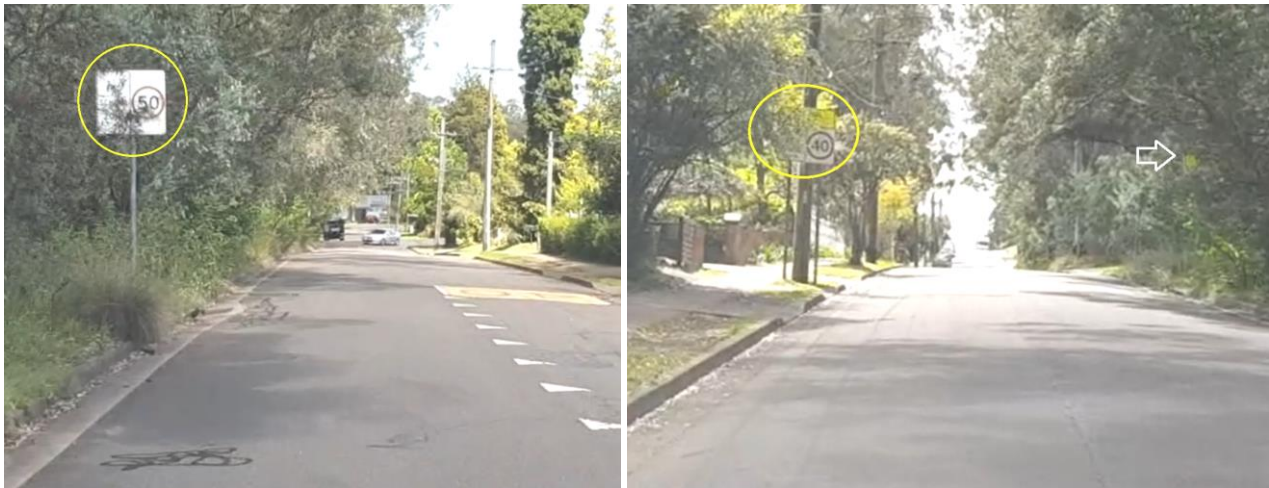
Ref	Theme/ location	Road safety audit finding	Priority
7a	General – Visually obscured signs.	<p>There are several signs along the audited length of Osborn Road which are visually obscured by tree foliage. The signs therefore lack effectiveness in conveying the regulatory and speed zoning advice. Many of these signs also contain time-based information, such as when the school zone (and hence variable speed limit of 40km/h) is in operation.</p> <p>The visually obscured signs are depicted below as well as in item 7b, with descriptions in the captions. These are generally mitigatable by tree pruning works.</p> <div data-bbox="535 357 1800 847">

</div> <p>Left: Looking southbound along Osborn Road towards the END SCHOOL ZONE sign. The sign is visually obscured by tree foliage. Right: Looking northbound along Osborn Road at the southern gateway (entry point) to the school zone. The left-hand SCHOOL ZONE sign (circled in yellow) is partially obscured by tree foliage. The right-hand sign (marked by the white arrow) is totally obscured and rendered ineffective.</p>	Medium

7.	<p>Comment: There are several signs along the audited length of Osborn Road which are visually obscured by tree foliage.</p> <p>Suggestion: These are generally mitigatable by tree pruning works.</p>	<p>Pruning works on trees which overhang the School property boundary are to be undertaken by the School. As noted above, any works to public land are the responsibility of the asset owner, so a request will be made to Council to prune the trees on public land.</p>

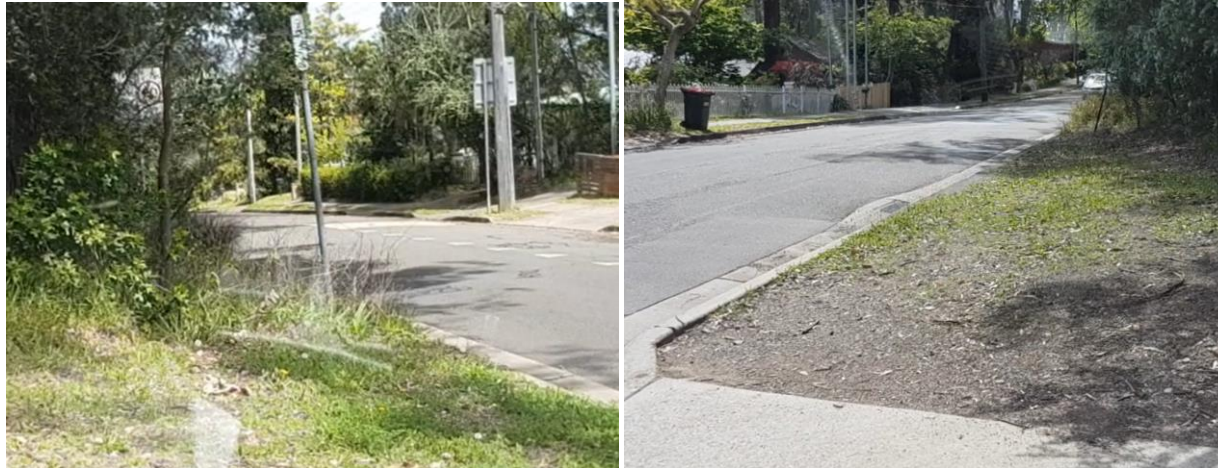
Ref	Theme/ location	Road safety audit finding	Priority
8	Gate O4 – Visibility conditions for outbound drivers.	<p>Outbound drivers from Gate O4 of Loreto Normanhurst would need to check for gaps in the northbound and southbound traffic streams of Osborn Road. This requires them to look to the left (south) and right (north). The driver views in these directions are shown below in the left and right-hand images respectively.</p> <p>As seen, there is limited <i>minimum gap sight distance</i> (MGSD) to the south due to a cluster of trees (left-hand image). The driver is unlikely to have a clear view to northbound traffic and may not be able to judge suitable gaps. This could lead to poor gap selection and consequential cross traffic crashes. Alternatively, a common response is for drivers to “creep” out into the roadway to improve their sightline. This would leave them exposed to impacts by southbound vehicles when stopped in such a position.</p> <p>The right-hand image shows the MGSD sightline to the north. This also shows a southbound vehicle that has just come into the driver’s view. The southbound vehicle would not have been visible from upstream of this point which also increases the risk of poor gap detection and selection by the outbound driver, and consequential <i>cross traffic</i> crashes. On-site observations revealed an approximate four-second gap between the southbound vehicle at this point (where it has just come into the view of the outbound driver) and the driveway where the <i>cross traffic</i> crash conflict would occur.</p> <p>The MGSD sight lines could be improved through tree pruning works.</p> <div data-bbox="533 600 1747 1069">

</div> <p>Left: The view from Gate O4 to the south (left). Right: The view from Gate O4 to the north (right).</p>	Medium

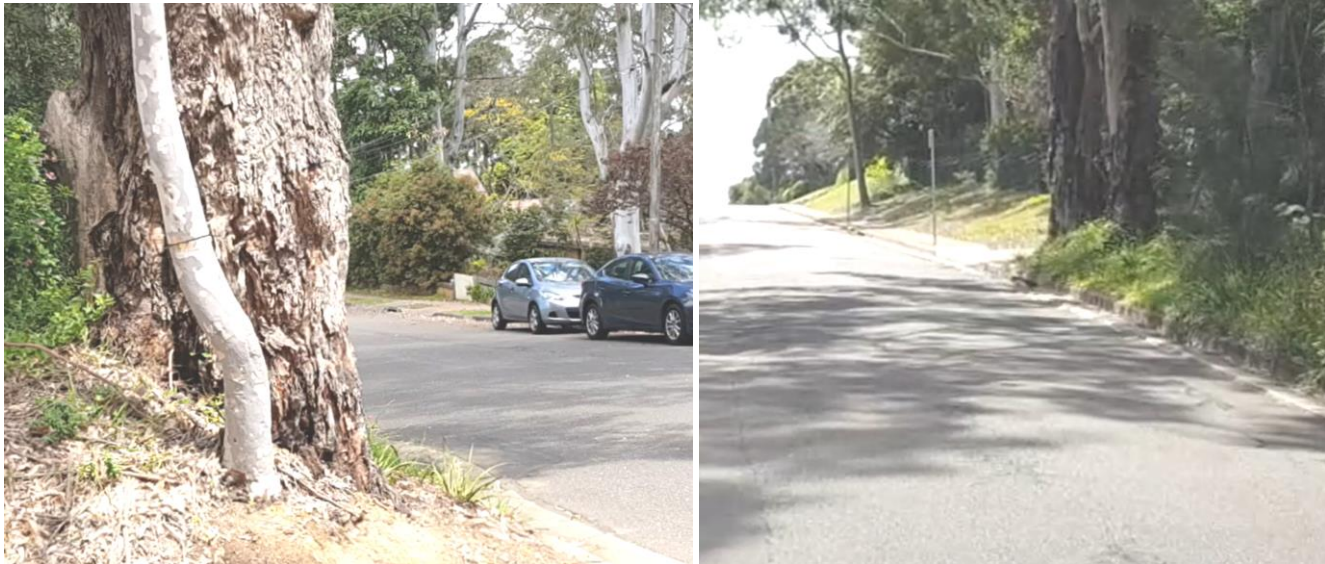
Ref	Theme/ location	Road safety audit finding	Priority
9	Gate O3 – Visibility conditions for outbound drivers.	<p>Outbound drivers from Gate O3 of Loreto Normanhurst would need to check for gaps in the northbound and southbound traffic streams of Osborn Road. This requires them to look to the left (south) and right (north). The driver view to the left (south) is shown in the left-hand image.</p> <p>As seen, there is limited <i>minimum gap sight distance</i> (MGSD) to the south due to a large tree (left-hand image). The driver is unlikely to have a clear view to northbound traffic and may not be able to judge suitable gaps. This could lead to poor gap selection and consequential <i>cross traffic</i> crashes. Alternatively, a common response is for drivers to “creep” out into the roadway to improve their sightline. This would leave them exposed to impacts by southbound vehicles when stopped in such a position.</p> <p>As the sight-limiting feature is a tree trunk and not the foliage, it is unreasonable to remove this tree on account of the affected sight line (unless other large-scale development changes were proposed at the school or along Osborn Road). As such, outbound drivers could be encouraged to use Gate O4 instead (provided that its MGSD sight lines are improved as described in item 8). Some degree of sight line improvement could be achieved by clearing out the understorey layer of low-level trees and plants. This would allow some “see-through” visibility between the large tree trunks. However, the resulting sight lines would not be totally failsafe.</p> <div data-bbox="535 592 1856 1158">

</div> <p>Left: The view from Gate O3 to the south which is affected by the large tree trunk. Right: Looking northbound along Osborn Road showing the limited view to the driveway (behind the trees).</p>	Medium

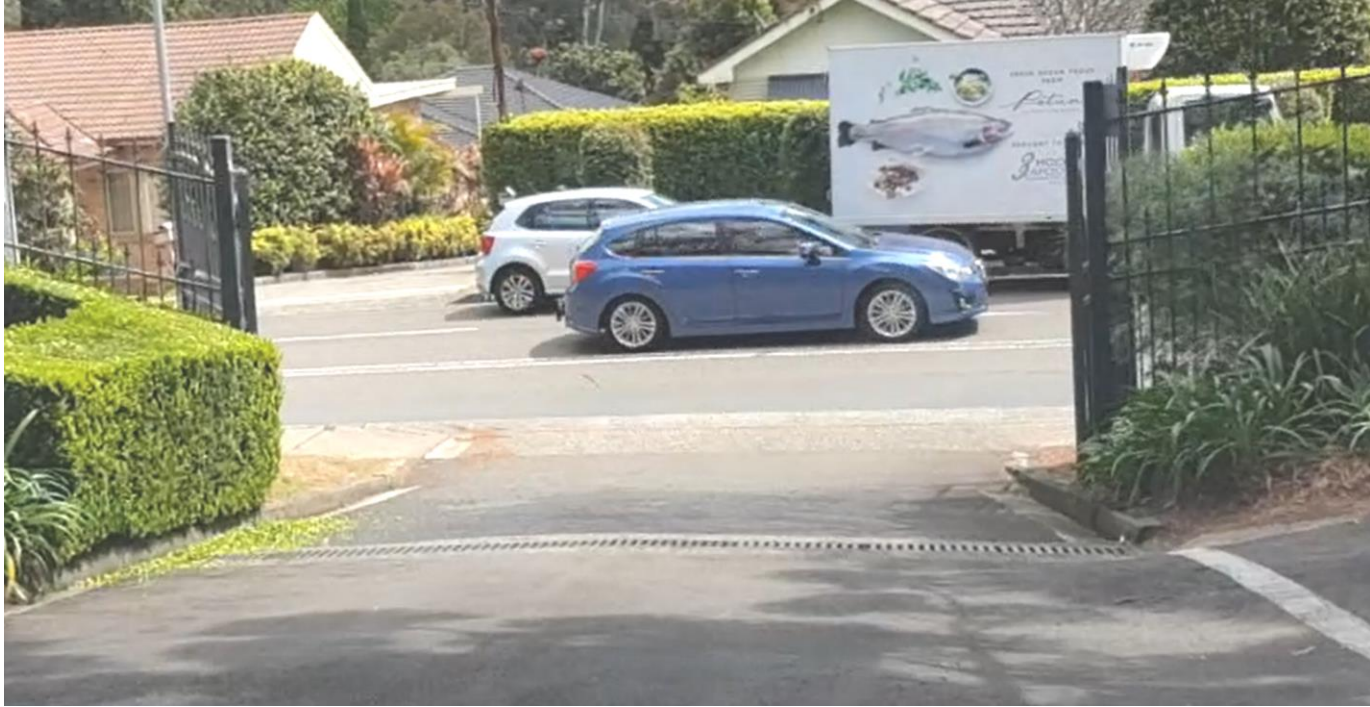
Ref	Theme/ location	Road safety audit finding	Priority
10	Gate O1 – Visibility of outbound drivers to pedestrians on the eastern footpath of Osborn Road.	<p>Gate O1 appears functions as a joint inbound and outbound gate to the school. Outbound drivers would have limited visibility to pedestrians on the eastern footpath of Osborn Road. This is due to the vegetation either side of the driveway. The limited visibility may increase the risk of <i>vehicle-pedestrian</i> crashes, particularly since the footpath is likely to be used by school children, including persons of shorter stature. Some mitigation measures would include:</p> <ul style="list-style-type: none"> ▪ Clearing the vegetation altogether. ▪ Trimming the vegetation to achieve a wider outbound vista. ▪ Trimming the vegetation to a lower height. This would work with respects to the shaped hedges. The un-shape-able trees could be “thinned out” to improve see through visibility. ▪ Provision of STOP signs and a stop hold line. ▪ Provision of convex mirrors. However, this is generally not failsafe since it does not entirely compensate for the lack of clear and unassisted visibility. Also, as the image is distorted, it is difficult to judge distances and speeds of pedestrians.

<p>Above: Looking outbound from Gate O1 showing the limited visibility to the footpath area either side of the gate.</p>	Medium

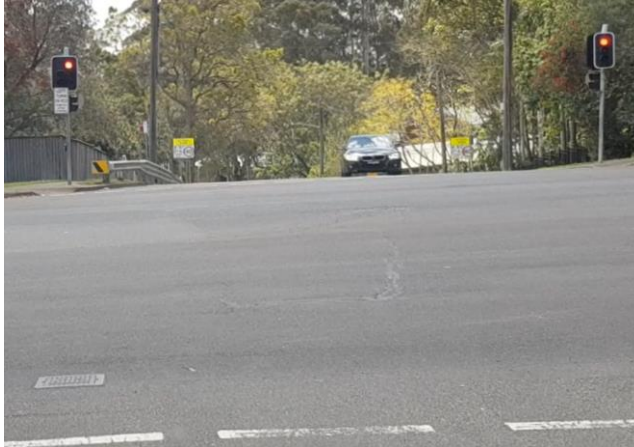
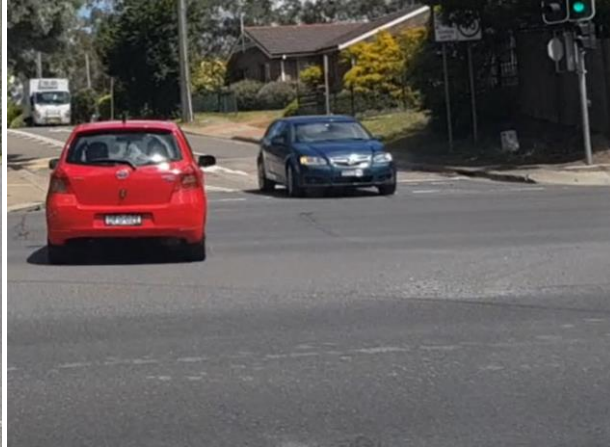
Ref	Theme/ location	Road safety audit finding	Priority
11	Pennant Hills Road/ Osborn Road intersection – Opposing right-turns.	<p>The northbound and southbound right-turns from Osborn Road and Normanhurst Road respectively, are both filtered right-turn movements. As such, the northbound right-turn is required to filter through the opposing (southbound) <i>through</i> movement, and left-turn movements from the Normanhurst Road leg. Similarly, the southbound right-turn is required to filter through the opposing (northbound) <i>through</i> and left-turn movements. Furthermore, both legs have two approach lanes, and hence two separate approach streams of traffic. The audit team notes the following visibility constraints:</p> <ul style="list-style-type: none"> Northbound right-turning drivers could have restricted visibility to the southbound <i>through</i> and left-turn movements due to the crest vertical curve and downhill grade in Normanhurst Road (see left-hand image). Northbound right-turning drivers could also have restricted visibility due to southbound right-turning traffic, who are often in queue whilst waiting to filter through the intersection as well. Southbound right-turning drivers could have restricted visibility to the northbound left-turn movements due to the northbound right-turning traffic, who are often in queue whilst waiting to filter through the intersection as well. <p>Increased controls on the right-turn movements could be considered including full control (non-filtered turns), part-day controls, or leading right-turn phases.</p> <div style="display: flex; justify-content: space-around;">

</div> <p>Left: Looking northbound from Osborn Road into the intersection with Pennant Hills Road. Note the crest vertical curve in Normanhurst Road which limits drivers' visibility to the opposing (southbound) <i>through</i> and left-turning traffic streams. The stopped southbound right-turning vehicle also blocks the sightline to any vehicles that may be moving up in the adjacent traffic lane. Right: Looking southbound into the intersection from Normanhurst Road. The driver's view to northbound left-turning traffic (there are no such vehicles performing this manoeuvre in this picture) could be blocked by the opposing (northbound) right-turning vehicle which has stopped at the hold line.</p>	Medium

11.	<p>Comment: Pennant Hills Road/Osborn Road intersection – opposing right-turns...visibility constraints.</p> <p>Suggestion: Increased controls on the right-turn movements could be considered including full control (non-filtered turns), part-day controls, or leading right-turn phases.</p>	<p>The concerns raised are with regard to opposing right turns at the PHR / Osborn Road signals. As discussed under Ref 3. the drone surveys and modelling analysis to date has illustrated that these signals operate efficiently and safely and therefore it is not Ason Group's recommendation to review the phasing at this time.</p> <p>Nevertheless, the RSA will be made available for RMS review and consideration.</p>

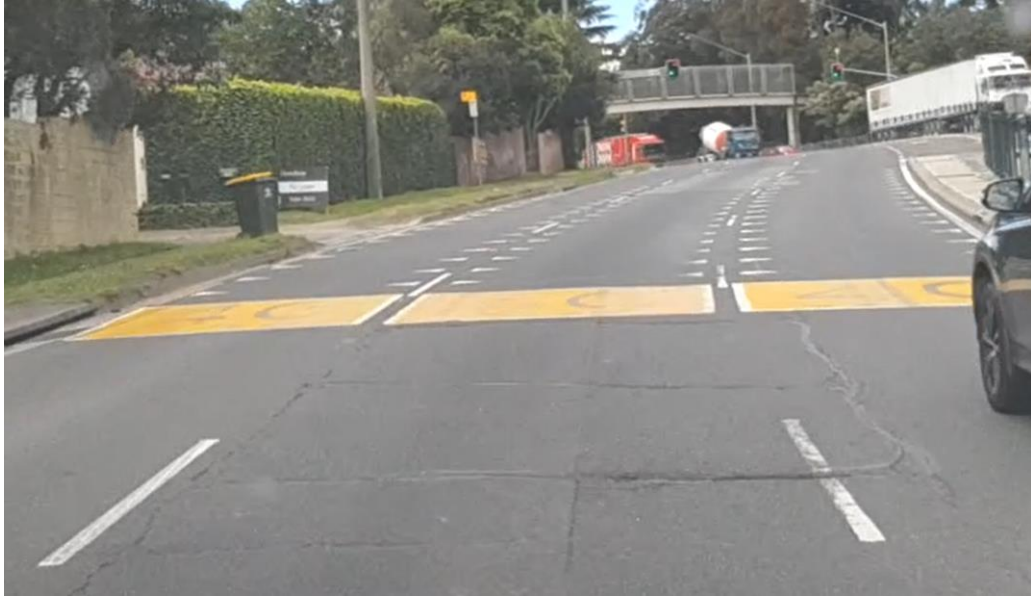
Ref	Theme/ location	Road safety audit finding	Priority
12	Pennant Hills Road to the west of Osborn Road.	<p>The 40k pavement patches associated with the start of the school zone have faded. These are critical features of the school zone signifying (i) the start of the school zone and (ii) the prevailing speed limit during school zone hours. As such, with the faded condition of the markings, drivers may lack awareness of the school zone and speed zoning conditions. Drivers may also use this as a legal excuse for non-compliance as well.</p> <p>Pennant Hills Road carries a high volume of traffic as one of the principle access routes to the M1 Motorway. Under heavy traffic conditions, pavement markings are especially beneficial to drivers since they need to maintain focus on the road ahead, and could be more likely to overlook signs on each side of the road. Also, as there are many school zones along Pennant Hills Road, it is important that drivers are aware of the start and end points of these zones.</p> <p>The pavement markings should be re-instated to improve the prominence of the western gateway to the school zone.</p>

<p>Above: Looking eastbound along Pennant Hills Road with a view of the faded 40k pavement patches to the west of Osborn Road.</p>	Low

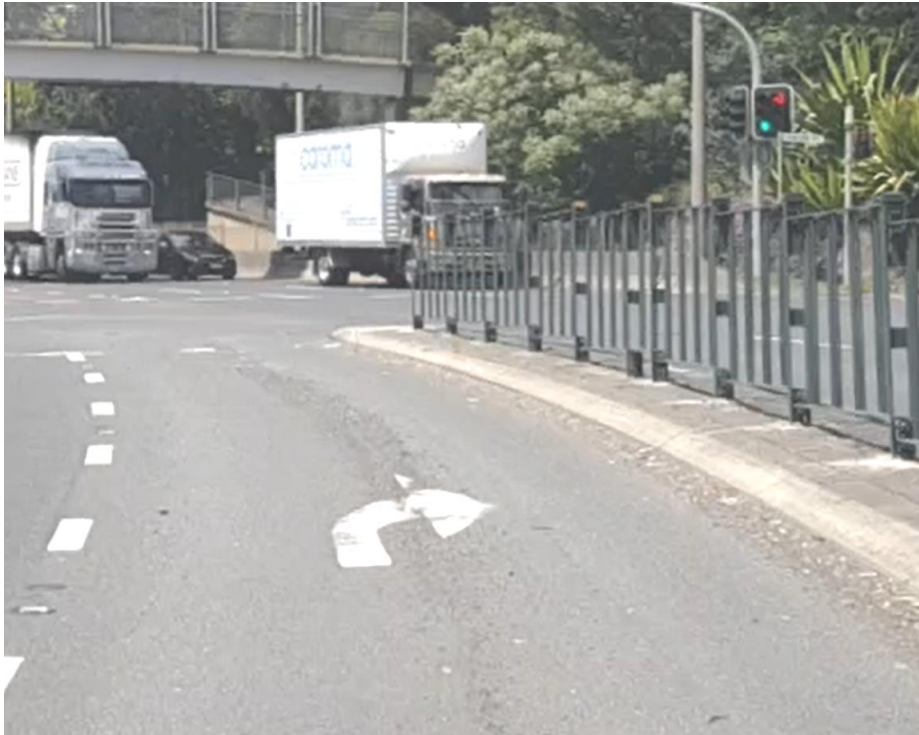
Ref	Theme/ location	Road safety audit finding	Priority
13	Pennant Hills Road, eastbound right-turn lane to Osborn Road and control area of the intersection.	<p>In general, the audit team noted that there was a substantial volume of loose gravel and debris at the Pennant Hills Road/ Osborn Road/ Normanhurst Road intersection. This included the eastbound right-turn lane to Osborn Road and the control area of the intersection. Loose gravel and debris tend to compromise skid resistance and tyre-to-pavement friction. This could affect braking performance and braking distance. It could also affect the stability of the vehicle as it negotiates turns. As such, the reduced skid resistance could increase the risk of <i>loss of control</i> crashes, <i>rear-end</i> crashes and even <i>cross traffic</i> crashes since some vehicles may not stop clear of the control area of the intersection.</p> <p>There is no immediately obvious source of this loose material. As such, the mitigations would tend to be reactive, such as street sweeping and maintenance.</p>

<p>Above: Evidence of loose gravel along the midline of the eastbound right-turn lane to Osborn Road. Note also the loose debris along the fringe of the median SF kerb.</p>	Low

13.	<p>Comment: In general, the audit team noted that there was a substantial volume of loose gravel and debris at the Pennant Hills Road/Osborn Road/ Normanhurst Road intersection.</p> <p>Suggestion: There is no immediately obvious source of this loose material. As such, the mitigations would tend to be reactive, such as street sweeping and maintenance.</p>	<p>As above, this is an issue for RMS to review.</p>
