**Re: Loreto Normanhurst – Early Learning Centre (ELC)
Response to Deferral Decision; Traffic and Transport**

Existing stage road safety audit

Osborn Road, Normanhurst

Mt Pleasant Avenue, Normanhurst

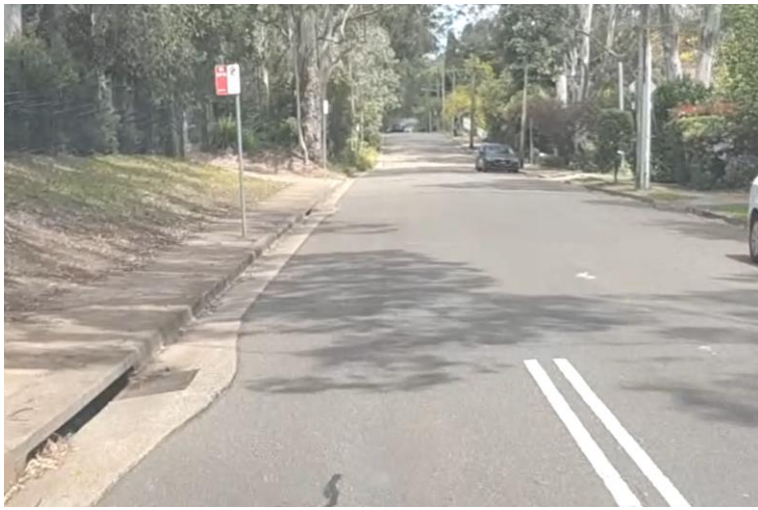
Ref	Theme/ location	Road safety audit finding	Priority
15	Eastern kerblane of Osborn Road between Gates O2 and O3.	<p>A portion of the eastern kerblane between Gates O2 and O3 is signposted as a NO PARKING zone (see below). NSW Road Rule 168 stipulates that drivers are permitted to stop along a kerblane signposted with NO PARKING signs provided that they are dropping off or picking up passengers, remain attending the vehicle, and do not layover for more than two minutes. The audit team acknowledges that the logical management method for formal pickup and drop off of students, and delivery of goods to the school, would be via the internal roadway. However, the audit team envisages that this kerblane would still be used in less formal situations. This could include:</p> <ul style="list-style-type: none"> Drop off and pick up of students outside the typical peak period such as for before-school or after-school activities. Buses and other long vehicles that are unwilling to enter the school grounds. <p>If this kerblane is to remain as a NO PARKING zone, it would need to be managed to minimise risks of congestion at this point. The audit team highlights a number of risky scenarios, as follows:</p> <ul style="list-style-type: none"> If the kerblane is mis-used by parents/ carers that are too impatient to enter the school grounds, it could lead to congestion and potential queue spill back to the north. The audit team noted that there is only 50m of kerb length available which is signposted as a NO PARKING zone. This could lead to upstream congestion if the kerblane is fully occupied (approximately seven passenger cars), or if vehicles stop midway along its length or towards the northern end of this zone. If the queue spills back to the BB double barrier centreline, it may also force trailing southbound drivers to cross this line to pass around the queue. Any vehicles stopped along this kerblane, or moving slowing into or out of a stopped position could also be exposed to <i>rear-end</i> crashes by trailing southbound vehicles. This kerblane is also located on the departure side of a sight-limited crest vertical curve. Trailing drivers may not see or expect slow-moving or stopped vehicles at this point. <p>Consideration could be given to extending the NO STOPPING designation to cover this zone. Alternatively, the risks described above would need to be "managed out" by the school and its policies and traffic management plan.</p>

<p>Left: Looking southbound along Osborn Road towards the NO PARKING zone on the eastern kerblane.</p>	Low

15.	<p>Comment: A portion of the eastern kerbline between Gates O2 and O3 is signposted as a NO PARKING zone...drivers are permitted to stop along a kerbline signposted with NO PARKING signs provided that they are dropping off or picking up passengers...the audit team envisages that this kerbline would still be used in less formal situations.</p> <p>Suggestion: Consideration could be given to extending the NO STOPPING designation to cover this zone.</p>	<p>As above, this was not observed to be an issue during on-site investigations nor the drone surveys.</p> <p>Further, it is noted that PUDO arrangements are currently being reviewed as part of the Master Plan, with the PUDO location to be moved to the southern part of School Grounds on Osborn Road, under the Oval.</p> <p>However, this will be monitored and if required, a request would be made to Council's Traffic Committee to install NO STOPPING signs.</p>

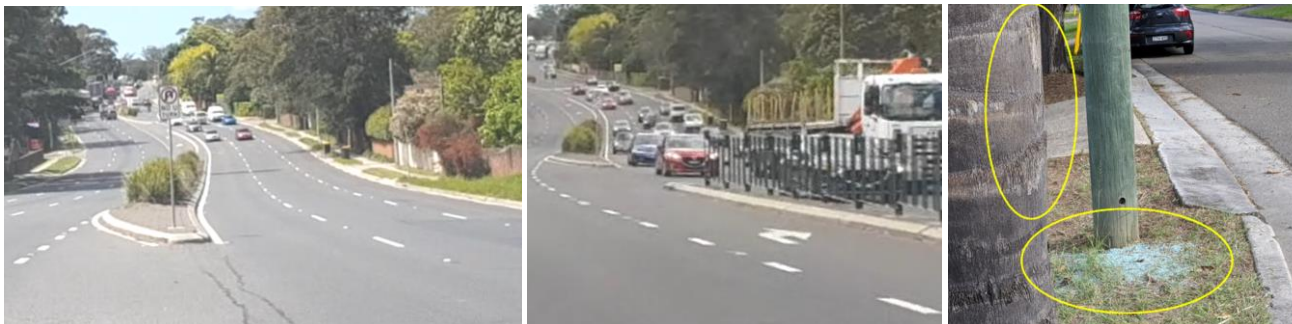
Ref	Theme/ location	Road safety audit finding	Priority
1	Eastbound right-turn movement from Pennant Hills Road to Mt. Pleasant Avenue.	<p>Under existing conditions, eastbound right-turn movements are permitted from Pennant Hills Road to Mt. Pleasant Avenue. This is an uncontrolled turn where the right-turning driver needs to filter across three westbound lanes (and hence three separate traffic streams). As Pennant Hills Road is a major arterial road and one of the primary feeders/ receivers of traffic to/ from the M1 Motorway (less than 1km to the north-east), this route experiences high volumes of traffic. Furthermore, there is also a significant volume of trucks on this route. The high traffic volumes mean that there are few gaps presented in the traffic streams. As a three-lane crossing, the right-turning driver also needs to judge <i>coinciding gaps</i> in all three lanes. The likelihood of gaps in all three lanes coinciding is substantially less than an individual gap in any one of those lanes.</p> <p>In these respects, the filtered right-turn movement would be extremely complex and prone to driver error. This includes poor gap judgement, and deliberate selection of substandard gaps (due to impatience and frustration). Also, another dangerous practice often used by drivers is to “creep out” into initial gaps in lane 3 to then “thread” through gaps in lanes 1 and 2. This method of incremental/ staggered crossing is risky since the driver heavily relies on a gap presenting itself in lanes 1 and 2. Also, if gaps do not present themselves, the driver could be left stranded and exposed to a <i>head on</i>-impact with traffic in westbound lane 3. Also, this method of gap acceptance assumes that vehicles in each respective westbound lane will continue to remain in their lanes. If any vehicle changes lanes, this could also make the gap conditions less predictable.</p> <p>The filtered right-turn movements across three opposing lanes is not ideal for the safety of school-related traffic (particularly due to the more vulnerable road user age groups involved). Also, during non-school zone periods, the opposing traffic is legally allowed to travel up to 70km/h.</p> <p>The audit team also scarring on the palm tree and broken glass at the base of the utility pole on the south-eastern corner of the intersection (see right-hand image). This is possible evidence of crashes involving rushed right-turn movements.</p> <p>Consideration should be given to banning or part-day banning this movement.</p> <div data-bbox="535 978 1823 1303">

</div> <p>Left: Looking eastbound along Pennant Hills Road from the head of the right-turn lane (to Mt. Pleasant Avenue). This is a situation where there are coinciding gaps in all three westbound lanes. Middle: More heavily congested conditions with a lack of gaps. Right: Evidence of previous crashes with scarring on the tree trunk and broken glass at the base of the utility pole.</p>	High

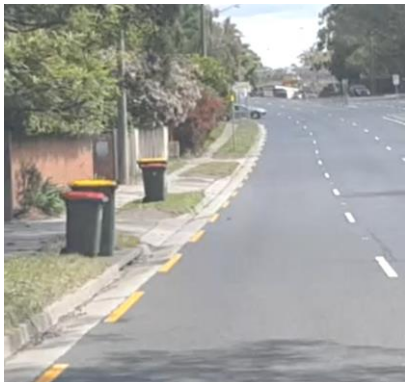
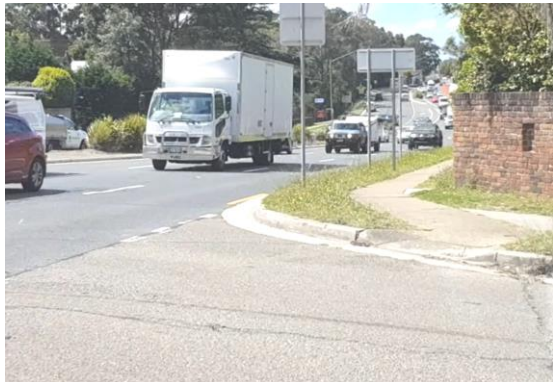
Ref	Theme/ location	Road safety audit finding	Priority
2	Sight line from the hold line of Mt. Pleasant Avenue to Pennant Hills Road North.	<p>The Mt. Pleasant Avenue approach to its intersection with Pennant Hills Road is STOP controlled. As such, all outbound drivers are required to stop, and then assess gaps and traffic conditions in Pennant Hills Road before turning left or right. There is limited <i>minimum gap sight distance</i> (MGSD) from this hold line to the north. The sight constraining features include (i) a brick property wall on the south-eastern corner of the intersection, and (ii) overhanging hedges and tree foliage from properties along the southern side of Pennant Hills Road. The limited MGSD sight line may result in poor gap detection and selection and consequential <i>cross traffic</i> crashes. This is also since there are three southbound approach lanes which makes the gap detection process very complicated. As an initial measure, the overhanging tree foliage from the southern properties could be pruned back to improve the MGSD sight line.</p> <p>Further to the above, right-turn movements are permitted from Mt. Pleasant Avenue to Pennant Hills Road North. This is a high-risk manoeuvre due to several constraining factors, as follows:</p> <ul style="list-style-type: none"> ▪ The MGSD sight line to the north is restricted as discussed above. ▪ The MGSD sight line to the south is also restricted due to the median pedestrian fence and the limited “see through” visibility as a result of the fence balusters and posts. ▪ The right-turn movement requires gap detection and selection, and then crossing of three individual westbound traffic lanes. It also requires gap detection and selection in the eastbound carriageway (up to six lanes altogether). Ideally, the driver should make the right-turn when there are gaps in all three eastbound lanes. However, in reality, many drivers may resort to using gaps in lanes 2 and 3, knowing that vehicles in lane 1 eastbound (kerbside lane) are less of a collision threat. The gap checking process is extremely complicated, and many drivers may also attempt a staggered crossing method, where they accept a gap in the westbound carriageway and then drift forwards slowly in the hope that a gap presents itself in the eastbound carriageway. This is a risky method of entry. If gaps do not present themselves in the eastbound carriageway, the right-turning vehicle would be left stranded and exposed to collisions by westbound vehicles. <p>Consideration should be given to banning the outbound right-turn from Mt. Pleasant Avenue, or at least implementing a part-day ban.</p> <div style="display: flex; justify-content: space-around; align-items: flex-start;"> <div style="text-align: center;">

<p>Left-hand image: Looking westbound along Pennant Hills Road towards Mt. Pleasant Avenue from lane 1. Note the restricted sight line between this traffic lane and the outbound vehicle from Mt. Pleasant Avenue. The sight-constraining features are the overhanging tree foliage from the southern properties. Note also how the outbound vehicle has advanced forwards into the westbound carriageway, to establish a better MGSD sight line.</p> </div> <div style="text-align: center;">

<p>Right-hand image: The view from the hold line of Mt. Pleasant Avenue to the north. Note the impact of the brick property wall on the MGSD sight line. To establish a better sight line, the driver would need to advance further out and possibly into the westbound carriageway of Pennant Hills Road. This would increase the risk of cross traffic crashes.</p> </div> </div>	High

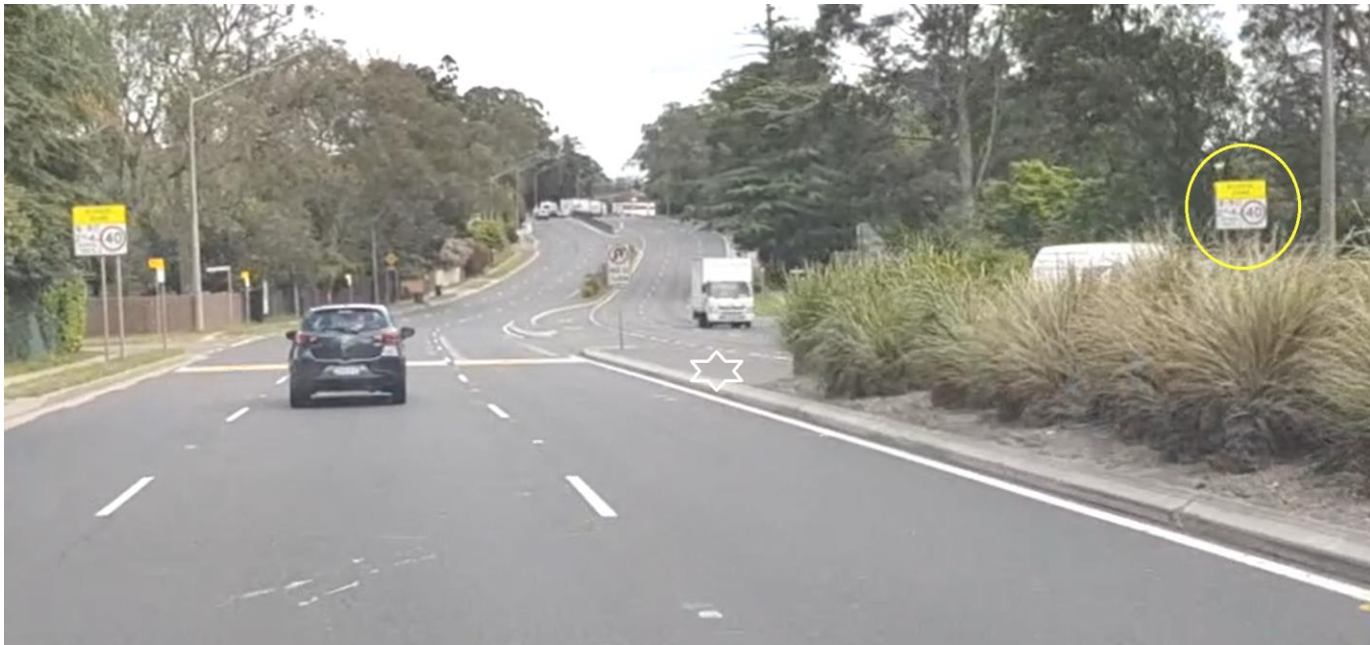
Ref	Theme/ location	Road safety audit finding	Priority
3	Westbound travel direction of Pennant Hills Road in approach to Mt. Pleasant Avenue.	<p>In the westbound travel direction of Pennant Hills Road, the school zone commences to the immediate east of Mt. Pleasant Avenue. This consists of a pair of SCHOOL ZONE signs, and 40k patches and dragon's teeth markings in each travel lane. However, the right-hand SCHOOL ZONE sign (circled in yellow) is placed on the northern side of the road which is well outside the forward field of view of westbound drivers. This sign would be more appropriately placed on the median (marked by the white star) to improve its visual prominence. If relocated to the median, the sign face should be mounted sufficiently high to maintain the sight lines between eastbound right-turners (in the right-turn lane to Mt. Pleasant Avenue) and westbound traffic that are approaching this point.</p> <p>The audit team also notes that whilst the eastbound travel direction of Pennant Hills Road contains a flashing light unit on the SCHOOL ZONE sign, there is no corresponding flashing light unit provided in the westbound direction (at the location shown below). This is a point of inconsistency. Whilst the flashing light assembly is not a mandatory requirement, it greatly enhances compliance with the 40km/h school zone speed limit since drivers are more certain as to when the school zone conditions are in effect. That is, there is less ambiguity as to whether the road is under a 40km/h school zone speed limit, or operating to the default 70km/h speed limit. In these respects, consideration should also be given to retrofitting a flashing light assembly at this point.</p> <p>The audit team also notes that the 40k pavement patches have faded which reduces the effectiveness of these as regulatory and advisory devices.</p>

<p>Above: Looking westbound along Pennant Hills Road showing the large lateral offset of the right-hand SCHOOL ZONE sign and the lack of flashing light units on either sign.</p>	Medium

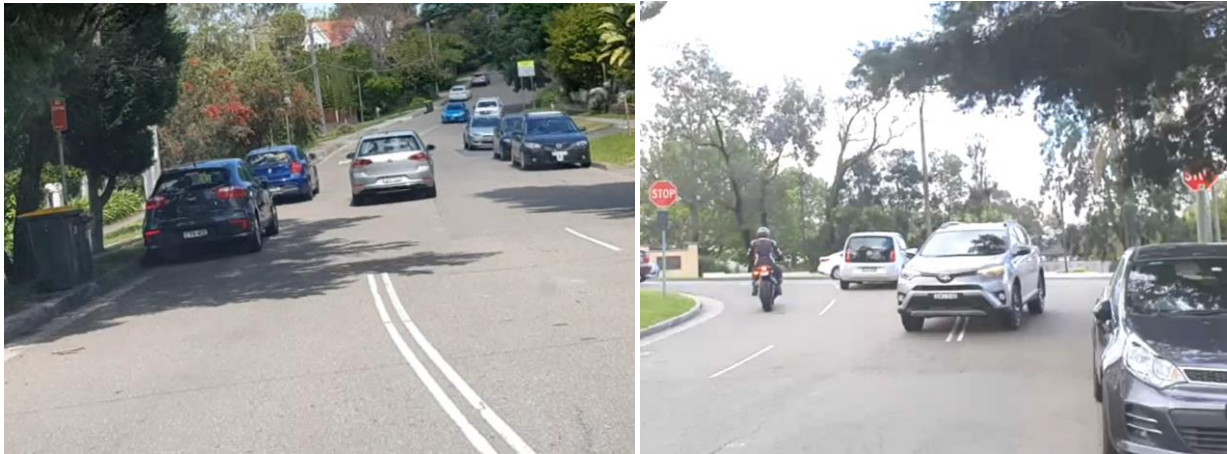
Ref	Theme/ location	Road safety audit finding	Priority
4	Eastern kerb line of Mt. Pleasant Avenue to the south of Pennant Hills Road.	<p>On the eastern side of Mt. Pleasant Avenue to the south of Pennant Hills Road, there is a NO STOPPING sign with a single-sided, north-facing arrow. As such, this allows vehicles to stop/ park along the eastern kerbline to the south of this point. As shown in the left-hand image, any vehicles parked along this kerb, would severely limit the space available for other southbound vehicles. The silver southbound vehicle has encroached well into the space of the opposing traffic stream. Furthermore, to take this travel path, it also crossed over the BB double barrier centreline. This presents <i>head-on</i> crash risks with the opposing (northbound traffic stream). The blue vehicle approaching this point would either need to stop to allow the southbound vehicle to clear through this squeeze point, or else they would be exposed to this <i>head-on</i> crash risk.</p> <p>Another risk scenario would be when there are queues in the northbound travel direction such that there is insufficient space/width for the southbound vehicle to pass (due to the parked vehicle on one side and a queued vehicle on the other). The southbound vehicle would be forced to stop until the queue dissipates. This is in the immediate departure from the intersection where they could be exposed to a rear-end impact by other trailing traffic.</p> <p>To reduce the risk of cross centreline breaches and <i>head-on</i> crashes, the NO STOPPING sign should be relocated further south.</p>

<p>Left: Looking southbound along Mt. Pleasant Avenue showing the impact of vehicles (legally) parked on the eastern kerbline, on the residual passing clearance for other southbound traffic. Right: Another example where a southbound vehicle was forced to cross the BB centreline due to a vehicle parked on the eastern kerbline. Note also the potential risk to queued vehicles in the northbound direction. If there were more vehicles in this queue, there would have either been (i) a crash risk between the cross centreline southbound vehicle and the queued vehicle or (ii) the southbound vehicle would be forced to stop in the immediate departure from the intersection where it would be exposed to rear-end crash by other trailing southbound vehicles.</p>	Medium

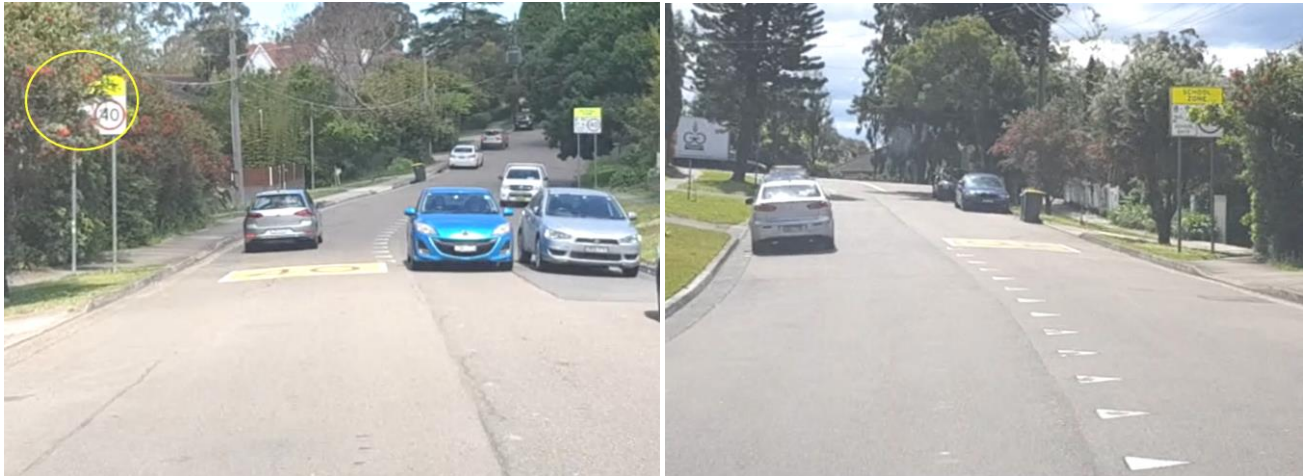
Ref	Theme/ location	Road safety audit finding	Priority
5a	General – Visually obscured signs along Mt. Pleasant Avenue.	<p>There are several signs along the audited length of Mt. Pleasant Avenue which are visually obscured by tree foliage. The signs therefore lack effectiveness in conveying the regulatory and speed zoning advice. Many of these signs also contain time-based information, such as when the school zone (and hence variable speed limit of 40km/h) is in operation.</p> <p>The visually obscured signs are depicted below as well as in item 5b, with descriptions in the captions. These are generally mitigatable by tree pruning works.</p>

<p>Left: Looking southbound along Mt. Pleasant Avenue with a view of the partially obscured SCHOOL ZONE sign. Right: Looking northbound at the reverse side of the first sign. The SCHOOL ZONE sign in this direction is also partially obscured by tree foliage.</p>	Medium

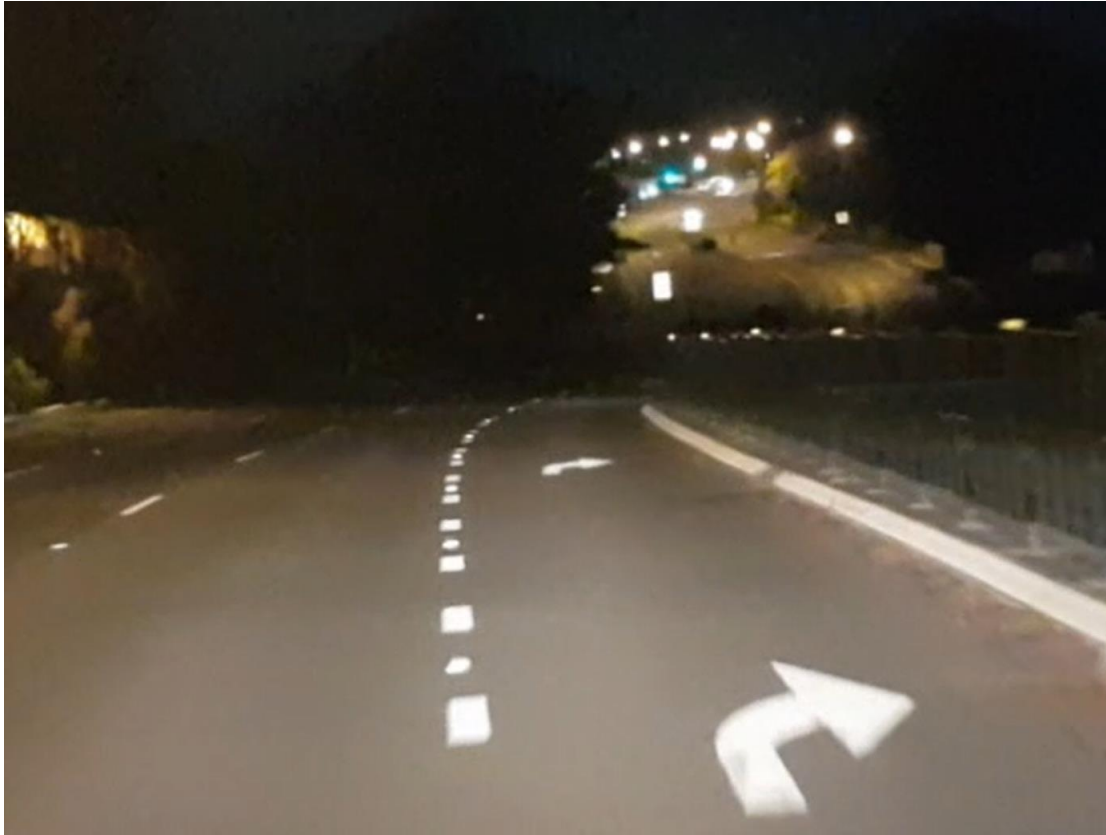
Ref	Theme/ location	Road safety audit finding	Priority
6	Pennant Hills Road, at its intersection with Mt. Pleasant Avenue.	<p>From the night time inspection of the site, the audit team noted that there is a relative dark patch along Pennant Hills Road at its intersection with Mt. Pleasant Avenue. This appears to be a result of missing or malfunctioning street light luminaires. The impact of the poor lighting is evident in the image below, showing the contrast between the poorly lit roadway in the foreground and the much better lighting performance further downstream (east).</p> <p>The poor lighting at this location could increase the risk of night time crashes. Especially if the object being struck is non-reflective or non-illuminated. Eg. a fallen load, damaged tyre etc. The poor lighting also means drivers would have less awareness of pavement conditions.</p>

<p>Above: Looking eastbound along Pennant Hills Road during the night time inspection, showing the poor lighting standard at the Mt. Pleasant Avenue intersection.</p>	Medium

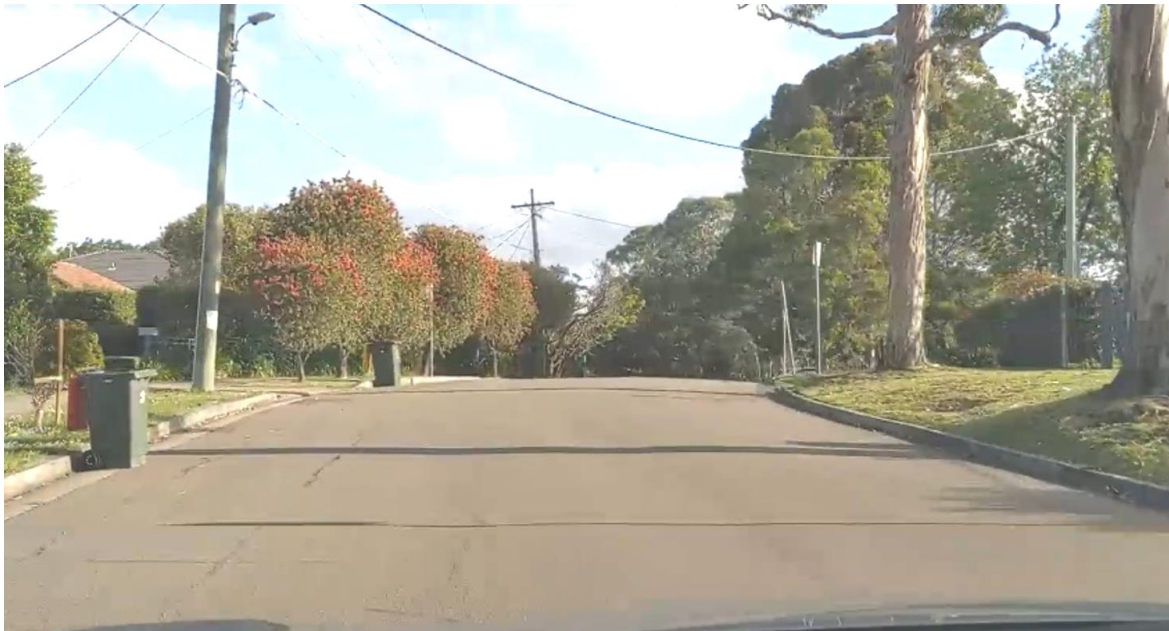
Ref	Theme/ location	Road safety audit finding	Priority
7	Section of Mt Pleasant Avenue at the main entrance to Loreto Normanhurst.	<p>There is a pair of right-left reverse curves in combination with a crest vertical curve. The combined effect of the horizontal curves and the crest has reduced driver visibility to the road ahead. As such, drivers may not be aware of the road alignment in the road ahead. This is particularly critical if drivers in either direction drift towards the midline of the road where there could be corresponding <i>head-on</i> crash risks with opposing vehicles. Consideration should be given to providing a centreline to define and separate opposing traffic streams.</p>

<p>Above: Looking southbound along Mt Pleasant Avenue towards the crest-curve combination.</p>	Medium

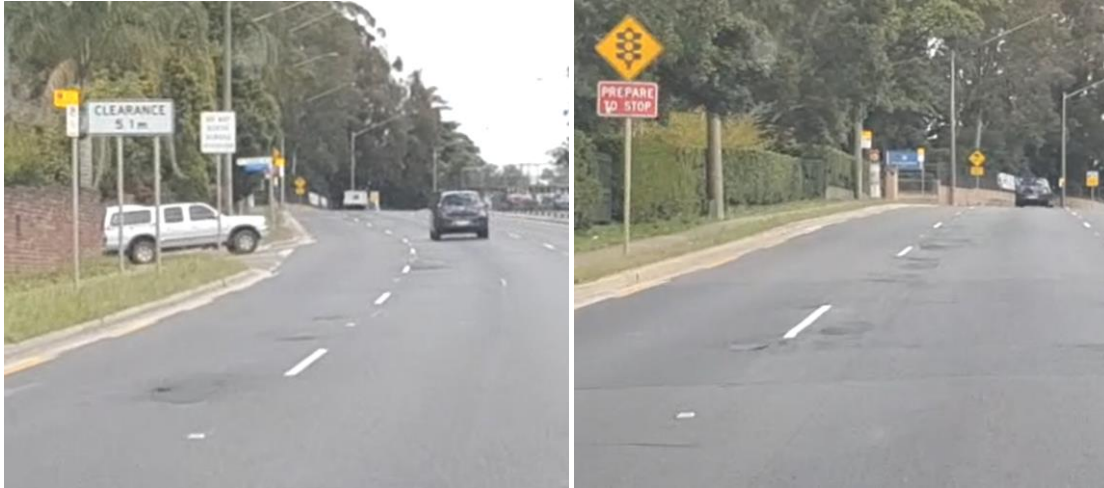
Ref	Theme/ location	Road safety audit finding	Priority
8	Pennant Hills Road, westbound carriageway between the start of the school zone and the pedestrian bridge.	<p>At the time of the inspections, there were numerous potholes and pavement failures in the westbound carriageway of Pennant Hills Road. These may destabilise vehicles and increase the risk of <i>loss of control</i> events. The potholes may also lead to progressive damage to the pavement and its sub-base. This is especially if water is able to seep in these voids. As such, without intervention, the potholes are likely to become larger and deeper.</p> <p>Many of these potholes are also in the wheelpaths of vehicles. The frequent wheel loading on these failures may also exacerbate the damage, and may also limit the effectiveness of any patchwork.</p> <div data-bbox="535 389 1635 879">

</div> <p>Left: Looking westbound along Pennant Hills Road with a view of pavement failures in lanes 1 and 2 of the westbound carriageway. Right: More potholes along the left-wheel path in lane 2, to the west of Mt. Pleasant Avenue.</p>	Low

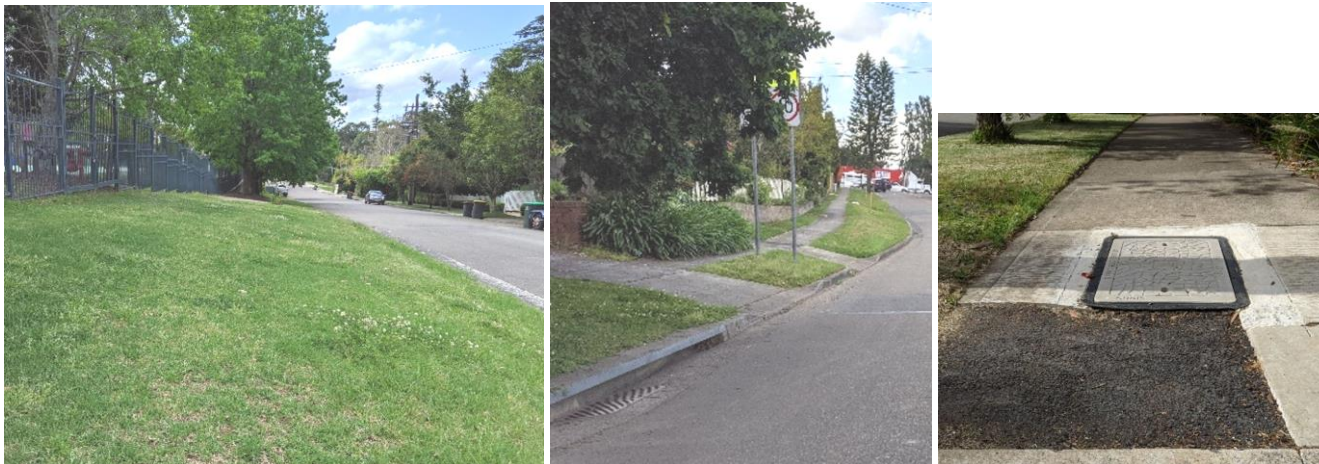
Ref	Theme/ location	Road safety audit finding	Priority
9	Western side of Mt. Pleasant Avenue.	<p>There is no footpath on the western side of the road along the school frontage (left-hand image). As such, any pedestrian traffic generated from the school would be forced to walk on the unpaved portions of the verge with increased risks of trips and falls. Alternatively, these pedestrians may resort to walking on the roadway, or crossing the road to access the eastern footpath. The steep cross fall of the verge (also evident in the left-hand image) would also discourage pedestrians from using this verge area. As such, any movements along or across the road would present risks of <i>vehicle-pedestrian</i> crashes including events that may involve school students and staff.</p> <p>Consideration should be given to providing a footpath on the western side of Mt. Pleasant Avenue to link into the pre-existing footpath further north. This would also allow greater flexibilities since any walk-based trips to/ from the east would be more conveniently catered for along this road, rather than using the Osborne Road gates and circuiting around (a much longer trip).</p> <p>Also, with the pre-existing footpath further north, there are several sections which have limited effective width due to overhanging bushes and trees (middle image). These should be cleared back to re-instate the full width of the footpath. Many sections of this path are also uneven and could present as current or future trip hazards (see right-hand image).</p> <div data-bbox="535 561 1850 1027">

</div> <p>Left: There are no footpaths on the western side of Mt Pleasant Avenue along the school frontage. Middle: the effective width of the footpath (further north) is reduced due to overhanging trees/ bushes. Right: An example of uneven path levels at this utility lid and backfilled trench.</p>	Low

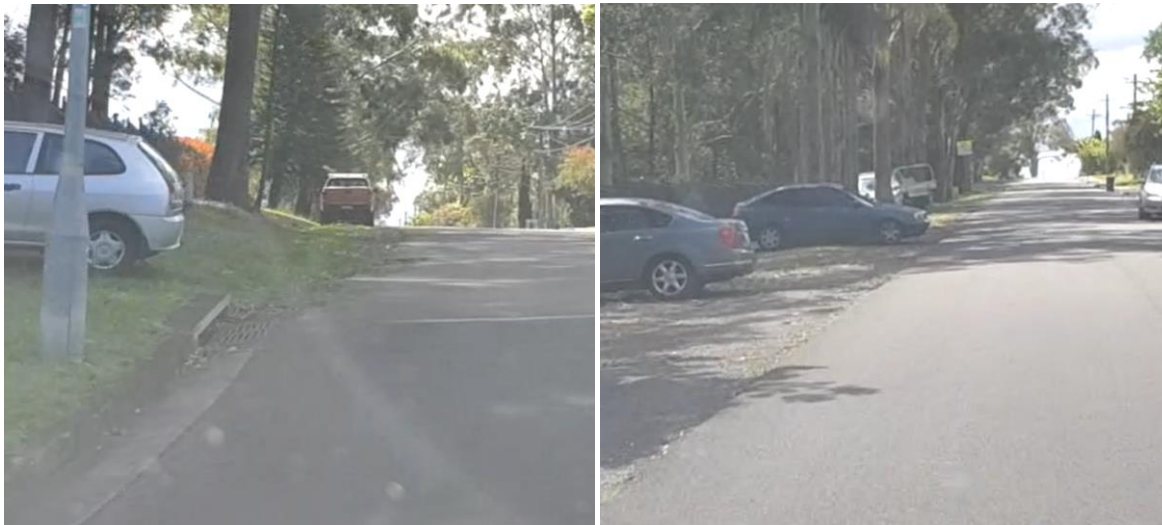
Ref	Theme/ location	Road safety audit finding	Priority
10	Western verge of Mt. Pleasant Avenue at the southern end of the school frontage.	<p>At the southern end of the audited length of Mt. Pleasant Avenue, the kerb-bounded section of this road transitions to an un-kerbed section with an unpaved verge. This is a rather informal road-verge interface for an urban and residential area. As such, the following issues were present:</p> <ul style="list-style-type: none"> With no continuing kerblines in place, there is a jagged pavement edge which forms a vertical lip. This could destabilise vehicles and also inhibit re-entry of vehicles to the roadway if they stray outside the traffic lanes. Pronounced vertical lips typically result in <i>tyre scrubbing</i> where the inside and vertical wall of the tyre scrubs along the vertical edge of the pavement. This can lead to tyre damage and also contribute to <i>loss of control</i> events. The lack of kerb and gutter, also presents an abrupt reduction in sealed and trafficable width. This is evident in the left-hand image where the kerblines suddenly terminates and the pavement boundary juts into the roadway. This would increase the risk of wheel tracking on the soft verge as well as across the pavement boundary where the frequent wheel contact and loading may also lead to progressive damage to the edge of pavement. The lack of a lined gutter also means that water accumulation along the informal interface is likely to ingress to the sub-base levels of the pavement. This could lead to structural weakening of the sub-base with consequential collapse of the overlying pavement. The deteriorating edges are evidence of this. The informal verge area is used as a parking area. The frequent trafficking of this area would lead to progressive damage to the edge of pavement. As the sealed and trafficable portion of road is narrower along this area, this also means vehicles parked at this location are able to be parked closer to road traffic with risks of impacts by passing traffic (see right-hand image). <div data-bbox="535 743 1693 1270">

<p>Left: Looking northbound along Mt. Pleasant Avenue at the point where the road transitions from kerb-bounded to an informal road-verge interface with variable edge conditions. Right: The narrower width of sealed and trafficable roadway allows parked cars to be positioned much closer to traffic with risks of impacts.</p> </div>	Low

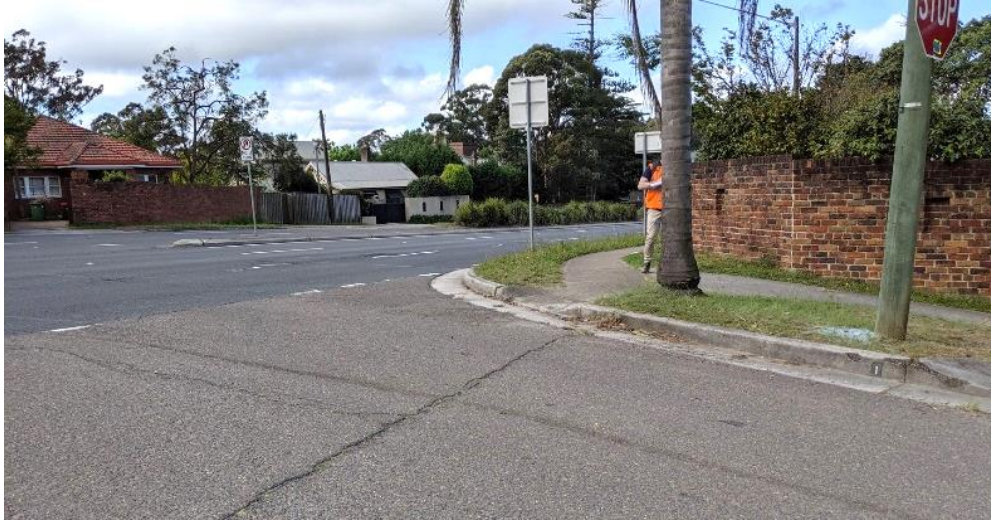
<p>Above: The kerb ramp on the south-eastern corner of the intersection.</p>	Low

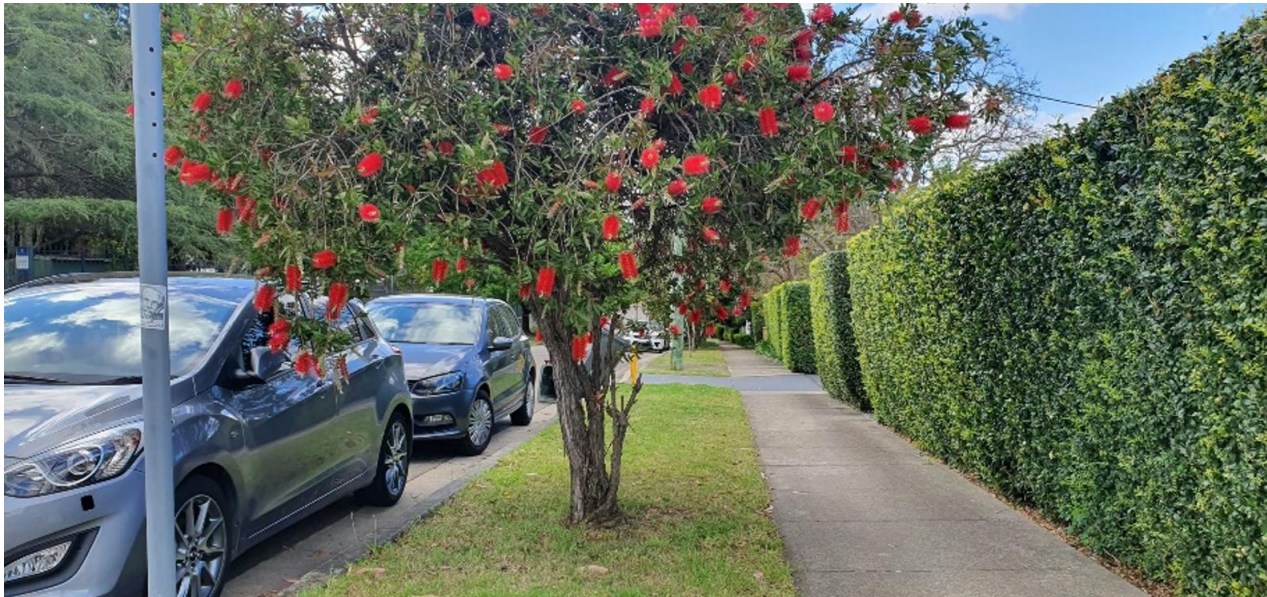
<p>Above: The view from one driveway on the eastern side of Mt Pleasant Avenue towards the north. The sight lines were obscured by trees in the eastern verge.</p>	Low
