## **ARBORICULTURAL IMPACT ASSESSMENT**

**Zhiva Living**

**3 QUARRY ROAD and 4 VINEY ROAD  
DURAL**

**MARCH 2019**

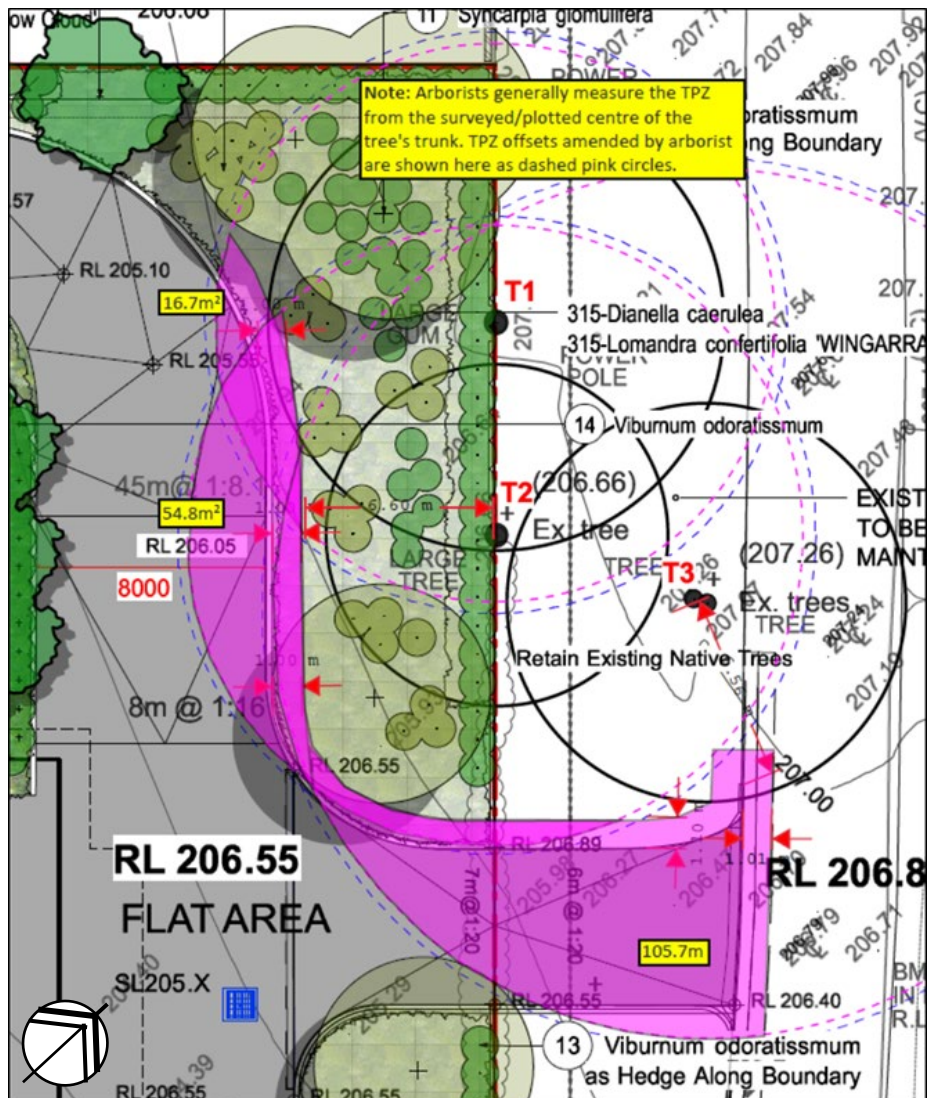
**Figure 1**

Illustrates the methodology used to determine the calculated TPZ encroachments. In this instance, the TPZ (dashed circles) of Trees 1, 2 and 3 are shown. The pink shaded areas depict the TPZ encroachments from the proposed internal road and crossover footprint (with approximately 1m or so 'disturbance zone' added).

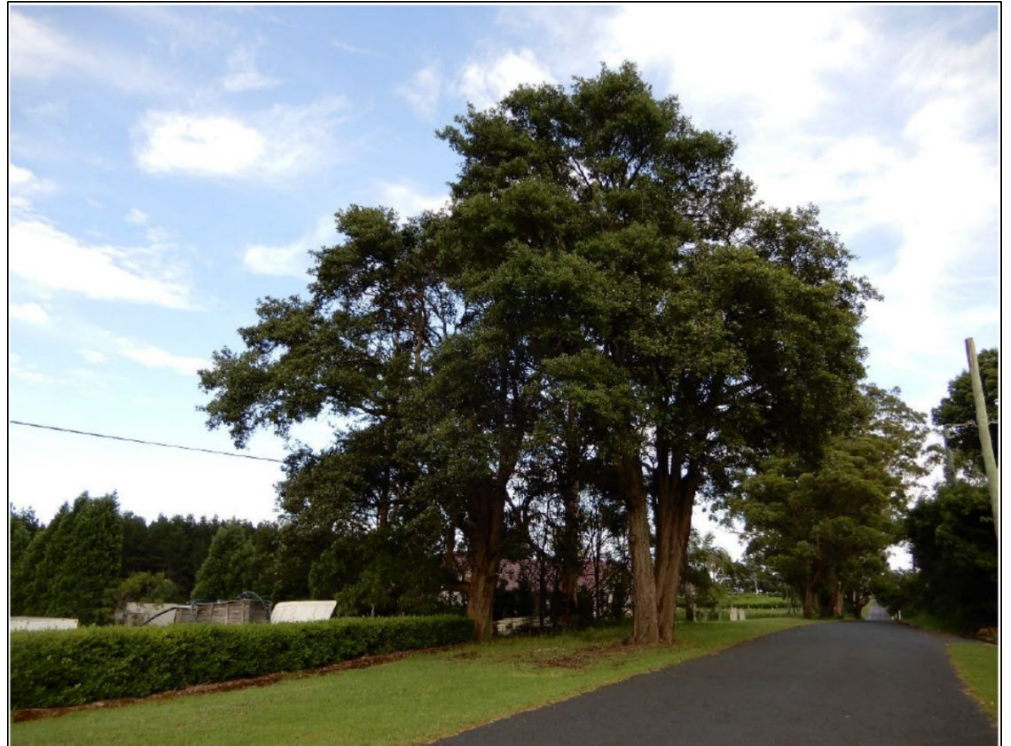
Photograph 2: Illustrating tree numbers 1, 2 and 3.

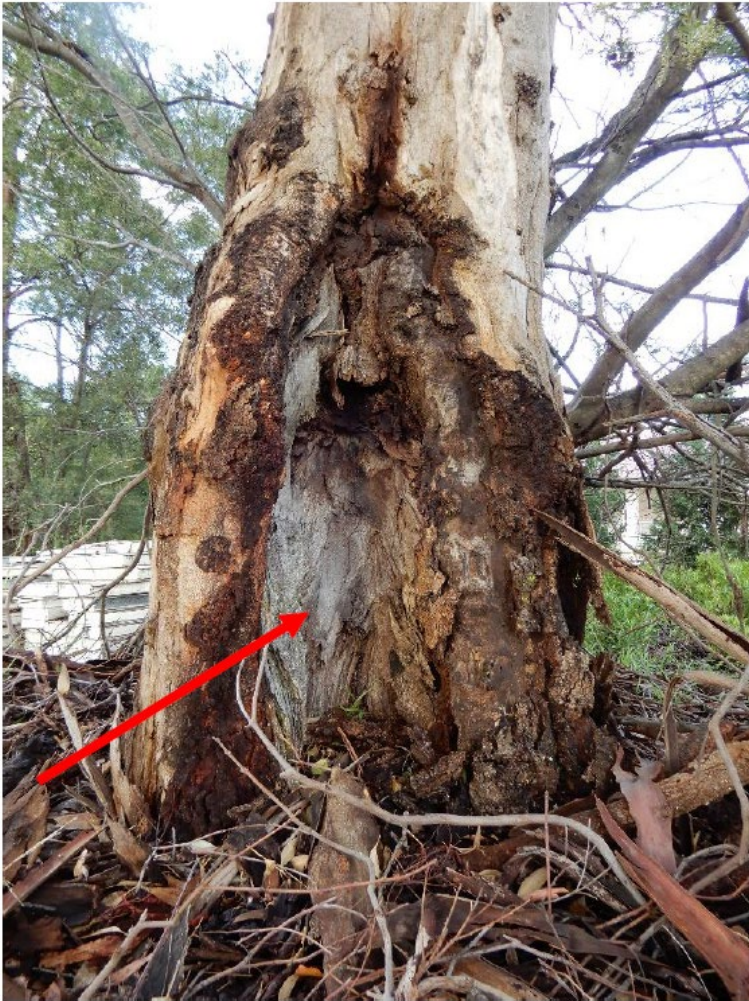
| TREE NO. | SCIENTIFIC AND COMMON NAME | TPZ | SRZ | COMMENTS |
|---|---|---|---|---|
| 1 | <i>Eucalypts punctata</i><br>(Grey Gum) | 9.8 metres | 3.4 metres | The tree's past canopy development has been suppressed. There is evidence of decay in the basal trunk at the site of past failure of a codominant leader on the NE side - exposed heartwood appears sound but further investigation and/or testing recommended to confirm structural integrity. The tree displays fair branch attachment with past failure of a codominant leader at ground level on the NE side and evidence of poor attachment at some branch junctions. At the time of inspection the tree was of fair vigour and exhibited low levels of dieback. |

Photograph 3: Illustrating past failure of a leader – tree no. 1.

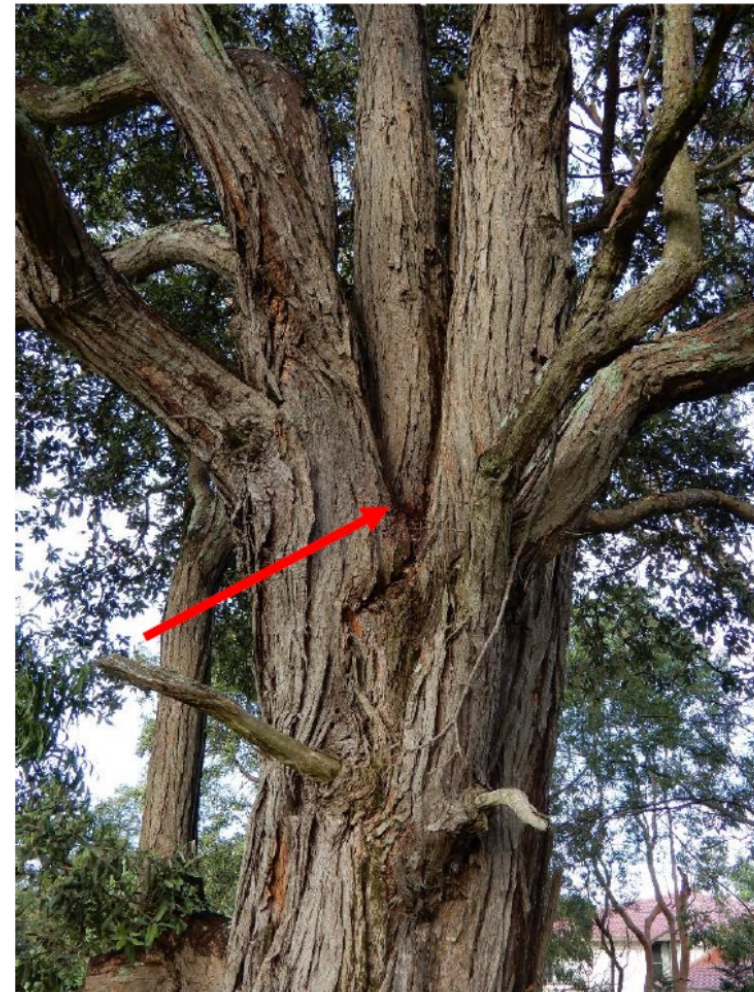
| TREE NO. | SCIENTIFIC AND COMMON NAME | TPZ | SRZ | COMMENTS |
|---|---|---|---|---|
| 2 | <i>Syncarpia glomulifera</i><br>(Turpentine) | 10.8 metres | 3.4 metres | The tree's past canopy development has been suppressed. The tree displays fair branch attachment with multiple leaders from 3 metres with some evidence of poor attachment at the junction - the junction is a weak point in the tree's structure with increased risk of failure but is not considered at risk of failure in the short |

Photograph 4: Illustrating multiple leaders from 3 metres – tree No. 2.

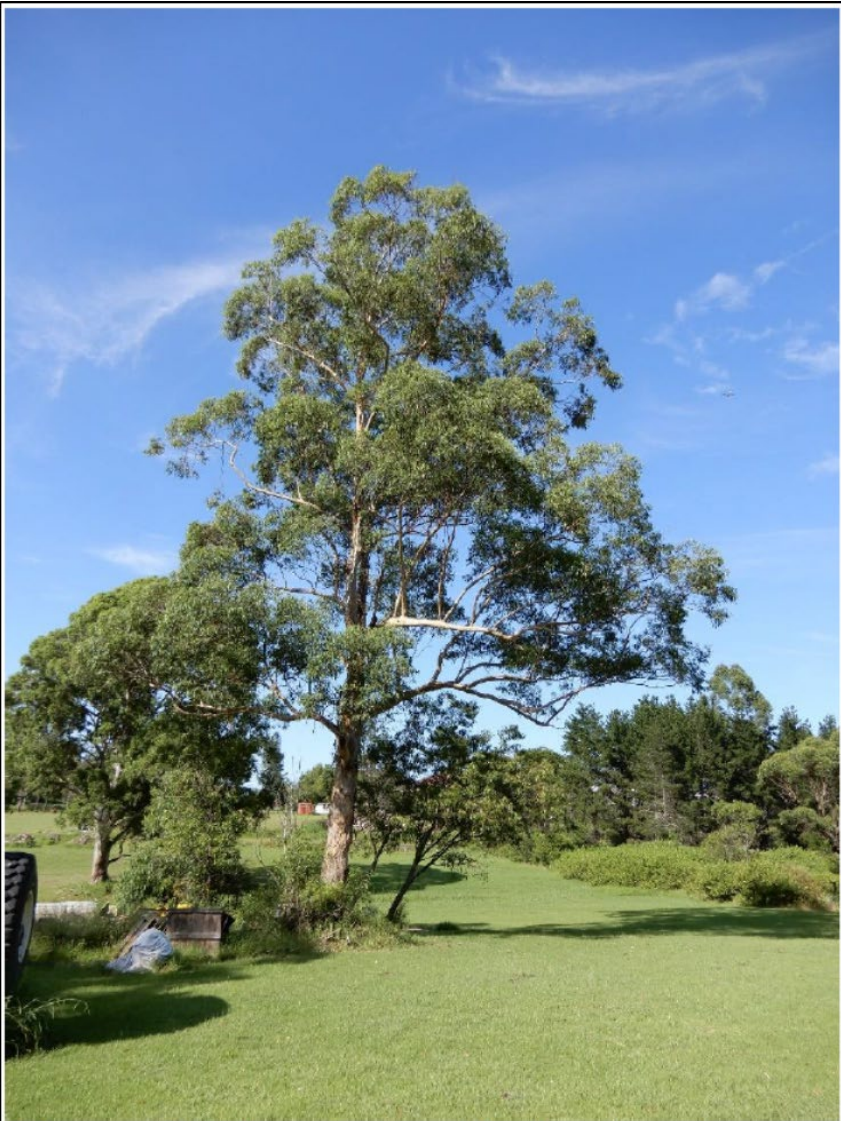
Photograph 5: Illustrating tree 10 – location and context.

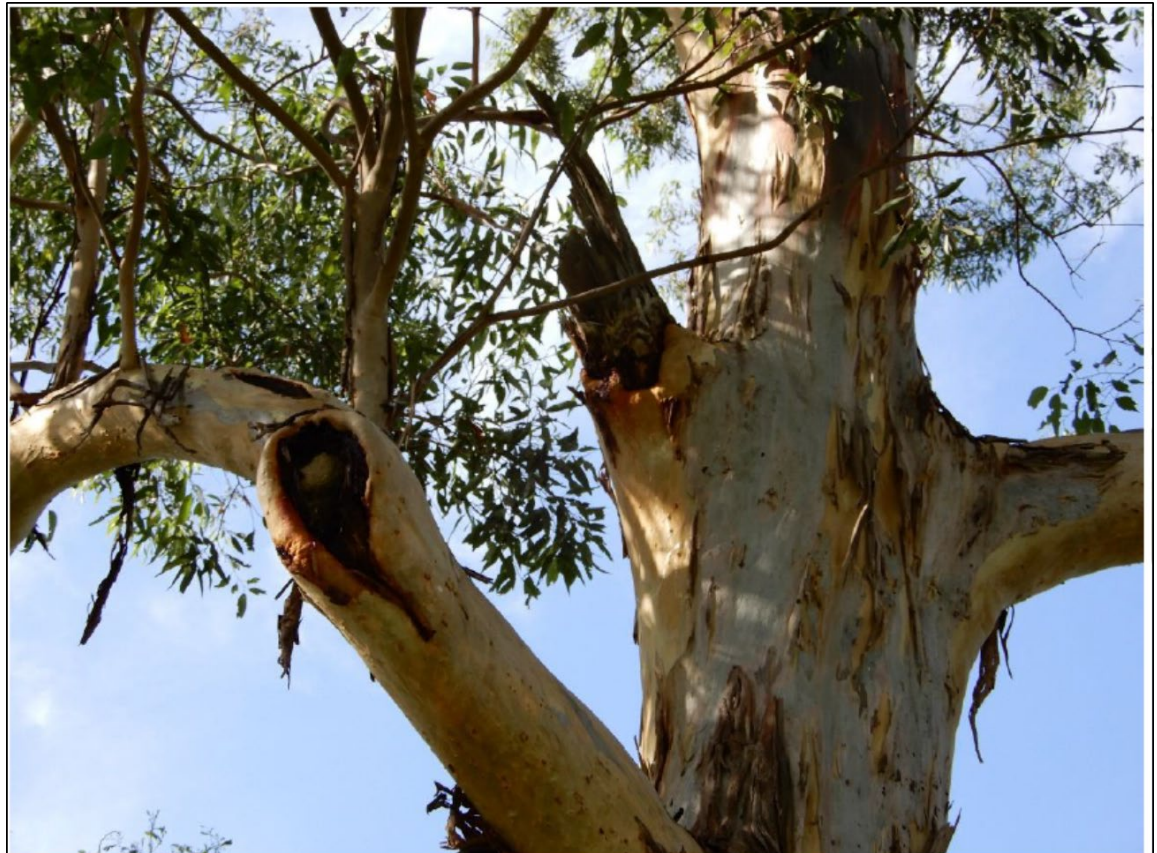
| 10 | <i>Eucalyptus saligna</i> (Sydney Blue Gum) | 10.8 metres | 3.4 metres | Past tissue loss and exposed heartwood at 11.6 metres on west side - cause unknown - monitor. The tree displays fair to poor branch attachment with evidence of multiple past branch failures from the low to mid/upper crown (including some storm damage) - further failures are predictable - limited access or exclusion zone around tree is recommended if tree is retained. |

Photograph 6: Illustrating past branch failures – tree 10.

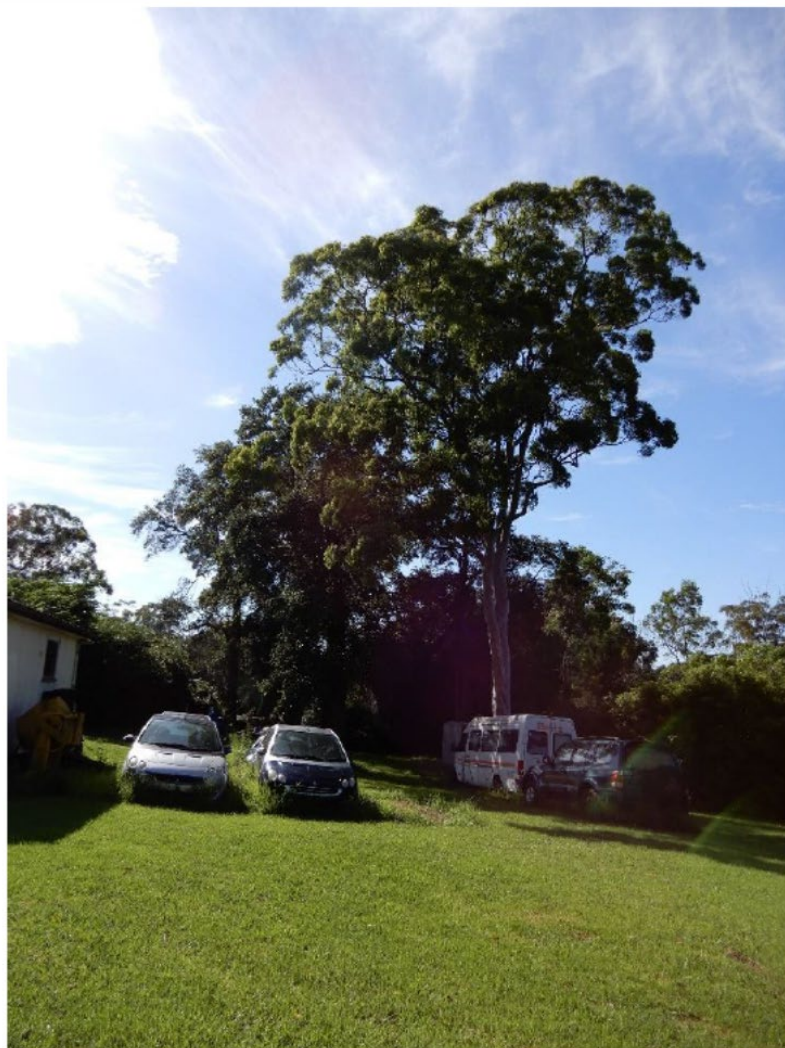
Photograph 7: Illustrating location and context tree Nos. 11 to 16.

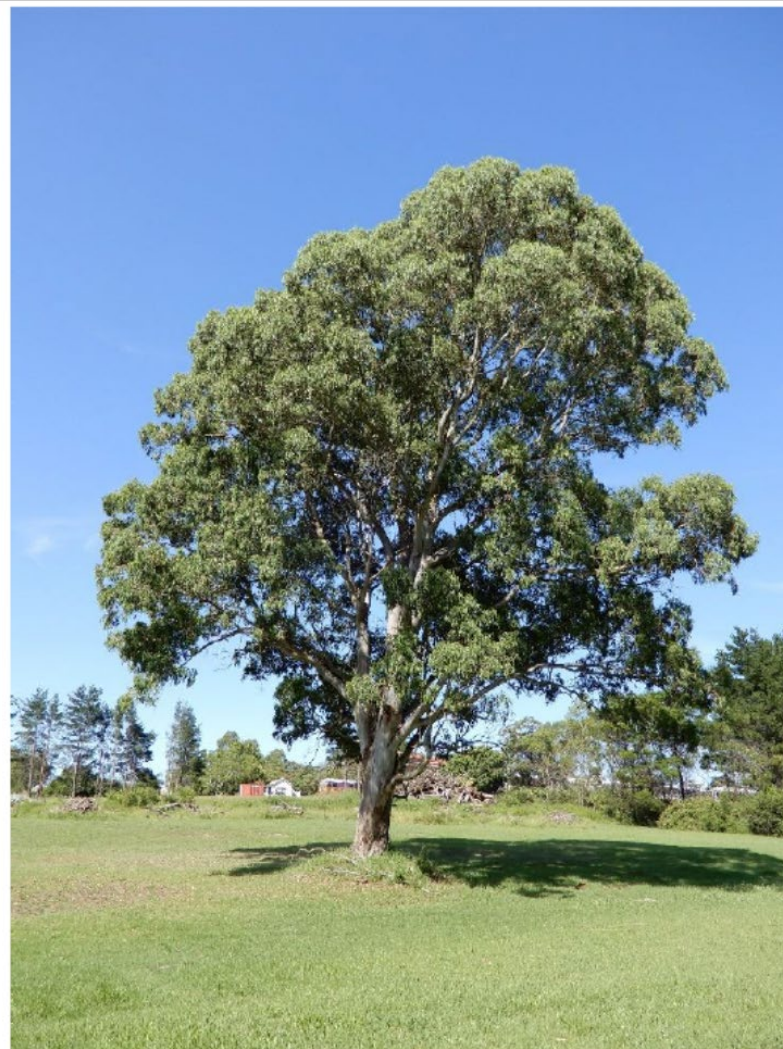
| 21 | <i>Eucalyptus tereticornis</i> (Forest Red Gum) | 13.7 metres | 3.7 metres | The tree displays fair branch attachment with evidence of multiple past branch failures (e.g. at 3.5 metres on north) and some evidence of poor attachment at junctions - further failures likely - restricted access or exclusion zone recommended if retained. |

Photograph 8: Illustrating location and context of tree 21

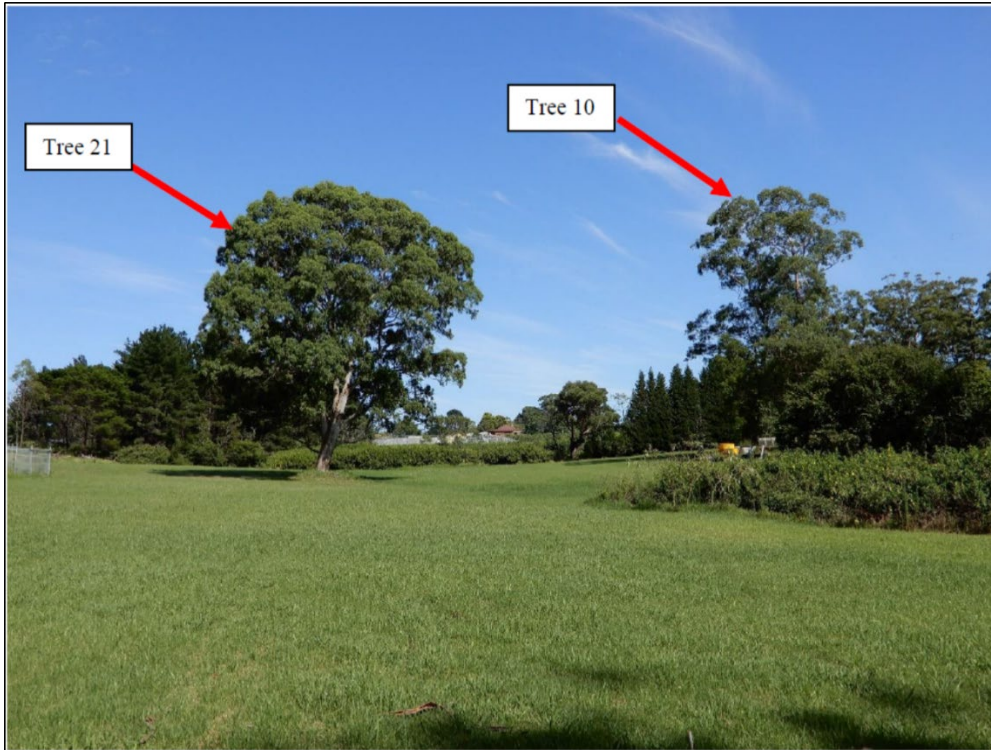
Photograph 9: Illustrating location and context of trees 10 and 21.

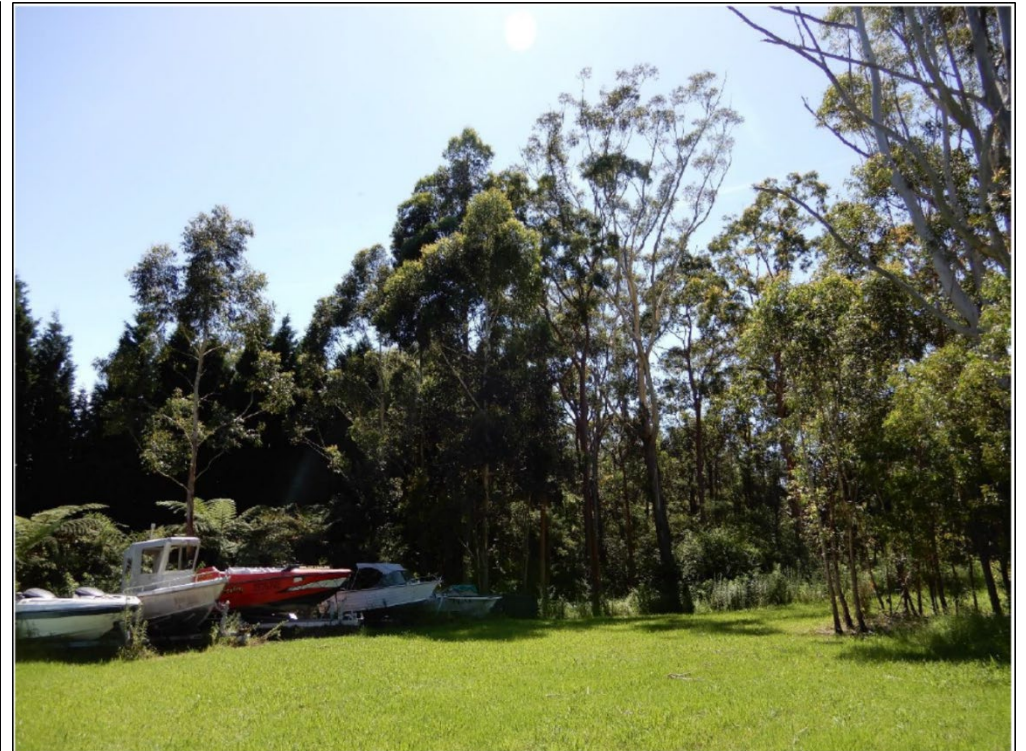
Photograph 10: Illustrating location and context of trees 22 to 38.

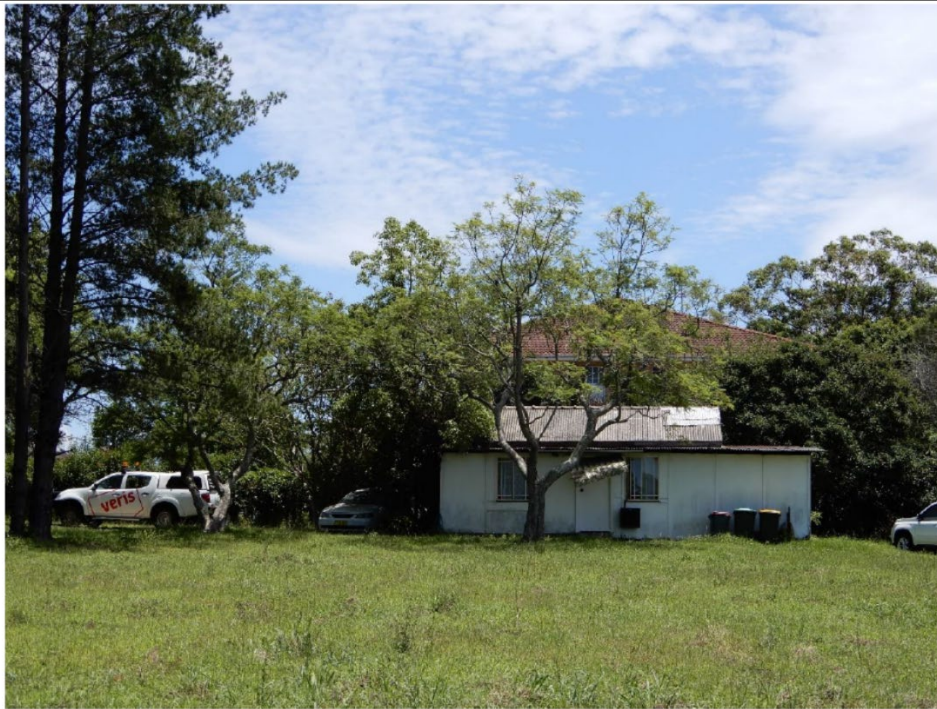
Photograph 11: Illustrating location of dwelling at 3 Quarry Road and context of trees 42 to 48.

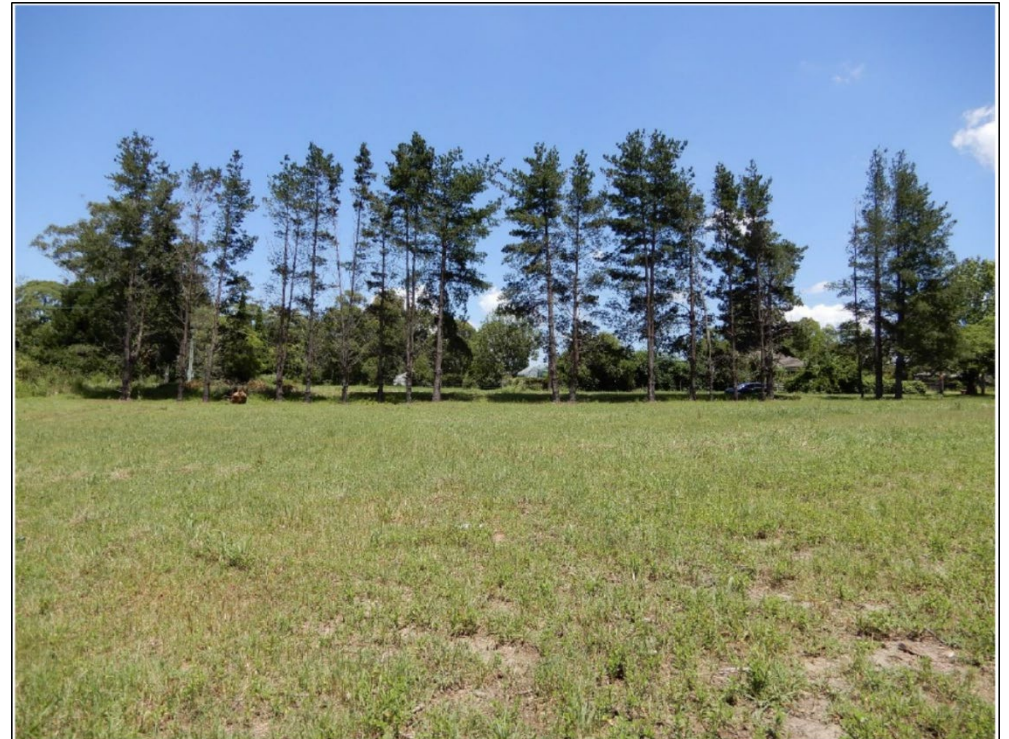
Whilst these Pine trees are nominally identified as retention value 2 trees I do not recommend retention of these Pine trees due to potential concerns regarding their stability. While the trees do not exhibit visual evidence of instability it is apparent they are isolated, remaining trees that were part of larger plantation planting with the majority of the trees removed in the recent past. The extent of the previous Pine plantation on the site is identified on Google Maps and, to a lesser degree, the site survey.

As such the trees are now subject to significantly greater wind loads than their root systems have adapted to rendering them at greater risk of failure. This is evidenced by a recently fallen Pine tree in the row of Pine trees parallel to the Quarry Road boundary of the site.

Photograph 12: Illustrating location and context of pine trees 49 to 63.
