CLEARANCE CERTIFICATE – ASBESTOS REMOVAL

CLIENT DETAILS	
Name of client:	Department of Education (NSW) C/O NSW Public Works Advisory
Project number:	PS110139
Client contact details:	Ray Sayad - ray.sayad@finance.nsw.gov.au
ASBESTOS REMOVAL WORK DETAILS	
Site address where asbestos removal work is being carried out:	Canterbury South Public School 20 High St, Canterbury NSW 2193
Date(s) asbestos removal work carried out:	25th January 2019
Scope of work (as advised by client/contractor):	Provide air-monitoring and perform a clearance inspection following the removal of asbestos containing fibre cement fragments from the visible and accessible surface portions of the delineated impacted area.
Details of the specific asbestos removal work area(s):	Removal area comprised of the visibly accessible, exposed ground surface portions of the southern playground area of the school and the area north west of Block F. (Refer to Appendix C).
Type of asbestos containing material removed:	<input type="checkbox"/> Friable <input checked="" type="checkbox"/> Non-Friable <input type="checkbox"/> Asbestos containing dust/debris

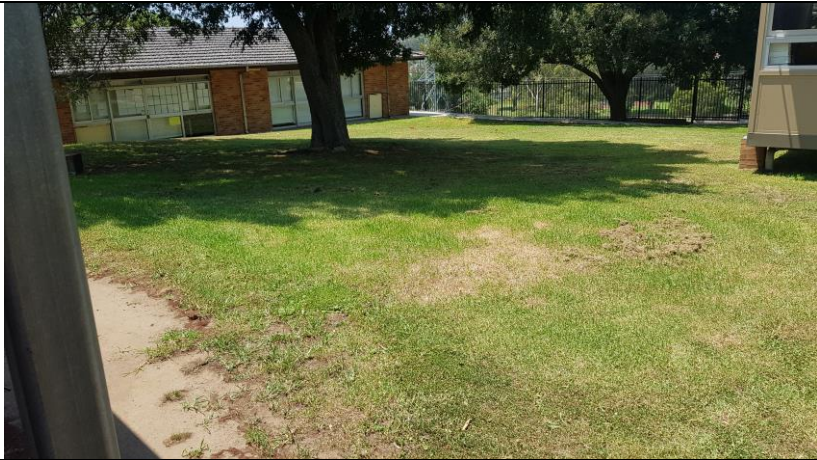
Photo 1: Southern playground area of school post removal.

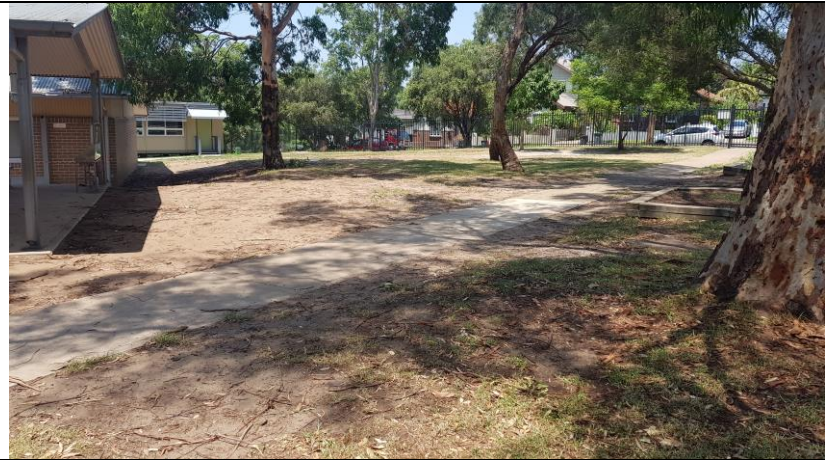
Photo 2: Southern playground area of school post removal.

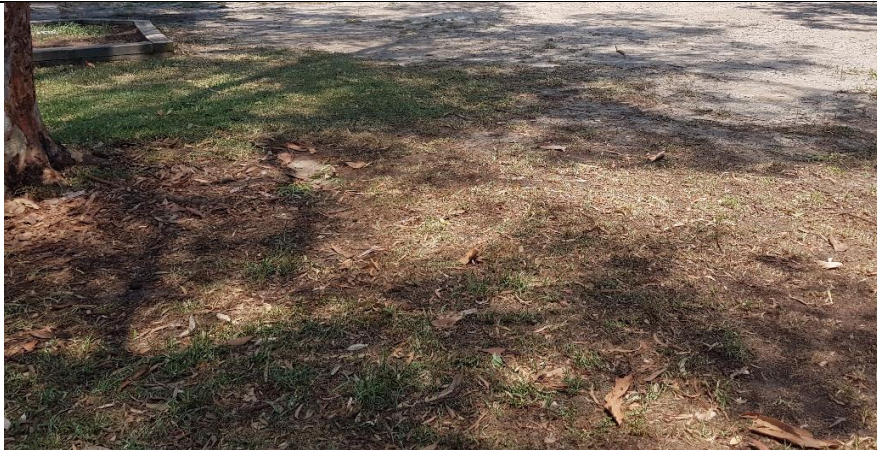
Photo 3: Area north west of Block F post removal.

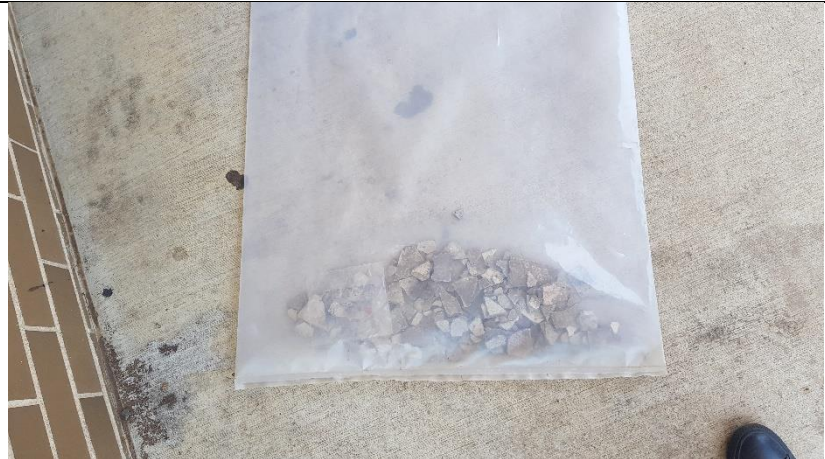
Photo 4: Fragments collected post removal works.
