Hazardous Material Survey

22-32 Queen Street, Campbelltown NSW

Report No: E24711.E10_Rev0

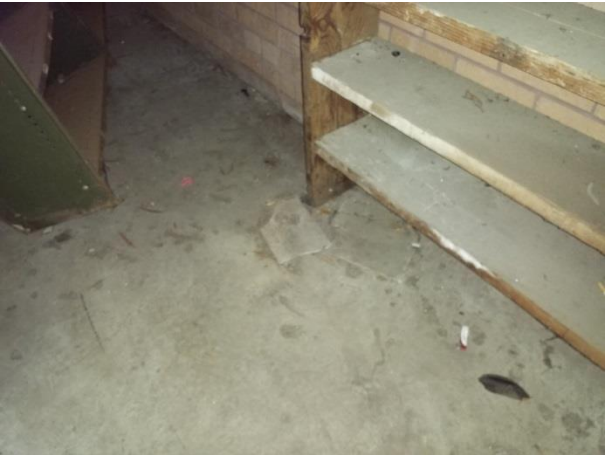
Asbestos									
Bowling alley, south eastern store room, redundant material	Asbestos cement sheeting	Non-friable	A01	Chrysotile Asbestos Detected	<1m ²	Fair Maintenance only	Priority 4: Negligible Risk Level	Remove prior to demolition works

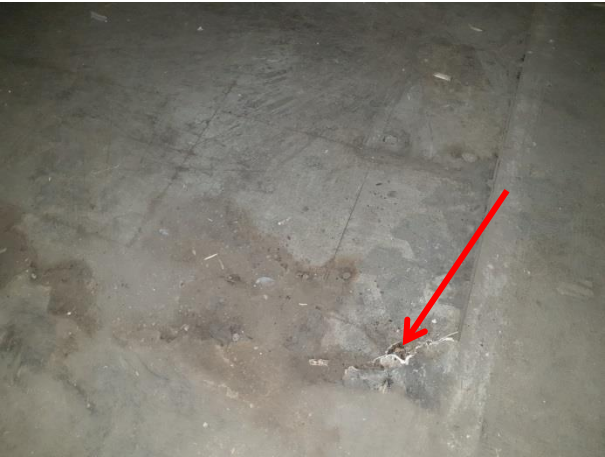
Friable asbestos was identified in the form of asbestos millboard backing attached to the brown vinyl sheeting beneath the grey vinyl tiles in the southern raised portion of the former bowling alley at 24 Queen Street Campbelltown. The composition of the vinyl sheeting is the millboard is encapsulated by the layers of vinyl forming the surface of the sheeting, and the glue used to adhere to the floor below. Additionally the layer of the vinyl tiles covering this sheeting is encapsulating the millboard. The vinyl sheeting is in good condition has been allocated a negligible asbestos related health risk.

Bowling alley, southern portion, floor (2 layers)	Grey vinyl tile over brown pattern vinyl floor sheeting	Friable (vinyl sheeting)	A02	Chrysotile Asbestos Detected	30m ²	Good Maintenance only	Priority 4: Negligible Risk Level	Remove prior to demolition works

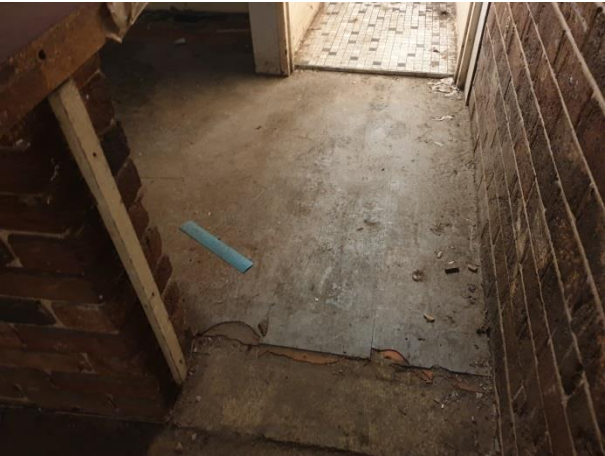
Bowling alley, kitchen, flooring (2 layers)	Grey fleck over brown vinyl floor tile	Non-friable	A04	Chrysotile Asbestos Detected	30m ²	Good Maintenance only	Priority 4: Negligible Risk Level	Remove prior to demolition works

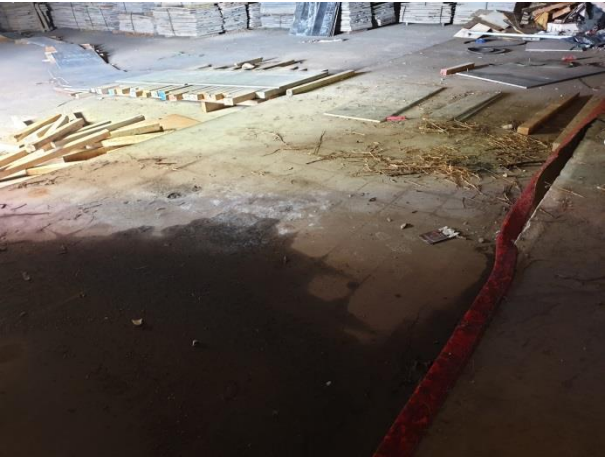
Bowling alley, north of kitchen, floor	Grey vinyl floor tile	Non-friable	A05	No Asbestos Detected	NA	NA	NA	NA

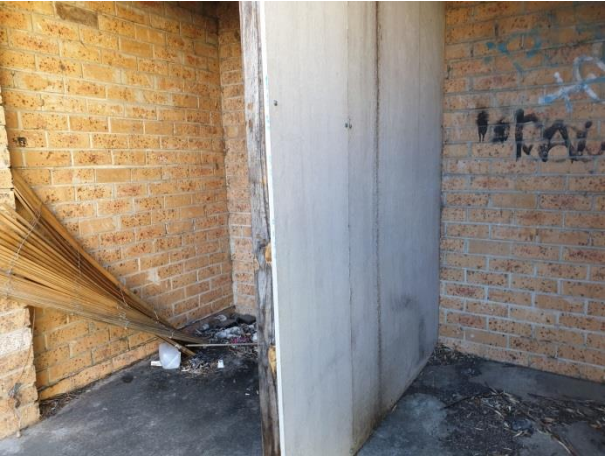
Bowling alley external storage hut, partitions wall	Fibre cement sheeting	Non-friable	A06	No Asbestos Detected Organic Fibres Detected	NA	NA	NA	NA

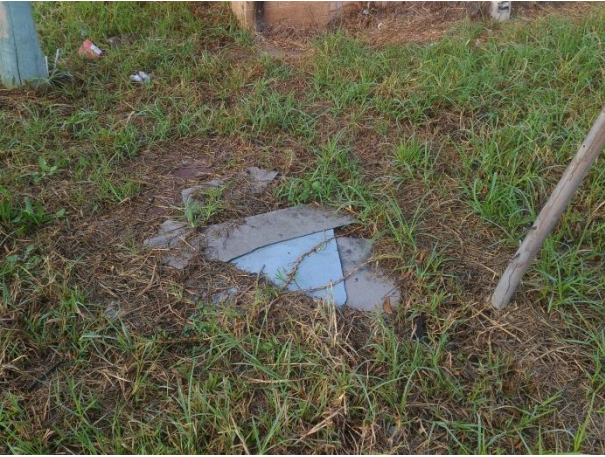
Bowling alley, northern elevation, ground surface	Fibre cement sheeting	Non-friable	A07	No Asbestos Detected Organic Fibres Detected	NA	NA	NA	NA

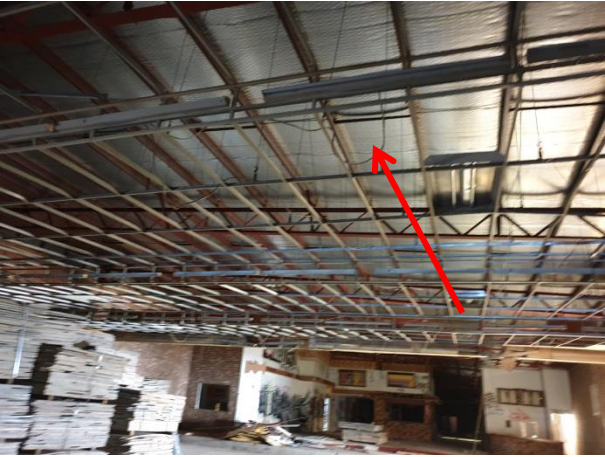
SMF									
Underside of roof	Foil backed SMF	Non-friable	Visual inspection	Assume Positive	Not determined	Good Maintenance only	Priority 4: Negligible Risk Level	Remove during to demolition works

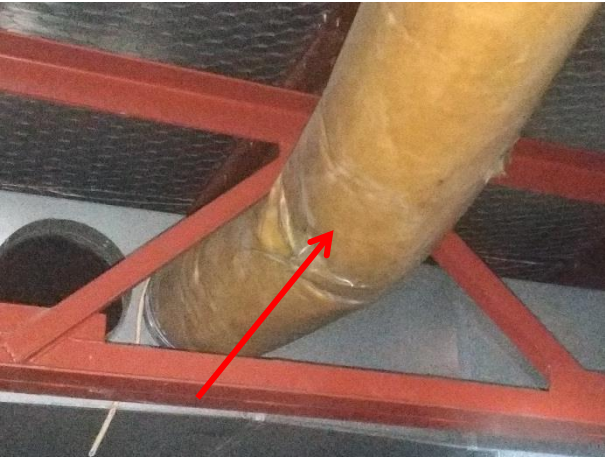
Internal, air conditioning ducting	Flexible SMF ducting	Non-friable	Visual inspection	Assume Positive	Not determined	Good Maintenance only	Priority 4: Negligible Risk Level	Remove during to demolition works

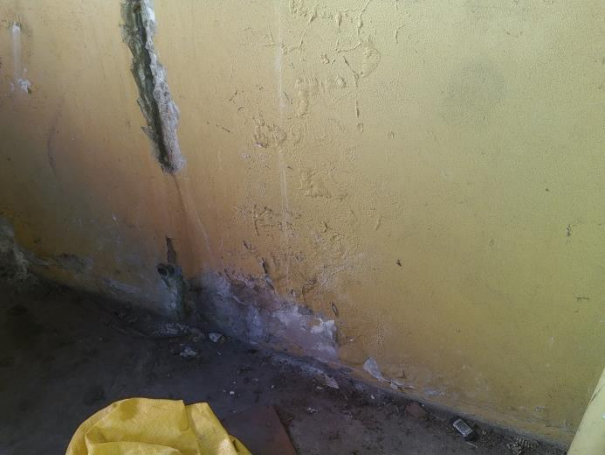
South western amenities, walls	Yellow	NA	P01	0.002	NA	NA	NA	NA

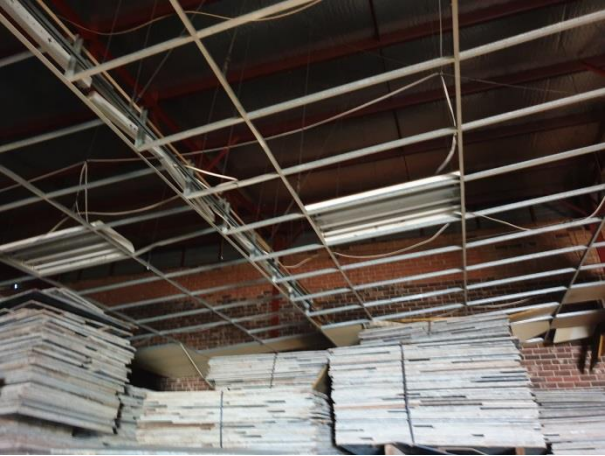
Internal, fluorescent light fittings (4 tube)	Plessey 427/1/00809/001, 13.0µF	NA	Visual inspection	Does not contain PCBs	NA	NA	NA	NA
