GPV Property Pty Ltd
PO Box 1021
WARNERS BAY NSW 2282

Project 81563.05
27 June 2022
R.001.Rev0
JPS:kd

Contamination Status Report
Proposed Medical Facility
31-33 Smith Street, Charlestown

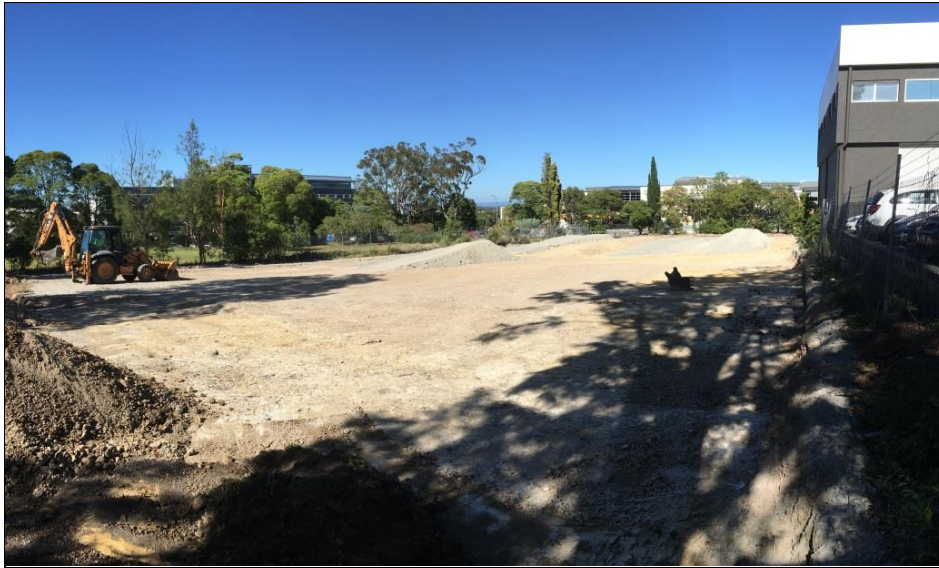
A recent DP investigation undertaken in April 2022 involved the waste classification of several stockpiles (shown below) comprising upper fill 'clean' materials stockpiled during previous remediation works in 2017. The waste classification confirmed materials were classified as Recovered Aggregate with reference to NSW EPA (NSW EPA, 2014c).

Figure 2: Majority of the remediated site, with the consolidated stockpiles of the excavated upper 'clean' fill and deeper fill within the RAC in the background, looking south west (11 December 2017).

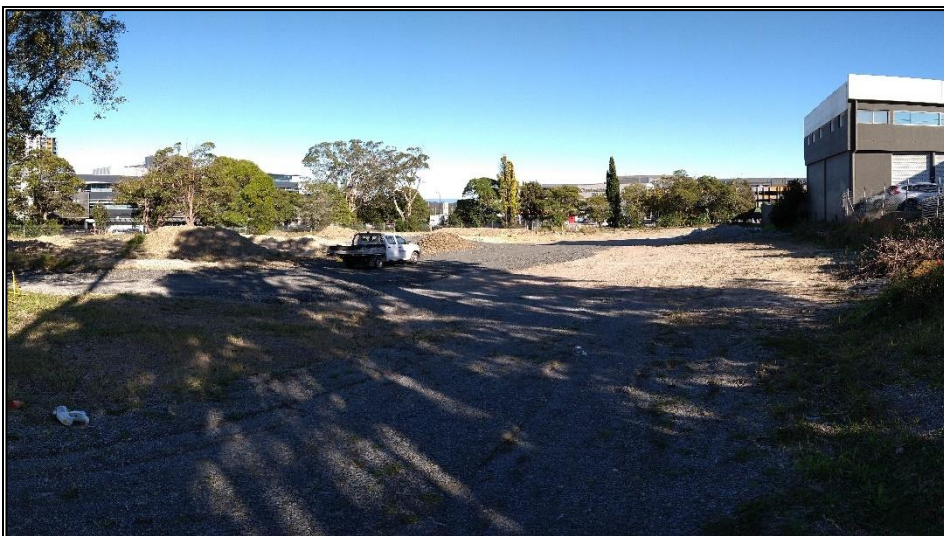
- The Site appeared vacant with similar site conditions observed during the remediation and validation works undertaken in 2018 (Figure 3);
- Remnants of fill stockpiles originating from the remediation works in 2018 were observed in the north western portion of the site (Figure 4). The previous reports classified the stockpiles as fill within the concentrations of the then proposed development (HIL B) which can remain onsite from a contamination perspective;

Figure 3: Site conditions, looking south west, 9 June 2022.

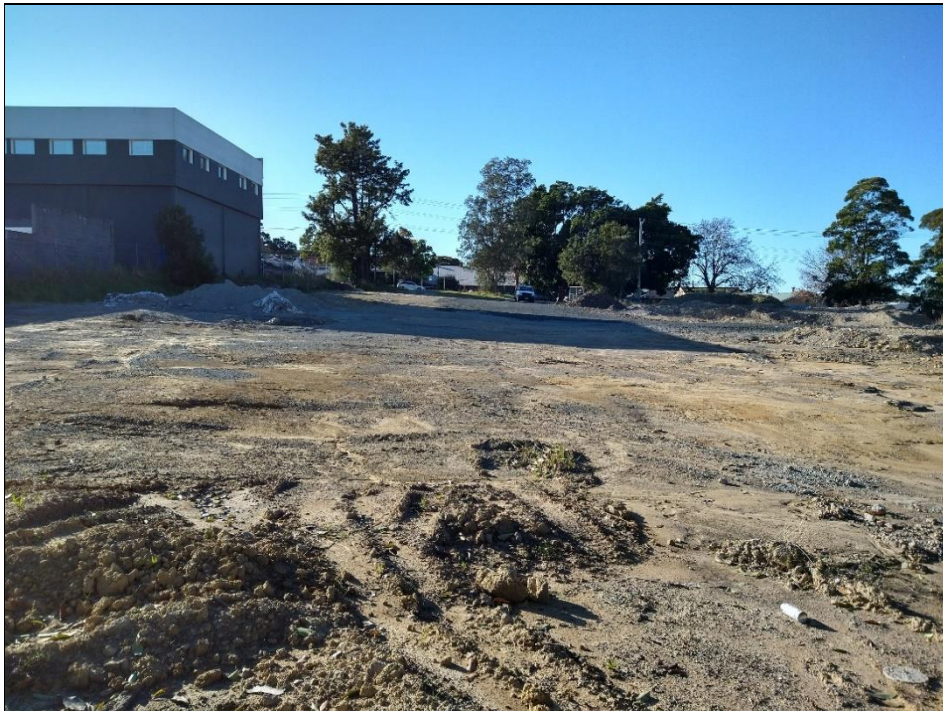
- Portions of the northern and south western sections of the site comprised natural clay and sandstone at the surface (Figures 3, 4 and 7).

Figure 4: Northern portion and remnants of fill stockpiles from remediation works in background looking east, 9 June 2022.

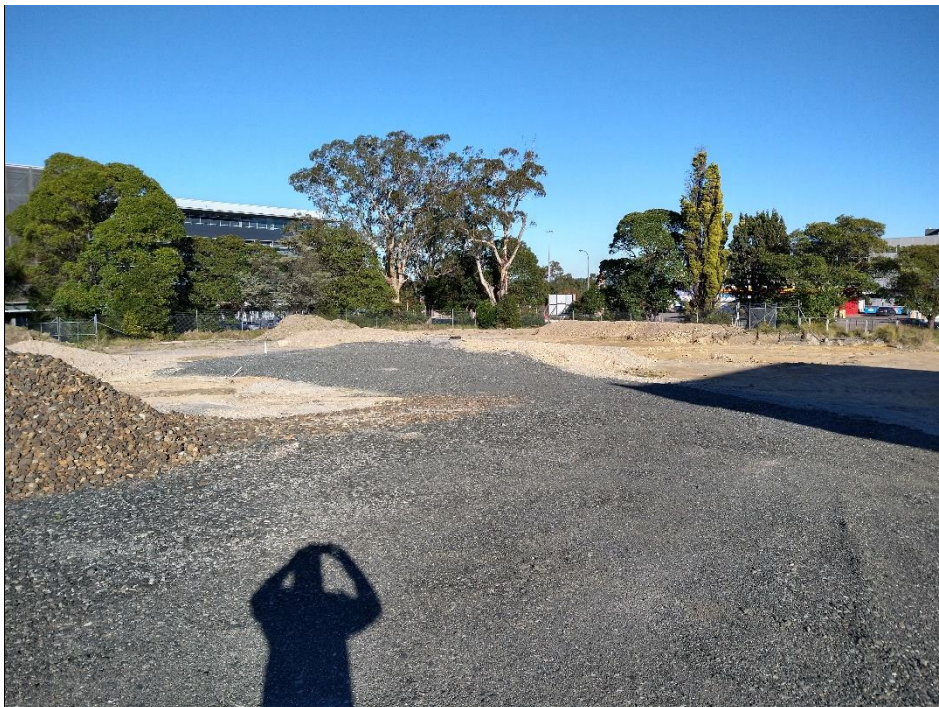
- A stockpile of quarried gravel and cobbles were piled and spread in the central south eastern portion of the site for use as an access track (Figures 3 and 5). The gravel and cobbles comprised natural ballast material and showed no signs of contamination;

Figure 5: Central portion, showing imported quarry gravel and cobbles, looking south west, 9 June 2022.

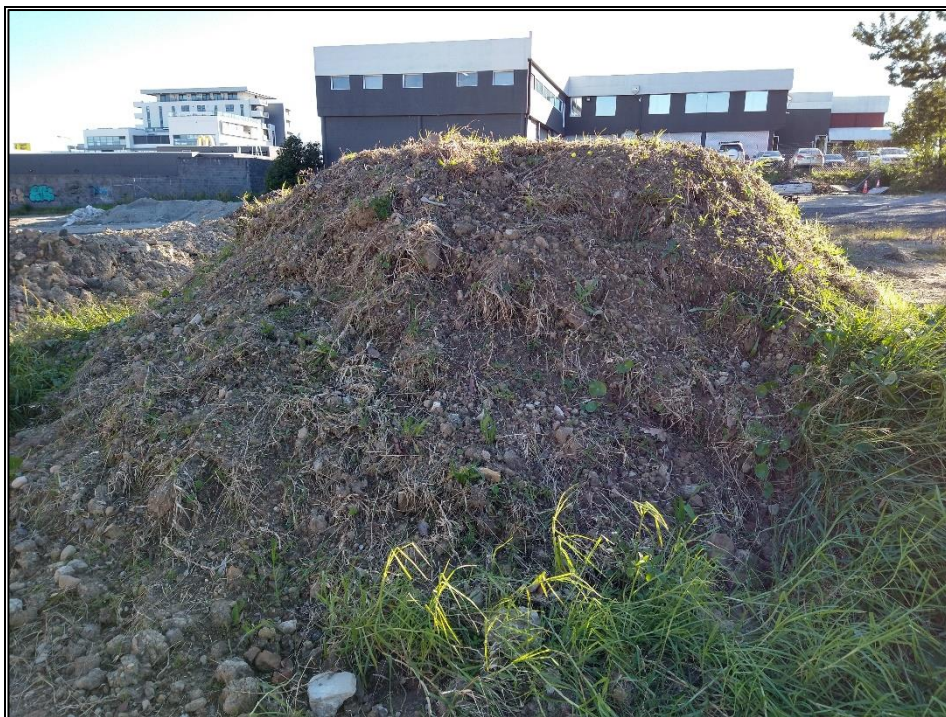
- Stockpiles of stripped surface fill were observed in the south western and south central portions of the site (Figures 3 to 7);
- The stockpiled fill comprised intermixed building materials (brick, concrete, ceramics and metal) (Figure 6);

Figure 6: Stockpile of stripped surface fill comprising some brick and concrete, 9 June 2022.

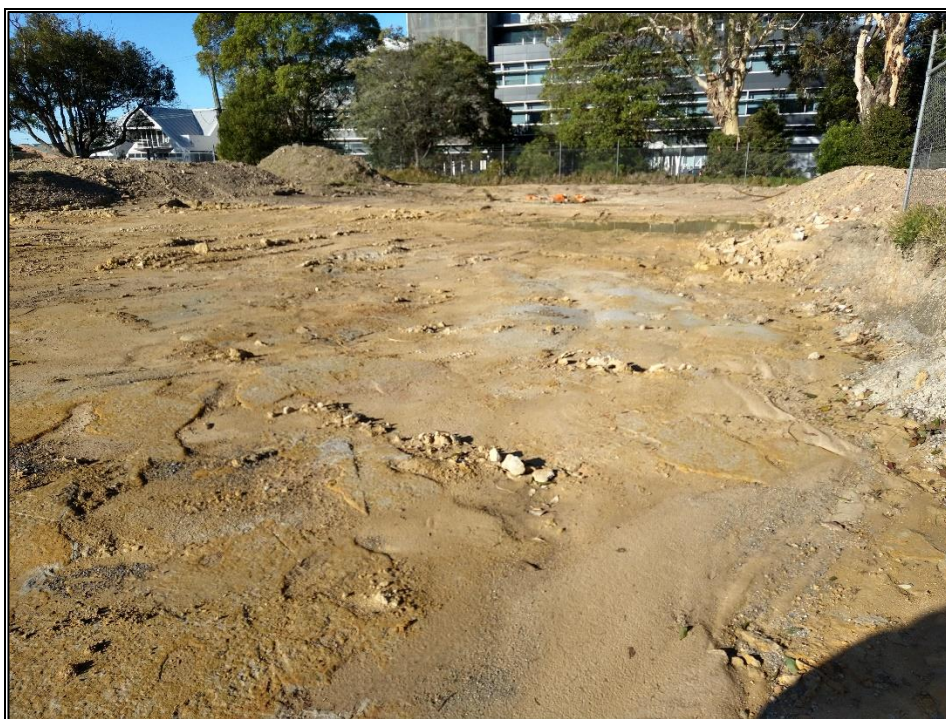
Figure 7: Exposed natural soils in south western portion and surrounding stockpiles of stripped fill materials, looking south west 9 June 2022.
