Arborist Impact Assessment

Proposed Commercial Retail Development
Lot 14, DP 258848
42 Fullerton Cove Road, Fullerton Cove, NSW

21 June 2024

AEP Ref: 3063.03

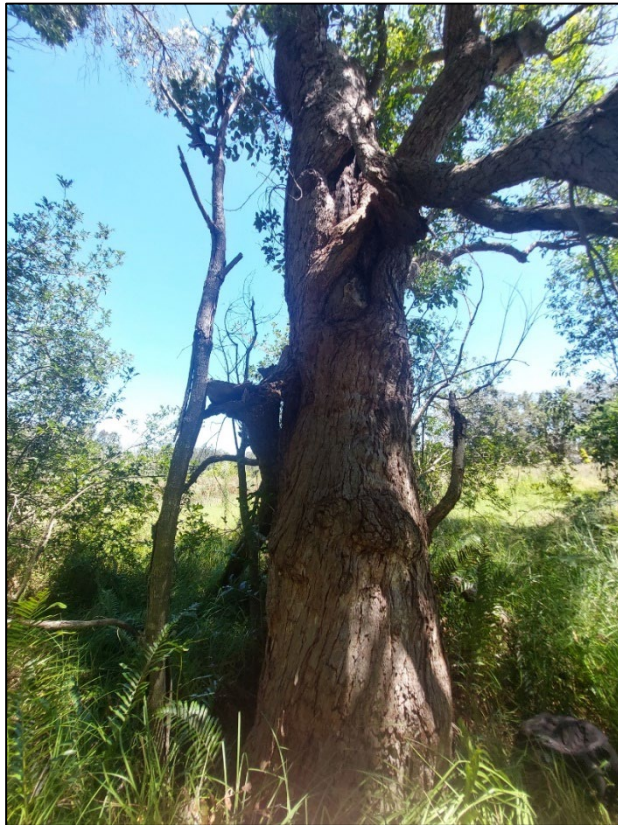
- Tree 2 - *Melaleuca quinquenervia* (Broad Leaved Paperbark) is a mature tree in good condition with hangers from a neighbouring dead tree;
- Tree 3 – *Eucalyptus robusta* (Swamp Mahogany) is an over- mature tree with a large central column of decay, multiple recent branch failures, the head of the tree has failed in the past leading to an asymmetric canopy. This tree is in poor structural condition with cavities and has associated borer attack;

- Tree 1 was observed to have a bird's nest in the western canopy; and
- Tree 3 has cavities and decay forming potential hollows in the trees structure.

Plate 1 Above: Tree 3. Note the central decay column which extends from the crown to base.

- Tree 3 has TPZ encroachment by the development footprint of approximately 20%, this area will require excavation and compacted fill during the construction phase, however this tree has potential to be retained with the establishment of a tree protection zone and critical care to be taken during excavation in the vicinity of the tree structure and SRZ area. TPZ fencing as displayed in **Figure 5** will be required for the duration of works. If a TPZ fence is impractical for construction, additional protection measures must be applied in lieu of fencing. These include trunk and low branch guards, and ground protection measures installed as displayed in **Figure 5** following guidance in Australian standard AS 4970 – 2009 Protection of trees on development Sites (**Appendix D**). The use of “soft” construction methods including manual and vacuum removal of soils is recommended for ground works conducted within the TPZ of Trees to be retained.

- It should be noted that this tree is in poor health and structural condition, and retention of this tree within close proximity to the development footprint could be hazardous to contractors and eventual site users. To mitigate this hazard, the western canopy of this tree should be reduced in weight, with branches that extend over the development footprint removed. All tree maintenance and pruning works should be carried out by a qualified tree worker in accordance with AS4373 –2007 Pruning of Amenity Trees.

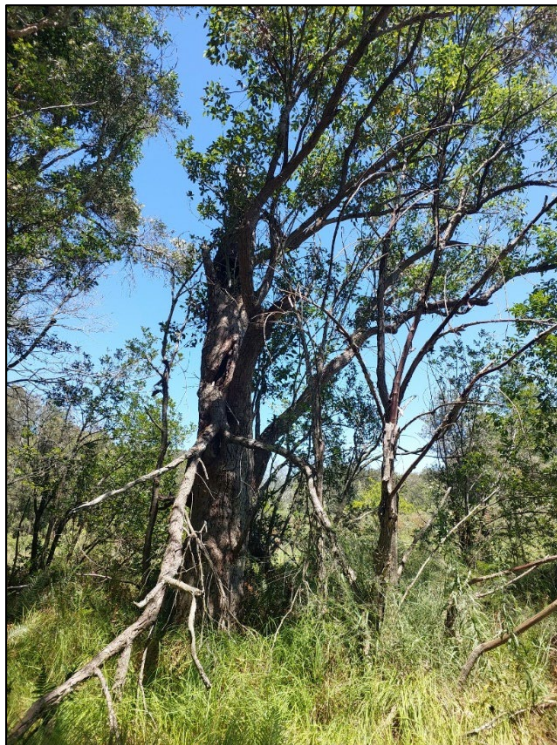
Plate 2 Below: Tree 3. Note the failed branches and canopy head.

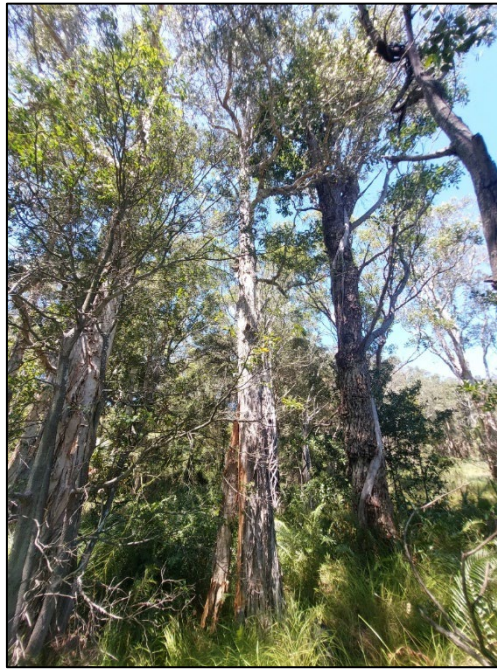
- Tree 6 – *Eucalyptus robusta* (Swamp Mahogany) is an over- mature tree impacted by borer attack, with a strangler fig that has established roots and is into the upper canopy with the high potential to dominate and suppress the original tree.

Plate 3 Above: Trees 4 (Left), 5 (Centre) and 6 (Right).

- Trees 2 & 4-6 have minimal to no encroachment into the TPZ by the development footprint, and can be retained with minimal impacts to tree viability. These trees will require the establishment of a tree protection zone similar to the above points, with TPZ fencing as displayed in **Figure 5** will be required for the duration of works. If a TPZ fence is impractical for construction, additional protection measures must be applied in lieu of fencing. These include trunk and low branch guards, and ground protection measures installed as displayed in **Figure 5** following guidance in Australian standard AS 4970 – 2009 Protection of trees on development Sites (**Appendix D**). The use of “soft” construction methods including manual and vacuum removal of soils is recommended for ground works conducted within the TPZ of Trees to be retained.

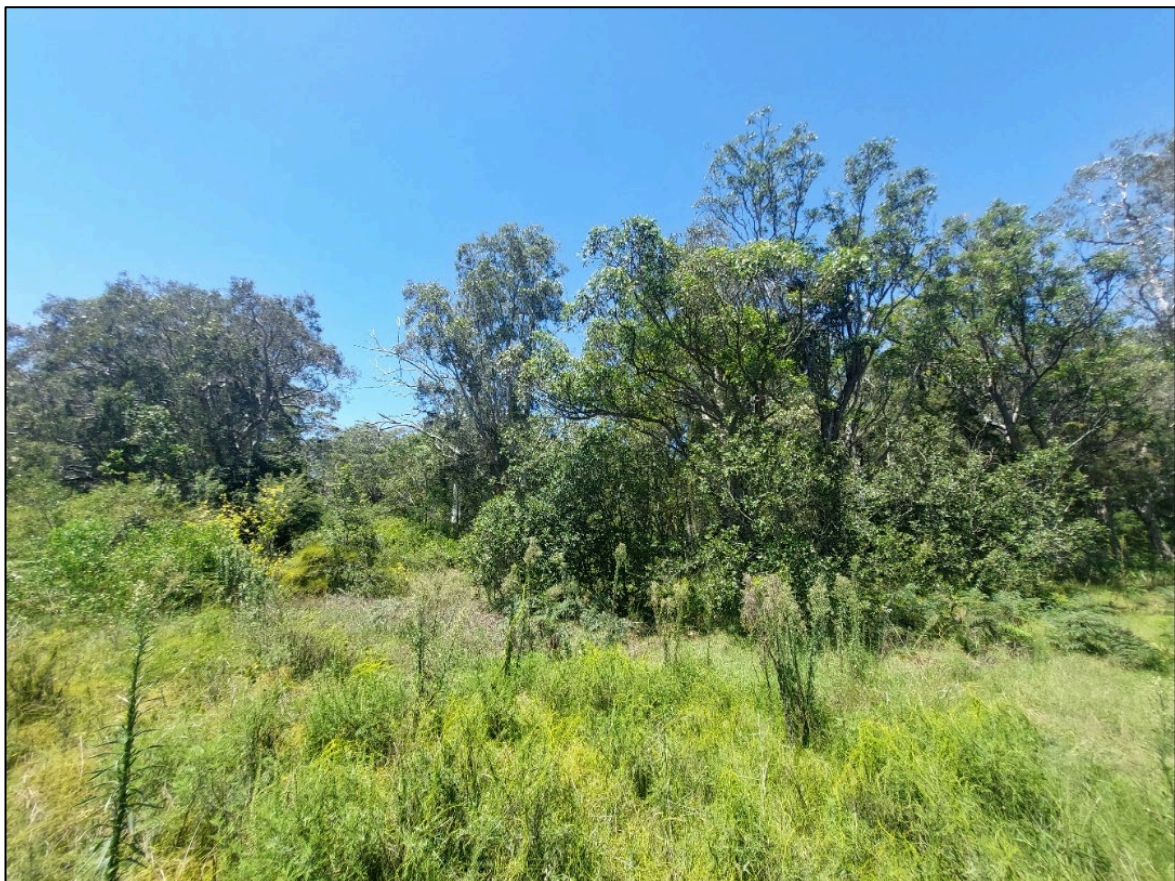
Plate 4 Below: Trees 1 (Left) to 6 (Right) from the development footprint.

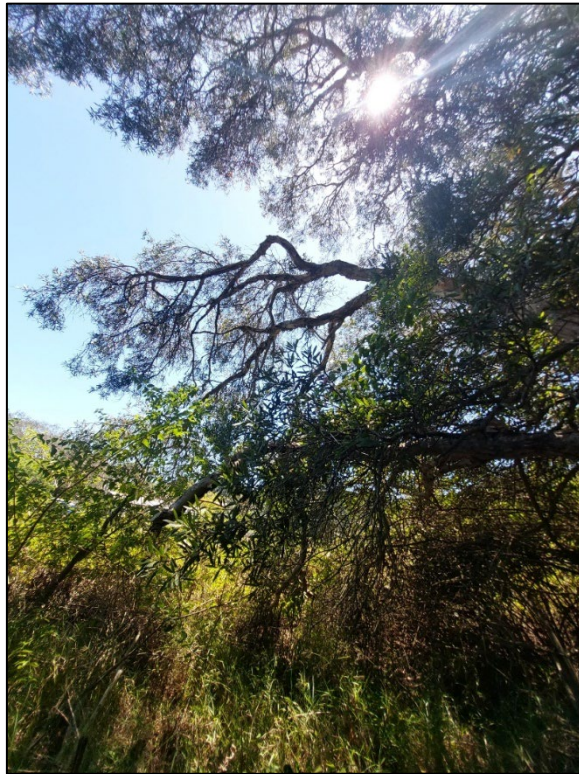
- Tree 1 – *Melaleuca quinquenervia* (Broad Leaved Paperbark) is the largest assessed tree the area with multiple large leaders and extensive low (<4m) canopy branches within the subject site;

Impacts are unlikely to be mitigated through tree protection measures without major design changes, and tree stability and viability cannot be guaranteed. Of particular note is Tree 1, which will have ~50% of the SRZ impacted by the proposed retaining wall and detention basin. Furthermore, Tree 1 would require extensive pruning of the western canopy to access the site area, which will further impact this tree by unbalancing the canopy.

Plate 5 Above: Tree 1 Canopy.

- Trees designated for removal within this report as outlined in **Section 6** should be removed by a qualified tree worker with appropriate professional liability insurance, and removed in a manner to prevent damage to retained trees.
- Trees designated for retention within this report as outlined in **Section 6** to the development footprint should be retained with Tree Protection Measures.

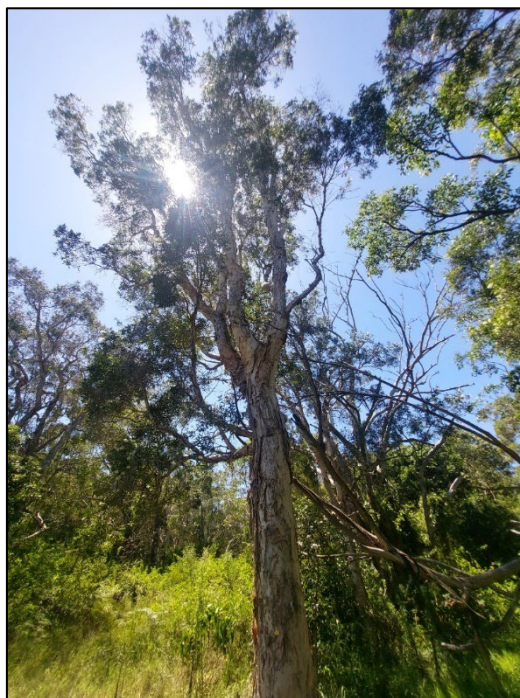
Plate 6 Below: Tree 2.

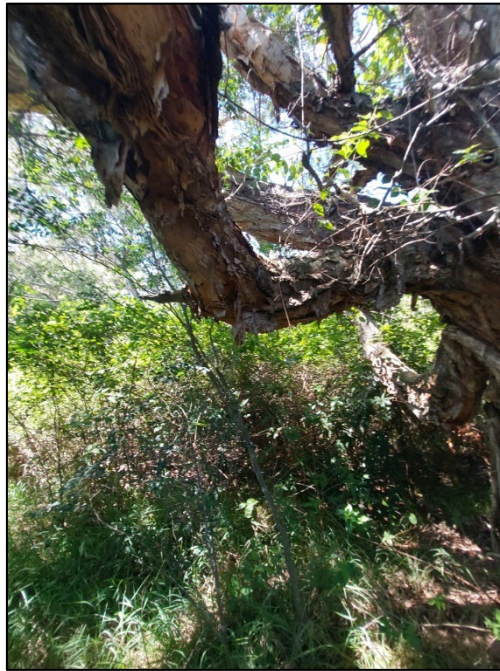
Plate 7 Above: Tree 1 Canopy branches within the subject site.

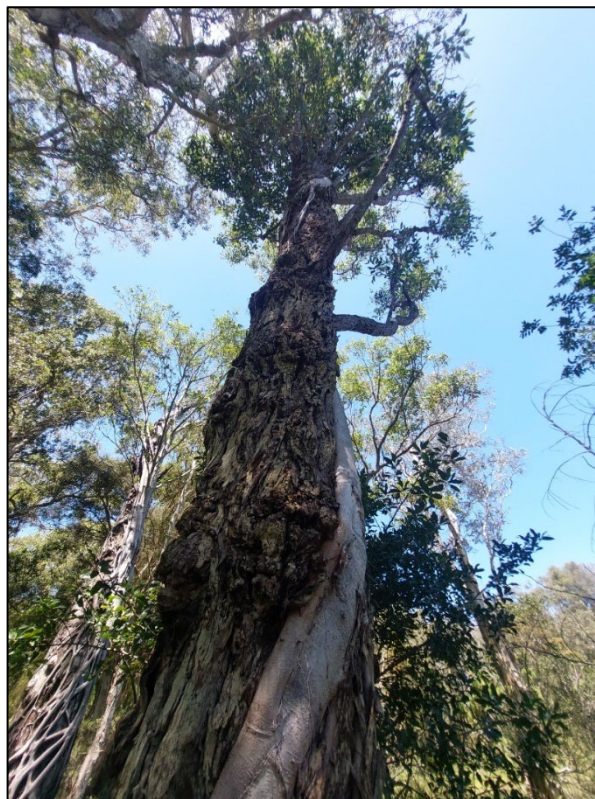
Plate 8 Below: Tree 6 canopy, with established strangler fig visible.
