Stephen Martin  
Park Street  
Hamilton, NSW.

# Hazardous Substances Audit

4 Fleet Street,  
Salamander Bay, NSW 2317.  
October 2021.

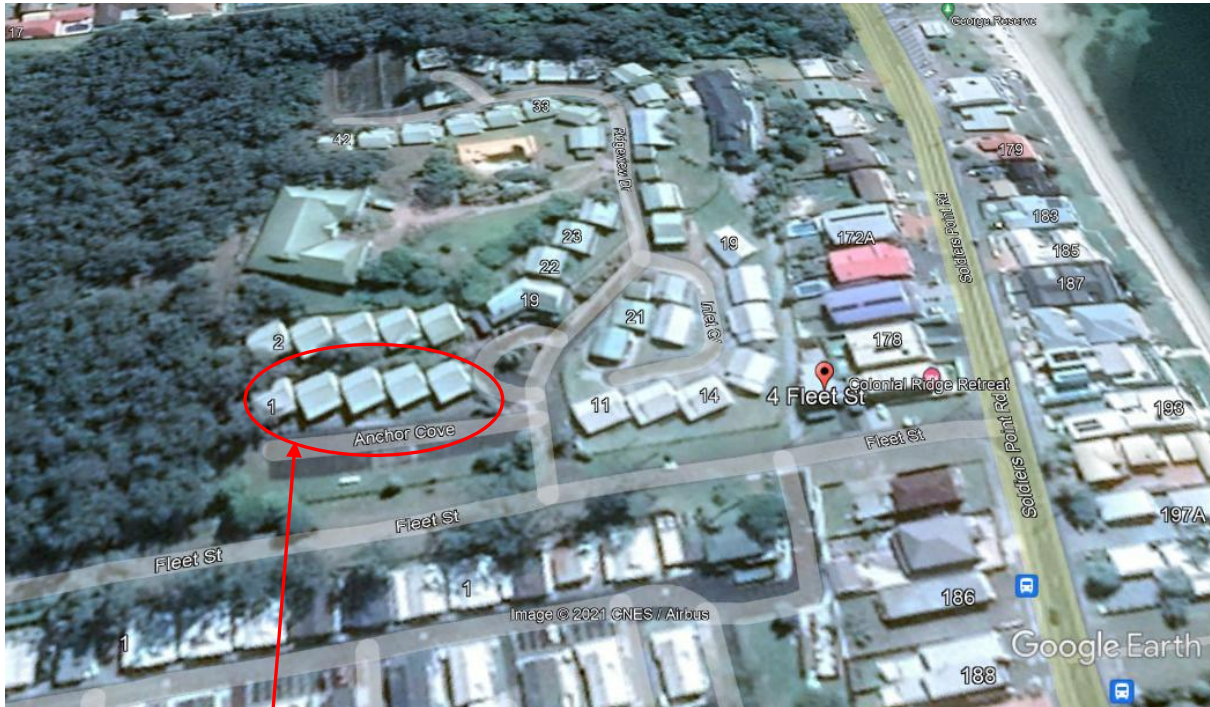
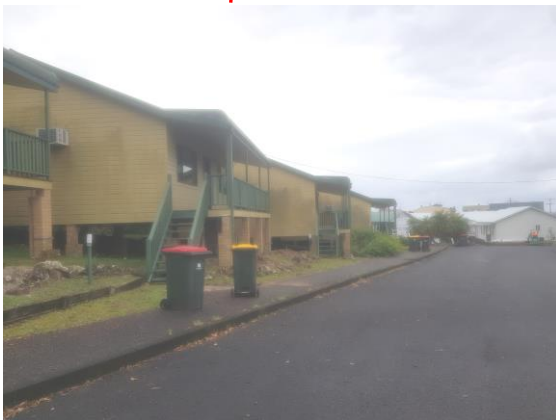
**The Subject Buildings at Colonial Ridge Resort, Salamander Bay NSW, 2317.**
