# Preliminary Arborist Assessment

Proposed Update of Fire trails on land  
Lot 2 DP 791551  
8 Fleet Street, Salamander Bay, NSW

**AEP Ref: 5466**

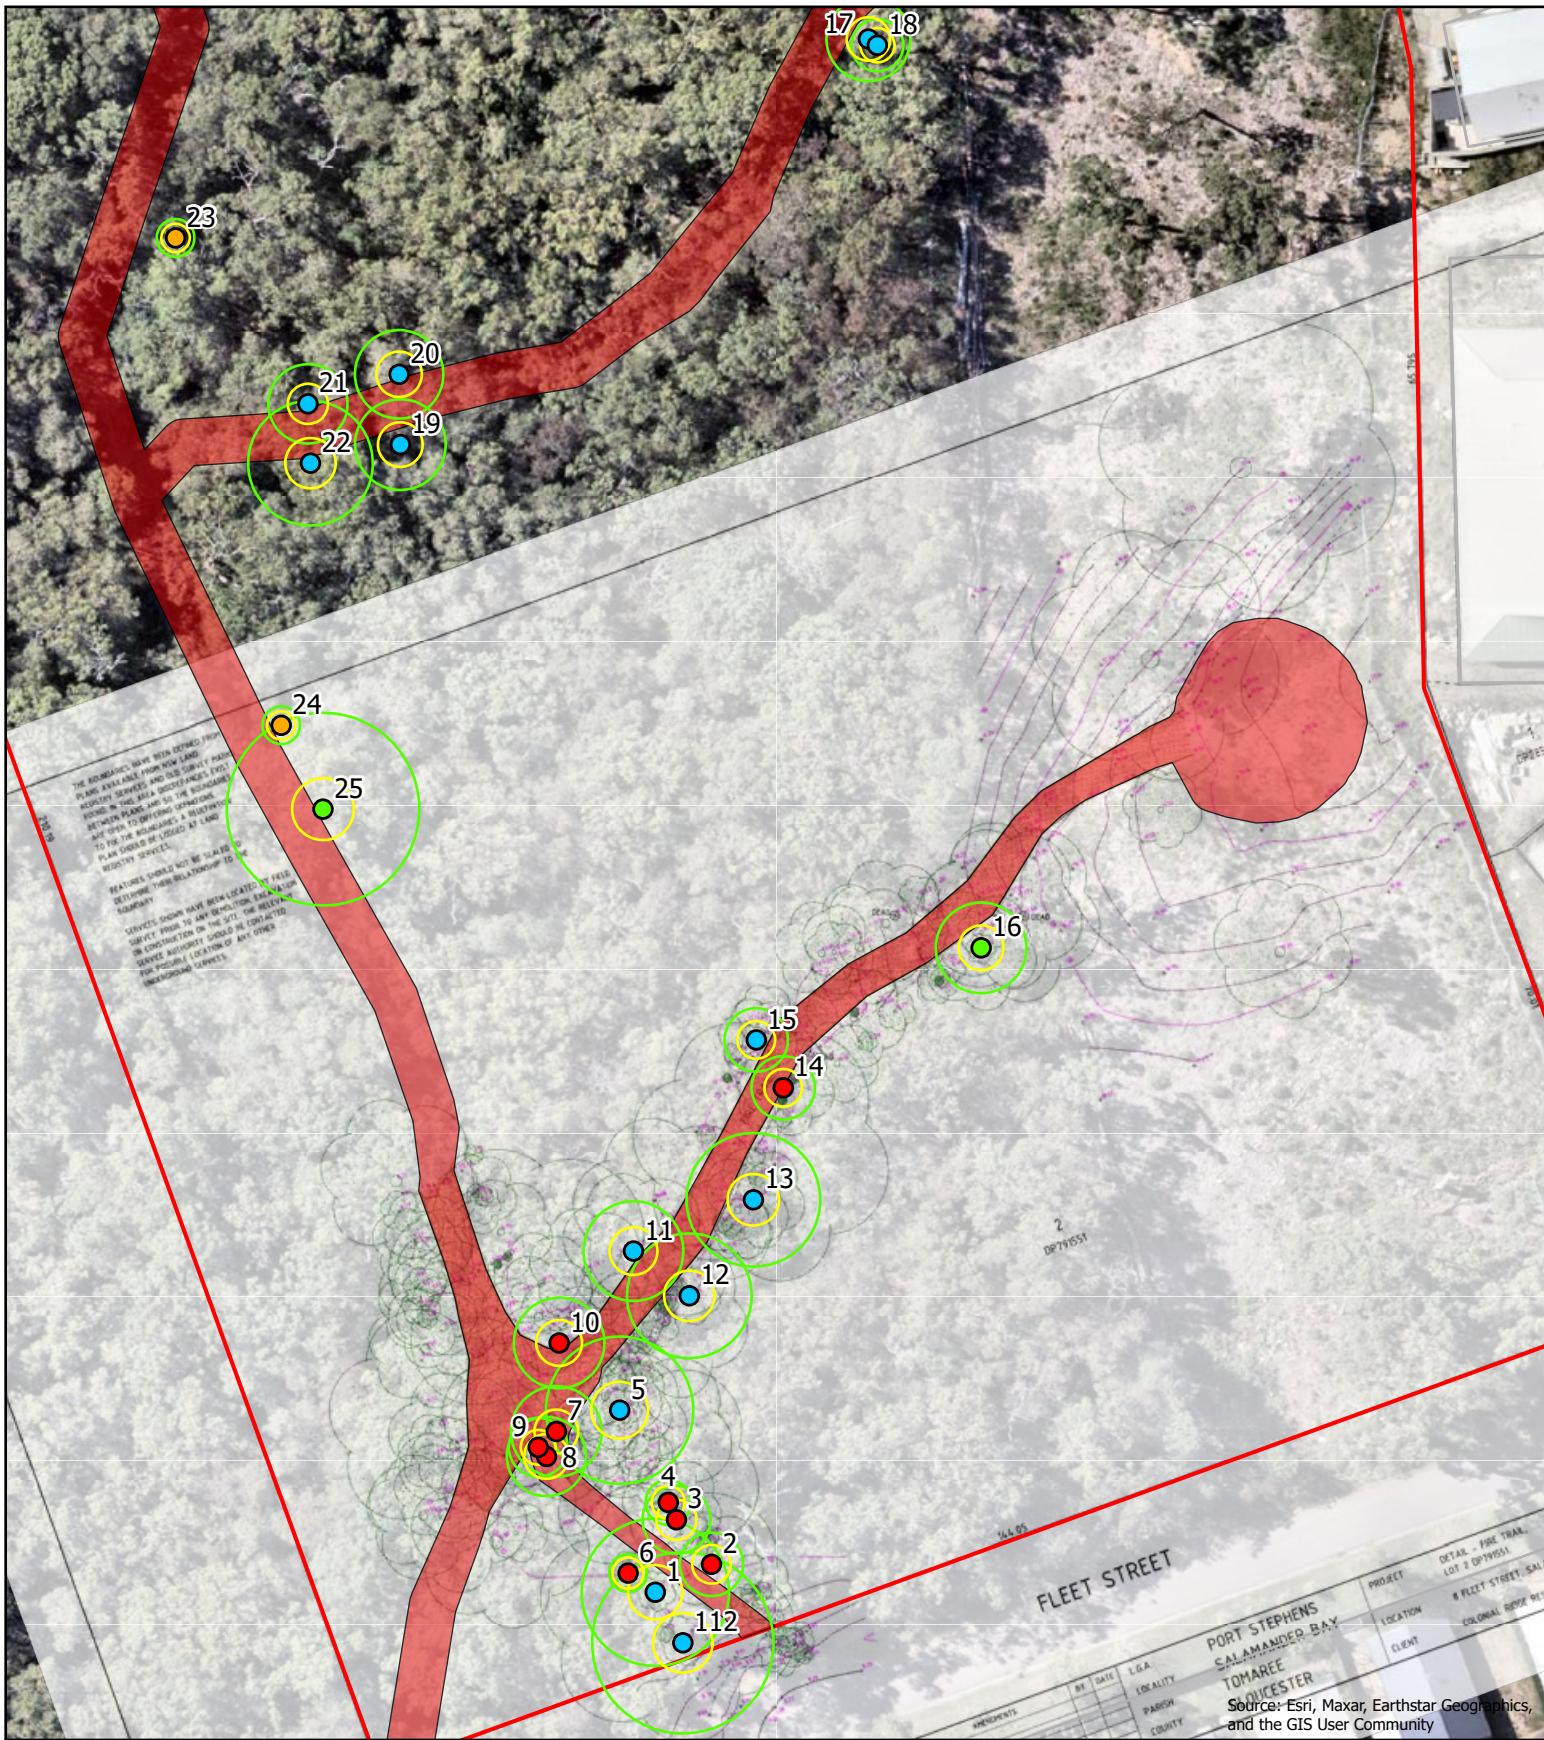
**Figure 4 – Tree Assessment**

To undertake the proposed trail excavation work for access off Fleet Street, the goal is to retain the high value trees (Trees 1, 112 and 5) but allow access for trucks and turning.

The removal of Trees 2, 3 & 4 will allow adequate space outside of the SRZ distance of Tree 112, will have minimal impact on Tree 1. Tree 5 should be retained and the tree protected by barrier placed at the SRZ distance from the trunk.

Trees 6, 7, 8, 9, 10 and 14 are recommended for removal to allow effective turning zones for larger vehicles and removing hazardous trees.

Trees 19 & 20 have a space of 4.1 m between the trunks forming a "pinch point" in the fire trail. The space between trees 21 & 22 is 4.2 m forming a second "pinch point". Access for fire fighting vehicles is just viable without removing any trees. In upgrading the trail between trees 19 – 22, the trunks of the trees should be protected by timber battens fixed around the trunk reducing damage to the trunks from accidental machinery contact.

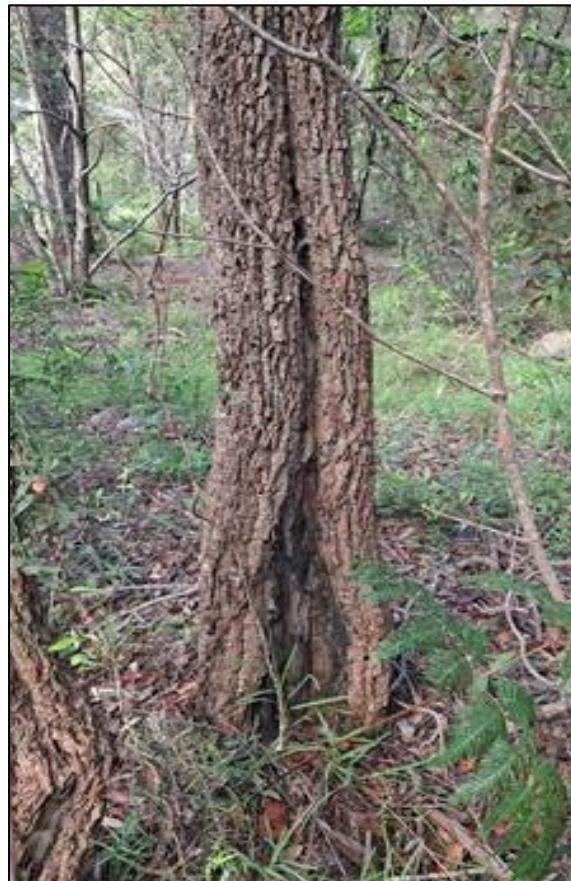
- Tree 3 – *Allocasuarina torulosa* (Forest Oak) is in poor structural condition due to fire damage and a cavity at the base of its trunk. This tree has low landscape significance as it is a poor representative of the species, displaying significant asymmetry in the canopy. Its live crown size is small, measuring less than 40m<sup>2</sup>.

**Plate 1 Above: Tree 3 – *Allocasuarina torulosa* exhibits poor structural condition.**

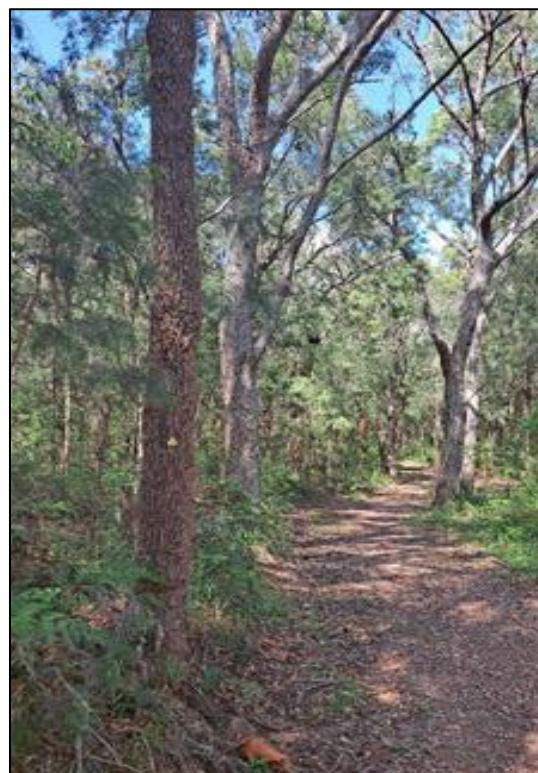
- Tree 14 – *Allocasuarina torulosa* (Forest Oak) is in poor structural condition due to a damage at the base of its trunk. It is positioned directly on the edge of the fire trail and previous grading by machinery severed a structural root that has allowed decay to develop at the base of the tree below ground level. It has fair health condition, with a thinning crown. This tree has low landscape significance as it is a poor representative of the species. Its live crown size is small, measuring less than 40m<sup>2</sup>.

**Plate 2 Below: Tree 14 – *Allocasuarina torulosa* leans over the track. This tree has basal damage and should be removed.**

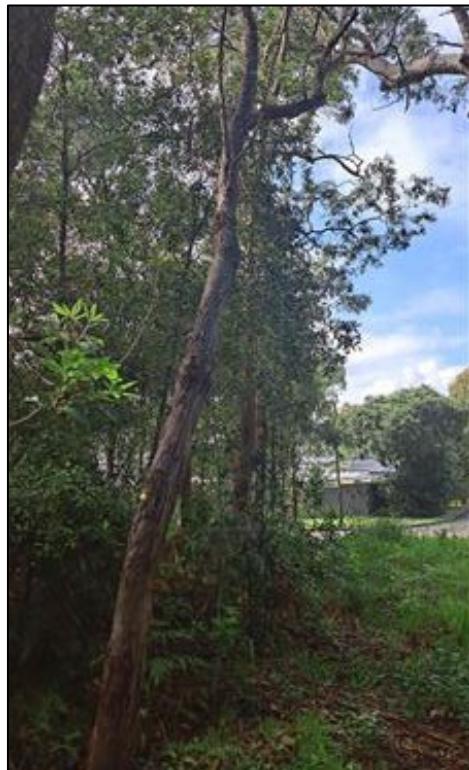
- Tree 4 – *Eucalyptus piperita* (Sydney Peppermint) is in fair structural condition due to its lean over the track and asymmetric crown. However, it remains in good health. This tree has low landscape significance displaying significant deviations from the typical form and branching habit. Its live crown size is small, measuring less than 40m<sup>2</sup>.

**Plate 3 Above: Tree 4 – *Eucalyptus piperita* showing fair structural condition, recommended for removal**

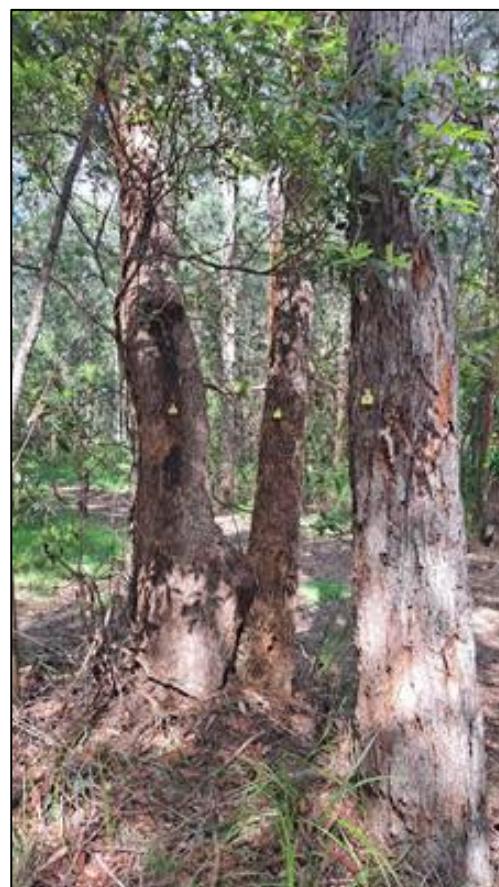
- Tree 8 – *Eucalyptus piperita* (Sydney Peppermint) is in fair structural condition with an asymmetric crown and leans over the track. Tree 9 is in contact with Tree 8 at the base and has been partially compartmentalised within the trunk tissue. Effectively, Tree 8 is the “parent” tree with Tree 9 the suppressed “child” tree. This tree has low landscape significance displaying significant deviations from the typical form. The 2 trees are likely to have intertwined root systems that effectively form one living organism of 2 species.

**Plate 4 Below: Trees 7, 8 & 9 – *Eucalyptus sp.*, all recommended for removal.**

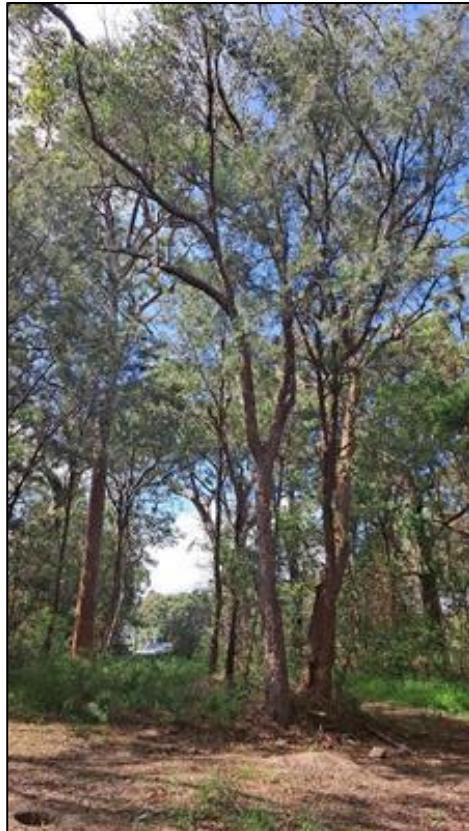
- Tree 9 – *Allocasuarina torulosa* (Forest Oak) is in fair structural condition and leans over the track as it is suppressed by tree 8. This tree has low landscape significance as it is a poor representative of the species, displaying significant deviations from the typical form and branching habit. Its live crown size is small, measuring less than 40m<sup>2</sup>.

**Plate 5 Above:** Tree 9 – *Allocasuarina torulosa* leans over the track, recommended for removal.

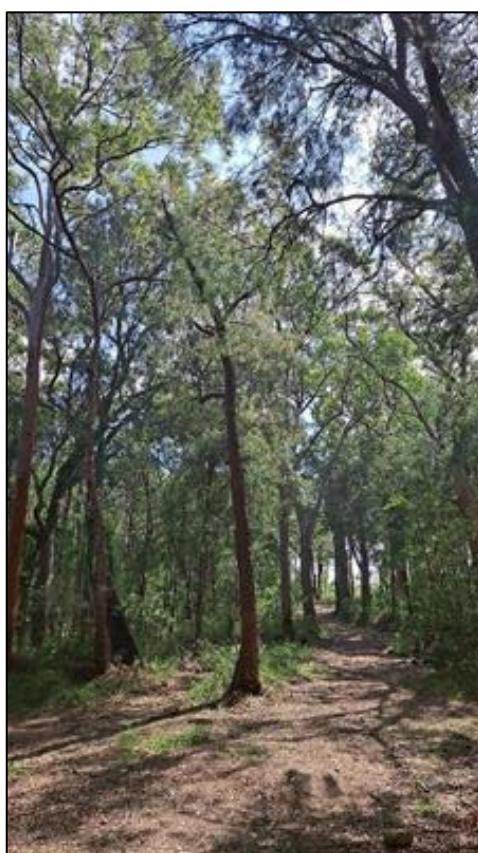
- Tree 10 – *Allocasuarina torulosa* (Forest Oak) has basal damage from vehicles and multiple branch failures in the canopy from age and storm damage. The tree has an asymmetrical form and has signs of decay in the middle section of the trunk. The tree is likely to be in close proximity to vehicles, and will obstruct turning movements for trucks.

**Plate 6 Below:** Tree 10 – *Allocasuarina torulosa* to be removed.

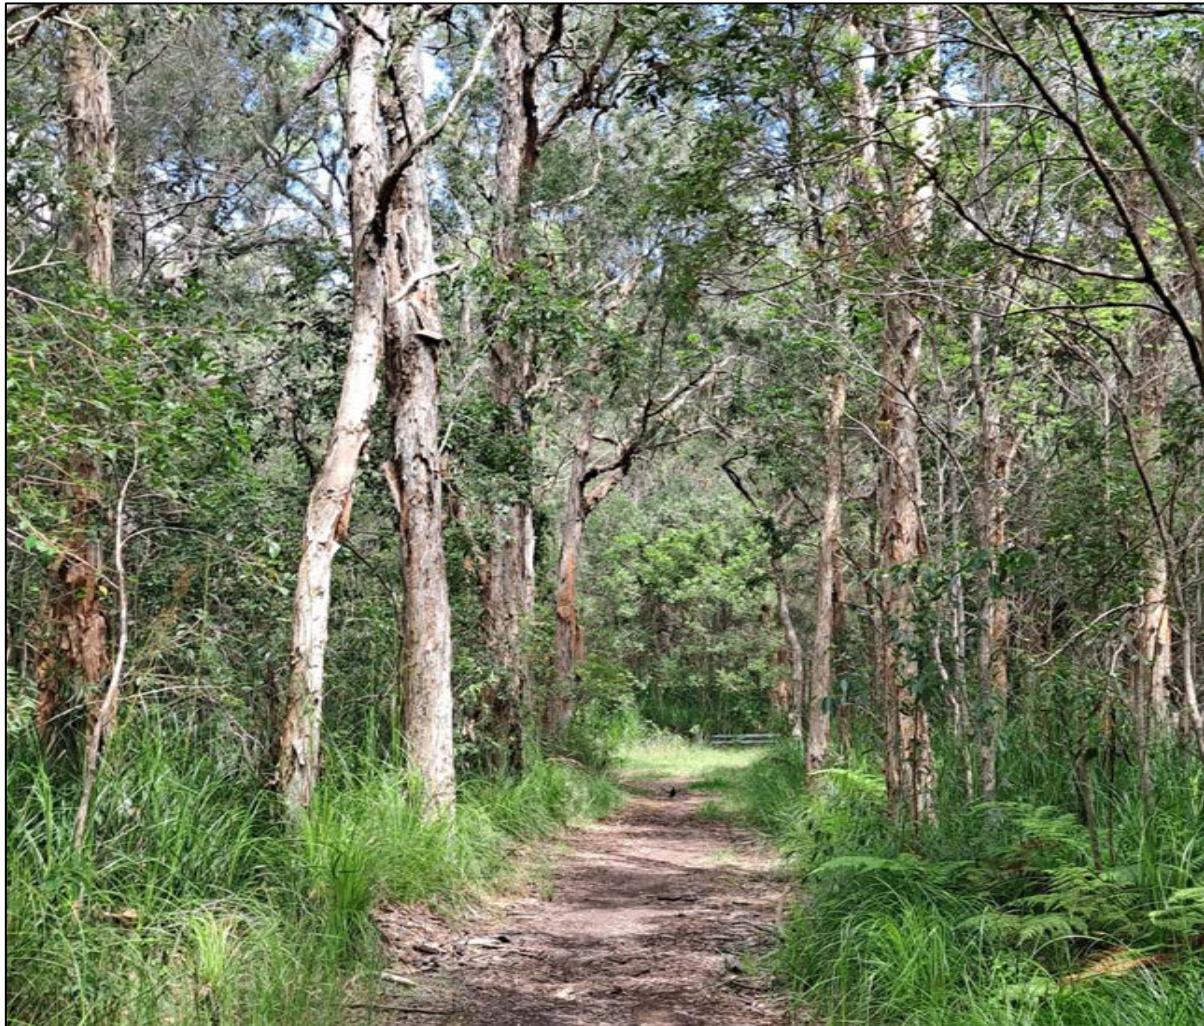
**Plate 7 above: Trees 19 – 22 ( *Melaleuca quinquenervia* ) create a reduced width in this section of the fire trail. Upgrading the trail surface will require protection of the trunks using timber battens strapped around the trunks in this area.**

Trees 11 – 13, 15 and 17 – 22 require trunk protection using battens strapped around the trunk to protect trees against machinery and vehicle damage. See **Figure 5** below for details
