### Muswellbrook Waste Transfer Station

Road Safety Assessment

Report Number		
H200851 RP#13		
Client		
Central Waste Station		
Date		
28 April 2022		
Version		
v2 Final		
Prepared by	Approved by	
Alla.	Lula

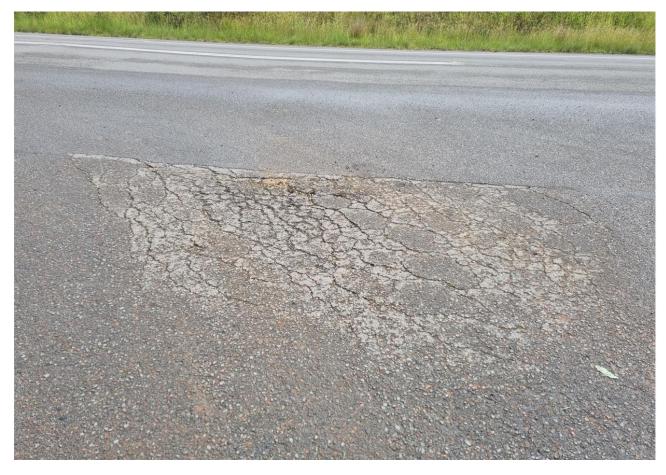
During the inspection, alligator cracking has been noted on the asphalt on southern side of Glen Munro Road at Thomas Mitchell Drive (Plate 2.4). This is often caused by a structural failure in the underlying base construction, which develops from when the pavement was initially installed. The failure can be caused by either a weakness in the original surface, a base layer that is too thin, or insufficient drainage. Cracks often begin appearing in the wheel paths, before flaring out into the larger scale cracks.

Plate 2.4 Cracked pavement on the southern side of Glen Munro Road at Thomas Mitchell Drive intersection

To fix this type of cracking, the thikness of the ashphalt and the underlying base material should be investigated by MSC. Based on the observed deformation, appropriate remedial action needs to be undertaken.

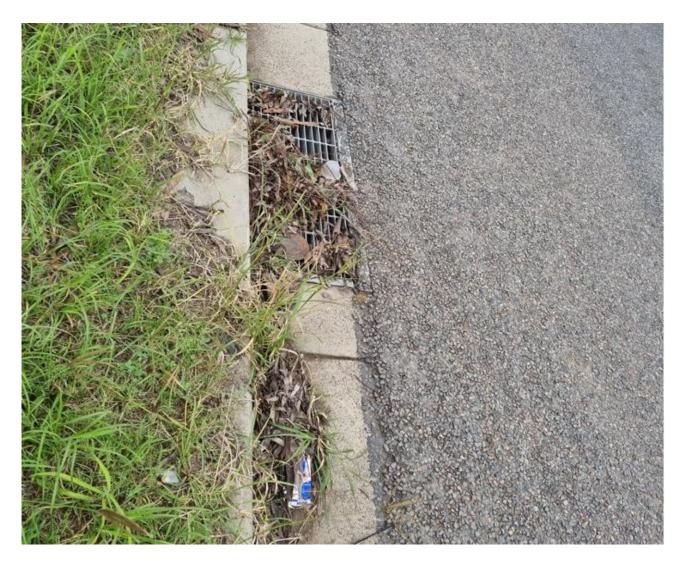
Plate 2.5 Uncleaned drainage pit located on eastern side of Thomas Mitchell Drive, south of Glen Munro Road

The drainage pits adjacent to the road pavement should also be cleaned regularly by MSC to minimise any water ponding during heavy rain (Plate 2.5).

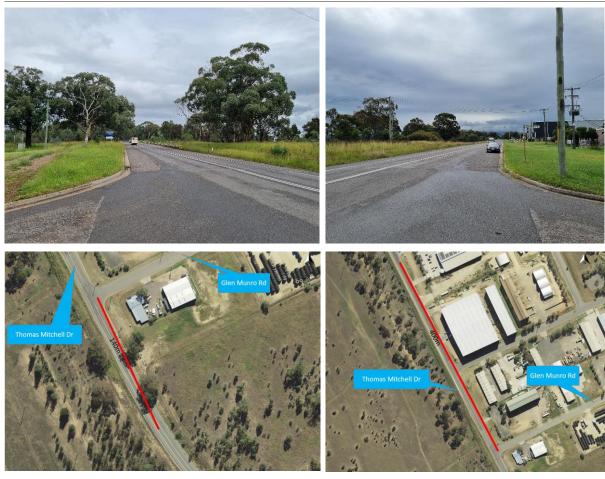
The sight distances on Glen Munro Road at Thomas Mitchell Drive have been estimated based on the line of sight and observation, as shown in Plate 2.6. Based on the estimated sight distance analysis, the sight distance to the right meets the minimum requirement (226 m), as stipulated in the Austroads Guide to Road Design.

However, sight distance to the left is limited due to the curve in the road, a TfNSW road upgrade sign and a number of existing roadside trees, on Thomas Mitchell Drive on approach to this intersection. This has restricted the sight distance to approximately 140 m to the right (Plate 2.6).

Sight distance to the left (<150 m)

Sight distance to the right (>400 m)

As a short-term mitigation measure, the sight distance could be improved by removing the existing three roadside trees and the TfNSW road upgrade sign which are all located on the eastern side of Thomas Mitchell Drive, as shown in the following pictures. This will allow visibility to a greater distance to the left.

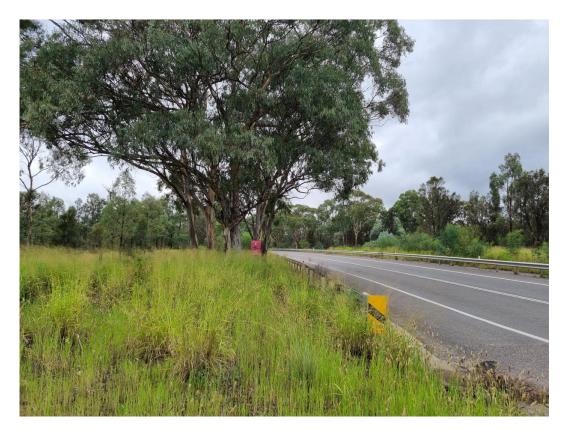
Plate 2.7 Overgrown vegetation and street trees restricting sight distance on Thomas Mitchell Drive

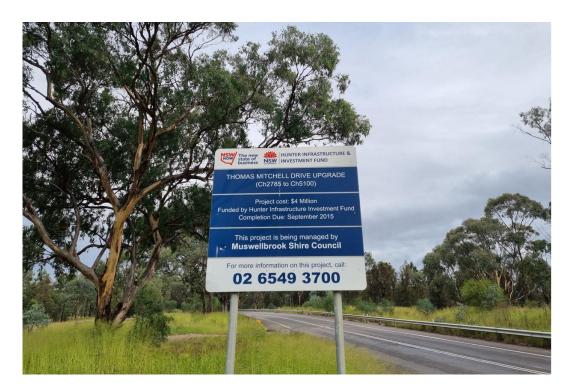
Figure 2.2 TfNSW Road upgrade signage needs reaction

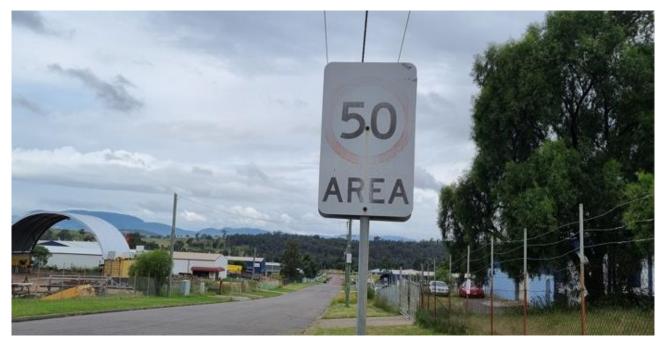
There is no speed limit sign at the entrance to Thomas Mitchell Drive at the primary side (left hand side of the motorists). In addition, the speed limit sign on the secondary side is faded which should be replaced by a new sign (Plate 2.8).

Plate 2.8 Faded 50 km/h sign on Glen Munro Road at Thomas Mitchell Drive intersection

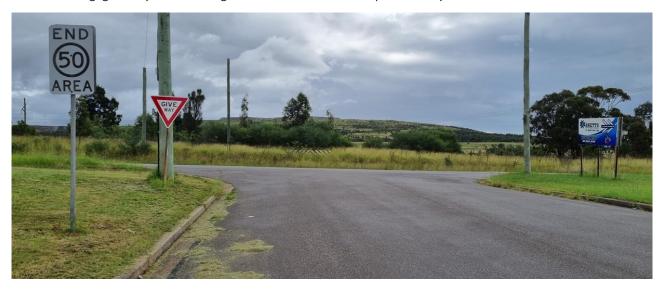
There is no existing 'give way' line marking for the traffic entering onto Thomas Mitchell Drive from Glen Munro Road. Installing 'give way' line marking at this intersection will improve safety.

#### Plate 2.9 No 'Giveway' line marking

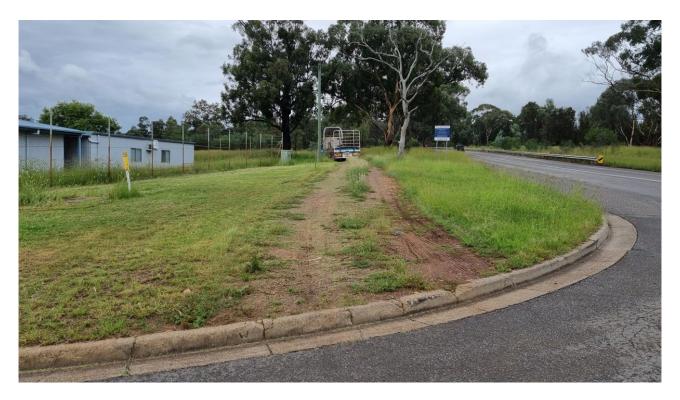
Apart from the speeding motorists along Thomas Mitchell Drive, discussed in section 2.5, another behaviour of concern was a truck driver taking a rest break (for approximately 15 minutes) parked on the road verge at the southeast corner of the intersection. This practice appears to be an ongoing occurrence which is obvious by the wheel tracks and lack of grass along the vehicular path (Plate 2.10 and Plate 2.11).

This illegal practice is potentially damaging the existing kerb, gutter and utility pits located in this area. Also, the vehicle was observed to cross the centre line of Thomas Mitchell Drive while exiting turning left, which is also a safety issue. Therefore, MSC should take appropriate action to stop this section of the area being use as a truck rest area, eg installation of high kerb, fencing etc. This should be discussed at the MSC's LTC.

Plate 2.10 Truck driver resting at the south-east corner of Thomas Mitchell Dr/Glen Munro Rd intersection

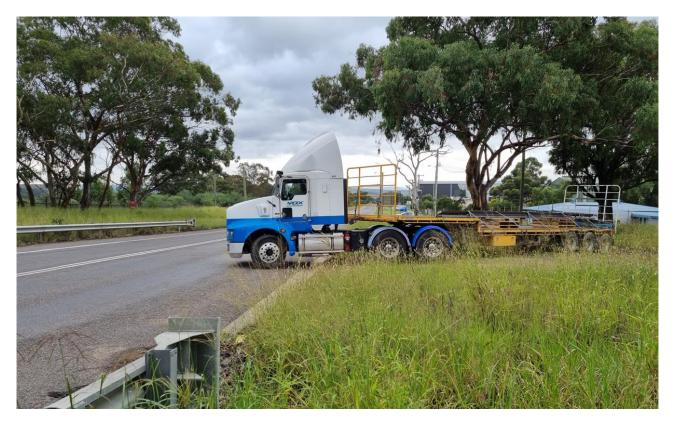
Plate 2.11 Truck leaving the rest area (turning left)

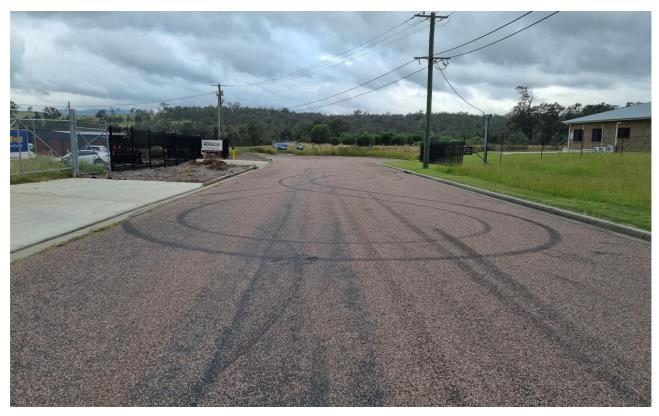
There were numerous tyre marks noted along Glen Munro Road, which as a result of inappropriate car driver behaviour (Plate 2.12). Despite, this not being within the study area, MSC and/or NSW Police should conduct further investigations of this situation and identify appropriate action to control the behaviour.

Plate 2.12 Tyre marks in Glen Munro Road (looking east)

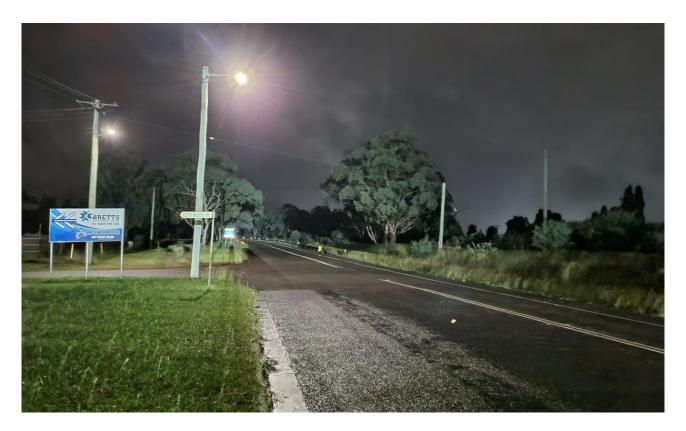
The night time lighting at this intersection is supported by two power poles with lanterns which appears to be adequate (Plate 2.13). When looking south, any presence of oncoming northbound traffic can be clearly noted by the headlights of the approaching vehicle. The observed traffic volumes using Thomas Mitchell Drive were significantly lower during the night time, so any arrival of traffic was also apparent from the sound of the vehicles.

Plate 2.13 Existing lighting at Thomas Mitchell Drive/ Glen Munro Road intersection

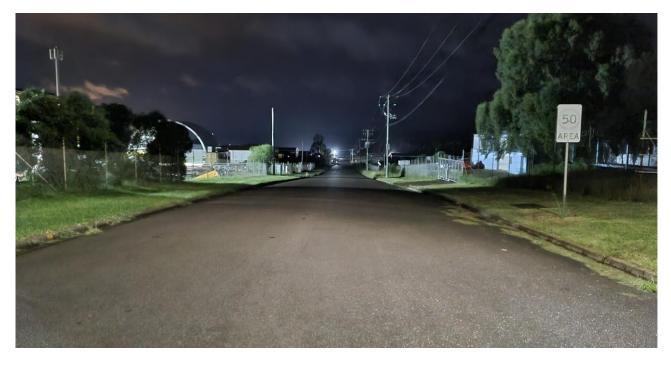
There is no street lighting along Glen Munro Road, however, the existing site lighting from the industrial properties is generally sufficient to provide adequate street lighting along this road (Plate 2.14).

Plate 2.14 Glen Munro Rd (looking east from Thomas Mitchell Drive)

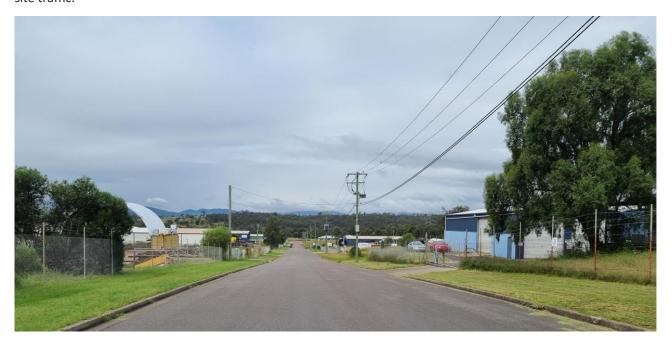
Overhead electrical cables were noted along Glen Munro Road, mostly on the southern side. The height of these cables when crossing Glen Munro Road, appeared to be over 4.5 m high (Plate 2.15).

Plate 2.15 Existing electrical cables on Glen Munro Road

To be certain, a trial run of the largest likely size of the vehicle using the site, should be undertaken by the applicant before commencing the site operations to confirm the existing overhead cables do not cause any safety risk to the site traffic.
