## **Dowe's Quarry**

### **Traffic Impact Assessment**

## **Traffic Impact Assessment**

## Stage 5 Road Safety Audit Dowe's Quarry Transportation Route

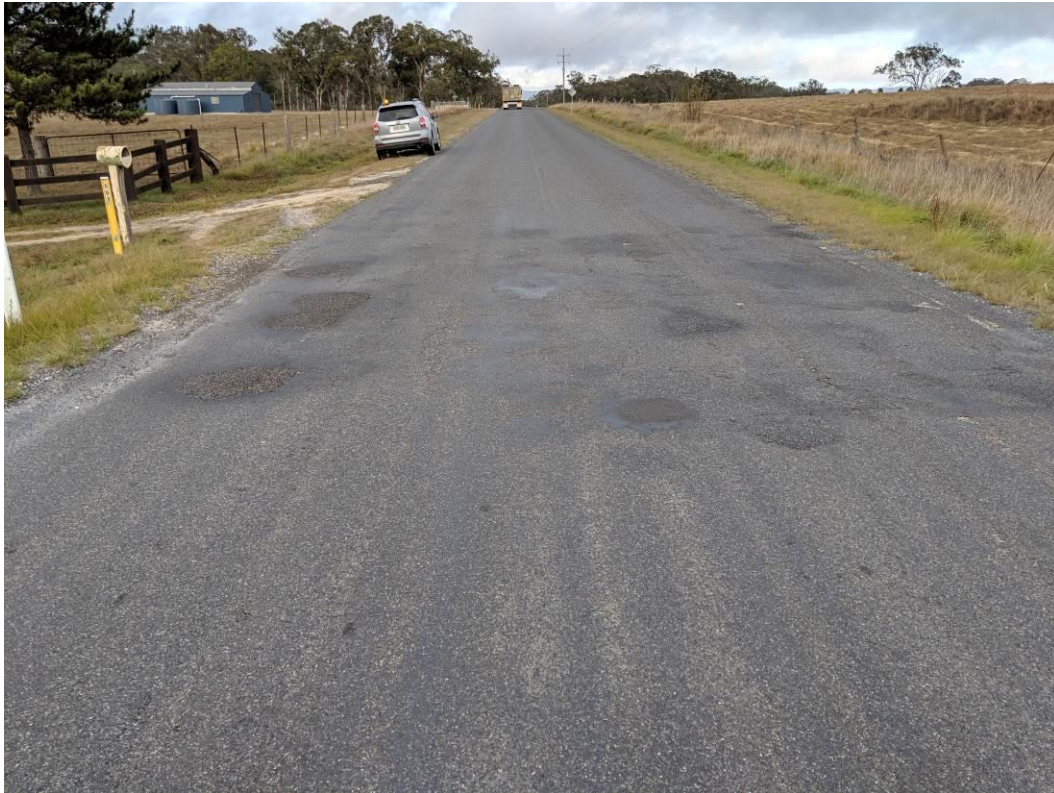
**Plate 2 - Pothole Patches near the Quarry Access Road**

Pavement deformations, edge break and other minor pavement defects should be rectified, in accordance with Council's intervention requirements, to prevent a vehicle losing control or the pavement ravelling. The bituminous seals should also be monitored to ensure moisture ingress is limited and a reasonable surface texture is maintained.

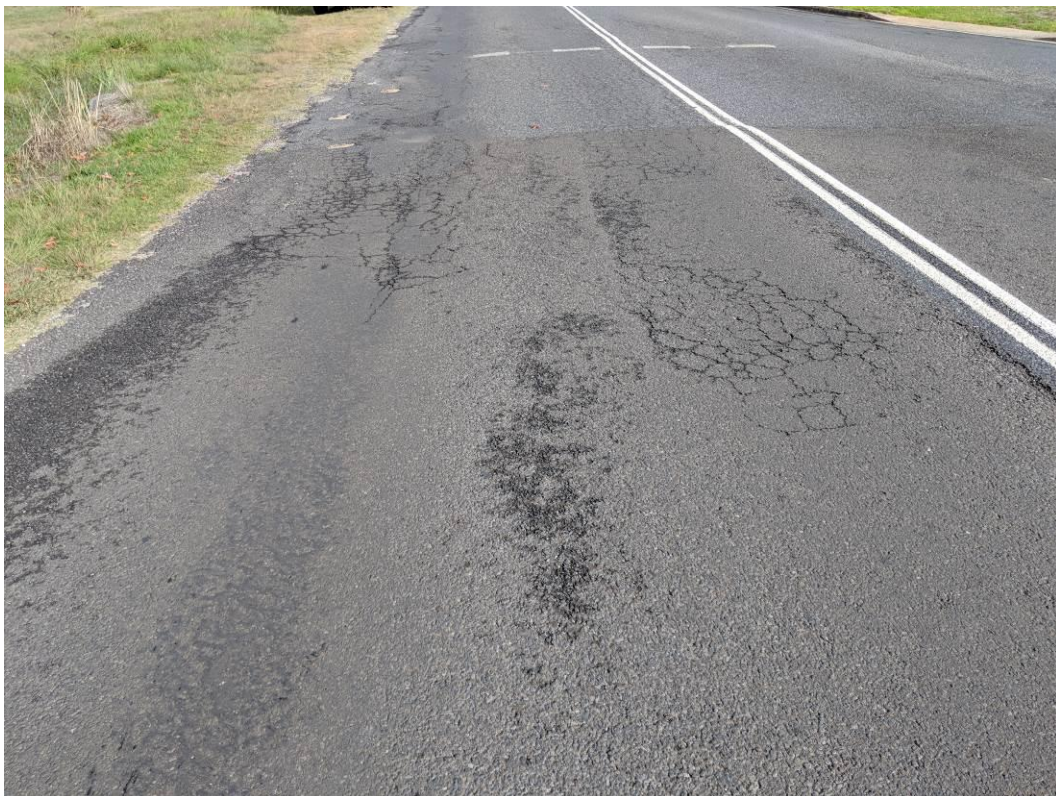
**Plate 3 - Naas Street Seal Cracking**

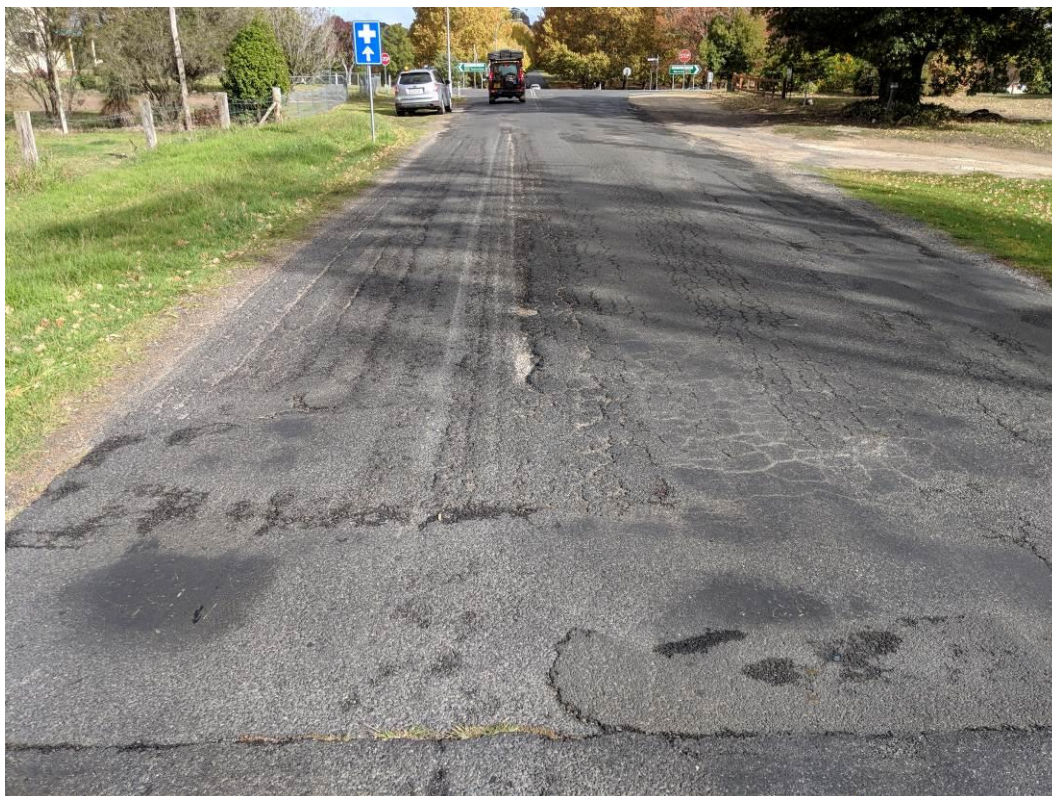
**Plate 4 - Naas Street Seal Cracking and Pavement Deformation**

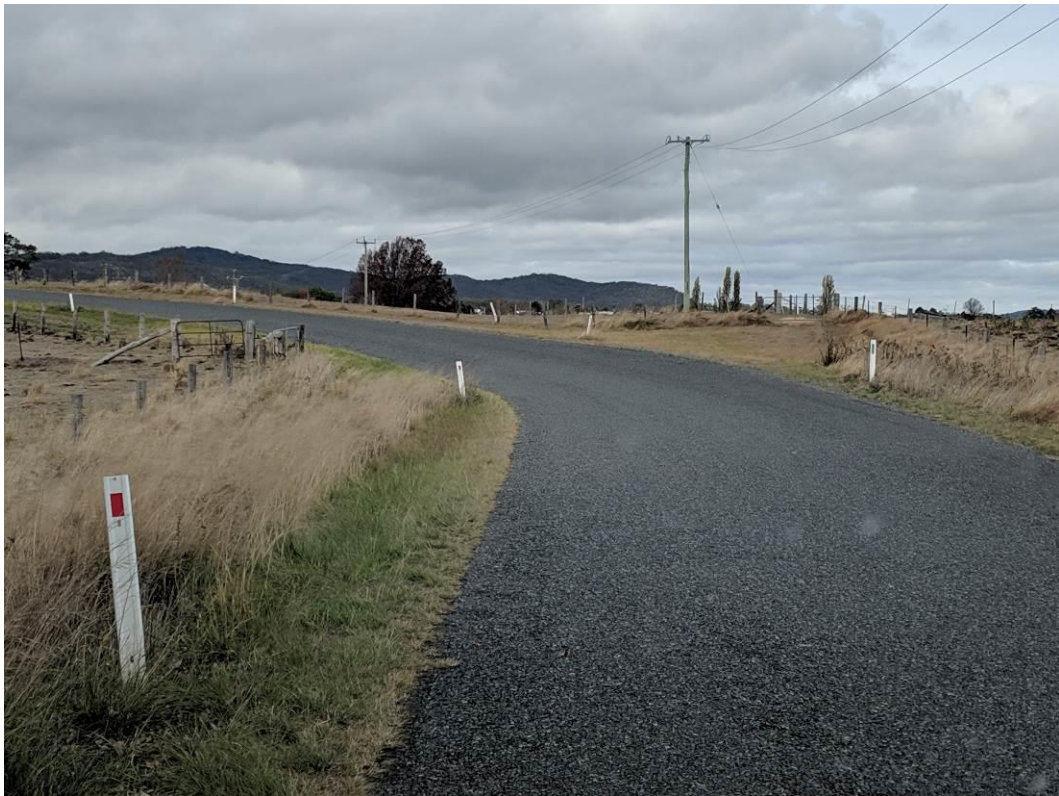
There are two causeways, one with depth markers and flood boom gates, and the other without depth markers. There are several tight radius curves without curve and speed advisory signs. There is no line marking and limited guideposts. There are also a number of crests with no advanced warning signs in place and no centreline marking over the crest.

**Plate 5 - Old Ballandean Road Tight Radius Horizontal Curve**

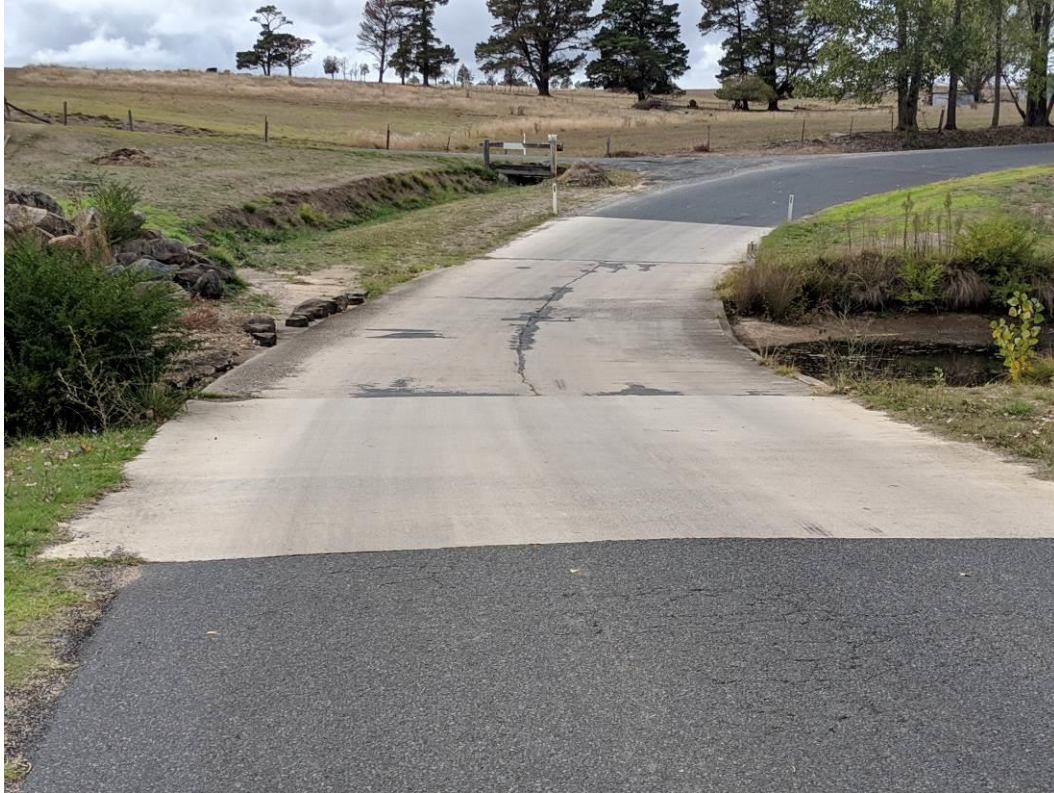
**Plate 6 - Old Ballandean Road Eastern Causeway**

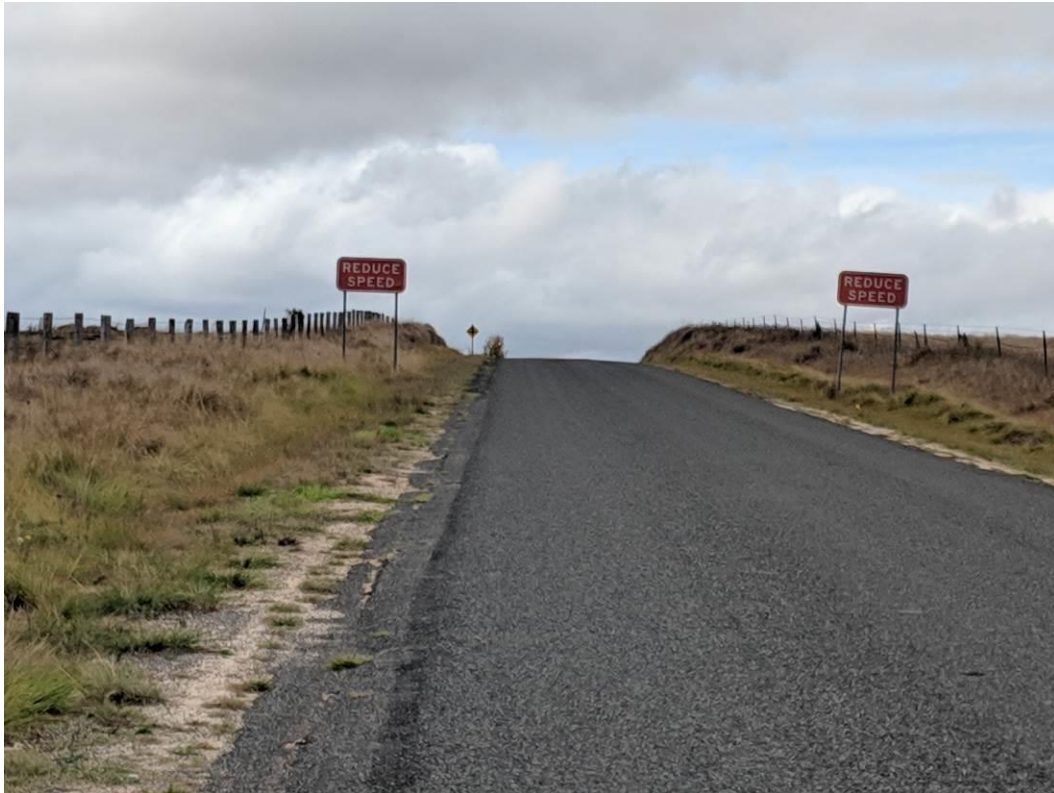
**Plate 7 - Crest along Old Ballandean Road**

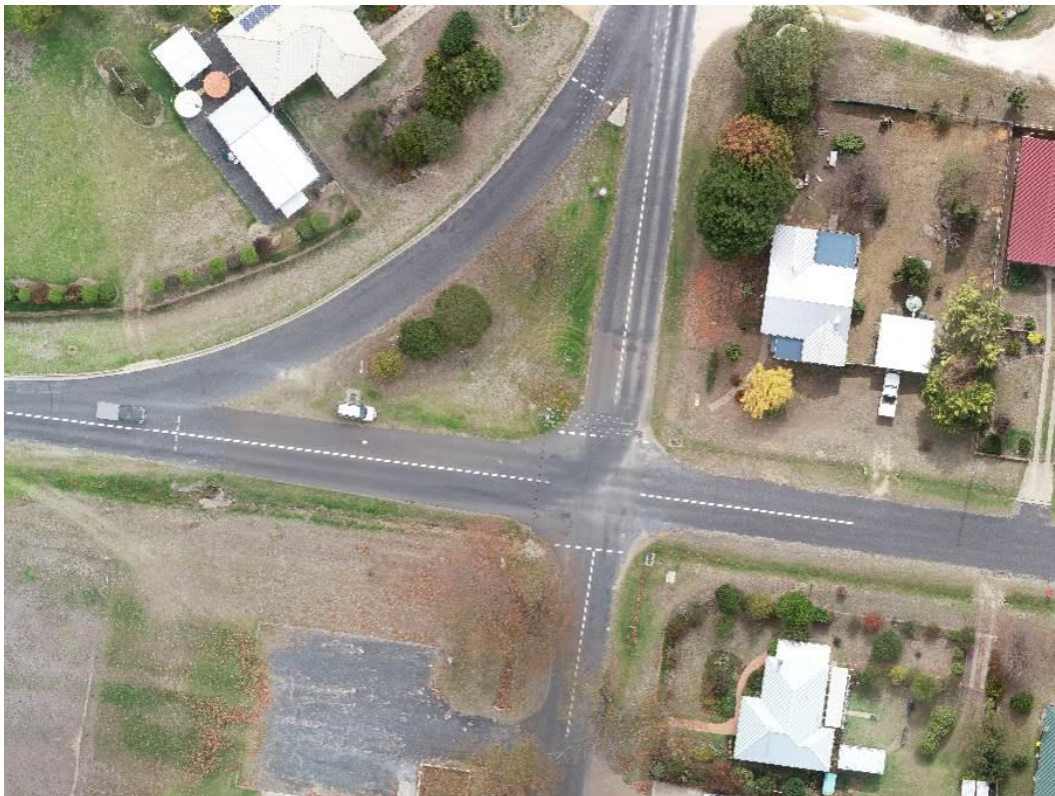
The pavement is in average condition with rutting prevalent however, a thin layer of asphaltic concrete surfacing has been applied and is likely assisting in avoiding excessive pavement defects as a result of screwing from vehicles undertaking turning manoeuvres. **Plate 9** shows the layout of the four way intersection.

**Plate 9 - Naas Street and Logan Street (Mt Lindesay Road) Intersection**

This intersection is utilised by the laden HVs turning right from Logan Street onto Naas Street. The tracking path of the HVs through the intersection is prevalent as shown in the drone imagery (**Plate 9**). Where possible the laden HVs should be encouraged to remain in the left lane without crossing the centreline on the approach to the intersection via Logan Street. The linemarking is worn and is unlikely to withstand repeated screwing.

Thermoplastic linemarking of the give way hold line and the centreline are recommended for the Logan Street approach. Some localised shoulder widening would also assist by providing improved dimensional capacity for the HVs to remain on the left hand side.

The condition of the pavement is deteriorating, therefore should be monitored to ensure a suitable pavement surface is maintained. Ideally the pavement in the intersection would be stabilised and an asphaltic concrete wearing course applied to avoid ongoing maintenance issues.

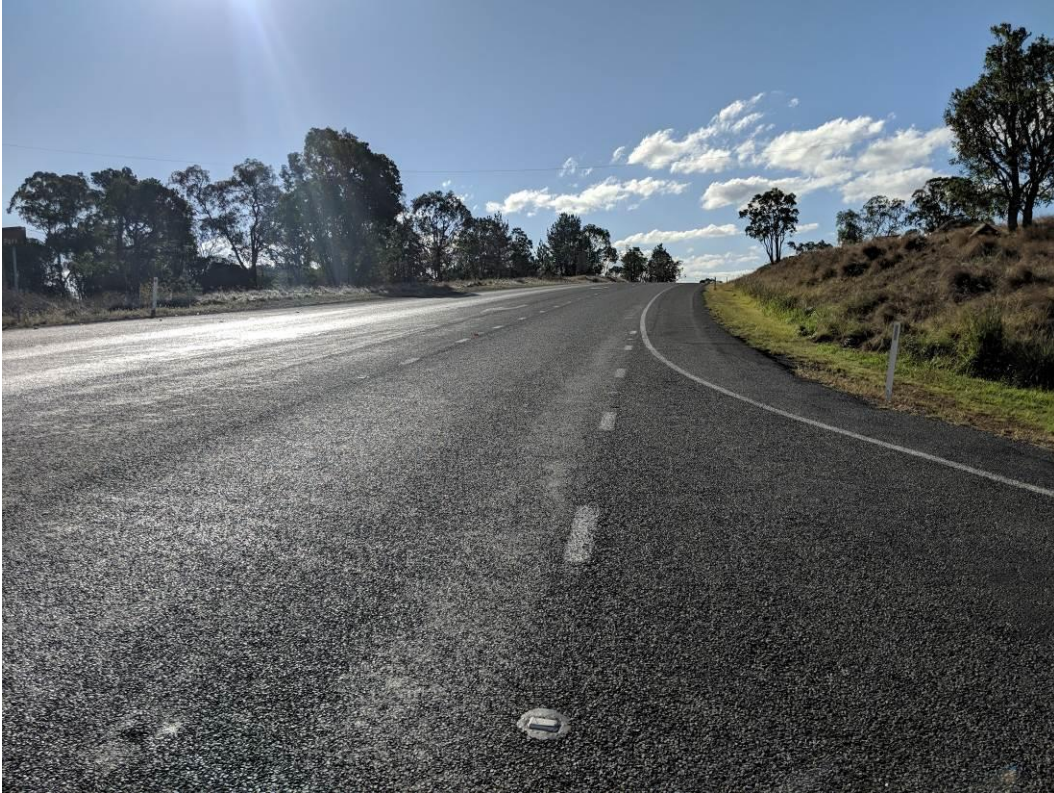
The sight distance along the New England Highway is limited to approximately 160m at the top of a crest to the north and is greater than 500m to the south. Safe intersection sight distance (SISD) for 100km/h is 248m as per the Austroad Guides and as a result, the available sight distance to the north in this speed environment is considered to be deficient. **Plate 12** shows the crest limiting sight distance to the north.

**Plate 12 - Limited sight distance due to crest looking north along the New England Highway**

The approved route for laden HVs via Tenterfield should be adhered to without exception. It is recommended that all drivers be tool boxed in relation to the issues associated with the SISD at this intersection to ensure it is not utilised and the inherent risks are known particularly given the recent crash history associated with the intersection.

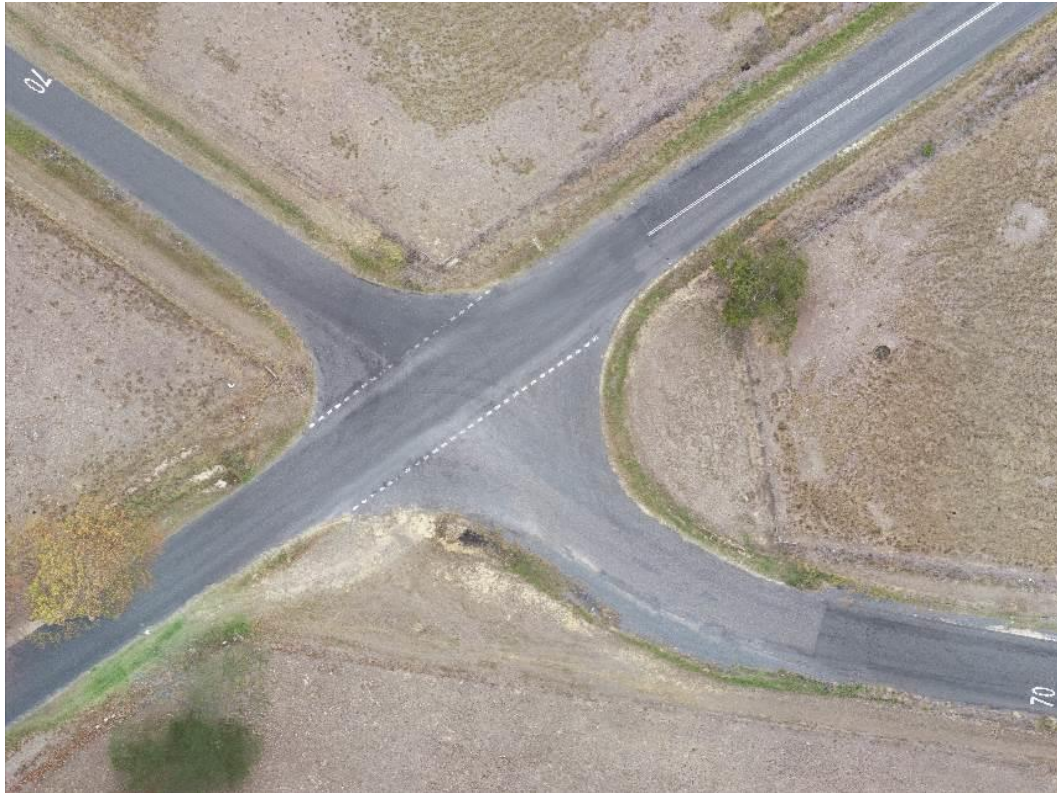
Plate 13 - Mt Lindesay Road & Old Ballandean Road Intersection

There is reasonable dimensional capacity for most turning manoeuvres although articulated vehicles turning right into Old Ballandean Road would likely track across the road centreline. The pavement condition is fair to reasonable with some evidence of rutting. Safe intersection sight distance (SISD) for a 70km/h speed zone is 151m as per the Austroad Guides and as a result, the available sight distance is considered to be adequate.

It is recommended that a centreline and hold line be provided on the Old Ballandean Road approach to encourage the HV drivers to stay on the left hand side and stop at a suitable location when required. This would assist in preventing the HVs taking up too much of the mouth of the intersection leaving insufficient room for vehicles turning right from the Mt Lindesay Road onto Old Ballandean Road.

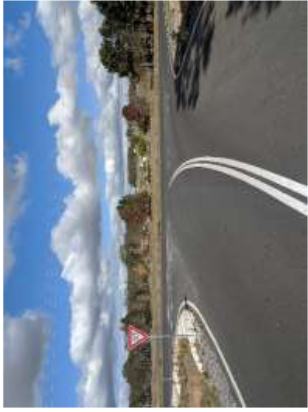
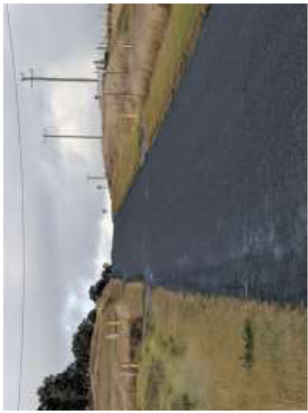
CAR No.	Audit Findings	Photographs
004	<p><b>Road Safety Category - Traffic Signs</b></p> <p><u>Missing Signs</u></p> <p>There are a number of locations where intersecting roads are not considered to be obvious to approaching drivers and there are no side road junction signs in place in advance of the intersection.</p> <p>There are a number of crests with no advanced warning signs and a number of curved with missing curve and speed advisory signage.</p> <p>There are number of intersections that have missing sight boards.</p> <p>Signs are provided to alert road users to oncoming features or changes in road condition. There is a risk that road users may not be aware of the oncoming conditions such as intersections or narrow culverts which may result in the possibility of a traffic collision with between and errant driver and merging traffic or an errant driver coming into contact with the substandard safety barriers potentially resulting in serious injuries to occupants of the vehicle.</p> <p>A lack of warning signage can compromise road safety as road users are not properly advised of the changed traffic conditions ahead.</p>

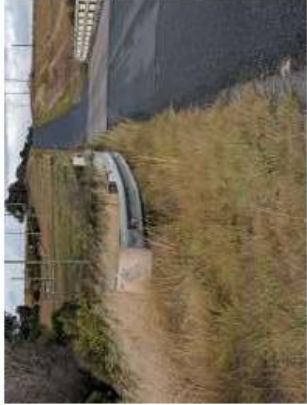
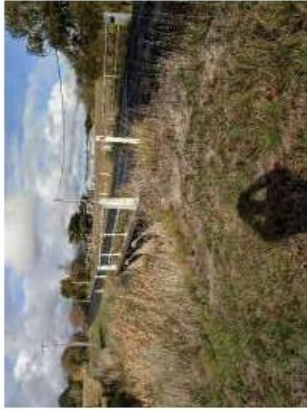
CAR No.	Audit Findings	Photographs
005	<p><b>Road Safety Category - Safety Barriers</b></p> <p>The end terminals for the safety barrier at the Bridge over Branch Creek are below current standards and have timber posts.</p> <p>There are number of locations along the inspected route where the safety barrier is too short and does not provide the maximum protection for road users, particularly adjacent to steep batters.</p> <p>There is a risk that an errant driver could leave the roadway and come into contact with a substandard safety barrier which does not correctly perform at impact due to the poor condition resulting with the potential for causing serious injuries to occupants of the vehicle.</p>

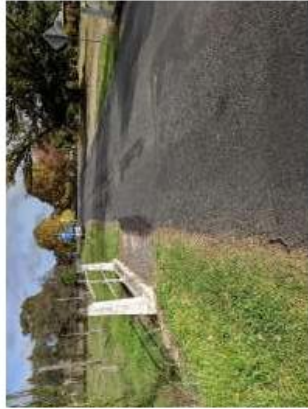
CAR No.	Audit Findings	Photographs
<b>Naas Street</b>		
007	<p><b>Road Safety Category - Safety Barriers</b></p> <p>The culvert has a steep drop off with a substandard railing and no safety barrier and end terminals on the approaches.</p> <p>There is a risk that an errant driver could leave the roadway and come into contact with a substandard safety barrier which does not correctly perform at impact due to the poor condition resulting with the potential for causing serious injuries to occupants of the vehicle.</p>

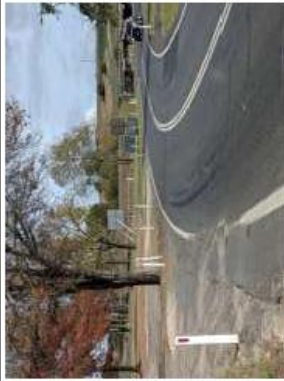
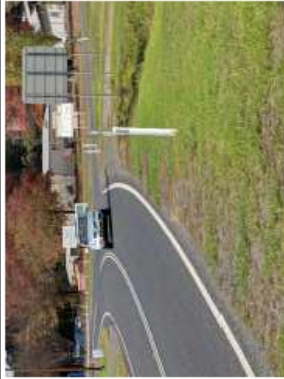
<b>New England Highway</b>		
008	<p><b>Road Safety Category -Roadside Hazards</b></p> <p><u>Objects within the Clear Zone</u></p> <p>There are a number of trees and culverts located within the clear zone that have no protection for road users.</p> <p>The location of these objects creates a hazard as there is a risk that errant drivers may leave the road and collide with unprotected objects within the clear zone which has the potential to cause serious injuries to the occupants of the vehicle.</p>

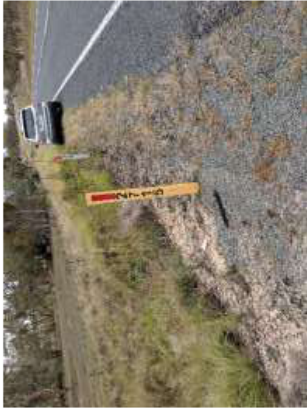
CAR No.	Audit Findings	Photographs
009	<p><b>Road Safety Category - Road Alignment and Cross Section</b></p> <p><u>Steep Batters</u></p> <p>There are a number of unprotected steep batters:</p> <p>There is a risk that an errant driver may leave the road, have insufficient shoulder width to recover and lose control down a steep batter as there is no safety barrier in place. This has the potential to cause serious injuries to the occupants of the vehicle.</p> <p>There is also an increased risk potential for vehicle rollover type crashes, particularly heavy vehicles, on the verge/batter as the road has batter slopes in numerous locations which are less than the minimum standard of 4:1 and less than the desirable minimum batter of 6:1 for heavy vehicles as per Austroads Guide to Road Design.</p>

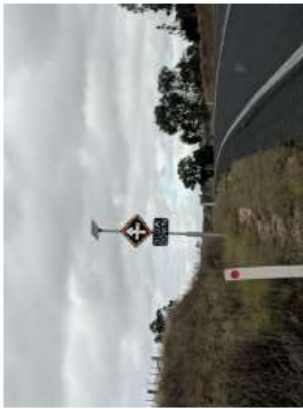
010	<p><b>Road Safety Category - Traffic Signs</b></p> <p><u>Damaged Signs</u></p> <p>The solar powered intersection ahead sign whilst operational during the day was not illuminated at night.</p> <p>Signs are provided to alert road users to oncoming features or changes in road condition. There is a risk that road users may not be aware of the oncoming conditions such as intersections or narrow culverts which may result in the possibility of a traffic collision with between and errant driver and merging traffic or an errant driver coming into contact with the substandard safety barriers potentially resulting in serious injuries to occupants of the vehicle.</p> <p>A lack of warning signage can compromise road safety as road users are not properly advised of the changed traffic conditions ahead.</p>

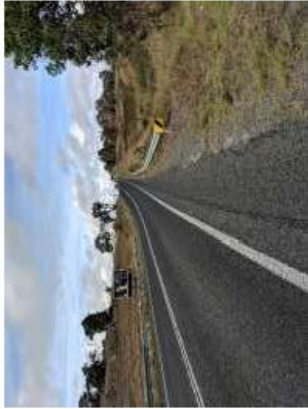
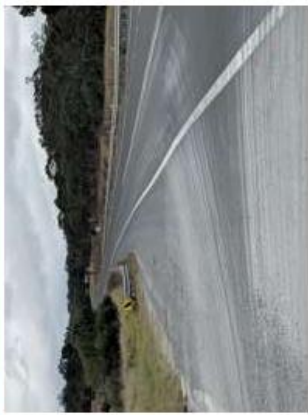
CAR No.	Audit Findings	Photographs
011	<p><b>Road Safety Category - Safety Barriers</b></p> <p>The end terminals for some of the safety barriers are substandard.</p> <p>There is a risk that an errant driver could leave the roadway and come into contact with a substandard safety barrier which does not correctly perform at impact due to the poor condition resulting with the potential for causing serious injuries to occupants of the vehicle.</p>

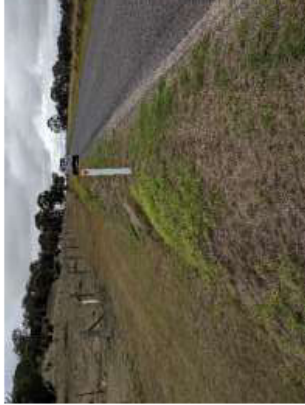
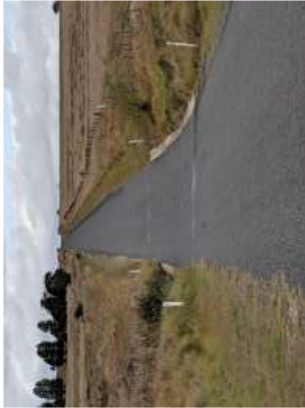
CAR No.	Audit Findings	Photographs
015	<p><b>Road Safety Category - Road Alignment and Cross Section</b></p> <p><u>Steep Batters</u></p> <p>There are a number of unprotected steep batters. There is a risk that an errant driver may leave the road, have insufficient shoulder width to recover and lose control down a steep batter as there is no safety barrier in place. This has the potential to cause serious injuries to the occupants of the vehicle.</p> <p>There is also an increased risk potential for vehicle rollover type crashes, particularly heavy vehicles, on the verge/batter as the road has batter slopes in numerous locations which are less than the minimum standard of 4:1 and less than the desirable minimum batter of 6:1 for heavy vehicles as per Austroads Guide to Road Design.</p>

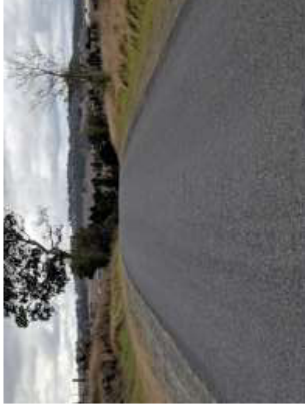
016	<p><b>Road Safety Category - Traffic Signs</b></p> <p><u>Damaged and Missing Signs</u></p> <p>Some signs have poor reflectivity at night.</p> <p>There are missing curve and speed advisory signs on the approaches to substandard curves.</p> <p>There are missing advanced warning signs on the approaches to crests.</p> <p>There are missing advanced warning signs on the approaches to obscured intersections.</p> <p>There are missing and obscured flood depth markers at a causeway.</p> <p>Signs are provided to alert road users to oncoming features or changes in road condition. There is a risk that road users may not be aware of the oncoming conditions such as intersections or narrow culverts which may</p>
