Geobag walls at Clarkes Beach, Byron Bay

WRL TR 2021/12, September 2021

By J T Carley and F Flocard

UNSW
Water Research
Laboratory

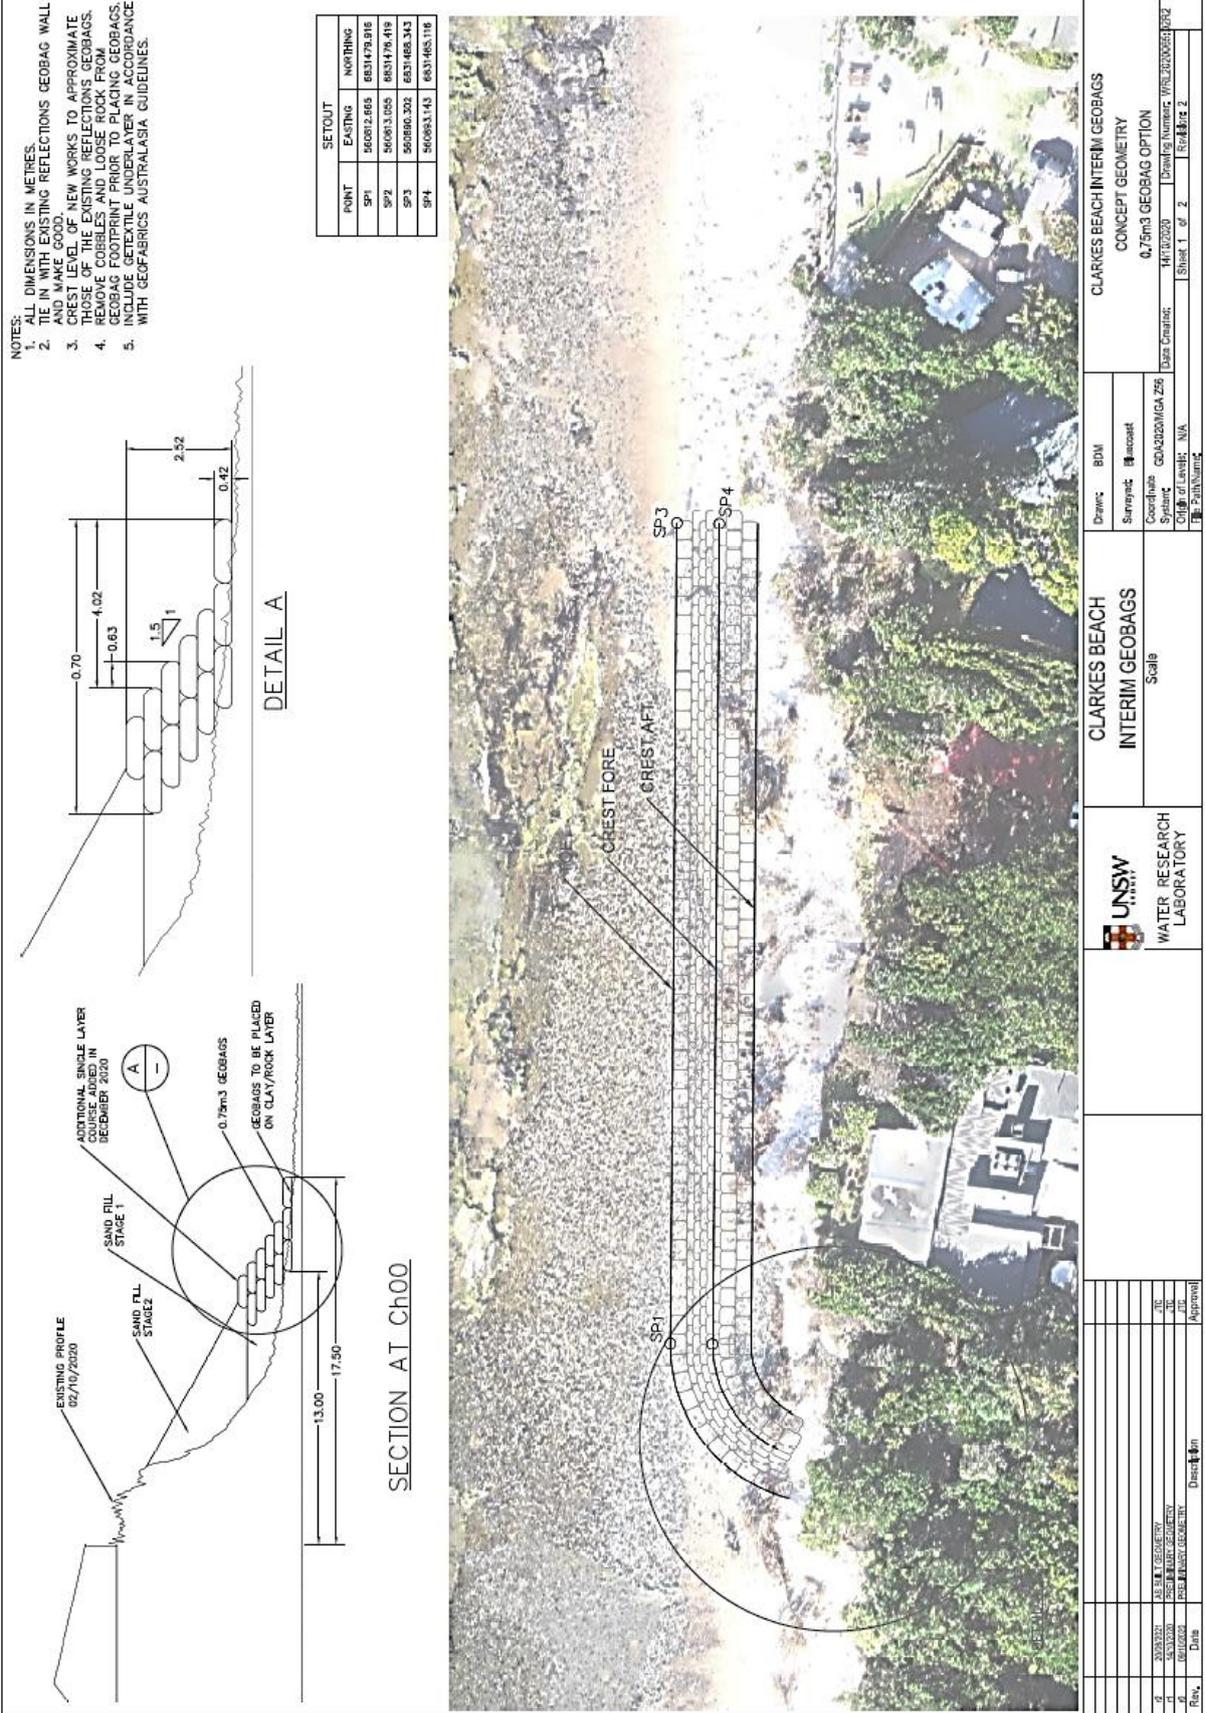
Figure 2.6 Plan and cross section of Cafe geobags – as modified

Note: One single width course was added to a significant portion of the crest in December 2020

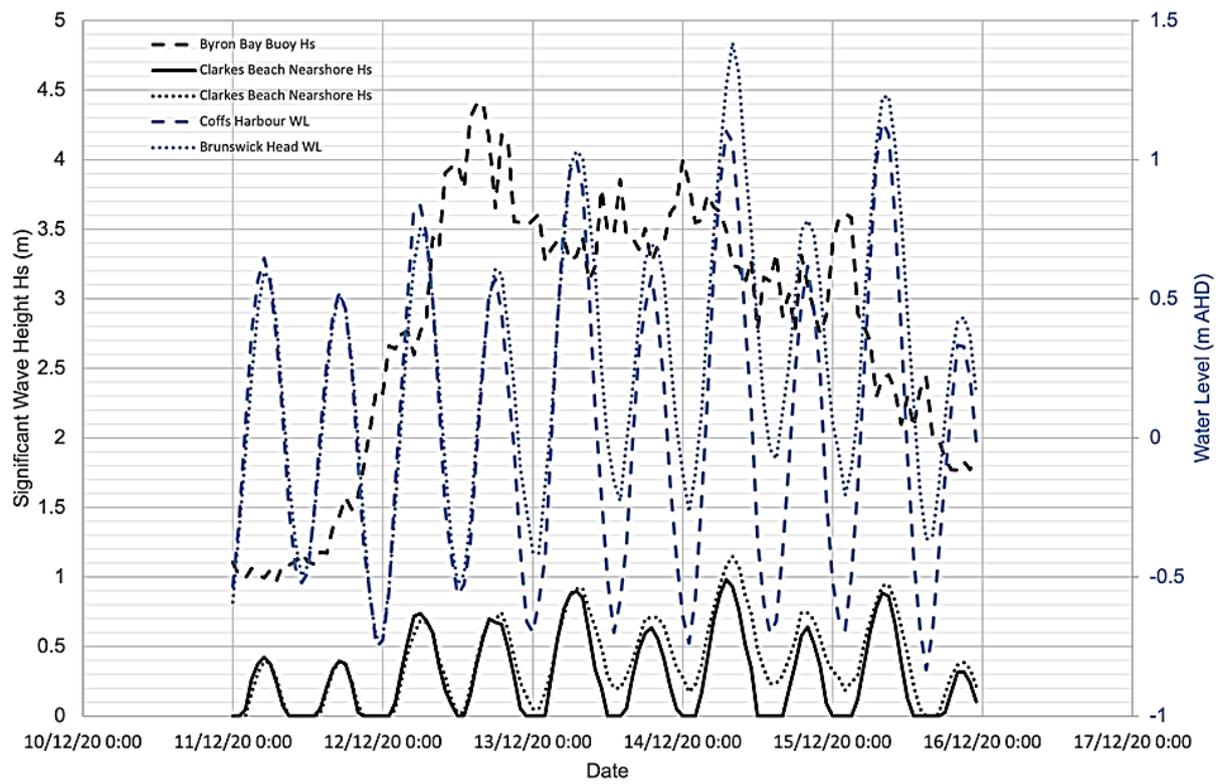
Figure 6.12 Waves and water levels for December 2020 storm event

The geobag structure withstood this event with minimal displacement of geobags. However, the structure was overtopped by waves, and sand was eroded from above the crest. An additional single layer course of geobags was added to the crest and additional sand was placed to restore the embankment behind the geobags.

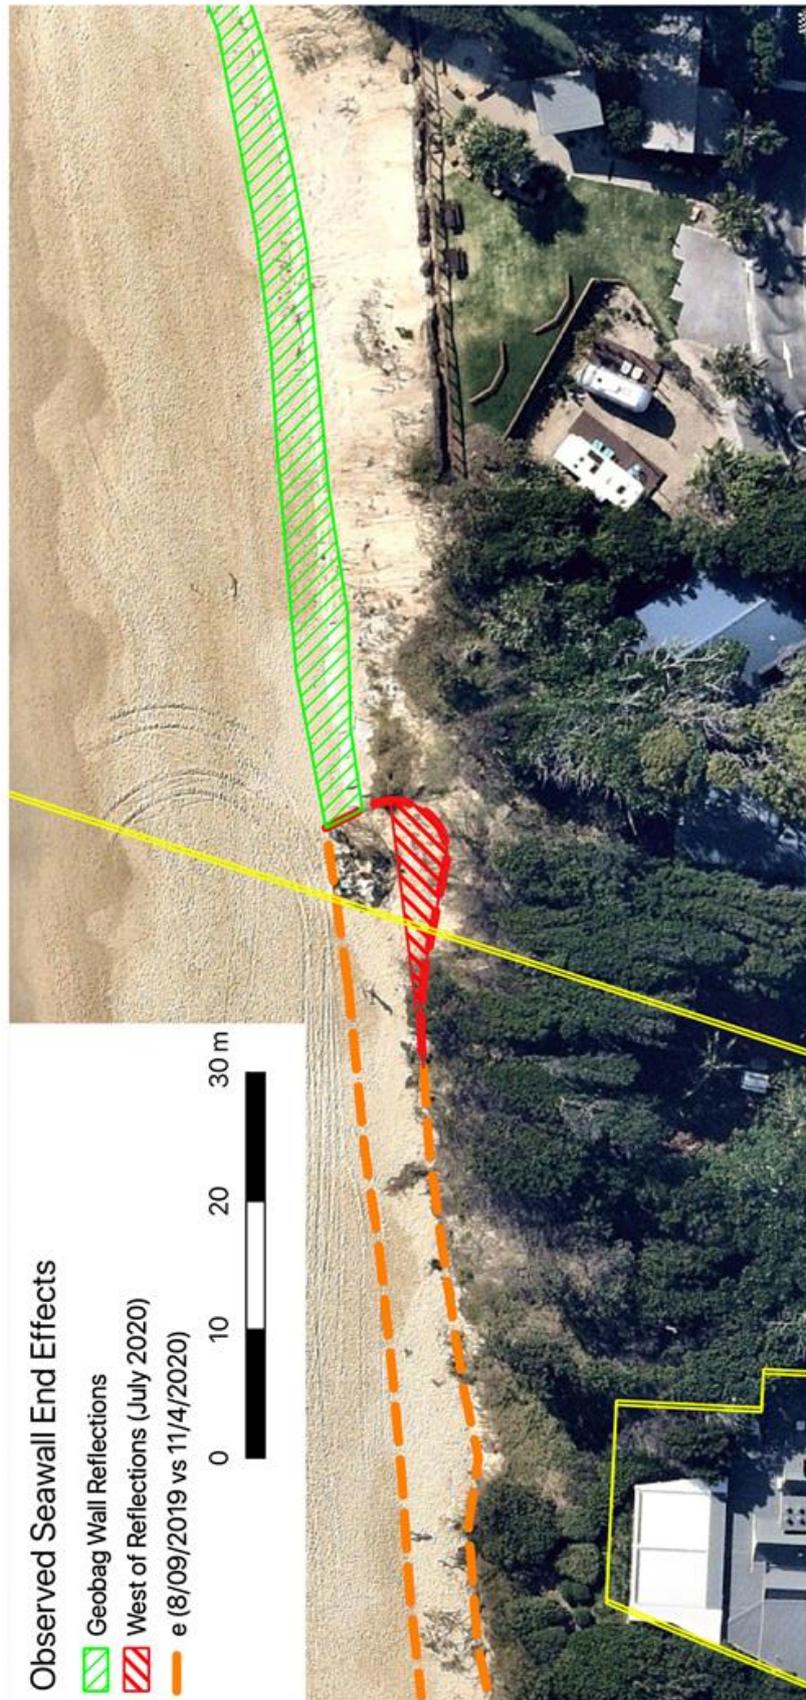
Figure 7.6 Observed end effect to date – Reflections only close up

Geobag wall	Embayment Zoom	Close up	r (m)	S (m)
Reflections only	Figure 7.5	Figure 7.6	4	20
Reflections plus Cafe	Figure 7.5	Figure 7.7	5	35

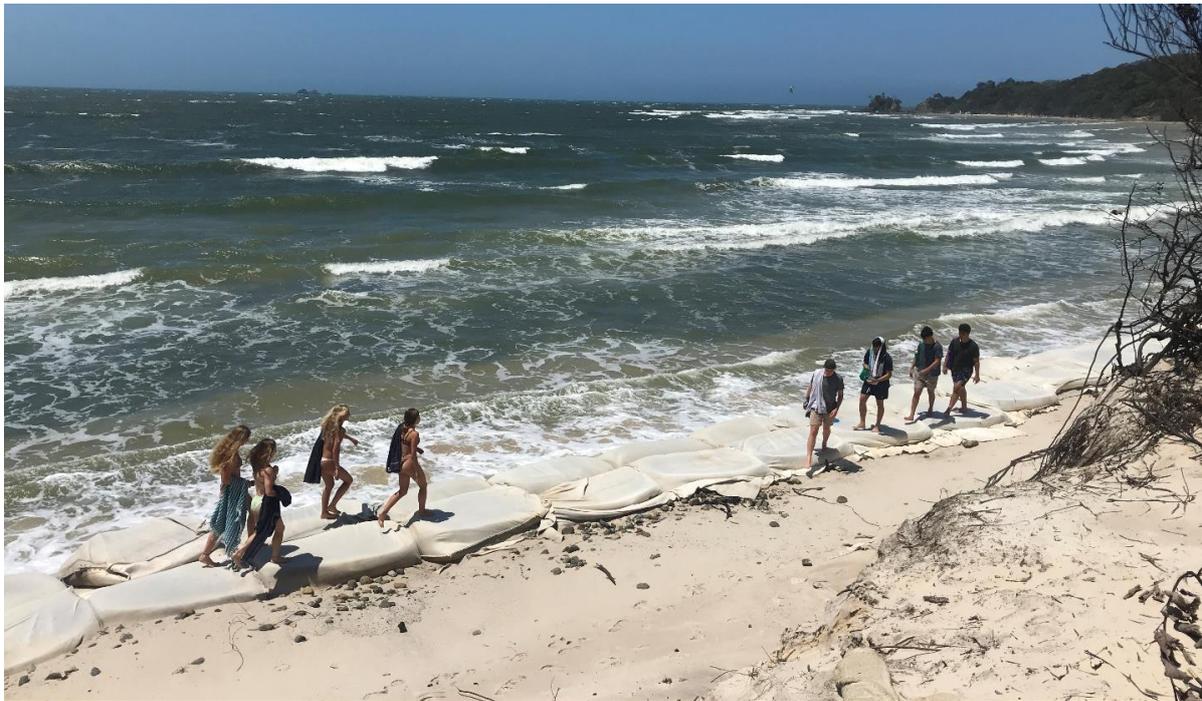
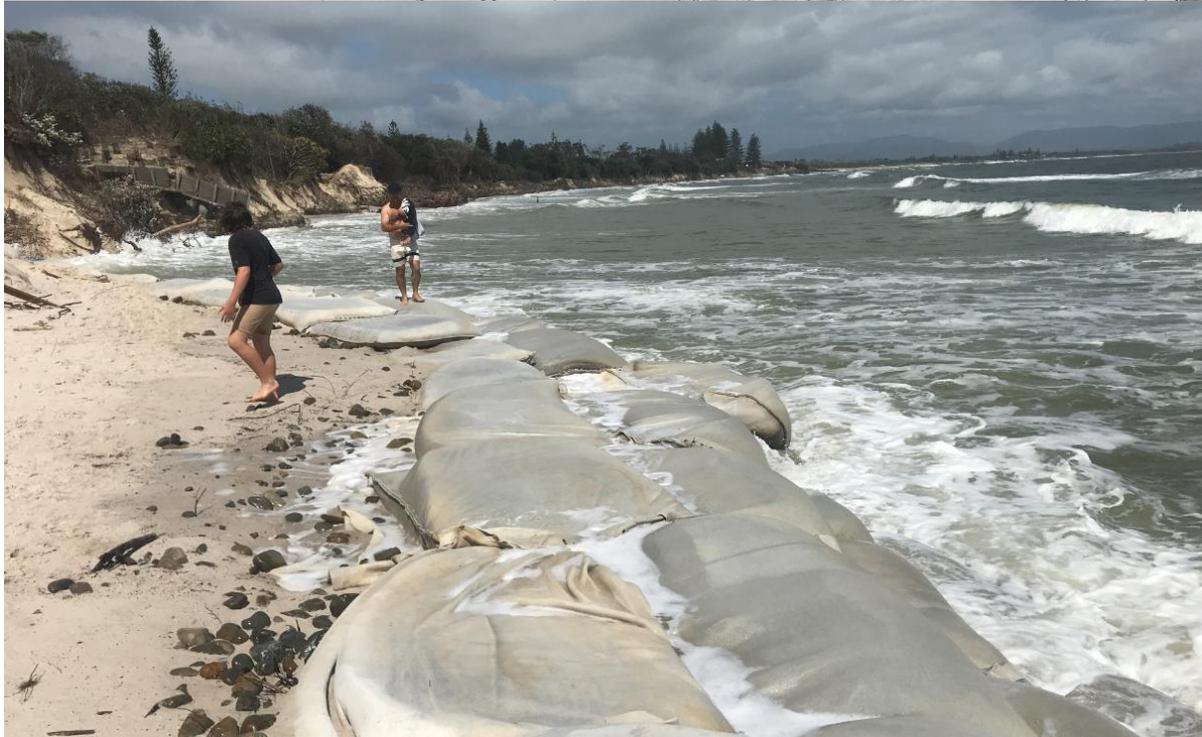
Photos: James Carley 18/12/2020

Given that impacts to alongshore public access are limited to times when the beach is in an eroded state, and that the structure is intended to be retained for the estimated 5 year life, the overall impact to public access is not considered to be unreasonable.

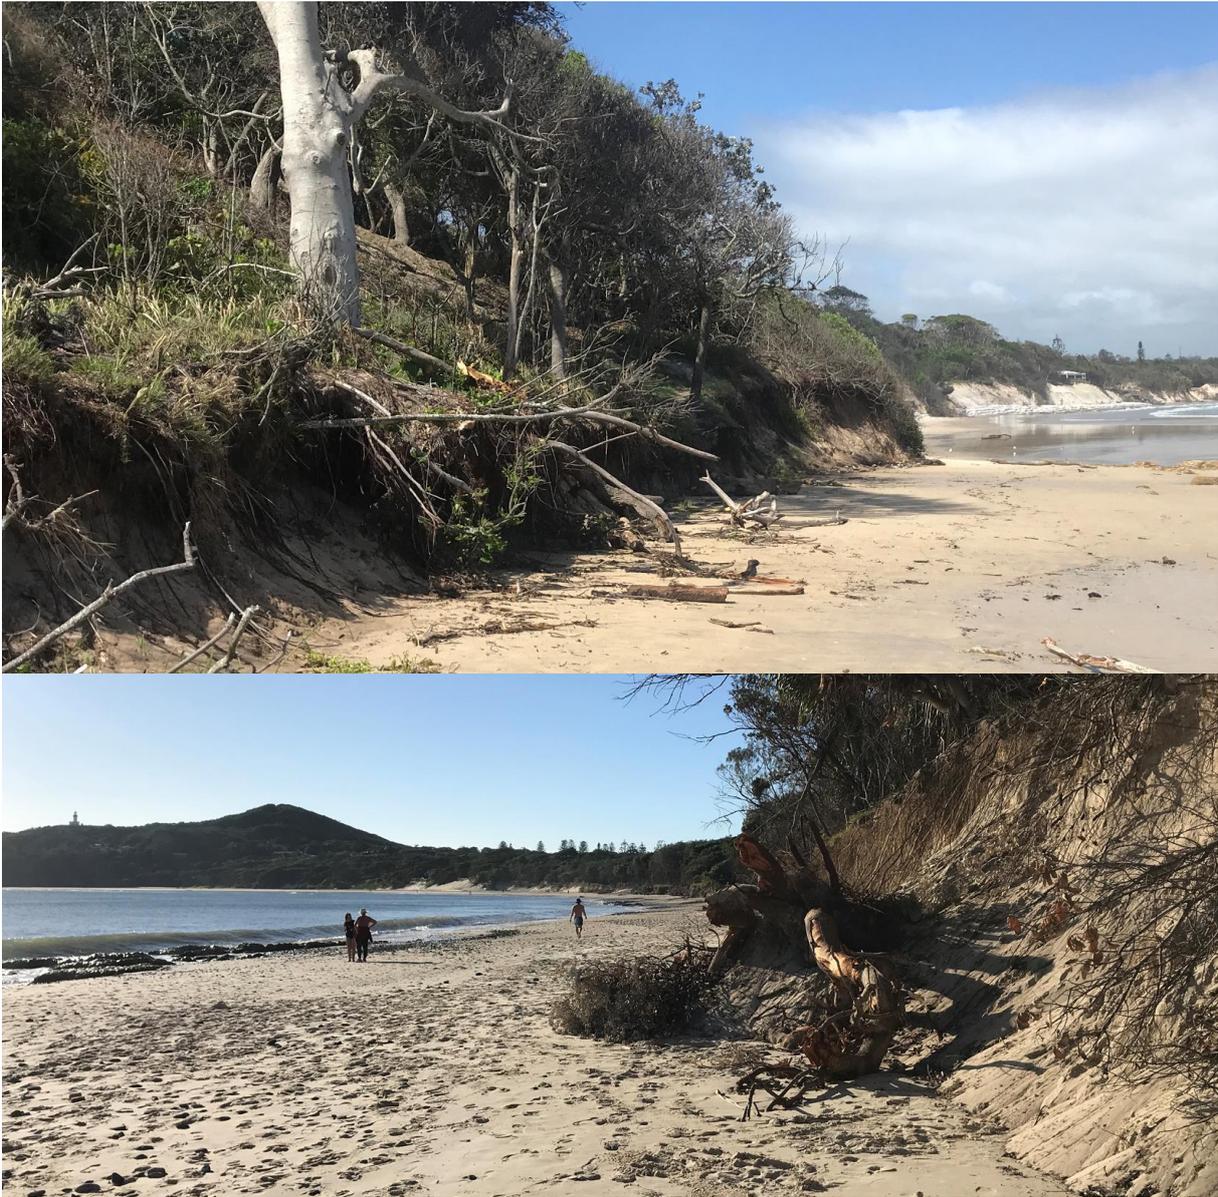
Photos: James Carley 18/12/2020 top, 23/04/2021 bottom

It should also be noted that parts of Clarkes and Main Beach without protection, this dune sand contribution is insufficient to cover the exposed rock/reefs, and involves the collapse of vegetation and formation of potentially dangerous scarps (Figure 9.2). The works prevent this occurring over their alongshore extent for storm wave conditions up to an approximately 5 year ARI storm wave event.
