CLARKES BEACH DUNE RECONSTRUCTION

Summary of Geotechnical and Risk Assessment

**NSW Department of Planning, Industry and Environment –
Crown Lands**

3rd September 2021

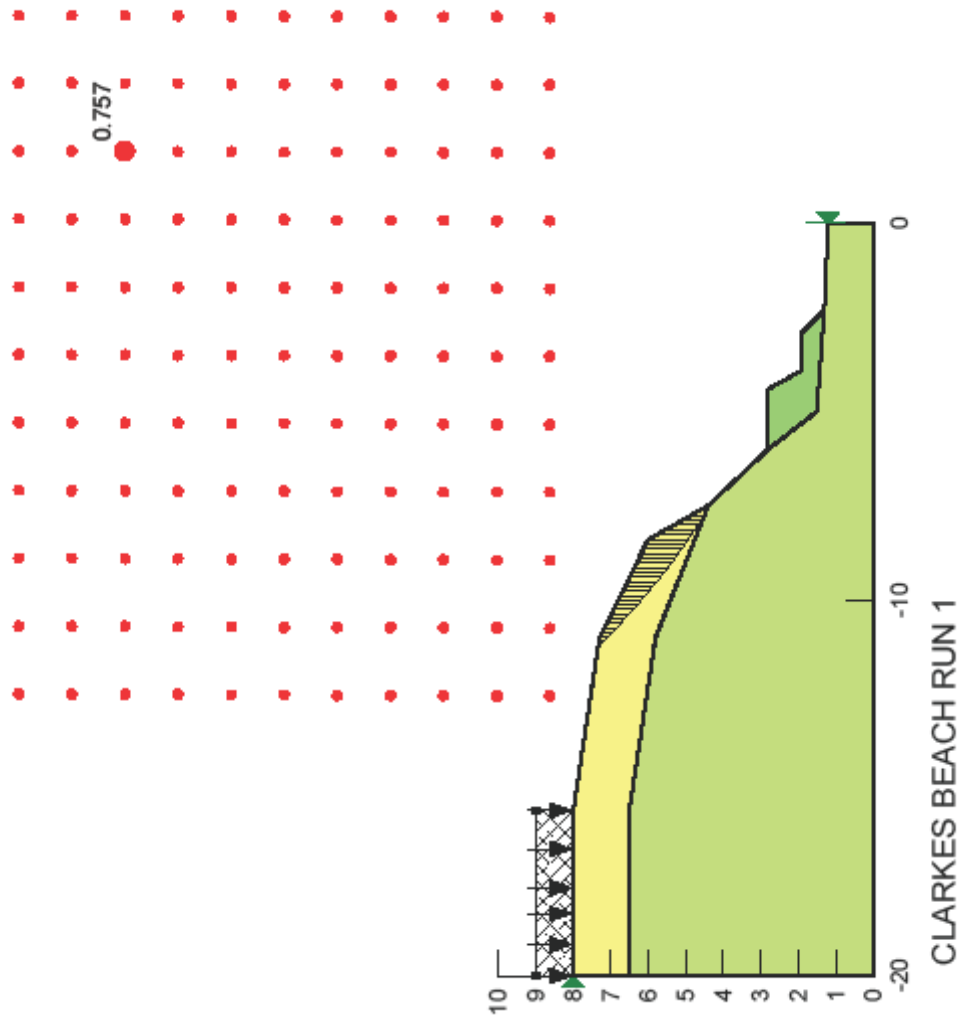
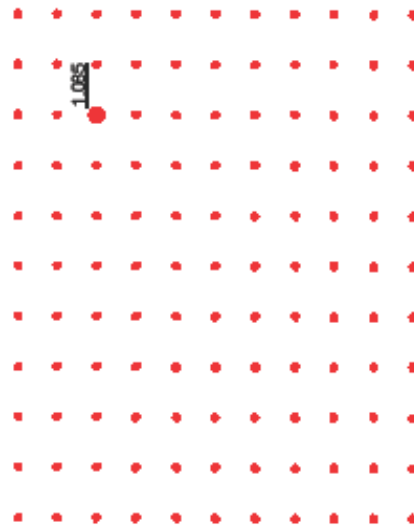
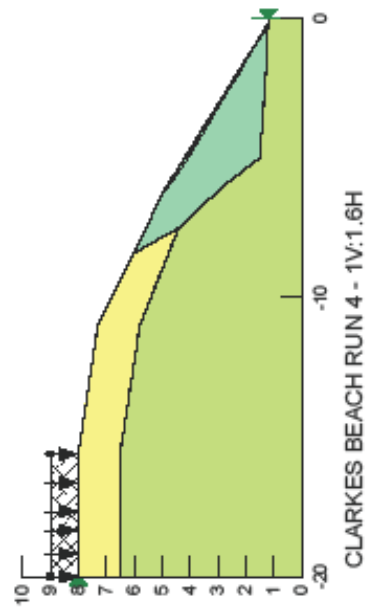
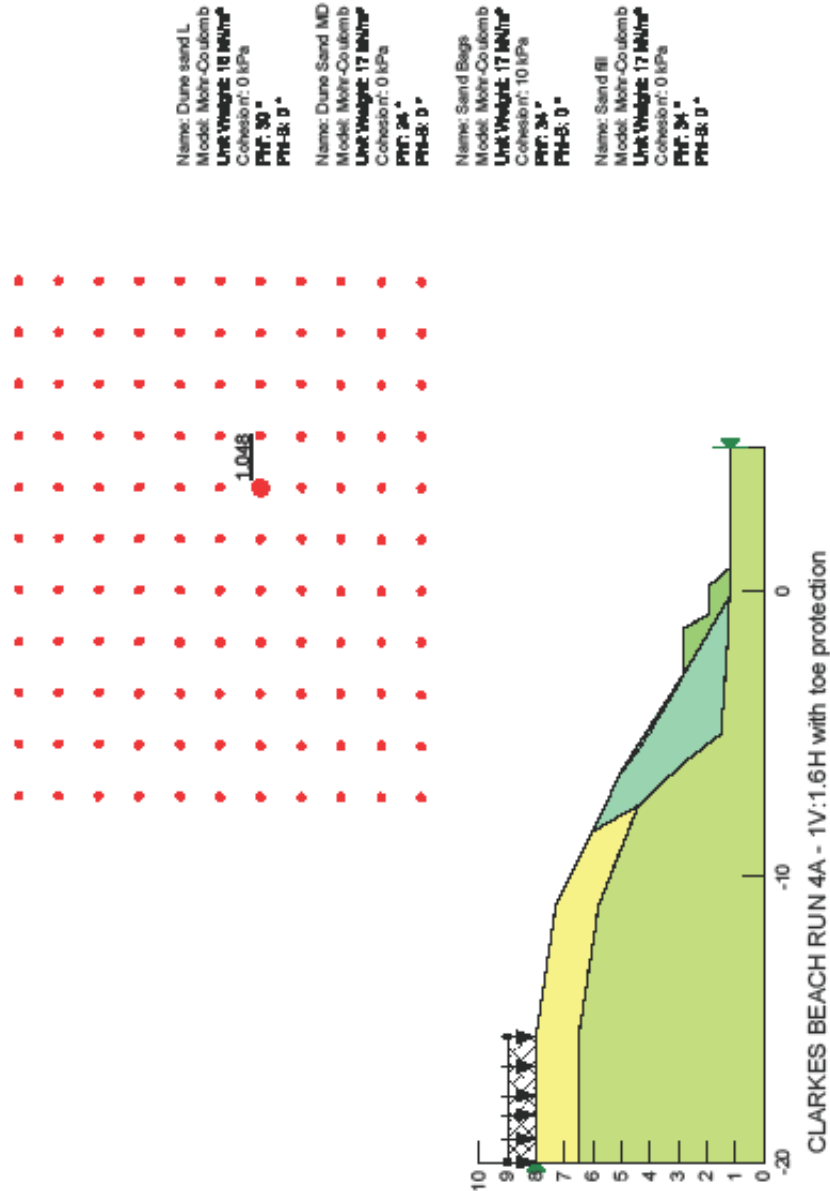
The results in the table show that the steeply (> 40 degrees) eroded dunes in front of the Beach Café were “unstable” in July 2020 with FoS value of 0.7 whilst the unaffected Reflections dunes were relatively stable with a FoS of 1.16. The repair options show that in terms of stability the only acceptable option in terms of Factors of Safety were for a reconstructed dune with or without toe reinforcement set at no greater than a 32 degree back slope. The decision on toe reinforcement is more effected by scour events. Without the toe a stable dune can be quickly undermined by minor storm events and tides as witnessed between July and October 2020.

The preliminary analysis shows the July 2020 event created local instability within the dune resulting in its gradual recession via flattening of the upper portions to achieve stability and retreat of the toe with wave and tidal effects.

The preliminary analysis shows acceptable levels of global stability are achieved for reseeded slopes of 32 degrees provided toe protection is included. Without toe protection the global FOS is marginal. Local stability values hover either side of unity for either protected or unprotected toes. This would be displayed as shallow ravelling of the front face. Revegetation would assist together with preventing human access.

For steeper (35 degree) slopes reported global stability is not considered acceptable unless other stabilising measures are incorporated.

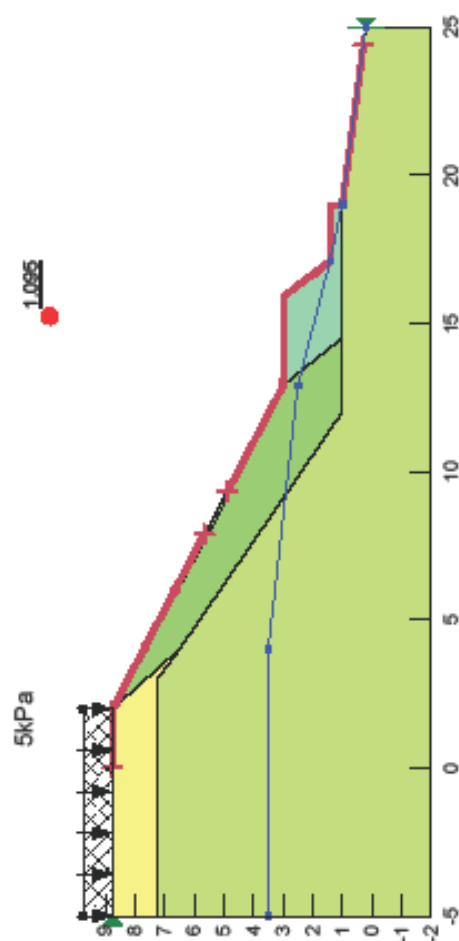
From the above results it can be seen that the FoS for a compacted (medium dense) sand dune at 32 degrees (highlighted in yellow), has similar FoS across the parameters investigated to that achieved by a 28 degree uncompacted dune (highlighted in blue). The medium dense sand at 28 degrees can be seen to generally outperform the 28 degree loose sand dune.

Clarks Beach Remedial Works
Loose Sand Fill
Batter at 28 degrees (crest pushed back 1m back into cafe are 17m from surcharge to toe)
Elevated water table behind sand bags
Construction Run 6

Hence the flatter slope of 28 degrees was adopted for the dune in front of the café as the factors of safety for steeper slopes for loose sand were considered too low. Consequently, the geobag toe protection could not be brought closer to the dune crest.

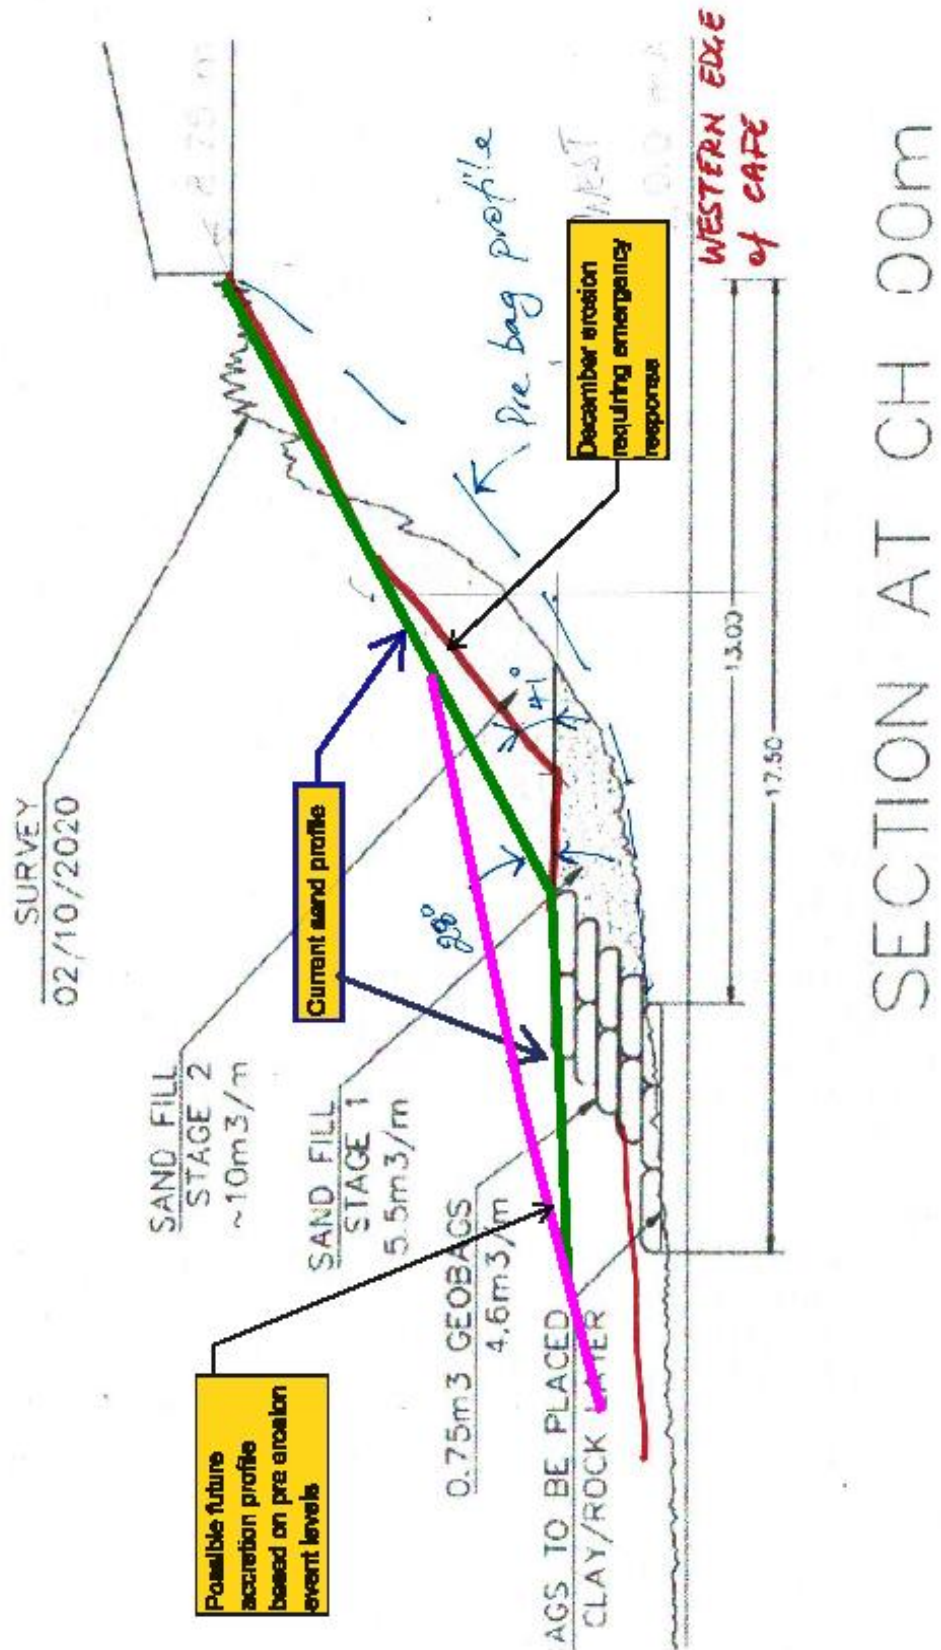
SKETCH 1: Various Dune Profiles recorded during 2020 Scour events

In December 2020 large tidal events and minor storms over topped the geobag toe protection and removed sand from the toe of the dune above the geobags. This resulted in a back slope of between 41 and 50 degrees as described in sketch 1 overleaf. This slope range was consistent with the short-term stability values previously observed. An emergency response was initiated by DPIE-Crown Lands which involved reinstating the eroded toe of the dune with approximately 800 cubic metres of sand and placing an extra row of Geobags on top of the existing installation.

- The sketch over leaf shows a local backslope at 41 degrees existed in the short term immediately prior to the December 2020 repair.
- The need to repair the Geobags would be assessed as part of a monitoring program. Repair is taken as replacing torn bags or reinstating dislodged bags. During the December 2020 event the Geobag work mainly involved placing an extra row of bags across the existing toe structure. Replacing torn or reinstating dislodged bags along the Reflections frontage was a relatively minor (1 day) exercise.

To maintain the adopted Factors of Safety the dune backslope is required to be kept at 28 degrees. In the short - medium term this may require supplementing the dune with additional sand. The maintenance frequency will be affected by the severity of beach scour events and the ability of the beach to be reinstated to pre-July 2020 profiles. Should the beach return to the pre July 2020 event then minimal maintenance will be required.
