ASBESTOS REMOVAL CLEARANCE CERTIFICATE: 168883_CC_TK_310523_1

Project Details			
Job Number	168883	Site Address	69 Evans St Inverell, NSW 2360
Purchase Order Number			
Client	Demex	Date of Inspection	31/05/2023
		Time of Inspection	1:41:00 PM
Client Address	PO Box 5557, QLD 4218	Inspected By	Thomas King
Client Contact	Carl Pump		
Client Telephone	1300 634 777		
Client Email	cpump@demex.com.au

Asbestos Removal Works Description			
Removal Contractor	DEMEX		
Contractor Contact	Aidan		
Contact Details	T:		E:
Date/s of Removal Works	31/05/2023		
Location of Works	69 Evans St Inverell, NSW 2360		
Specific Location(s) of Works	Top of soil to former asbestos containing pipe encased in cement. Top of soil to former asbestos cement sheeting.		
Friability of ACM Removed	Non-Friable	Total Work Area (m²/m³)	45 m2
Material(s) Removed	Asbestos piping encased in cement

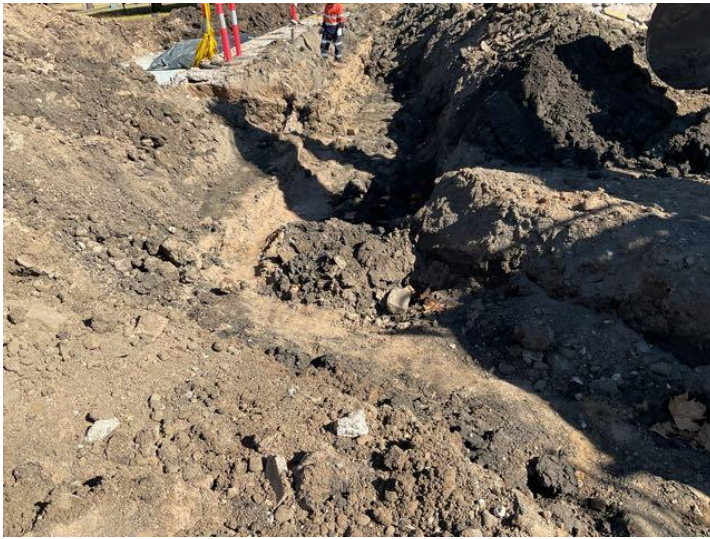
Top of soil to former
asbestos piping
containing cement. No
Asbestos was present at
time of inspection.

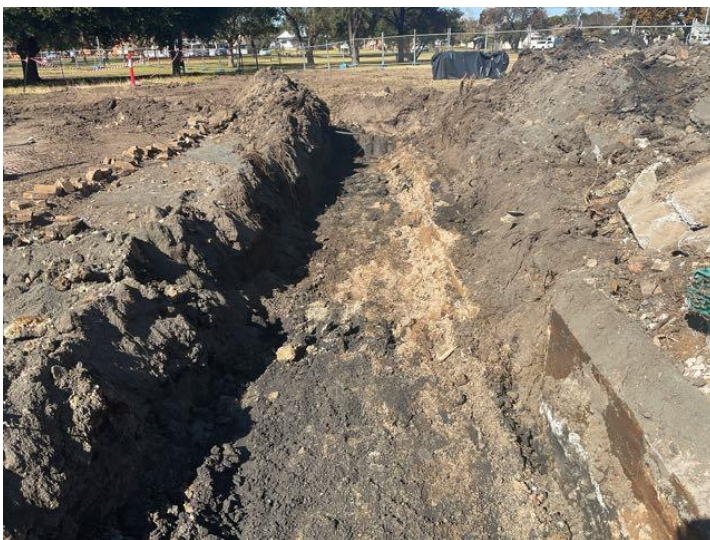
Top of soil to former
asbestos piping
containing cement. No
Asbestos was present at
time of inspection.

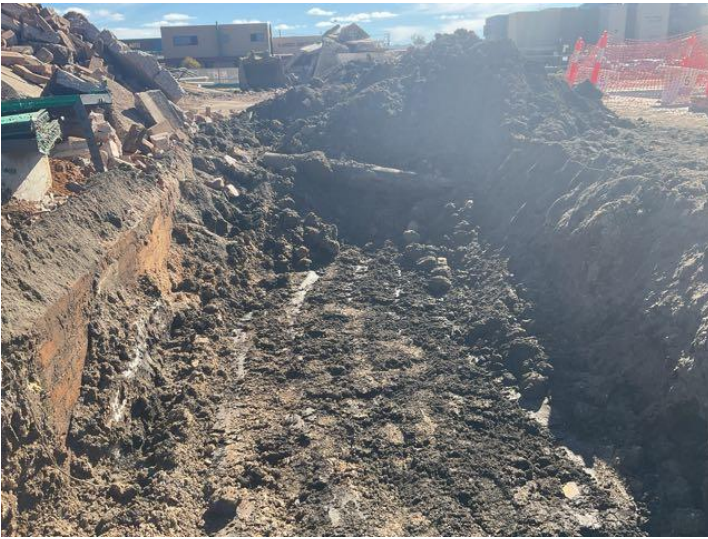
Top of soil to former
asbestos piping
containing cement. No
Asbestos was present at
time of inspection.

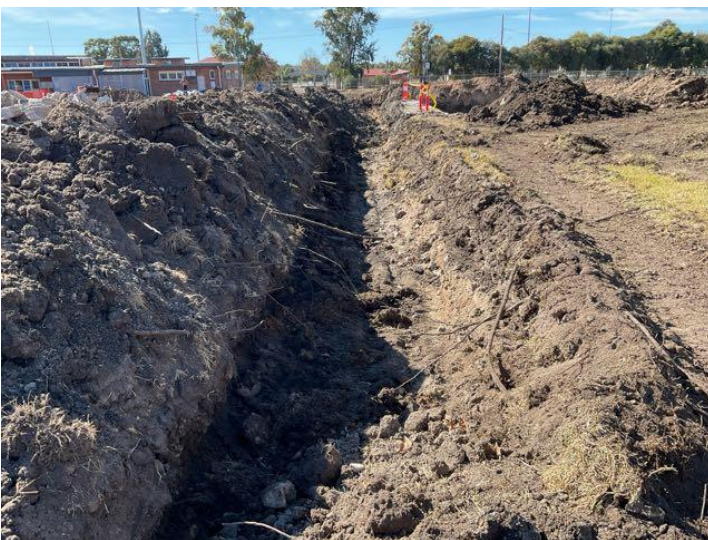
Top of soil to former
asbestos piping
containing cement. No
Asbestos was present at
time of inspection.

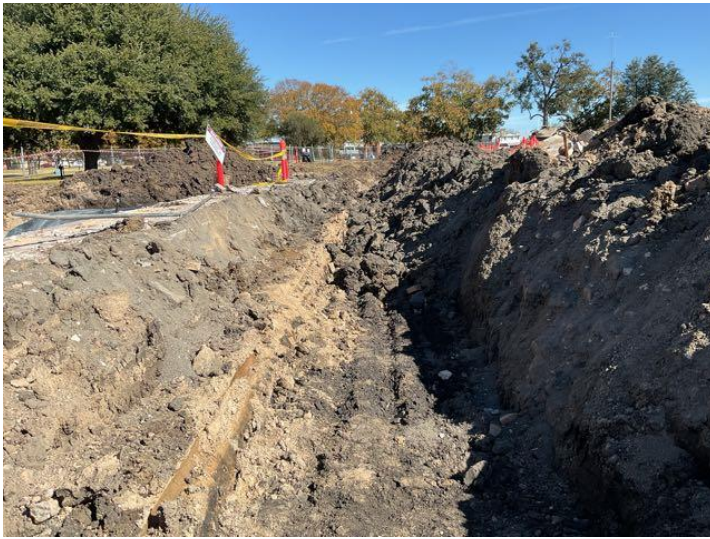
Top of soil to former
asbestos piping
containing cement. No
Asbestos was present at
time of inspection.

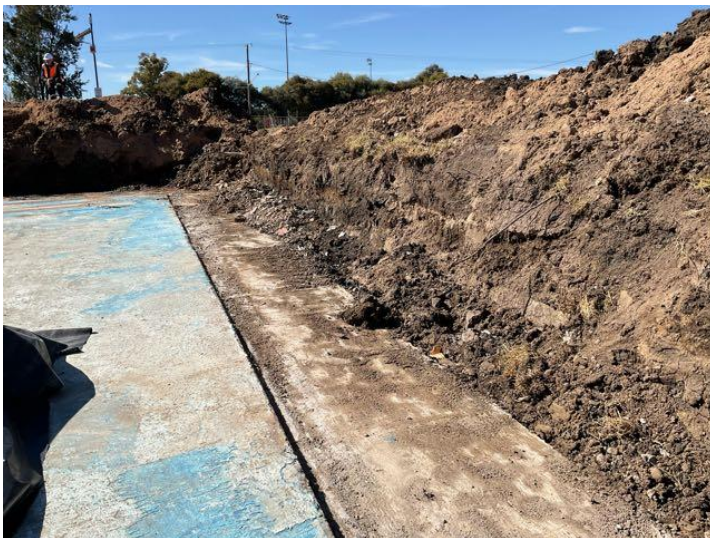
Top of soil to former
asbestos cement
sheeting. No Asbestos
was present at time of
inspection.

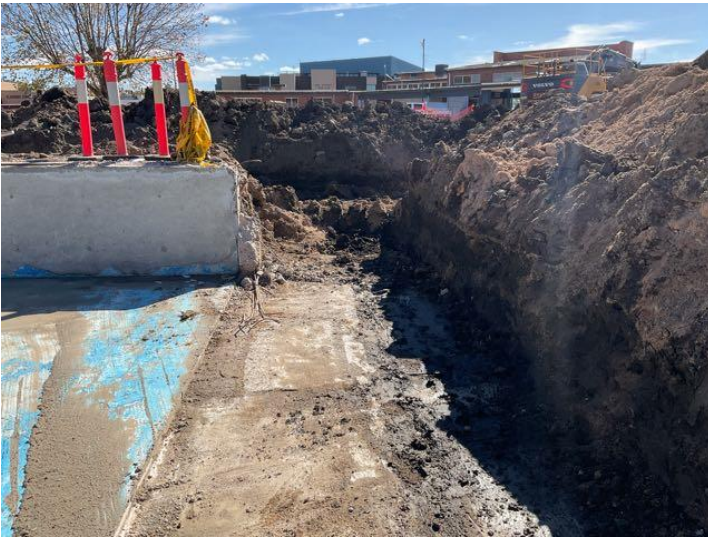
Top of soil to former
asbestos piping
containing cement. No
Asbestos was present at
time of inspection.

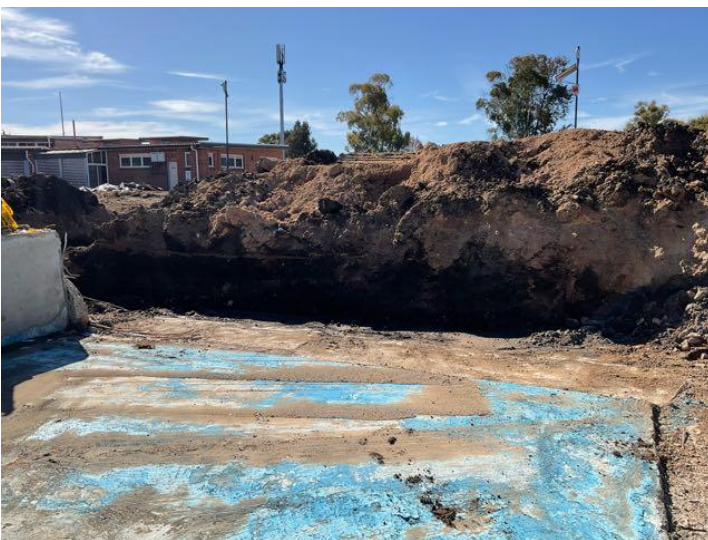
Top of soil to former
asbestos piping
containing cement. No
Asbestos was present at
time of inspection.

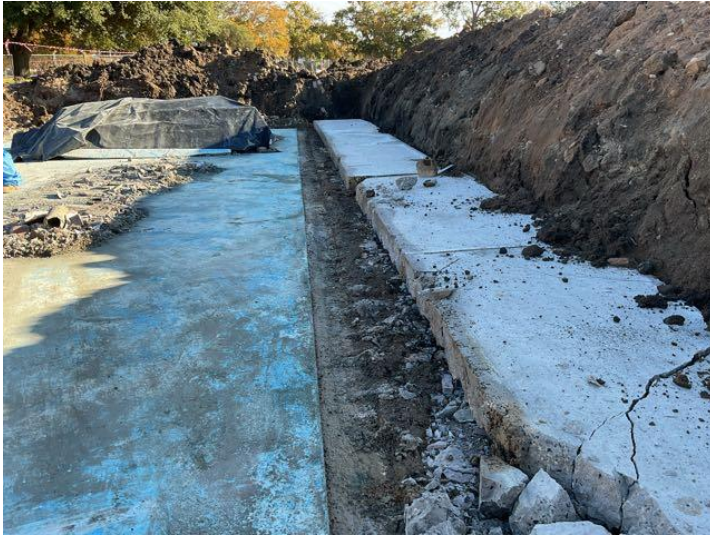
No asbestos was present
at time of inspection.

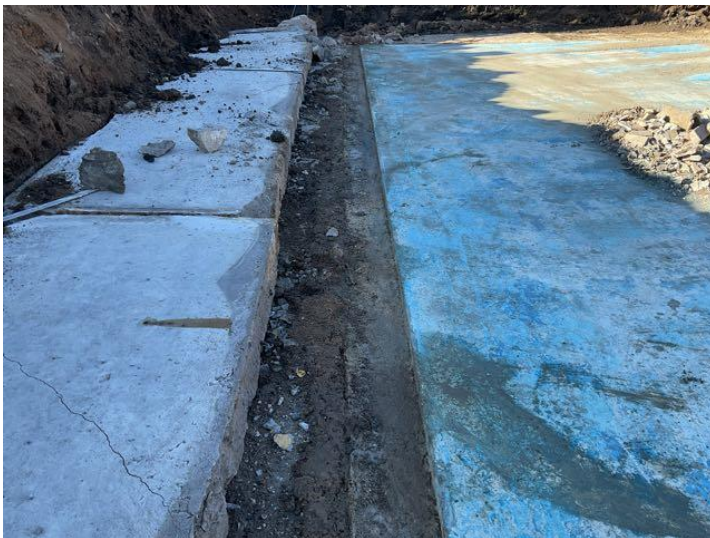
No asbestos was present
at time of inspection.

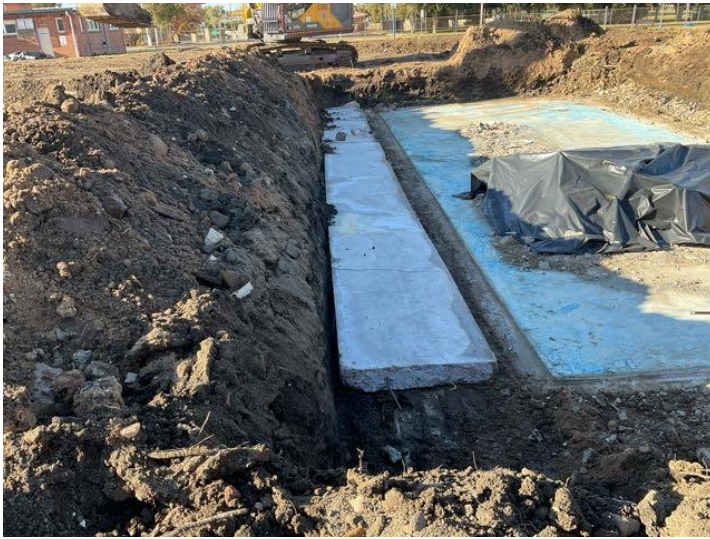
No asbestos was present
at time of inspection.

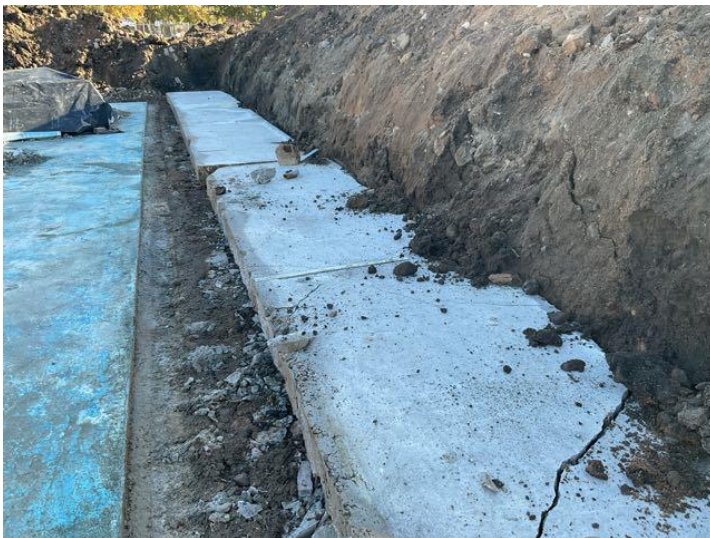
No asbestos was present
at time of inspection.

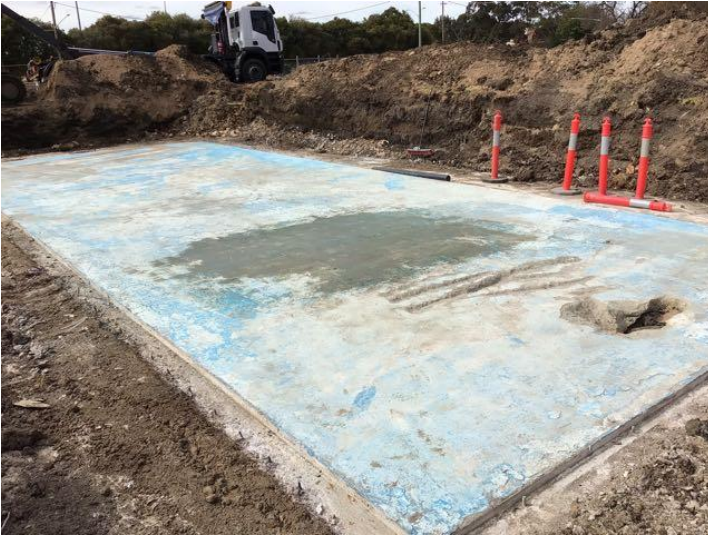
Northern Pool, top of
concrete surface to
former asbestos cement
sheeting and debris

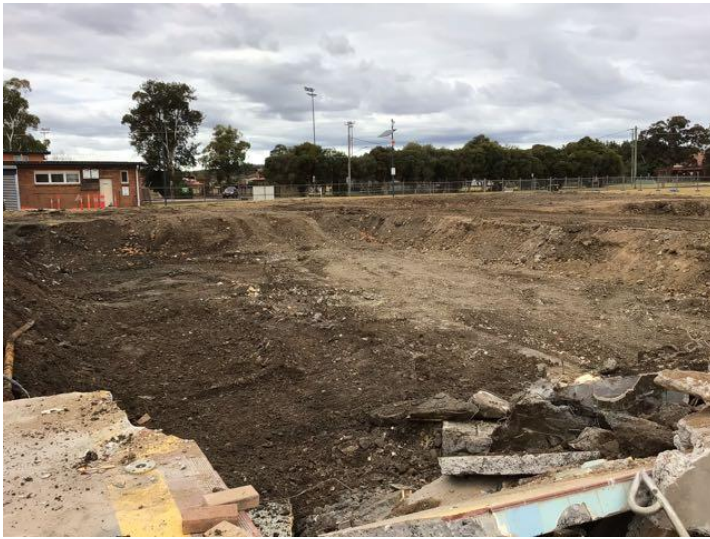
Eastern exterior (facing east), 50m Pool, top of soil surface to pre-existing asbestos-containing Pipework embedded within concrete wall linings of eastern section only

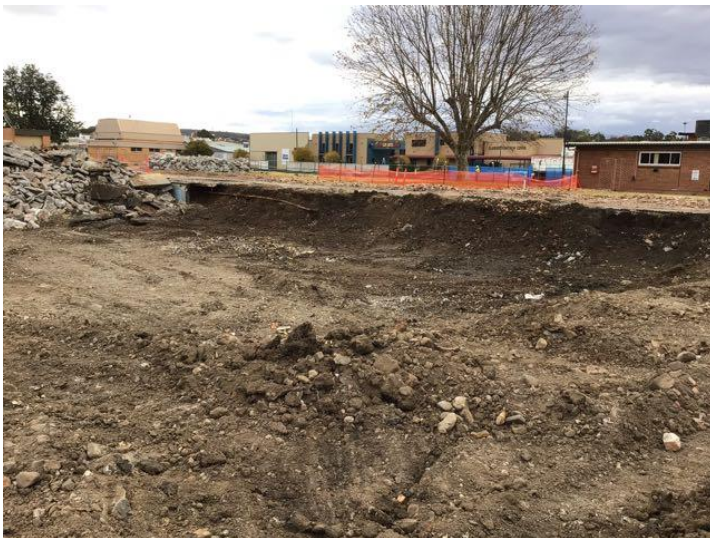
Eastern exterior (facing north-west), 50m Pool, top of soil surface to pre-existing asbestos-containing Pipework embedded within concrete wall linings of eastern section only
