Report on
Geotechnical Assessment

Fahey's Pit
9632 Armidale Road, Tyringham

Prepared for
Sheridans Hard Rock Quarry

Project 211755.00
November 2022

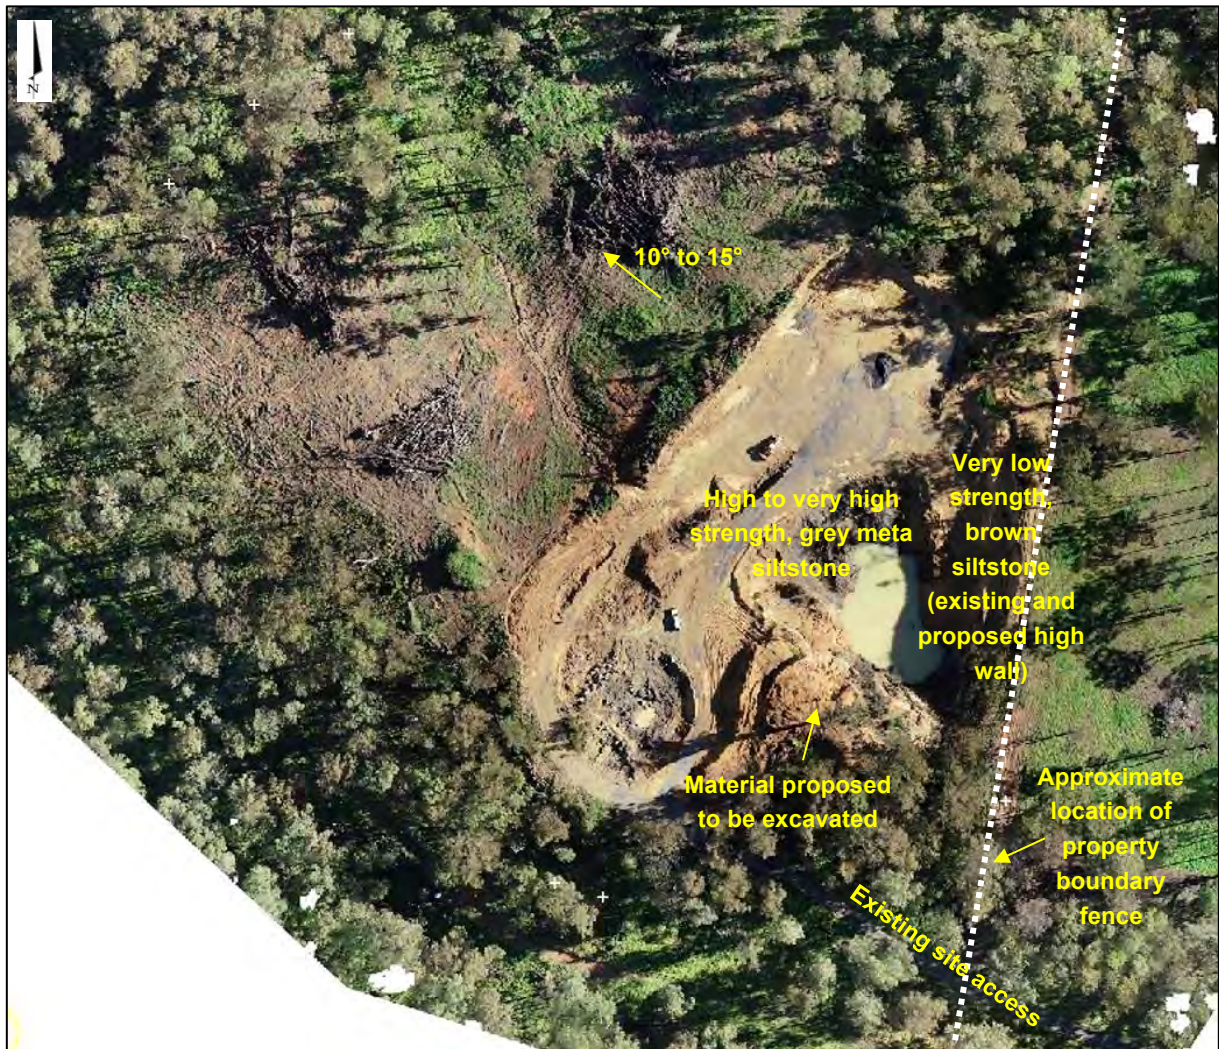
Figure 4: Aerial image of Fahey's Pit (image supplied by client).

An aerial image of Fahey's Pit with some marked up site features, based on a site inspection, is shown in Figure 4.

- Very low strength brown siltstone in the eastern part of the quarry. Two existing cut batters typically sloped down to the west at about 45° to 55° and were about 4 m to 6 m high with benches about 2 m to 6 m wide. Some variable medium to high strength siltstone was observed in the cut batters in parts. There were also some parts of the cut batters in very low strength siltstone that had some shallow rill erosion. The crest of the top cut batter is generally located approximately at least 5 m to the west of the property boundary fence;
- High to very high strength grey meta-siltstone was exposed in the deepest part of the existing quarry and over parts of the existing quarry floor;
- The northern part of the proposed quarry had been cleared of vegetation and topsoil was exposed at the ground surface; and
- Overall slope was generally about 10° to 15° down towards the north-west.

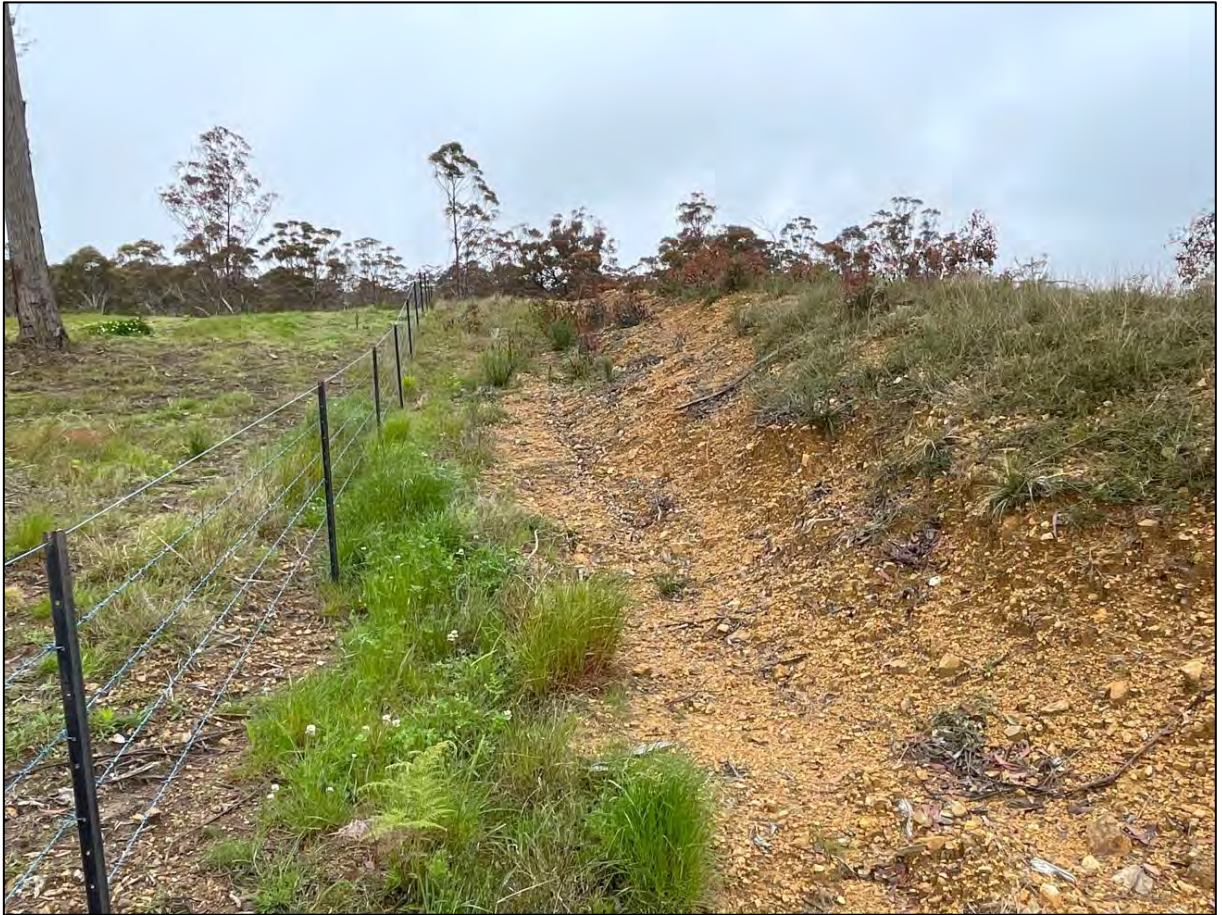
Figure 5: Looking south along the eastern boundary fence (quarry on the right)

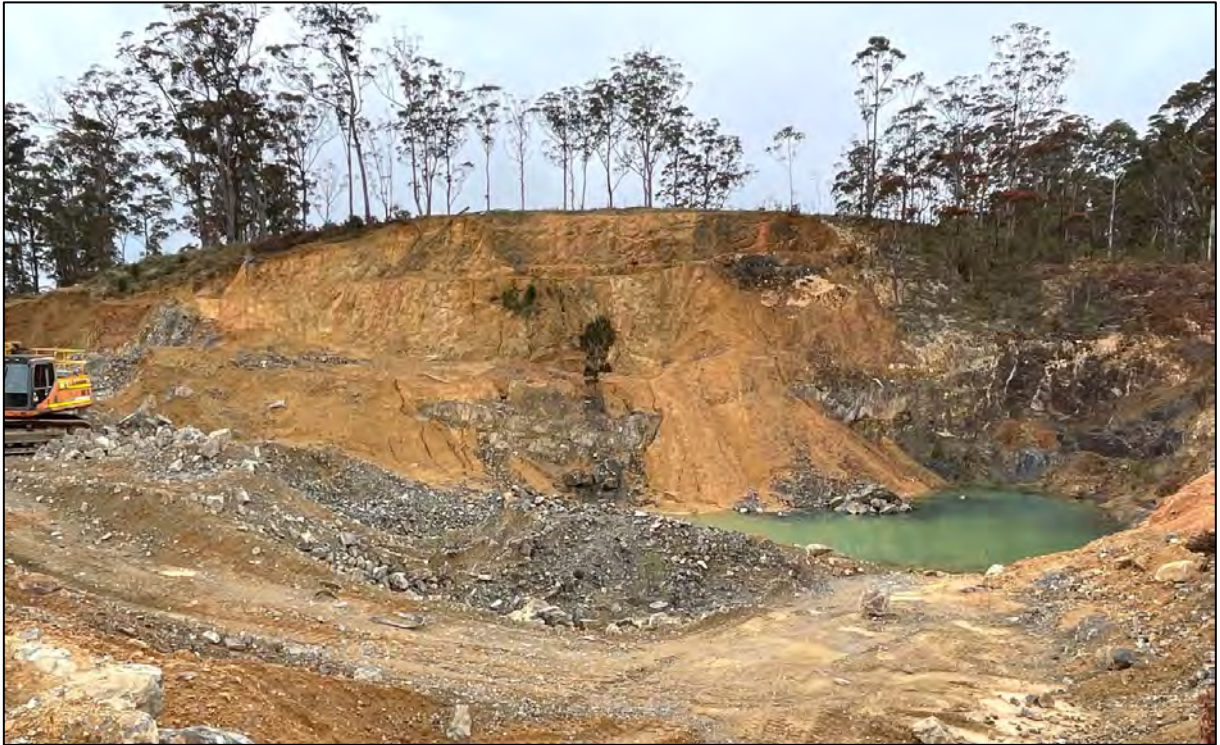
Figure 6: Looking east towards the existing eastern cut slope.

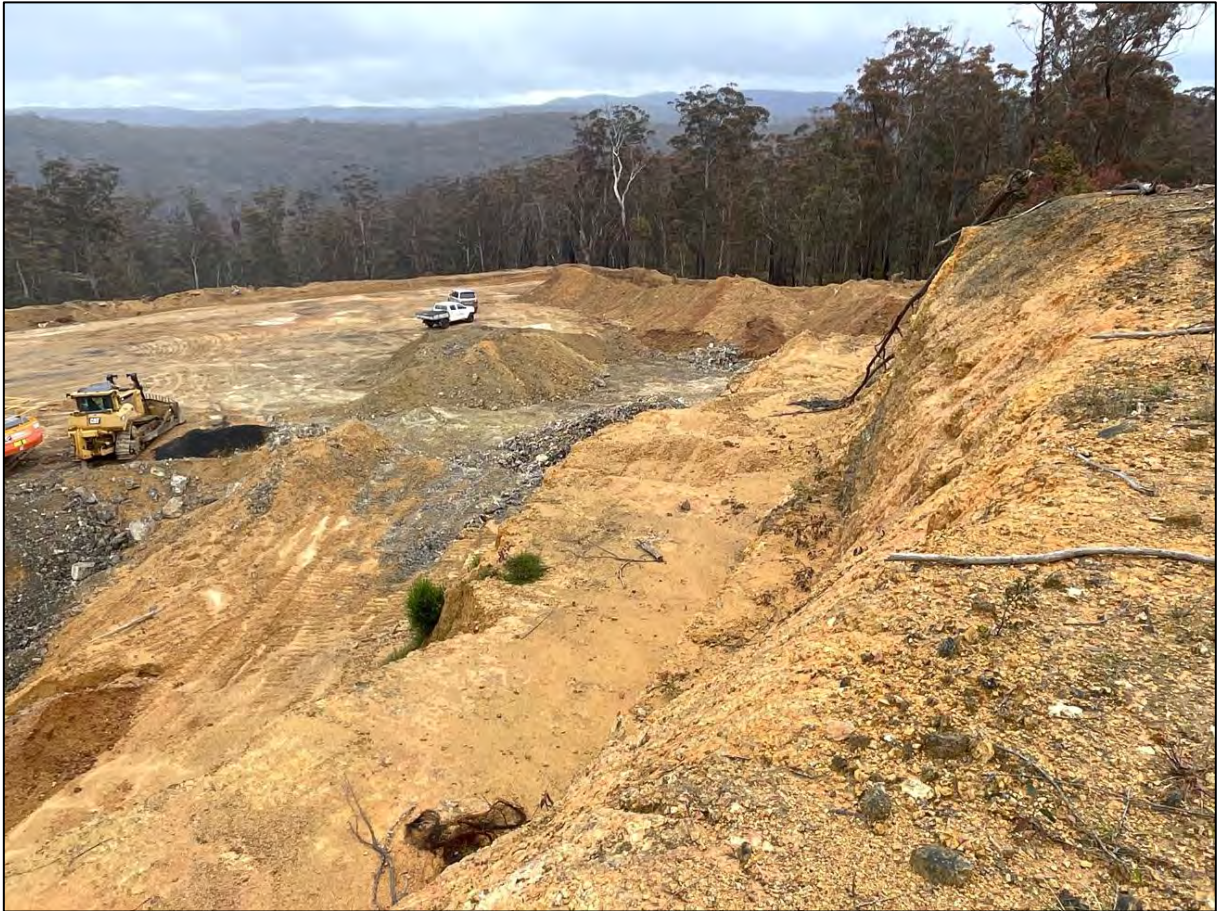
Figure 7: From the south-eastern part of the quarry looking north.

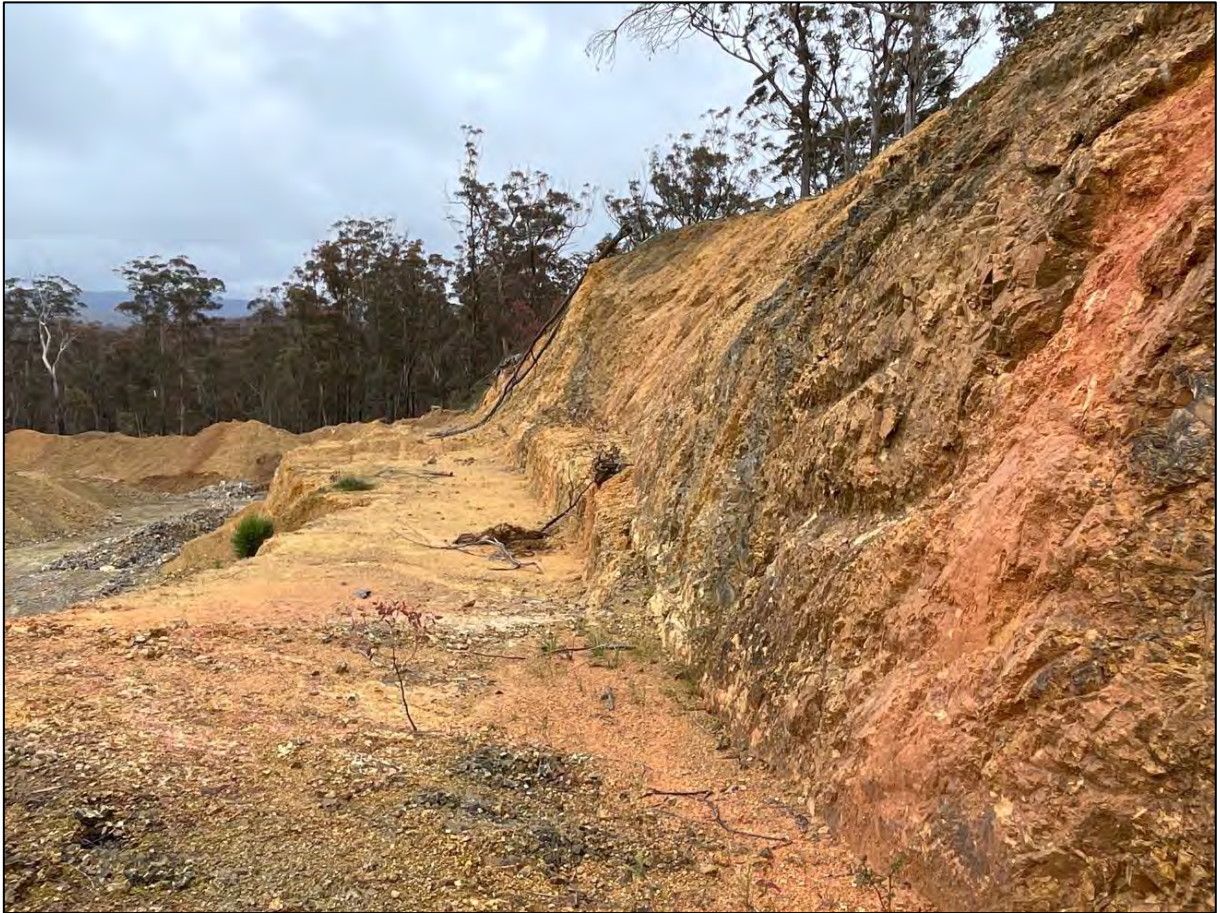
Figure 8: Looking north along the existing cut batter and bench in the eastern part of the quarry (typically very low strength siltstone exposed).

The site contains existing cut batter slopes of up to 12 m in total height and have been formed at slopes generally ranging from about 45° to 55°. The cut batters typically exposed very low strength siltstone in the eastern part of the quarry.

The current assessment comprised a walkover and visual assessment of site features and assumptions have been made based on the exposed rock at the time of the inspection. It is recommended that geotechnical inspection is performed periodically during quarry excavation (say each 5 m of excavation height) to assess geotechnical properties of the material exposed in the cut slopes and continued suitability for the proposed cut geometry.

It is therefore recommended that periodical geotechnical inspection be performed during quarry excavation (e.g. say initially every 5 m of vertical excavation of the final cut slope batters) to assess rock strength, geotechnical parameters, rock jointing and confirm design assumptions and applicability to long term cut slope stability. If adverse conditions are encountered, additional stabilisation measures may be required.

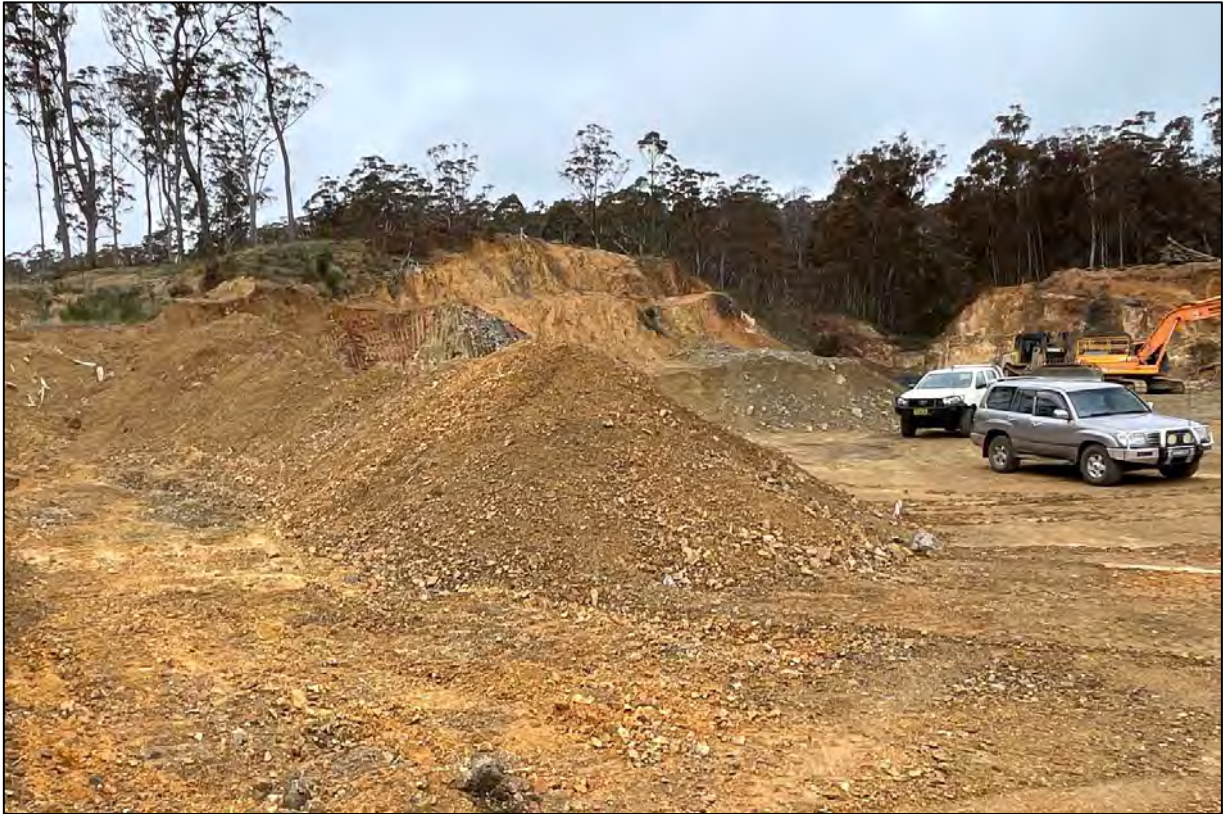
Figure 9: From the northern part of the quarry looking south-east

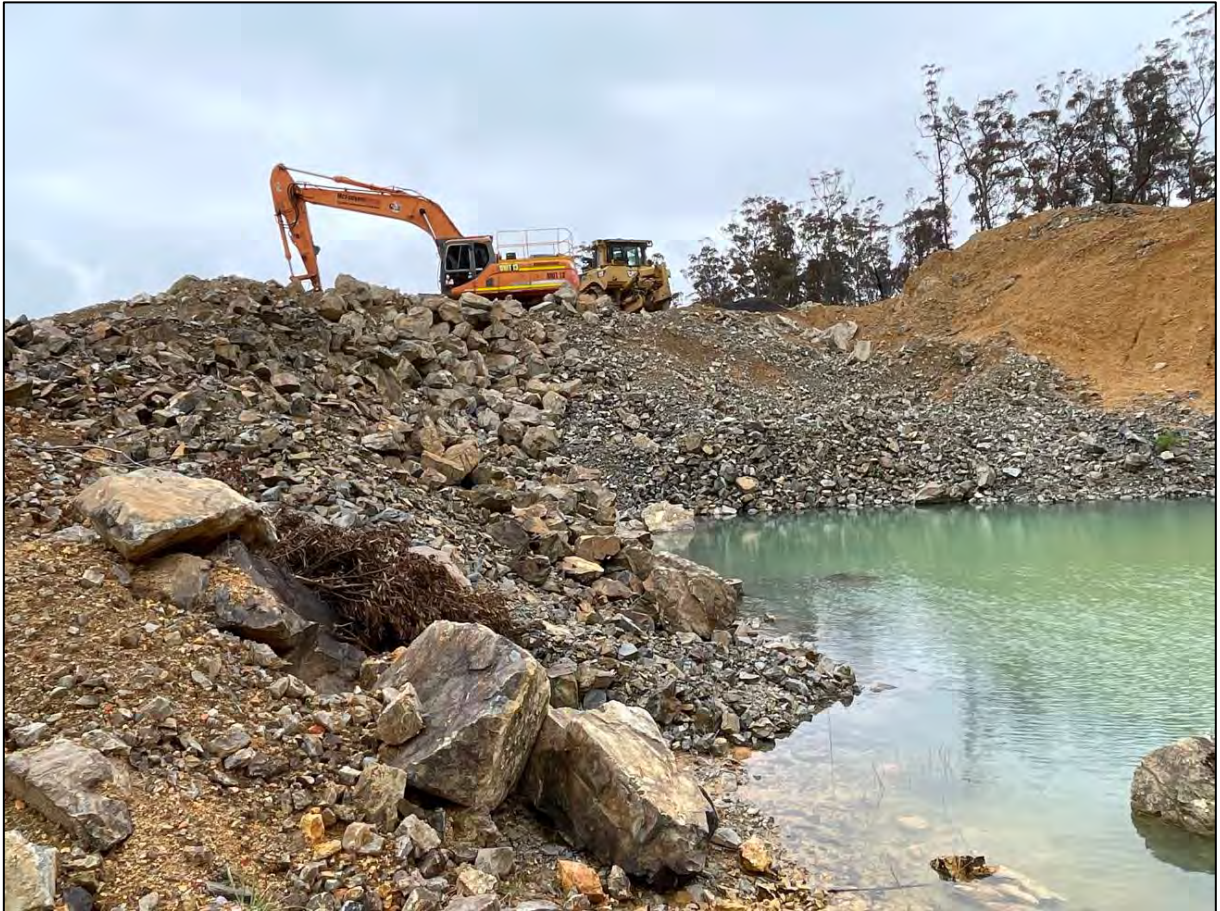
Figure 10: Central part of the existing quarry, high to very high strength meta siltstone.

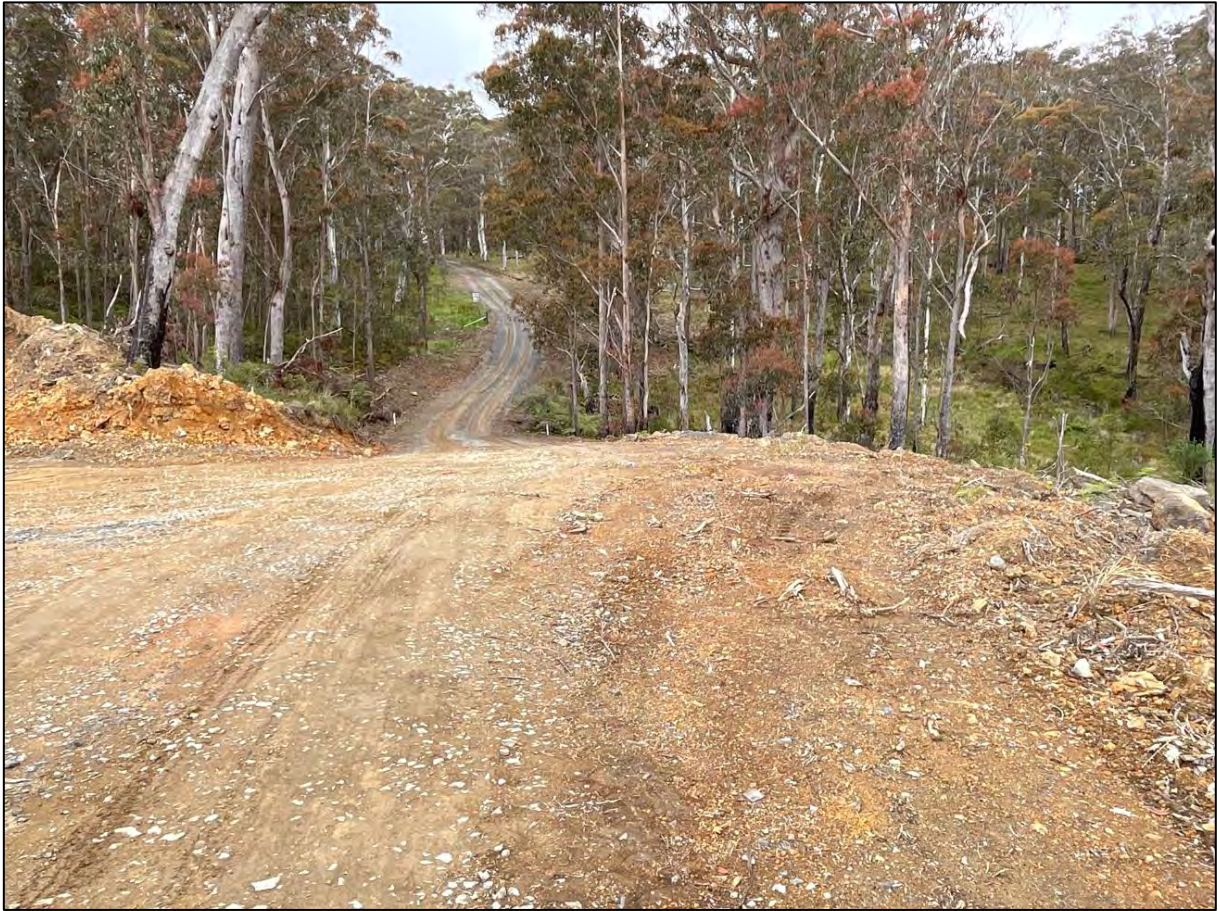
Figure 11: From the southern part of the quarry looking east to the existing access road.

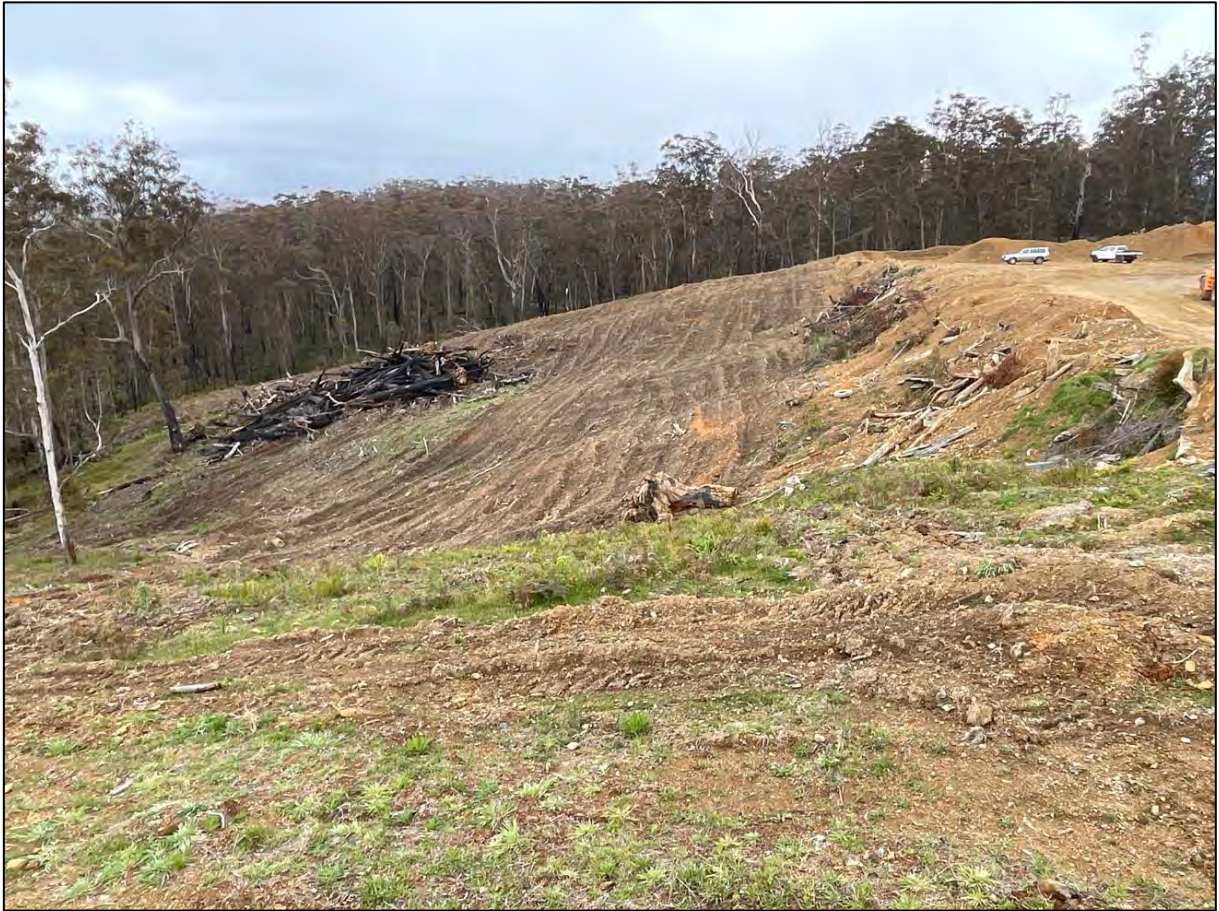
Figure 12: From the north-western part of the proposed quarry looking north-east.
