ROAD SAFETY AUDIT

EXISTING ROAD

McAuleys Lane, Myocum

Between Mullumbimby Road and Myocum Road

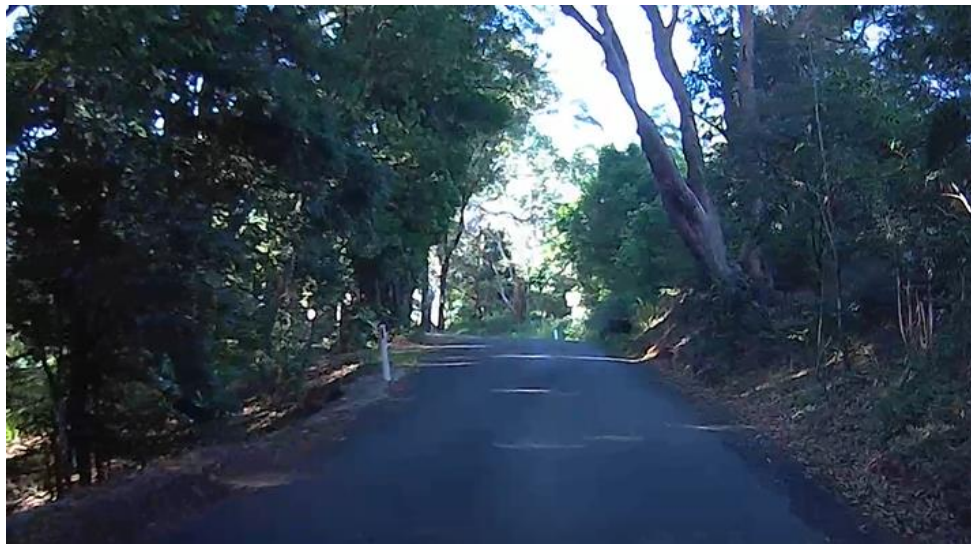
Number	Description	Risk Rating
01	<p>Road Width</p> <p>The road width is consistently narrow for most of the length. Many sections have narrow or non-existent shoulders. Some sections are very narrow (at the “slip” – refer Finding 17 and 18), winding, and in poor condition. In some locations, cars were parked on the road shoulder/verge at the time of the inspection, further reducing the available road carriageway width.</p> <p>Due to the narrow width there is no painted centreline.</p> <p>There is a risk that drivers may not allow for the narrow road and not drive to the conditions, and lose control and collide with an oncoming vehicle or a roadside hazard.</p> <p><i>Refer to Photo 1, 2</i></p> <p><i>Location: Entire length</i></p>	<p>Frequency: Improbable</p> <p>Severity: Serious</p> <p>Risk: Medium</p>
02	<p>Road Shoulders/Roadside Drainage</p> <p>The road shoulders are narrow or non-existent in many locations. Pavement edges are damaged. Some of the road shoulders are above the level of the road surface. Some roadside drains are silted or overgrown, or non-existent. Inadequate roadside drainage can result in water ponding or flowing on the road surface.</p> <p>Where there is no shoulder, there is no recovery area for errant vehicles or refuge for stopped vehicles. There is less room for cyclists and pedestrians.</p> <p>There is a risk that vehicles may hit the damaged road edges or water on the road edge and lose control, resulting in a collision with a roadside hazard or another vehicle. Drivers may tend to keep a distance from the shoulders, increasing the risk of a head-on collision.</p> <p><i>Refer to Photo 3, 4</i></p> <p><i>Location: Numerous</i></p>	<p>Frequency: Improbable</p> <p>Severity: Serious</p> <p>Risk: Medium</p>

Photo 1: Example of narrow road width

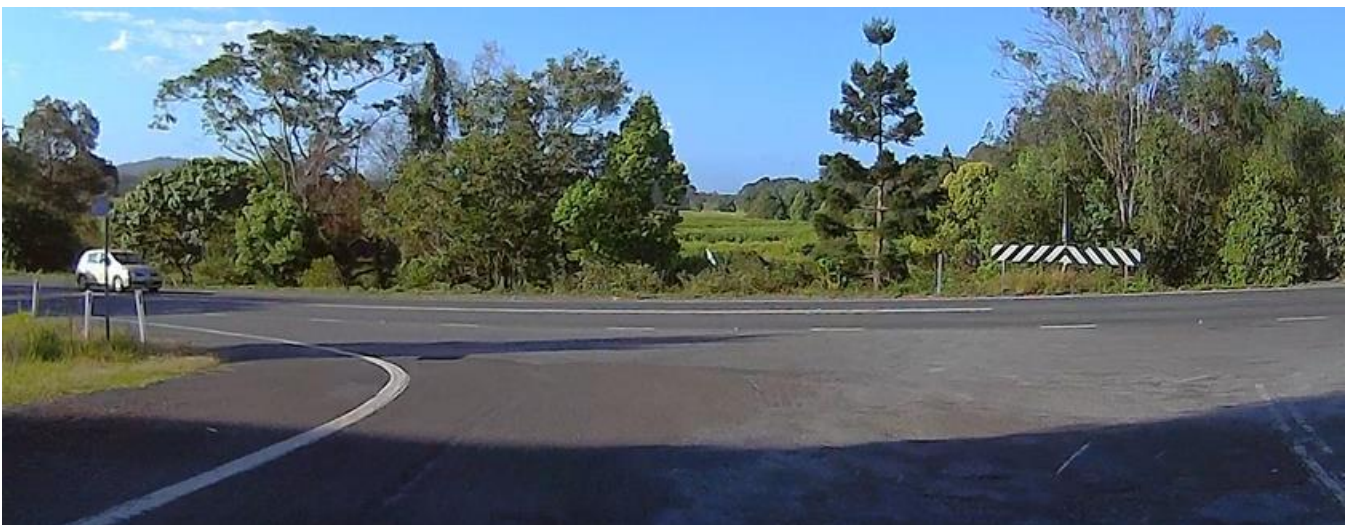
12	<p>Lack of Intersection Signs/Lines</p> <p>There is a lack of relevant signs and line marking at the following intersections:</p> <ul style="list-style-type: none"> • Mullumbimby Road – no ‘Stop’ or ‘Give Way’ signs or hold line. • Muli Court – no ‘Stop’ or ‘Give Way’ signs, no hold line, no sight board. • Bilin Road – no ‘Stop’ or ‘Give Way’ signs, no hold line, no sight board. <p>There is a risk that drivers will misjudge the intersection controls resulting in a collision with an oncoming or turning vehicle.</p> <p><i>Refer to Photo 15</i></p> <p><i>Location: As listed</i></p>	<p>Frequency: Improbable</p> <p>Severity: Serious</p> <p>Risk: Medium</p>
13	<p>Line Marking at Intersections</p> <p>The line marking at the Mullumbimby Road and Myocum Road intersections is badly worn. There is no line marking at the Muli Court and Bilin Road intersections. There are also no RRPM’s at the intersections.</p> <p>Without adequate delineation, there is a risk that drivers may incorrectly interpret the road alignment or travel path at the intersections and cross to the incorrect side of the road, particularly at night, resulting in a collision with an oncoming vehicle.</p> <p><i>Refer to Photo 16</i></p> <p><i>Location: As listed</i></p>	<p>Frequency: Improbable</p> <p>Severity: Serious</p> <p>Risk: Medium</p>

Photo 15: Example of lack of intersection signs/lines – Mullumbimby Road (no stop/give way sign, or hold line)

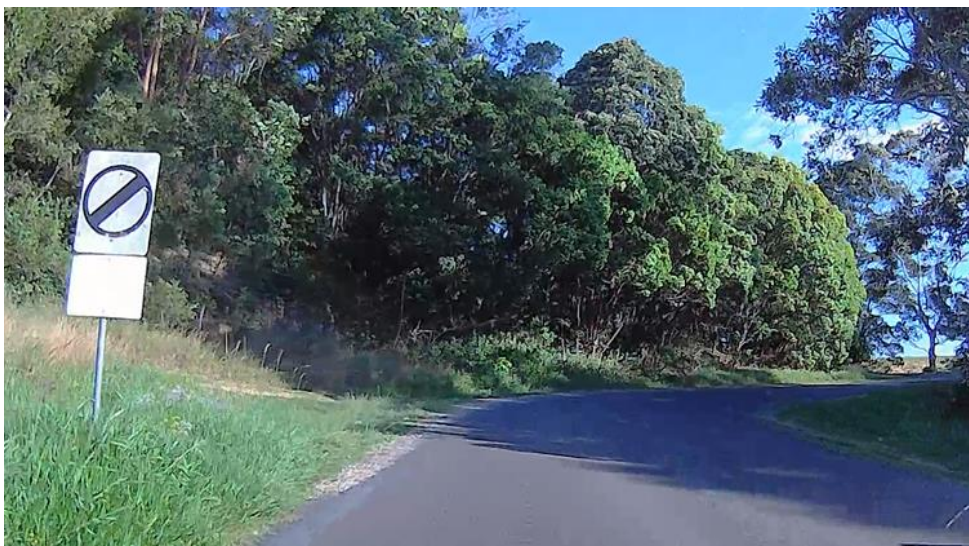
22	<p>Signposting of Speed Limits</p> <p>McAuleys Lane is incorrectly signposted as a “derestricted” speed zone. This sign is no longer in use and should be replaced. As the intersecting roads at each end (Mullumbimby Road and Myocum Road) are 80km/h roads, the correct signage on entering McAuleys Lane at each end is the ‘End 80’ sign. Due to the road conditions, the sign should be supplemented with a ‘Reduce Speed to Conditions’ sign.</p> <p>At each end of McAuleys Lane, an ‘80’ sign should be installed to indicate a return to an 80km/h speed zone on the intersecting roads. An ‘80’ painted on the road pavement adjacent to the signs may also be warranted.</p> <p>There is a risk that a driver will not adequately perceive the correct speed limit and travel too fast along the road.</p> <p><i>Location: Change in speed zones</i></p>	<p>Frequency: Occasional</p> <p>Severity: Serious</p> <p>Risk: High</p>

Photo 17: Superseded speed zoning sign; 'Drive to Conditions' sign is totally illegible
