**Asbestos and Hazardous Materials Pre-Demolition Assessment  
V2**

Broadwater Public School

9 Byrnes Street

754-SYDGE319200-1 – Broadwater Public School - HMDR – 03072023 V2

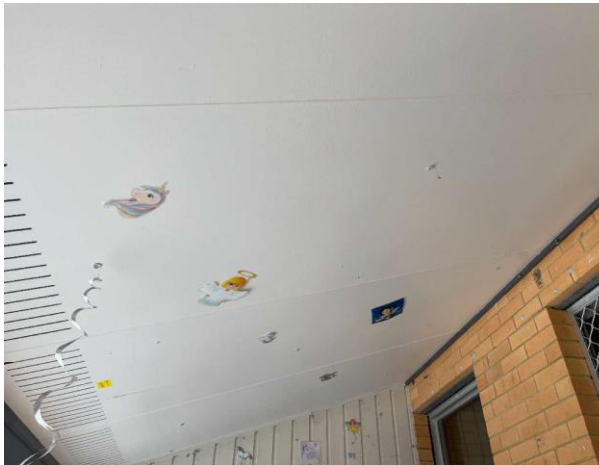
| Area | Location | Material Description | Hazard | Reference No. | Result | Friable | Quantity | Condition | Risk Rating | Reinspect Date | Recommendations | Line ID |
|---|---|---|---|---|---|---|---|---|---|---|---|---|
| External | Building A, Level 1 / Verandah / Ceiling | Fibre Cement Sheet | Asbestos | A25919.2 | Chrysotile Asbestos Detected | Non-Friable | 15 m² | Stable | Low | 5 Yearly Reinspection | Label as containing asbestos and maintain in current condition if to remain in-situ. Remove under controlled non-friable asbestos removal conditions prior to refurbishment or demolition works by a Class B (non-friable) licensed asbestos removal contractor in accordance with relevant State Regulations, Compliance Codes, Codes of Practice and Guidance Notes. | 7 |

Line ID 7: External, Building A, Level 1, Verandah, Ceiling, Fibre Cement Sheet - Chrysotile Asbestos Detected

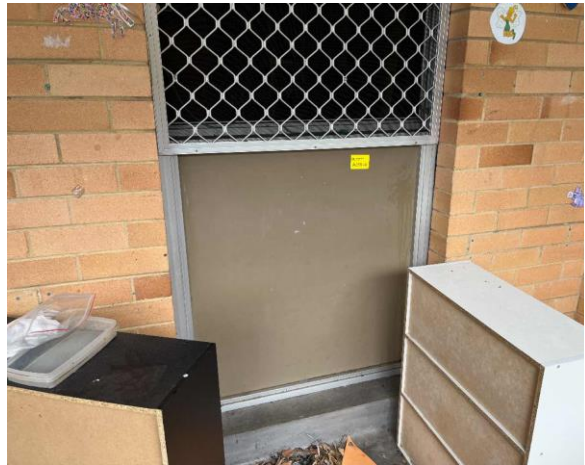
| Area | Location | Material Description | Hazard | Reference No. | Result | Friable | Quantity | Condition | Risk Rating | Reinspect Date | Recommendations | Line ID |
|---|---|---|---|---|---|---|---|---|---|---|---|---|
| External | Building A, Level 1 / Verandah / Infill Panel, Below Window | Compressed Cement Sheeting | Asbestos | A25918 | Chrysotile Asbestos Detected | Non-Friable | 1 m² | Stable | Low | 5 Yearly Reinspection | Label as containing asbestos and maintain in current condition if to remain in-situ. Remove under controlled non-friable asbestos removal conditions prior to refurbishment or demolition works by a Class B (non-friable) licensed asbestos removal contractor in accordance with relevant State Regulations, Compliance Codes, Codes of Practice and Guidance Notes. | 8 |

Line ID 8: External, Building A, Level 1, Verandah, Infill Panel, Below Window, Compressed Cement Sheet - Chrysotile Asbestos Detected

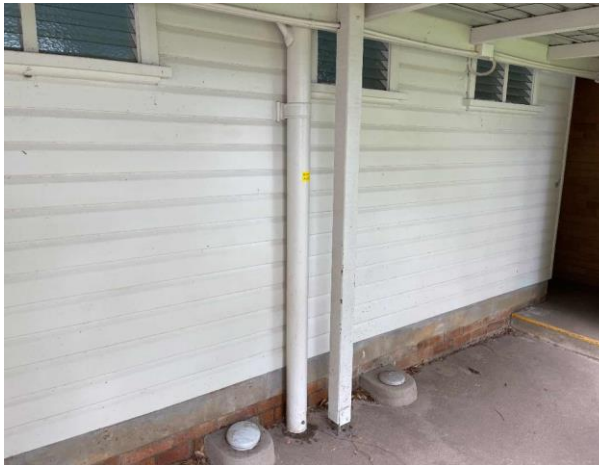
| Area | Location | Material Description | Hazard | Reference No. | Result | Friable | Quantity | Condition | Risk Rating | Reinspect Date | Recommendations | Line ID |
|---|---|---|---|---|---|---|---|---|---|---|---|---|
| External | Building B / Throughout / Down Pipe to Western Wall | Moulded Fibre Cement | Asbestos | A25904 | Chrysotile Asbestos Detected | Non-Friable | 4 m | Stable | Low | 5 Yearly Reinspection | Label as containing asbestos and maintain in current condition if to remain in-situ. Remove under controlled non-friable asbestos removal conditions prior to refurbishment or demolition works by a Class B (non-friable) licensed asbestos removal contractor in accordance with relevant State Regulations, Compliance Codes, Codes of Practice and Guidance Notes. | 9 |

Line ID 9: External, Building B, Throughout, Down Pipe to Western Wall, Moulded Fibre Cement - Chrysotile Asbestos Detected

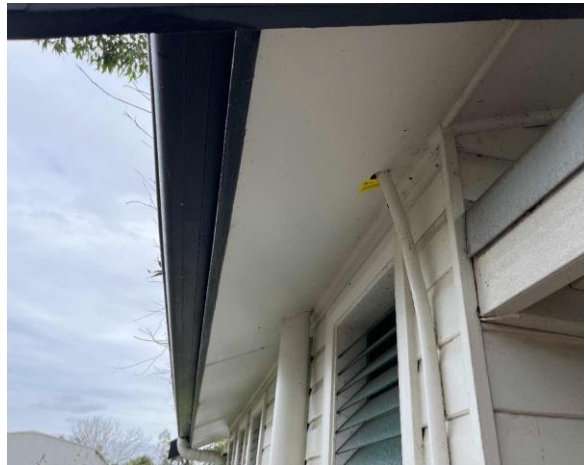
| Area | Location | Material Description | Hazard | Reference No. | Result | Friable | Quantity | Condition | Risk Rating | Reinspect Date | Recommendations | Line ID |
|---|---|---|---|---|---|---|---|---|---|---|---|---|
| External | Building B / Throughout / Eaves | Fibre Cement Sheeting | Asbestos | A25907 | Chrysotile Asbestos Detected | Non-Friable | 8 m² | Stable | Low | 5 Yearly Reinspection | Label as containing asbestos and maintain in current condition if to remain in-situ. Remove under controlled non-friable asbestos removal conditions prior to refurbishment or demolition works by a Class B (non-friable) licensed asbestos removal contractor in accordance with relevant State Regulations, Compliance Codes, Codes of Practice and Guidance Notes. | 10 |

Line ID 10: External, Building B, Throughout, Eaves, Fibre Cement Sheet - Chrysotile Asbestos Detected

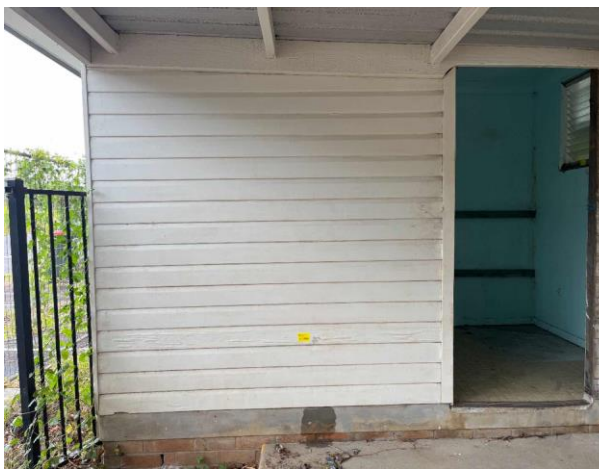
Line ID 11: External, Building B, Throughout, To Walls, Cream Paint (Coating Material) - No Asbestos Detected

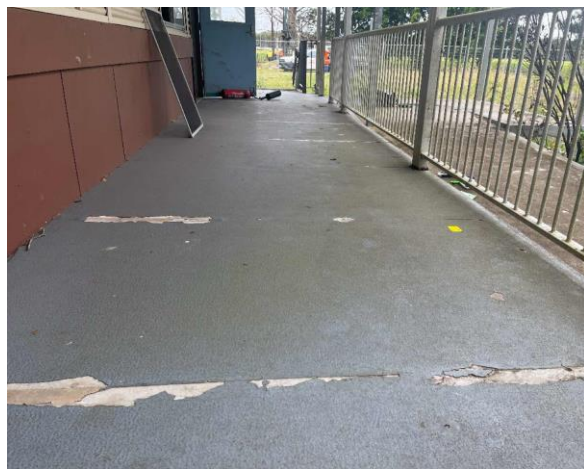
Line ID 12: External, Building E, South Side, Verandah Floor, Compressed Cement Sheet - No Asbestos Detected

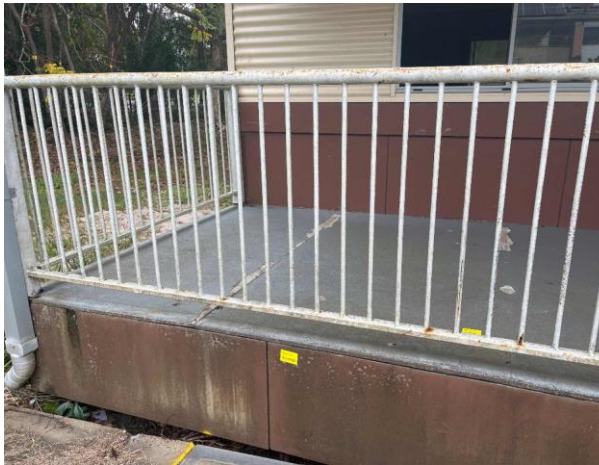
Line ID 13: External, Building E, Throughout, Lower 1/3 of Walls, Compressed Cement Sheet - No Asbestos Detected

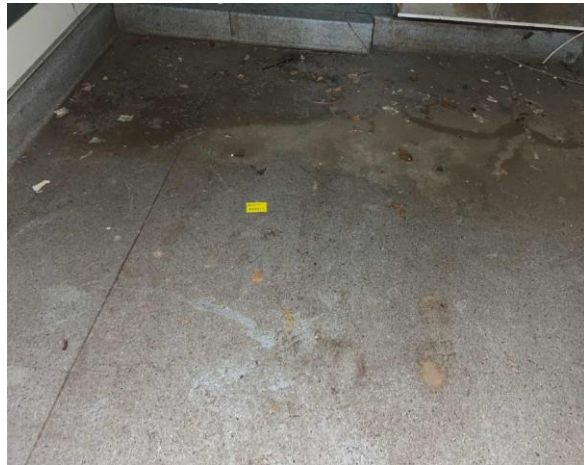
Line ID 14: Internal, Building A, Ground Floor, Canteen, Floor, Blue Vinyl Sheet - No Asbestos Detected

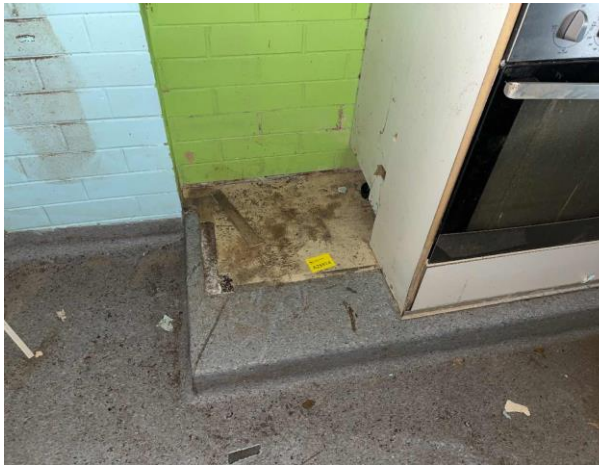
Line ID 15: Internal, Building A, Ground Floor, Canteen, Floor, Under Cabinets, Beige Vinyl Sheet - No Asbestos Detected

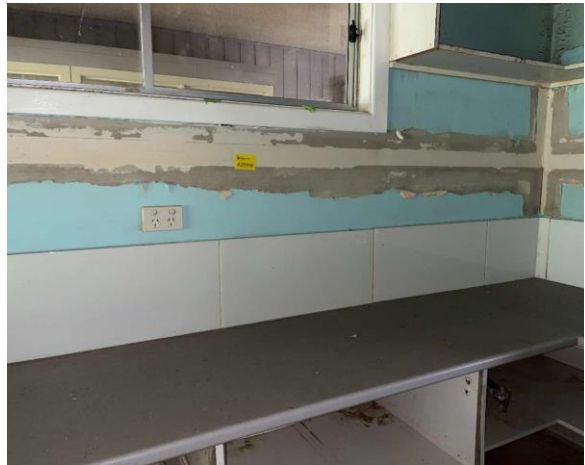
Line ID 16: Internal, Building A, Ground Floor, Canteen, North, East and South Walls, Fibre Cement Sheet - No Asbestos Detected

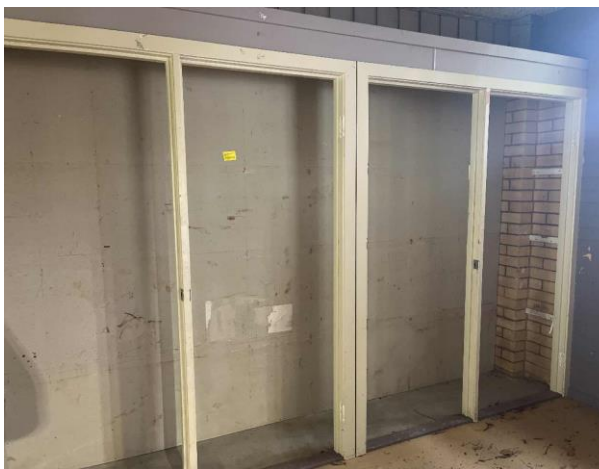
Line ID 17: Internal, Building A, Ground Floor, Central Room, Internal and External Walls of Cupboards, Fibre Cement Sheet - No Asbestos Detected

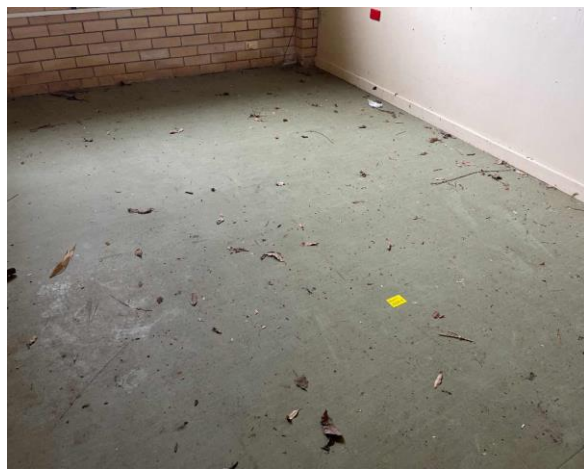
Line ID 18: Internal, Building A, Ground Floor, Eastern Room, Floor, Green Vinyl Sheet - No Asbestos Detected

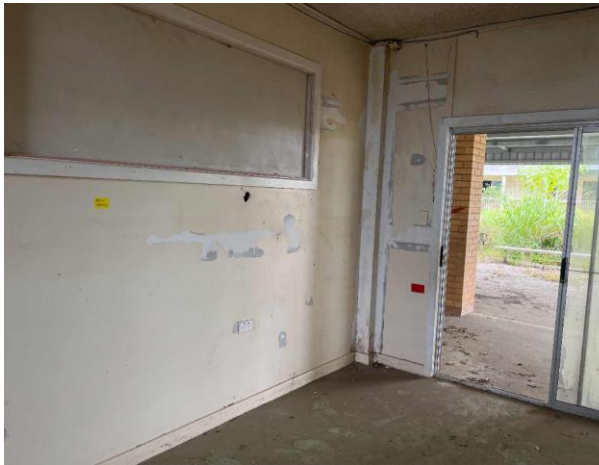
Line ID 19: Internal, Building A, Ground Floor, Eastern Room, Northern and Western Walls, Fibre Cement Sheet - No Asbestos Detected

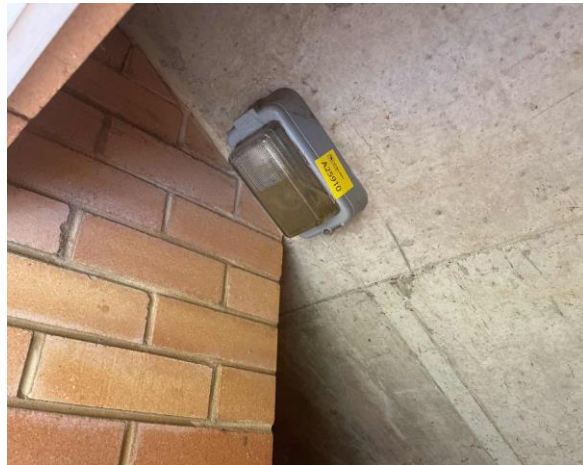
| Area | Location | Material Description | Hazard | Reference No. | Result | Friable | Quantity | Condition | Risk Rating | Reinspect Date | Recommendations | Line ID |
|---|---|---|---|---|---|---|---|---|---|---|---|---|
| Internal | Building A, Ground Floor / Storage Room Under Stairs / Between Metal and Glass of Wilco Light | Mastic | Asbestos | A25910 | Chrysotile Asbestos Detected | Non-Friable | 1 Unit | Stable | Low | 5 Yearly Reinspection | Remove light whole without direct disturbance to caulking under controlled non-friable asbestos removal conditions prior to refurbishment or demolition works by a Class B (non-friable) licensed asbestos removal contractor. If scraping out of caulking is undertaken as the removal method (i.e. material is being crumbled, pulverized, rendered to a powder), this should be done under friable asbestos removal conditions by a Class A (friable) licensed asbestos removal contractor. | 20 |

Line ID 20: Internal, Building A, Ground Floor, Storage Room Under Stairs, Between Metal and Glass of Wilco Light, Mastic - Chrysotile Asbestos Detected

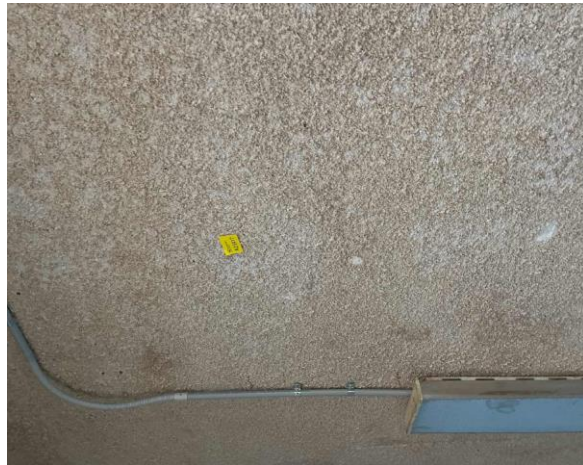
Line ID 22: Internal, Building A, Ground Floor, Throughout, Ceiling, Vermiculite - No Asbestos Detected

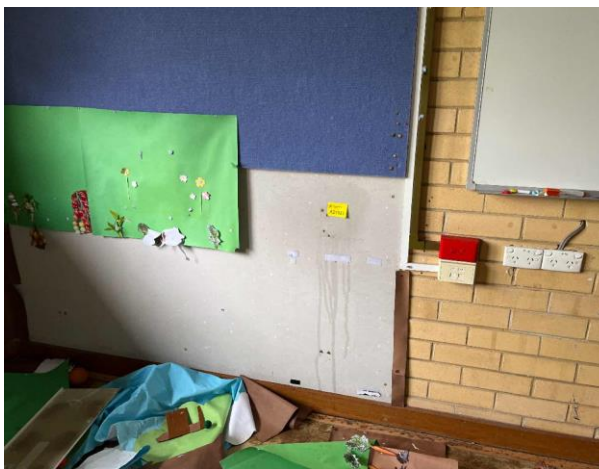
Line ID 23: Internal, Building A, Level 1, Class Room, South West Corner, Infill Panel, Fibre Cement Sheet - No Asbestos Detected

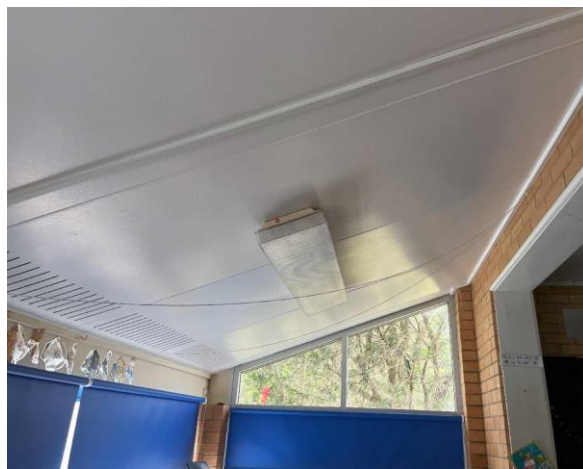
| Area | Location | Material Description | Hazard | Reference No. | Result | Friable | Quantity | Condition | Risk Rating | Reinspect Date | Recommendations | Line ID |
|---|---|---|---|---|---|---|---|---|---|---|---|---|
| Internal | Building A, Level 1 / Enclosed Verandah / Ceiling | Fibre Cement Sheet | Asbestos | A25919.1 | Chrysotile Asbestos Detected | Non-Friable | 12 m² | Stable | Low | 5 Yearly Reinspection | Label as containing asbestos and maintain in current condition if to remain in-situ. Remove under controlled non-friable asbestos removal conditions prior to refurbishment or demolition works by a Class B (non-friable) licensed asbestos removal contractor in accordance with relevant State Regulations, Compliance Codes, Codes of Practice and Guidance Notes. | 24 |

Line ID 24: Internal, Building A, Level 1, Enclosed Verandah, Ceiling, Fibre Cement Sheet - Chrysotile Asbestos Detected

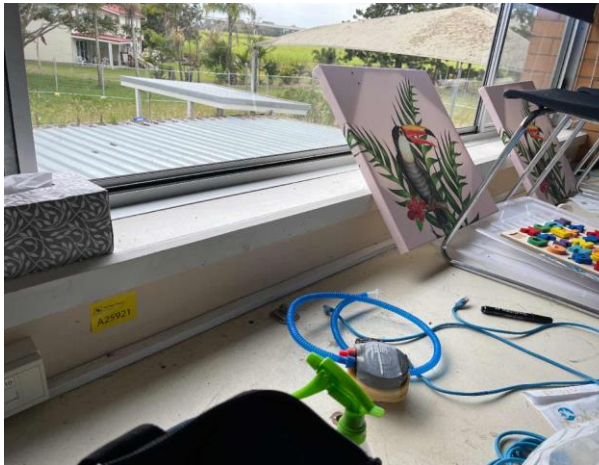
Line ID 25: Internal, Building A, Level 1, Enclosed Verandah, Northern and Western Infill Panels Below Windows, Compressed Cement Sheet - No Asbestos Detected

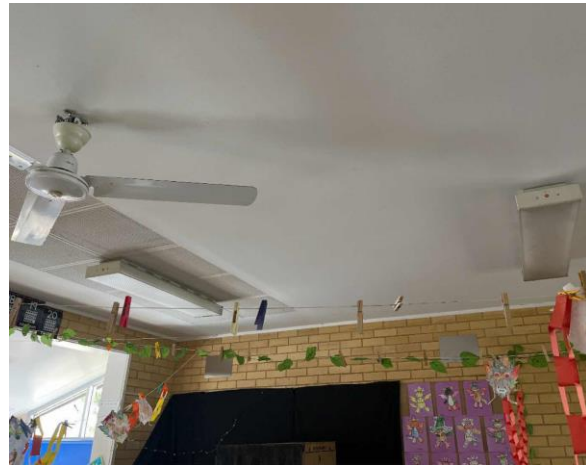
Line ID 26: Internal, Building A, Level 1, Throughout, Ceilings, Plaster Board - No Asbestos Detected

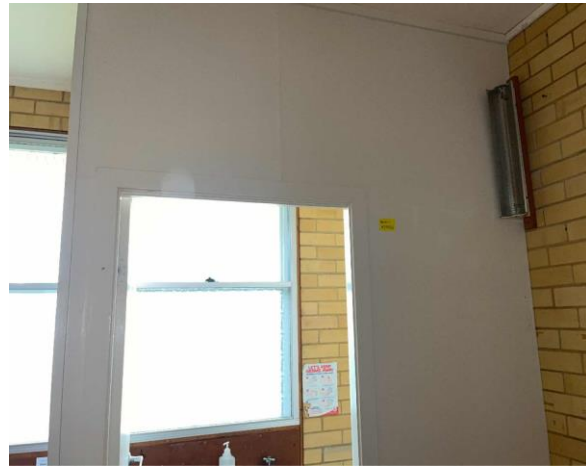
Line ID 29: Internal, Building A, Level 1, Toilet, South West Walls, Fibre Cement Sheet - No Asbestos Detected

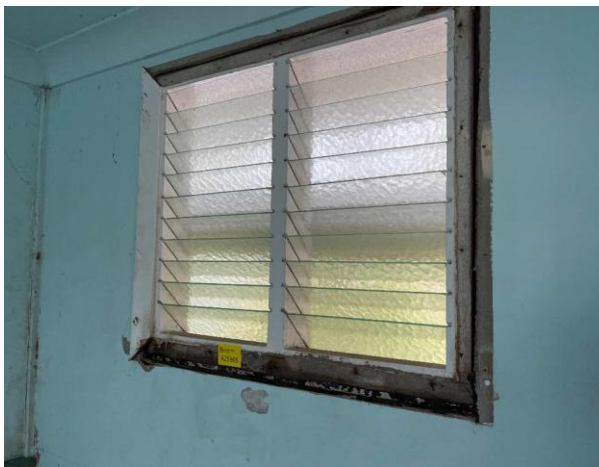
Line ID 30: Internal, Building B, Northern and Central Room, Mastics Between Wooden Pieces of Window Frame, Mastic Sealant - No Asbestos Detected

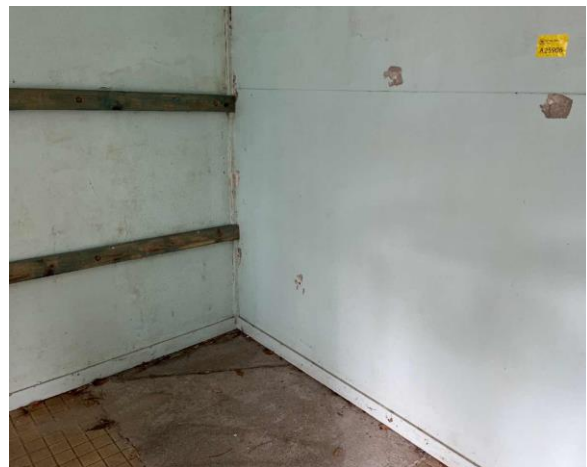
Line ID 31: Internal, Building B, Northern and Central Room, Walls (Excluding Center Wall Between Rooms), Fibre Cement Sheet - No Asbestos Detected

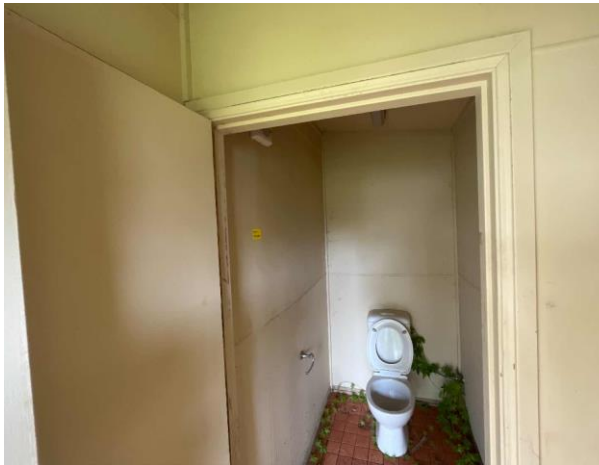
Line ID 32: Internal, Building B, Toilet Rooms, Walls And Ceilings, Fibre Cement Sheetting - No Asbestos Detected

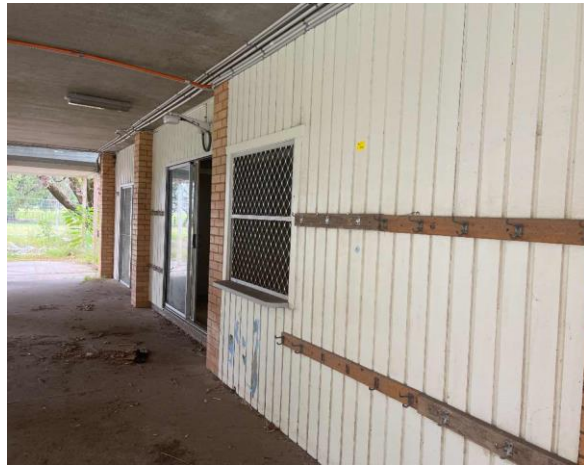
Line ID 33: External, Building A, Level 1, Throughout, Northern Walls, Cream Paint - Lead Detected (<0.005% w/w)

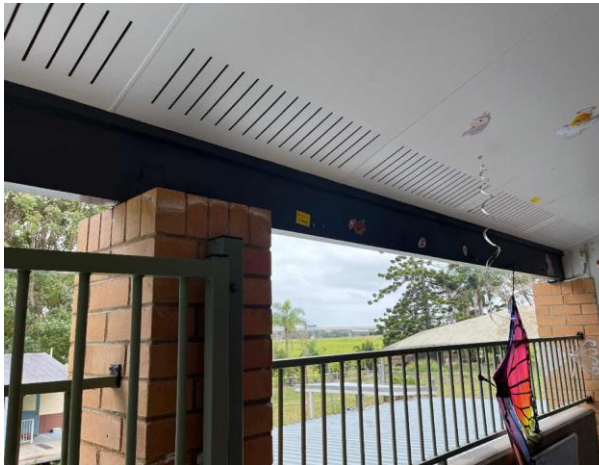
Line ID 34: External, Building A, Level 1, Verandah, Beams and Trim, Dark Grey Paint - Lead Detected (0.03% w/w)

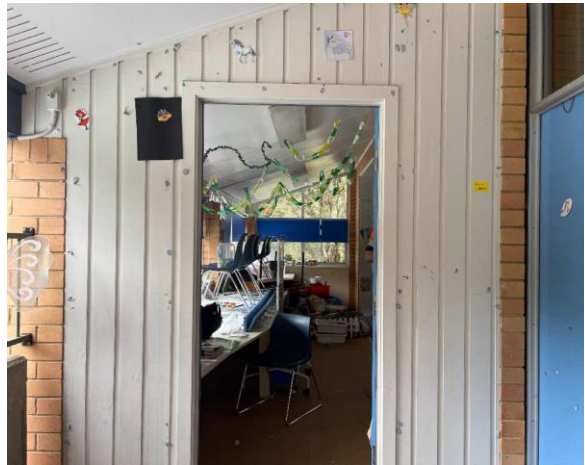
Line ID 35: External, Building A, Level 1, Verandah, Wall Surrounding Door, Cream Paint - Lead Detected (<0.005% w/w)

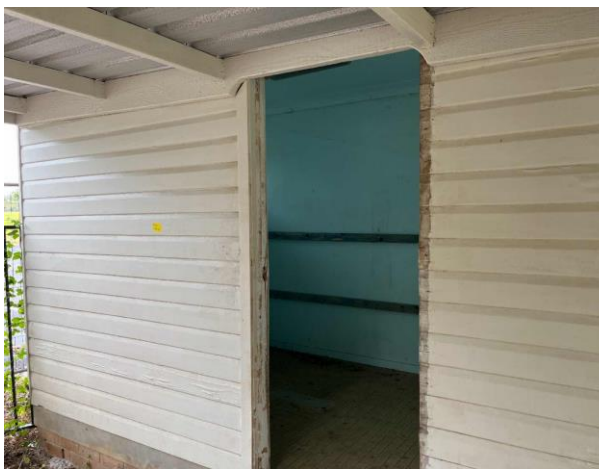
Line ID 36: External, Building B, Throughout, Walls, Eaves and Columns/Frame Work of Walkway, Cream Paint - Lead Detected (<0.005% w/w)

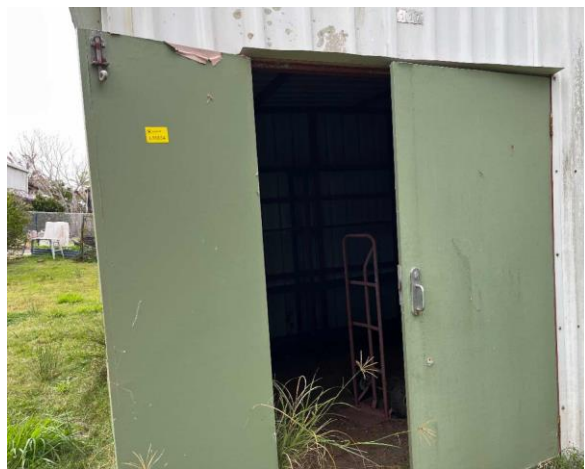
Line ID 37: External, Building C, Throughout, Doors, Green Paint - Lead Detected (0.12% w/w)

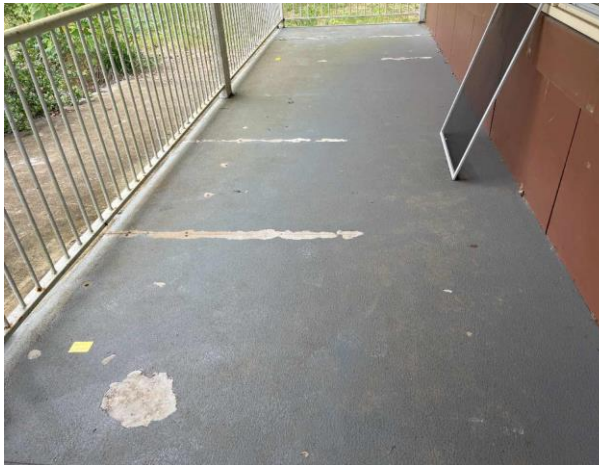
Line ID 38: External, Building E, South Side, Floor, Blue Paint - Lead Detected (<0.005% w/w)

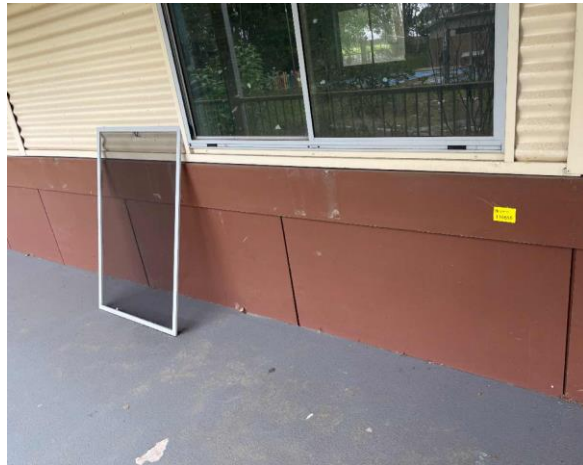
Line ID 39: External, Building E, Throughout, Lower Walls, Brown Paint - Lead Detected (0.01% w/w)

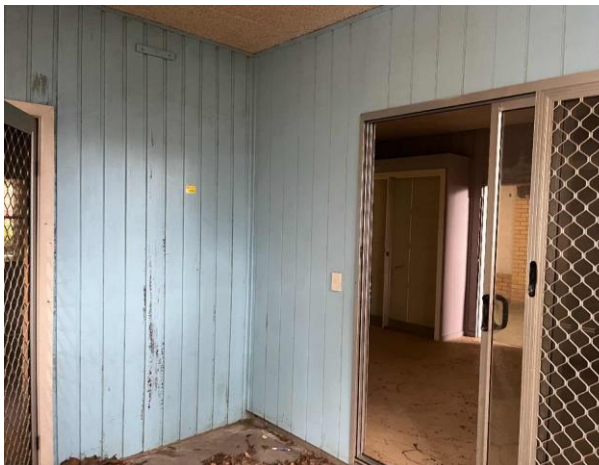
Line ID 40: Internal, Building A, Ground Floor, Bubbler Room, Walls, Blue (Light) Paint - Lead Detected (<0.005% w/w)

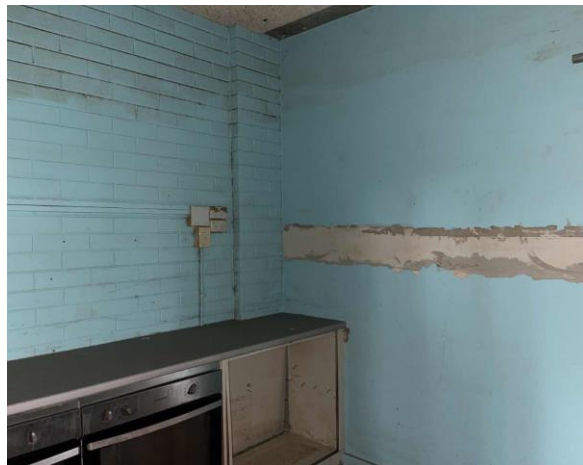
Line ID 41: Internal, Building A, Ground Floor, Canteen, Walls, Blue (Light) Paint - Lead Detected (<0.005% w/w)

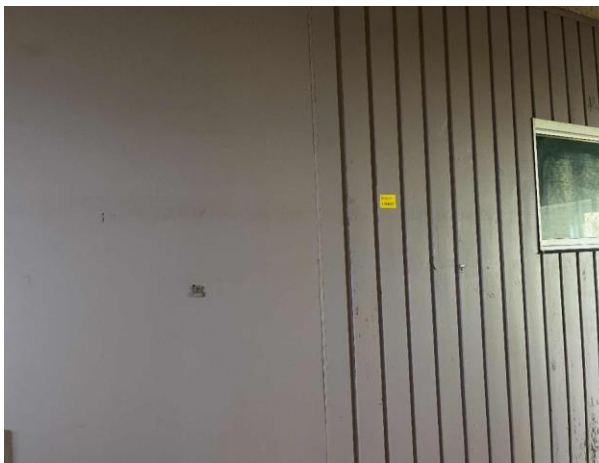
Line ID 42: Internal, Building A, Ground Floor, Central Room, Walls, Purple Paint - Lead Detected (<0.005% w/w)

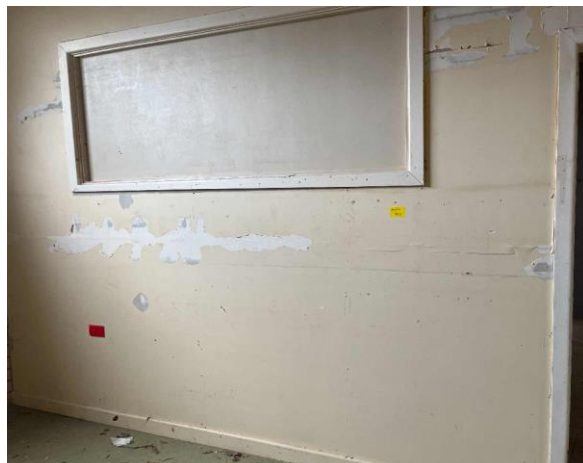
Line ID 43: Internal, Building A, Ground Floor, Eastern Room, Northern and Western Walls, Cream Paint - Lead Detected (<0.005% w/w)

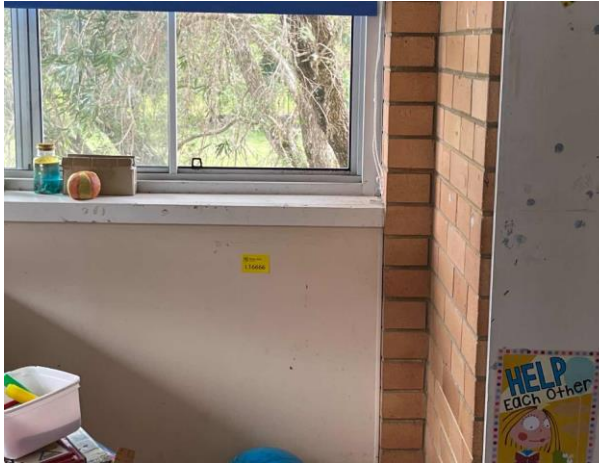
Line ID 44: Internal, Building A, Level 1, Enclosed Verandah, Infill Panels and Trim, Beige Paint - Lead Detected (<0.005% w/w)

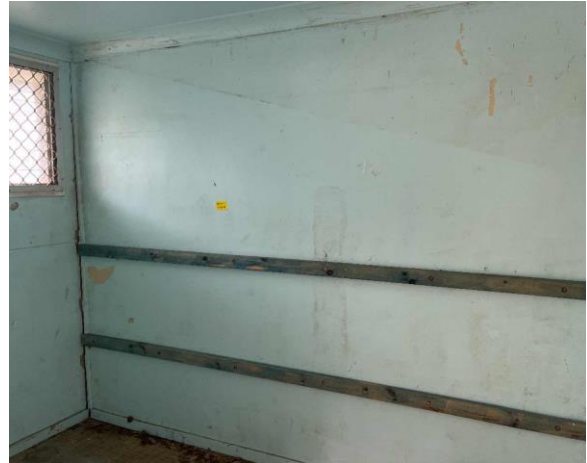
Line ID 45: Internal, Building B, Northern and Central Room, Walls and Ceiling, Blue Paint - Lead Detected (0.061% w/w)

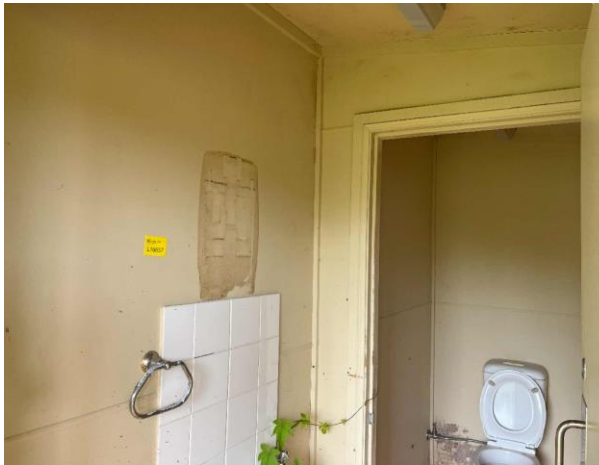
Line ID 46: Internal, Building B, Toilet Rooms, Walls and Ceilings, Beige Paint - Lead Detected (<0.005% w/w)

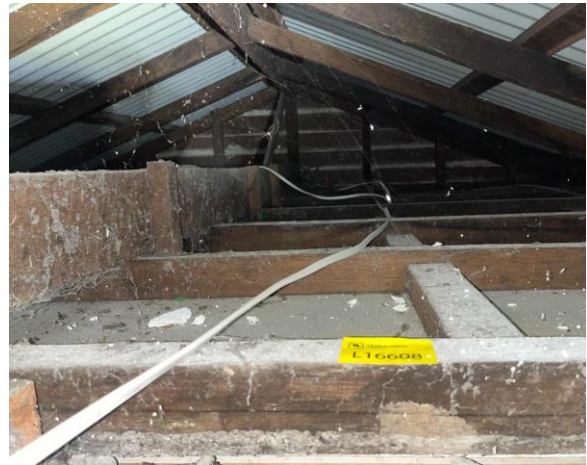
Line ID 47: Internal, Building B, Ceiling Space, Throughout, Dust - Lead Detected (330mg/kg)

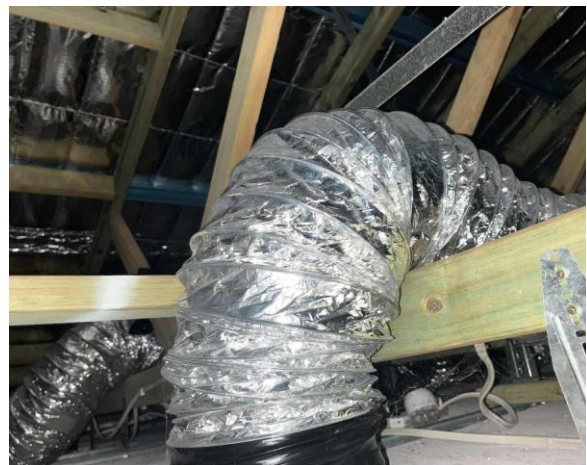
| Location | Material Description | Risk Rating |
|---|---|---|
| Internal / Amenities Block / Ceiling Void / Flexible Air Conditioning Ductwork Throughout | Insulation Material | Very Low |

Line ID 49: Internal, Amenities Block, Ceiling Void, Flexible Air Conditioning Ductwork Throughout, Insulation Material - Suspected SMF

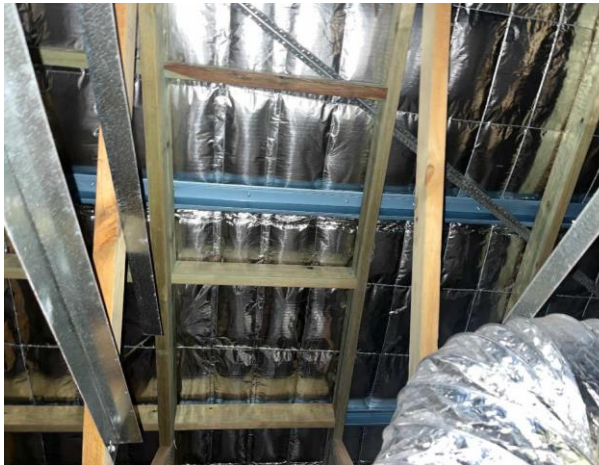
Line ID 50: Internal, Amenities Block, Ceiling Void, Throughout, Sarking Insulation - Suspected SMF

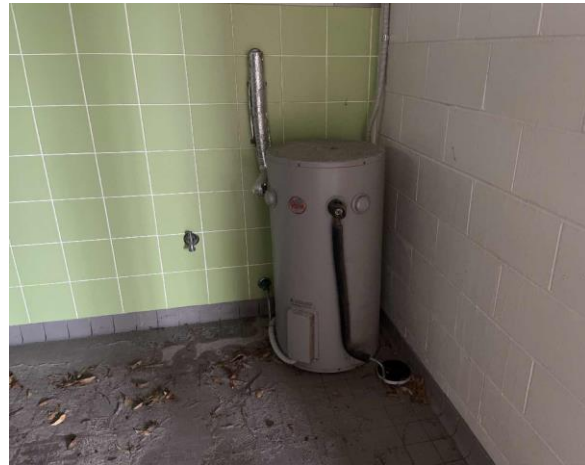
Line ID 51: Internal, Amenities Block, Female Ambulant Toilets, Within Hot Water Heater, Internal Insulation - Suspected SMF

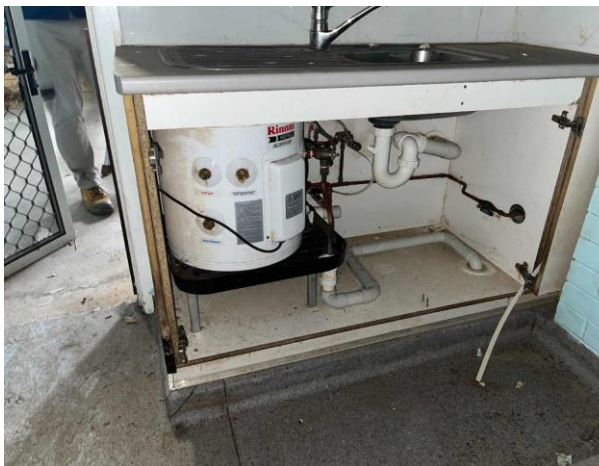
Line ID 52: Internal, Building A, Ground Floor, Canteen, Hot Water Heater Under Bench, Internal Insulation - Suspected SMF

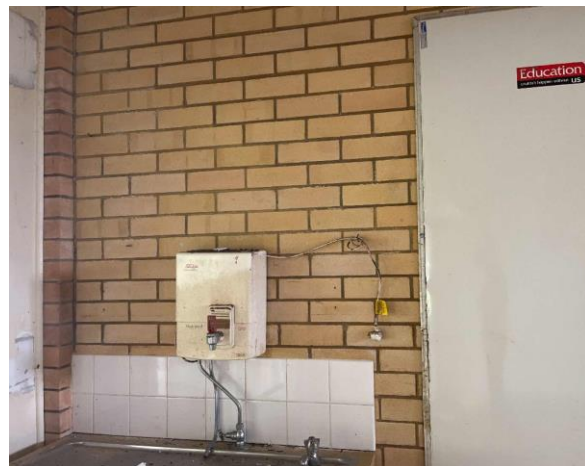
Line ID 53: Internal, Building A, Ground Floor, Eastern Room, Hot Water Boiler, Above Sink, Internal Insulation - Suspected SMF

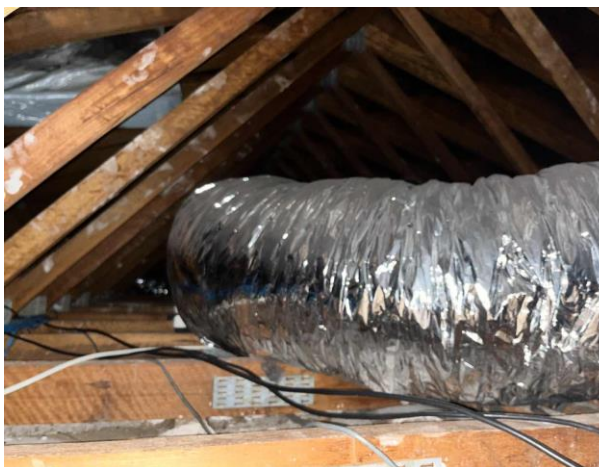
| Location | Material Description | Risk Rating |
|---|---|---|
| Internal / Building A, Level 1 / Ceiling Void / Flexible Air Conditioning Ductwork Throughout | Internal Insulation | Very Low |

Line ID 54: Internal, Building A, Level 1, Ceiling Void, Flexible Air Conditioning Ductwork Throughout, Internal Insulation - Suspected SMF

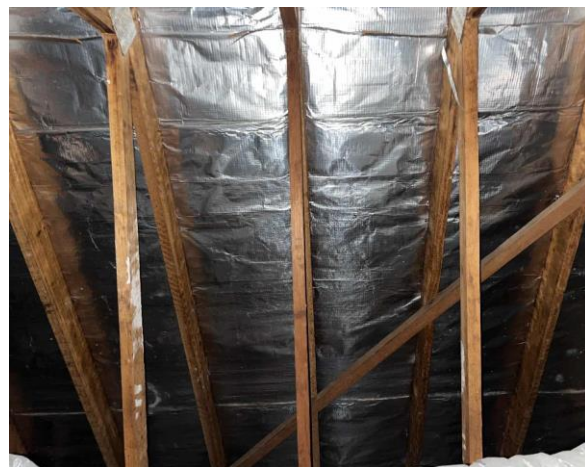
Line ID 55: Internal, Building A, Level 1, Ceiling Void, Throughout, Sarking Insulation - Suspected SMF

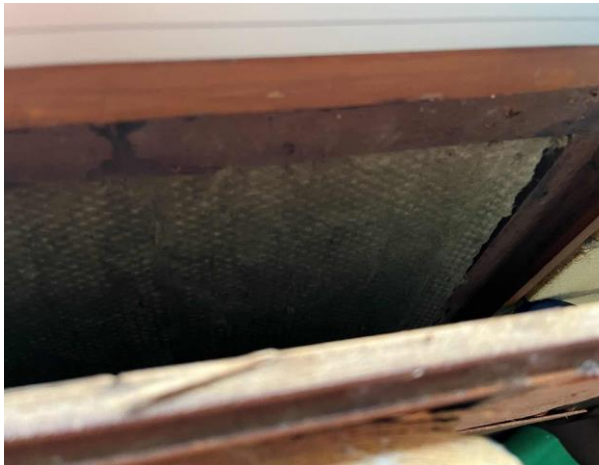
Line ID 56: Internal, Building A, Level 1, Throughout, Southern Wall, Behind Wooden Panels, Below Windows, Insulation Material - Suspected SMF

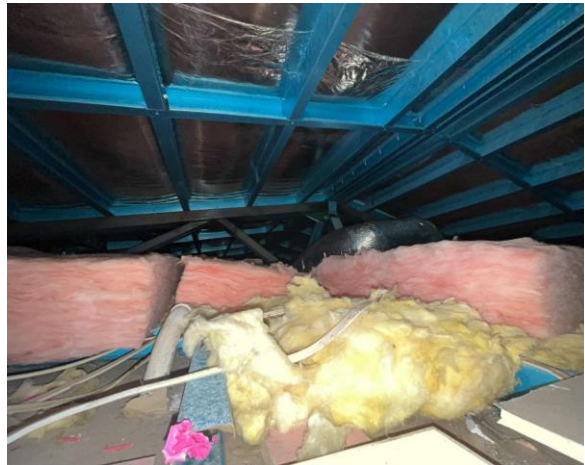
| Location | Material Description | Risk Rating |
|---|---|---|
| Internal / Building E Ground Floor / Ceiling Space / Throughout | Loose Insulation | Very Low |

Line ID 57: Internal, Building E Ground Floor, Ceiling Space, Throughout, Loose Insulation - Suspected SMF

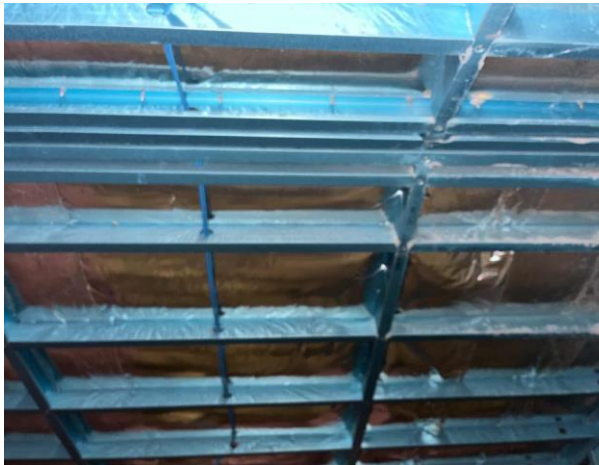
Line ID 58: Internal, Building E Ground Floor, Ceiling Space, Throughout, Sarking Insulation - Suspected SMF

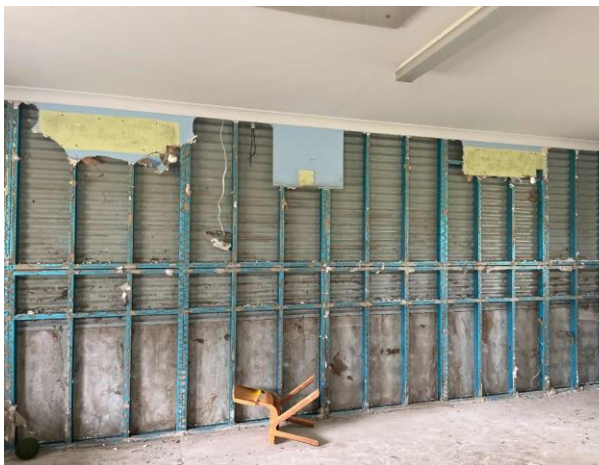
Line ID 59.1: Internal, Building E Ground Floor, West side, Behind Remanding Wall, Insulation Batts - Suspected SMF

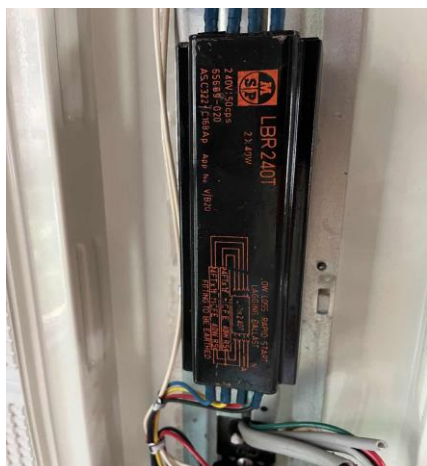
Line ID 61: Internal, Building A, Level 1, Throughout, Light Fittings, Ballast(s) - Suspected PCB

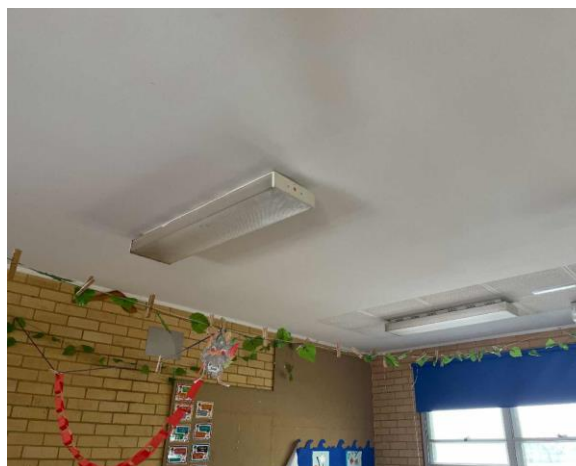
Line ID 61.1: Internal, Building A, Level 1, Throughout, Light Fittings, Ballast(s) - Suspected PCB

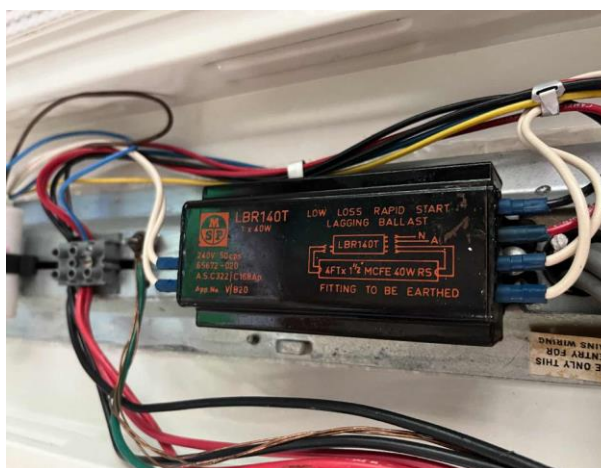
Line ID 61.2: Internal, Building A, Level 1, Throughout, Light Fittings, Ballast(s) - Suspected PCB

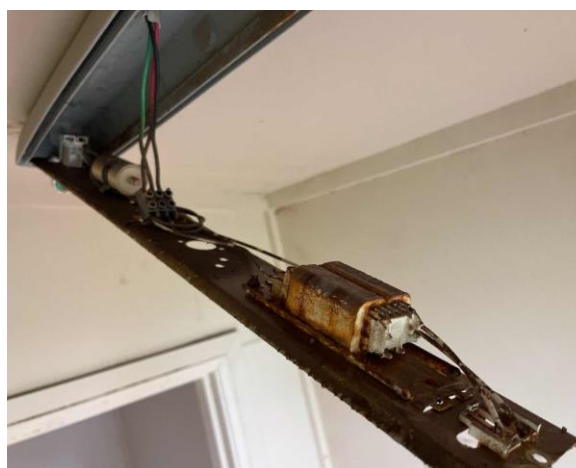
Line ID 62: Internal, Building B, Toilet Rooms, Ceiling, Capacitor(s) - Suspected PCB

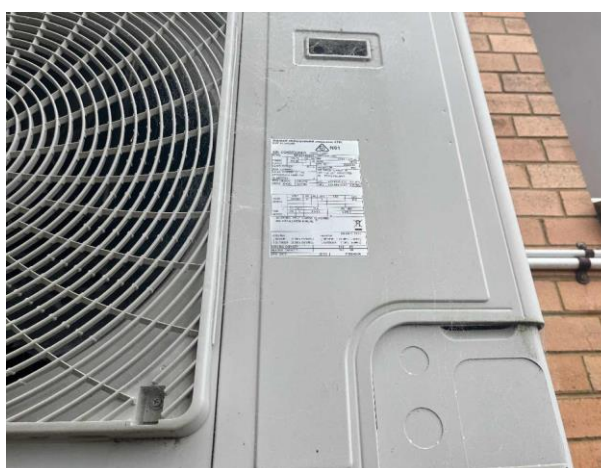
Line ID 63: External, Building A, Level 1, South Side, Daikin Air Conditioning unit, R410A Hydrofluorocarbon (HFC) - Non ODS Refrigerant
