26 September 2023

**Arboricultural Impact Assessment (AIA) report regarding twenty-five (25) trees located within the vicinity of the proposed Grafton Base Hospital redevelopment – acquisition site at Grafton Base Hospital, 184 Arthur Street, Grafton NSW**

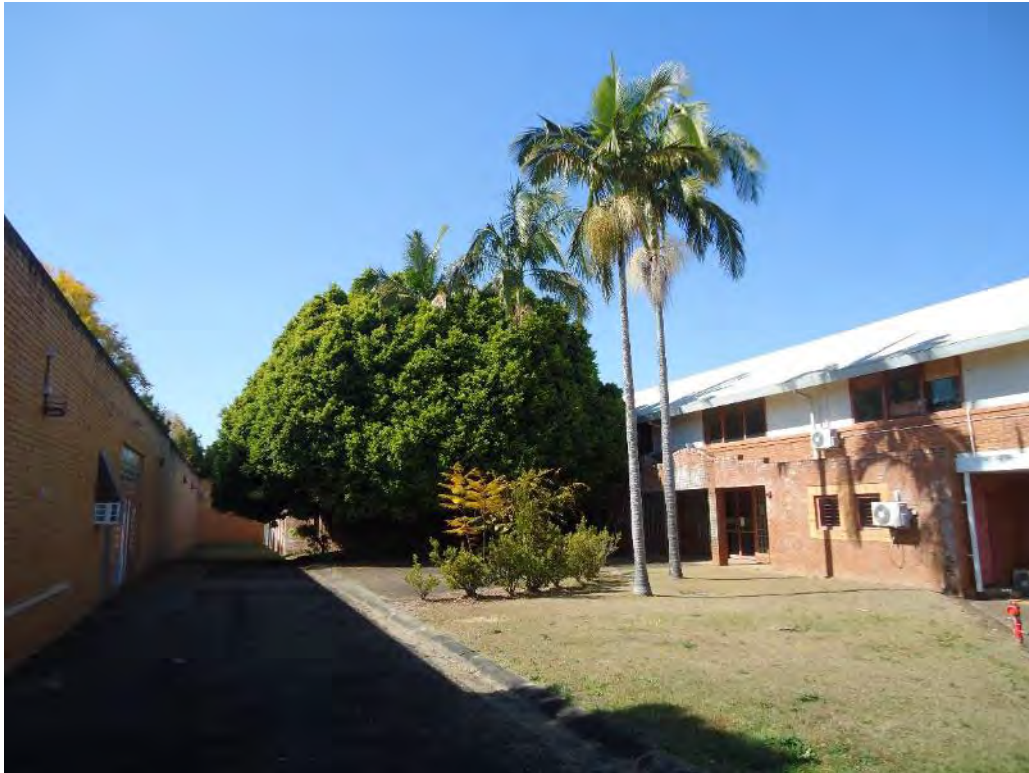
- 5.2.4 The most impressive tree was a mature *Ficus microcarpa* var. *Hilli* (Hills Weeping Fig) situated within the forecourt of the Correctional Centre forecourt. The tree was a multi-stemmed specimen situated within an existing garden bed and displayed an impressive array of aerial root development, used for stability and additional nutrient gathering capability, which bodes well for its longevity.

Figure 3. Image of Tree 42 – *Ficus benjamina* (Weeping Fig) within the Correctional Centre forecourt. (ArborSafe, September 2023).

- 7.12.1 It is anticipated that minor pruning only may be required on tree 42, largely centred on reduction or crown lifting to facilitate site access during construction. Any pruning is to be no greater than 10% of the trees total crown area or 15% of any individual branch volume. It is considered such pruning would have minimal long-term health or amenity impact on the tree.
- 7.12.2 All pruning is recommended to be completed in accordance with the Australian Standard AS 4373–2007: *Pruning of Amenity Trees* (Standards Australia, 2007) and undertaken by a suitably qualified arborist (minimum AQF 3 arborist).
- 7.12.3 Reduction pruning should focus on the removal of smaller diameter branches where feasible and remove no greater than 10% of the total crown. Branches no greater than 50mm diameter are to be removed unless specifically approved by the project arborist.

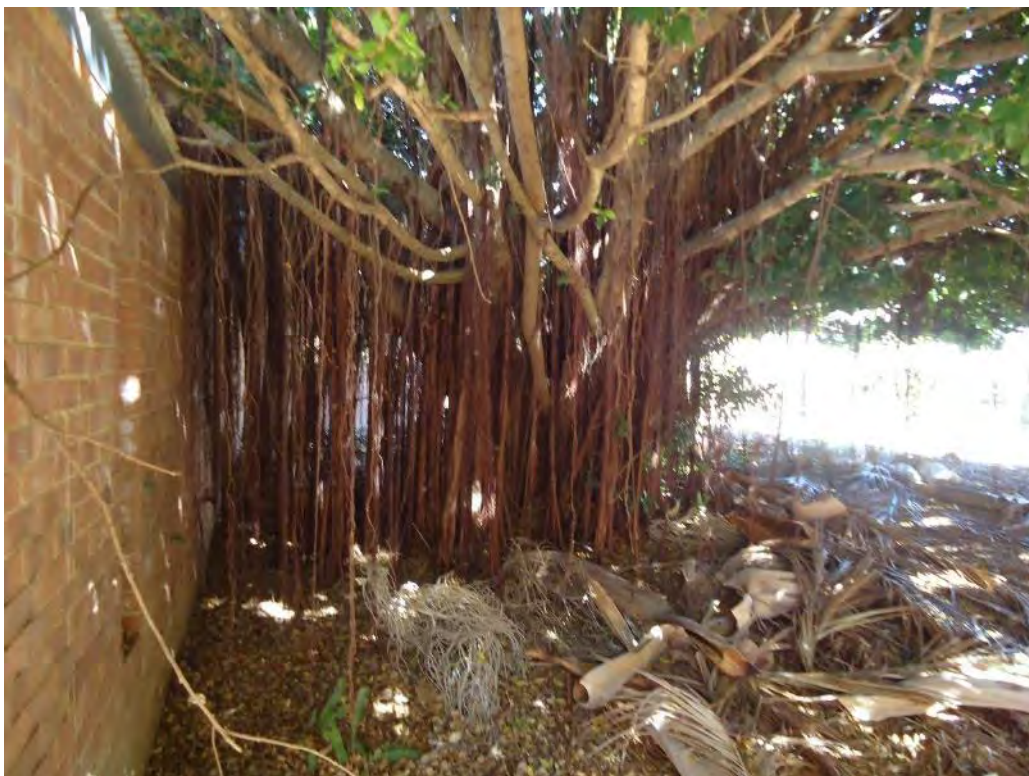
Figure 4. Image of the aerial roots extending from Tree 42 – *Ficus benjamina* (Weeping Fig) within the Correctional Centre forecourt. (ArborSafe, September 2023).

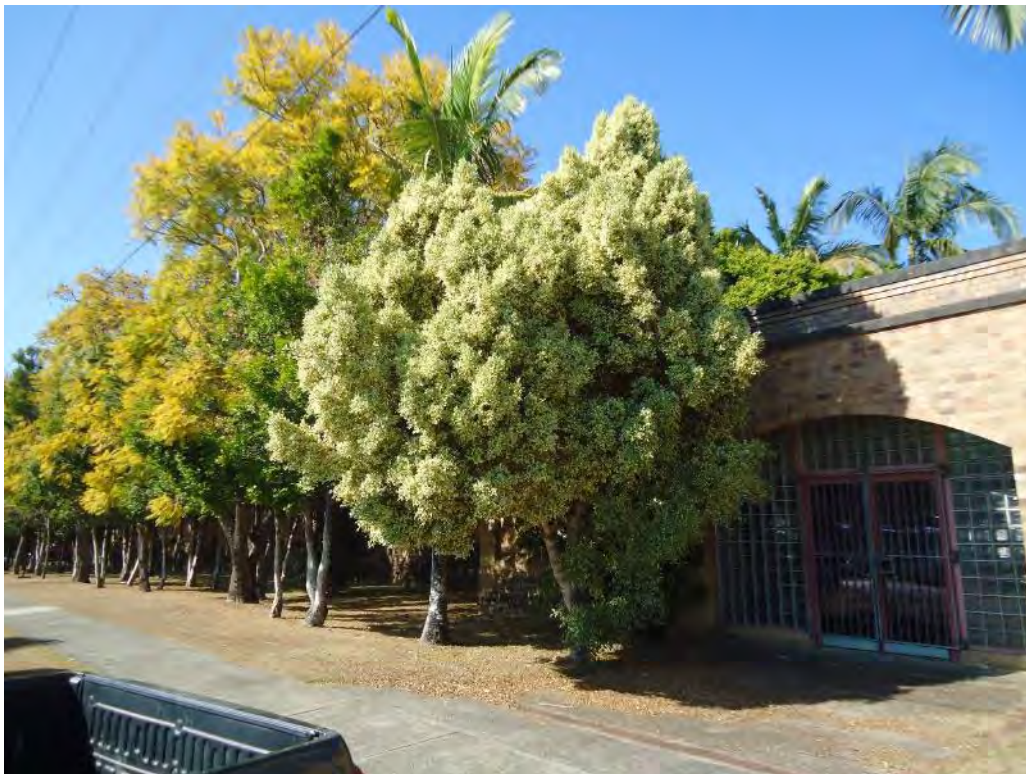
Figure 5. Image of the line of mixed street trees, with Tree 24 *Ficus microcarpa* var. *hillii* (Hill's Weeping Fig) in the foreground, situated along Arthur Street to the front of the entrance gates of the Correctional Centre. (ArborSafe, September 2023).

- 6.2.1 A review of the proposed design has been undertaken in the context of tree retention and removal across the site.
- 6.2.2 One (1) juvenile *Ficus microcarpa* var. *hillii* (Hill's Weeping Fig), identified as Tree 24, is recommended for removal to allow for enhanced visibility into the jail access gate. To retain this tree a redesign of the entry way would be required however given its small stature, inappropriate location in close proximity to the concrete footpath and heritage wall, and Low Retention Value (Category C) it should not be considered a constraint on the development.

- 1.1.4 Tree 24, a juvenile *Ficus microcarpa* var. *hillii* (Hill's Weeping Fig) is recommended for removal to allow for enhanced visibility into the jail access gate.

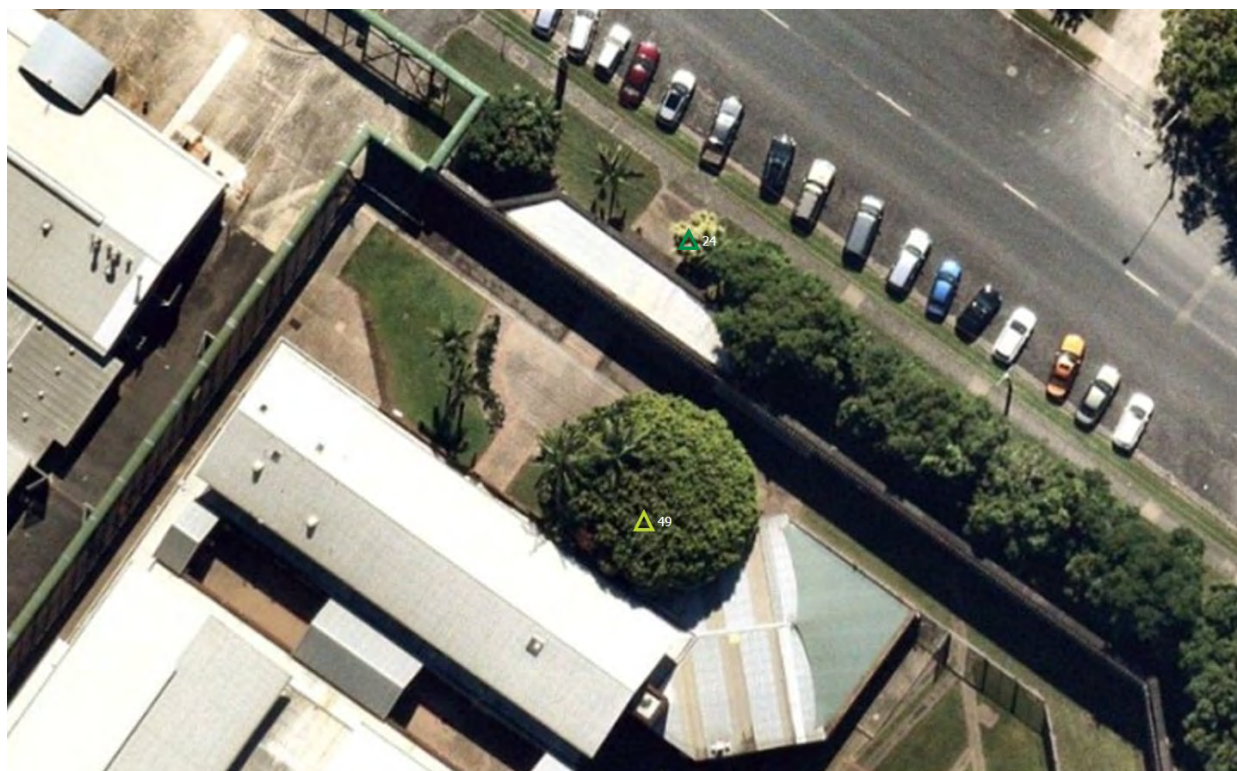
- 6.2.3 Tree 49, *Schefflera actinophylla* (Umbrella Tree), was an escaped pot plant situated within the Correctional Centre forecourt growing in close proximity to an existing brick wall and suppressed under the southern canopy of the larger *Ficus benjamina*. It is a Category U tree and was also recommended for removal before it negatively affects both the stability of the brick wall and/or the structure of the Fig tree (refer to Figure 7).

Figure 7. Site map showing trees requiring removal to facilitate development. (ArborSafe, September 2023).

- 1.1.5 Tree 49 should be removed irrespective of development (Category U) due to it being an inappropriate species and its location within the forecourt of the complex.

7.1.2 A further one (1) tree should be removed irrespective of development (Category U) due to its inappropriate species and location.

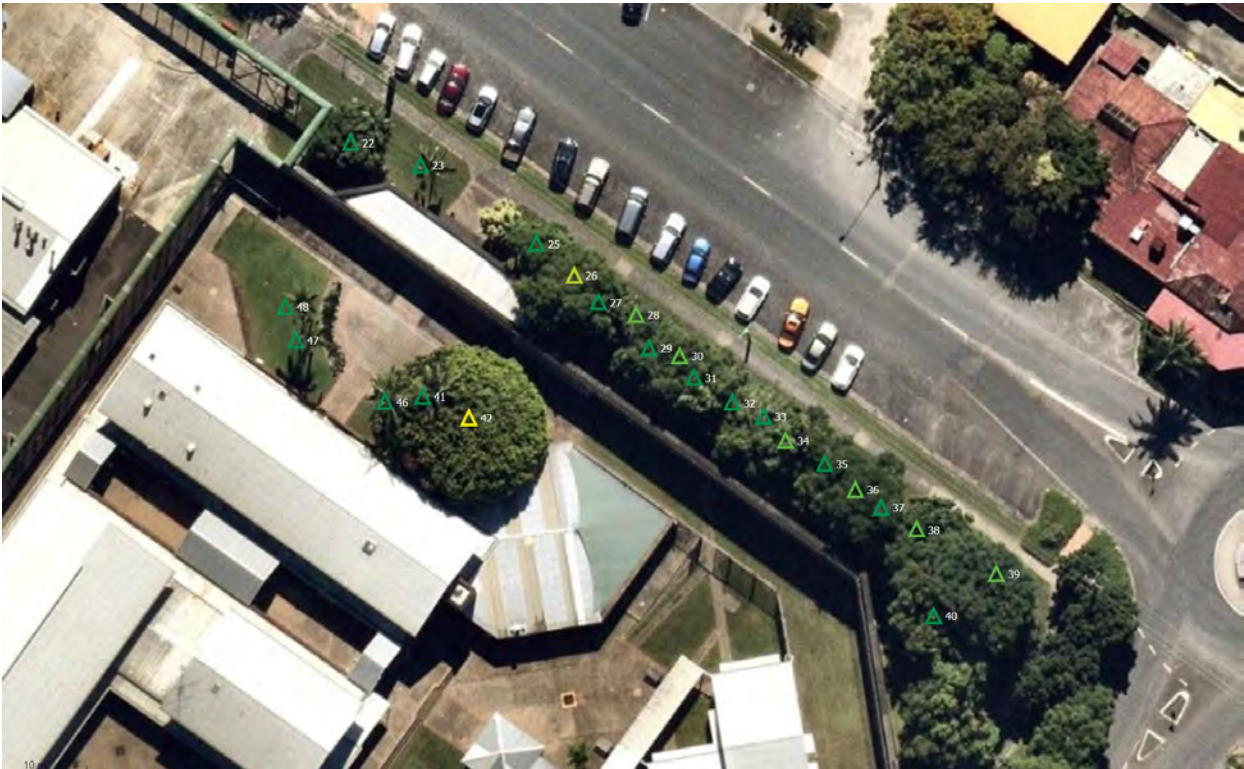
Figure 8. Site map showing tree requiring generic protection measures. (ArborSafe, September 2023).

7.2.1 Twenty-Three (23) trees were recommended for retention and require generic protection measures during construction to ensure that they remain viable following the completion of works.

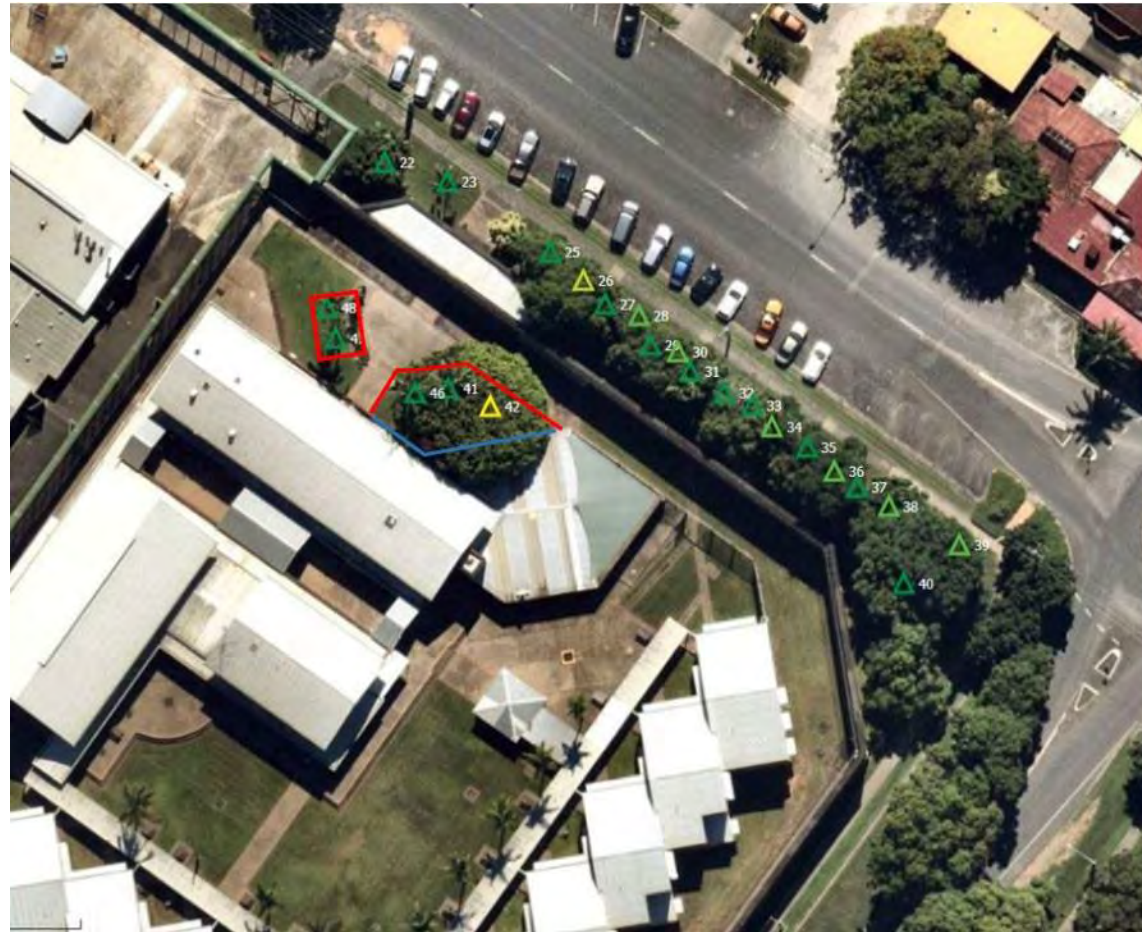
Figure 12. Site map showing retained trees with suggested Tree Protection Fence locations (Red) and the existing brick walls (Blue). (ArborPlan, September 2023).

Install protection fencing around the northern and western aspects of the existing garden bed surrounding Tree 42, tying in with the existing brick walls on the eastern and southern aspects to complete the containment.
