Stringybark Solar Farm

Traffic and Transport Assessment

Stage 5 - Road Safety Audit

Stringy Bark Solar Farm Transportation Route

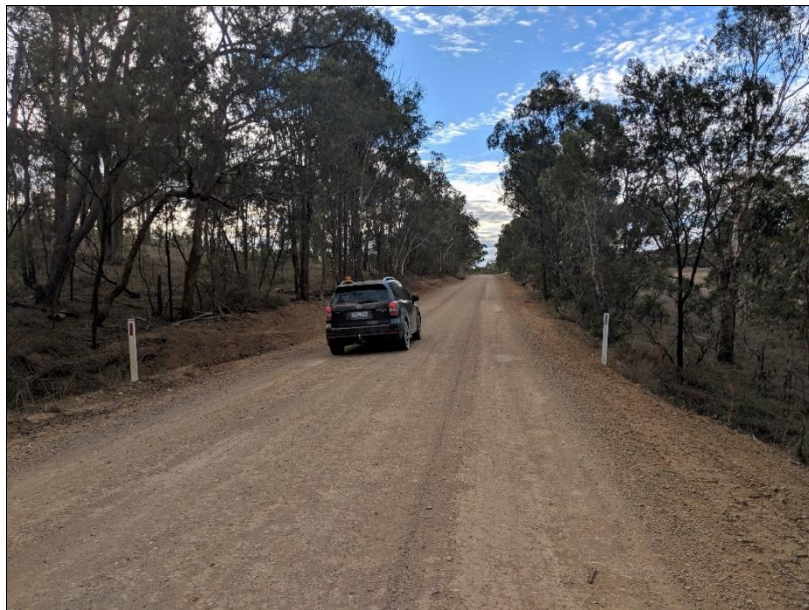
Gara Road is unsealed however there is a bitumen seal for the first 100m from the Waterfall Way intersection. The gravel pavement width varies however, it is generally between 5m and 6m. The horizontal and vertical alignment consists of several curves, crests and single lane causeways. The overall condition of the unsealed pavement was considered to be good however there were some sections where corrugations were present (refer **Photo 2**).

Photo 2 – Typical Section of Gara Road

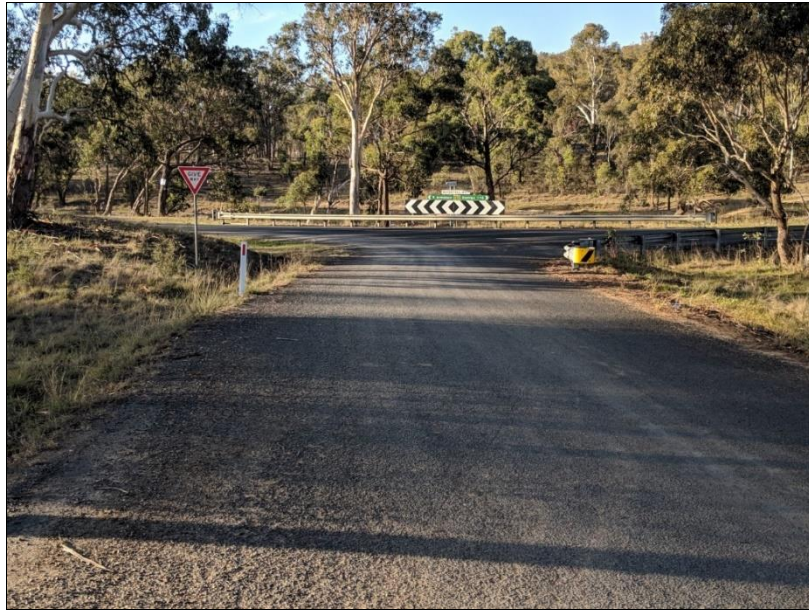
The intersection of Waterfall Way and Gara Road is a basic T-intersection configuration with Waterfall Way as the priority road. There are no auxiliary turn lanes on Waterfall Way. Sight distance in both directions is greater than 300m along Waterfall Way and signage consists of a Give Way sign and sight board located opposite the intersection. There is a continuity line at the intersection but no give way (TB) line. The pavement is sealed and considered to be in reasonable condition in the mouth of the intersection (refer **Photo 3** and **Photo 4**).

Photo 3 – Gara Road Approach to Waterfall Way

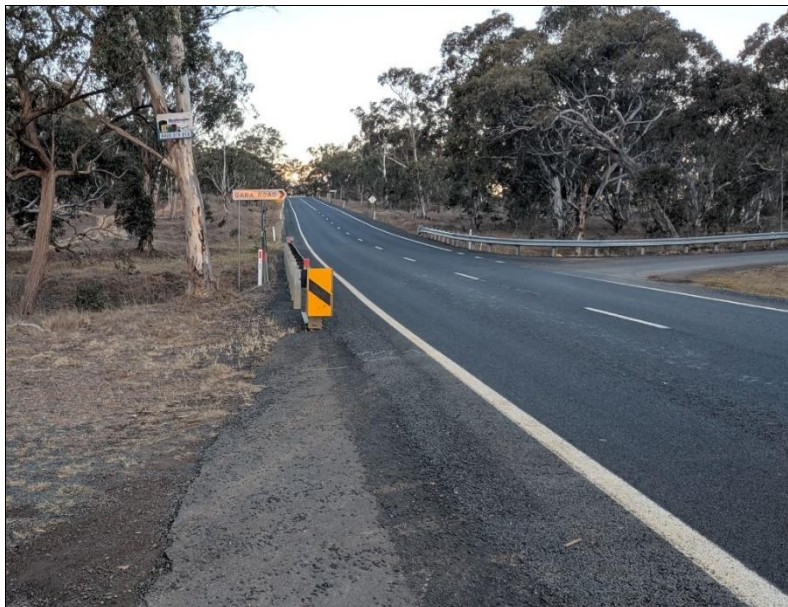
Photo 4 – Waterfall Way and Gara Road intersection – Looking East

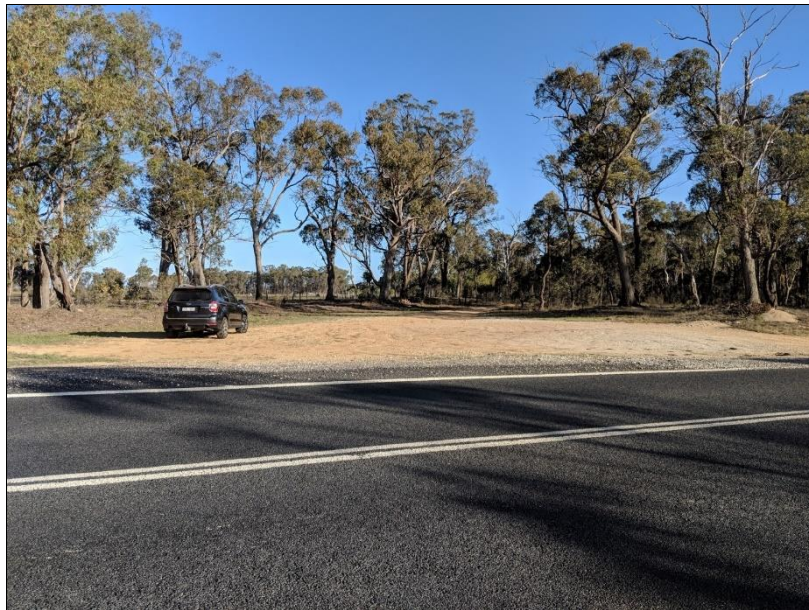
This access is proposed for use by vehicles only associated with the construction of the substation, however, if approved, could also cater for the proposed Olive Grove Solar Farm traffic as well. (*Note: the Olive Grove Solar Farm will be subject to a separate development application*).

Photo 5 – Proposed Substation Site Access off the Waterfall Way (MR76)

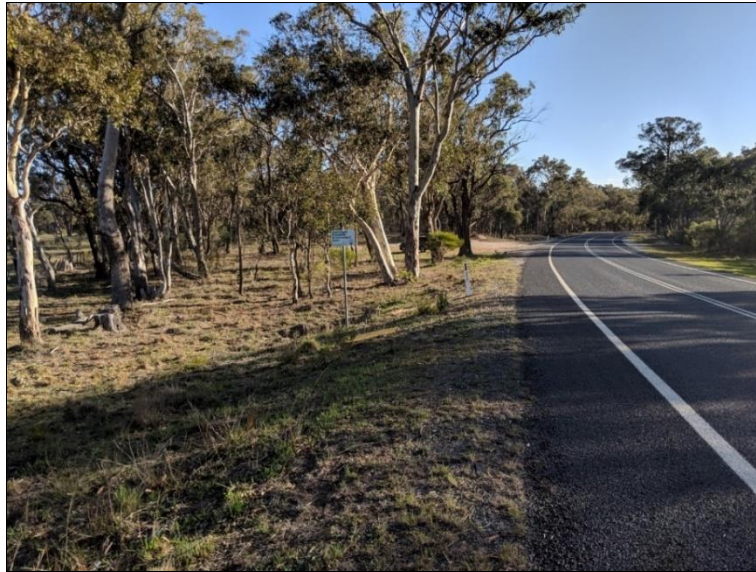
Photo 9 – Trees within the Clear Zone along Waterfall Way adjacent to the westbound approach to the Proposed Substation Site Access

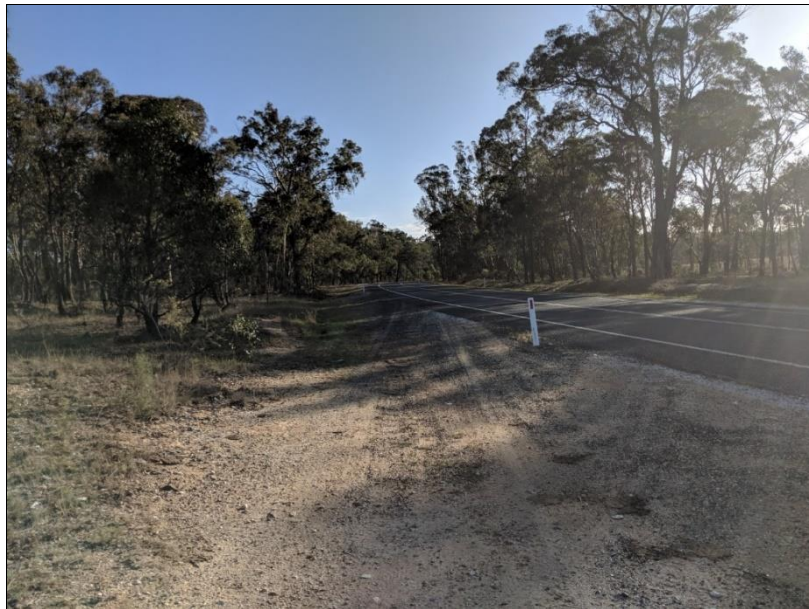
Another potential road safety concern is the limited sight distance for eastbound vehicles on approach to the proposed substation site access. The sight distance is obscured due to the curve and presence of trees and vegetation located adjacent to the eastbound lane (refer **Photo 10**).

Photo 10 – Looking west from the Site Access, trees adjacent to the eastbound lane obscure sight distance at the curve

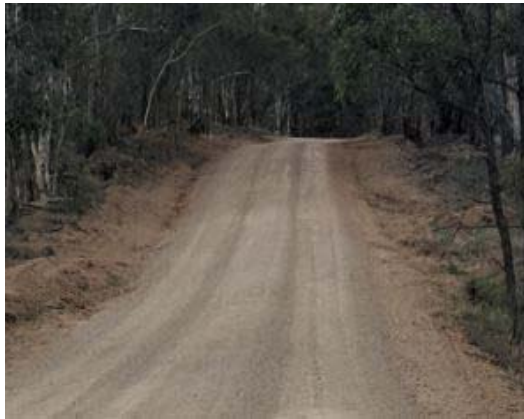
| CAR No. | Audit Findings | Photographs |
|--|--|---|
| 001 | <p><u>Missing Guide Post(s)</u></p> <p>Guide posts are only provided at culverts. There are no guide posts in place to delineate the alignment of the road including crests and curves as per the requirements of Section 16 of the RTA Delineation Guide.</p> <p>Missing guide posts can make it difficult for road users to visualise the road alignment, particularly at night. This is undesirable as an errant driver may run off the road and lose control of the vehicle potentially resulting in serious injury to the vehicle occupants given the relatively narrow road formation width.</p> | |

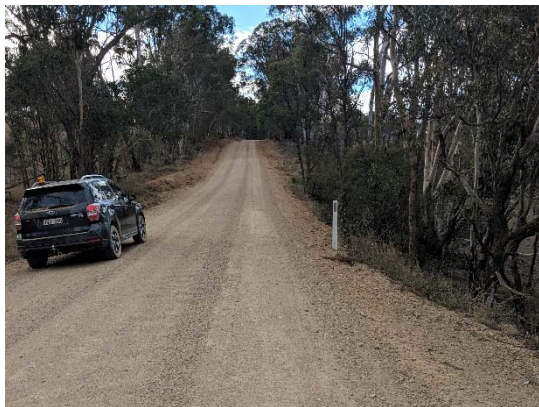
| CAR No. | Audit Findings | Photographs | |
|--|--|---|--|
| 002 | <p><u>Steep Embankment Batters</u></p> <p>There are number of unprotected steep batters located at numerous locations.</p> <p>There is a risk that an errant driver may leave the road, have insufficient shoulder width to recover and lose control down a steep batter. In most cases there is insufficient clear zone area at the base of the batter to allow recovery of the vehicle without impacting obstacles.</p> <p>There is also an increased risk potential for vehicle rollover type crashes, particularly heavy vehicles, on the verge/batter as the road has batter slopes in numerous locations which are less than the minimum standard of 4:1 and less than the desirable minimum batter of 6:1 for heavy vehicles as per Austroads Guide to Road Design.</p> | | |

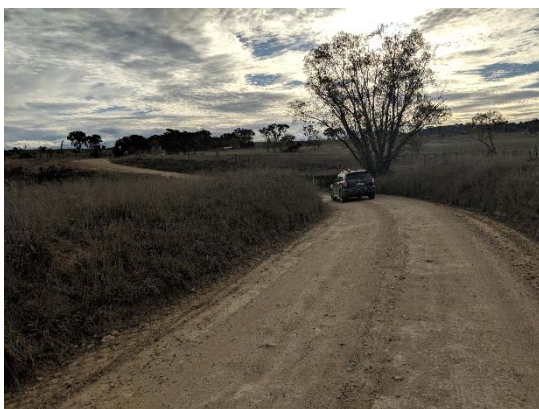
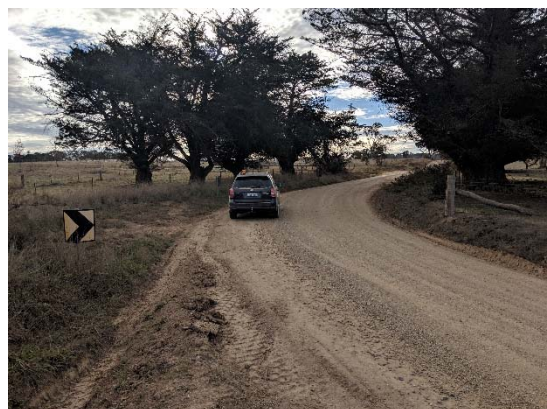
| CAR No. | Audit Findings | Photographs | |
|--|--|---|--|
| 003 | <p><u>Narrow Formation on Tight Radius Curves</u></p> <p>There are a number of locations where there are tight radius substandard curves.</p> <p>There is a risk that an errant driver driving at speed may lose control at the curve and leave the road which has the potential to cause serious injuries to the occupants of the vehicle, particularly if there are objects within the clear zone</p> | | |

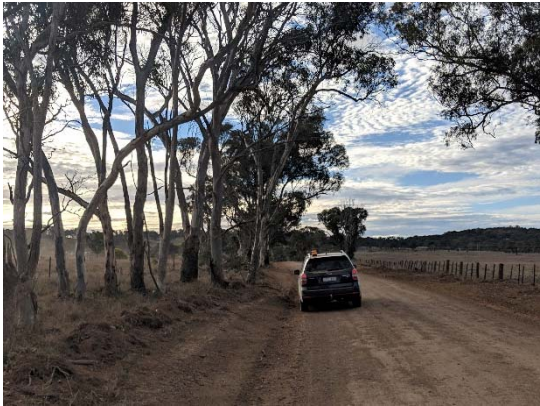
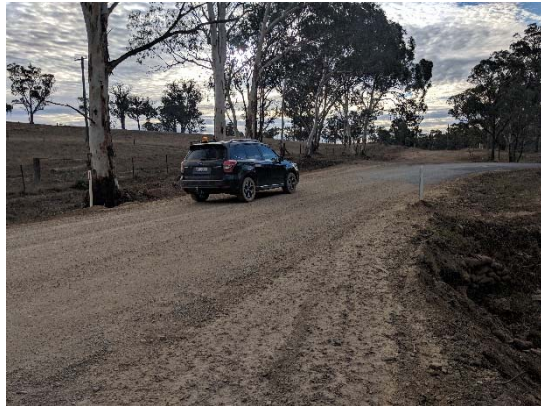
| CAR No. | Audit Findings | Photographs | |
|--|---|---|---|
| 004 | <p><u>Objects within the Clear Zone</u></p> <p>There are a number of non-frangible trees, fence strainer posts and culverts with steep drop offs located within the clear zone.</p> <p>The location of these objects creates a hazard as there is a risk that errant drivers may leave the road and collide with unprotected objects within the clear zone which has the potential to cause serious injuries to the occupants of the vehicle.</p> | | |

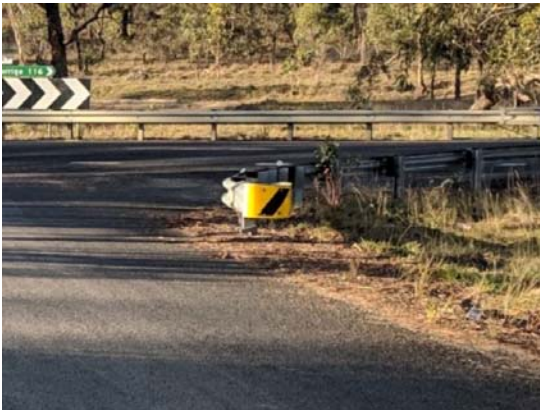
| CAR No. | Audit Findings | Photographs | |
|--|---|---|---|
| 005 | <p><u>Substandard End-Terminals</u></p> <p>The is a substandard end terminal at the end of the safety barrier on approach to the Waterfall Way intersection.</p> <p>There is a risk that an errant driver could leave the roadway and come into contact with a substandard safety barrier which does not correctly perform at impact due to the poor condition resulting with the potential for causing serious injuries to occupants of the vehicle.</p> | | |

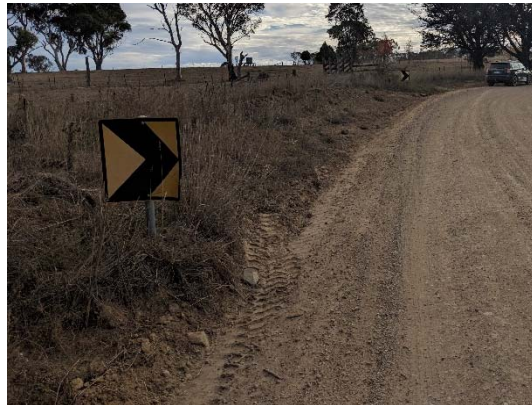
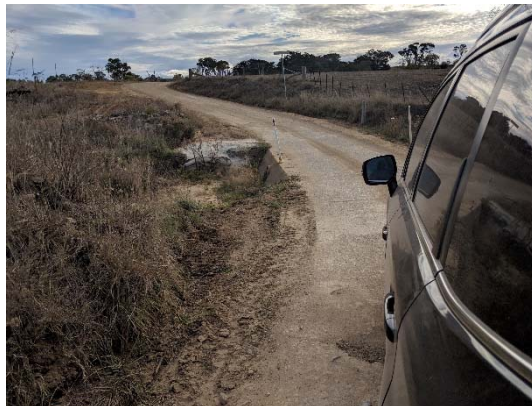
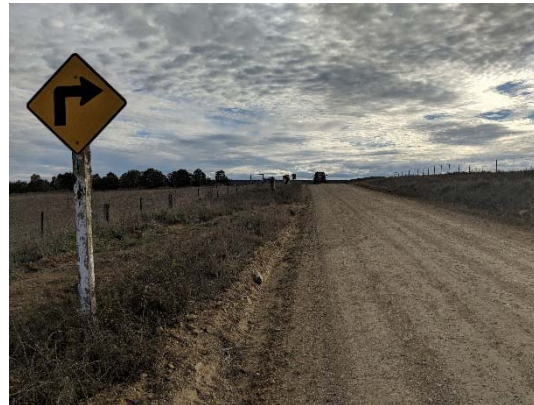
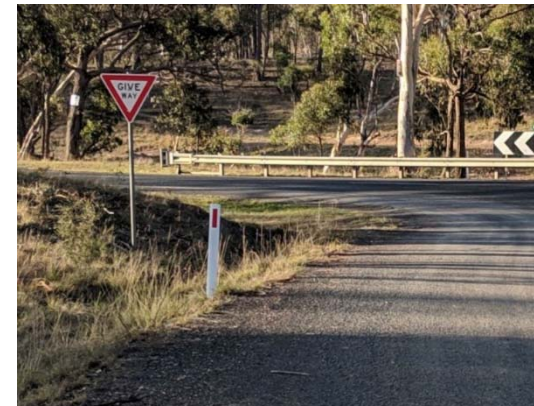
| CAR No. | Audit Findings | Photographs | |
|---|--|--|--|
| 006 | <p><u>Damaged and Missing Signs</u></p> <p>There are a number of substandard curve warning signs on the approaches to substandard curves.</p> <p>There are missing advanced warning signs on the approaches to crests.</p> <p>There is a causeway without advanced warning signs on the approaches or depth markers at the causeway.</p> <p>Many of the CAMs provided for substandard curves are damaged, faded, or at a substandard height.</p> <p>The Give Way sign at the Waterfall Way intersection is located too far back from the intersection.</p> <p>Signs are provided to alert road users to oncoming features or changes in road condition. There is a risk that road users may not be aware of the oncoming conditions such as substandard curves which may result in the possibility of an errant driver coming into contact with oncoming traffic or leaving the roadway potentially resulting in serious injuries to occupants of the vehicle.</p> <p>A lack of warning signage can compromise road safety as road users are not properly advised of the changed traffic conditions ahead.</p> | | |

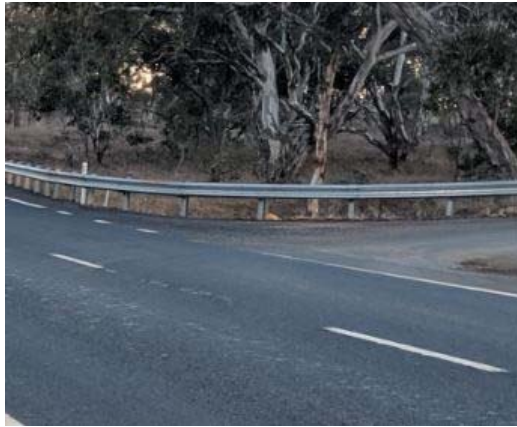
| CAR No. | Audit Findings | Photographs | |
|---|--|---|--|
| 007 | <p><u>Transverse Line Marking</u></p> <p>There is a Give Way signs in place at the Waterfall Way intersection however, there is no holding line, only the continuity line for the west bound travel lane.</p> <p>Holding lines at intersections with Give Way control are required to indicate to road users the safe position for their vehicles to be held when waiting at the intersection.</p> <p>There is a risk that when there is no holding line, an errant road user may encroach into the travel lane of the through road (100km/h speed zone) that may result in a vehicle collision.</p> | | |

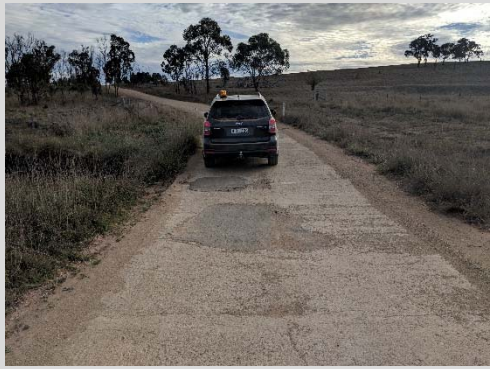
| Start Chainage | Finish Chainage | Day / Night | Travel Direction | Photo | Category | Hazard Description | Location / notes | Likelihood | Consequence | Risk Rating | CARs |
|---|---|---|---|---|---|--|---|---|---|---|---|
| 1.6 | | day | west | | Traffic Signs | sign missing - causeway advanced warning | on approach to causeway in both directions | 2 Unlikely | 2 Minor | Low | 006 |

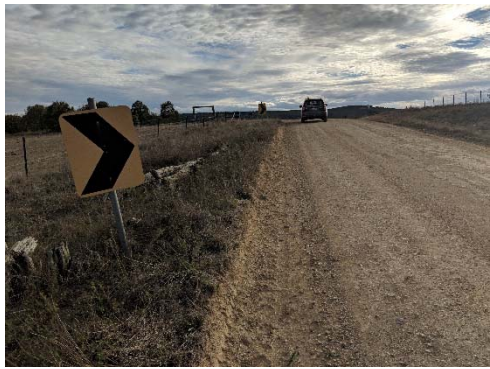
| Start Chainage | Finish Chainage | Day / Night | Travel Direction | Photo | Category | Hazard Description | Location / notes | Likelihood | Consequence | Risk Rating | CARs |
|---|---|---|---|---|---|---|--|---|---|---|---|
| 2.3 | | day | west | | Traffic Signs | sign low – Chevron Alignment Markers (CAMs) | located on the southern side of the road on both sides of the curve through the crest | 2 Unlikely | 3 Moderate | Medium | 006 |

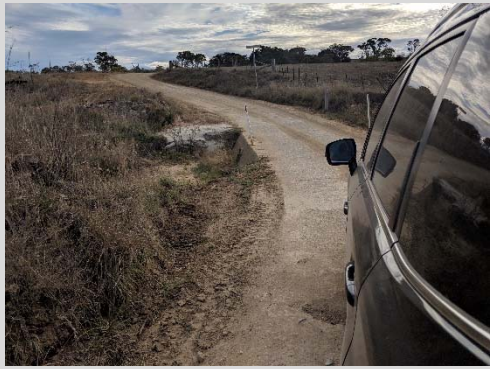
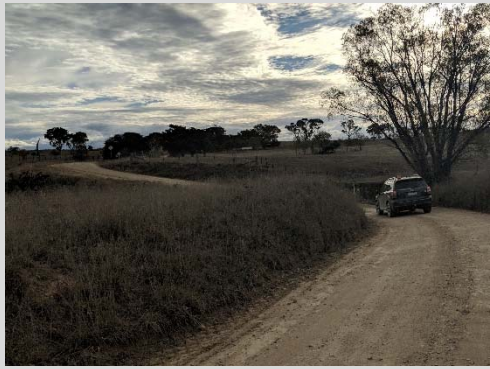
| Start Chainage | Finish Chainage | Day / Night | Travel Direction | Photo | Category | Hazard Description | Location / notes | Likelihood | Consequence | Risk Rating | CARs |
|---|---|---|---|---|---|---|--|---|---|---|---|
| 2.3 | 1.6 | day | west | | Road Alignment and Cross Section | Narrow formation and tight radius curves | through causeway with relatively steep grades on each approach. (Burying Ground Creek) | 2 Unlikely | 3 Moderate | Medium | 003 |

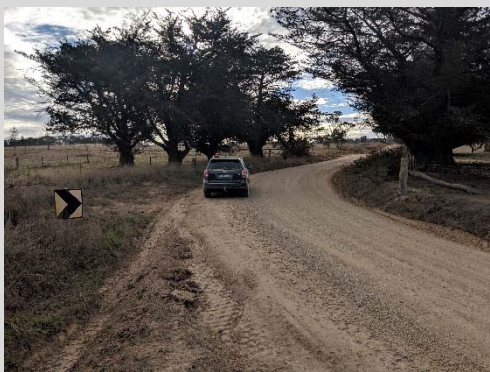
| Start Chainage | Finish Chainage | Day / Night | Travel Direction | Photo | Category | Hazard Description | Location / notes | Likelihood | Consequence | Risk Rating | CARs |
|---|---|---|---|--|---|---|--|---|---|---|---|
| 2.9 | | day | west | | Road Alignment and Cross Section | tight radius curves | limited sight distance as vegetation obscures sight distance through the curve | 2 Unlikely | 3 Moderate | Medium | 003 |

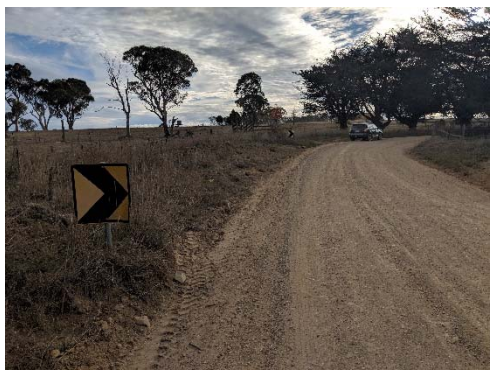
| Start Chainage | Finish Chainage | Day / Night | Travel Direction | Photo | Category | Hazard Description | Location / notes | Likelihood | Consequence | Risk Rating | CARs |
|---|---|---|---|--|---|---|--|---|---|---|---|
| 2.9 | | day | west | | Traffic Signs | sign low - Chevron Alignment Markers (CAMs) | outside of curve in both directions. | 2 Unlikely | 3 Moderate | Medium | 006 |

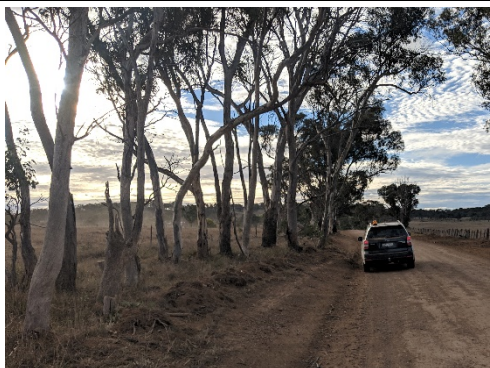
| Start Chainage | Finish Chainage | Day / Night | Travel Direction | Photo | Category | Hazard Description | Location / notes | Likelihood | Consequence | Risk Rating | CARs |
|---|---|---|---|--|---|---|--|---|---|---|---|
| 3.1 | 3.6 | day | west | | Roadside Hazards | clear zone obstruction - tree(s) | south side of road | 2 Unlikely | 3 Moderate | Medium | 004 |

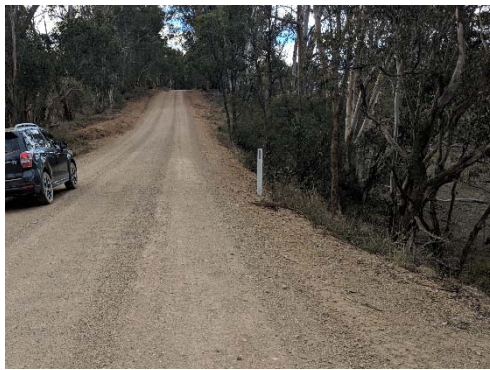
| Start Chainage | Finish Chainage | Day / Night | Travel Direction | Photo | Category | Hazard Description | Location / notes | Likelihood | Consequence | Risk Rating | CARs |
|---|---|---|---|--|---|---|--|---|---|---|---|
| 4.8 | | day | west | | Road Alignment and Cross Section | batters steep | both sides of road | 2 Unlikely | 3 Moderate | Medium | 002 |

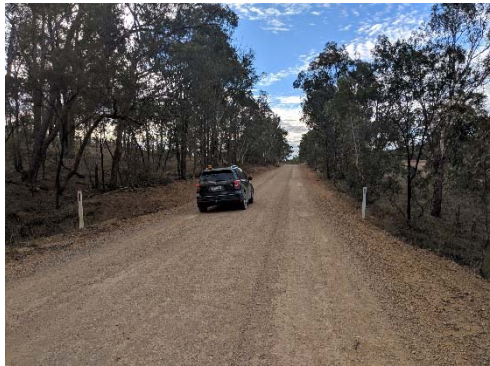
| Start Chainage | Finish Chainage | Day / Night | Travel Direction | Photo | Category | Hazard Description | Location / notes | Likelihood | Consequence | Risk Rating | CARs |
|---|---|---|---|--|---|---|--|---|---|---|---|
| 5.2 | | day | west | | Roadside Hazards | clear zone obstruction - culvert | headwalls in clear zone | 2 Unlikely | 3 Moderate | Medium | 004 |

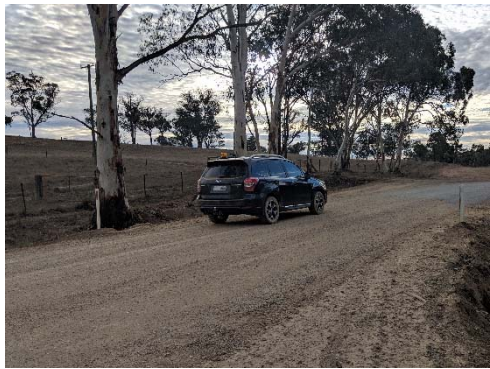
| Start Chainage | Finish Chainage | Day / Night | Travel Direction | Photo | Category | Hazard Description | Location / notes | Likelihood | Consequence | Risk Rating | CARs |
|---|---|---|---|--|---|--|--|---|---|---|---|
| 5.8 | | day | west | | Roadside Hazards | clear zone obstruction - tree(s) | south side of road | 2 Unlikely | 3 Moderate | Medium | 004 |
