**Client:** ICMG Sydney Inc  
**Project Reference:** N1908018  
**Date:** August 21, 2019  
**Version:** 1

## Hazardous Materials Audit Report

62-64 Mountford Ave, Guilford NSW 2161

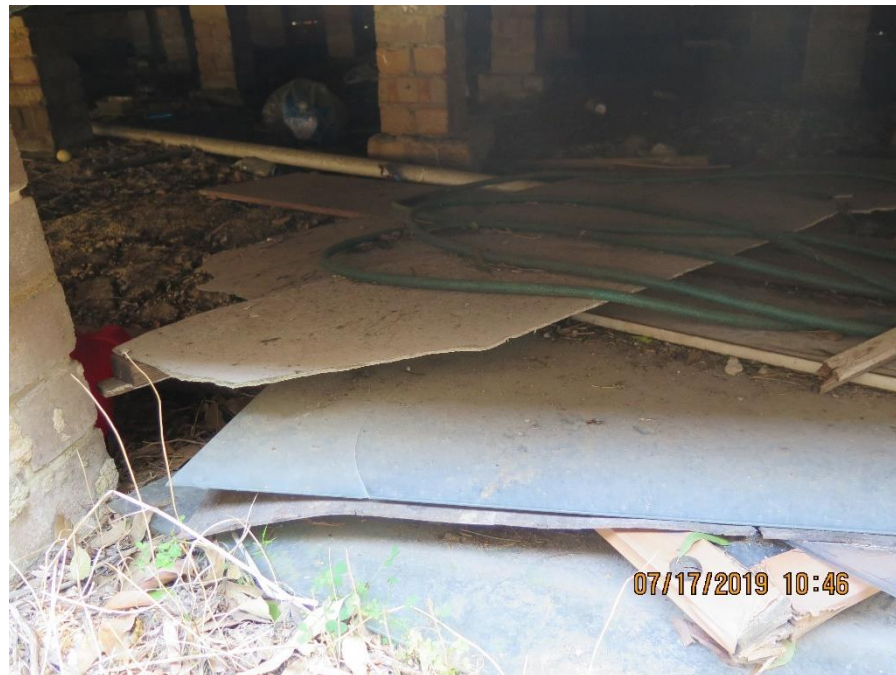
**Photo 1:**

| Sample Number | Primary Location | Specific Location | Material application | Material type | Quantity | Laboratory analysis result (asbestos type) | Friable / Non-Friable | Sealed / Unsealed / Enclosed | Condition | Activities that may lead to further damage/deterioration | Risk assessment | Control of risk/Comments | Photo number |
|---|---|---|---|---|---|---|---|---|---|---|---|---|---|
| <b>125514</b> | Exterior- Classroom | Under floor of Classroom - Throughout | Miscellaneous FCS debris | FCS & Super 6 Cement Sheeting | NQ | <b>Chrysotile Asbestos Detected</b> | Non-friable | Unsealed | High damage | Renovations or demolition | <b>Medium</b> | Remove ACM materials prior to any renovations or demolition. Licensed asbestos removalist required to remove ACM materials. | Photo 1 |

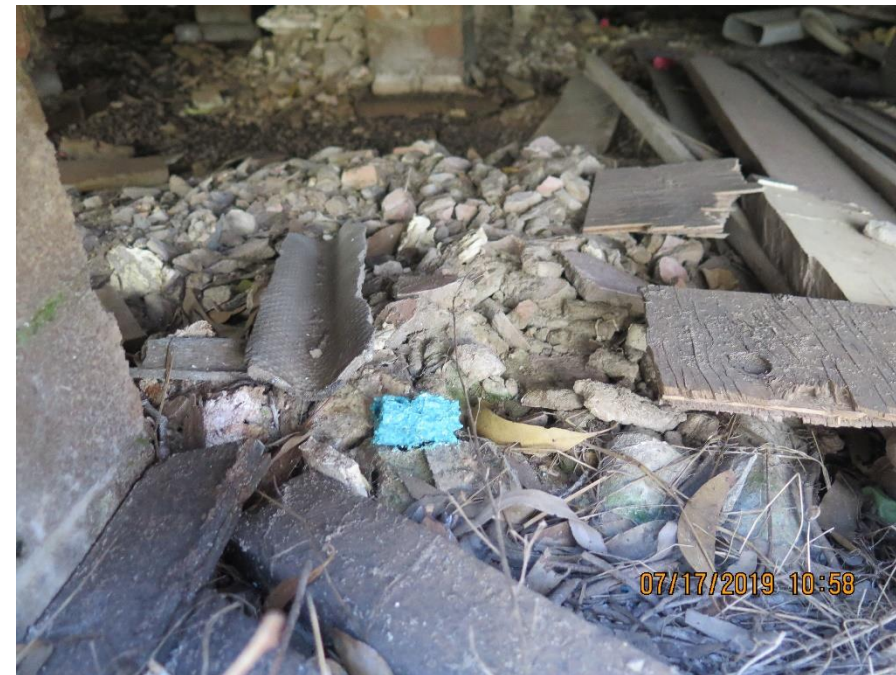
**Photo 2:**

| Sample Number | Primary Location | Specific Location | Material application | Material type | Quantity | Laboratory analysis result (asbestos type) | Friable / Non-Friable | Sealed / Unsealed / Enclosed | Condition | Activities that may lead to further damage/deterioration | Risk assessment | Control of risk/Comments | Photo number |
|---|---|---|---|---|---|---|---|---|---|---|---|---|---|
| <b>Same as 125514</b> | Exterior- Conference Hall | Under floor of conference hall - Throughout | Miscellaneous FCS debris | FCS & Super 6 Cement Sheeting | NQ | <b>Chrysotile Asbestos Detected</b> | Non-friable | Unsealed | High damage | Renovations or demolition | <b>Medium</b> | Remove ACM materials prior to any renovations or demolition. Licensed asbestos removalist required to remove ACM materials. | Photo 2 |

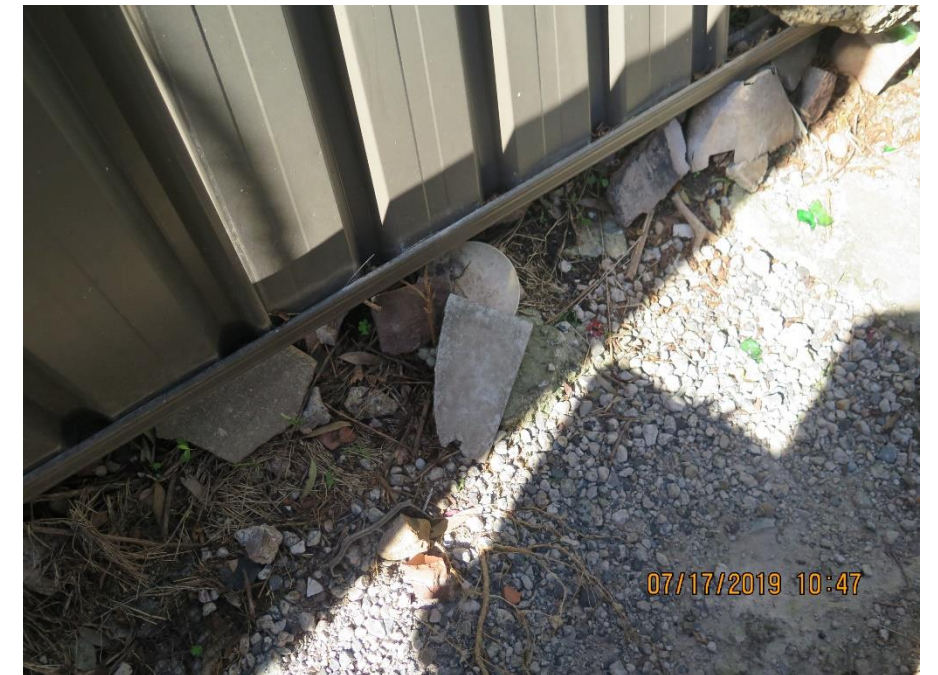
**Photo 3:**

| Sample Number | Primary Location | Specific Location | Material application | Material type | Quantity | Laboratory analysis result (asbestos type) | Friable / Non-Friable | Sealed / Unsealed / Enclosed | Condition | Activities that may lead to further damage/deterioration | Risk assessment | Control of risk/Comments | Photo number |
|---|---|---|---|---|---|---|---|---|---|---|---|---|---|
| <b>Same as 125514</b> | Exterior- Classroom & Conference Hall | Along fence line path | Miscellaneous FCS debris | FCS | NQ | <b>Chrysotile Asbestos Detected</b> | Non-friable | Unsealed | High damage | Renovations or demolition | <b>Medium</b> | Remove ACM materials prior to any renovations or demolition. Licensed asbestos removalist required to remove ACM materials. | Photo 3 |

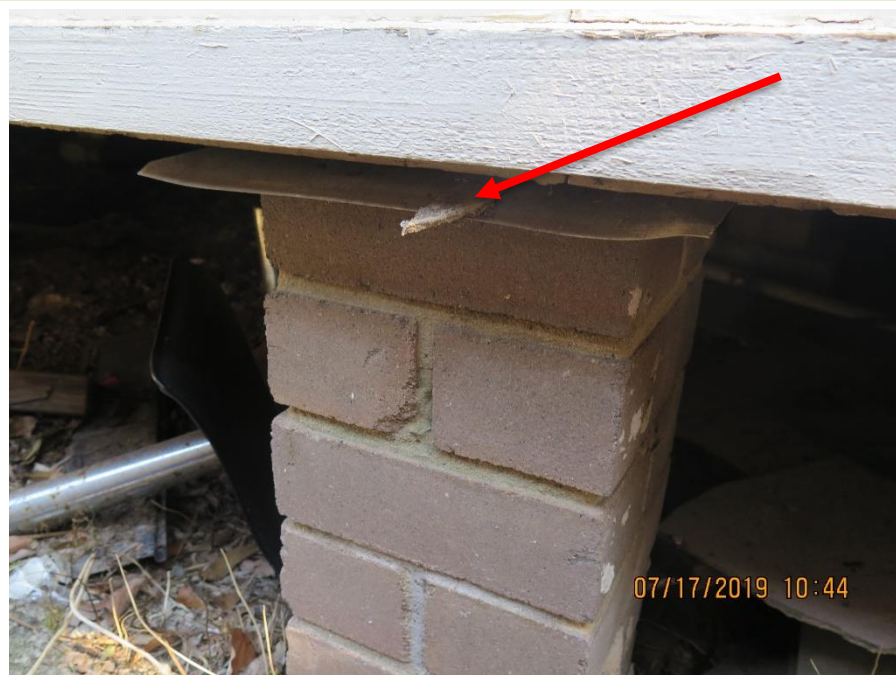
**Photo 4:**

| Sample Number | Primary Location | Specific Location | Material application | Material type | Quantity | Laboratory analysis result (asbestos type) | Friable / Non-Friable | Sealed / Unsealed / Enclosed | Condition | Activities that may lead to further damage/deterioration | Risk assessment | Control of risk/Comments | Photo number |
|---|---|---|---|---|---|---|---|---|---|---|---|---|---|
| <b>Same as 125514</b> | Exterior- Classroom & Conference Hall | Piers | Joist Packers levellers | FCS | NQ | <b>Chrysotile Asbestos Detected</b> | Non-friable | Unsealed | High damage | Renovations or demolition | <b>Medium</b> | Remove ACM materials prior to any renovations or demolition. Licensed asbestos removalist required to remove ACM materials. | Photo 4 |

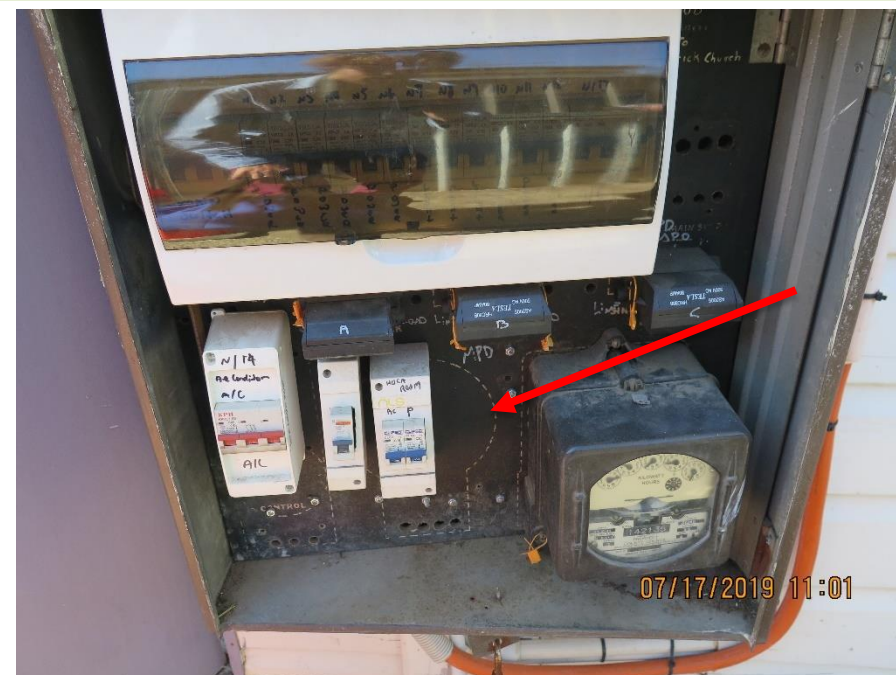
**Photo 5:**

| Sample Number | Primary Location | Specific Location | Material application | Material type | Quantity | Laboratory analysis result (asbestos type) | Friable / Non-Friable | Sealed / Unsealed / Enclosed | Condition | Activities that may lead to further damage/deterioration | Risk assessment | Control of risk/Comments | Photo number |
|---|---|---|---|---|---|---|---|---|---|---|---|---|---|
| Suspected | Exterior - Conference Hall | Conference Hall Western Area | Electrical Backing Board | Zelemite | < 1 m <sup>2</sup> | Assume Material(s) Contain Asbestos | Non-friable | Sealed | Good | Renovations or demolition | Low | Remove ACM materials prior to any renovations or demolition. Licensed asbestos removalist required to remove ACM materials. | Photo 5 |

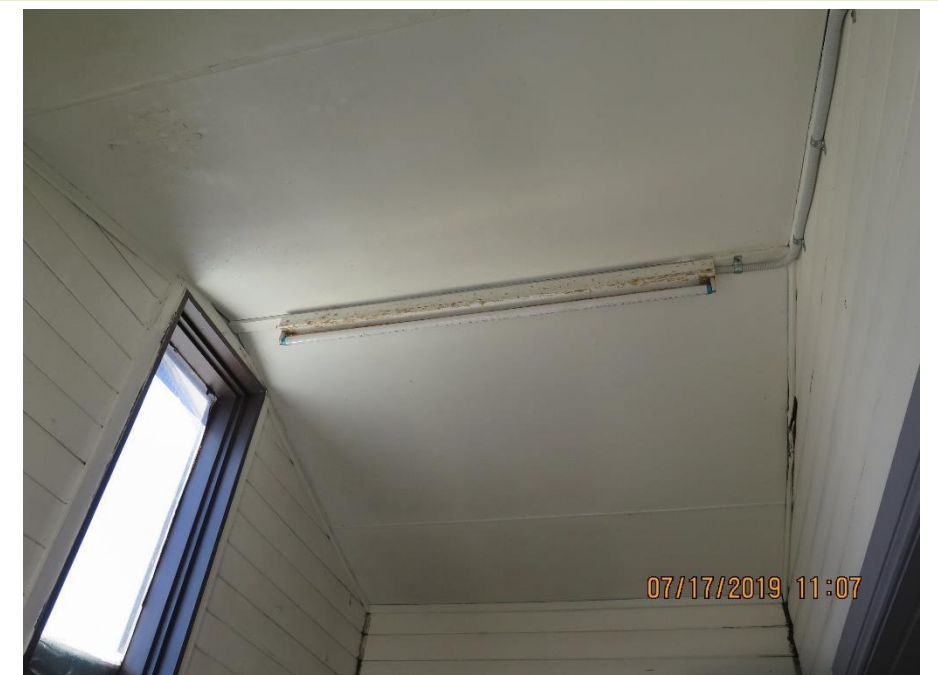
**Photo 6:**

| Sample Number | Primary Location | Specific Location | Material application | Material type | Quantity | Laboratory analysis result (asbestos type) | Friable / Non-Friable | Sealed / Unsealed / Enclosed | Condition | Activities that may lead to further damage/deterioration | Risk assessment | Control of risk/Comments | Photo number |
|---|---|---|---|---|---|---|---|---|---|---|---|---|---|
| Same as 125514 | Exterior- Classroom | Classroom - Entrance awning | Ceiling Lining | FCS | 5 m <sup>2</sup> | Chrysotile Asbestos Detected | Non-friable | Sealed | Good | Renovations or demolition | Low | Remove ACM materials prior to any renovations or demolition. Licensed asbestos removalist required to remove ACM materials. | Photo 6 |

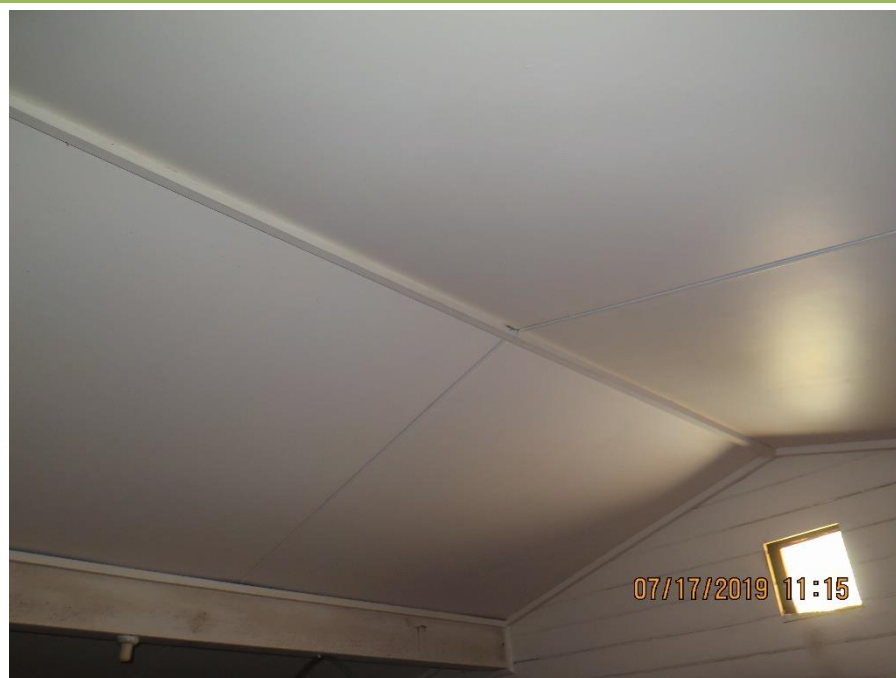
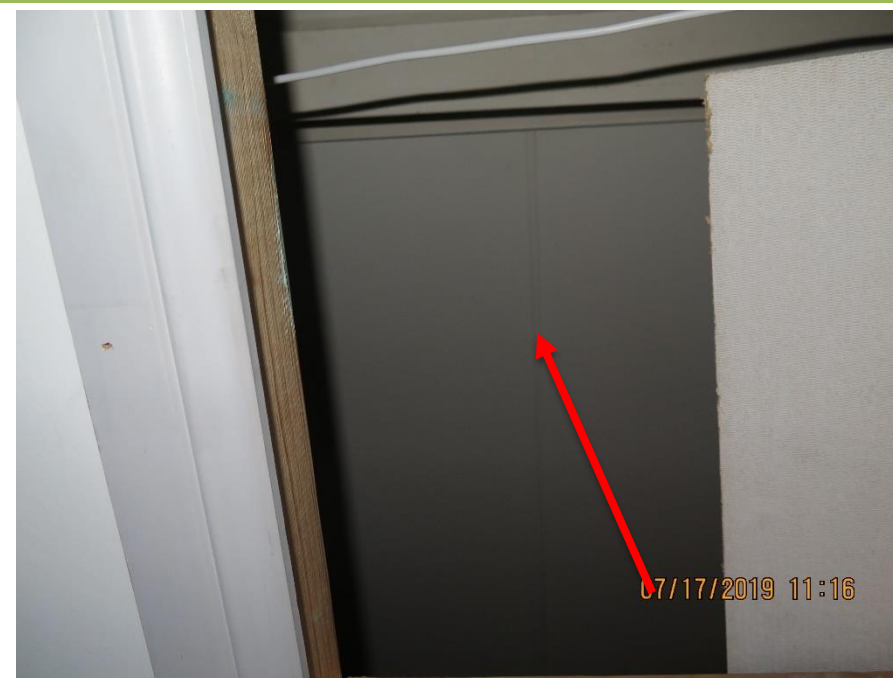
| Sample Number | Primary Location | Specific Location | Material application | Material type | Quantity | Laboratory analysis result (asbestos type) | Friable / Non-Friable | Sealed / Unsealed / Enclosed | Condition | Activities that may lead to further damage/deterioration | Risk assessment | Control of risk/Comments | Photo number |
|---|---|---|---|---|---|---|---|---|---|---|---|---|---|
| Same as 125514 | Interior- Classroom | Classroom - Ceiling Cavity - Above current ceiling - Throughout | Ceiling Lining | FCS | > 50 m <sup>2</sup> | Chrysotile Asbestos Detected | Non-friable | Sealed | Low damage | Renovations or demolition | Low | Remove ACM materials prior to any renovations or demolition. Licensed asbestos removalist required to remove ACM materials. | Photo 7-8 |

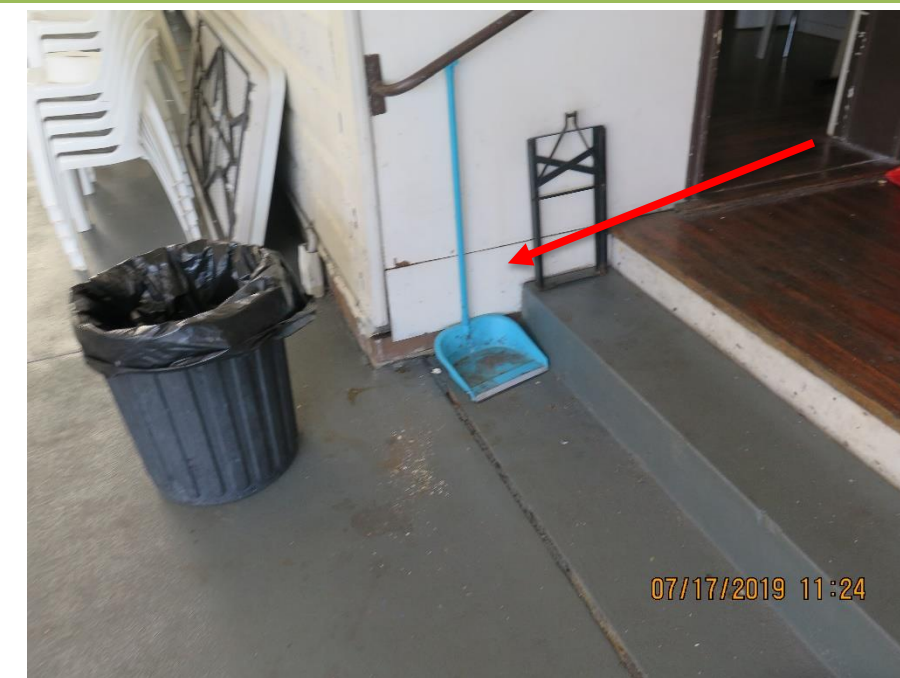
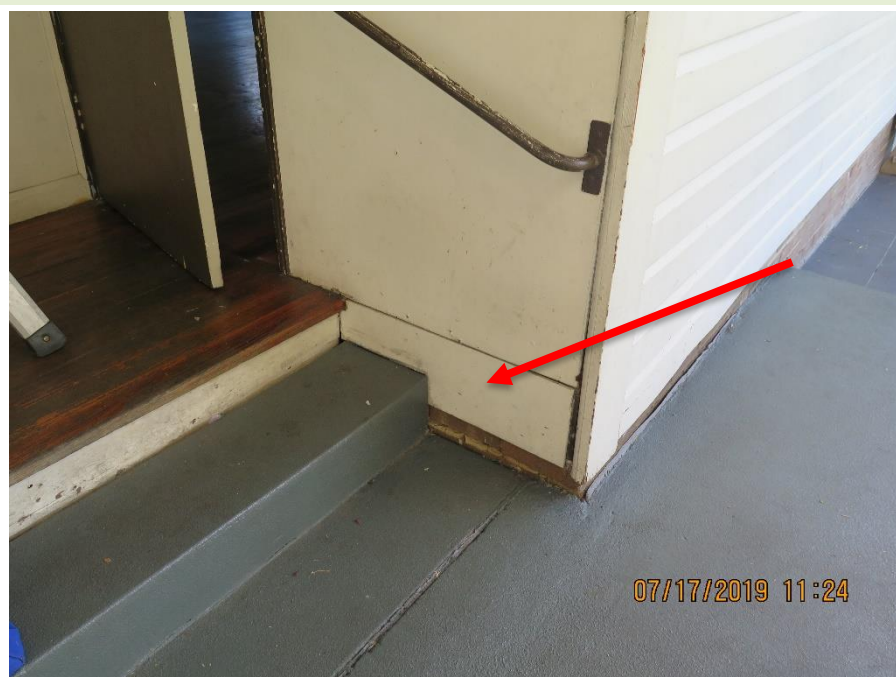
| Sample Number | Primary Location | Specific Location | Material application | Material type | Quantity | Laboratory analysis result (asbestos type) | Friable / Non-Friable | Sealed / Unsealed / Enclosed | Condition | Activities that may lead to further damage/deterioration | Risk assessment | Control of risk/Comments | Photo number |
|---|---|---|---|---|---|---|---|---|---|---|---|---|---|
| Same as 125514 | Exterior- Conference Hall | Conference Hall Stairs - Eastern Entry Area | Infill panels | FCS | 2x < 1 m <sup>2</sup> panels | Chrysotile Asbestos Detected | Non-friable | Sealed | Low damage | Renovations or demolition | Low | Remove ACM materials prior to any renovations or demolition. Licensed asbestos removalist required to remove ACM materials. | Photo 9-10 |

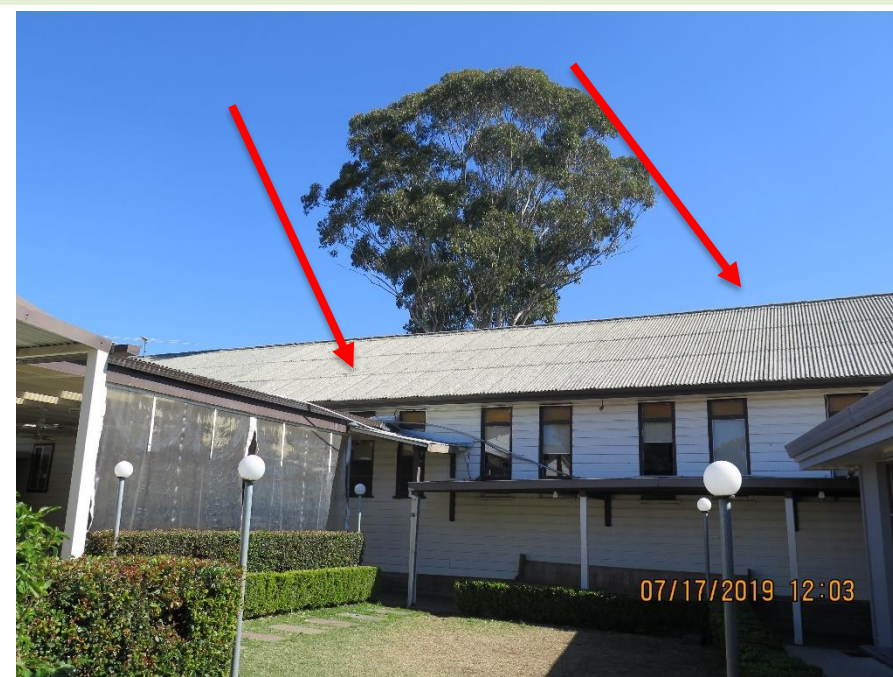
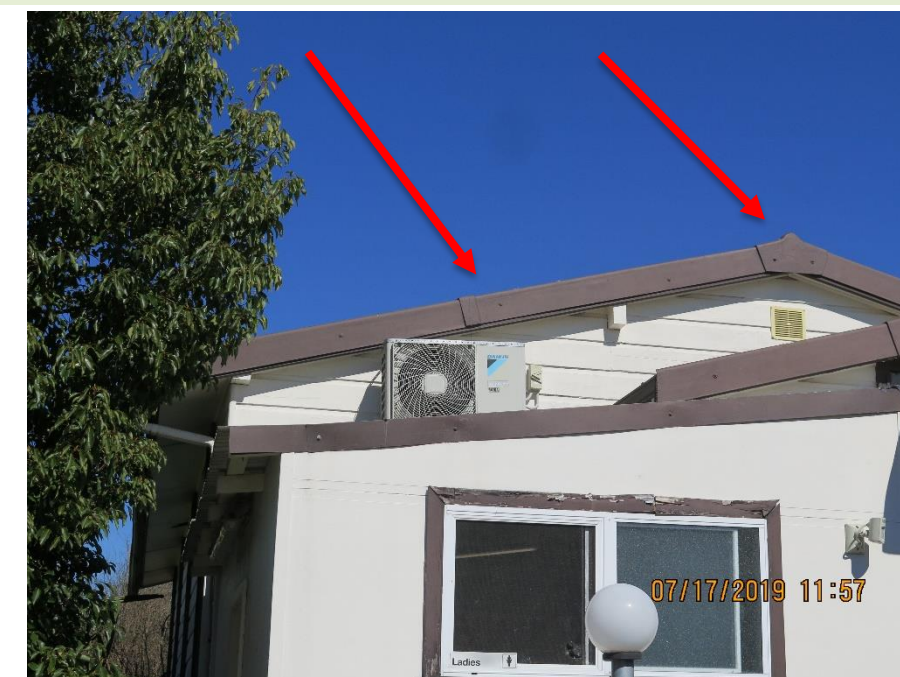
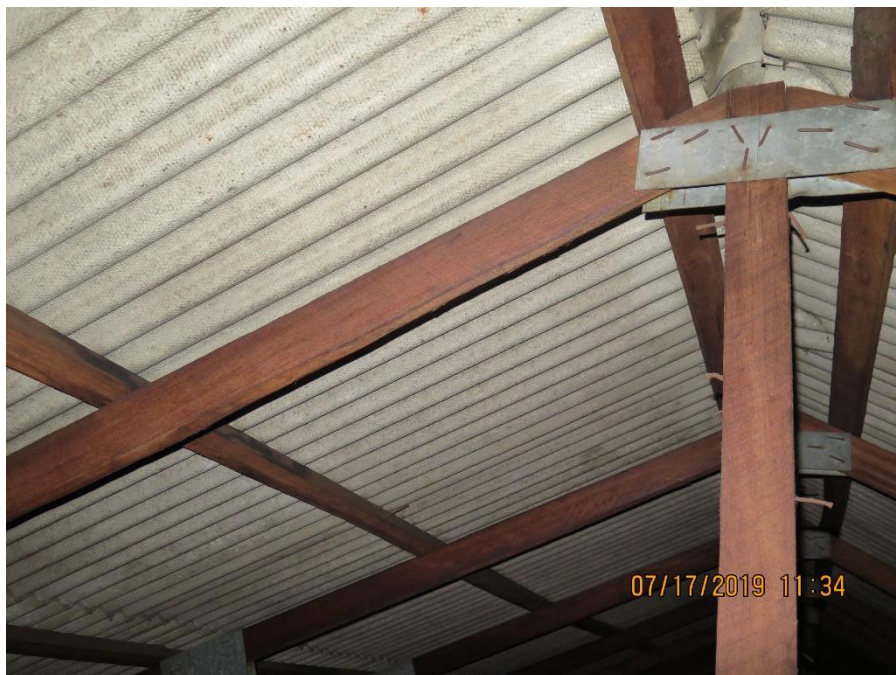
| Sample Number | Primary Location | Specific Location | Material application | Material type | Quantity | Laboratory analysis result (asbestos type) | Friable / Non-Friable | Sealed / Unsealed / Enclosed | Condition | Activities that may lead to further damage/deterioration | Risk assessment | Control of risk/Comments | Photo number |
|---|---|---|---|---|---|---|---|---|---|---|---|---|---|
| <b>125516</b> | Exterior- Classroom & Conference Hall | Classroom & Conference Hall - Roof throughout | Roof lining | Super 6 Cement Sheeting | > 100 m <sup>2</sup> | <b>Chrysotile &amp; Crocidolite Asbestos Detected</b> | Non-friable | Unsealed | Low damage | Renovations or demolition | <b>Low</b> | Remove ACM materials prior to any renovations or demolition. Licensed asbestos removalist required to remove ACM materials. | Photo 11-13 |
| <b>Same as 125516</b> | Exterior- Classroom & Conference Hall | Classroom & Conference Hall - Ridge line | Ridge capping | Compressed fibre cement | 50 linear meters | <b>Chrysotile &amp; Crocidolite Asbestos Detected</b> | Non-friable | Unsealed | Low damage | Renovations or demolition | <b>Low</b> | Remove ACM materials prior to any renovations or demolition. Licensed asbestos removalist required to remove ACM materials. | Photo 11-13 |

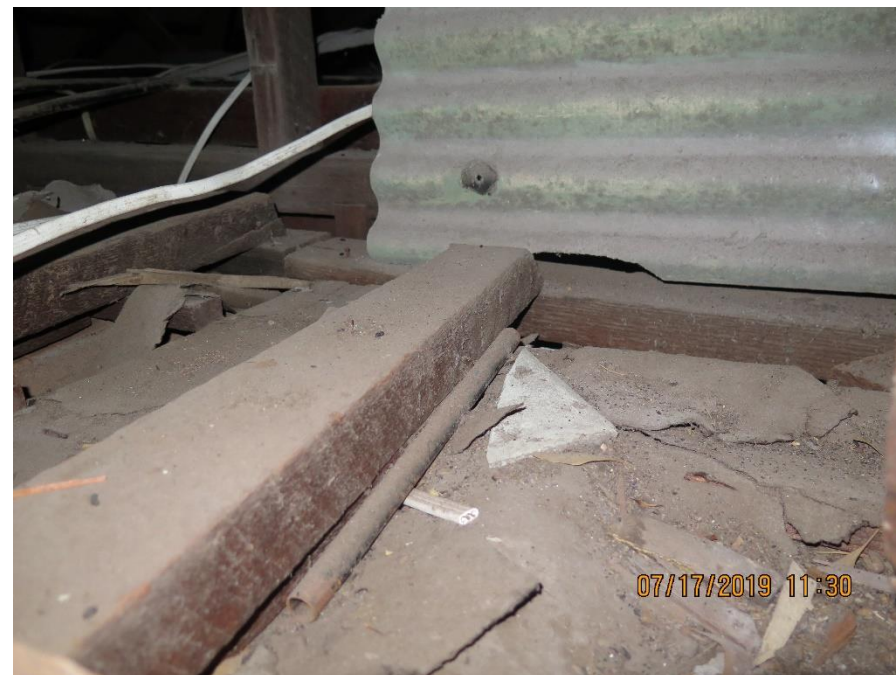
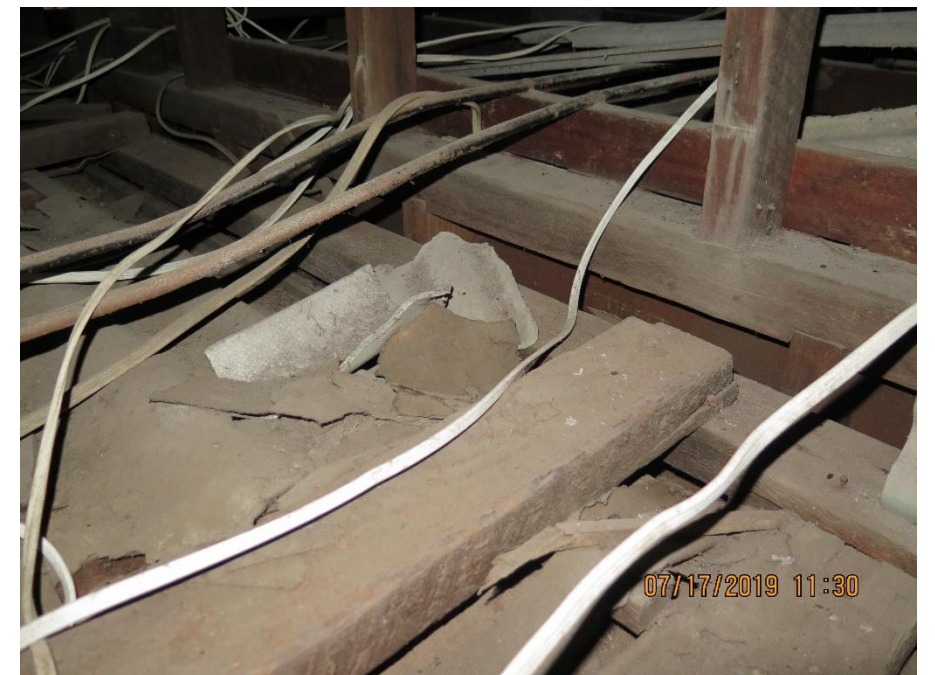
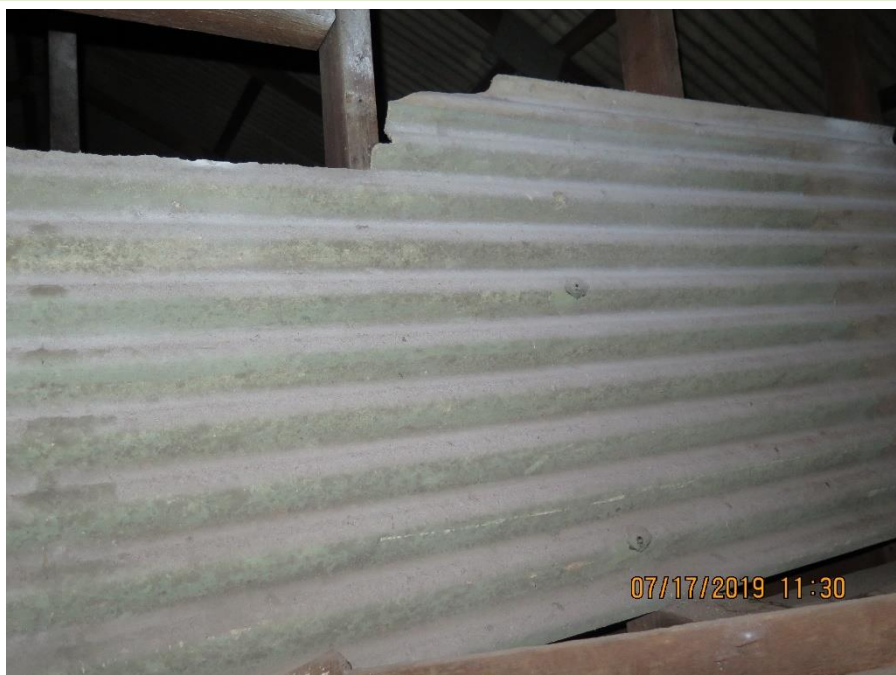
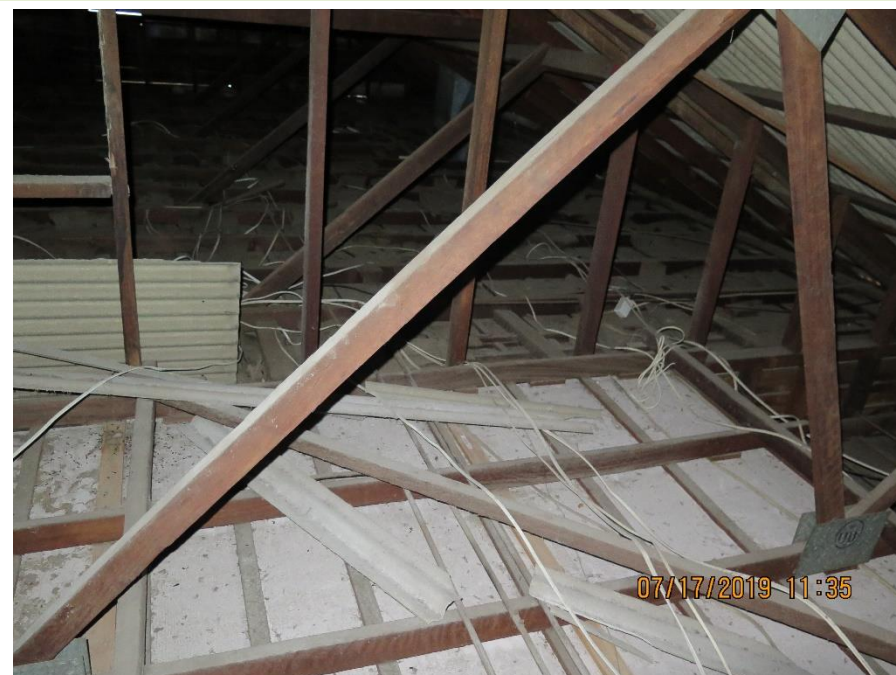
| Sample Number | Primary Location | Specific Location | Material application | Material type | Quantity | Laboratory analysis result (asbestos type) | Friable / Non-Friable | Sealed / Unsealed / Enclosed | Condition | Activities that may lead to further damage/deterioration | Risk assessment | Control of risk/Comments | Photo number |
|---|---|---|---|---|---|---|---|---|---|---|---|---|---|
| <b>Same as 125516</b> | Interior - Conference Hall | Ceiling/roof cavity - Throughout | Miscellaneous super 6 debris | Super 6 Cement Sheeting | NQ | <b>Chrysotile &amp; Crocidolite Asbestos Detected</b> | Non-friable | Unsealed | High damage | Renovations or demolition | <b>Medium</b> | Remove ACM materials prior to any renovations or demolition. Licensed asbestos removalist required to remove ACM materials. | Photo 14-17 |

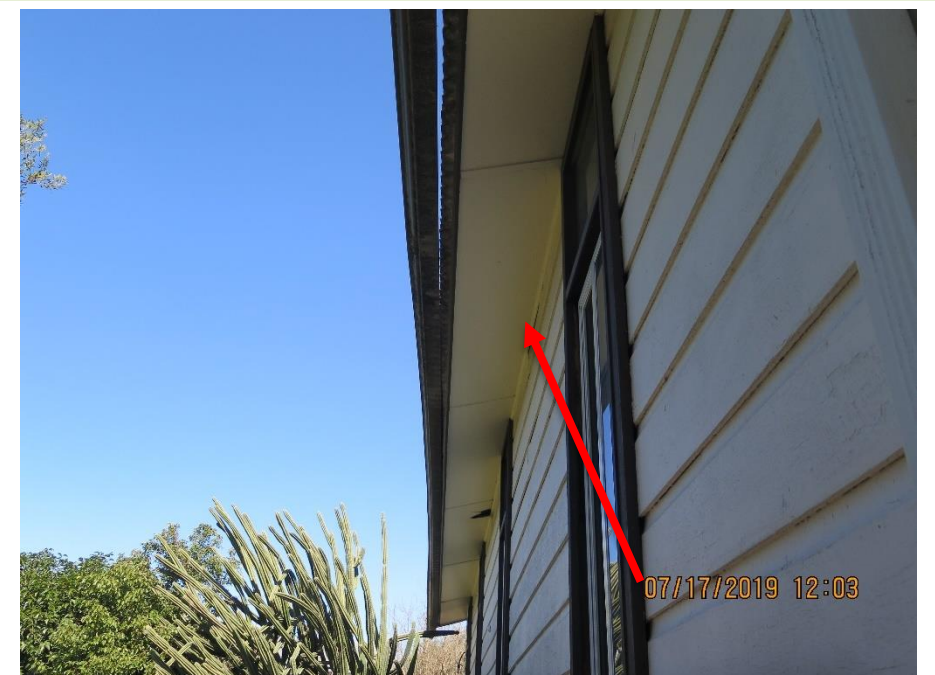
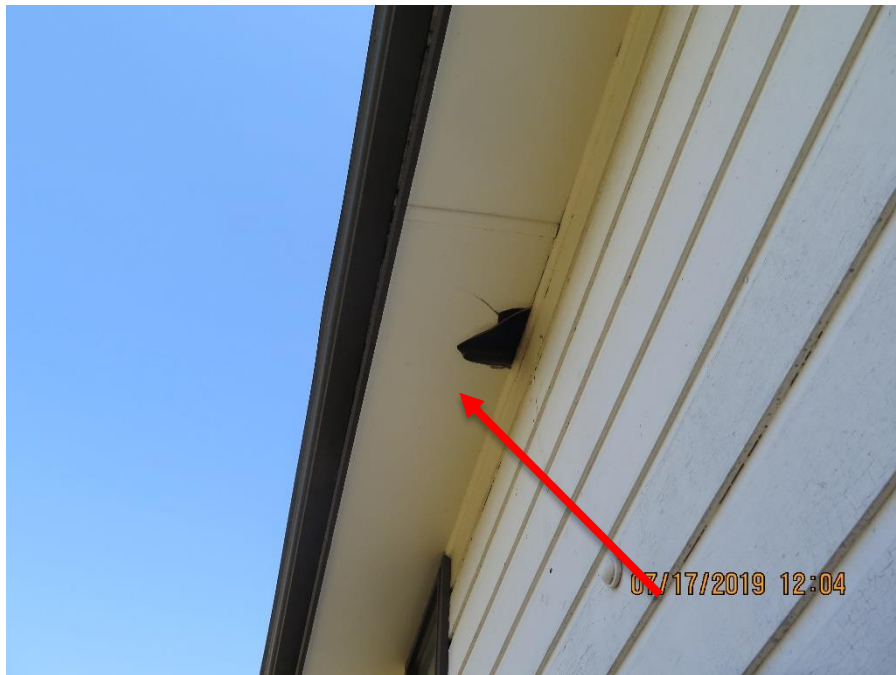
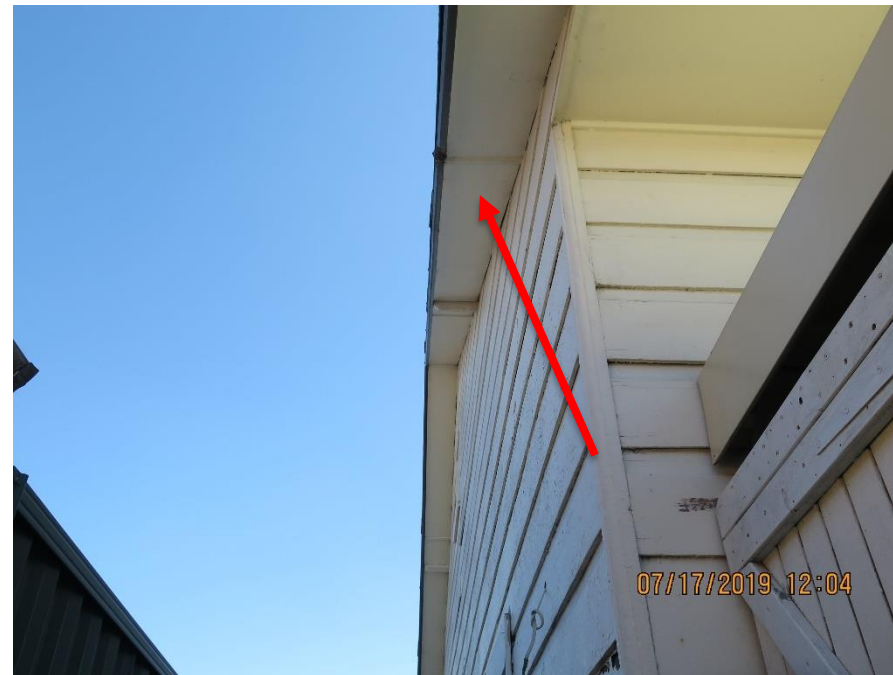
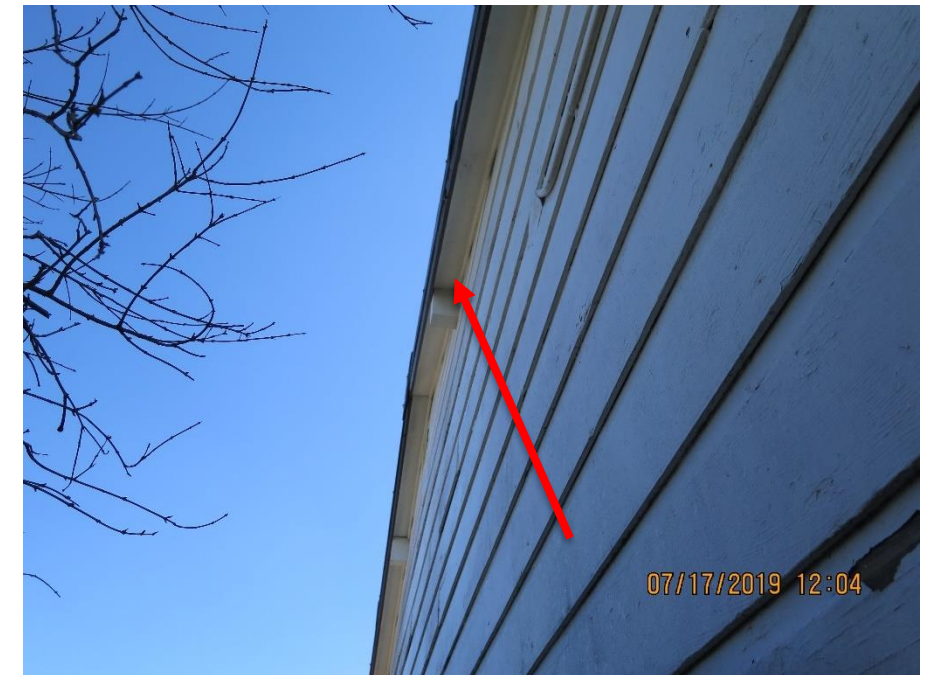
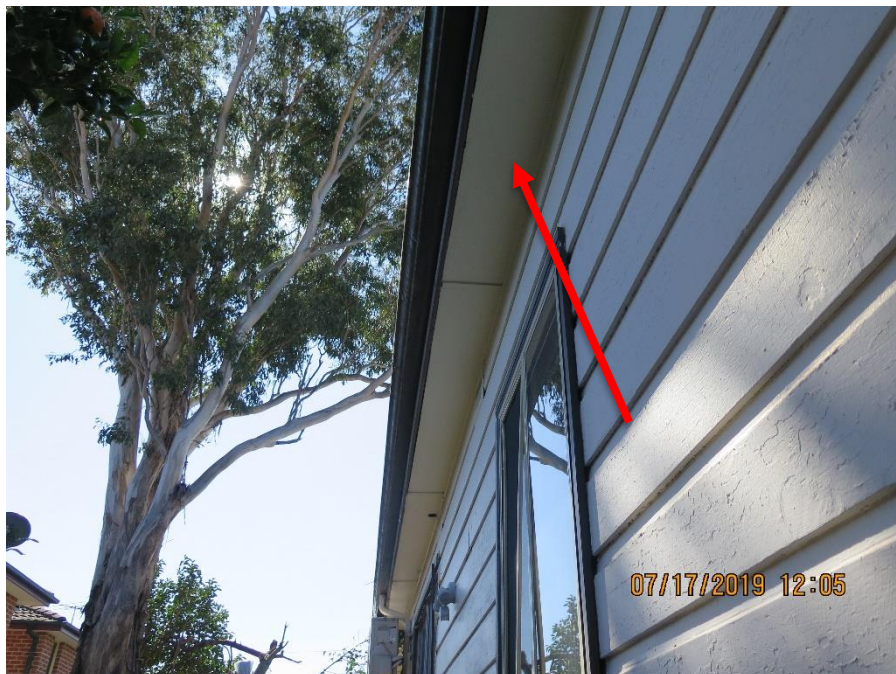
| Sample Number | Primary Location | Specific Location | Material application | Material type | Quantity | Laboratory analysis result (asbestos type) | Friable / Non-Friable | Sealed / Unsealed / Enclosed | Condition | Activities that may lead to further damage/deterioration | Risk assessment | Control of risk/Comments | Photo number |
|---|---|---|---|---|---|---|---|---|---|---|---|---|---|
| <b>Same as 125514</b> | Exterior- Classroom & Conference Hall | Classroom & Conference Hall | Eaves lining | FCS | 50 m <sup>2</sup> | <b>Chrysotile Asbestos Detected</b> | Non-friable | Sealed | Low damage | Renovations or demolition | <b>Low</b> | Remove ACM materials prior to any renovations or demolition. Licensed asbestos removalist required to remove ACM materials. | Photo 18-22 |

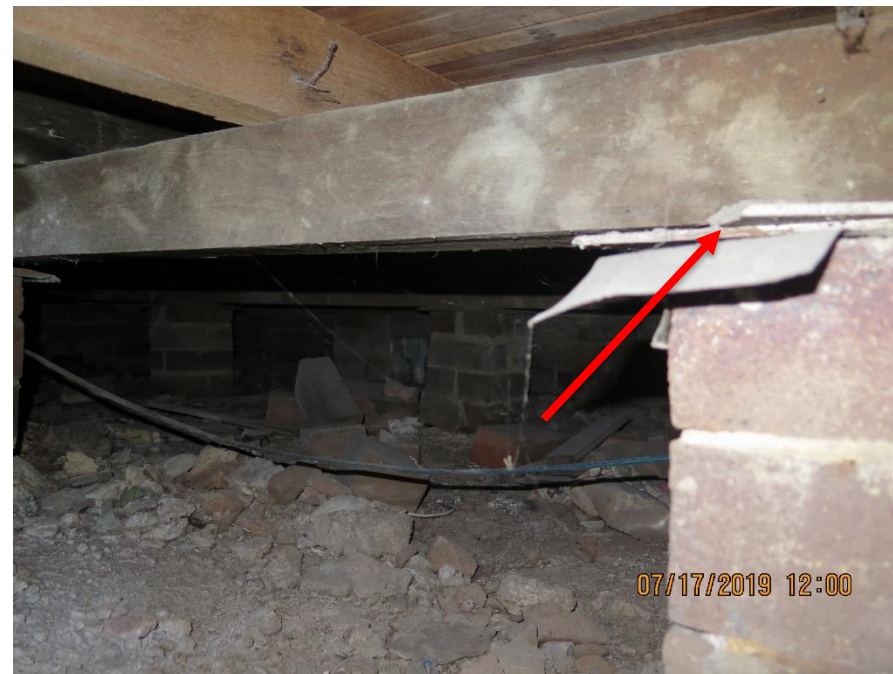
**Photo 23:**

| Sample Number | Primary Location | Specific Location | Material application | Material type | Quantity | Laboratory analysis result (asbestos type) | Friable / Non-Friable | Sealed / Unsealed / Enclosed | Condition | Activities that may lead to further damage/deterioration | Risk assessment | Control of risk/Comments | Photo number |
|---|---|---|---|---|---|---|---|---|---|---|---|---|---|
| <b>Same as 125514</b> | Exterior- Mosque | Piers | Joist Packers levellers | FCS | NQ | <b>Chrysotile Asbestos Detected</b> | Non-friable | Unsealed | High damage | Renovations or demolition | <b>Medium</b> | Remove ACM materials prior to any renovations or demolition. Licensed asbestos removalist required to remove ACM materials. | Photo 23 |

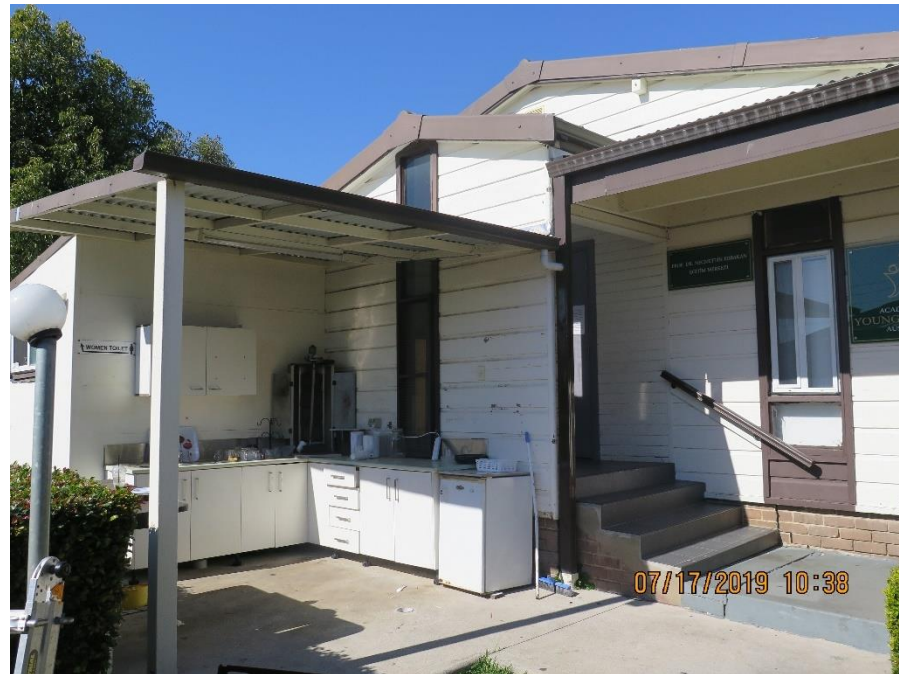
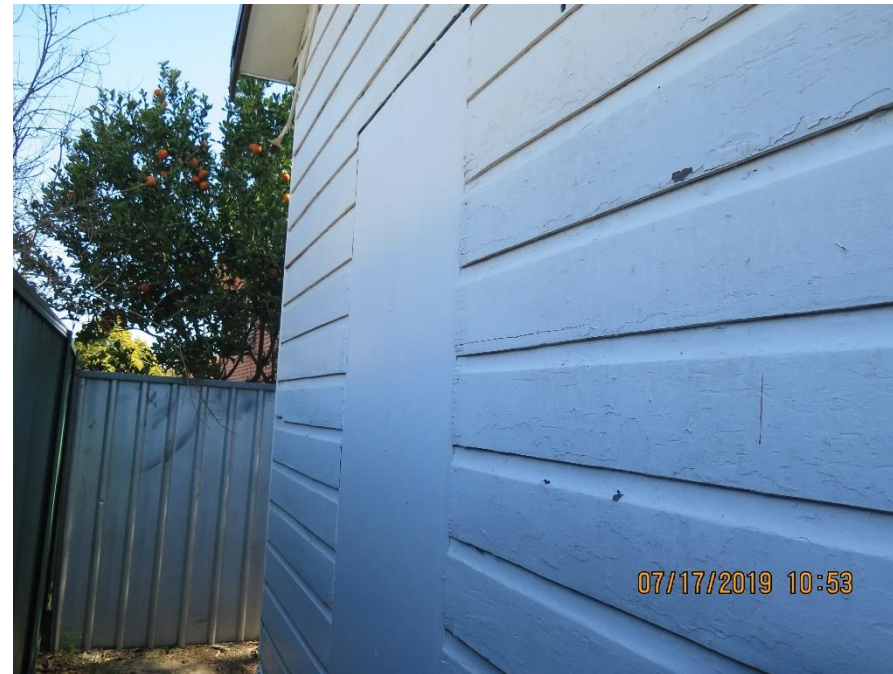
| Sample Number | Primary Location | Specific Location | Material Application | Colour | Quantity | Unit | Lead content analysis (% w/w) | Above action limit of 0.1% w/w | Condition | Activities that may lead to worker exposure during demo and renovations | Control of risk | Comments | Photo Number |
|---|---|---|---|---|---|---|---|---|---|---|---|---|---|
| <b>125518</b> | Exterior - Classroom & Conference Hall | Walls & ceilings - Throughout | Walls & ceilings lining | Cream & white | > 100 | m <sup>2</sup> | <b>0.22</b> | <b>Yes</b> | Low Damage | Renovations or demolition | Refer section 3: Guide to hazardous paint management Part 2: Lead paint in residential, public and commercial buildings, AS/NZS 4361.2:2017 | Classified as 'lead paint' according to AS/NZS 4361.2:2017 | Photo 24-25 |

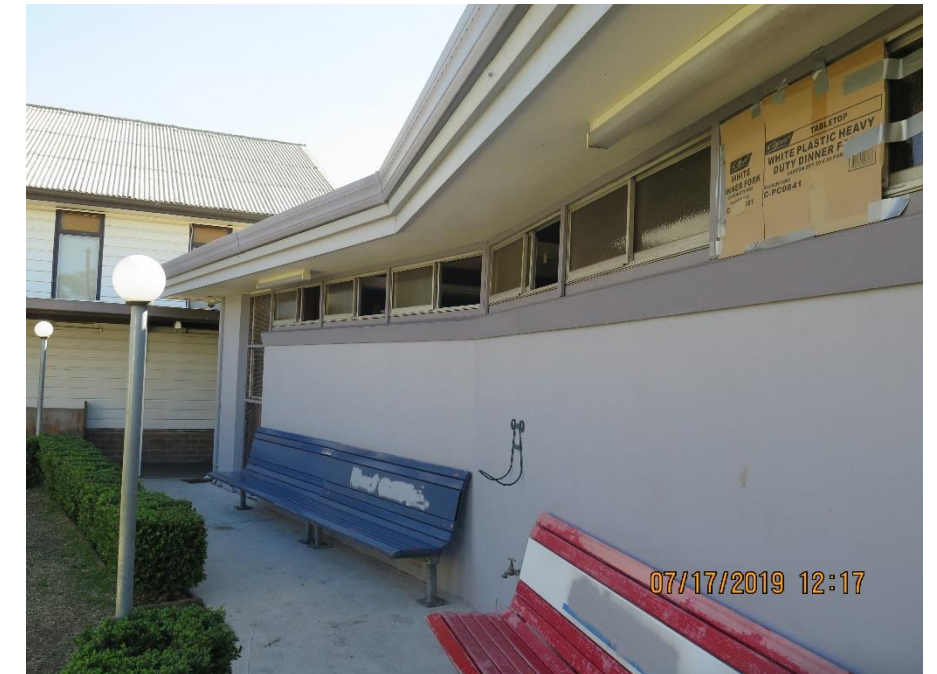
**Photo 26:**

| Sample Number | Primary Location | Specific Location | Material Application | Colour | Quantity | Unit | Lead content analysis (% w/w) | Above action limit of 0.1% w/w | Condition | Activities that may lead to worker exposure during demo and renovations | Control of risk | Comments | Photo Number |
|---|---|---|---|---|---|---|---|---|---|---|---|---|---|
| <b>125520</b> | Exterior- Mosque | Walls lining outside of Mosque | Walls lining | Blue & grey | > 100 | m <sup>2</sup> | <b>1.8</b> | <b>Yes</b> | Good | Renovations or demolition | Refer section 3: Guide to hazardous paint management Part 2: Lead paint in residential, public and commercial buildings, AS/NZS 4361.2:2017 | Classified as 'lead paint' according to AS/NZS 4361.2:2017 | Photo 26 |

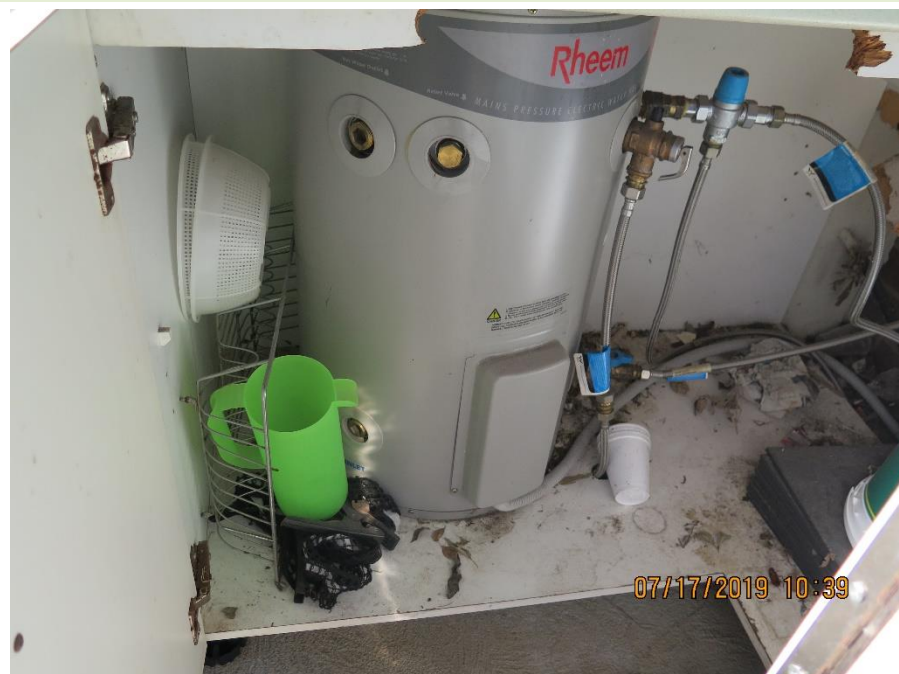
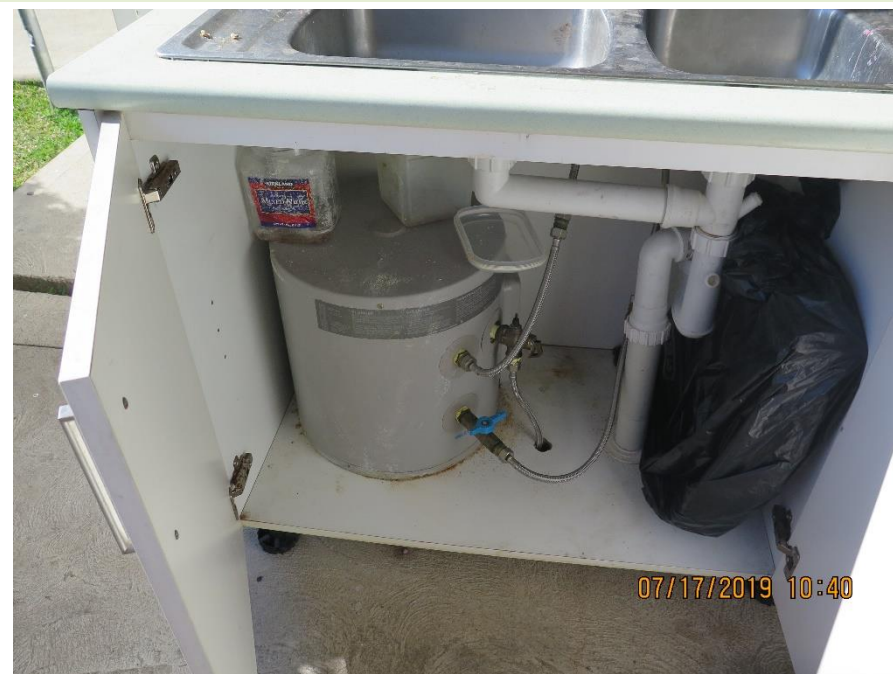
| Hazard type | Primary Location | Specific Location | Material application | Quantity | Control of risk | Photo Number |
|---|---|---|---|---|---|---|
| <b>SMF</b> | Exterior - Classroom | Kitchenette - Under bench top | Hot Water Heater | 2 Units | Remove during general demolition with suitable controls to prevent exposure to dust | Photo 27 |
| <b>SMF</b> | Interior - Conference hall | Kitchen - Under bench top | Hot Water Heater | 2 Units | Remove during general demolition with suitable controls to prevent exposure to dust | Photo 27-28 |
