**Client:** ICMG Sydney Inc  
**Project Reference:** N1908018  
**Date:** August 21, 2019  
**Version:** 1

## Hazardous Materials Audit Report

62-64 Mountford Ave, Guilford NSW 2161

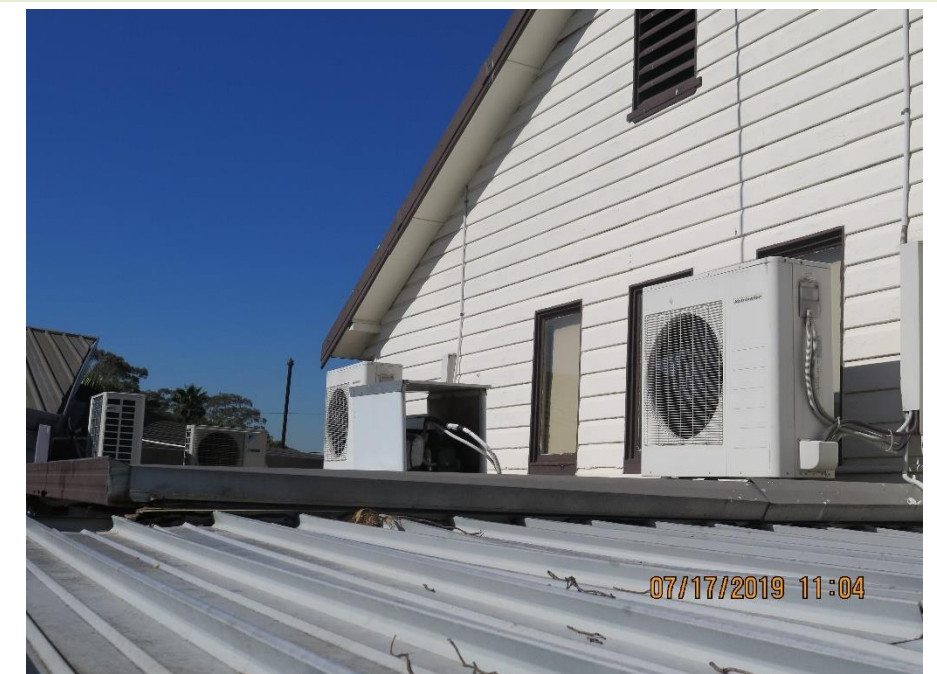
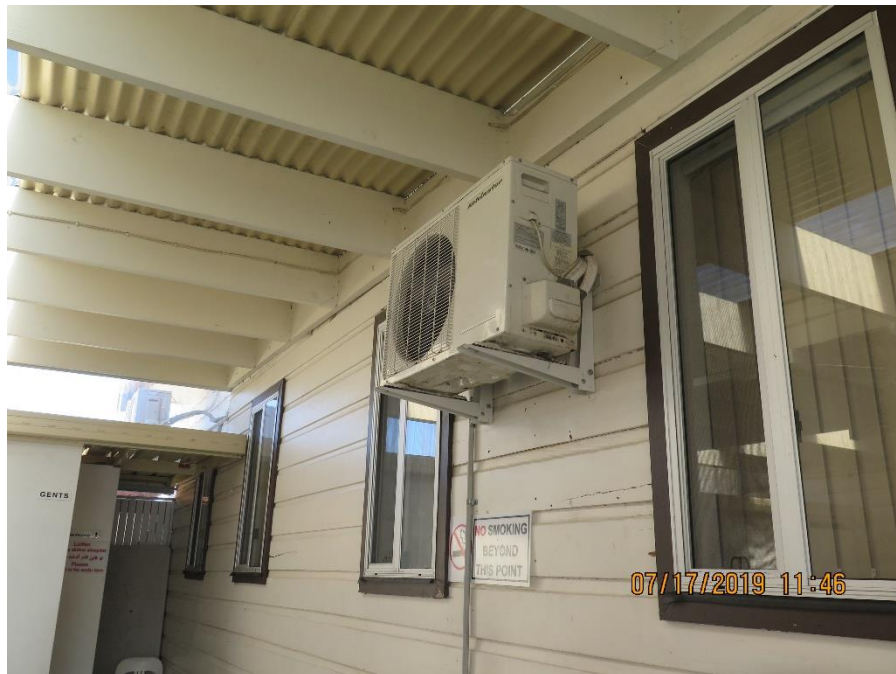
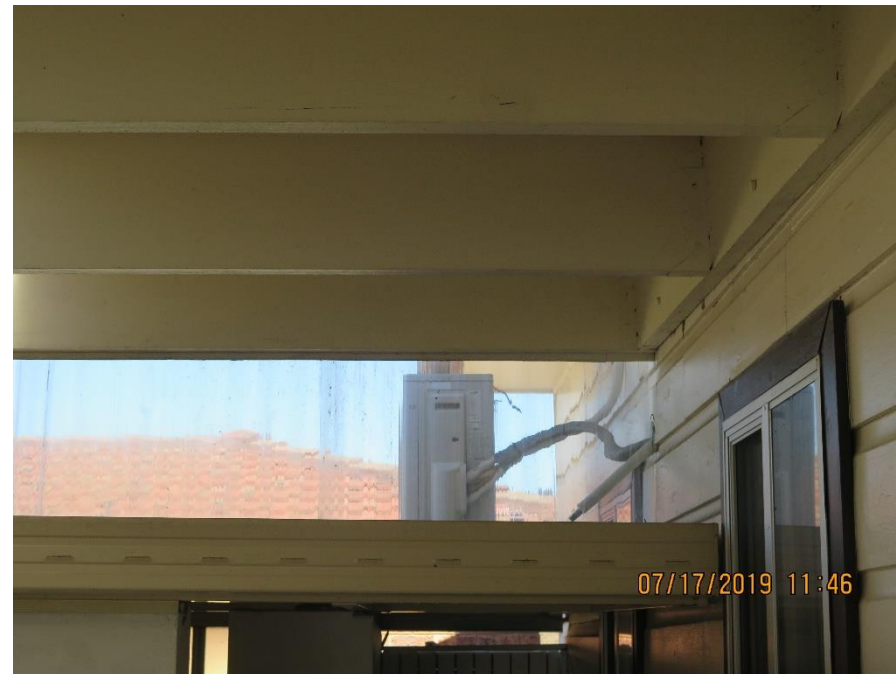
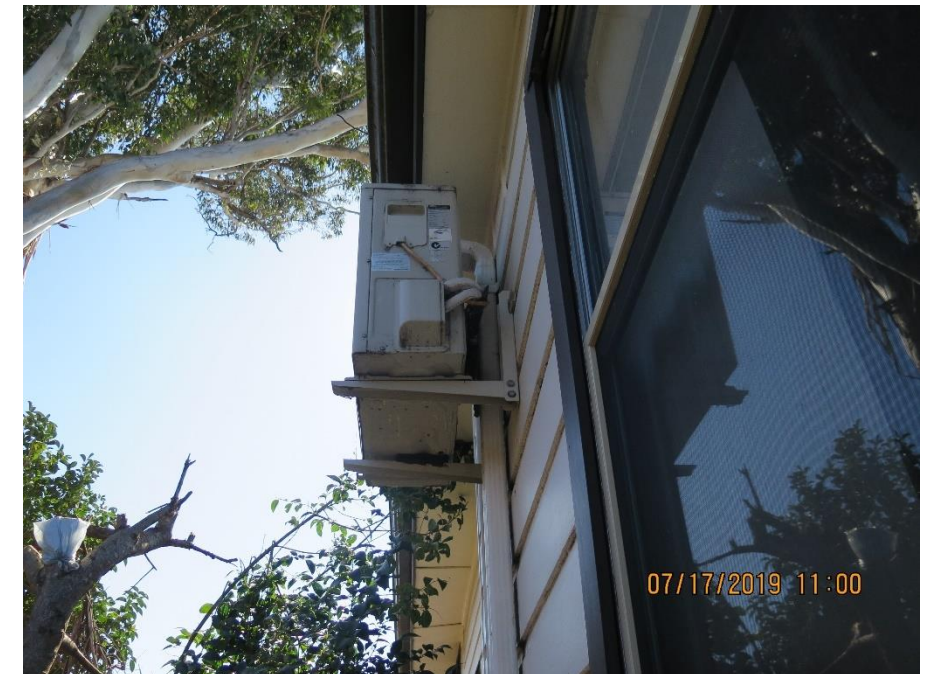
| Hazard type | Primary Location | Specific Location | Material application | Quantity | Control of risk | Photo Number |
|---|---|---|---|---|---|---|
| <b>ODS</b> | Exterior - Conference Hall | Conference Hall Western Area | AC Unit | 6 Units | Qualified & licensed contractor to de-gas all refrigerant units for any works. All de-commissioned units should have gas removed and stored appropriately to prevent gas loss. | Photo 29-32 |

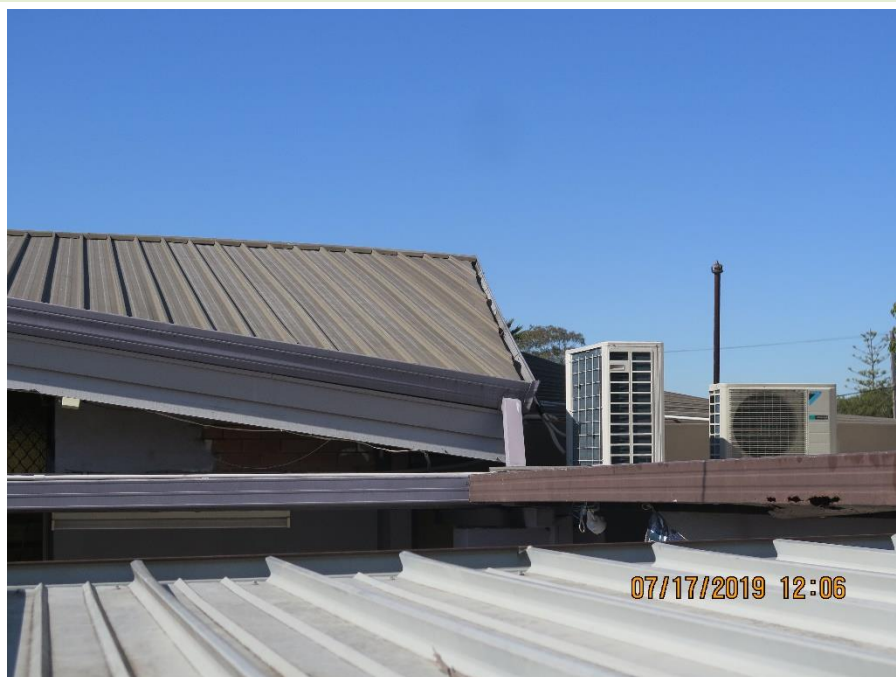
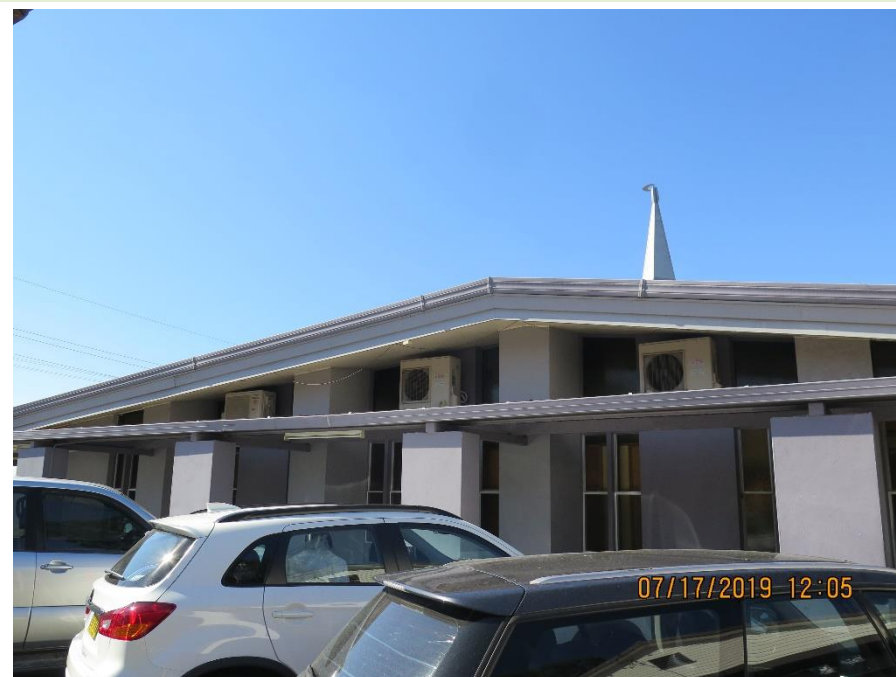
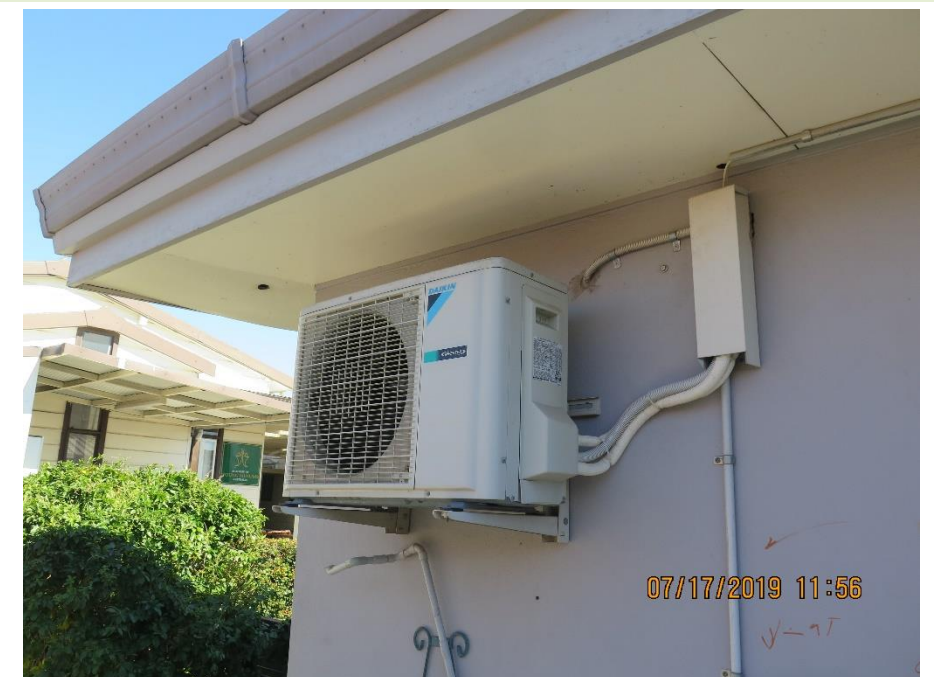
| Hazard type | Primary Location | Specific Location | Material application | Quantity | Control of risk | Photo Number |
|---|---|---|---|---|---|---|
| <b>ODS</b> | Exterior- Mosque | Outside of Mosque | AC Unit | 6 Units | Qualified & licensed contractor to de-gas all refrigerant units for any works. All de-commissioned units should have gas removed and stored appropriately to prevent gas loss. | Photo 33-35 |

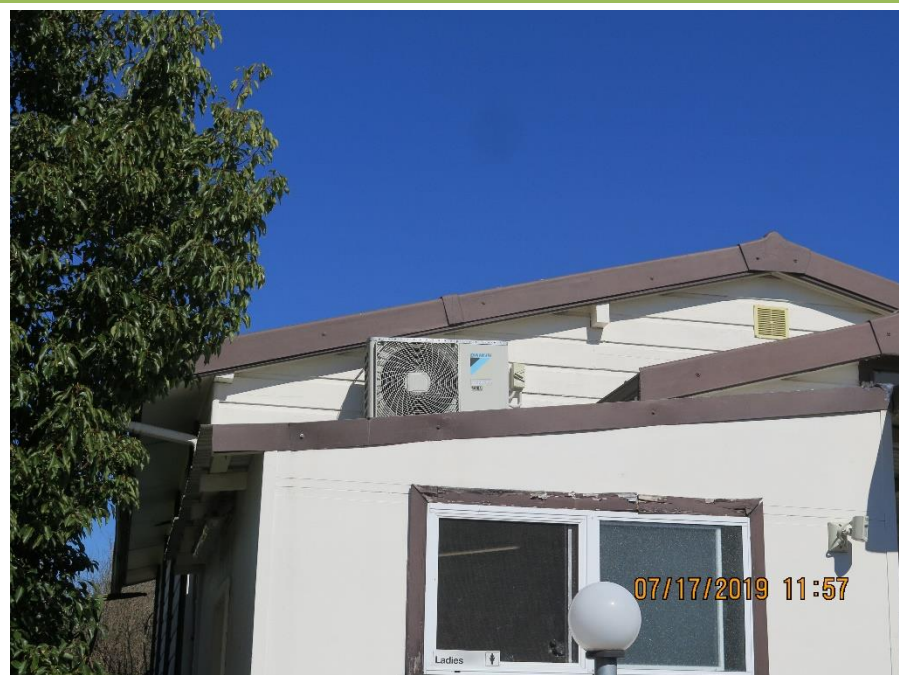
**Photo 36:**

| Hazard type | Primary Location | Specific Location | Material application | Quantity | Control of risk | Photo Number |
|---|---|---|---|---|---|---|
| <b>ODS</b> | Exterior- Classroom | Outside of Classroom | AC Unit | 1 Unit | Qualified & licensed contractor to de-gas all refrigerant units for any works. All de-commissioned units should have gas removed and stored appropriately to prevent gas loss. | Photo 36 |

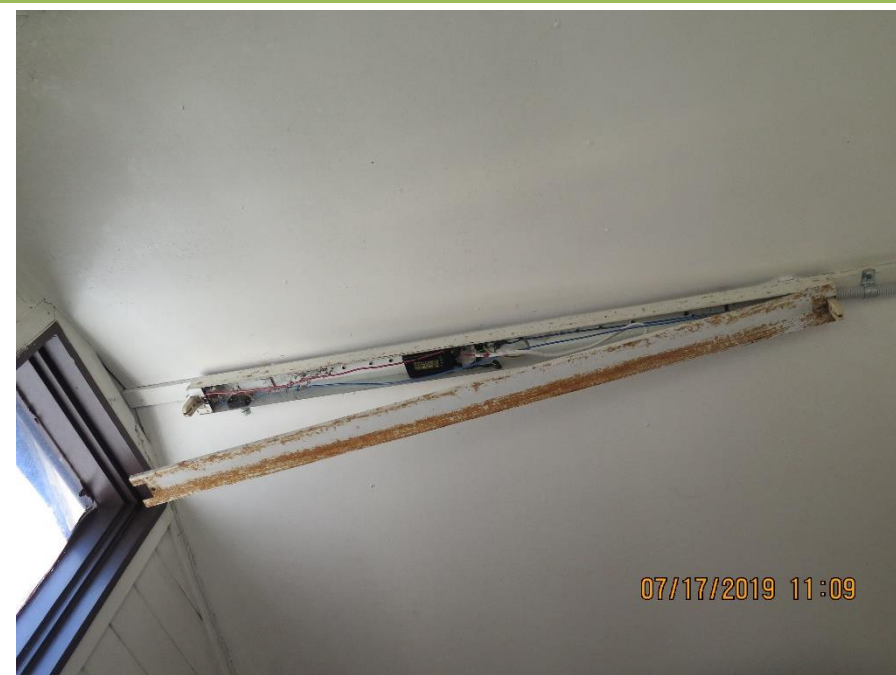
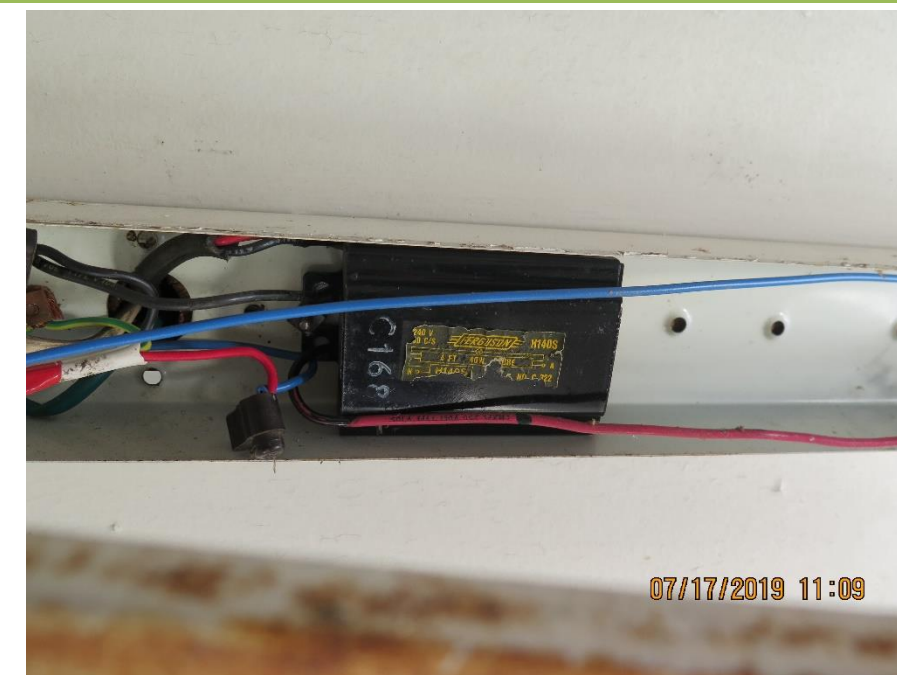
| Hazard type | Primary Location | Specific Location | Material application | Quantity | Control of risk | Photo Number |
|---|---|---|---|---|---|---|
| <b>PCB</b> | Exterior- Classroom | Entrance awning - Ceiling light | Light capacitor | 1 Capacitor | Remove prior to any renovations or demolition. Dispose of at a waste facility that can lawfully receive this waste. | Photo 37-38 |

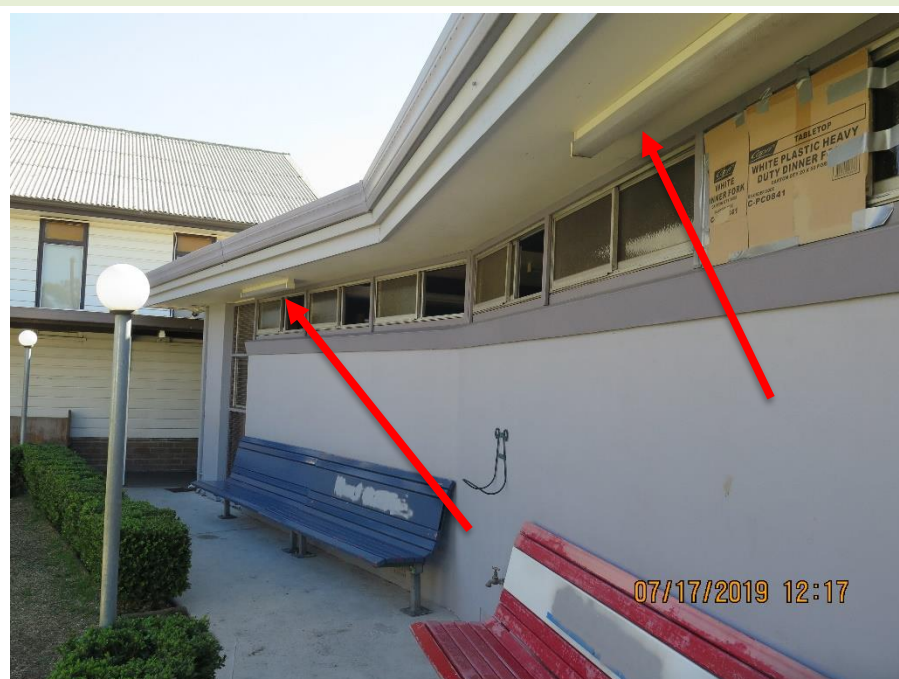
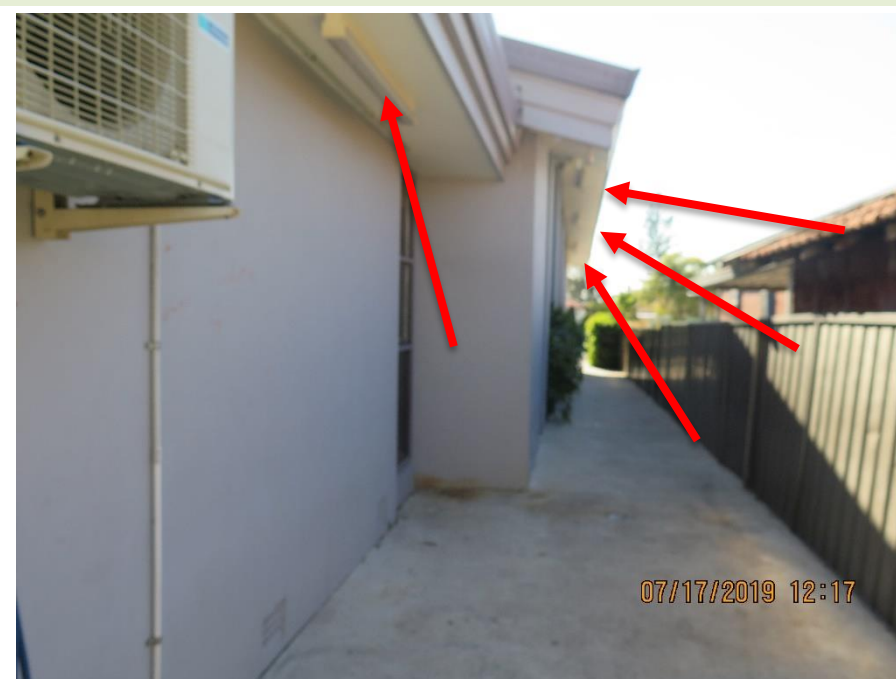
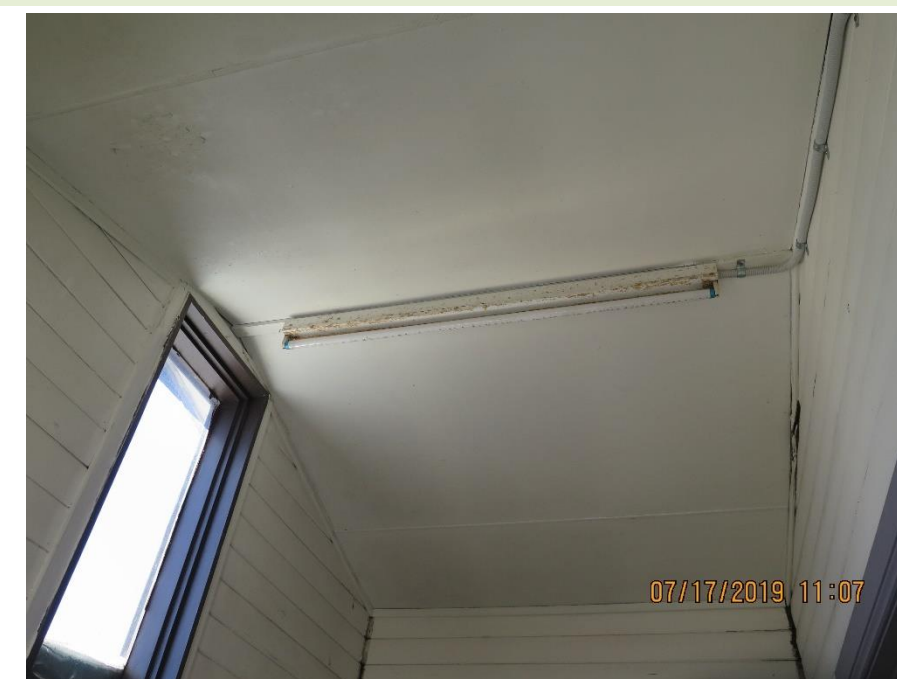
| Hazard type | Primary Location | Specific Location | Material application | Quantity | Control of risk | Photo Number |
|---|---|---|---|---|---|---|
| <b>Mercury</b> | Exterior & Interior - Classroom, conference hall & mosque | Ceilings & walls | Fluorescent light tubes | Approx. 10 Tubes | All fluorescent light tubes contain mercury, avoid breaking tubes | Photo 39-401 |
