# GRAN CENTRAL, GRANVILLE

## GOOD ST, COWPER ST AND PARRAMATTA RD

### HAZARDOUS BUILDING MATERIALS REPORT

OCTOBER 2019

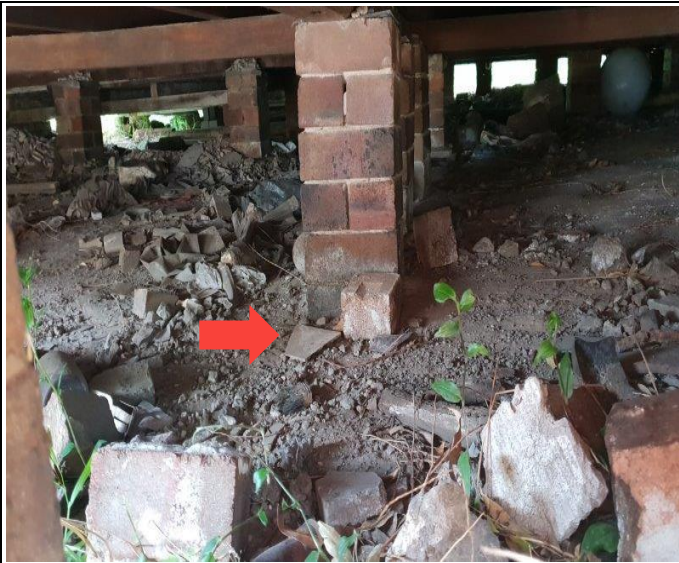
| MATERIAL IDENTIFICATION | | | | | | | | | | | RISK ASSESSMENT | | | | RISK MANAGEMENT | CORRECTIVE ACTIONS | |
|---|---|---|---|---|---|---|---|---|---|---|---|---|---|---|---|---|---|
| 1 | 59 Cowper Street | Ground | Old Dwelling - Exterior | Western aspect to subfloor | Fibre cement sheeting | Packing material | WSP-104427 | A, CH | <1 m <sup>2</sup> | 1 | NF | 3 | D | L | Maintain in current condition if to remain in-situ. Remove under controlled non-friable asbestos removal conditions prior to refurbishment or demolition works by a Class B (non-friable) licensed asbestos removal contractor. | | |

Photo 1: 59 Cowper Street, western aspect to subfloor, fibre cement material observed.

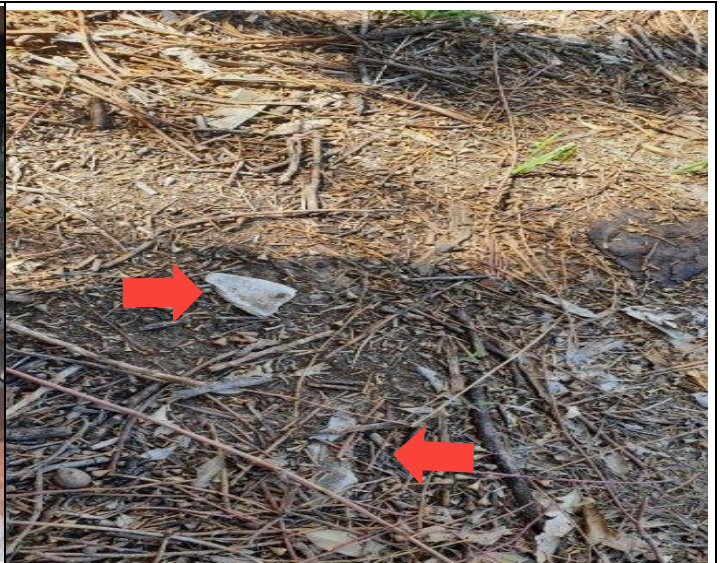
| MATERIAL IDENTIFICATION | | | | | | | | | | | RISK ASSESSMENT | | | | RISK MANAGEMENT | CORRECTIVE ACTIONS | |
|---|---|---|---|---|---|---|---|---|---|---|---|---|---|---|---|---|---|
| 2 | 59 Cowper Street | Ground | Old Dwelling - Exterior | North western aspect, Fibre cement sheet fragments scattered on ground surfaces | Fibre cement sheeting | Debris | Same as WSP-109335 | CH, OF | <1 m <sup>2</sup> | 2 | NF | 2 | C | M | Debris scattered to ground surfaces, likely to disturb if area occupied. Remove under controlled non-friable asbestos removal conditions by a Class B (non-friable) licensed asbestos removal contractor when reasonably practicable | | |

Photo 2: 59 Cowper Street, north western aspect, asbestos-containing fibre cement fragments identified on ground surface.

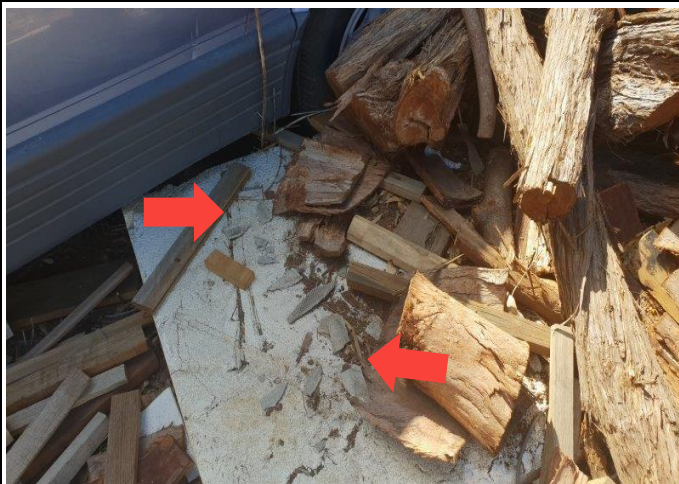
| MATERIAL IDENTIFICATION | | | | | | | | | | | RISK ASSESSMENT | | | | RISK MANAGEMENT | CORRECTIVE ACTIONS | |
|---|---|---|---|---|---|---|---|---|---|---|---|---|---|---|---|---|---|
| 3 | 61 Cowper Street | Ground | Vacant block, central aspect to yard | Fibre cement sheeting scattered on ground surfaces | Fibre cement sheeting | Debris | WSP-109334 | CH | <1 m <sup>2</sup> | 3 | NF | 2 | C | M | Debris scattered to ground surfaces, likely to disturb if area occupied. Remove under controlled non-friable asbestos removal conditions by a Class B (non-friable) licensed asbestos removal contractor when reasonably practicable | | |

Photo 3: 61 Cowper Street, Vacant block, central aspect to yard, asbestos-containing fibre cement fragments identified on ground surface.

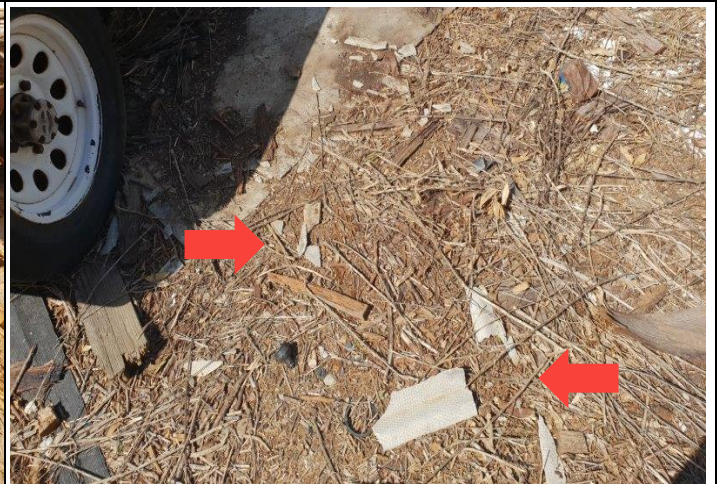
| MATERIAL IDENTIFICATION | | | | | | | | | | | RISK ASSESSMENT | | | | RISK MANAGEMENT | CORRECTIVE ACTIONS | |
|---|---|---|---|---|---|---|---|---|---|---|---|---|---|---|---|---|---|
| 4 | 61 Cowper Street | Ground | Vacant block, northern aspect to yard | Fibre cement sheeting scattered on ground surfaces | Fibre cement sheeting | Debris | WSP-109335 | CH, OF | <3 m <sup>2</sup> | 4 | NF | 2 | C | M | Debris scattered to ground surfaces, likely to disturb if area occupied. Remove under controlled non-friable asbestos removal conditions by a Class B (non-friable) licensed asbestos removal contractor when reasonably practicable | | |

Photo 4: 61 Cowper Street, vacant block, northern aspect to yard, asbestos-containing fibre cement fragments identified on ground surface.

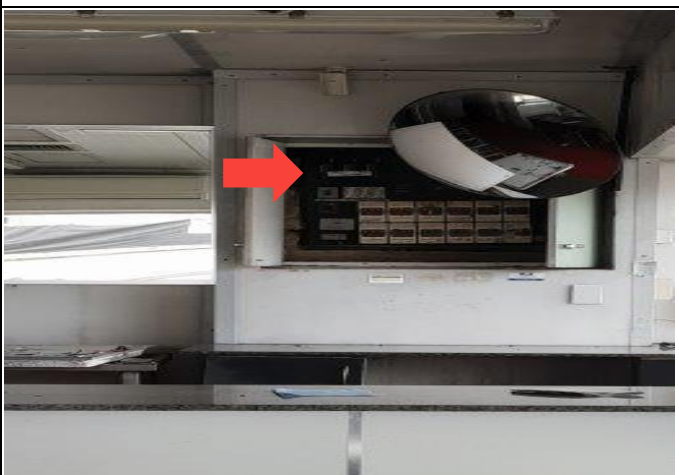
| MATERIAL IDENTIFICATION | | | | | | | | | | | RISK ASSESSMENT | | | | RISK MANAGEMENT | CORRECTIVE ACTIONS | |
|---|---|---|---|---|---|---|---|---|---|---|---|---|---|---|---|---|---|
| 6 | 26 Good Street | Ground | Tony Francis Quality Meat | Northern wall | Zemelite | EDB | Presumed same as WSP-064184 | CH | 1 Board | 5 | NF | 4 | D | L | Maintain in current condition if to remain in-situ. Remove under controlled non-friable asbestos removal conditions prior to refurbishment or demolition works by a Class B (non-friable) licensed asbestos removal contractor. | | |

Photo 5: 26 Good Street, northern wall, asbestos-containing electrical distribution board.

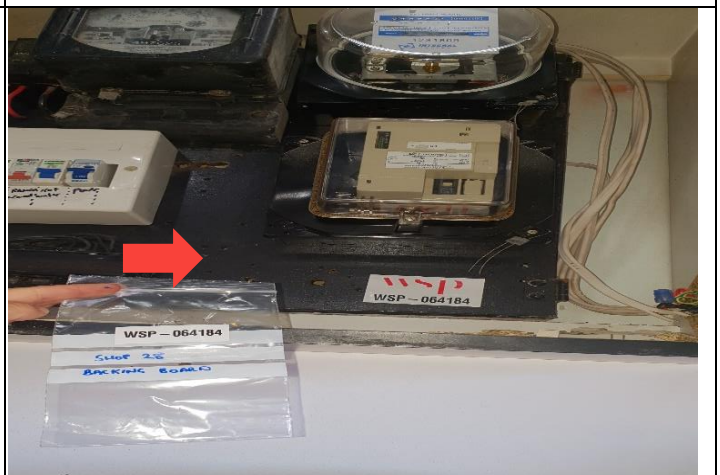
| MATERIAL IDENTIFICATION | | | | | | | | | | | RISK ASSESSMENT | | | | RISK MANAGEMENT | CORRECTIVE ACTIONS | |
|---|---|---|---|---|---|---|---|---|---|---|---|---|---|---|---|---|---|
| 8 | 28-30 Good Street | Ground | Heaven on Earth Holy Shop | Northern wall | Zemelite | EDB | WSP-064184 | CH | 1 Board | 6 | NF | 4 | D | L | Maintain in current condition if to remain in-situ. Remove under controlled non-friable asbestos removal conditions prior to refurbishment or demolition works by a Class B (non-friable) licensed asbestos removal contractor. | | |

Photo 6: 28-30 Good Street, northern wall, asbestos-containing electrical distribution board.

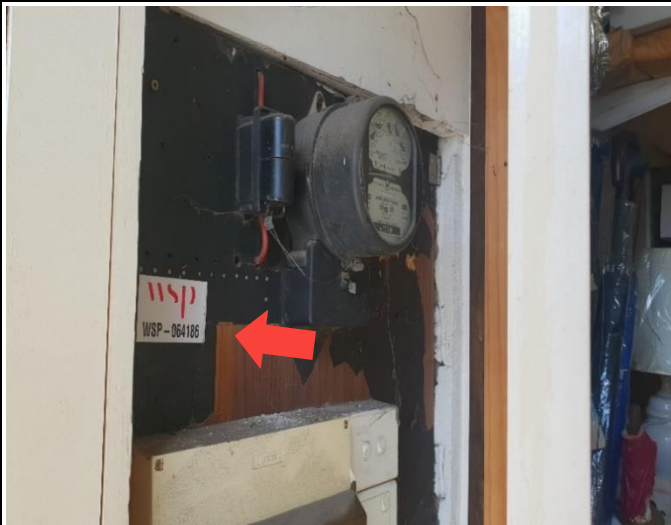
**Photo 7:** 32 Good Street, southern wall, asbestos-containing electrical distribution board.

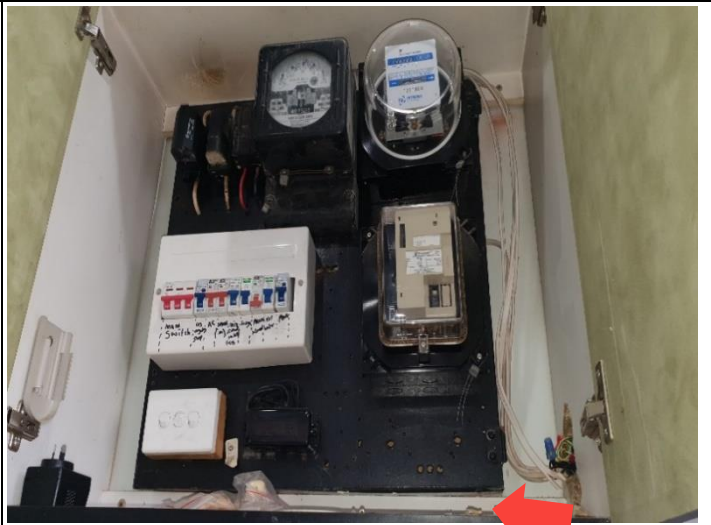
**Photo 8:** 34 Good Street, northern wall asbestos-containing electrical distribution board.

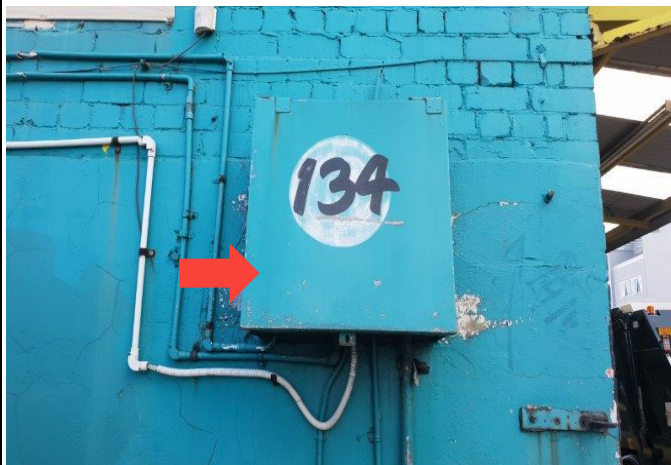
**Photo 9:** 134 Parramatta Road, north western corner to lot, asbestos-containing electrical distribution board.

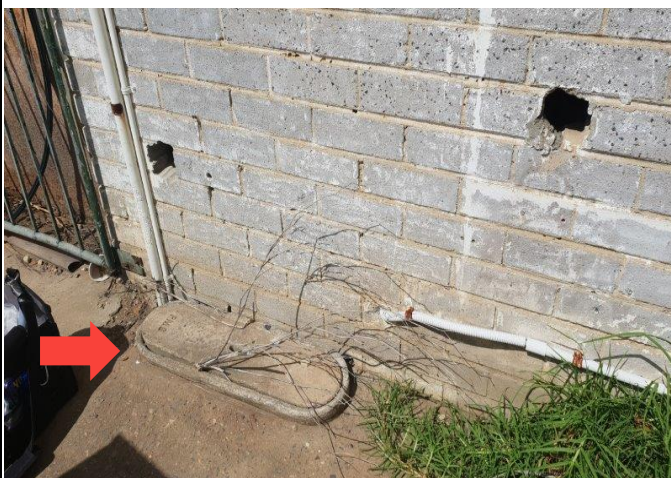
**Photo 11:** 32-34 Good Street, ground floor, western aspect adjacent parking, asbestos-containing fibre cement mould of telecommunications pit

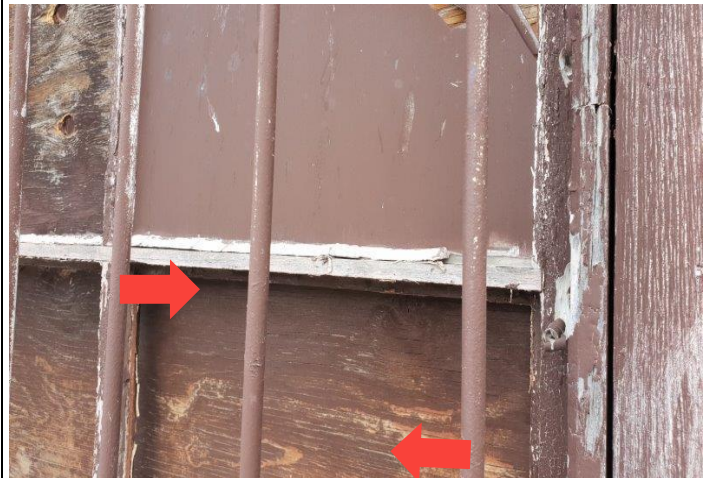
**Photo 12:** 38 Good Street, Western elevation, asbestos-containing fibre cement infill panel to window

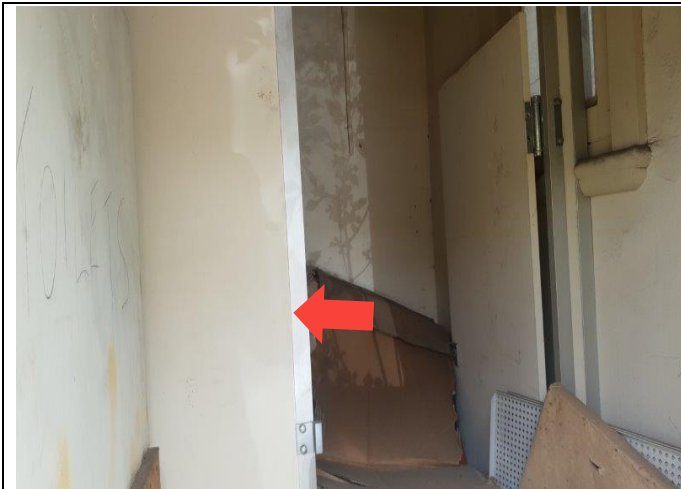
**Photo 13:** 38 Good Street, Western Elevation - Male Toilets partition walls, asbestos-containing fibre cement Sheetting.

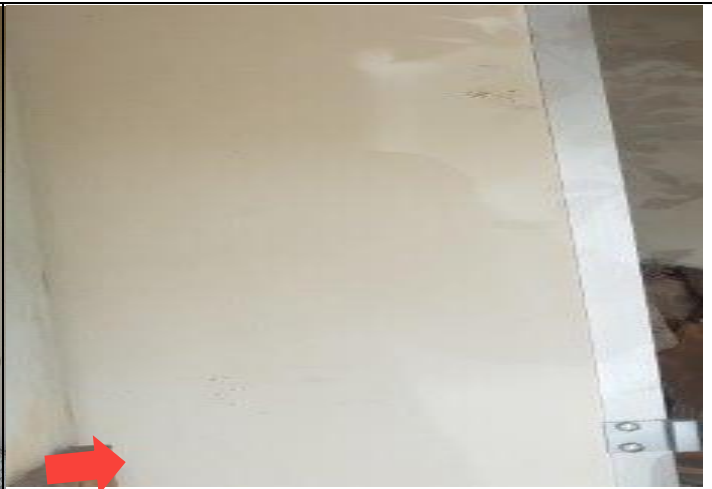
**Photo 14:** 38 Good Street, Western Elevation, Female Toilets partition walls asbestos-containing fibre cement Sheetting.

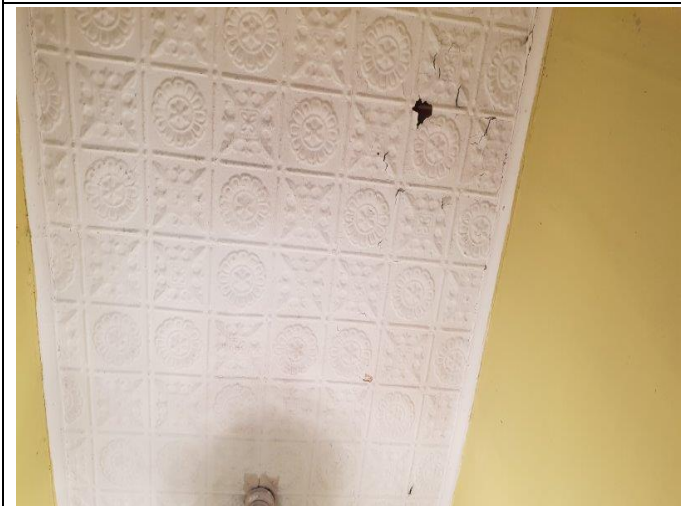
**Photo 15:** 59 Cowper Street, Dwelling - Interior, Compressed metal ceiling, lead containing white paint (WSP-104436).

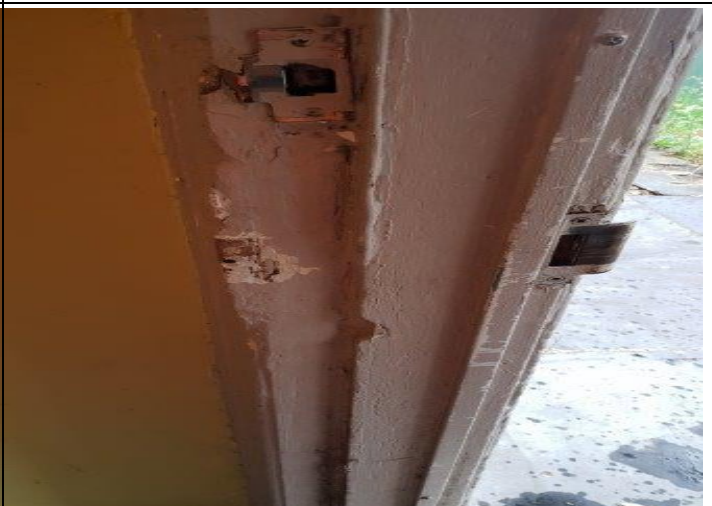
**Photo 16:** 59 Cowper Street, Dwelling - Interior, Timber door frames, lead containing white paint (WSP-104435).

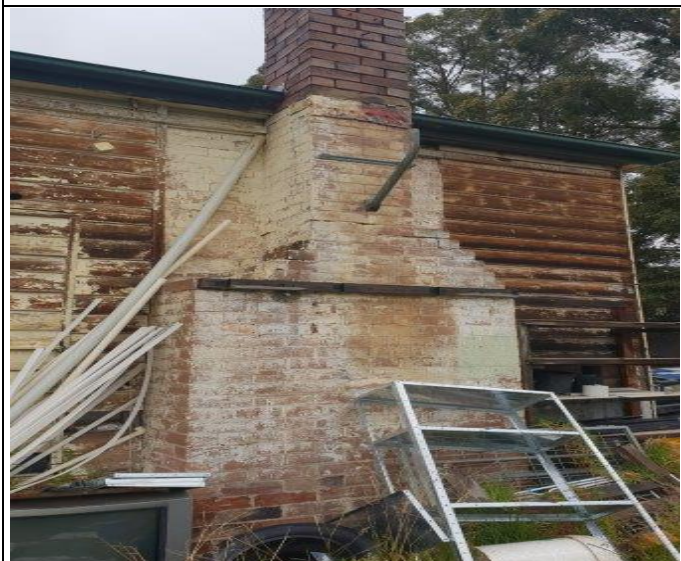
**Photo 17:** 59 Cowper Street, Dwelling - Exterior, Northern aspect, chimney, lead containing white paint (WSP-104433).

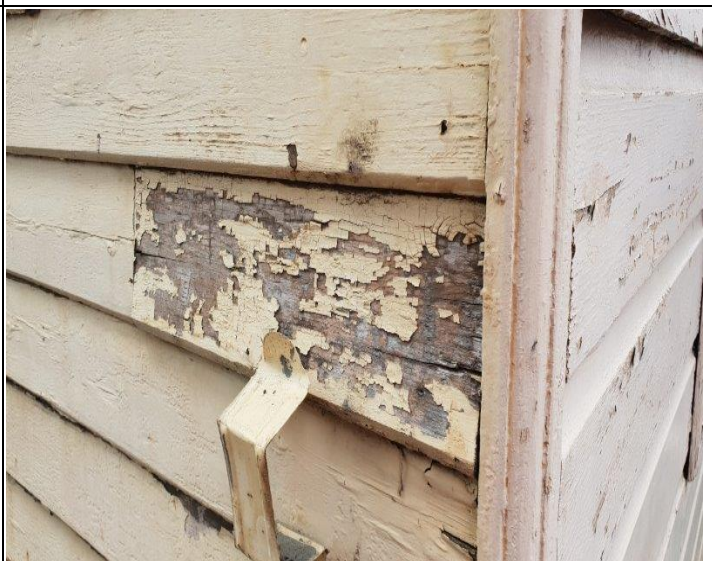
**Photo 18:** 59 Cowper Street, Dwelling - Exterior, Timber walls surrounding dwelling, lead containing yellow paint (WSP-104432).

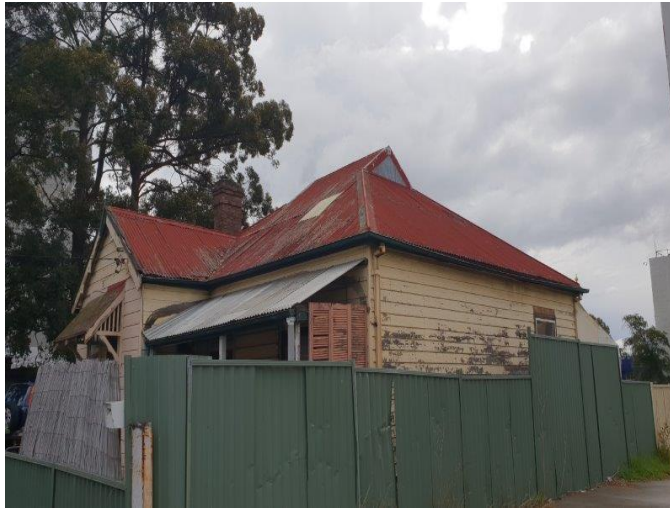
**Photo 19:** 59 Cowper Street, Dwelling – Exterior, Roof gutters, lead containing green paint (WSP-104431).

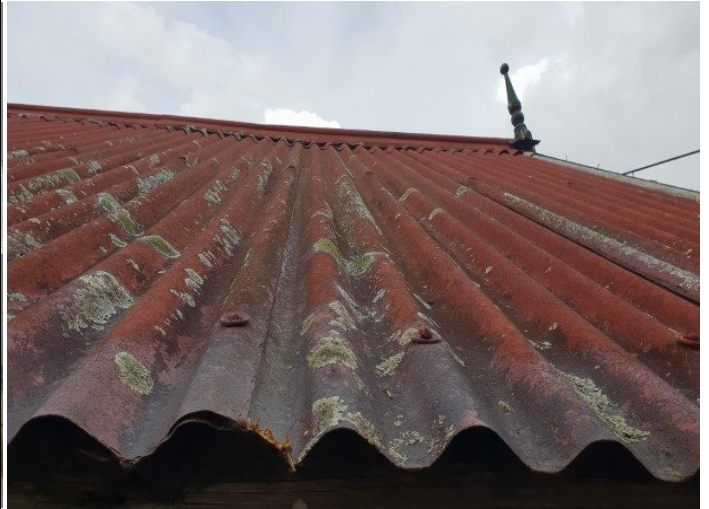
**Photo 20:** 59 Cowper Street, Dwelling – Exterior, Steel roofing, lead containing red paint (WSP-104430).

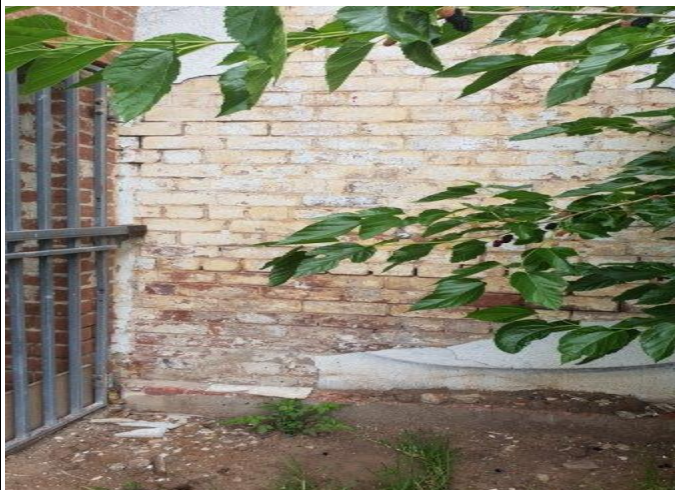
**Photo 21:** 26 Good Street, Bricked walls beneath cement render façade, lead containing white paint (WSP-104452).

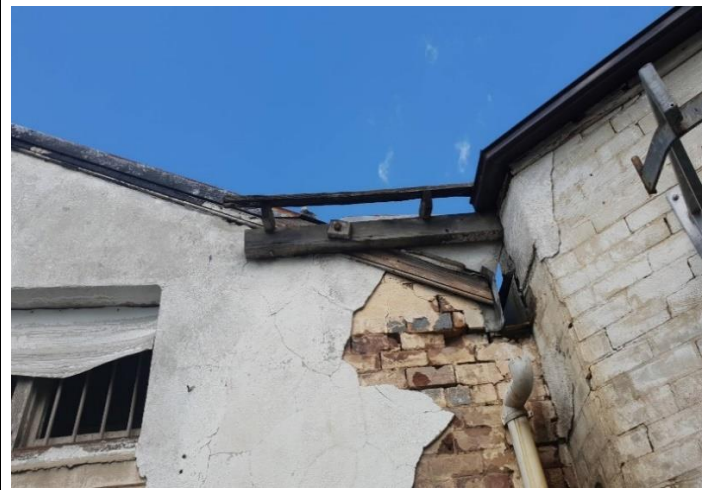
**Photo 22:** 28-30 Good Street, Bricked walls beneath cement render façade, lead containing white paint (WSP-104452).

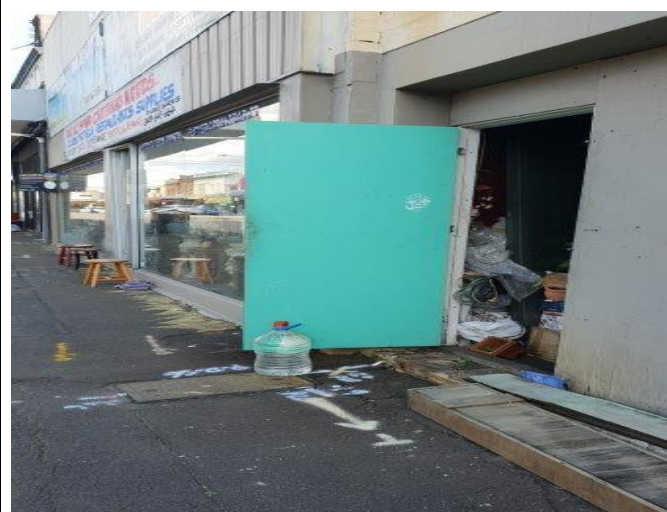
**Photo 23:** 32-34 Good Street, Shop front façade, lead containing grey paint (WSP-104450).

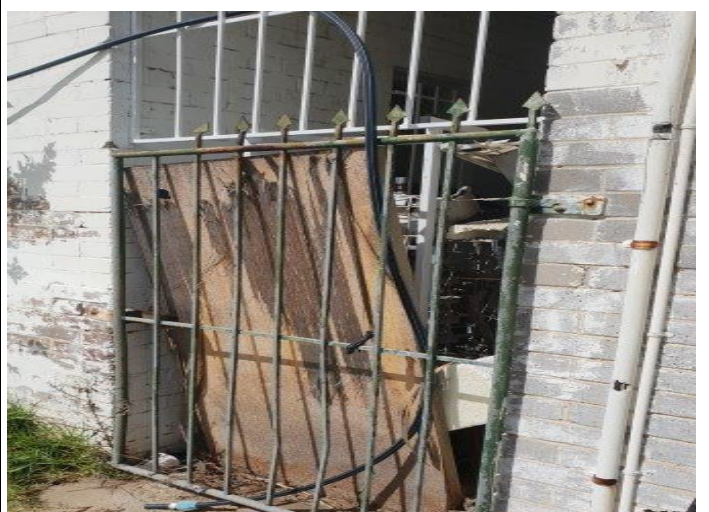
**Photo 24:** 32-34 Good Street, western elevation, gate, lead containing white paint (WSP-104453).

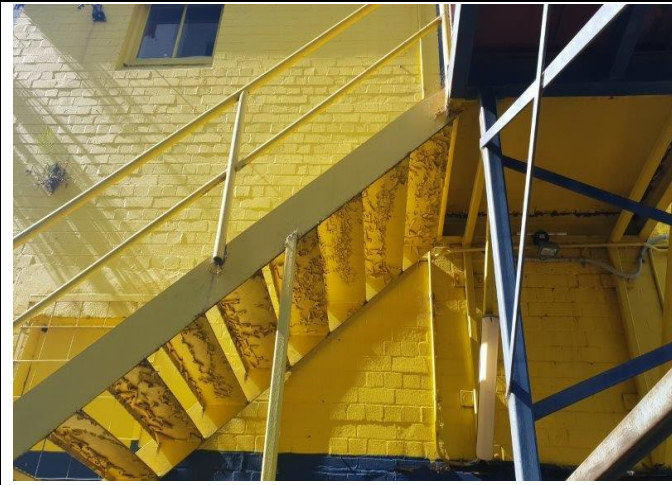
**Photo 25:** 138 Parramatta Road, metal staircase, lead containing yellow paint (WSP-064198).

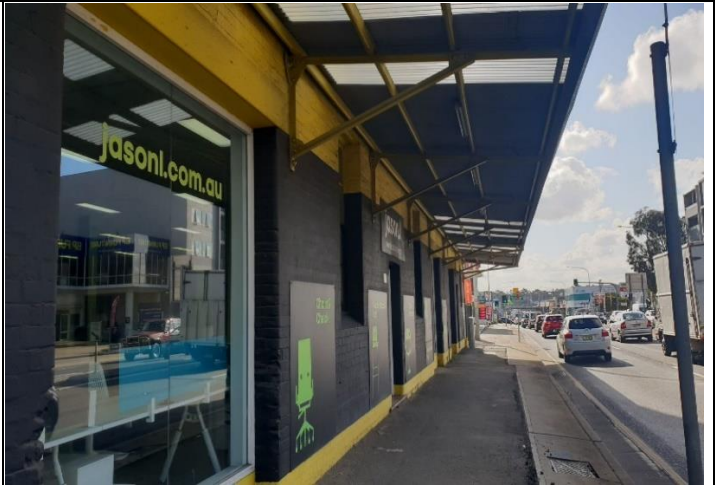
**Photo 26:** 138 Parramatta Road, metal awning structure, lead containing yellow paint (WSP-064198).

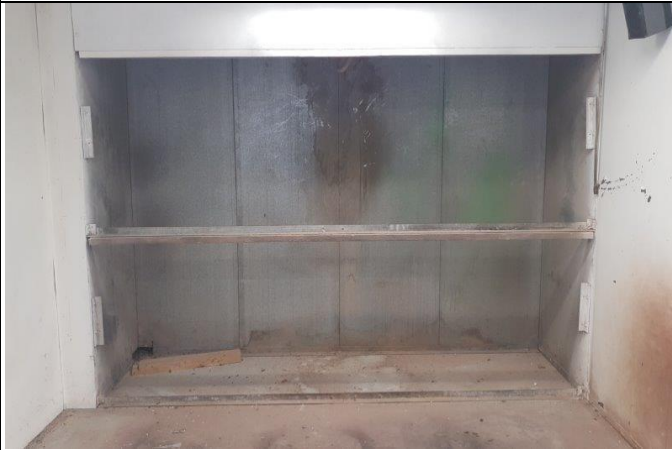
**Photo 27:** 138 Parramatta Road, spray booth, lead containing white paint (WSP-104443).

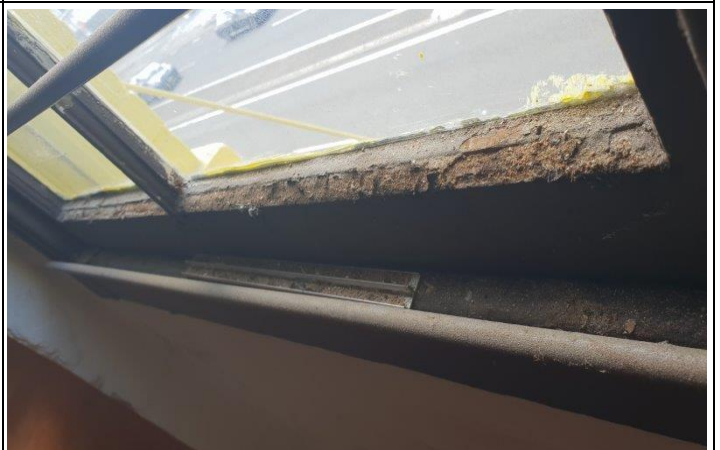
**Photo 28:** 138 Parramatta Road, window frames, lead containing brown paint (WSP-064190).

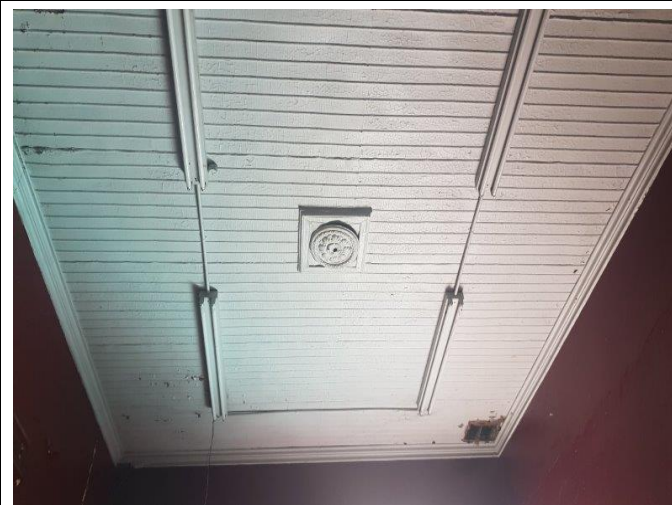
**Photo 29:** 38 Good Street, ground floor, southern room ceiling, lead containing white paint (WSP-104454).

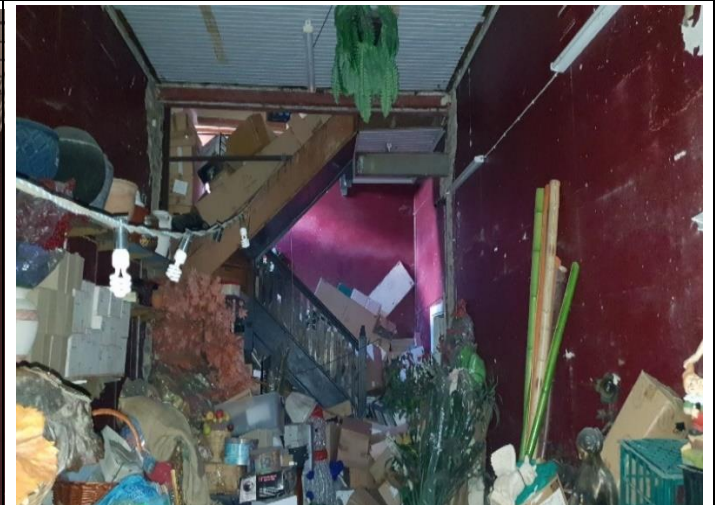
**Photo 30:** 38 Good Street, ground floor, southern room walls, lead containing maroon paint (WSP-104455).

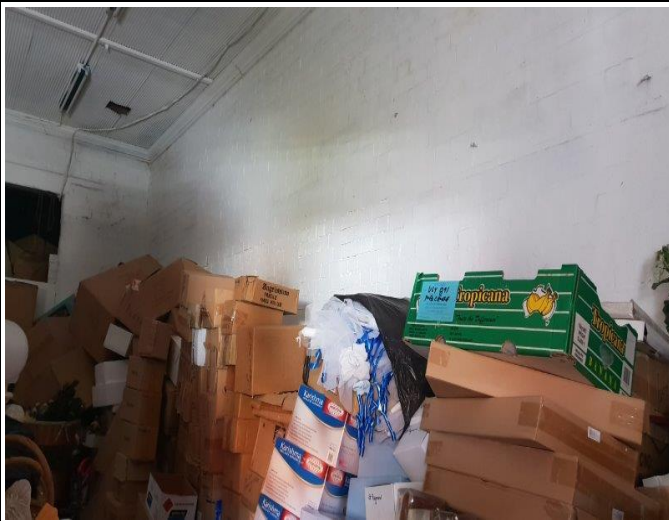
**Photo 31:** 38 Good Street, ground floor, northern room, walls, lead containing white paint (WSP-104456).

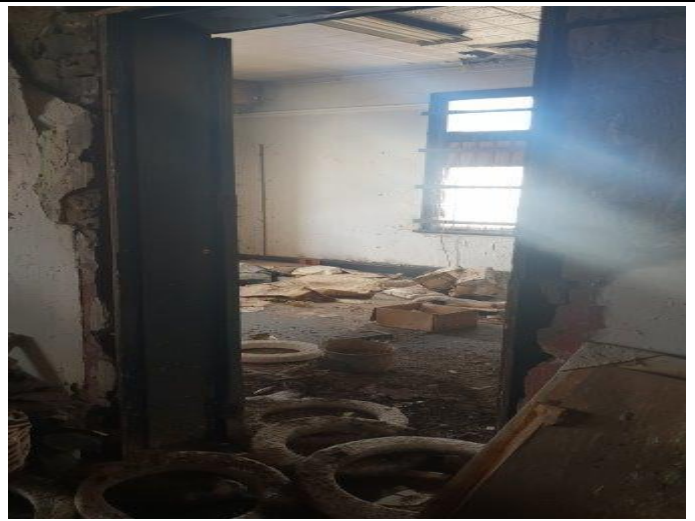
**Photo 32:** 38 Good Street, first floor, eastern room, walls, lead containing grey paint (WSP-104456).

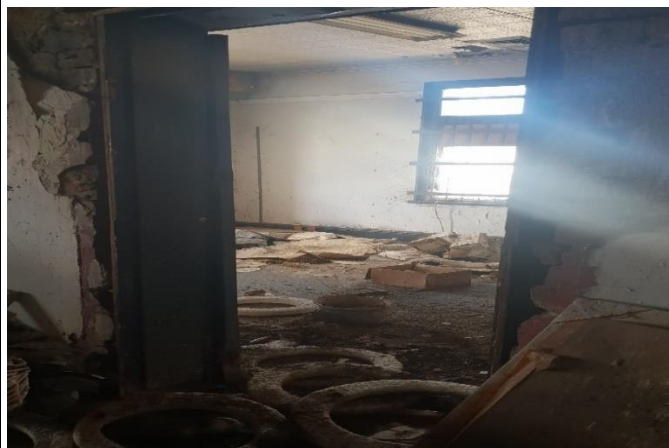
**Photo 33:** 38 Good Street, first floor, Eastern room, blue door framing, lead containing white paint underneath blue overcoat (WSP-104454).

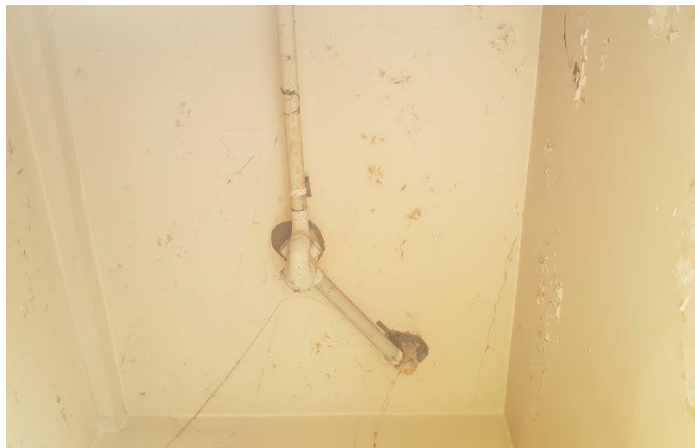
**Photo 34:** 38 Good Street, first floor, Western elevation, exterior toilet walls, lead containing white paint (WSP-104461).

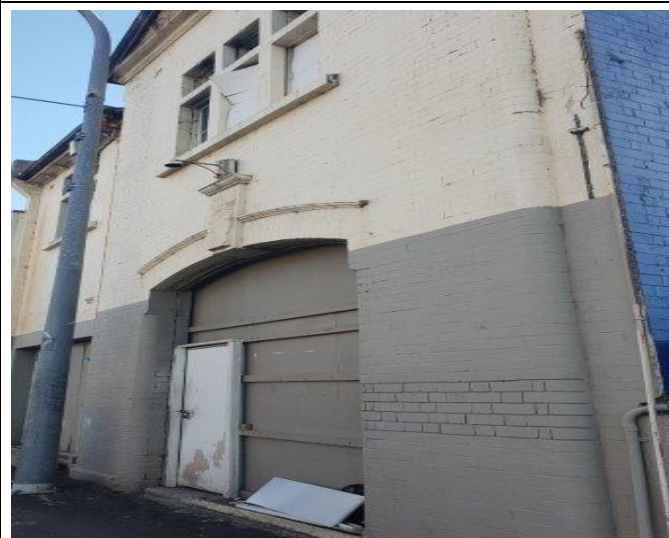
**Photo 35:** 38 Good Street, eastern Façade brickwork, lead containing white paint (WSP-104459).

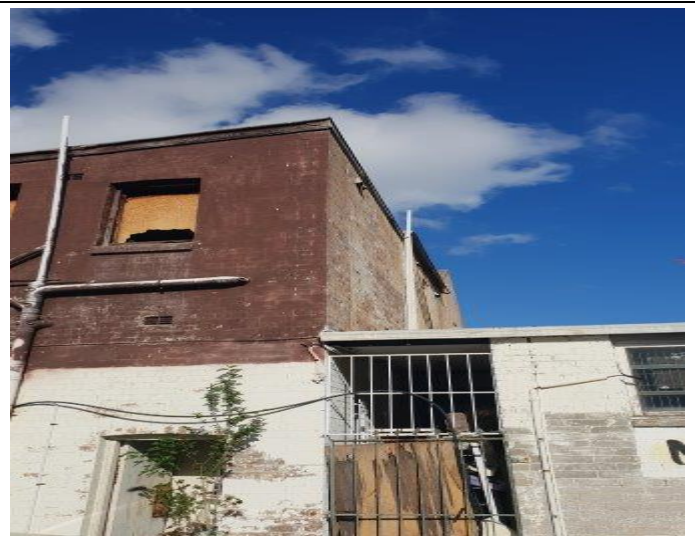
**Photo 36:** 38 Good Street, Western façade timber framing, lead containing maroon paint (WSP-104460).

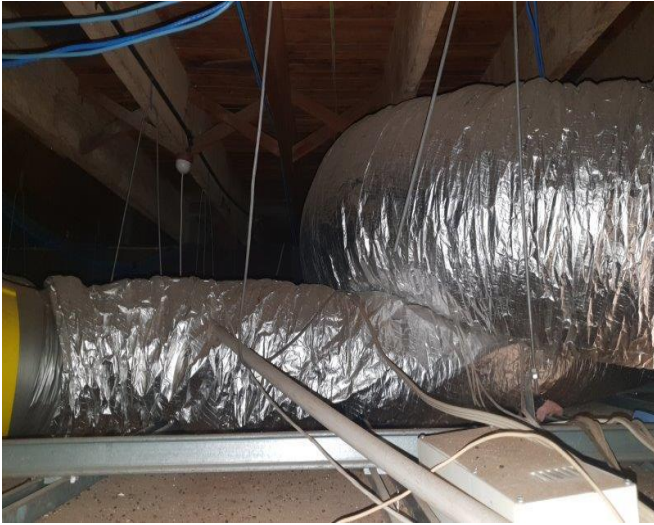
**Photo 37:** 138 Parramatta Road, ground floor, ceiling space, Flexi-ducting contains SMF.

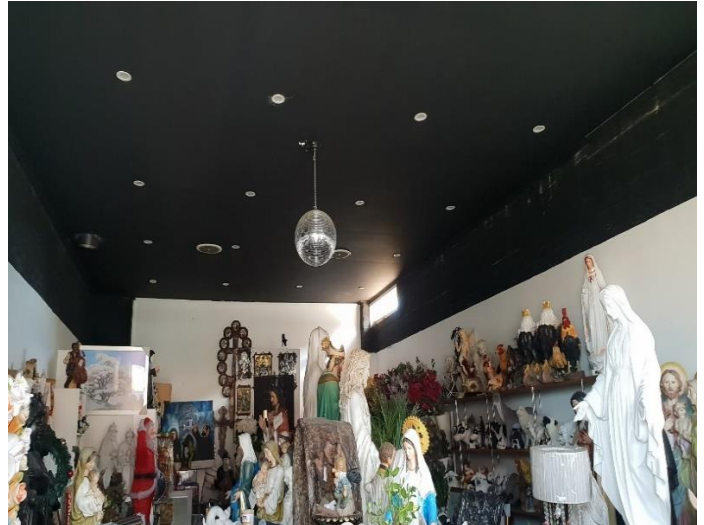
**Photo 38:** 28-30 Good Street, ground floor, black ceiling tiles contain SMF material.

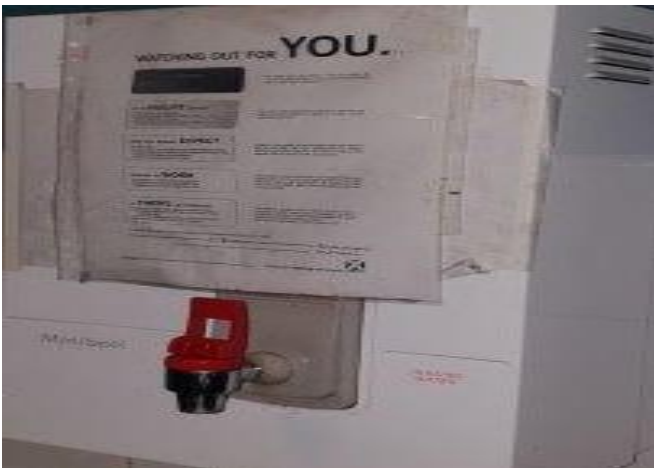
**Photo 39:** This water heater is the same as identified, 138 Parramatta Road zip brand heater, kitchen

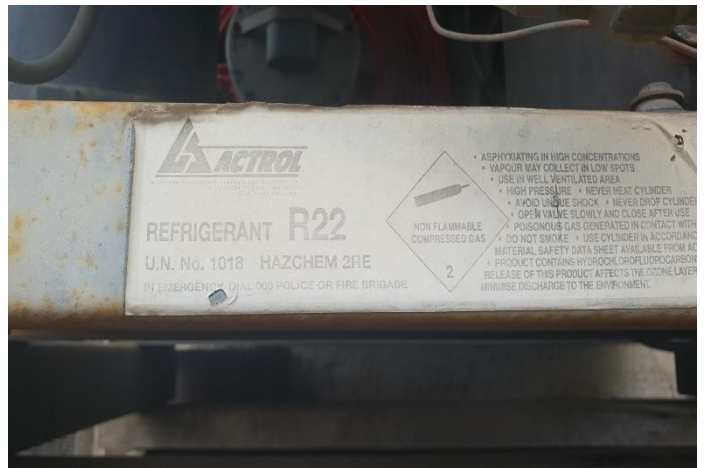
**Photo 40:** 28-30 Good Street, ground floor, Western aspect, adjacent rear carpark, refrigerant, ODS containing material.

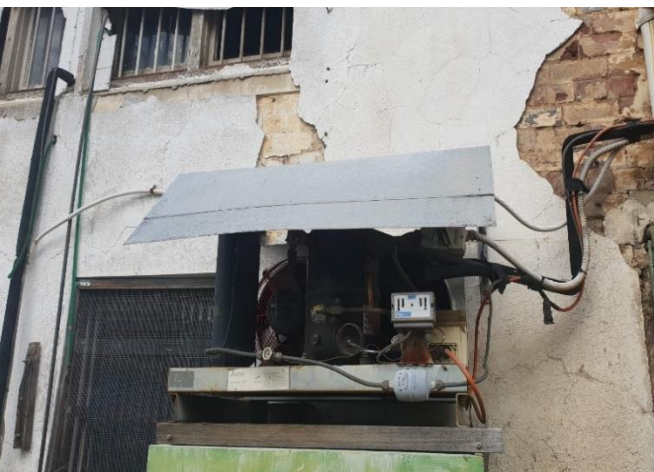
**Photo 41:** 28-30 Good Street, ground floor, western aspect, adjacent rear carpark, refrigerant, ODS containing material.
